Report on  
Geotechnical Investigation

Proposed Industrial Estate  
813-913 Wallgrove Road, Horsley Park

Prepared for  
Gazbuild Pty Ltd

Project 99735.00  
April 2021

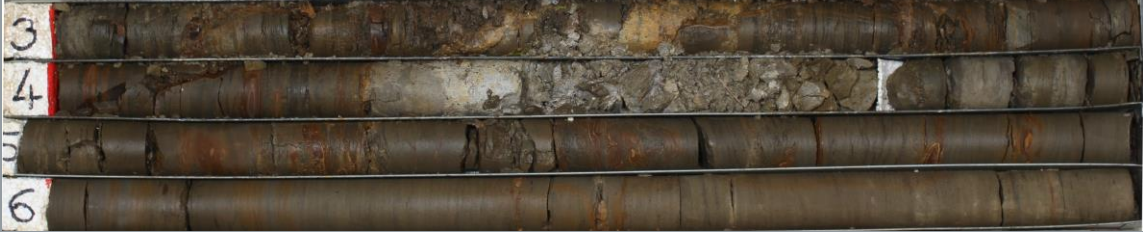
2.60 - 7.00m

99735.00 BH101 2.6m START.

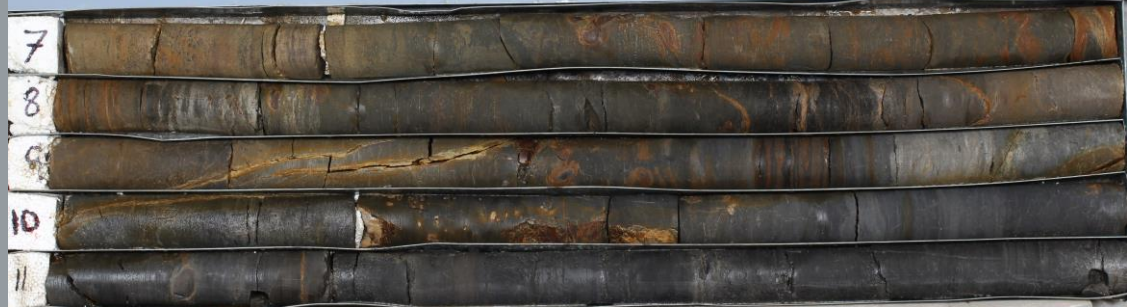
7.00 - 12.00m

Project No: 99735  
BH ID: BH 101  
Depth: 7.00 - 12.00 m  
Core Box No.: 2

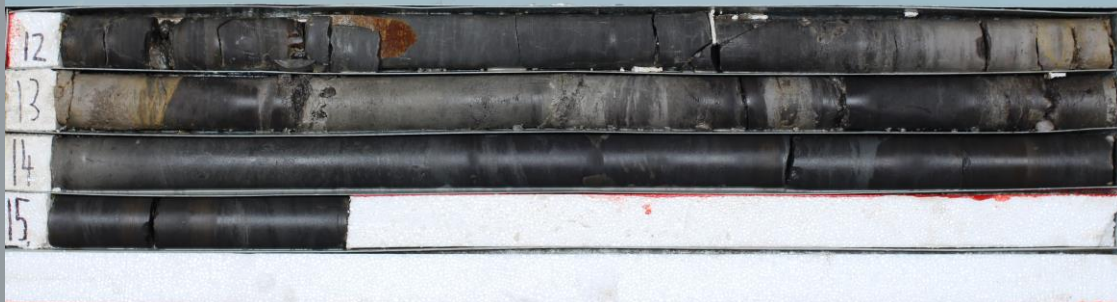
Project No: 99735  
BH ID: BH 101  
Depth: 12.00 - 15.28m  
Core Box No.: 3

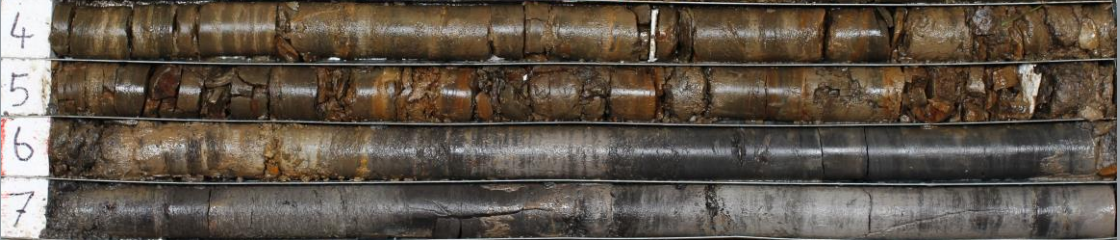
3.45 - 8.00m

99735.00 BH102 3.45m START

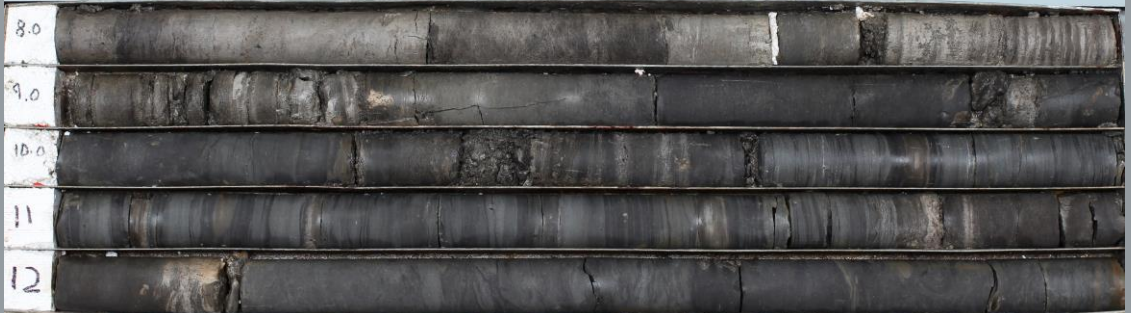
8.00 - 13.00m

Project No: 99735.00  
BH ID: BH 102  
Depth: 8.00 - 13.00 m  
Core Box No.: 2

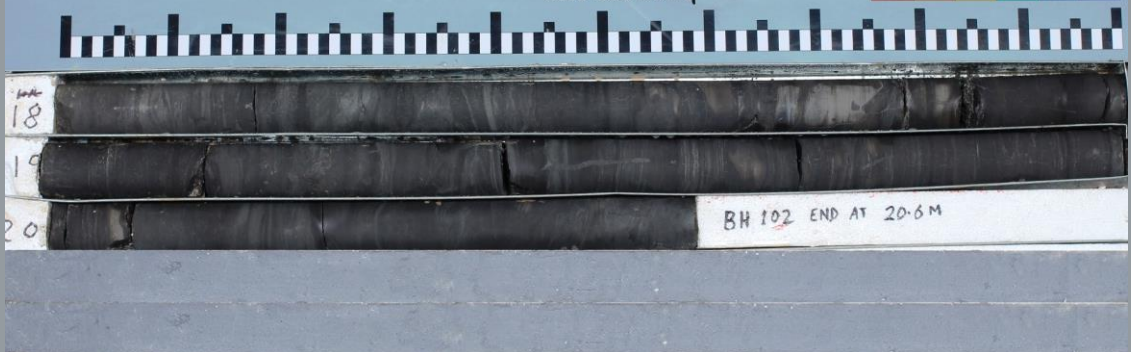
18.00 - 20.60m

Project No: 99735.00  
BH ID: BH 102  
Depth: 18.00 - 20.60 m  
Core Box No.: 4

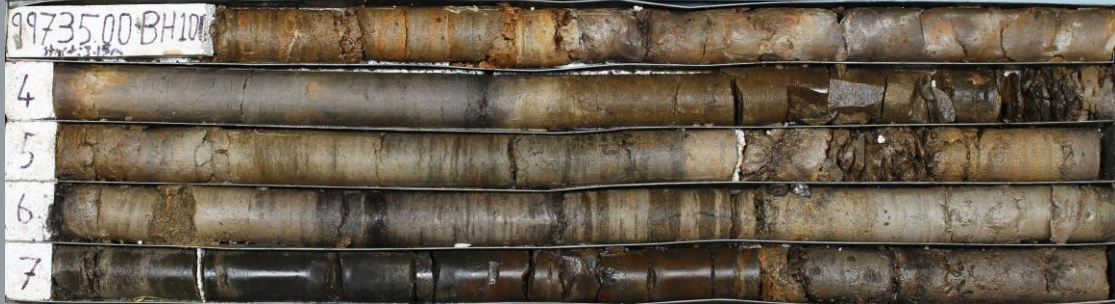
3.15 - 8.00m

Project No: 99735  
BH ID: BH 103  
Depth: 3.15 - 8.00 m  
Core Box No.: 1

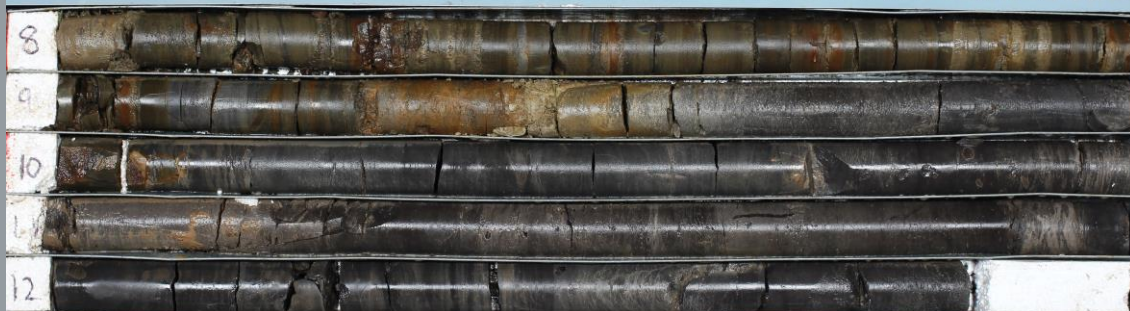
8.00 - 12.85m

Project No: 99735  
BH ID: BH 103  
Depth: 8.00 - 12.85 m  
Core Box No.: 2

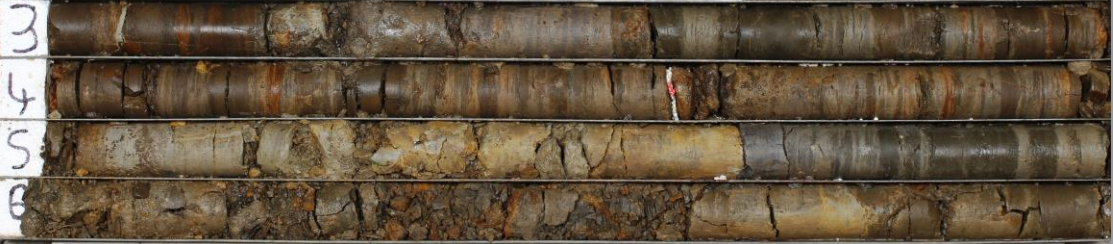
2.65 - 7.00m

99735.00 BH104 START 2.65m SCOUT 1

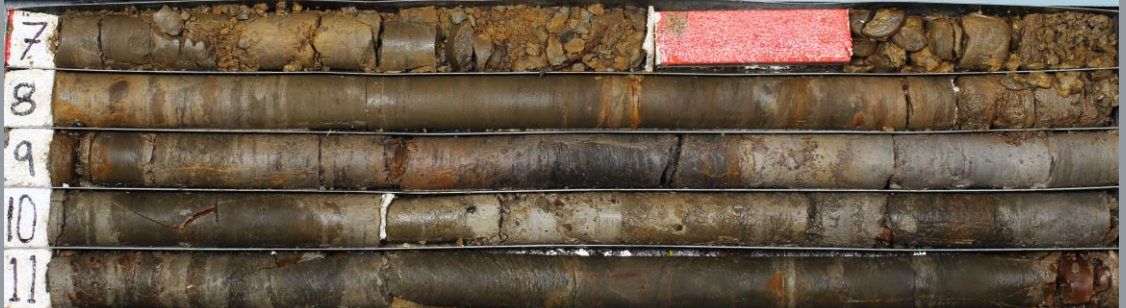
7.00 - 12.00m

Project No: 99735  
BH ID: BH 104  
Depth: 7.00 - 12.00 m  
Core Box No.: 2

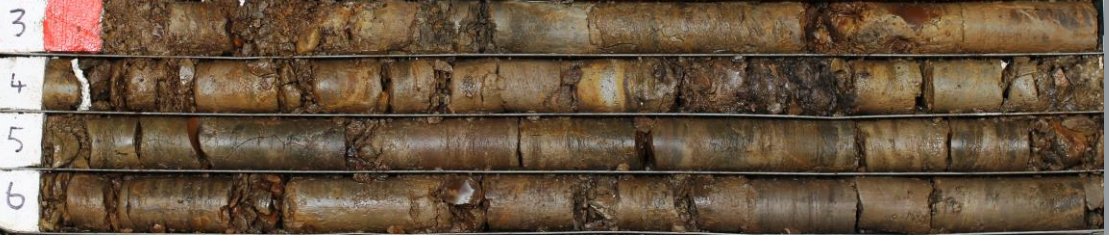
2.50 - 7.00m

99735.00 BH105 2.5m START

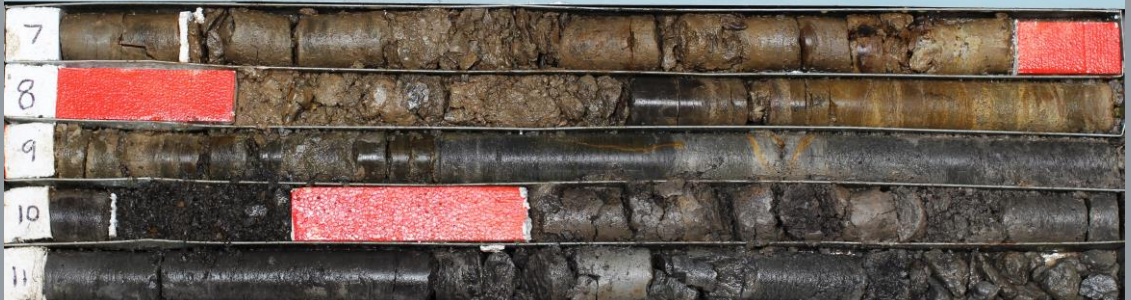
7.00 - 12.00m

Project No: 99735  
BH ID: BH 105  
Depth: 7.00 - 12.00 m  
Core Box No.: 2
