Re: Due Diligence Assessment for Aboriginal Archaeological Heritage: Dubbo Base Hospital Redevelopment: Stage 1 & 2 – Review Environmental Factors (REF)

This letter documents a due diligence assessment of Aboriginal Archaeological Heritage at Dubbo Base Hospital. This document fulfills Health Infrastructure's obligation under the *Due Diligence Code of Practice for the Protection of Aboriginal Objects in New South Wales* (DECCW 2010). This assessment has been written by Anna Nardis, and reviewed internally by Samantha Higgs and Samantha Gibbins (Biosis Research Pty. Ltd.).

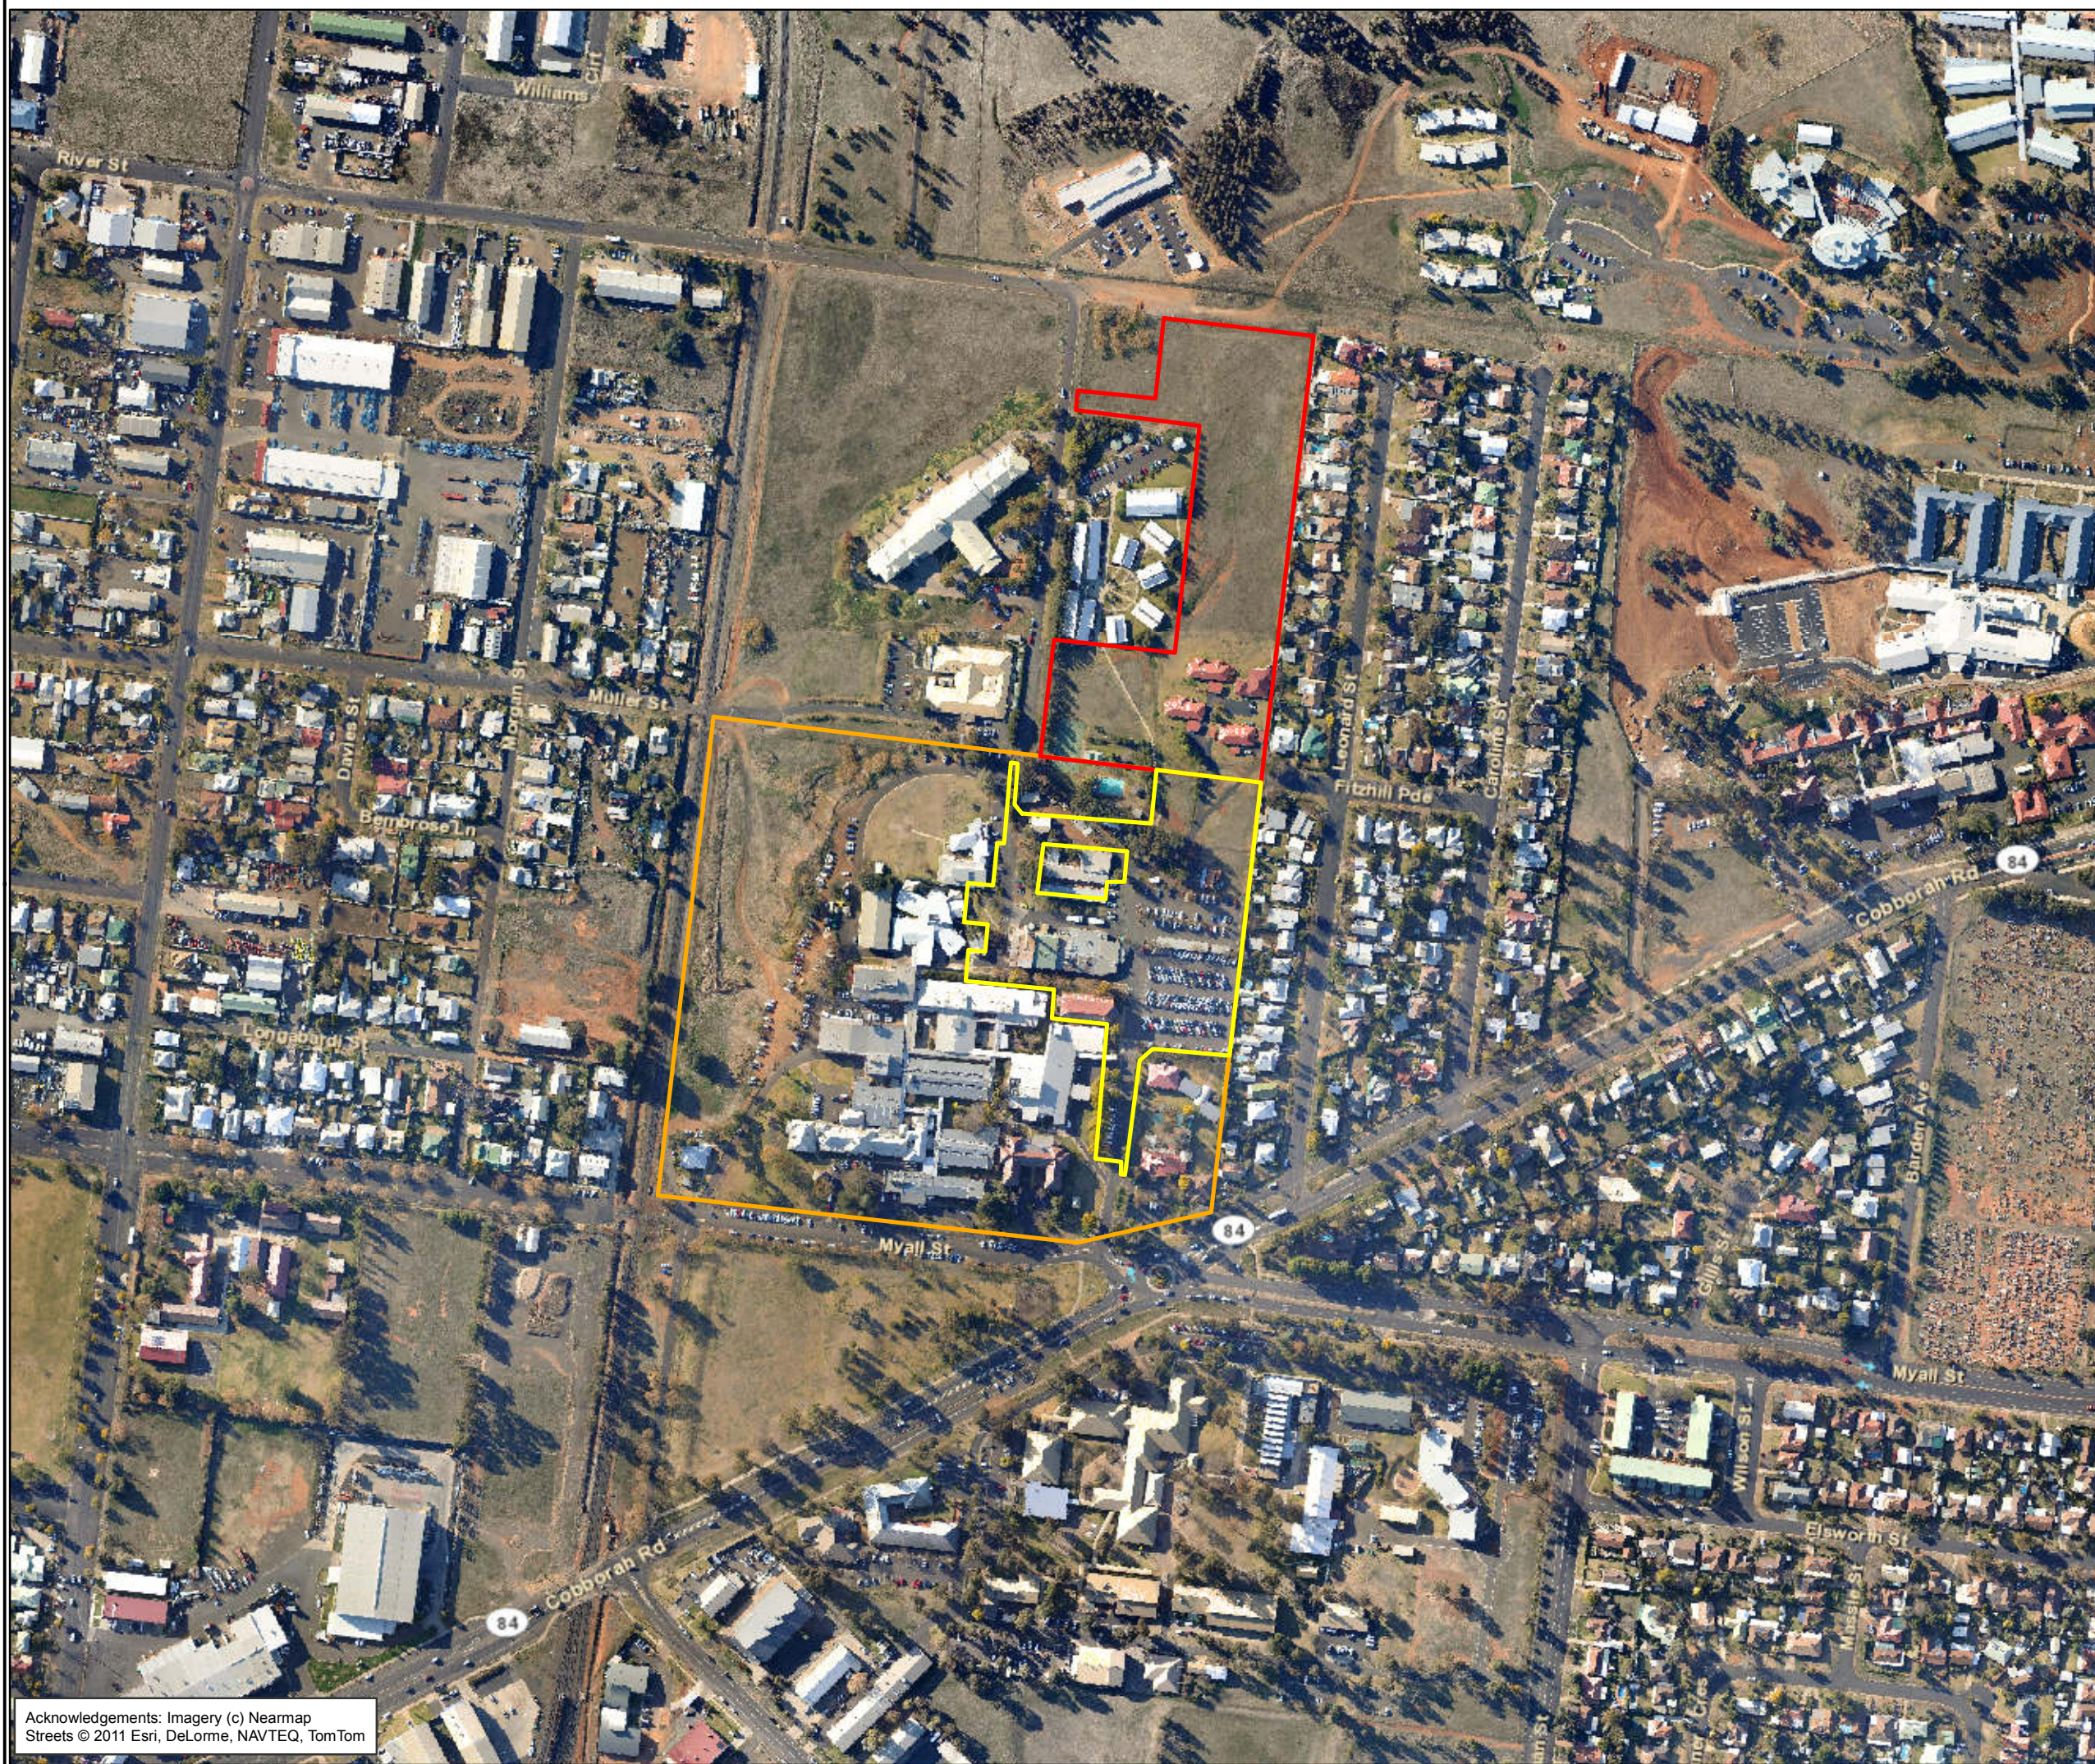
Figure 2: Project Area

The results of the site visit have been divided into three sections; the western section, the northern section and the impact area (refer to figure 1 and 2). The project area was accessed on foot. The entire area was covered during the site visit with each section assessed to its boundary.

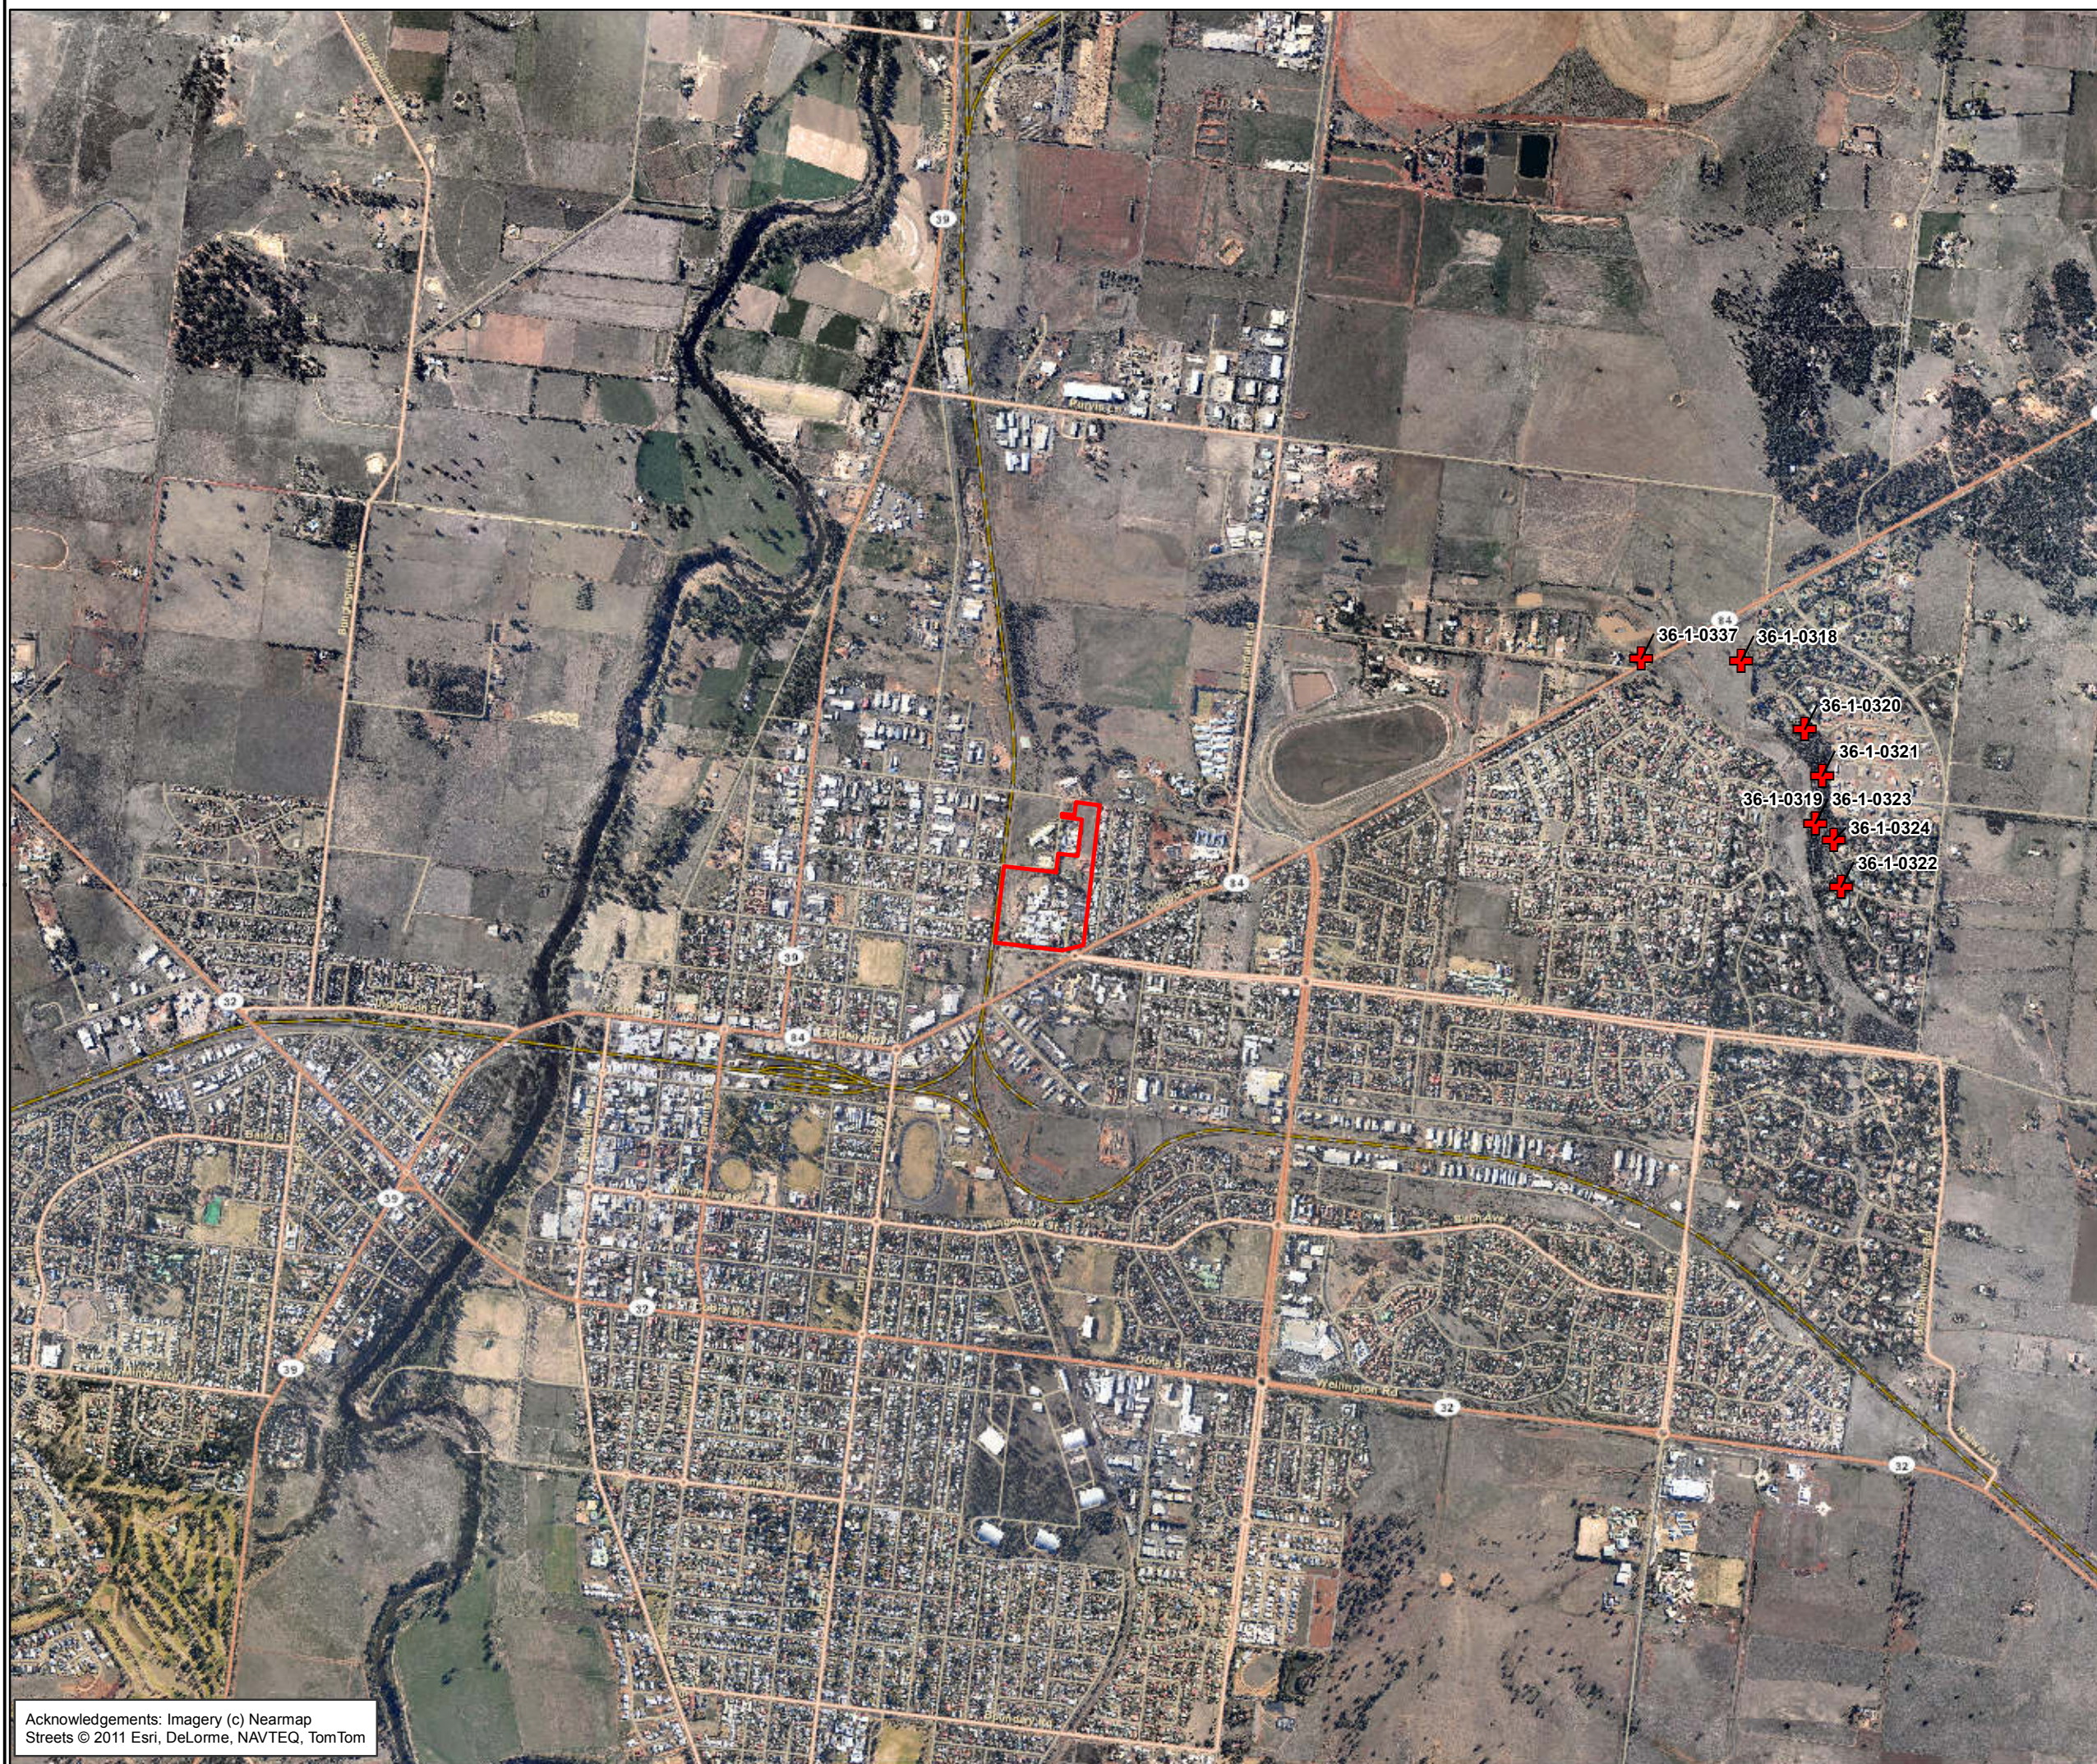
Figure 3: AHIMS Results near the Project Area

the project area. Details of these sites are provided in table below and their locations are shown in figure 3.

No sites have been recorded within the current project area. Of the 8 sites previously recorded nearby, the predominant site type is Open Camp Site (n=4). The term ‘Open Camp Site’ is used to describe a surface scatter of lithic (stone) artefacts.

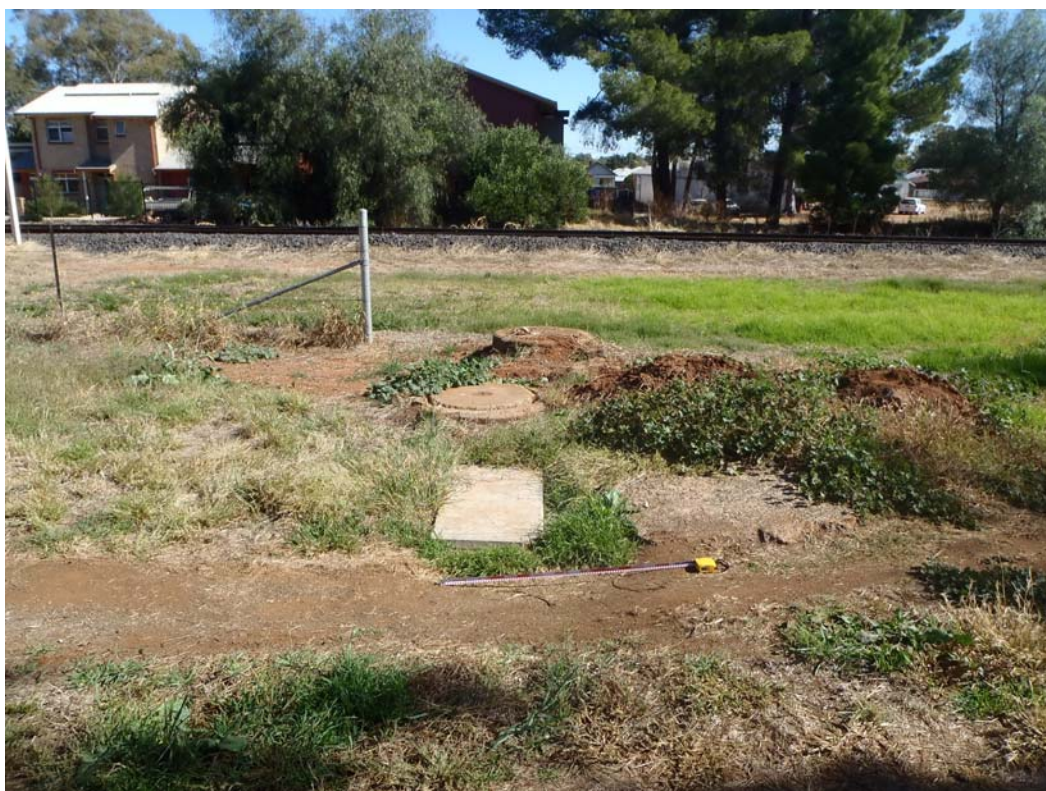
track, sewerage works which has involved concreting and the installation of fencing and gates (Plate 1). Other disturbances include a current construction site observed in the north west of the area and a makeshift car park (Plate 2). Dense long grass cover resulted in nil visibility except in areas of exposure near an unpaved access track used by vehicles and areas near the sewerage works. There is also a new construction area cordoned in the north west of the western section (Plate 3). The construction has commenced prior to the survey.

Plate 1: Sewage installation and vehicle disturbance (note railway in the background), view west

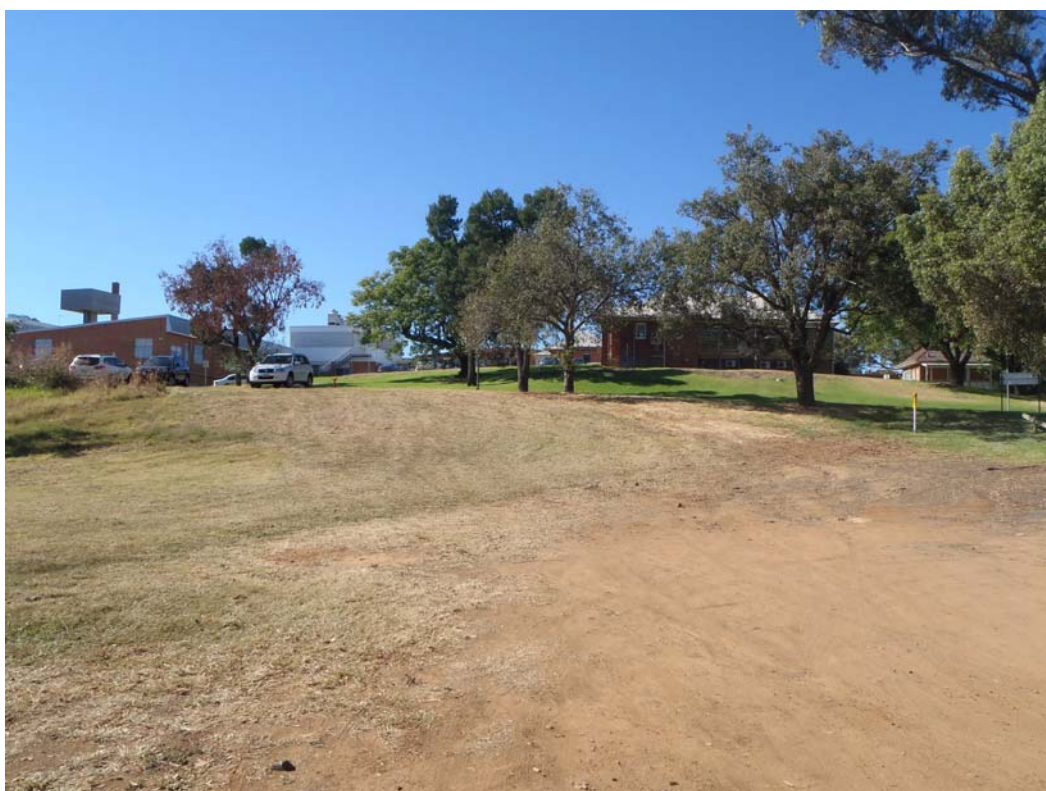
Plate 2: Upslope towards hospital buildings, noting large exposure which is part of make shift car park in foreground, view east

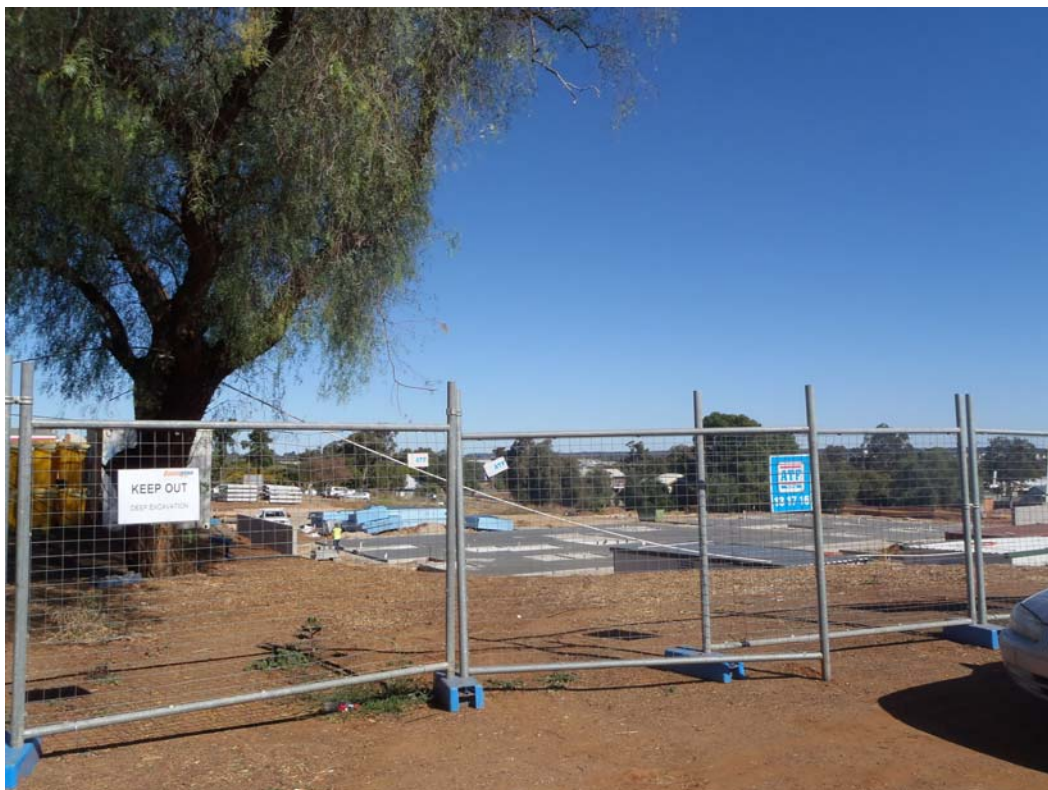
Plate 3: view south west across new construction area to the western section (note this construction was started before survey)

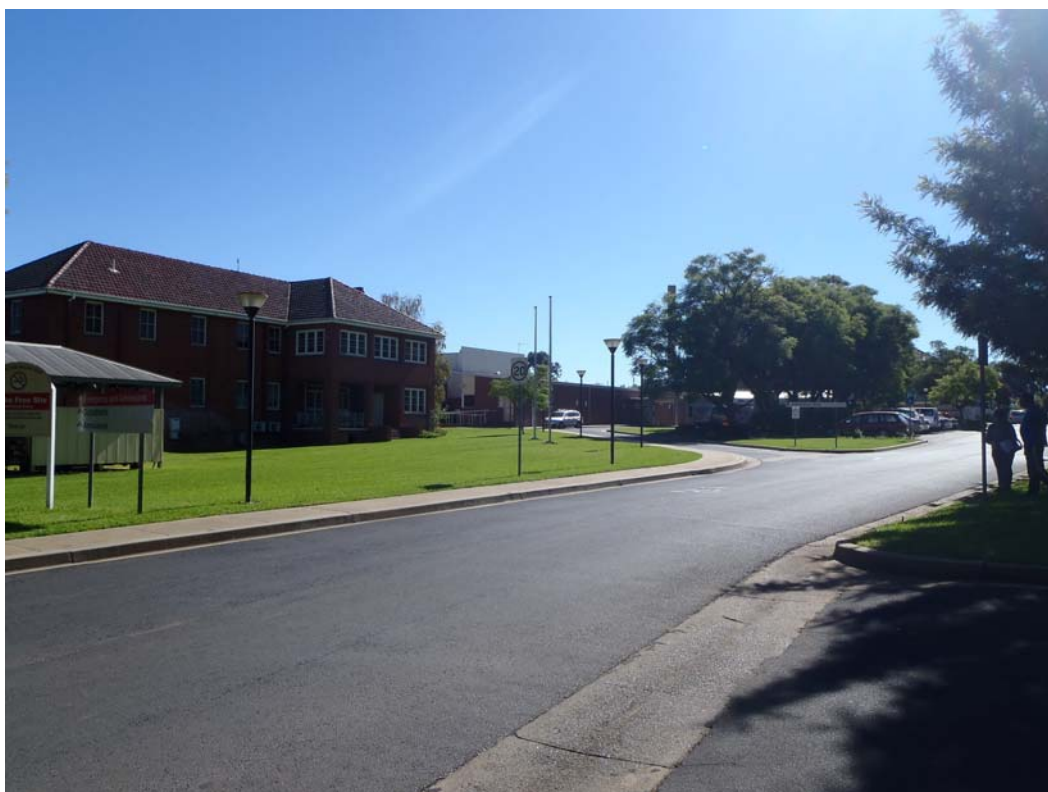
Further east, the landform is a lower slope with dense grass coverage which resulted in zero visibility. There are high levels of disturbances including picnic area with chairs and tables, paved pathways and walkways, car parks and buildings (Plate 4).

Plate 4: context shot of hospital grounds taken from main entry, corner of McGuinn and Myall Streets, view east

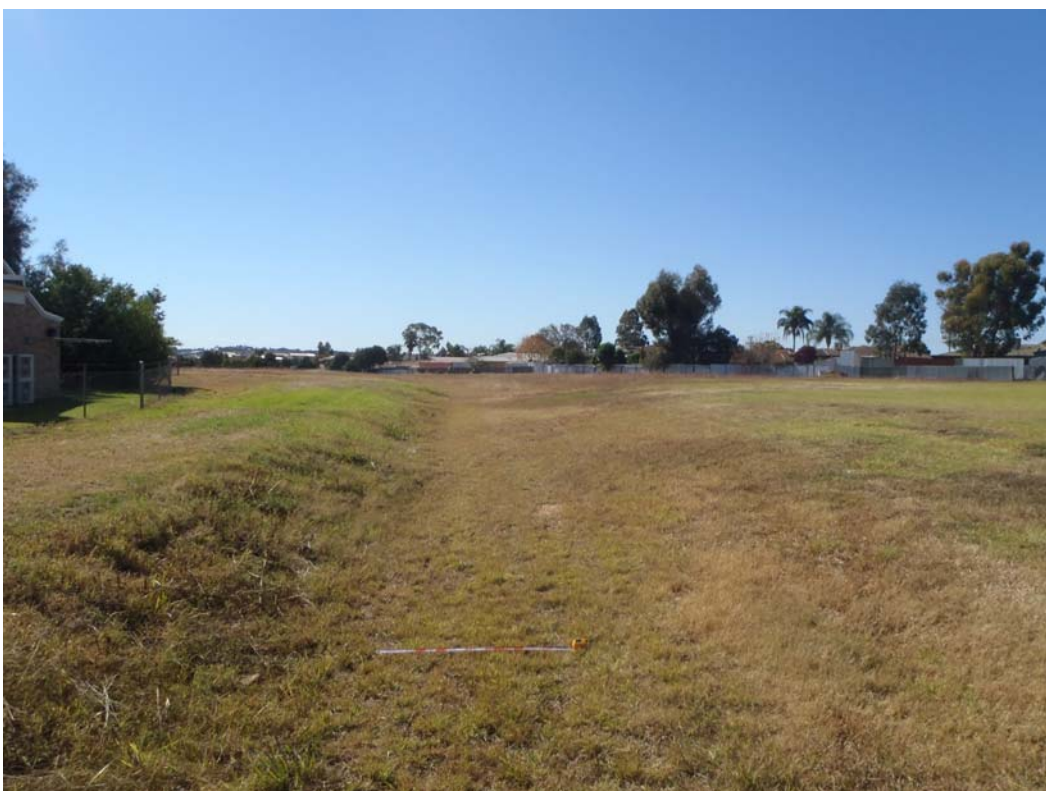
The northern section included a makeshift car park and the area up to the hospital that borders a dirt road off River Street. It is situated on a very gentle north – west facing slope and a slope to the north. Vehicle tracks were observed throughout the section (Plate 5). An earthen levy for drainage appears to have been constructed in this area (Plate 6). Visibility was generally nil due to dense long grass cover, with few areas of exposures made by vehicles (Plate 7). In the north west corner there were a group of trees (Plate 8). Other disturbances in the vicinity include vegetation clearance for housing, a recreational area including a pool and tennis courts and associated facilities, fencings, paved pathways, planted pine trees and the use of vehicle tracks.

Plate 6: constructed earthen levy/drainage view north east

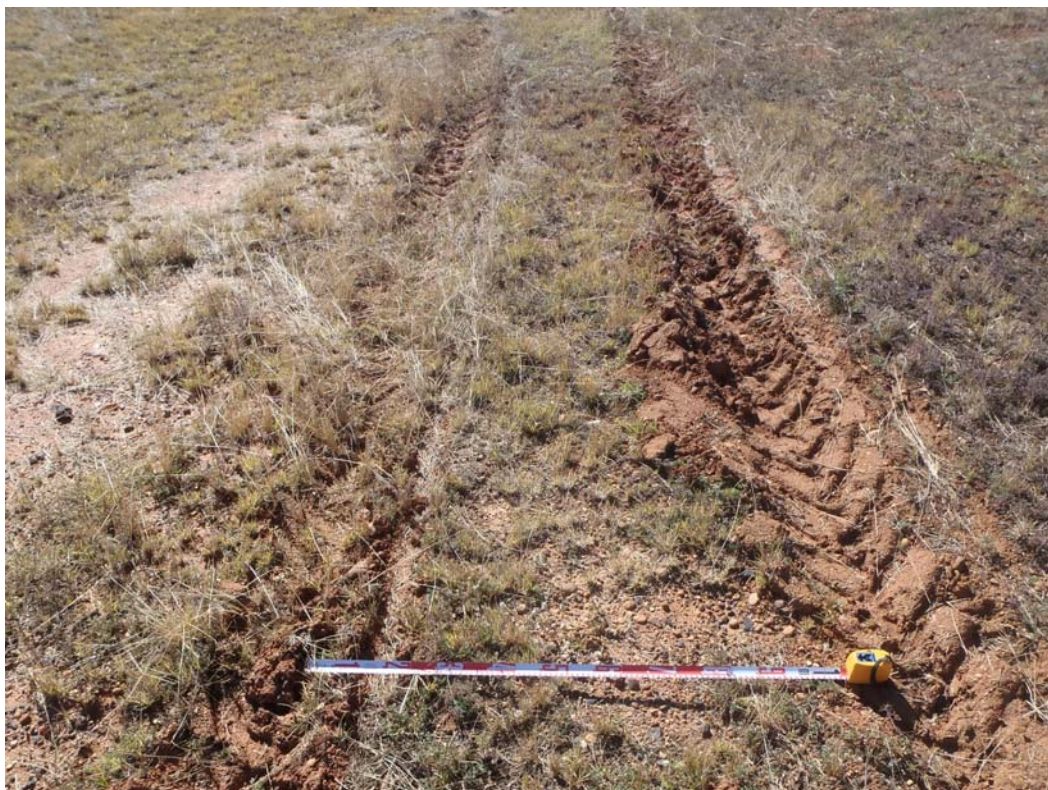
Plate 7: vehicle tracks in the northern section, view north

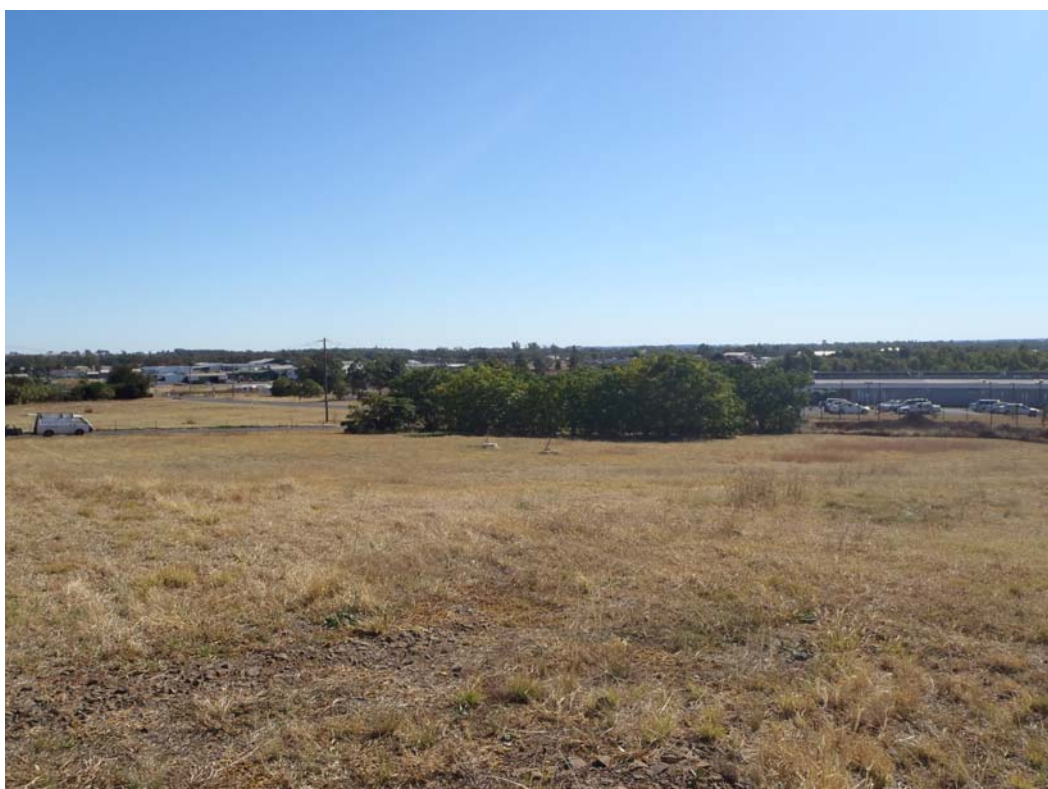
Plate 8: view north west corner of project area

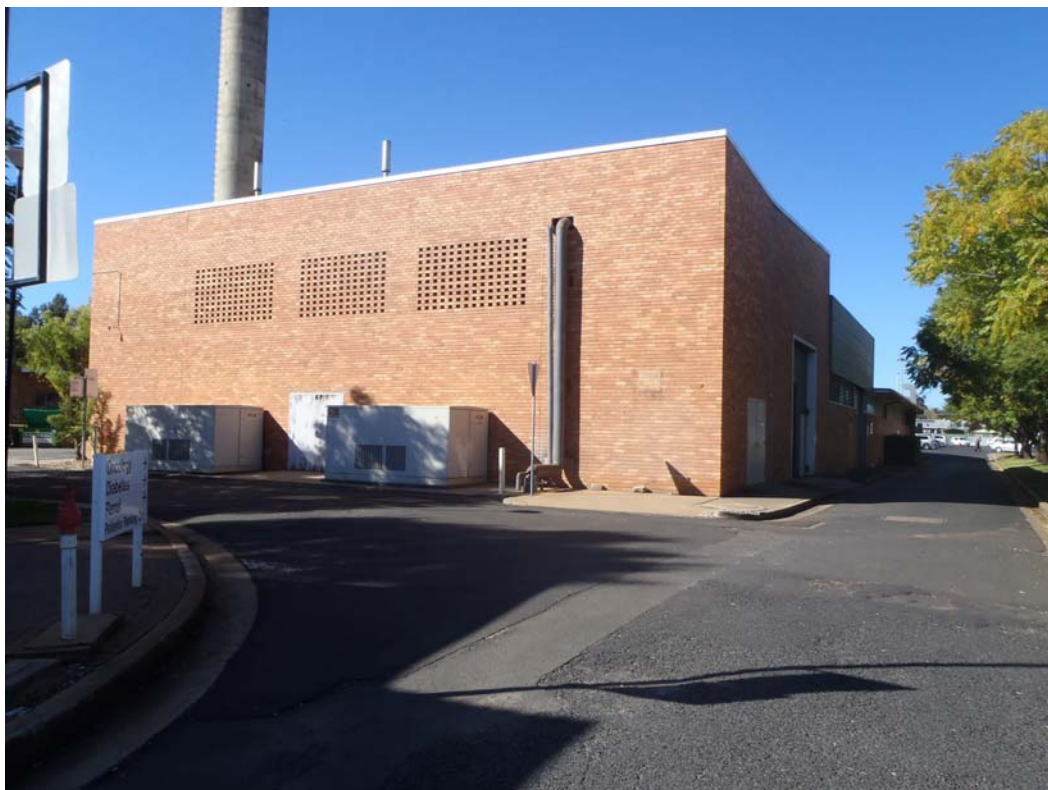
The area to be impacted by the proposed development includes two large buildings (Plate 9 and 10) in a highly disturbed area comprising of paved footpath and roads, fencing and other buildings close by. An area for the proposed car park was also inspected. This area is currently in use as a makeshift car park (Plate 11). Ground surface visibility was hindered by roads and footpaths which resulted in nil visibility. There were areas of exposure immediately surrounding the buildings, these were also inspected.

Plate 9: building to be demolished under current proposal, view north east

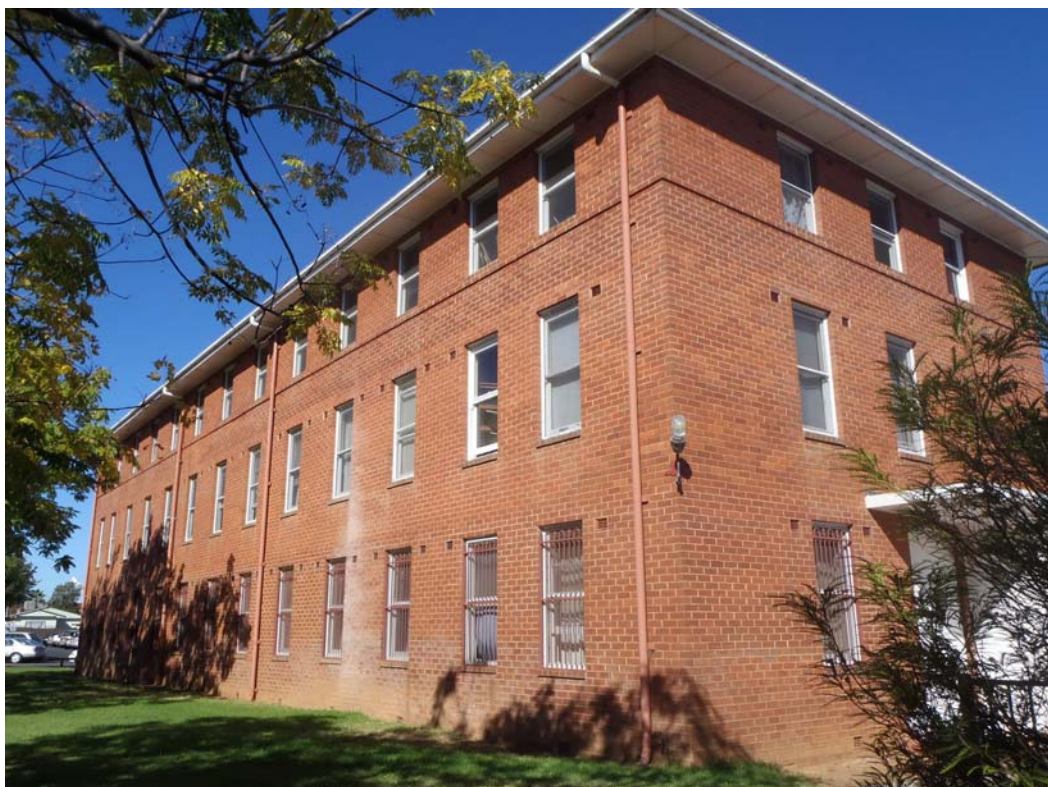
Plate 10: second building to be demolished under current proposal, view south east

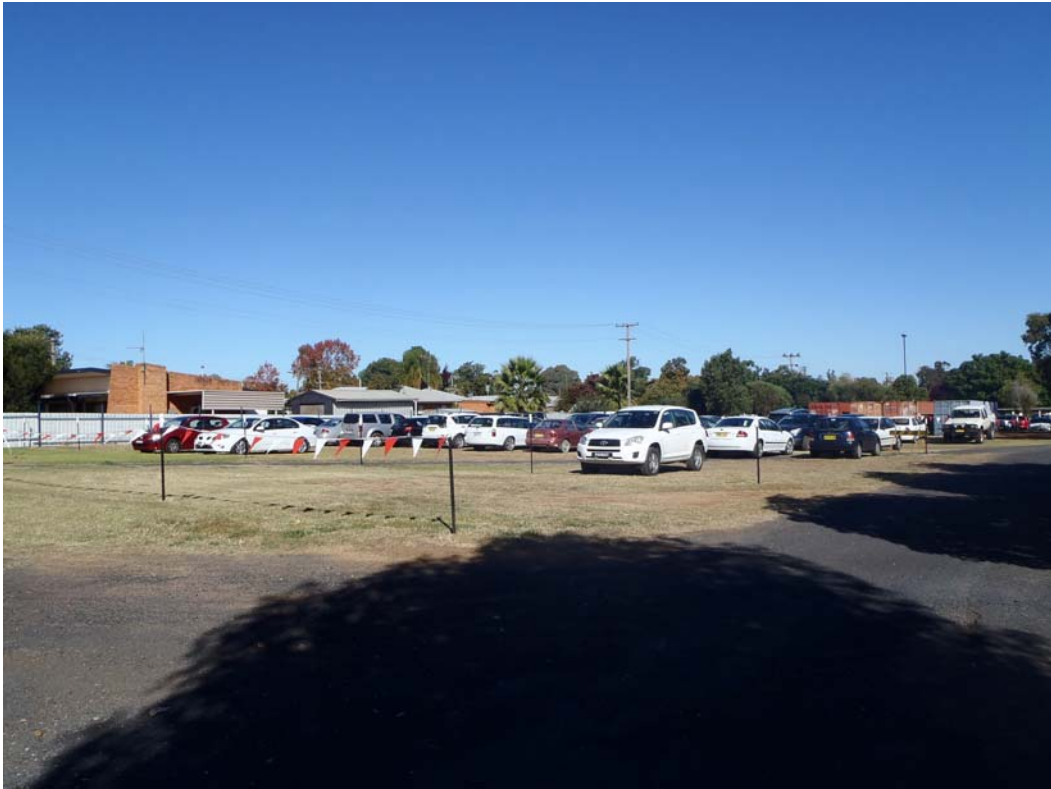
Plate 11: Proposed car park extension area (note cars already parked in area), view south
