Aboriginal Objects Due Diligence Assessment

Opal Bella Vista

28 Norbrik Drive, Bella Vista, NSW

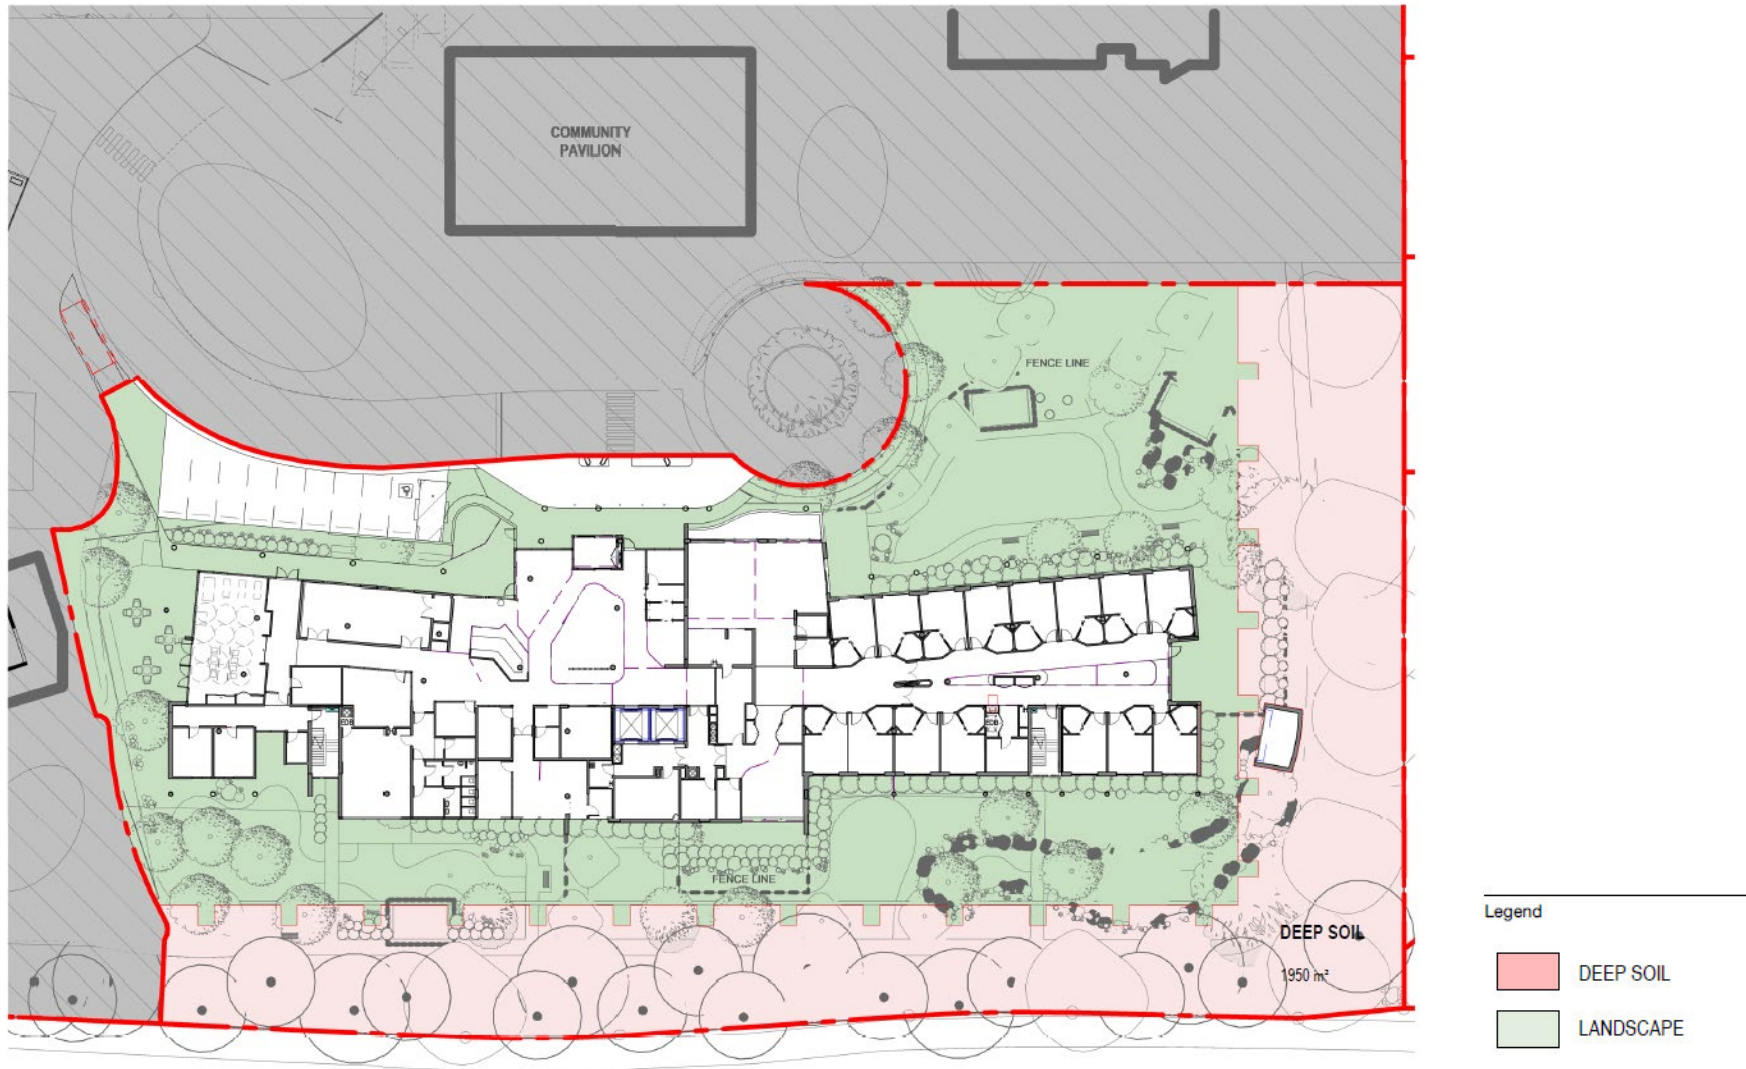
Figure 7 – Proposed landscape area plan and deep soil planting area.

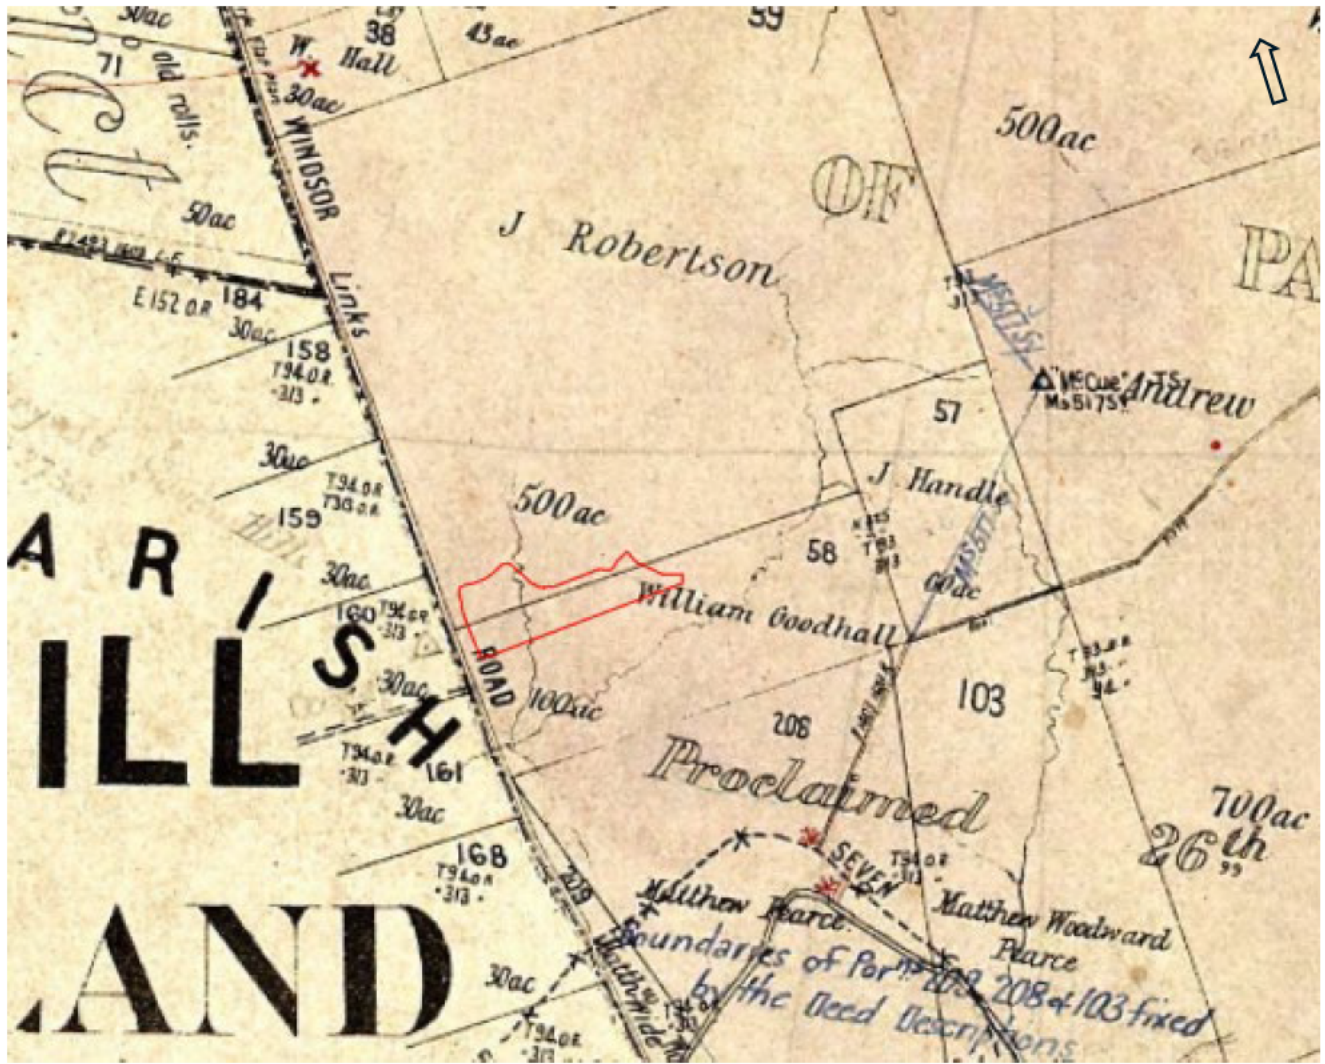
Figure 14 – Undated Parish map of Castle Hill likely from the late 19th Century shows a tributary of Caddie’s Creek running through the subject area (outlined in red).

Hydrology: The nearest existing natural water source to the subject area is a tributary of Caddies Creek which flows in an east west direction. The creek line is located 680m north of the subject area. However, historical aerials and maps show that an unnamed creek line originally ran north to south through the central portion of the subject area (Figure 14).

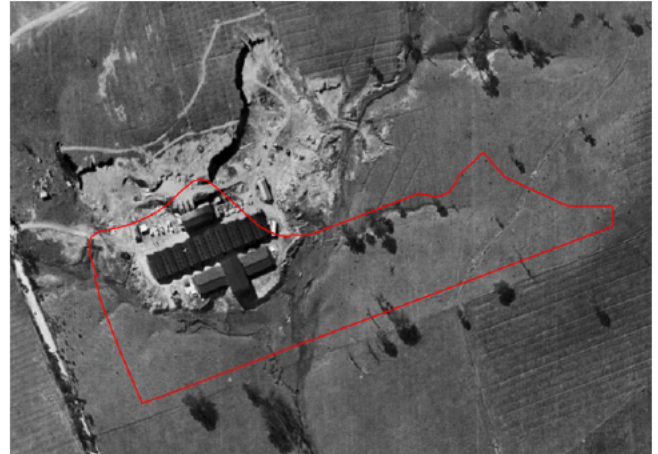
Figure 16 – 1965 aerial showing a quarry site operating out of the subject area.

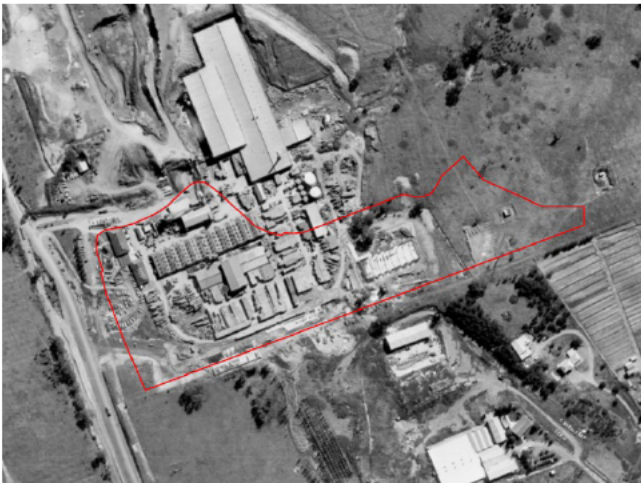
Figure 17 – 1978 aerial showing the development of the quarry into an industrial precinct.

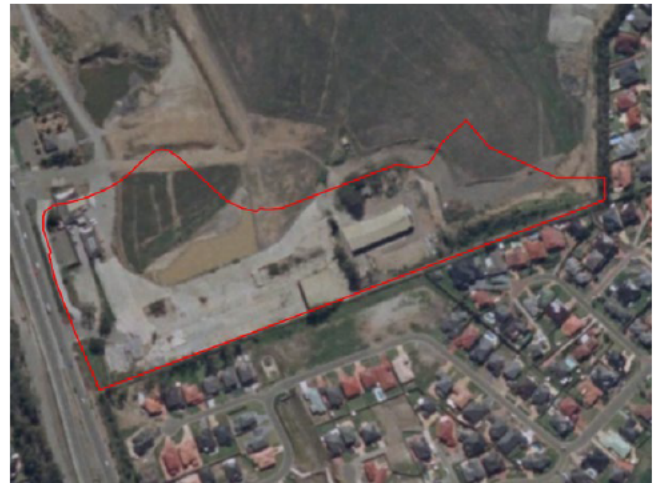
Figure 18 – 2004 aerial showing the earlier buildings on the subject area had been demolished.

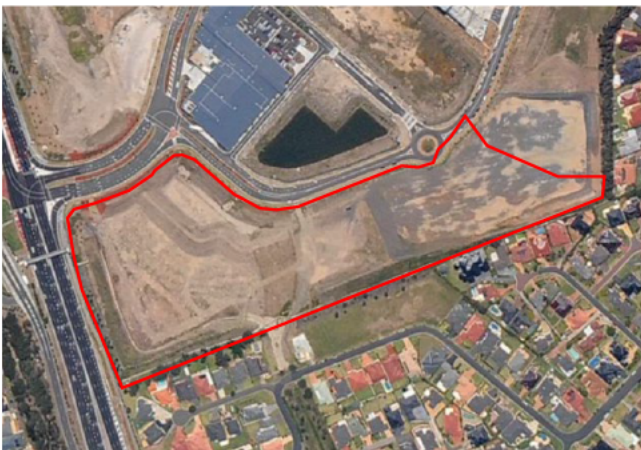
Figure 19 – 2009 aerial showing the subject area as cleared and vacant.

In the early 20th century, the 1930 aerial photograph show the subject area as vacant farmland with some evidence of cultivation (Figure 15). In 1949 'Bella Vista' was sold to the North Sydney Brick and Tile Company (later known as Norbrick) (Worley Parsons 2013: 16). The company started making bricks in 1956 and expanded their operations in the 60s and 70s to include the subject area and its surrounds. The 1965 aerial photograph shows several large buildings occupying the site and a quarry operating out of the subject area (Figure 16). The 1978 aerial shows the development of the quarry into an industrial precinct (Figure 17). By 2004, the earlier buildings on the subject area had been demolished (Figure 18). The subject area had been cleared and is vacant by 2009 (Figure 19).

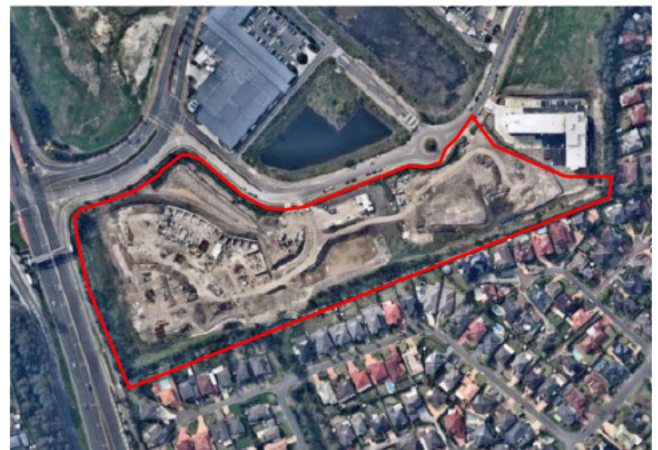
Figure 20 – 2016 aerial showing development occurring the subject area and construction of deep drainage basins.

By 2016, construction of a multistorey building in the western portion of the subject area had begun (Figure 20). The development was finished in 2020 and included the excavation of two deep drainage basins to the north and east of the development that caused high disturbance and removal of all natural soils in these locations (Figure 21). The eastern portion of the subject area does not currently contain any structures. However, there is clear and observable ground disturbance from clearance of vegetation and topsoils, machinery activity for cut and fill activities, vehicle activity in use of the area as a carpark, and construction of a multi-storey development with deep drainage basins.

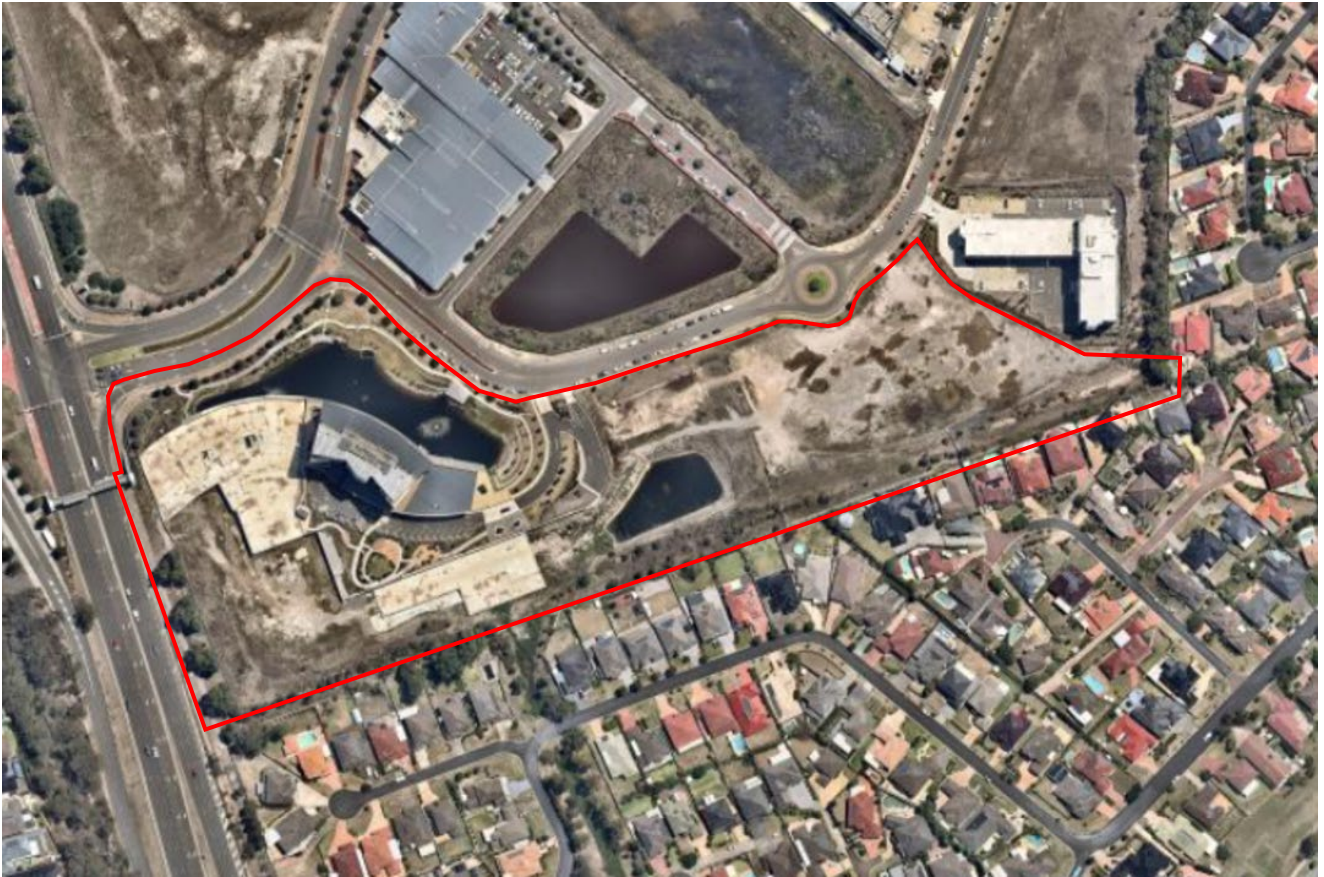
Figure 21 – Aerial of the subject area in 2020 with a multi-storey development present on the western portion. Deep drainage basins are also present and clear and observable ground disturbance has been undertaken on the eastern portion.
