Bank Street Park
Blackwattle Bay / Tjerruing

Site Audit Report (Ramboll Australia Pty Ltd)

SITE AUDIT REPORT REMEDIATION ACTION PLAN, BANK STREET PARK, PYRMONT NSW

Remedial Action Plan

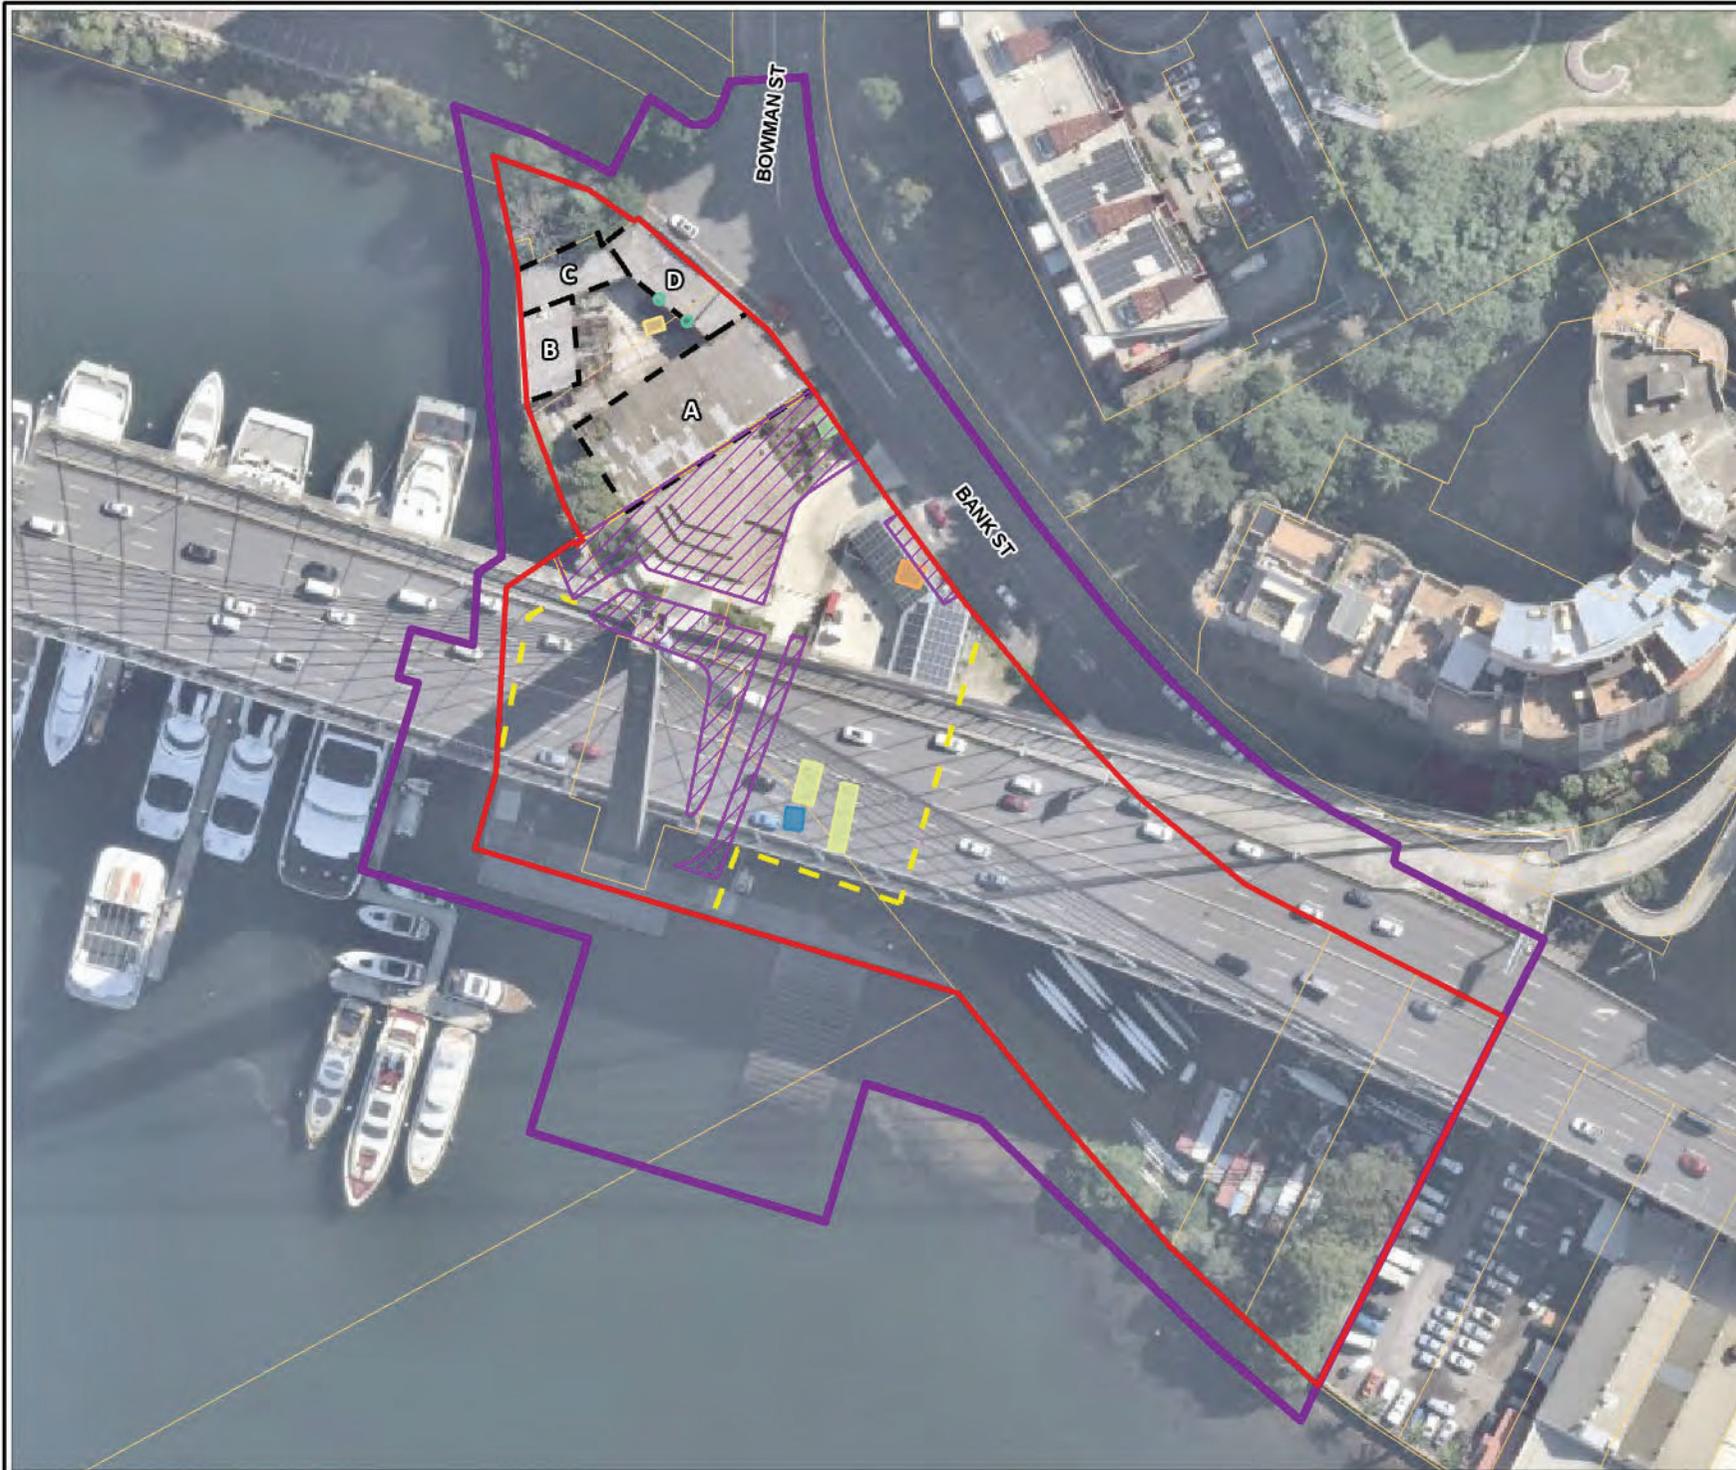
FIGURE 2A

SITE LAYOUT

- Legend:**
- Approximate Site Boundary
 - Broader Site Boundary
 - NSW Cadastre
 - Impacted Material, CONSARA 2020a
 - Extent of Marker Layer, CONSARA 2020a
- Site Features**
- Building Footprint
 - AST
 - Potential UST
 - Shipping Containers
 - Substation
 - Vent
 - Workshop

Key site features observed by JBS&G, including the indicative footprint of the existing containment area in the central portion of the site (Section 1.3), are shown on Attachment 4, Appendix A.

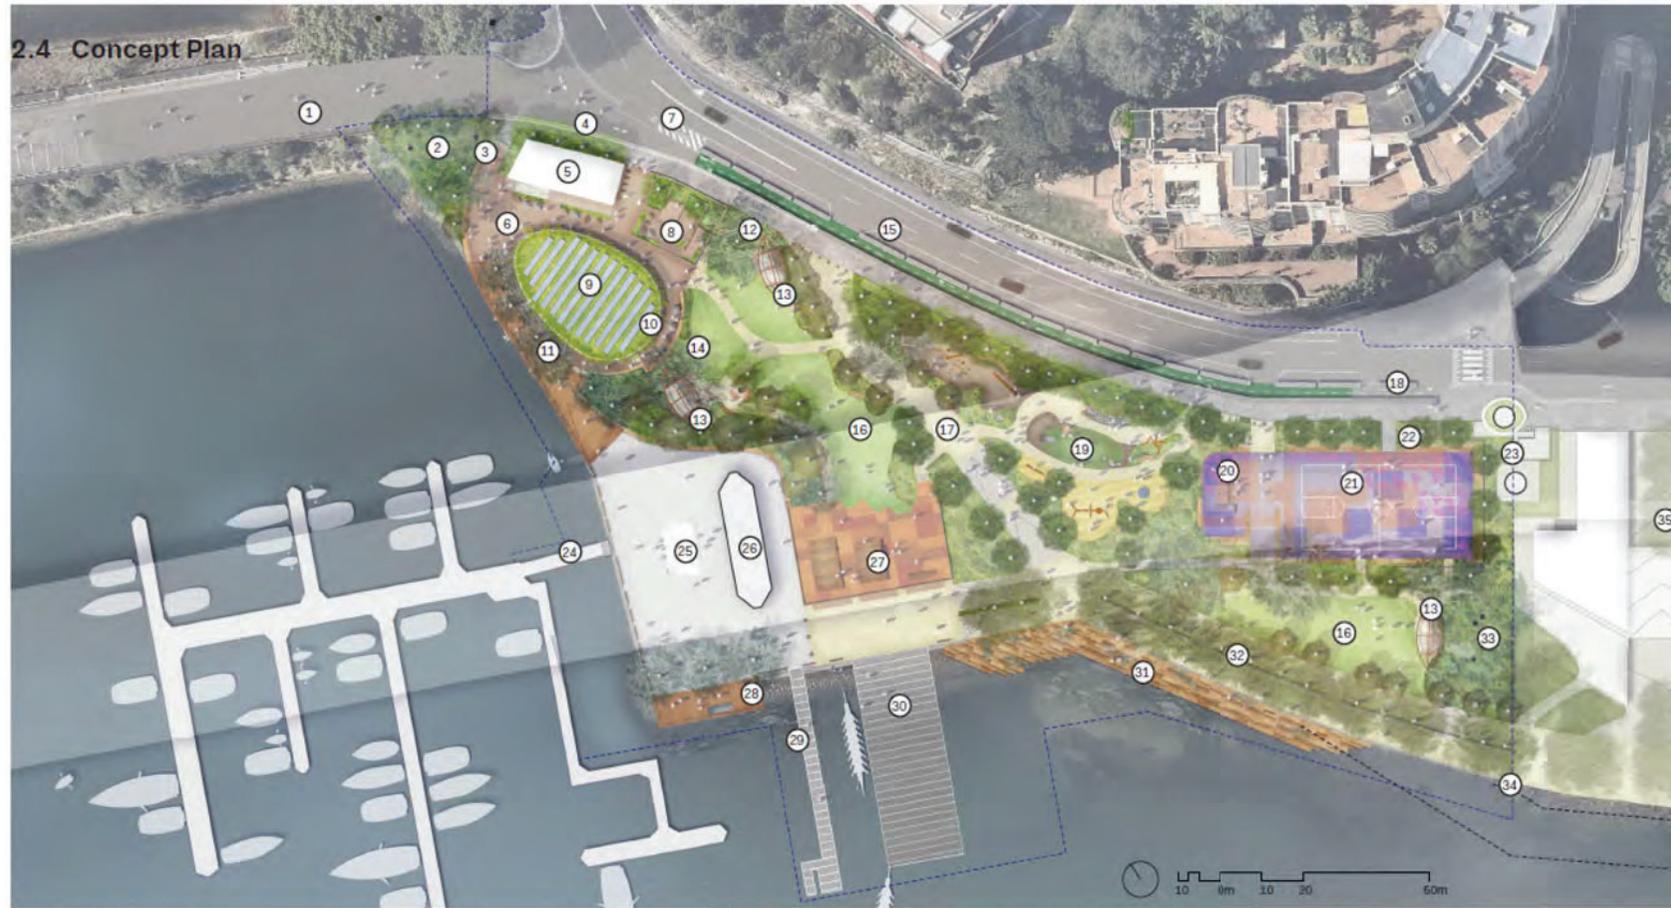
FIGURE 2B

2.4 Concept Plan

| 1 Glebe Island Bridge - potential pedestrian and cycle connection | 7 Loading zone on Bank Street | 13 Seating shelters amongst planting | 19 Nature-based inclusive playspace for ages 2-12 | 25 Potential future kayak storage / kiosk | 31 Sandstone blocks terracing into water to improve marine habitat |

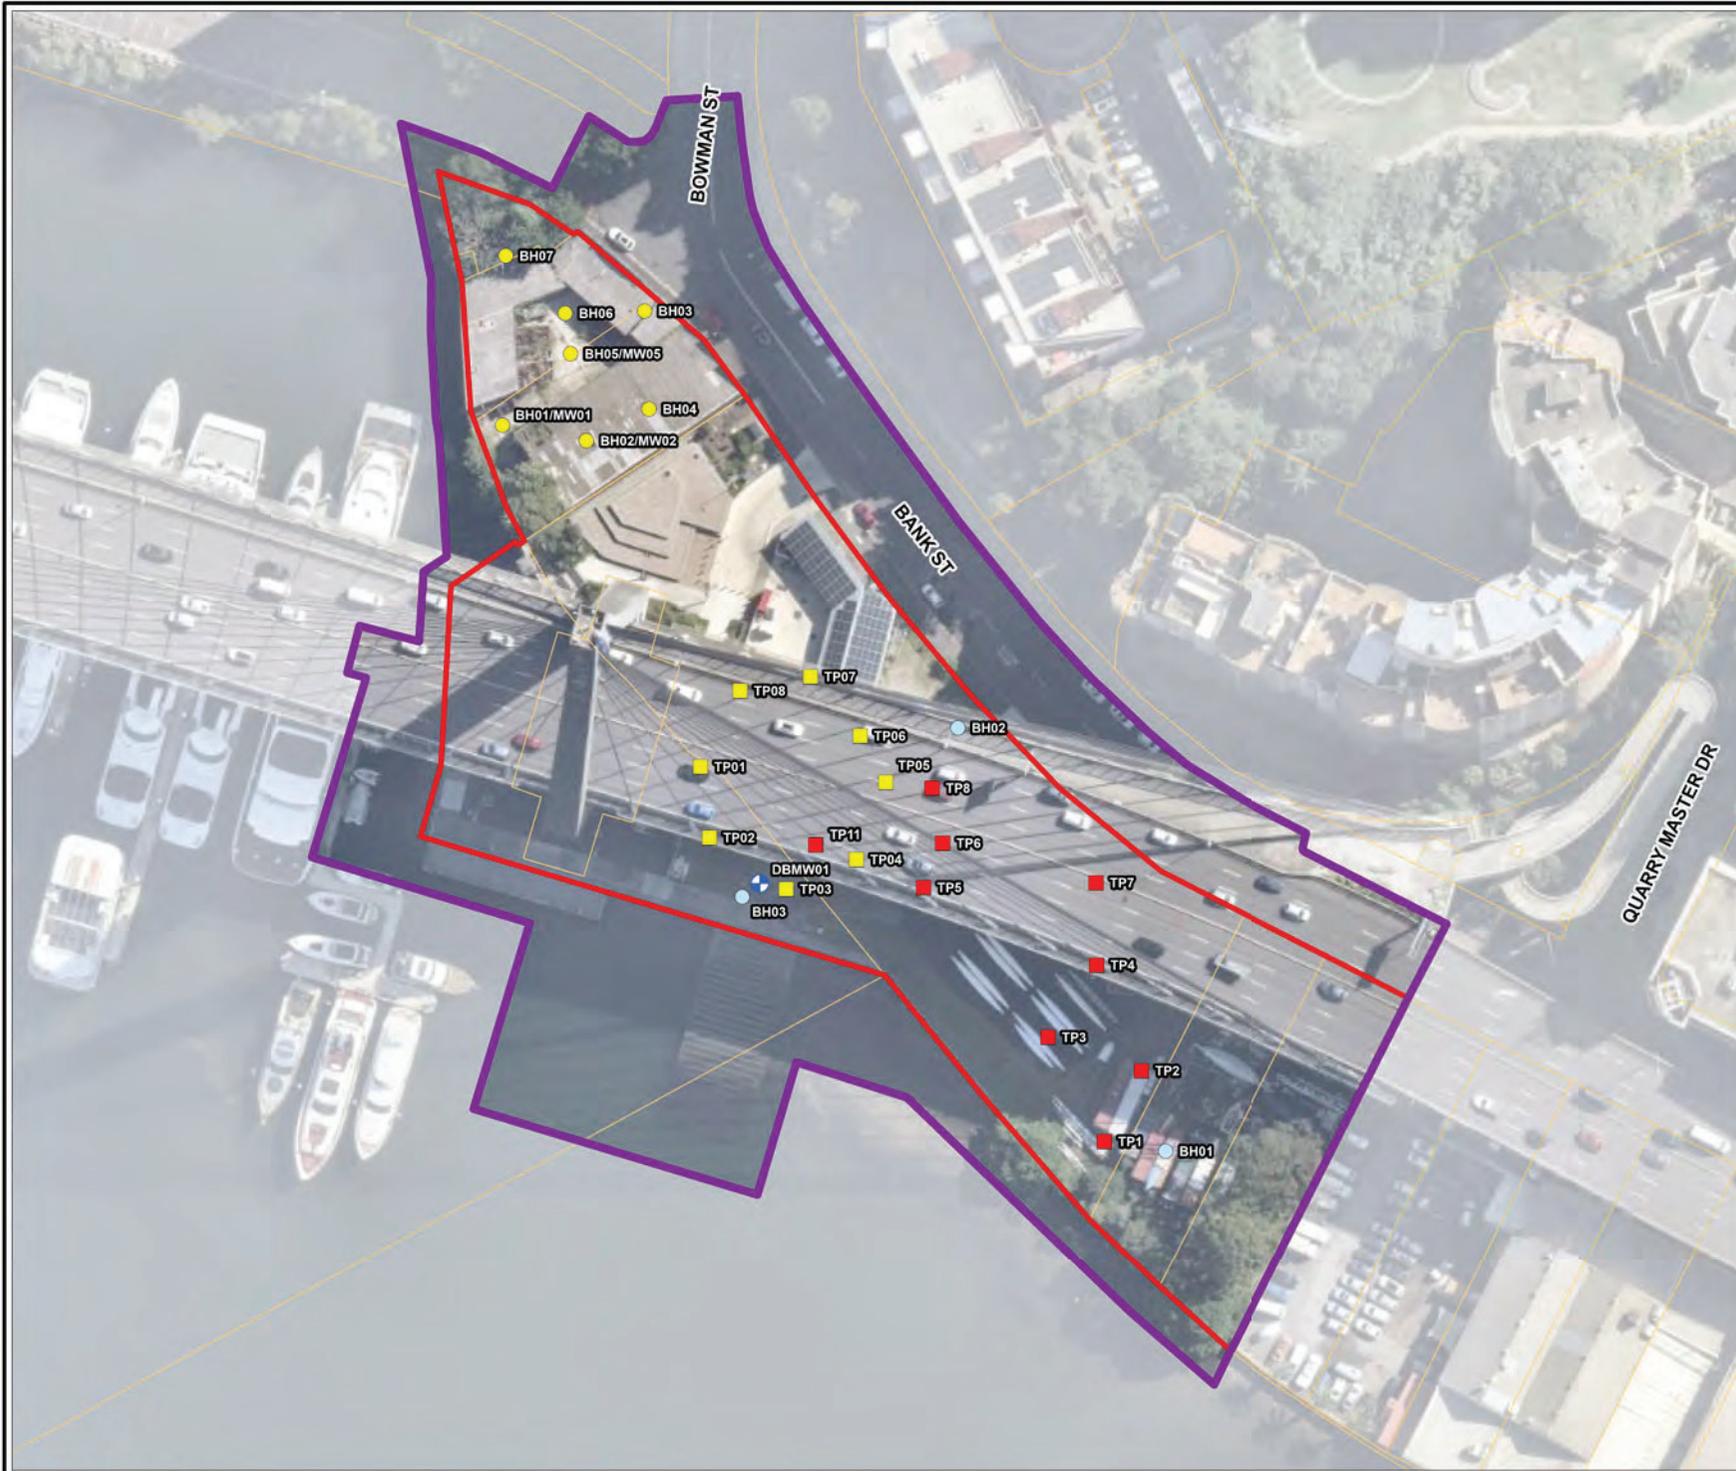
FIGURE 3

- Legend:**
- ▬ Approximate Site Boundary
 - ▬ Broader Site Boundary
 - ▬ NSW Cadastre
 - Sample Locations - JBS&G (2015)**
 - ⊕ Soil Sampling / Monitoring Well
 - Previous Sample Locations**
 - Sample Location - CDM (2012b)
 - Sample Location - E3C (2012)
 - Sample Location - RCA (2011)
 - Sample Location - NAA (2010)

HISTORICAL SAMPLE LOCATIONS

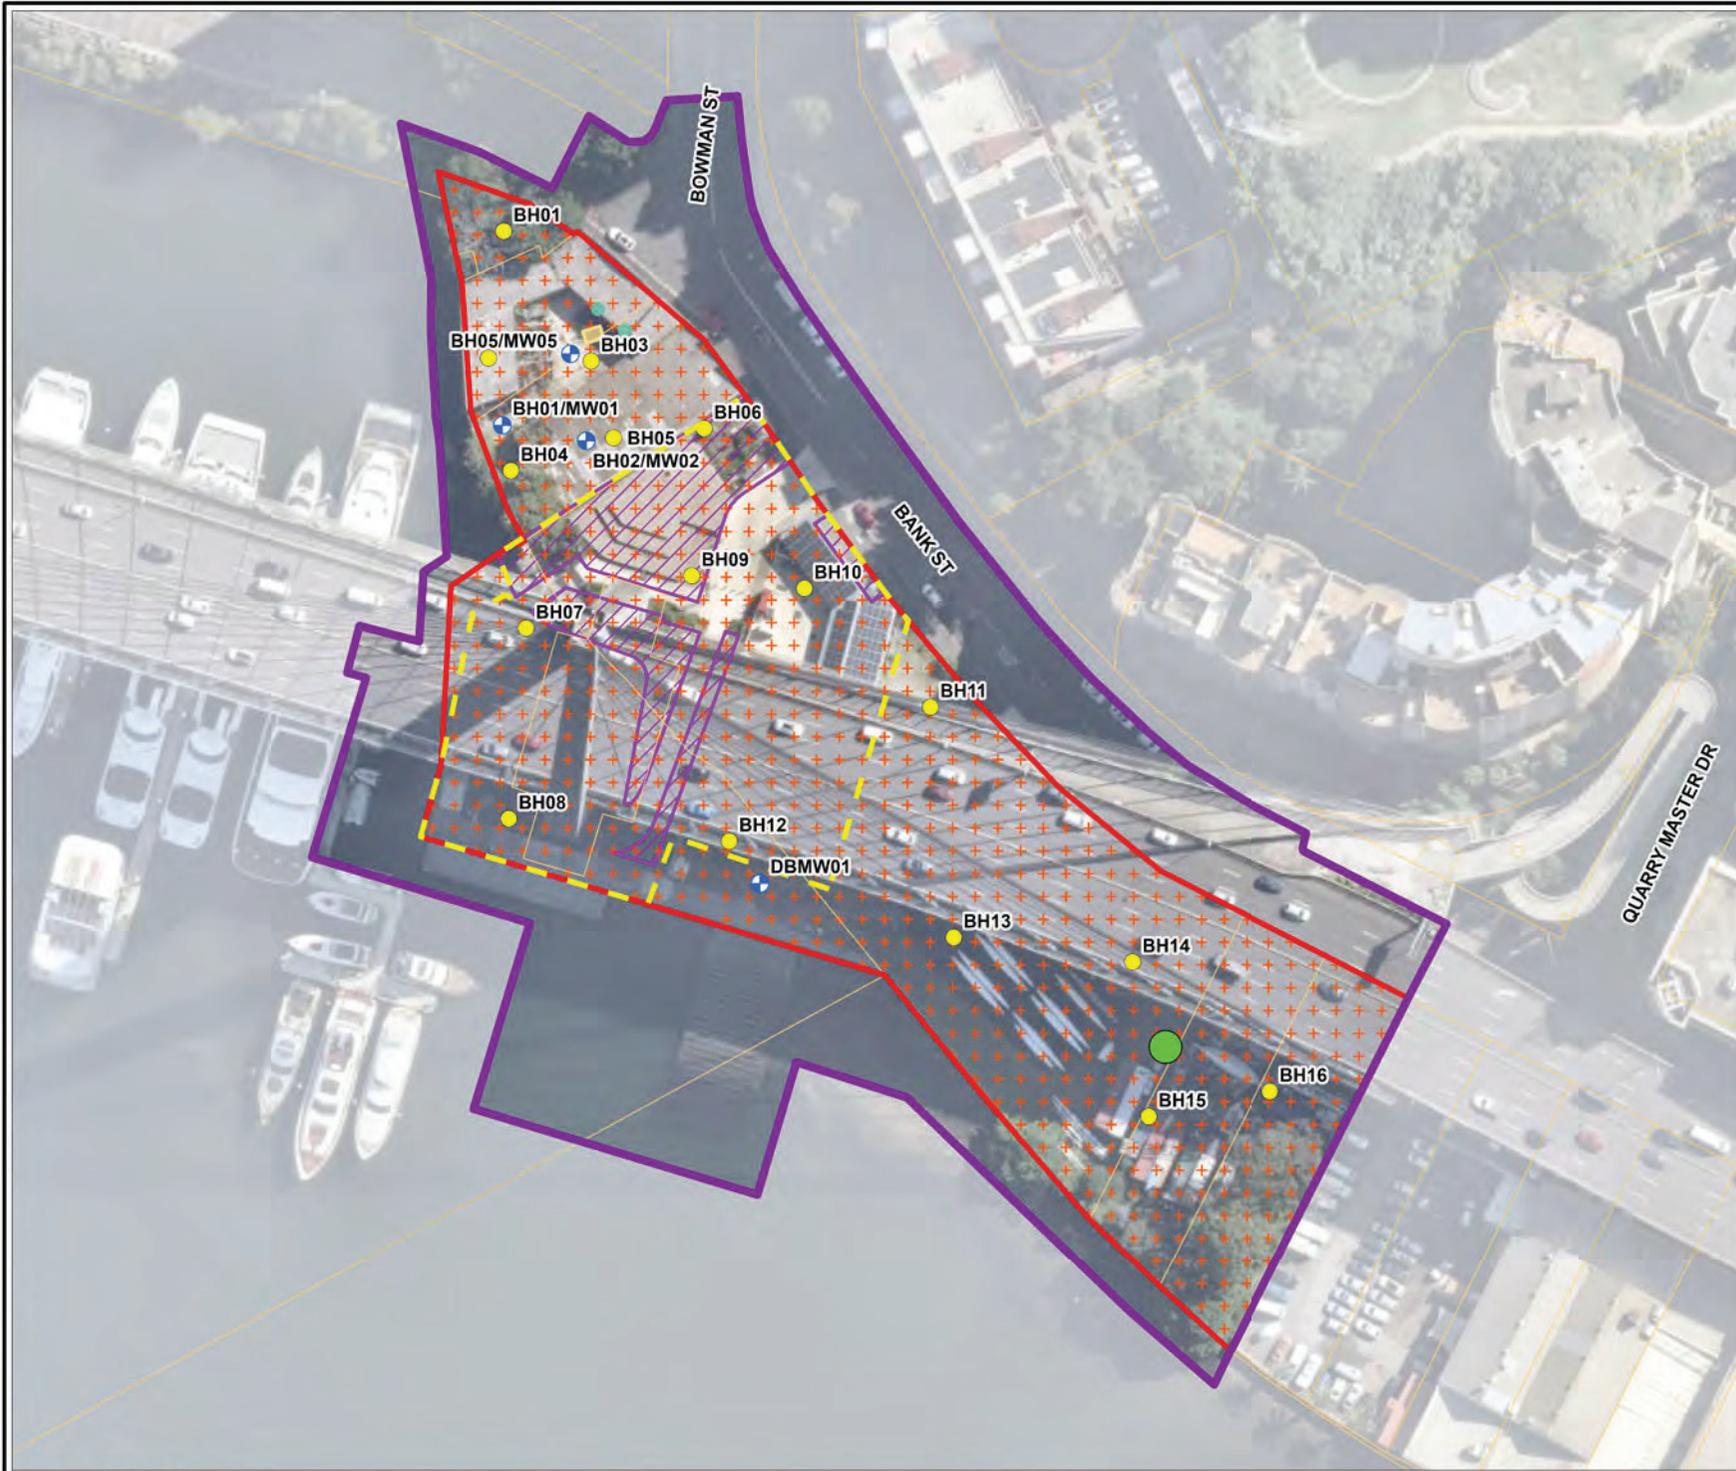
- Legend:**
- Approximate Site Boundary
 - Broader Site Boundary
 - NSW Cadastre
 - Impacted Material, CONSARA 2020a
 - Extent of Marker Layer, CONSARA 2020a
 - Asbestos, Heavy Metals, TRH and PAH
- Site Features**
- Potential UST
 - Vent
- Sample Locations**
- Groundwater Sample Location
 - Soil Sample Location
 - Hydrocarbon Odour

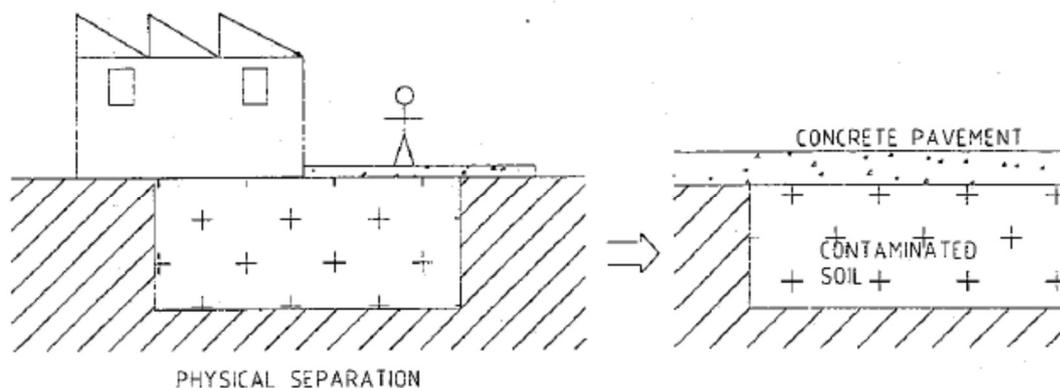
- Permanent pavement measures such as a concrete ground slab, asphalt surfaced pavement, mortared stone/concrete pavers or similar. The pavement base course shall be underlain by an easily discernible visual marker layer; or
- A thickness of soil that is unlikely to be penetrated by future users during everyday activities at the site (or relevant parts thereof). A minimum soil cover thickness of 0.5m is nominated in general site areas where exposed soil is proposed, which is to be underlain by a visual marker layer. However, it is noted that to achieve ecological objectives, increased depths of suitable non-contaminated soil may be required.

An example of such measure is shown schematically below:

The purpose of the marker layer is to serve as a visual signal to those disturbing the capping system of the presence of potentially contaminated fill material at depth. The marker layer should be of a distinctive bright colour such that future workers and/or site users will be alerted to conditions as documented in a site environmental management plan (EMP) prior to breaching the marker layer.

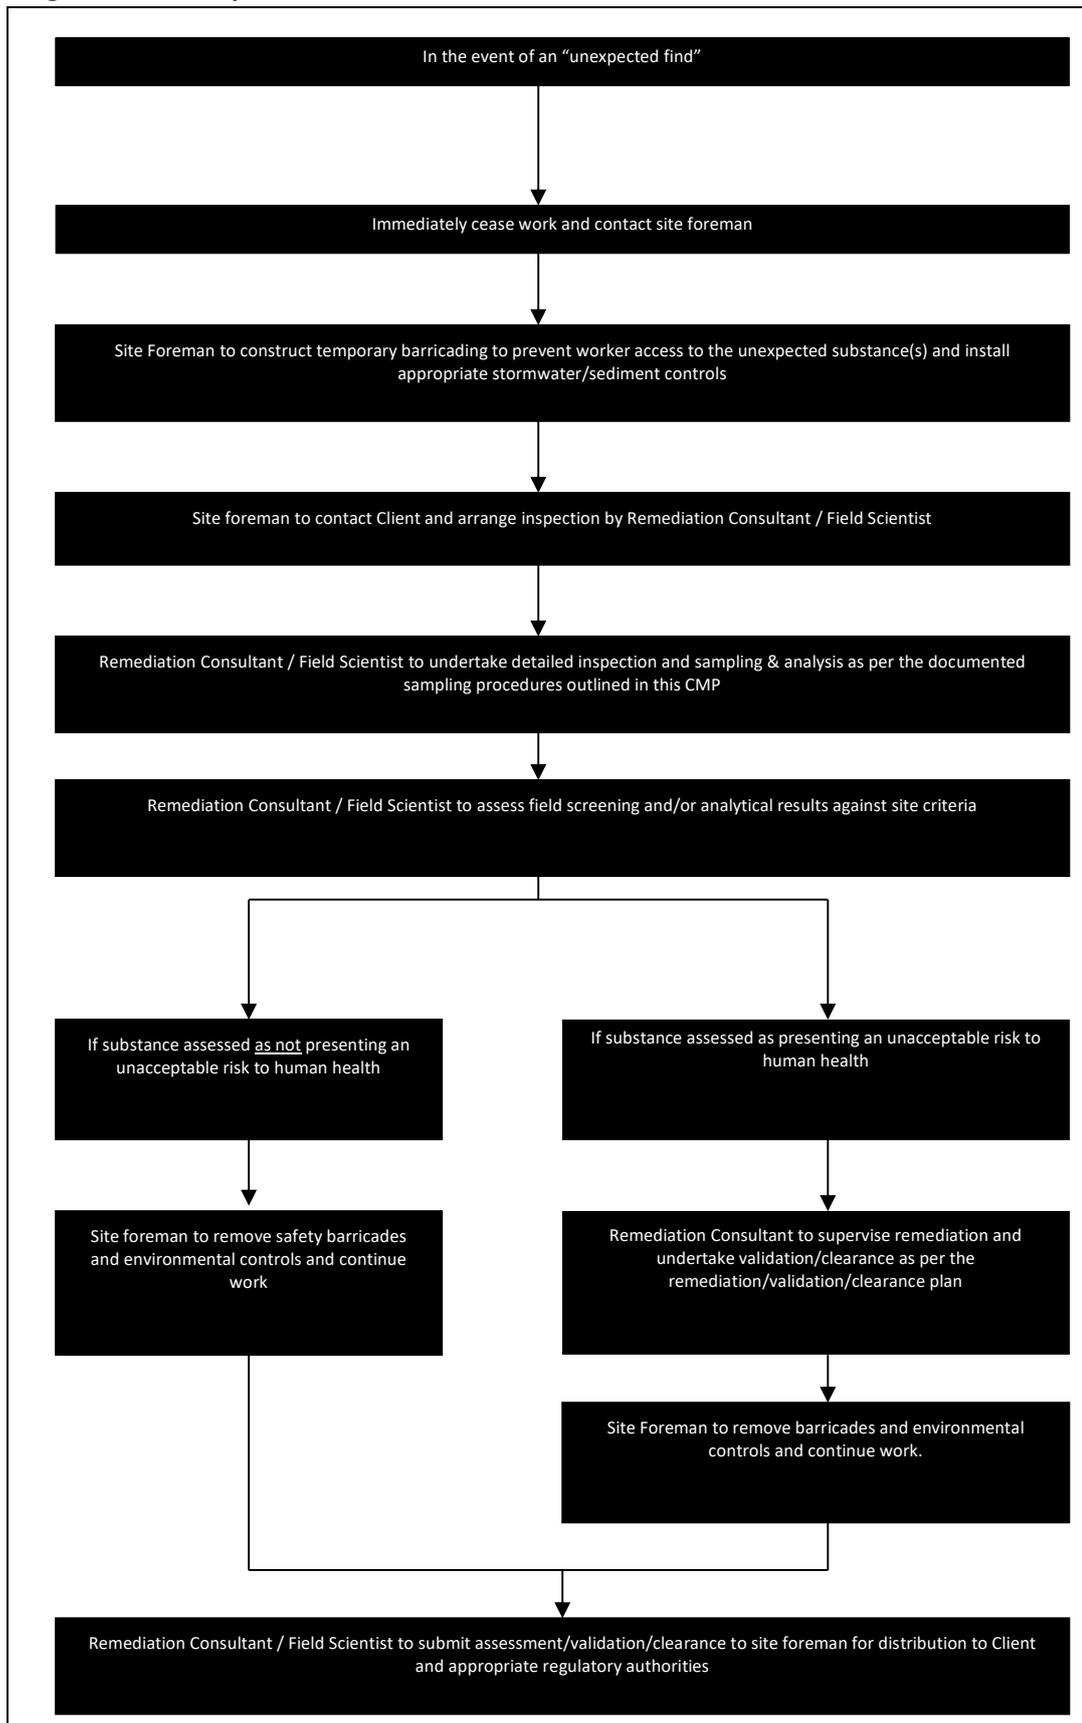
Figure 6.1 - Unexpected Finds Protocol

The sampling approach for each unexpected find shall be undertaken in accordance with the protocols presented in EPA (2022a). It is not possible to provide a specific sampling approach prior to encountering the unexpected find(s) as the approach will require to be altered on the basis of observable material characteristics and an updated CSM as specific to the unexpected find. Similarly, the approach for validating remediation of any further contaminated media discovered at the site will need to be determined if/when any such media are encountered.

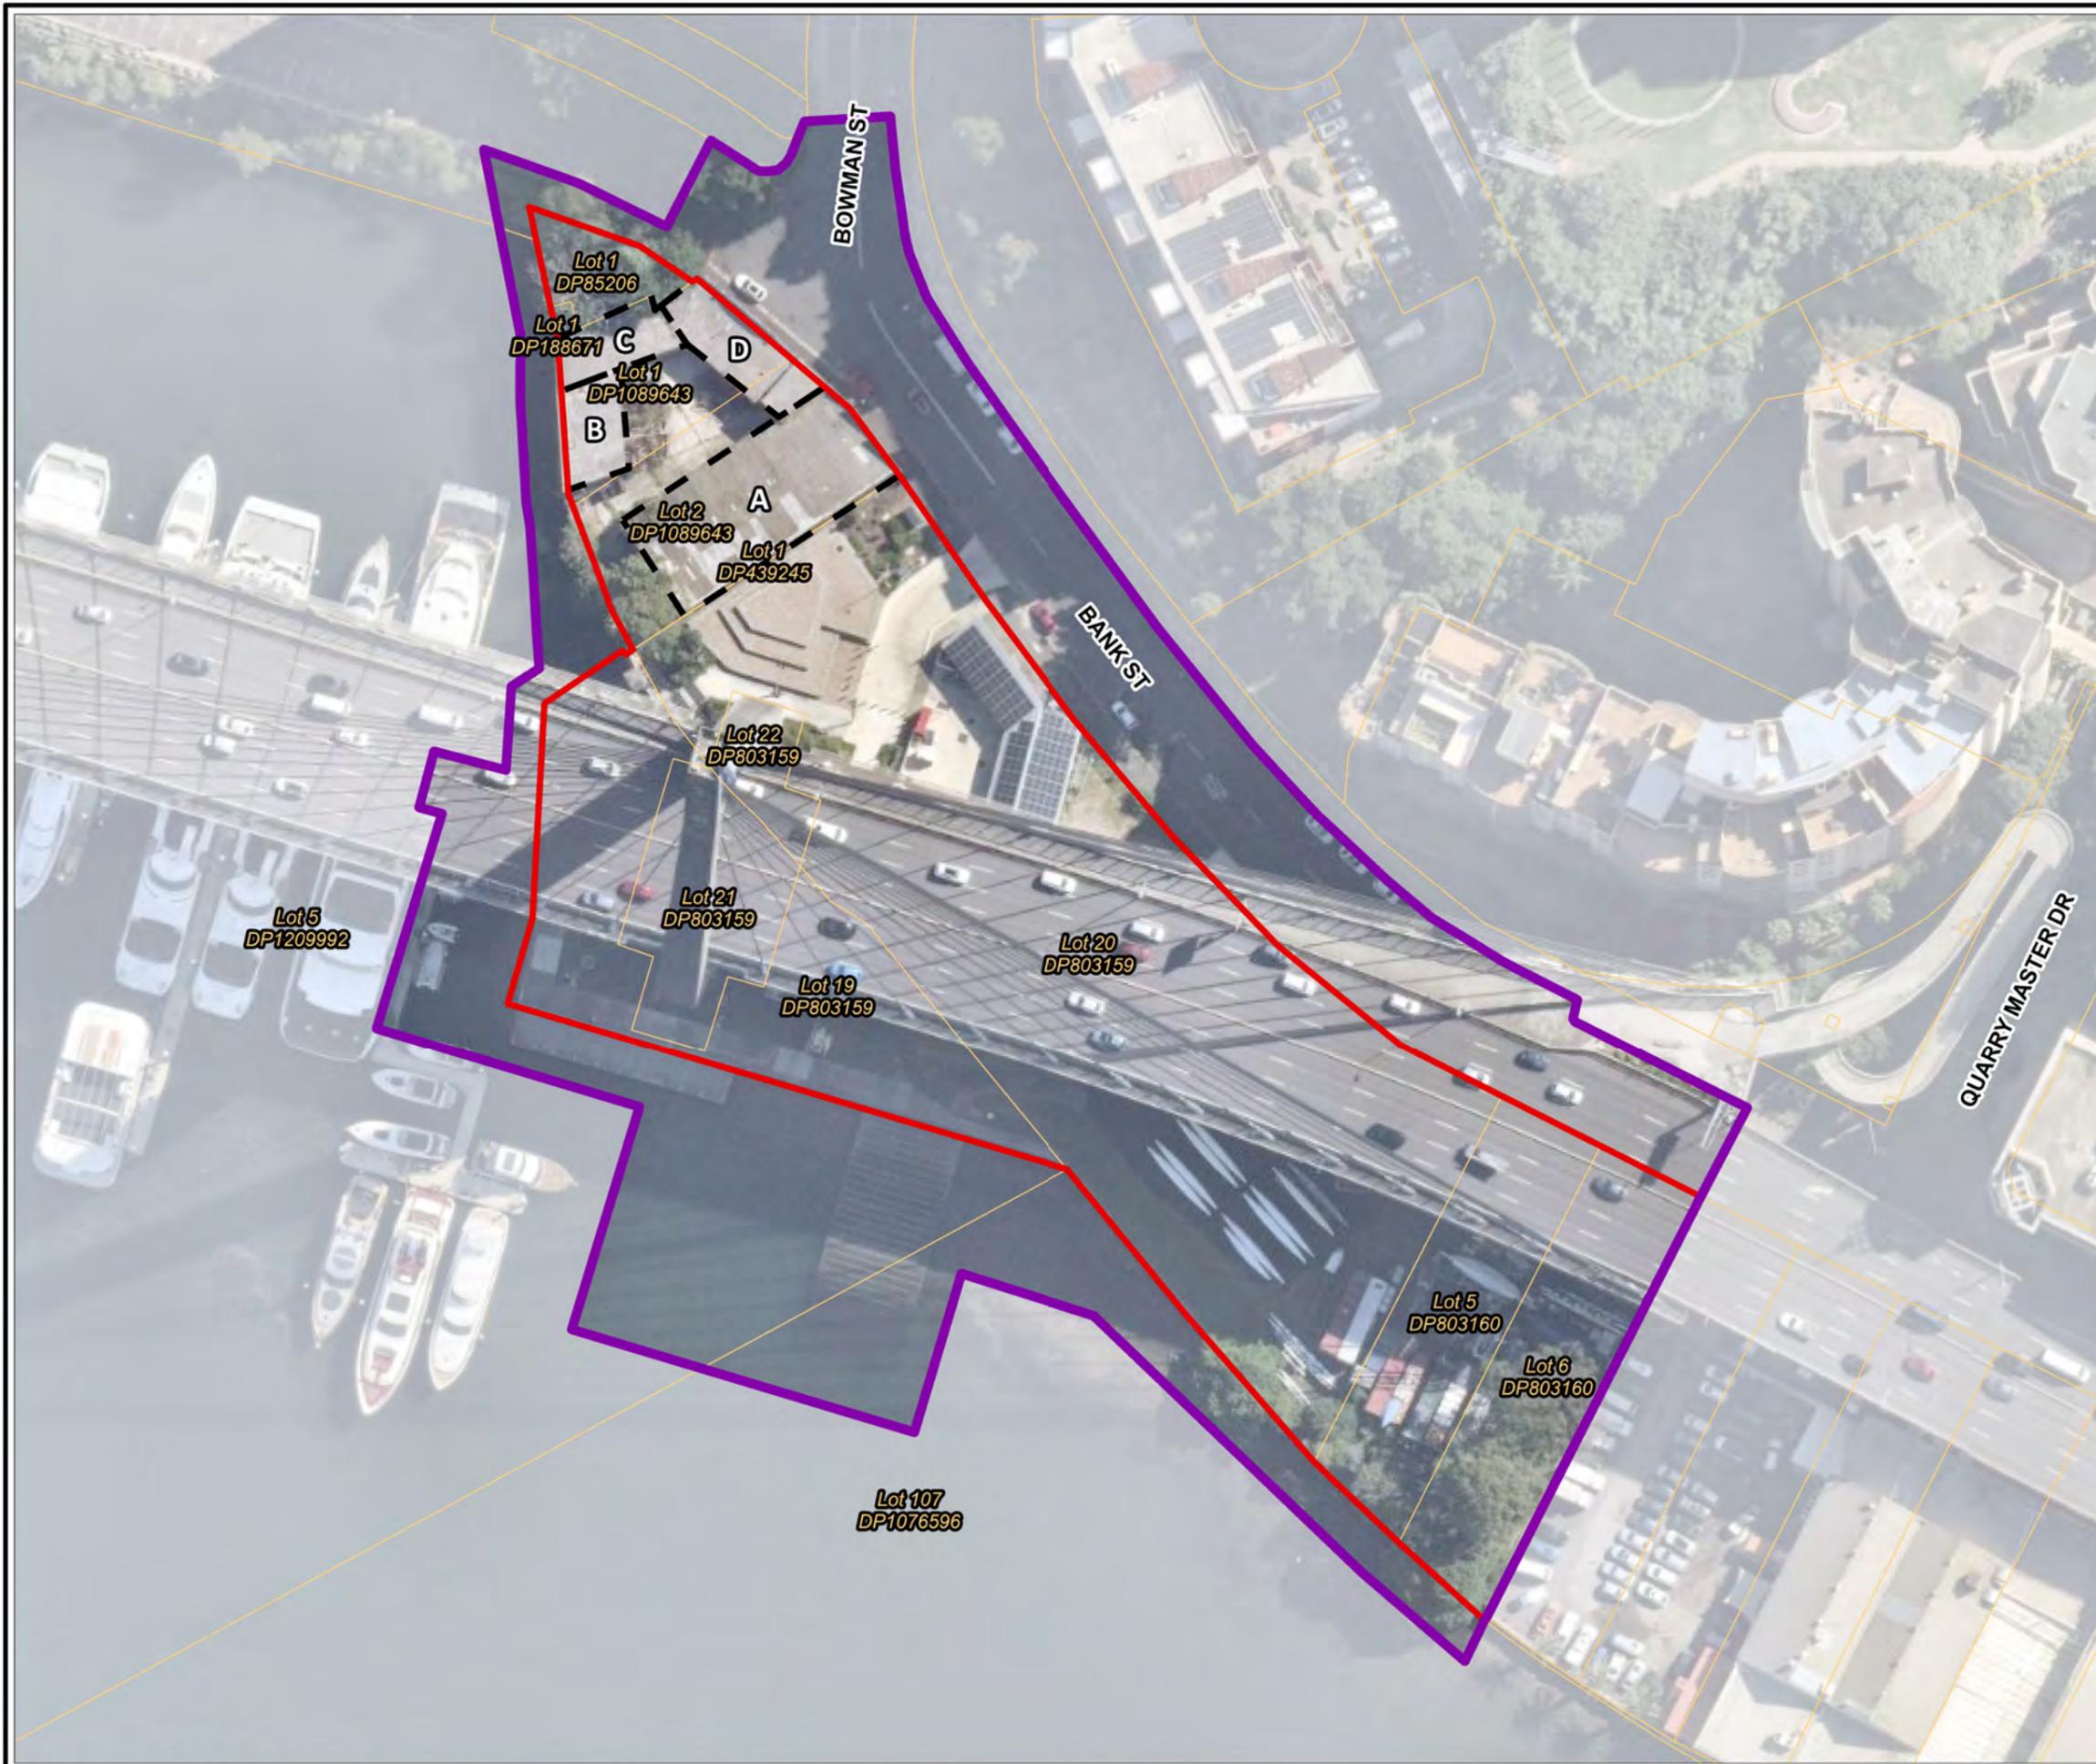
FIGURE 2A

- ▭ Site Area
- ▭ Broader Site Area
- ▭ NSW Cadastre
- Building Footprint

SITE LAYOUT

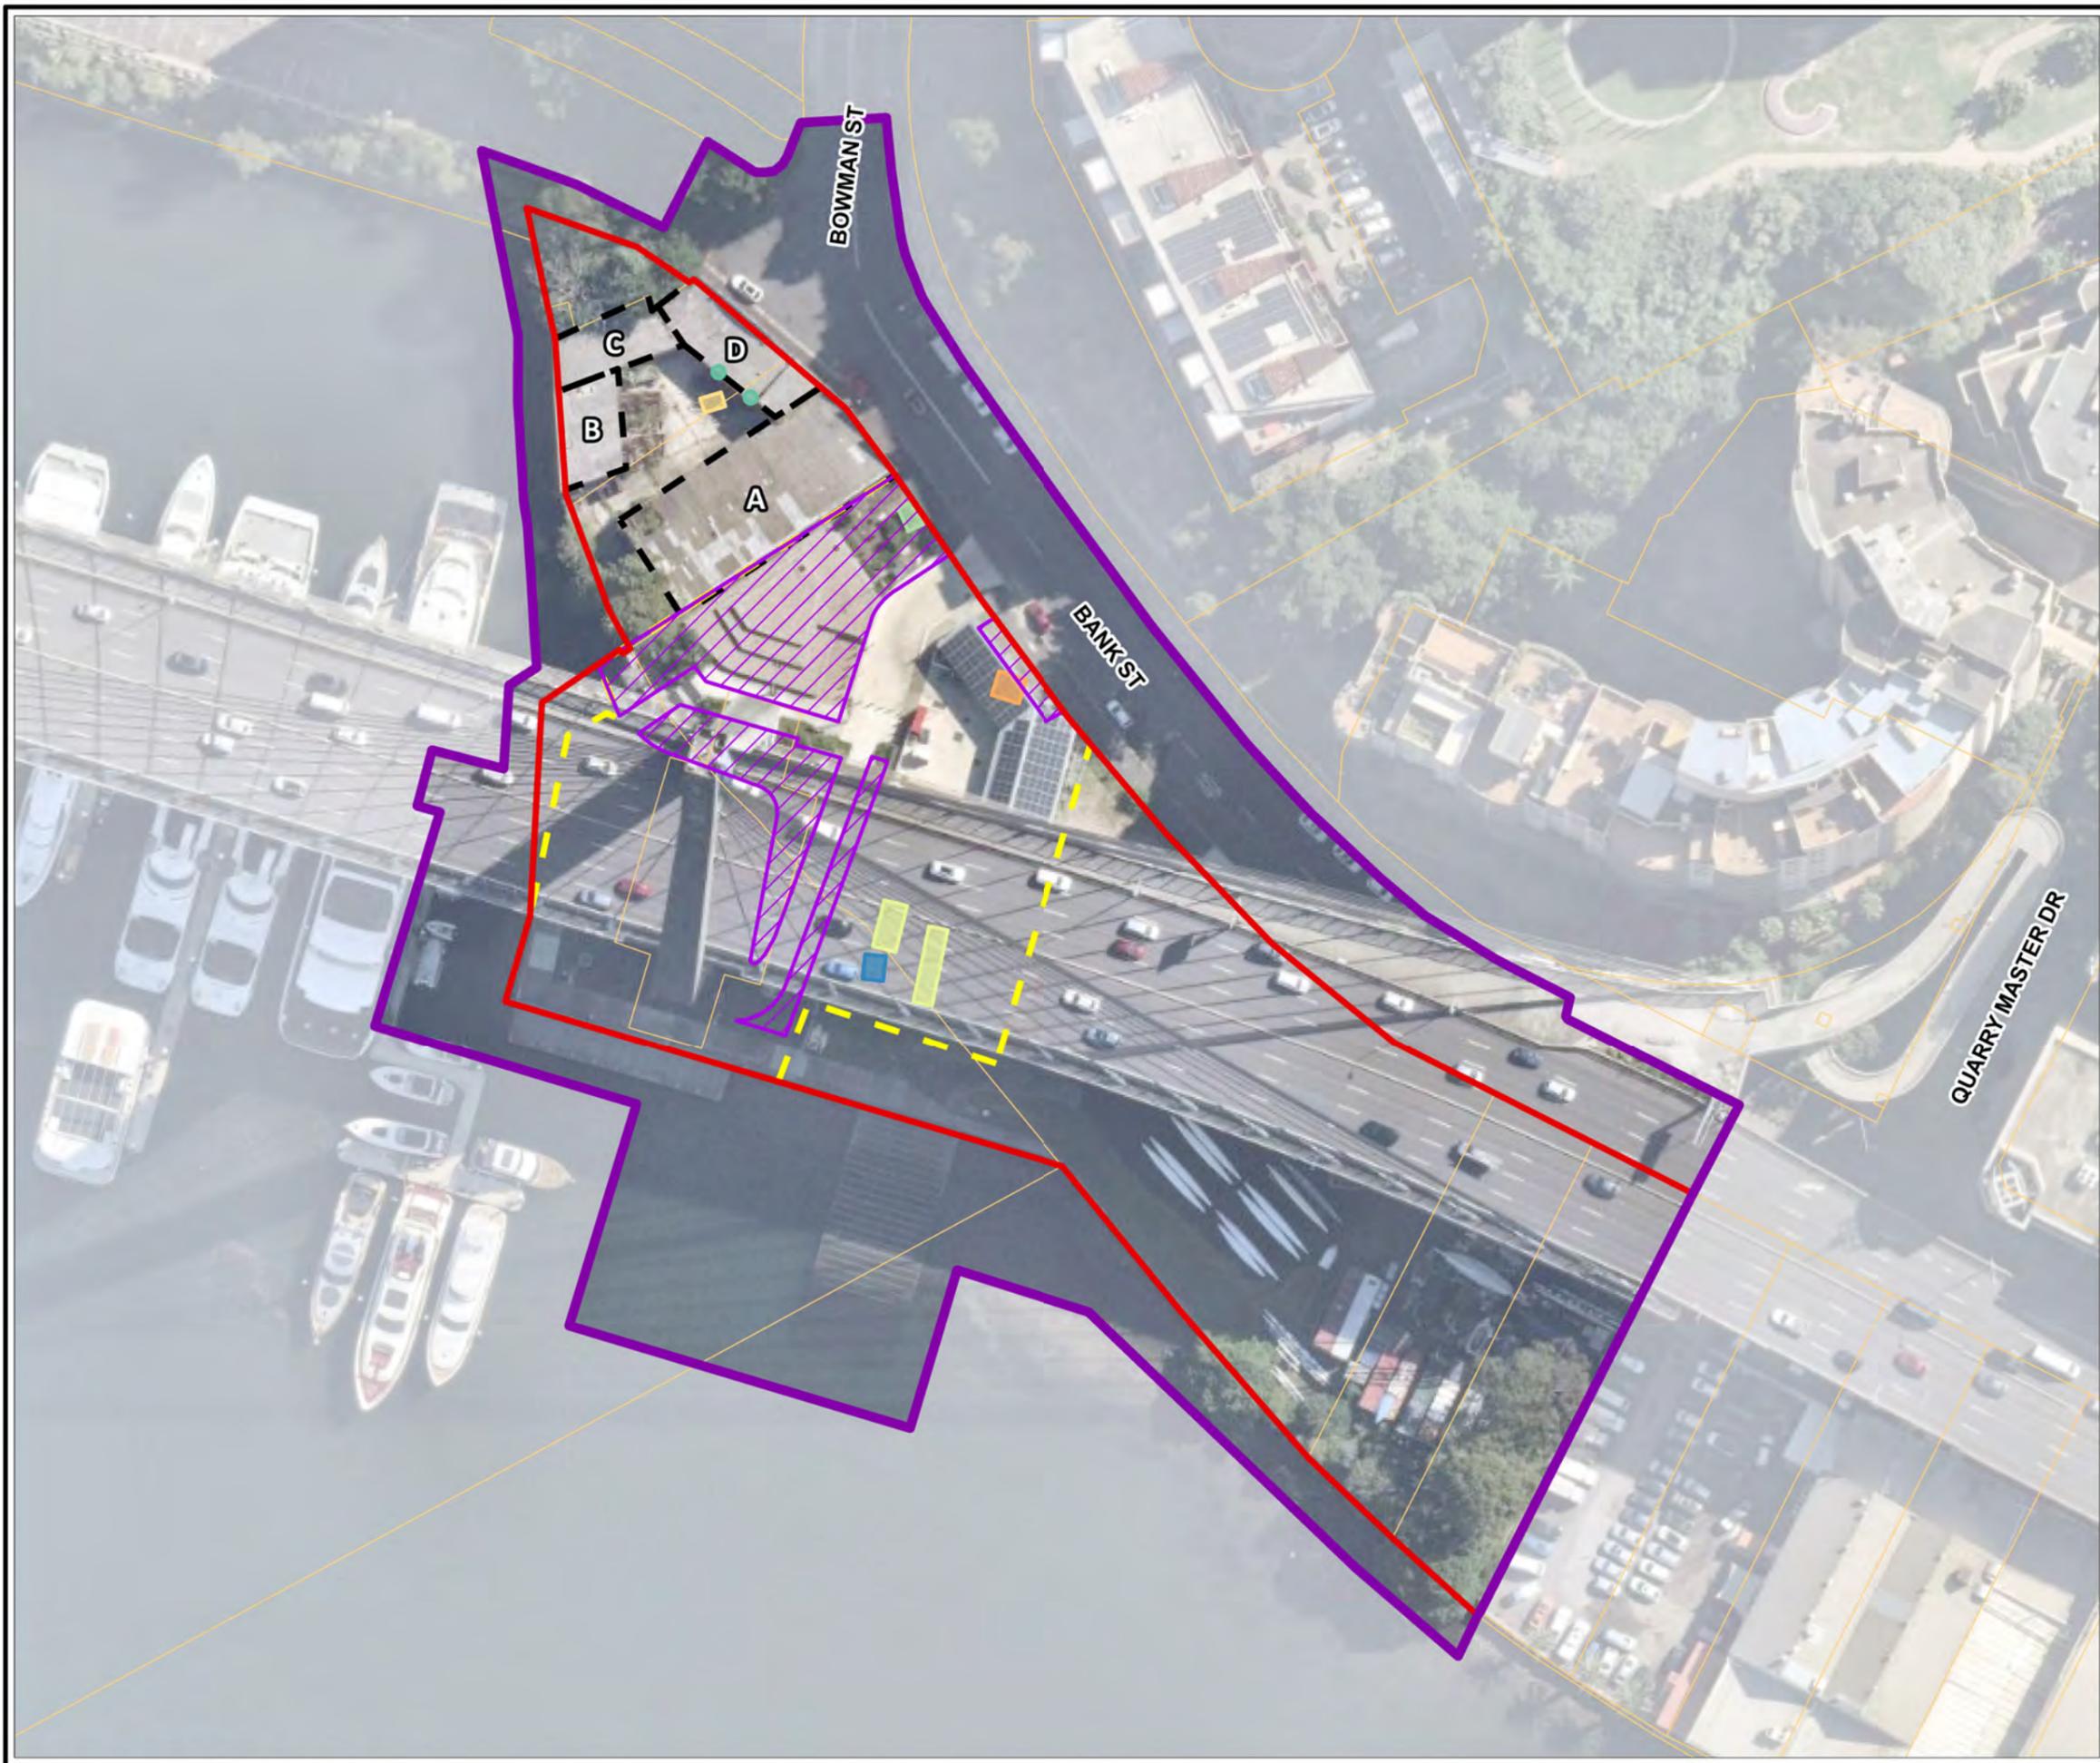
FIGURE 2B

- Legend:**
- ▬ Site Area
 - ▬ Broader Site Area
 - NSW Cadastre
 - Impacted Material, CONSARA 2020a
 - Extent of Marker Layer, CONSARA 2020a
- Site Features**
- Building Footprint
 - AST
 - Potential UST
 - Shipping Containers
 - Substation
 - Vent
 - Workshop

SITE FEATURES
