Bank Street Park
Blackwattle Bay / Tjerruing

Site Audit Report (Ramboll Australia Pty Ltd)

SITE AUDIT REPORT REMEDIATION ACTION PLAN, BANK STREET PARK, PYRMONT NSW

Remedial Action Plan

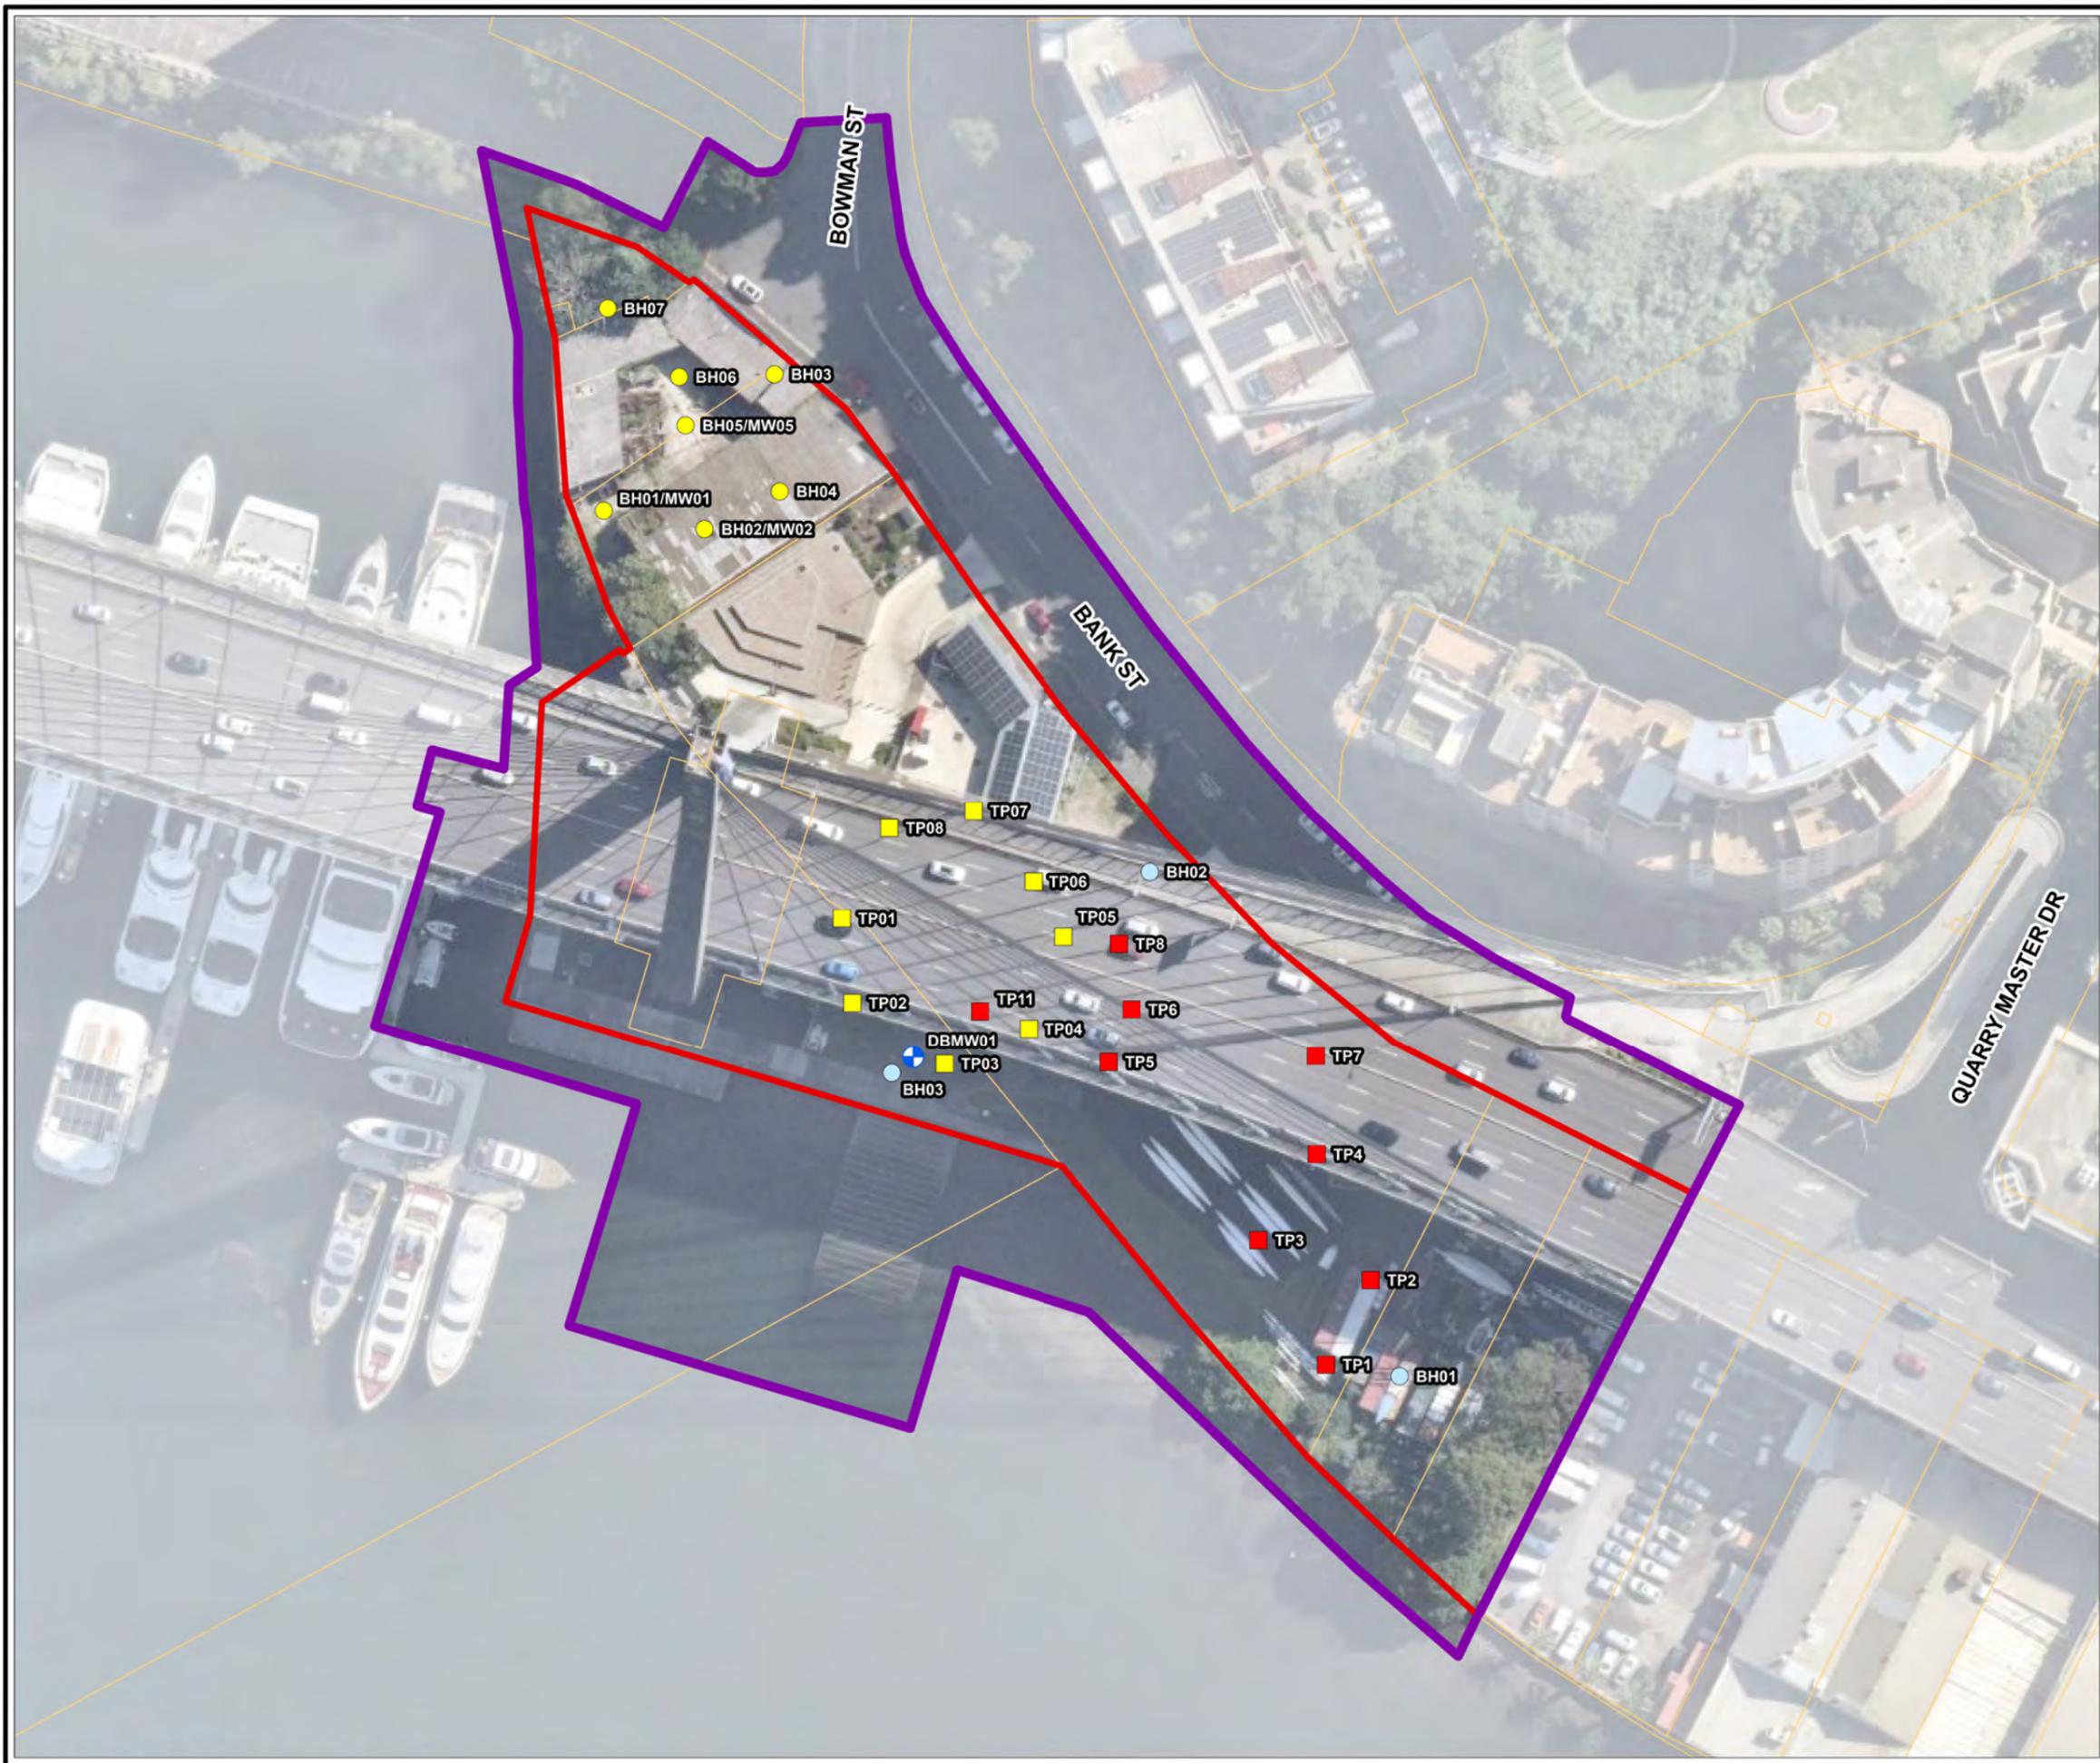
FIGURE 3

- Legend:**
- ▭ Site Area
 - ▭ Broader Site Area
 - ▭ NSW Cadastre
 - Sample Locations - JBS&G (2015)**
 - Soil Sampling / Monitoring Well
 - Previous Sample Locations**
 - Sample Location - CDM (2012b)
 - Sample Location - E3C (2012)
 - Sample Location - RCA (2011)
 - Sample Location - NAA (2010)

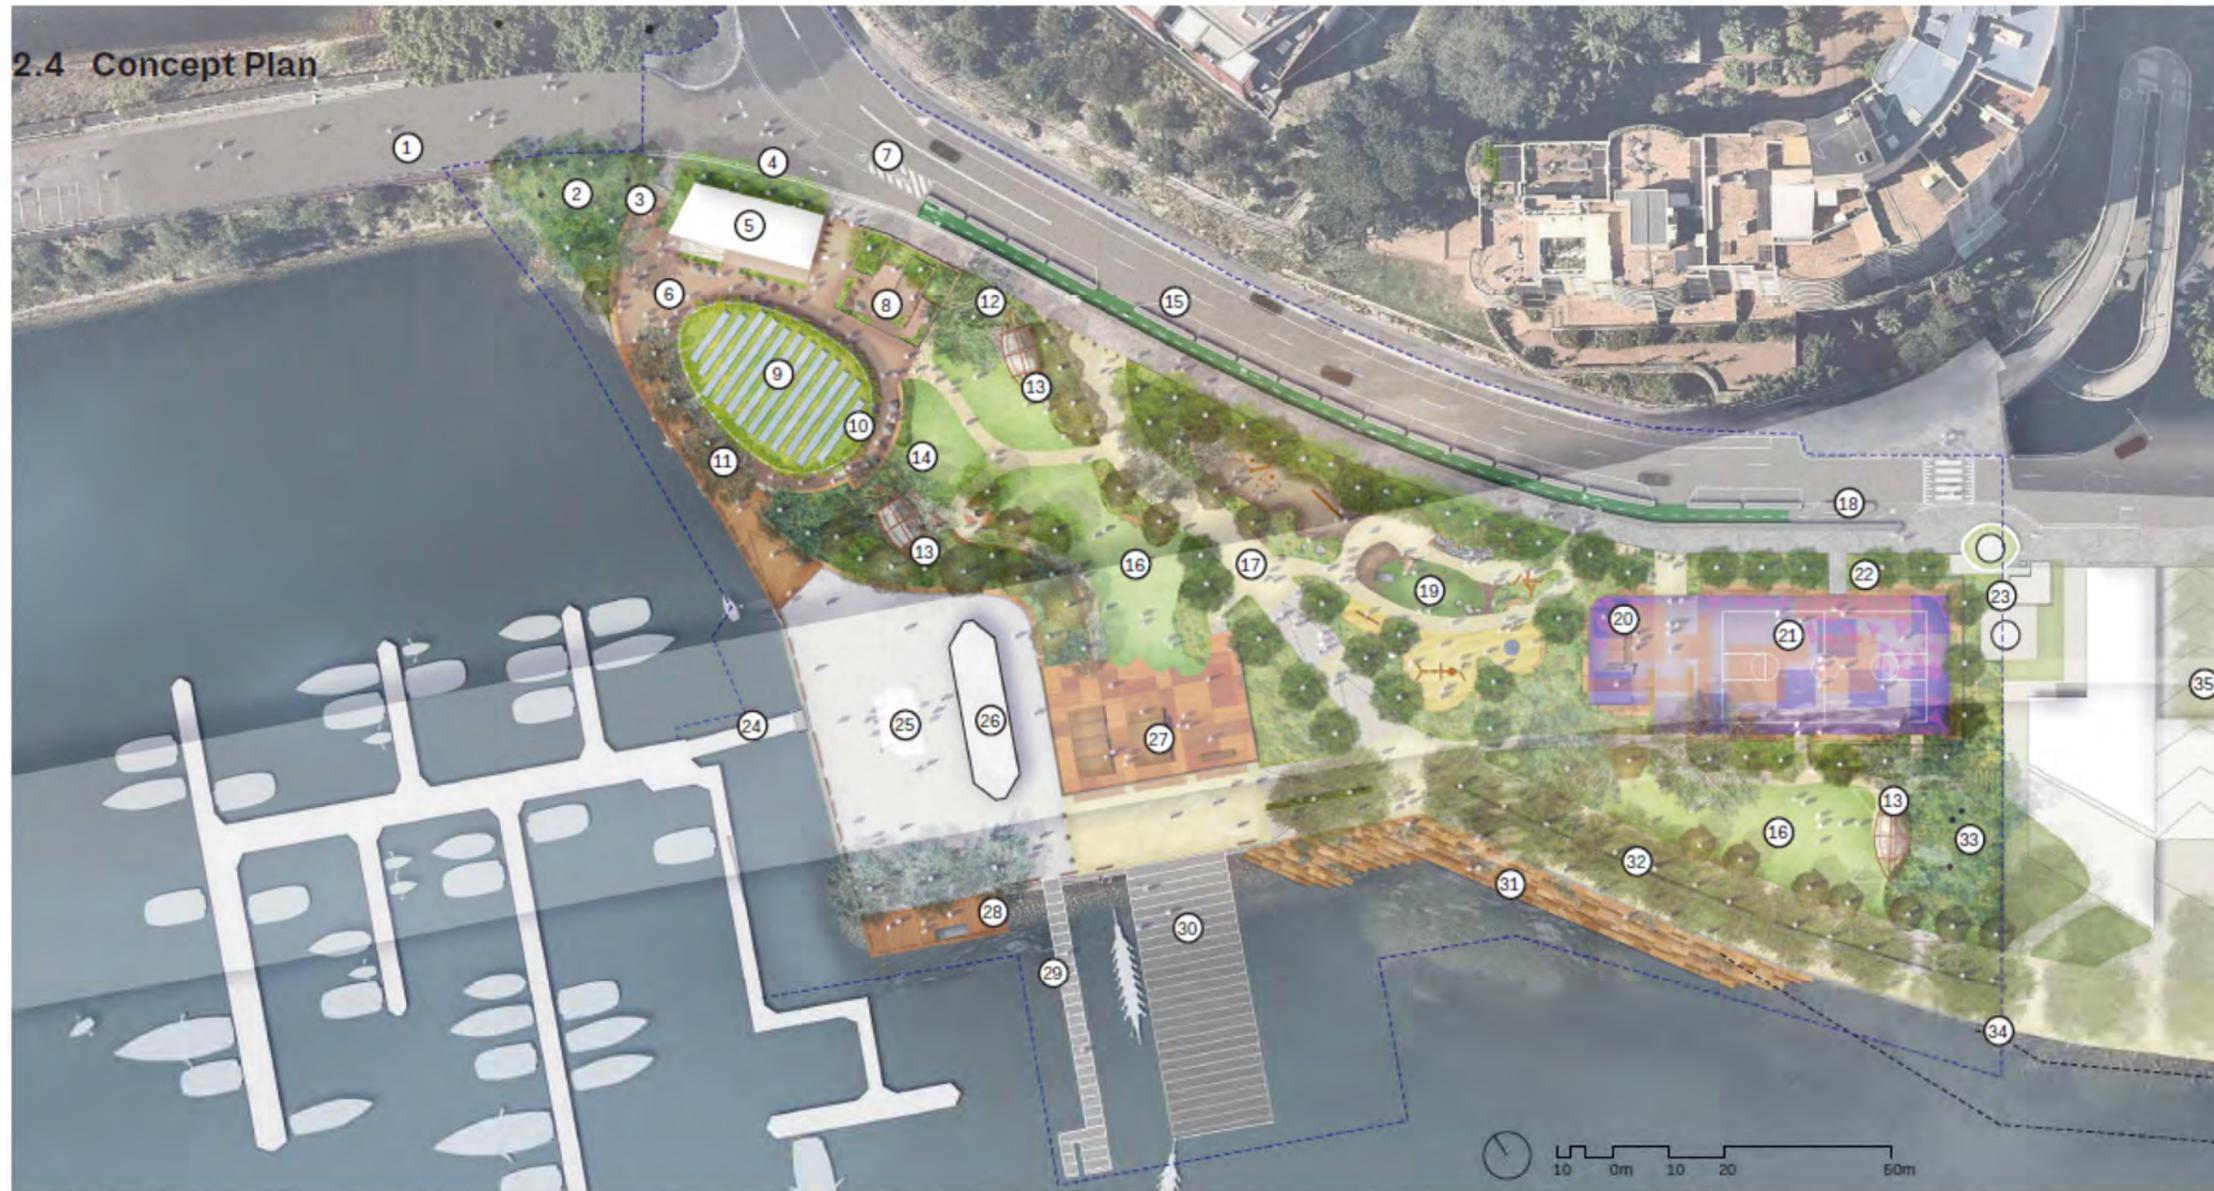
2.4 Concept Plan

| Legend | | | | | |
|---|---|---|---|---|--|
| ① | Glebe Island Bridge - potential pedestrian and cycle connection | ⑦ | Loading zone on Bank Street | ⑬ | Seating shelters amongst planting |

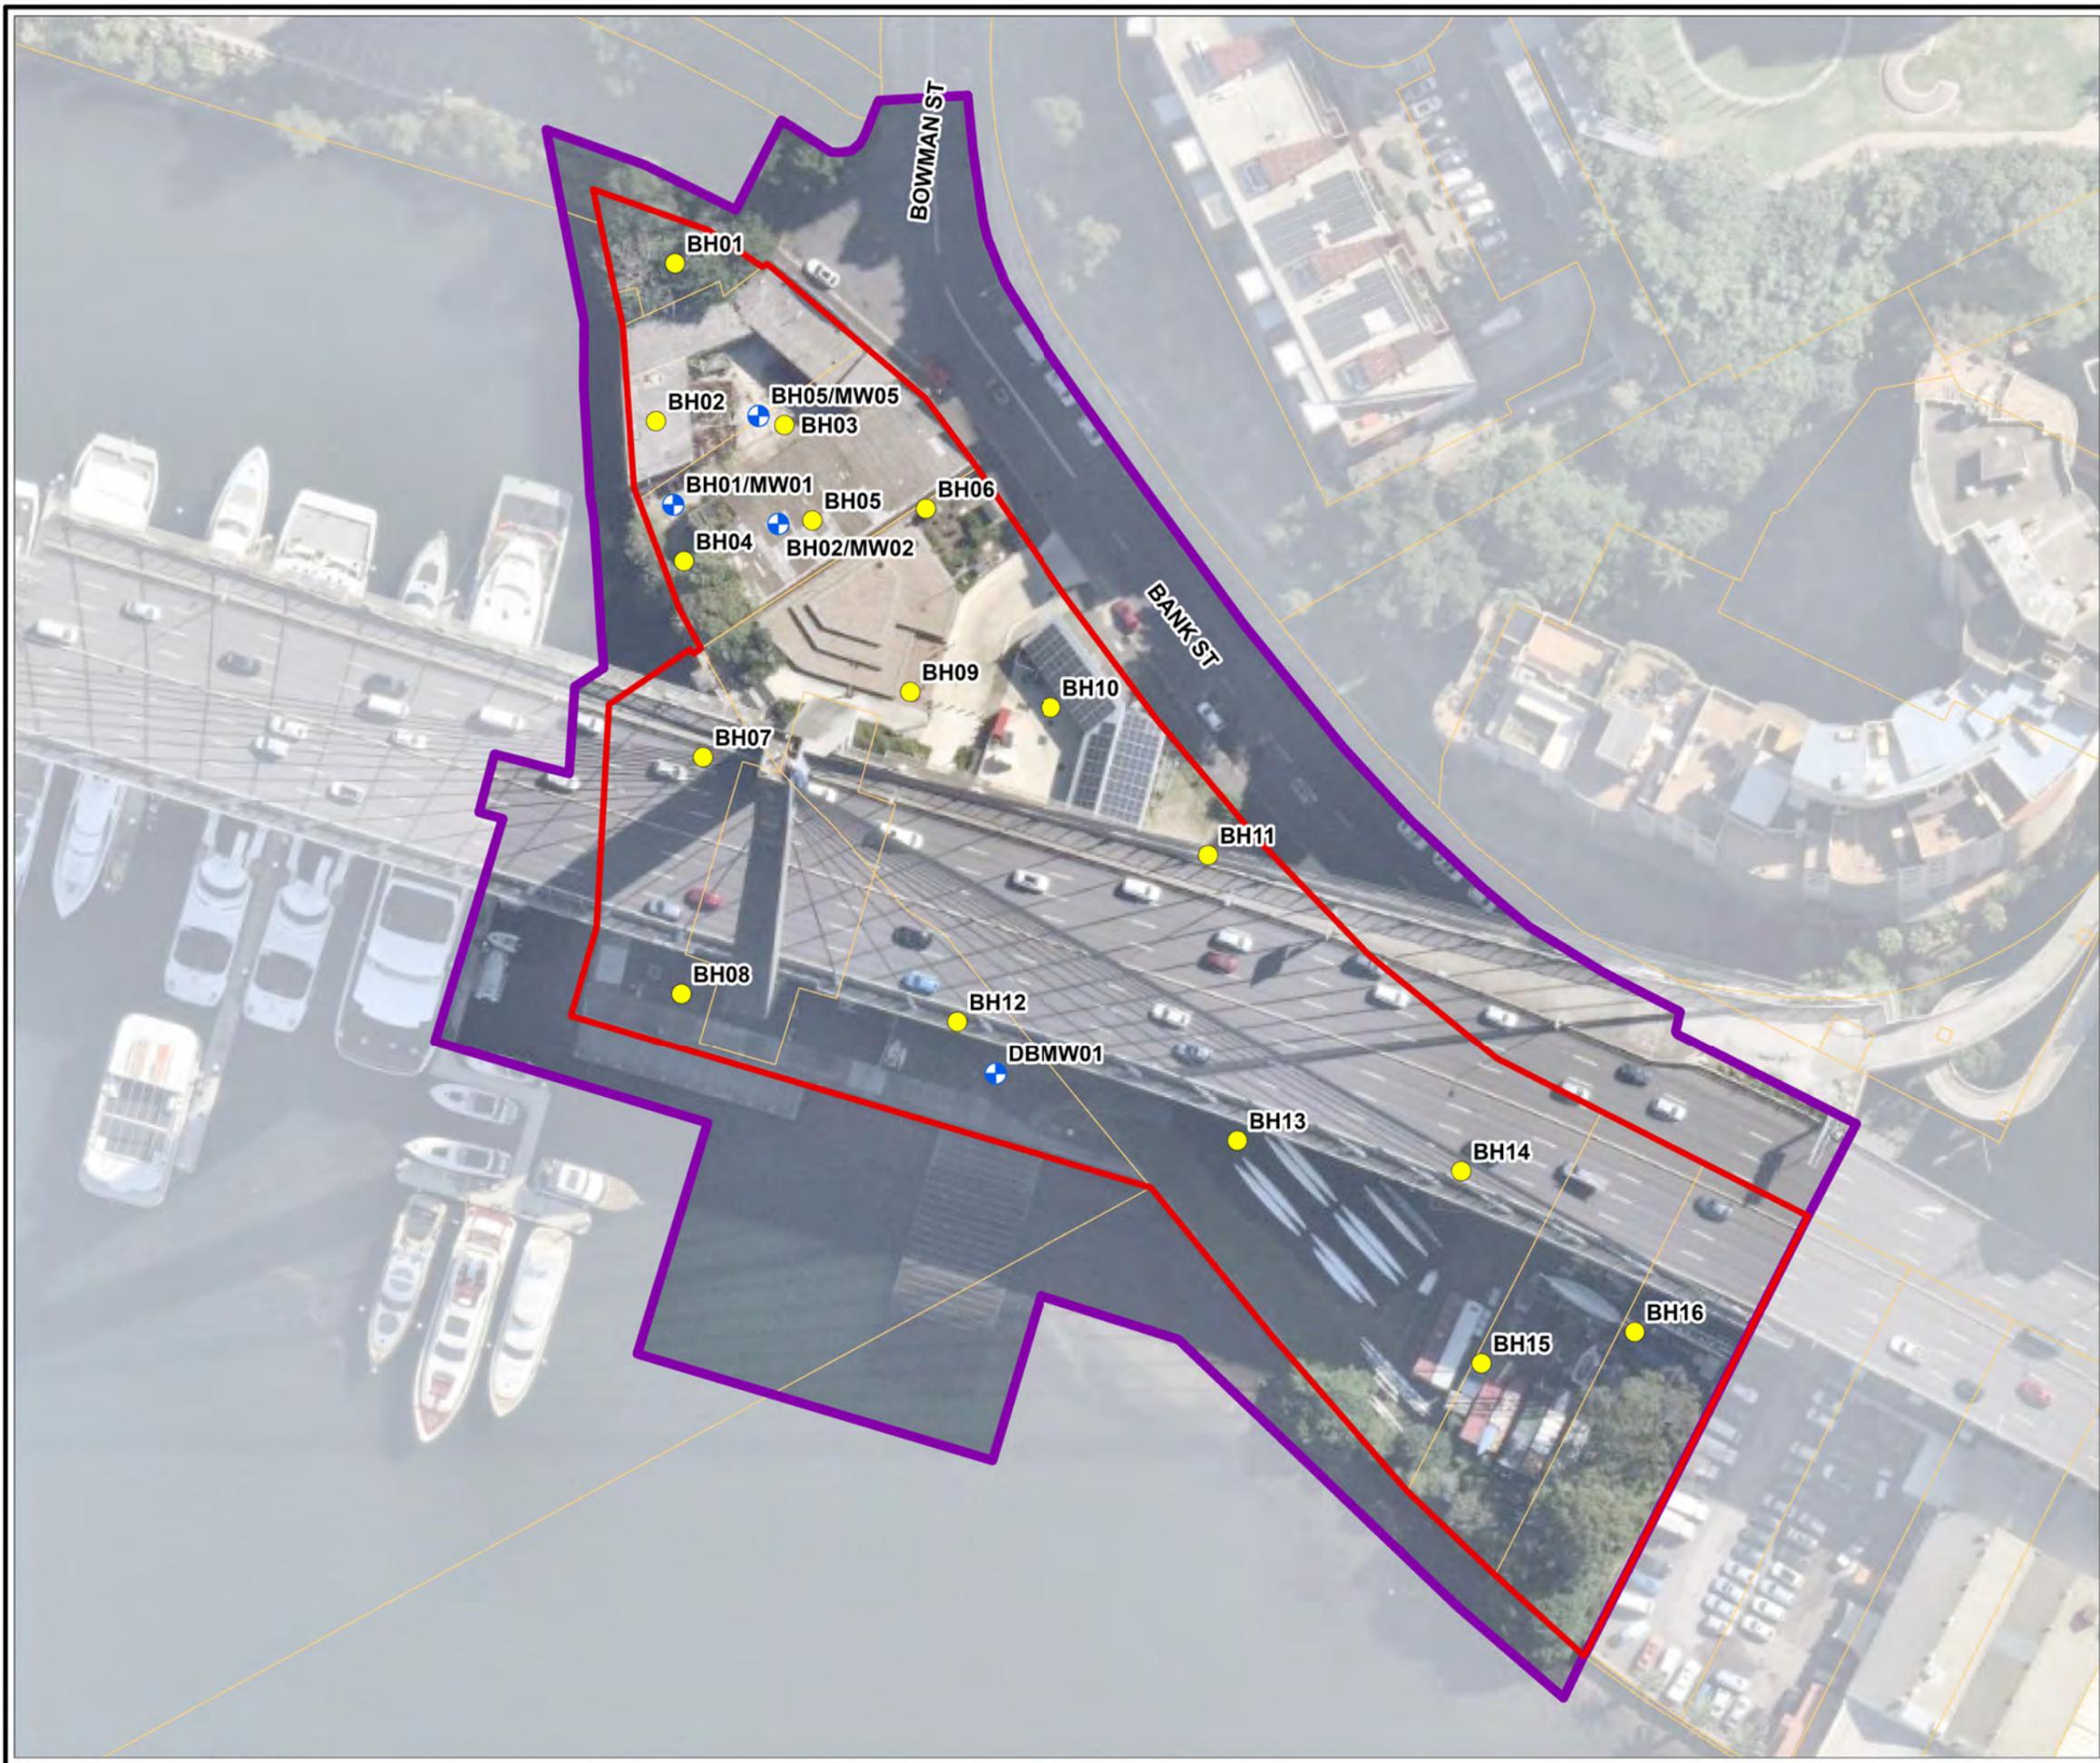
FIGURE 5

- Legend:**
- ▭ Site Area
 - ▭ Broader Site Area
 - ▭ NSW Cadastre
 - Soil Sample Location
 - ⊕ Groundwater Sample Location

SAMPLING LOCATIONS

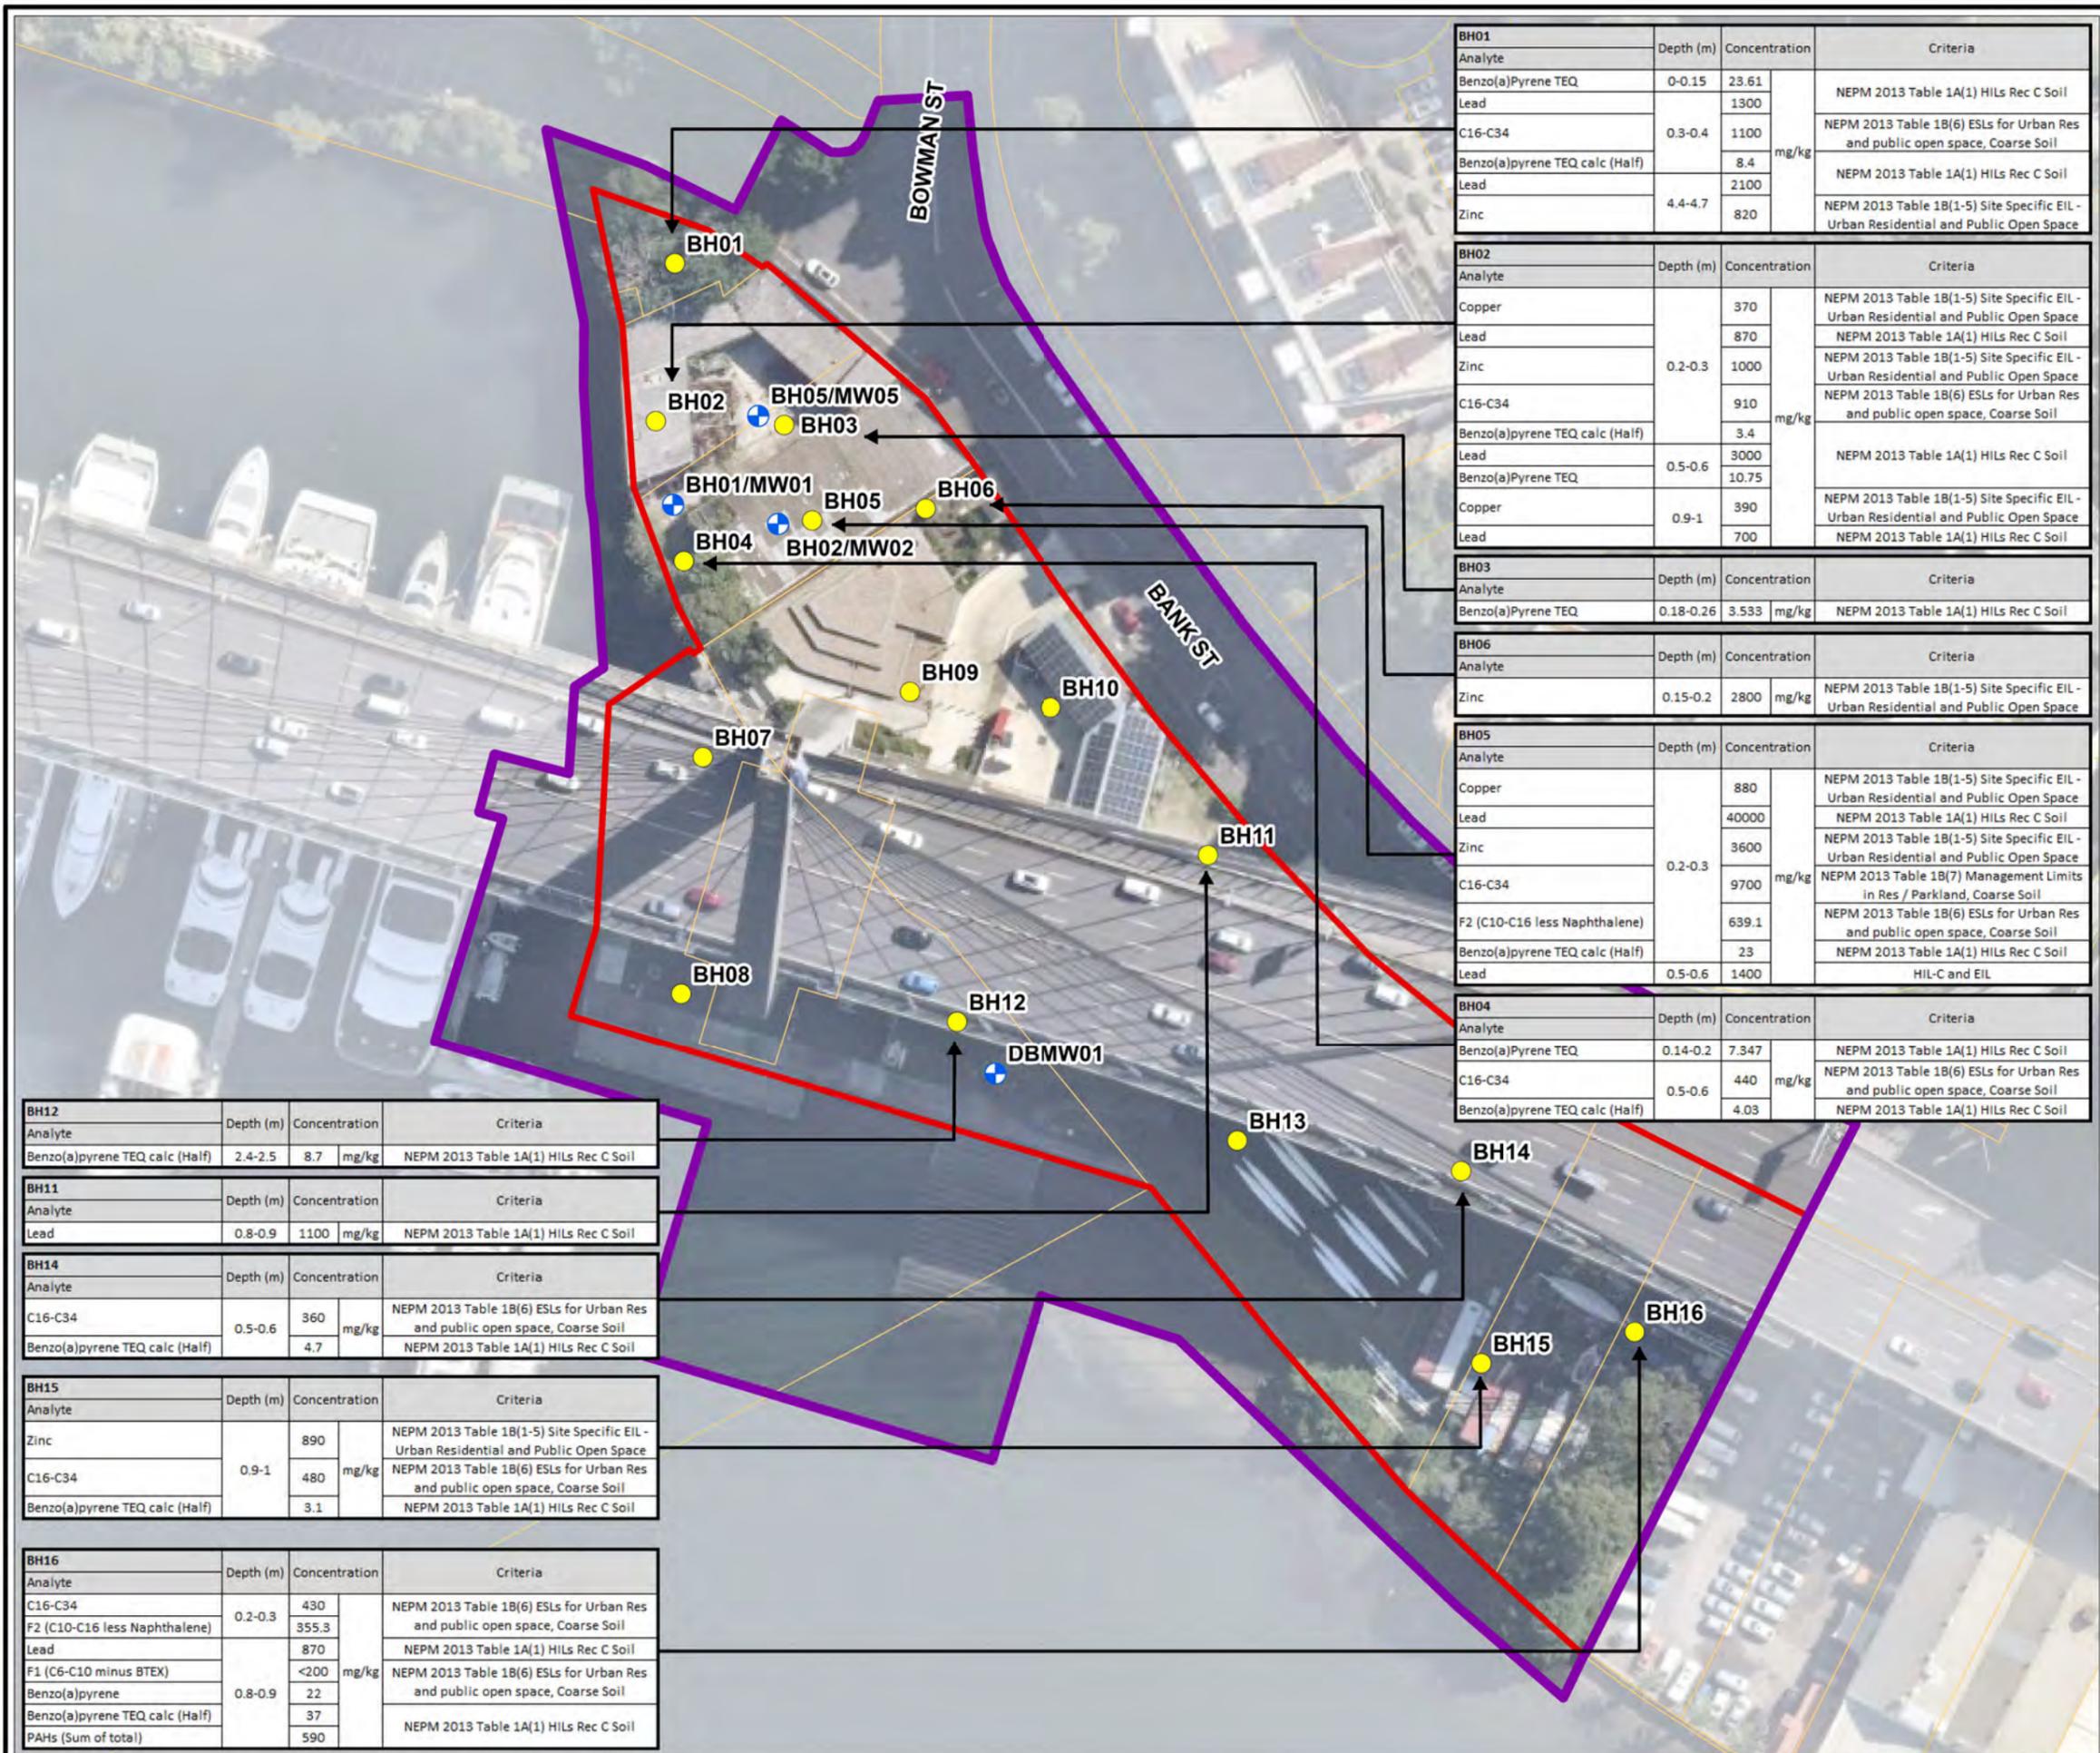
- Legend:**
- ▬ Site Area
 - ▬ Broader Site Area
 - NSW Cadastre
 - Soil Sample Location
 - ⊕ Groundwater Sample Location

**Bank St
 Pyrmont, NSW**
SOIL CHEMICAL EXCEEDANCES

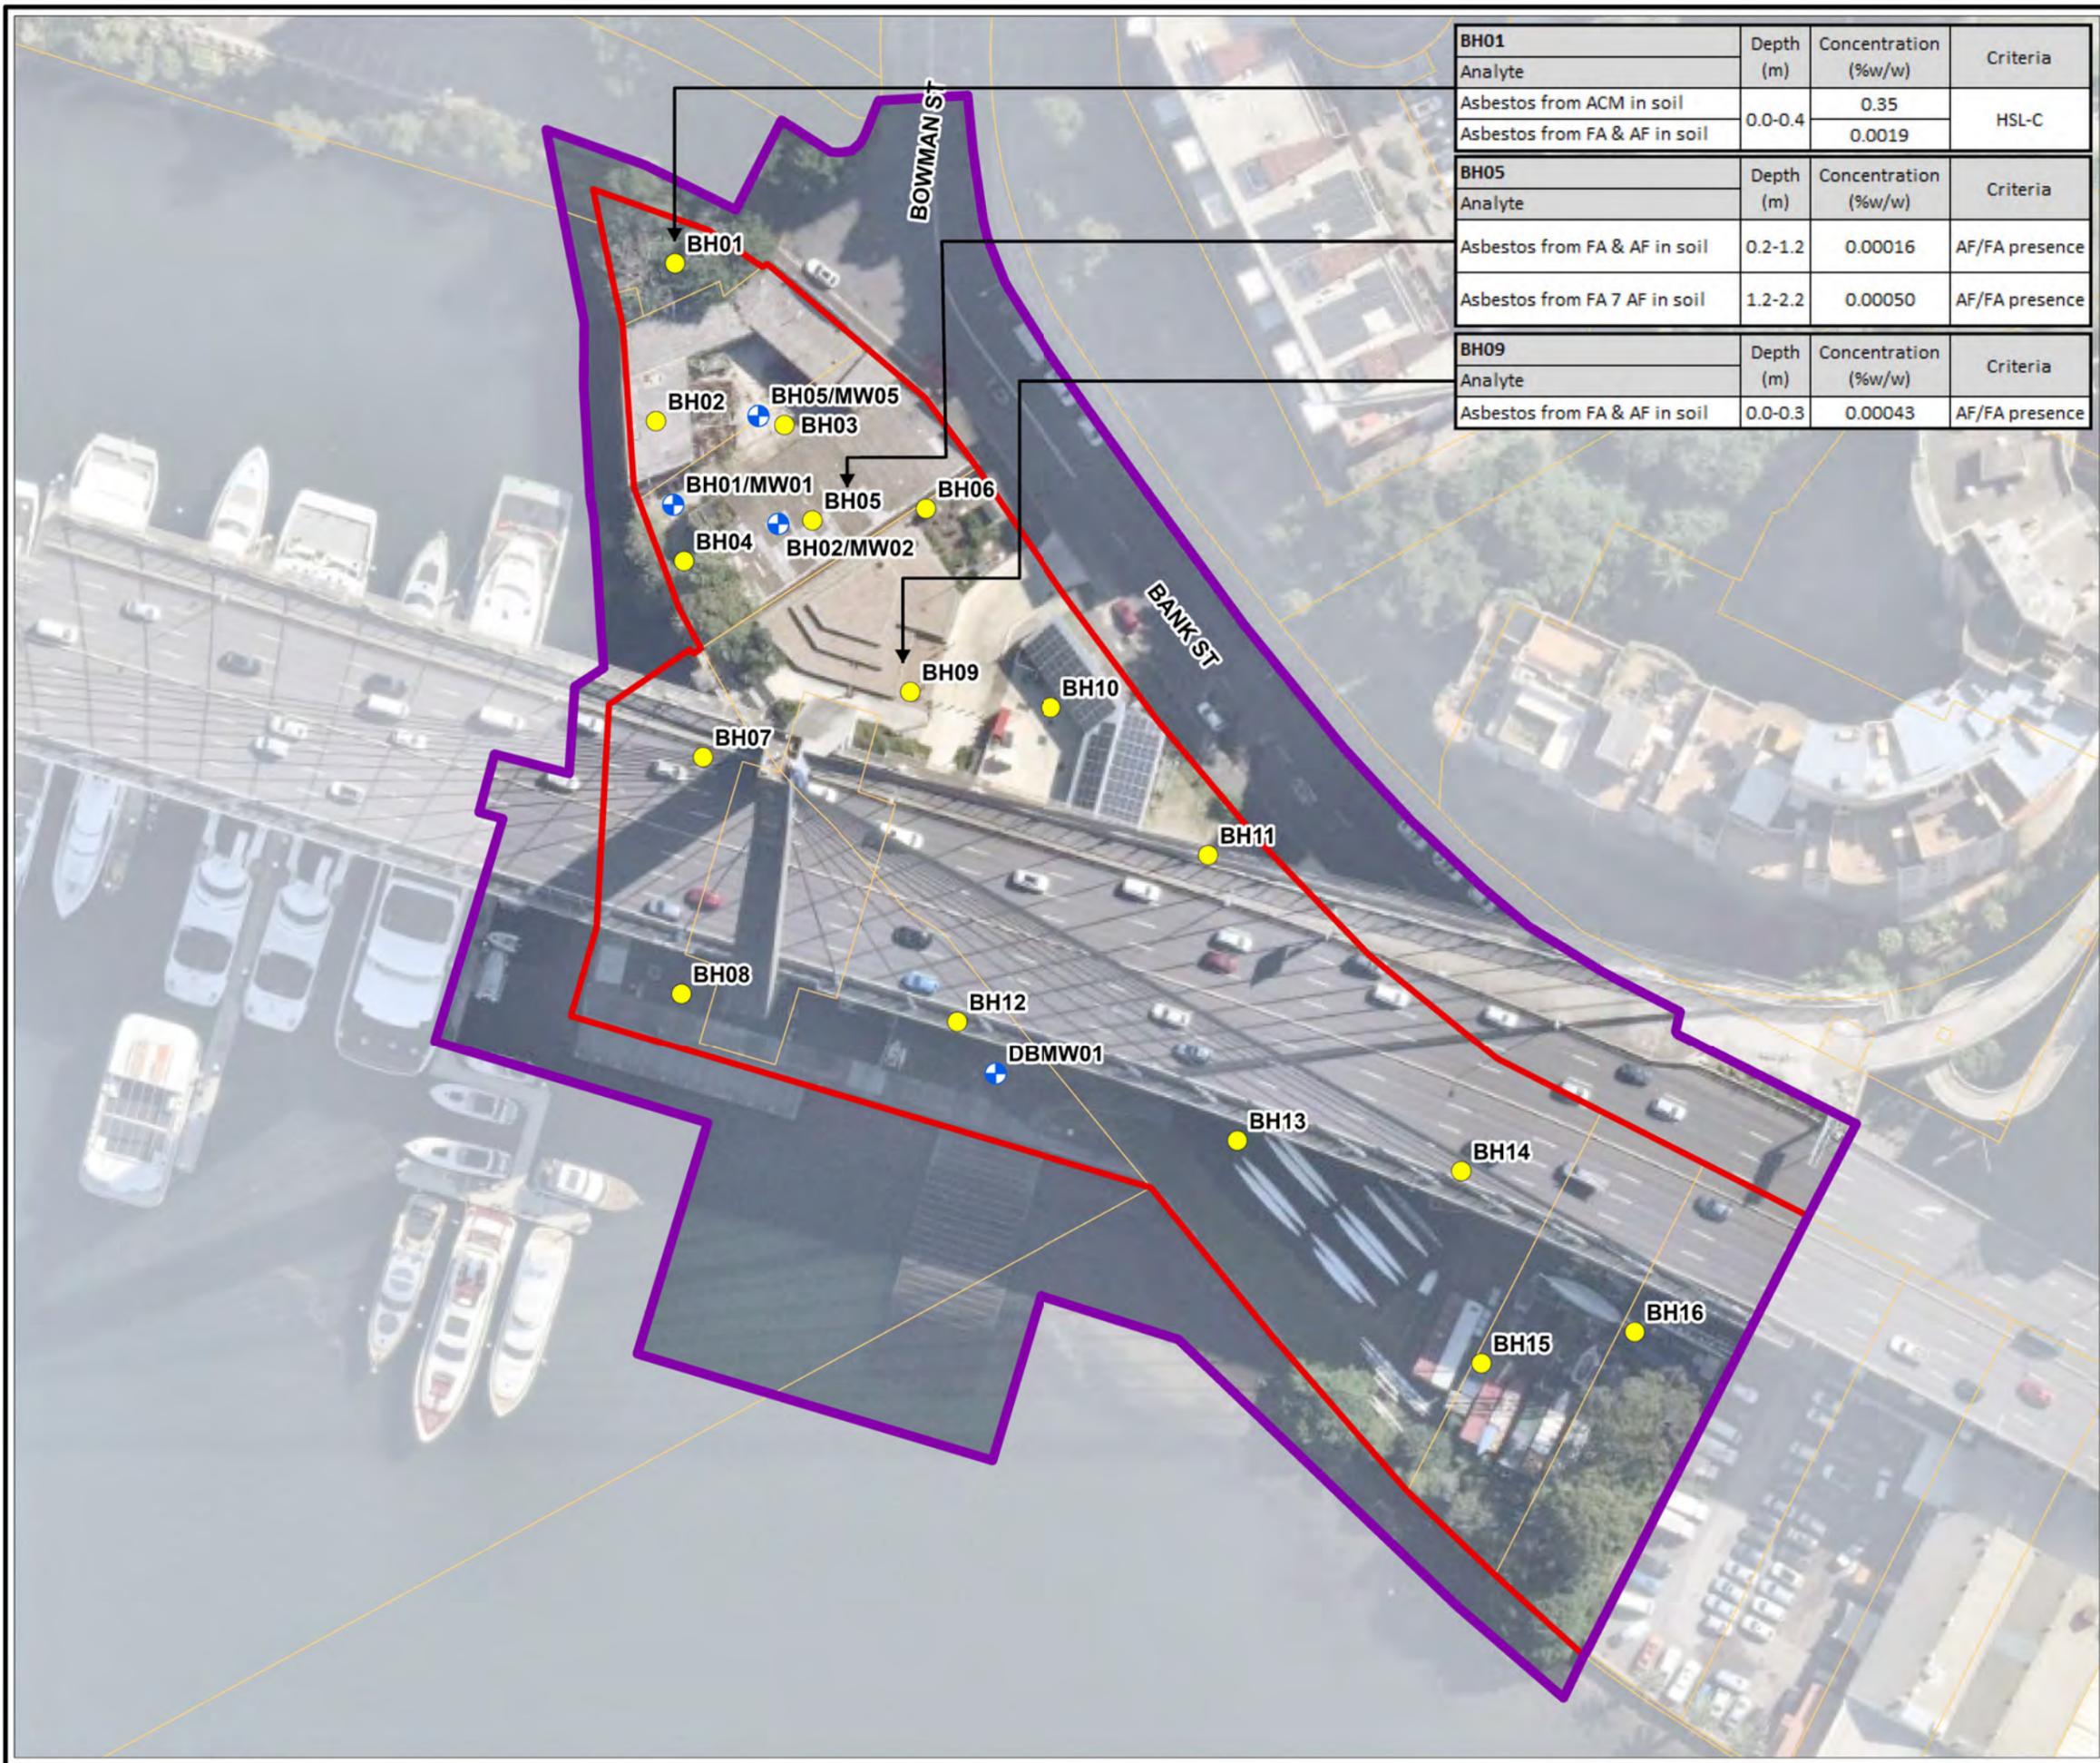
FIGURE 6B

**Bank St
 Pyrmont, NSW**
SOIL ASBESTOS EXCEEDANCES

- The data is likely to be representative of the overall conditions. The Auditor notes that sampling from boreholes is not ideal to assess for asbestos in heterogenous fill and further testing for asbestos has been proposed in the RAP (Figure 12.1, Section 12.3). The Auditor also notes that well construction details are not available for DBMW01, however the overall groundwater data set is sufficient to characterise groundwater conditions and identify remedial requirements.
- The data is complete.
- There is a high degree of confidence that data is comparable.
- The primary laboratory provided sufficient information to conclude that data is of sufficient precision.
- The data set is likely to be accurate.

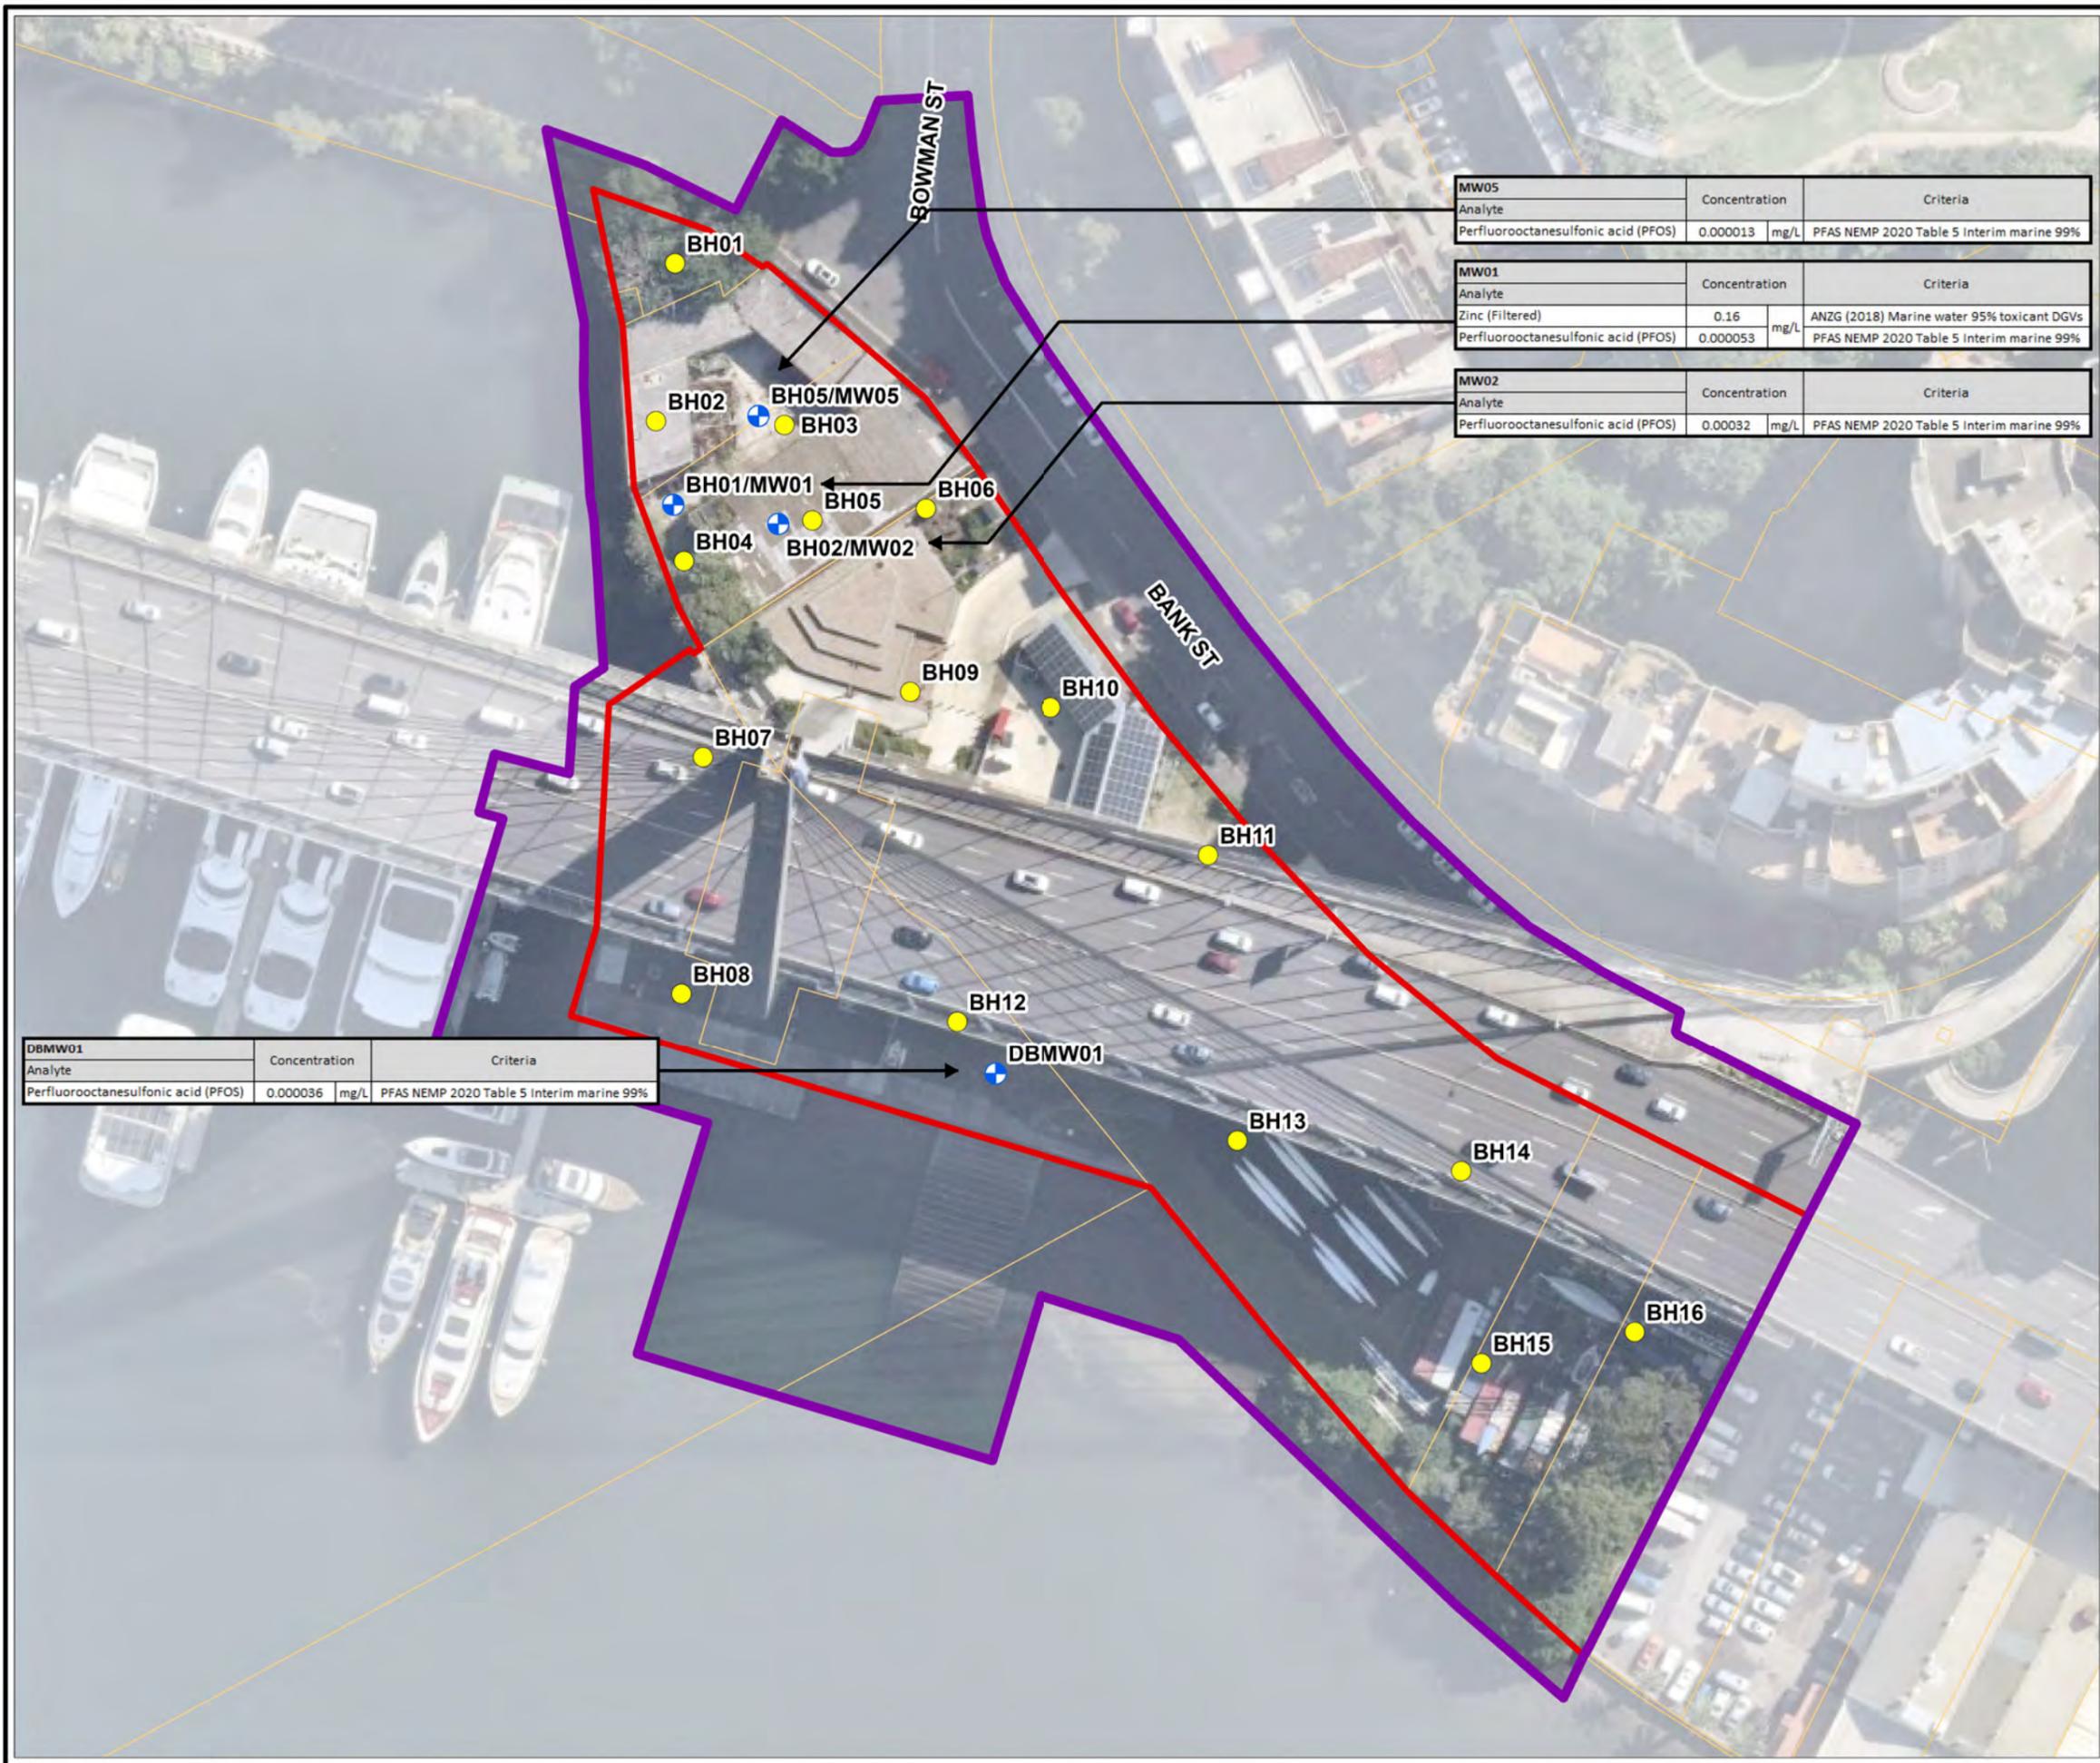
FIGURE 7

| MW05 | Concentration | | Criteria |

**Bank St
 Pyrmont, NSW**
GROUNDWATER EXCEEDANCES

- Low concentrations of TRH (>C₁₀-C₄₀ fractions) were detected in the groundwater sample from well MW05 and the reported concentrations were below the adopted environmental quality criteria. MW05 is located near the suspected UST.
- PFAS were detected in groundwater from the sampled wells including the inferred up hydraulic gradient well MW05. As such, the PFAS detections are likely to be representative of background conditions. It is, however, noted the reported PFAS concentration in MW02 (0.00032 mg/L) was an order of magnitude higher than those reported in the surrounding wells (0.000053 mg/L in MW01 and 0.000013 mg/L in MW05).
- Contaminant concentrations in groundwater were below the adopted human health criteria.

- Contaminant concentrations were below the adopted ecological criteria, except for copper, zinc, lead and PFOS. It is noted that:
 - Metal concentrations are likely to be representative of background conditions in the urban city environment.
 - PFOS concentration exceeding the HEPA (2020) 95% species protection ecological criterion for marine water was limited to MW02.
