Bank Street Park
Blackwattle Bay / Tjerruing

Site Audit Report (Ramboll Australia Pty Ltd)

SITE AUDIT REPORT REMEDIATION ACTION PLAN, BANK STREET PARK, PYRMONT NSW

Remedial Action Plan

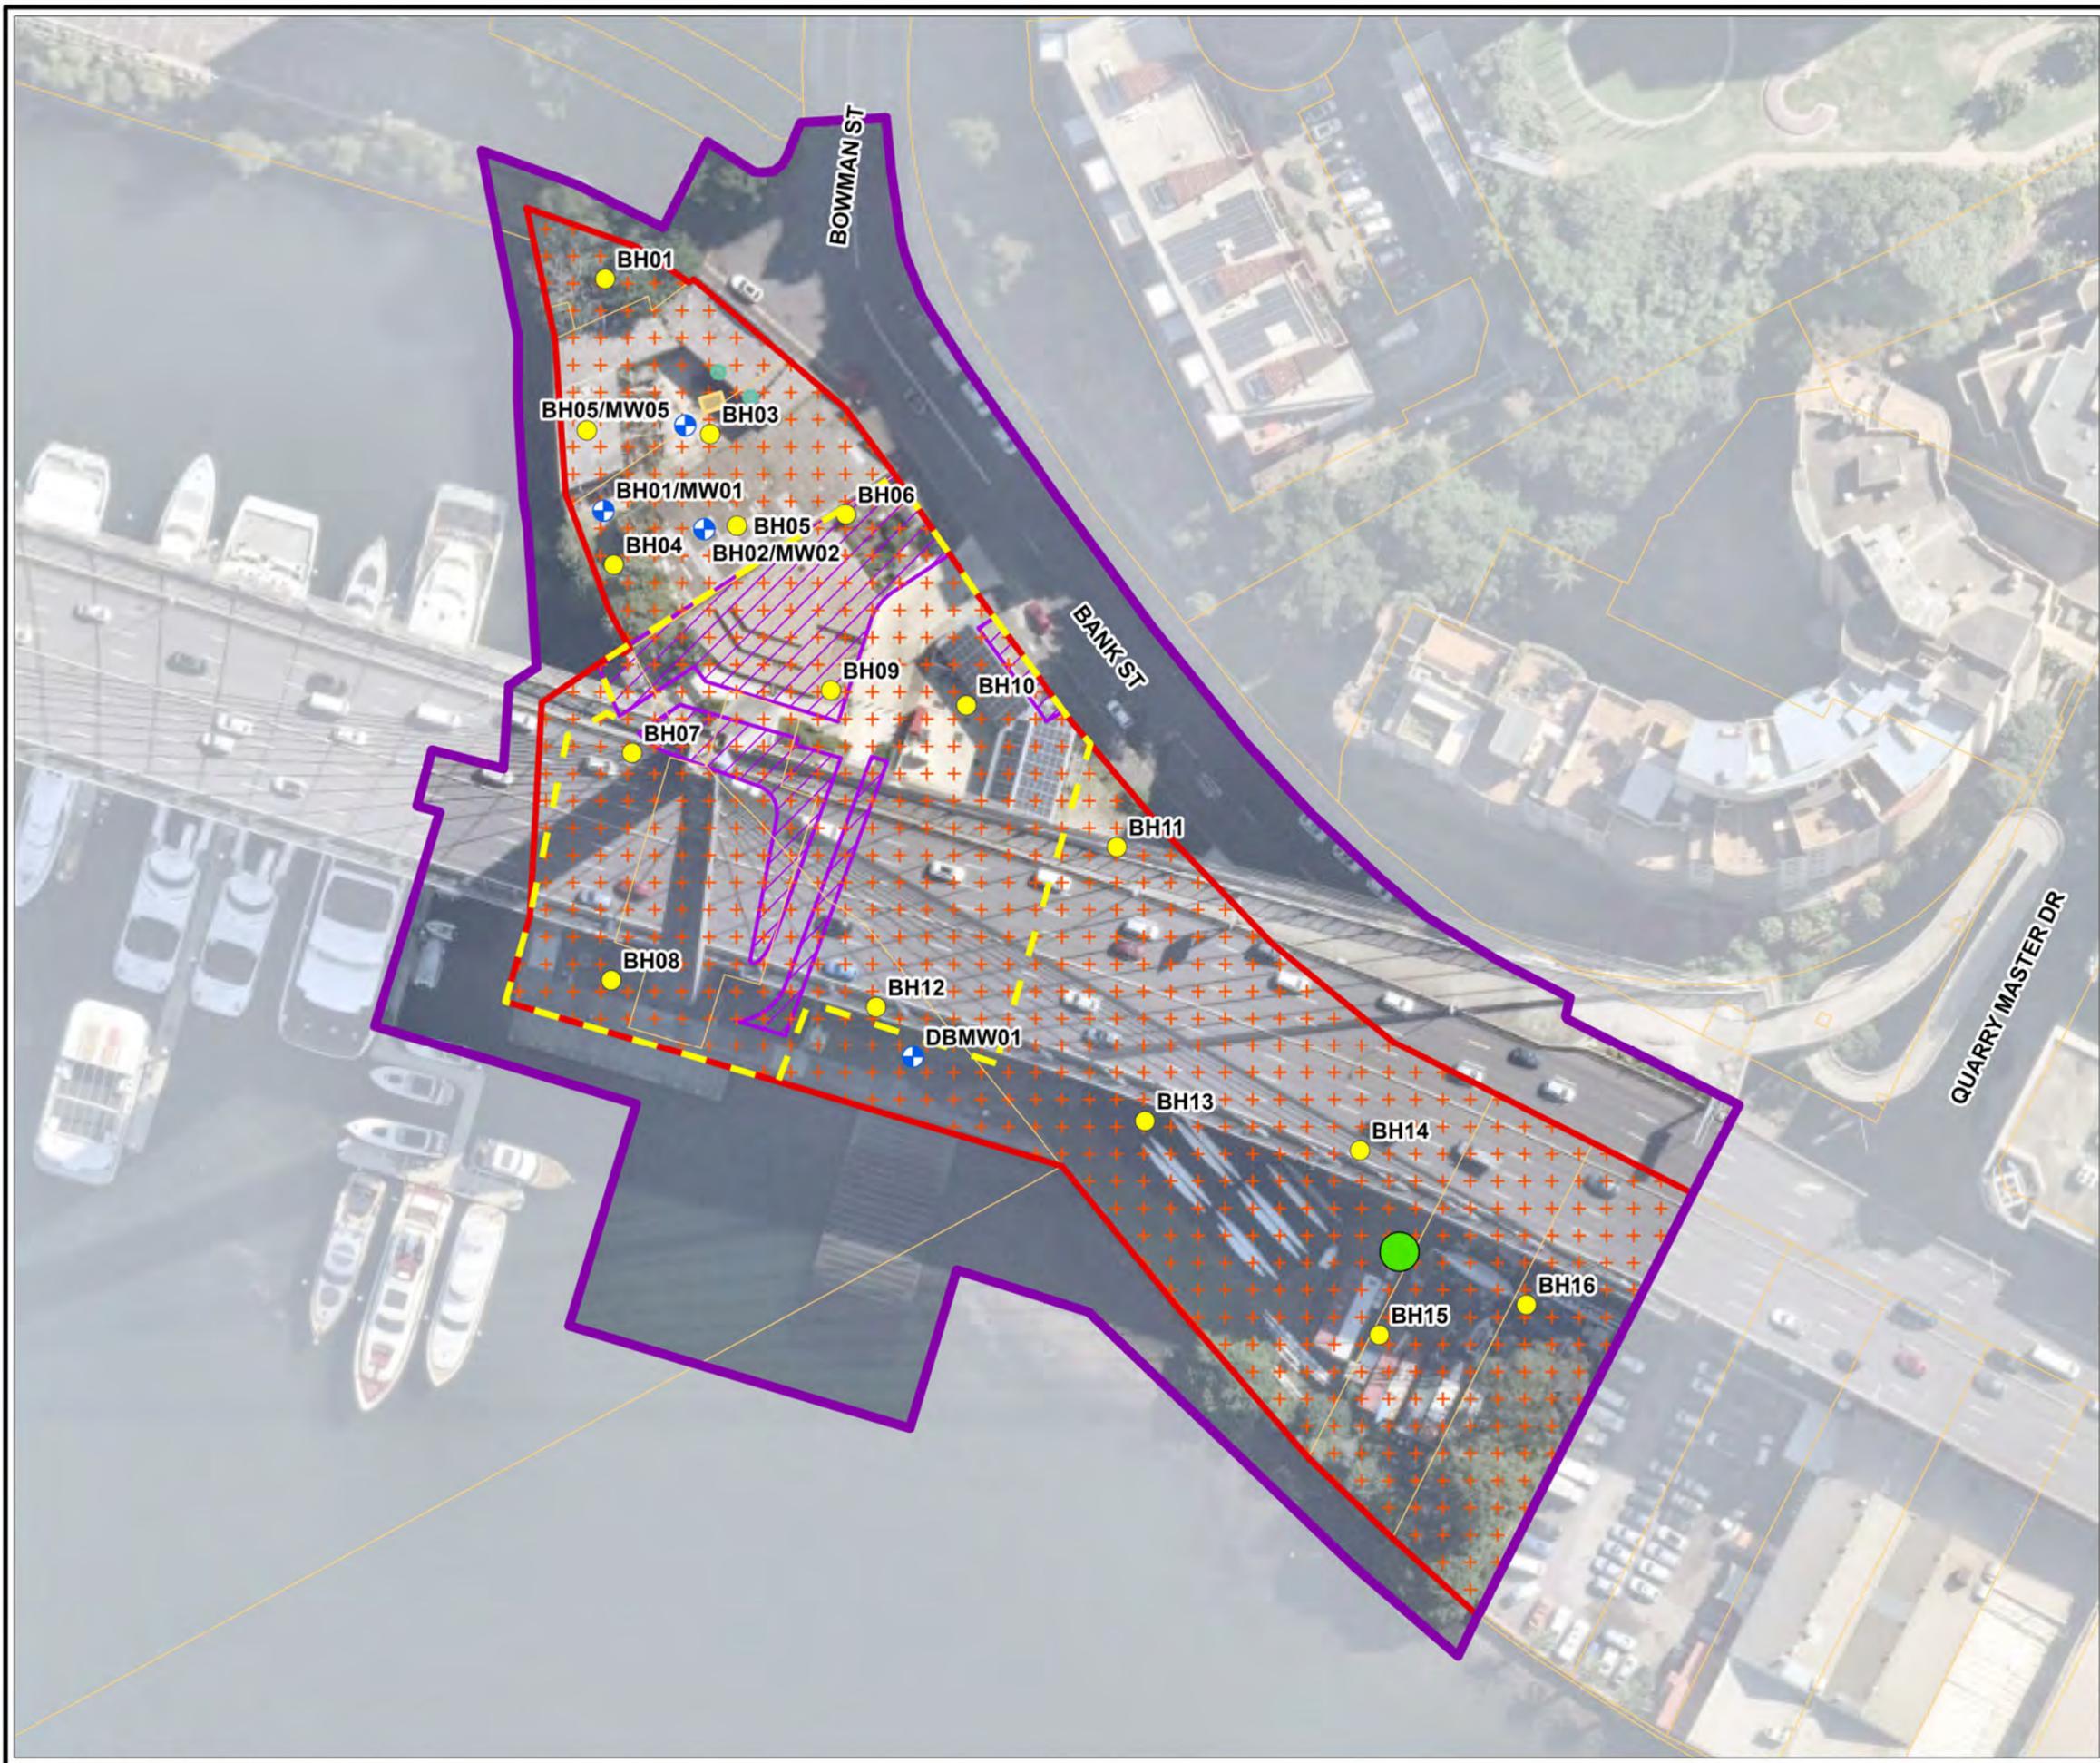
FIGURE 8

- Legend:**
- ▭ Site Area
 - ▭ Broader Site Area
 - ▭ NSW Cadastre
 - ▭ Impacted Material, CONSARA 2020a
 - ▭ Extent of Marker Layer, CONSARA 2020a
 - ▭ Asbestos, Heavy Metals, TRH and PAH
- Site Features**
- ▭ Potential UST
 - ▭ Vent
- Sample Locations**
- Groundwater Sample Location
 - Soil Sample Location
 - Hydrocarbon Odour

REMEDIATION EXTENT

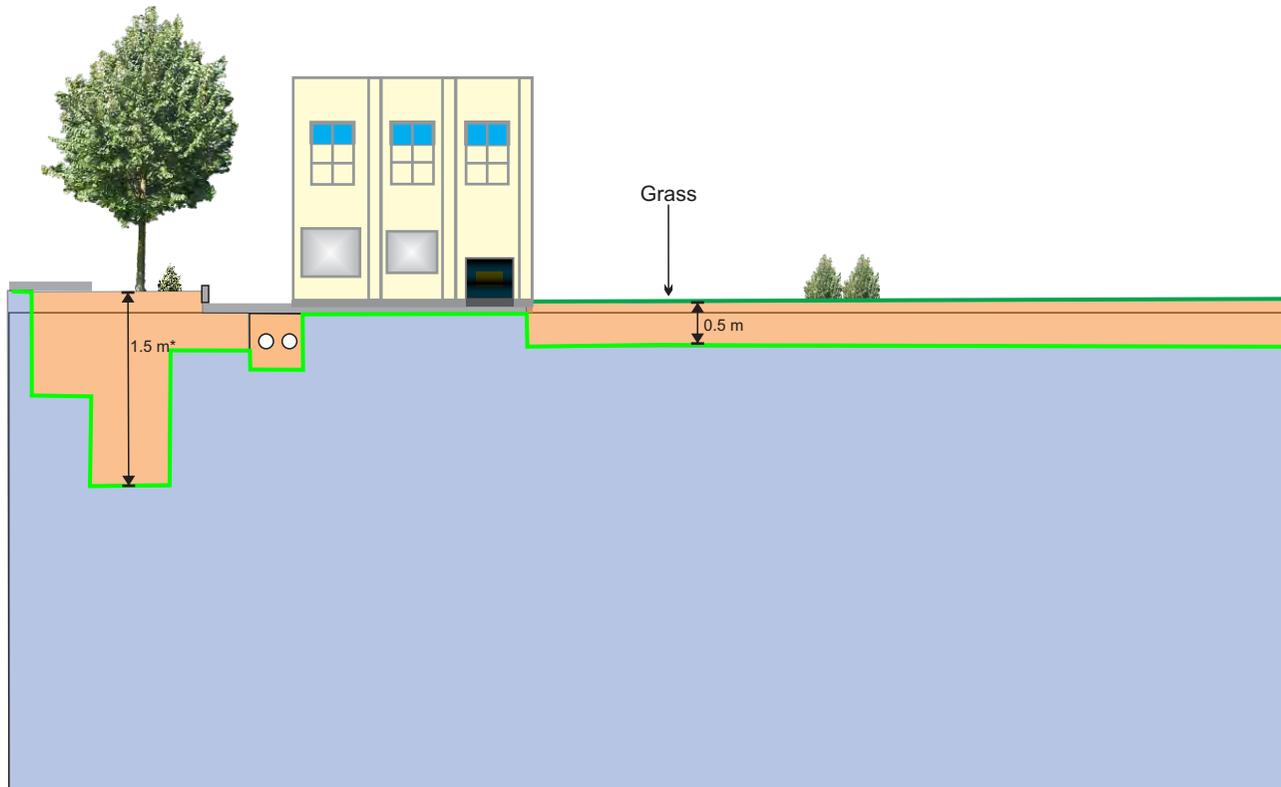
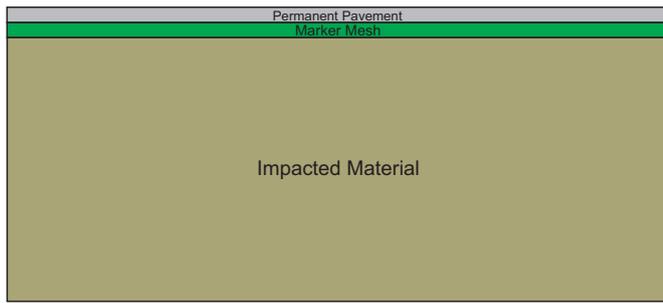
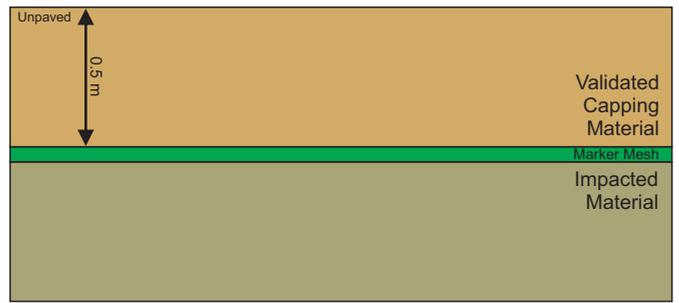
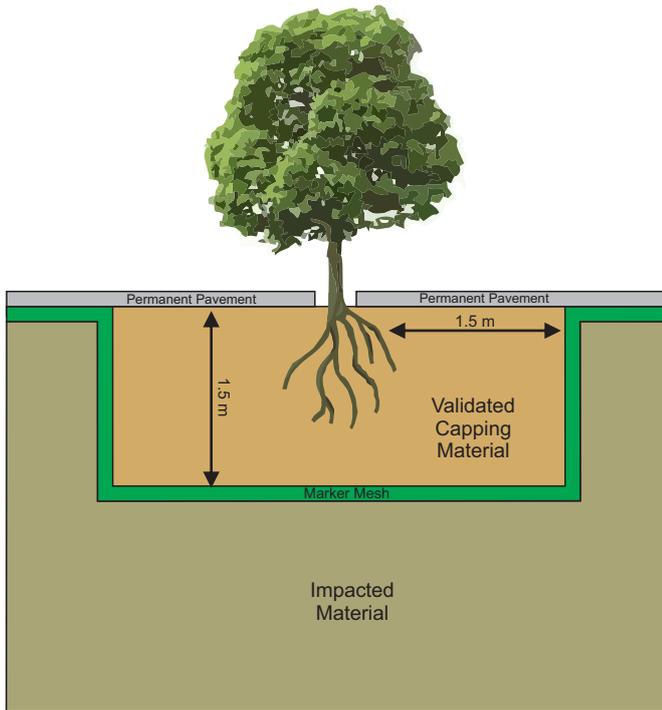
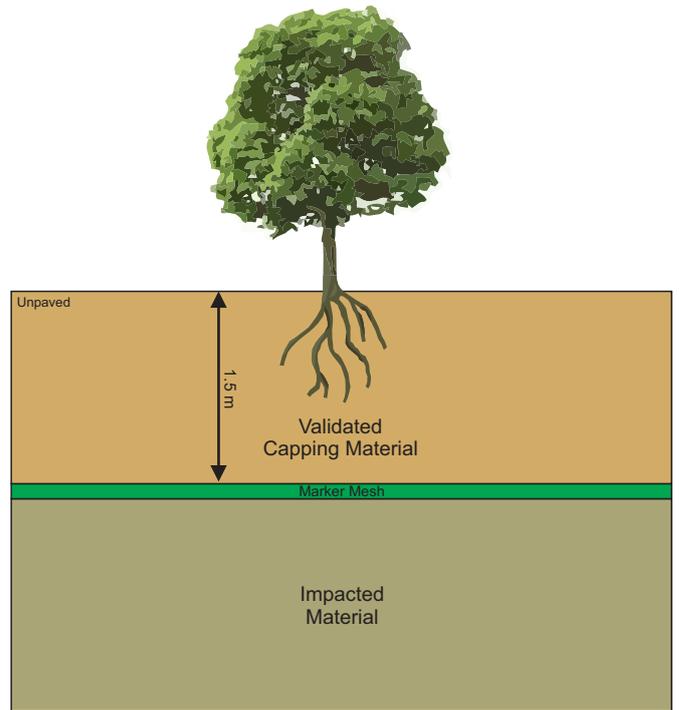
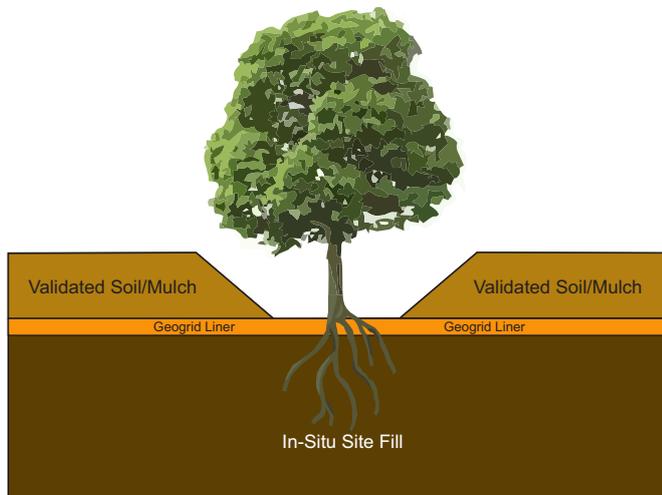
FIGURE 9A

- Services
- Marker Layer
- Capping Material
- Impacted Material

Capping Arrangement Under Permanent Pavement

Capping Arrangement Under Landscaped Areas (Shallow Rooted Plants)

Capping Arrangement For Deep Rooted Trees Under Permanent Pavement

Capping Arrangement For Deep Rooted Trees Under Landscaped Areas

Capping Arrangement For Existing Trees

| Remediation Action Plan | Auditor Comments |
|--|---|
| <ul style="list-style-type: none"> Pavement removal and excavation works to confirm the presence of the suspected UST and associated pipelines and subsequent decommissioning and removal of this infrastructure and associated impacts (if the UST is found to be present). Excavation and offsite disposal of fill soils with an elevated contaminant leachate generation/migration potential that are unsuitable to be retained under a cap and containment remedial strategy. Implementation of civil works and installation of a permanent physical barrier to cap and contain the balance of fill soils. <p>Types of capping proposed in the RAP include:</p> <ul style="list-style-type: none"> Beneath permanent structures: A marker layer over contaminated fill soils followed by a permanent concrete slab as the physical barrier. Permanent hardstand structures (e.g., concrete slabs): A marker layer overlying potentially contaminated material followed by pavement base course. Within underground services trenches/services: Services will require remediation to 150 mm below the depth of services, with a marker layer installed on the vertical and horizontal trench faces, followed by service installation and backfill consisting of environmentally suitable materials for potential human and/or ecological exposure. Turfed areas/shallow rooted plants: A marker layer at a minimum depth of 500 mm below final finished site level, with a capping layer consisting of environmentally suitable material for potential human and/or ecological exposure. New tree pit zones: Installation of an open cell mesh marker layer at a minimum depth of 1500 mm below the final finished site level, with a capping layer consisting of drainage/growing media that is environmentally suitable material. The marker layer should extend the depth required for installation of the new tree's root ball. Existing trees: The proposed methodology will be confirmed by consultation with the arborist, but is anticipated to comprise the careful removal of the existing ground cover by hand, installation of an open cell mesh marker layer and subsequent covering with environmentally suitable material for potential human and/or ecological exposure comprising free draining, no-fines inorganic mulch (10-20 mm diameter pea gravel or river pebbles, hard wood mulch, or similar). <p>Capping options are presented in Figures 9A and 9B of the RAP.</p> | |
