Bank Street Park
Blackwattle Bay / Tjerruing

Bank Street Park, Blackwattle Bay Precinct

Historical Archaeological Assessment

Archaeological Research Design and Excavation Methodology

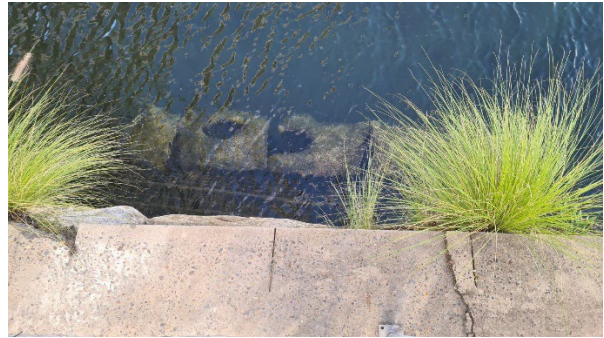
Figure 3.5 Detail of sandstone and metal mesh feature in water below sandstone seawall. View to southwest.

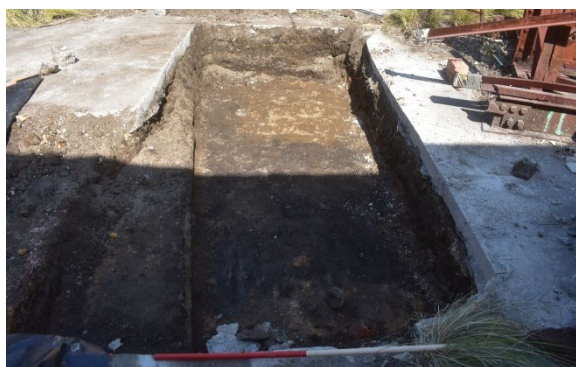
Figure 3.23 TT01 showing black fill and a patch of redeposited sandy topsoil. View to east. Scale 1m.

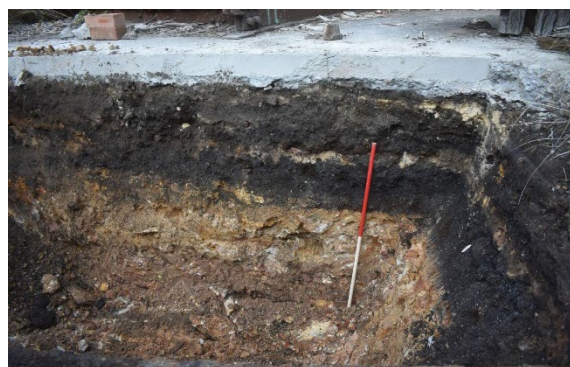
Figure 3.24 Section of TT01 showing historic fills and reclamation. View to south. Scale 1m.

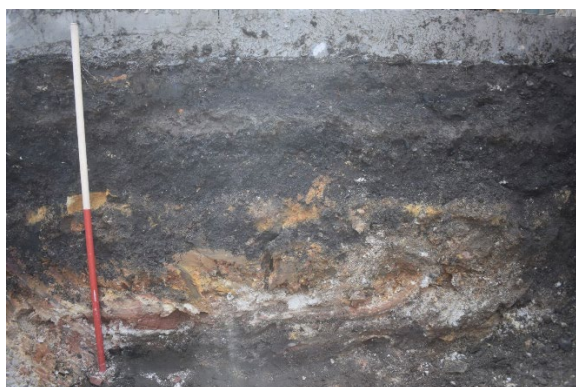
Figure 3.25 Section of TT02 showing sequence of historical fills. View to south. Scale 1m.

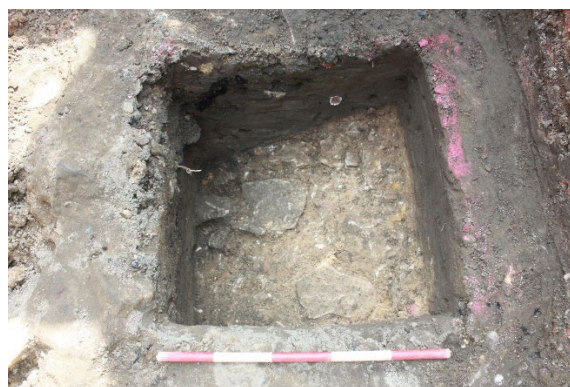
Figure 3.26 TU02 within TT2 showing potential colluvial/alluvial sediment above possible weathered bedrock or reclamation fill. View to west. Scale 0.5m

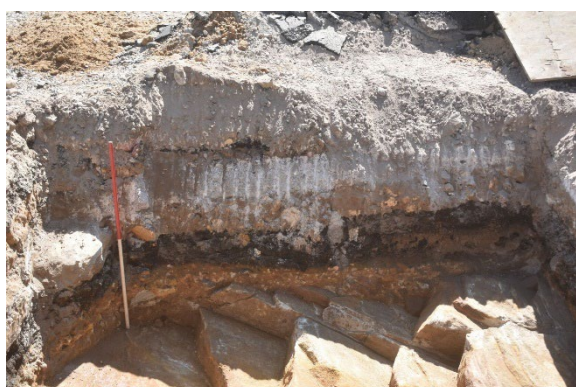
Figure 3.27 Section of TT03 showing modern and historical fills above bedrock. View to north.

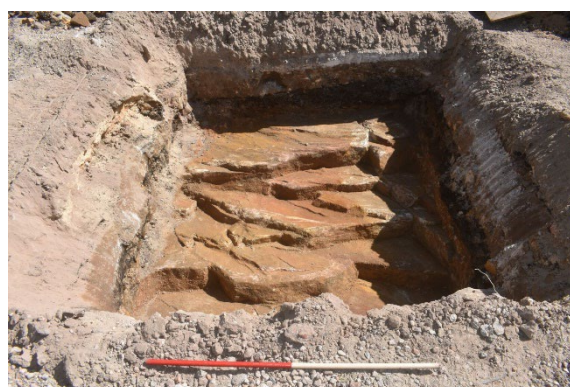
Figure 3.28 TT03 showing stepped and undulating bedrock at base. View to west. Scale 1m.

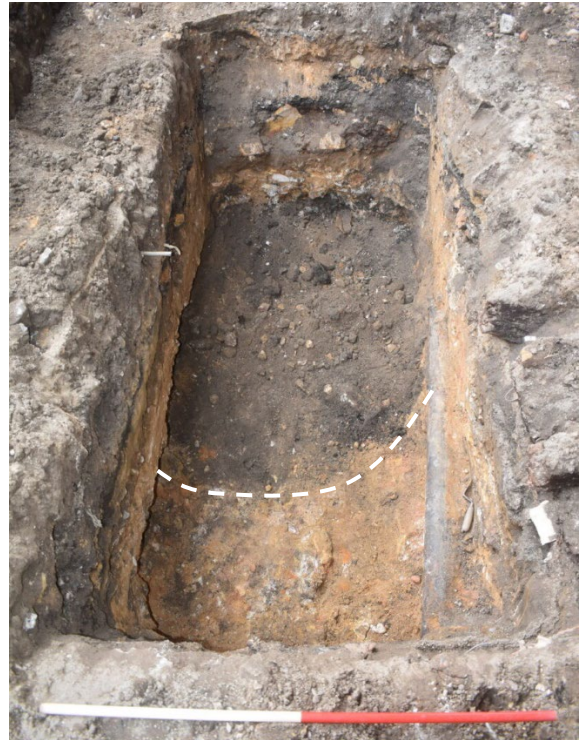
Figure 3.31 Possible cut/fill at the base of TT04. View to west. Scale 1m.

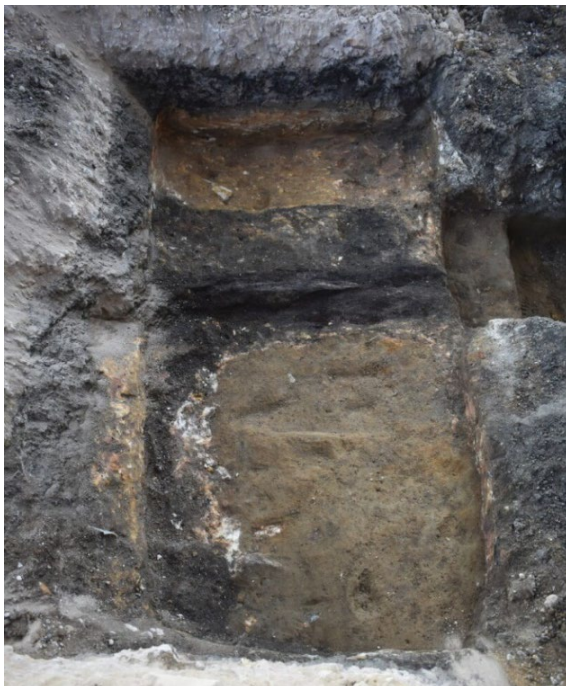
Figure 3.32 TT05 showing the possible wall slot cutting a possible natural deposit. View to north.

TT05, TU05 (Lot 20, DP 803159) Figure 3.32, Figure 3.33, Figure 3.34, Figure 3.35	Dimensions: 4.1 x 4.7m, 1.4m (depth) RLs: 4.42m AHD (surface) 2.93m AHD (base of excavations)	Phase 4: 1980s–present —modern levelling fills Phase 3/2: 1895–1980s —sequence of historic fills, including a sandy historic topsoil and various construction/levelling fills. Possible wall trench with a remnant timber beam (depth of c800mm), and possible channel in the bedrock. Phase 1: 1803–1895 —crushed sandstone reclamation/levelling fill. Bedrock observed at depth of 1.1m from surface.

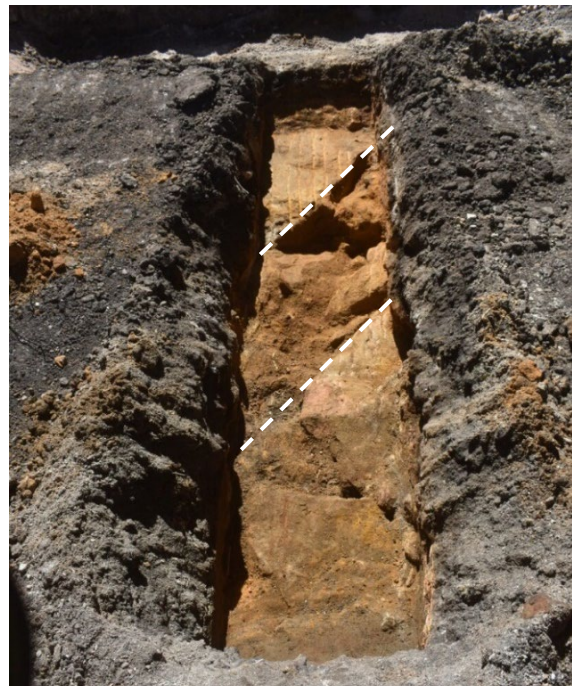
Figure 3.33 Bedrock at the base of TT05, with possible linear channel. View to north.

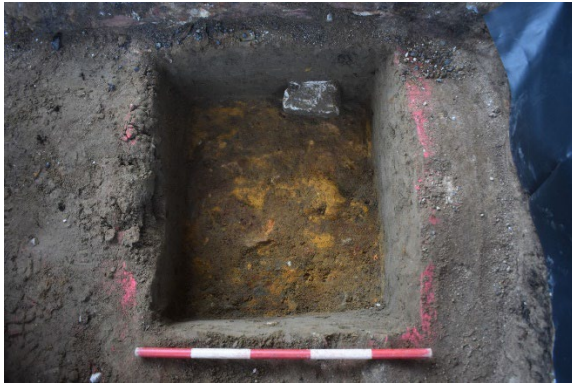
Figure 3.34 Mid-excavation TU05 within TT05.

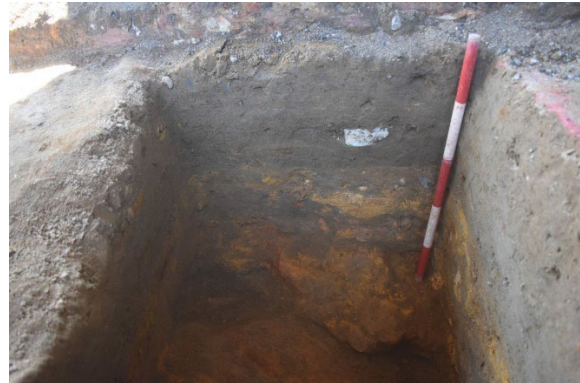
Figure 3.35 Post-excavation of TU05 within TT05.

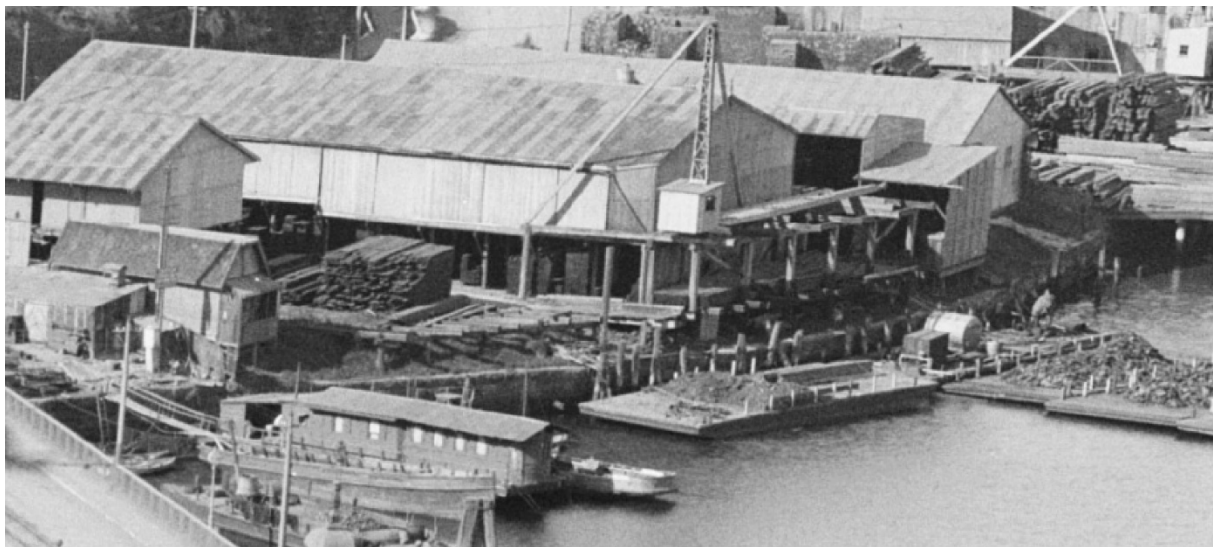
Figure 3.37 Detail from c1920s photograph of Glebe Island bridge showing the subject site. A stone seawall is visible running from the bridge to the jetty. The buildings are largely timber and iron construction. (Source: SLNSW, ON 30/Box 34–41)

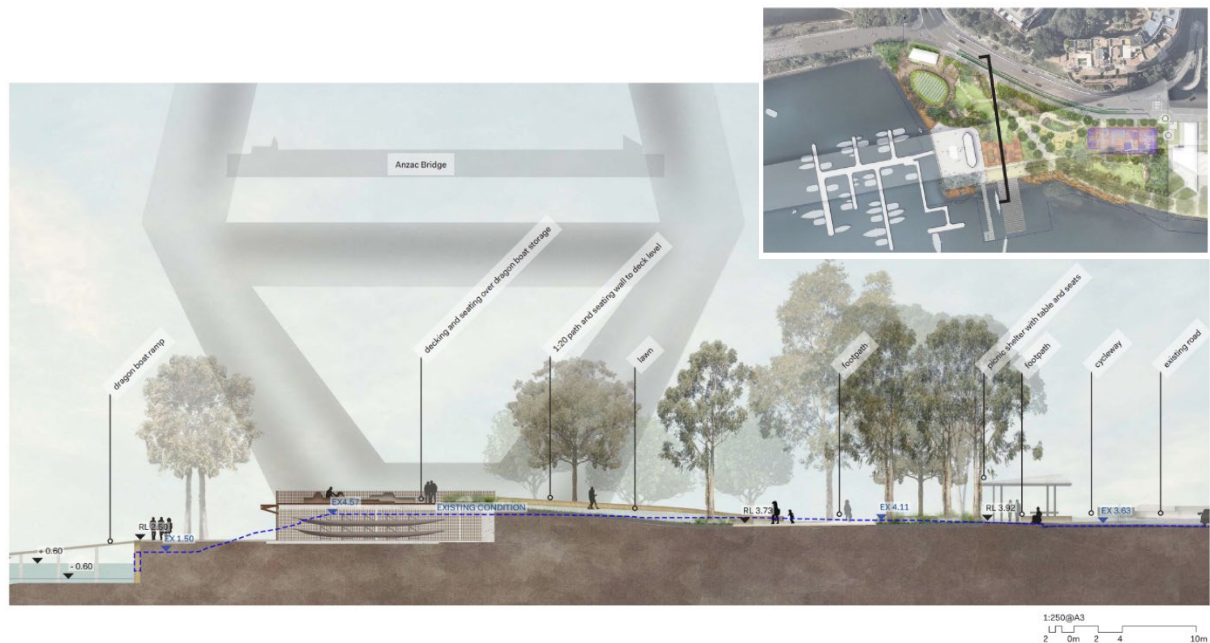
Figure 4.5 Section C (north-south section) through centre of Bank Street Park, showing the proposed reduction of ground level at the site of the proposed Dragon Boat Storage. (Source: Client provided)
