Bank Street Park
Blackwattle Bay / Tjerruing

Appendix U

Maritime Archaeological Assessment (GML)

Maritime Archaeological Assessment

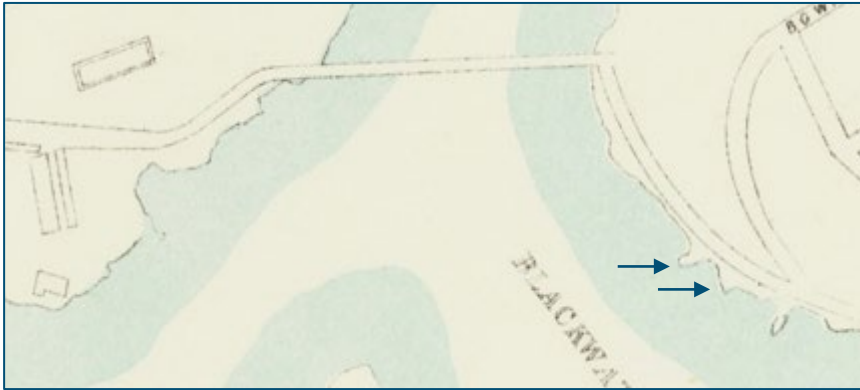
Figure 11: 1891 Sketch map of the City of Sydney & suburbs (Govt. printing Office, SLNSW DQ342.91/3; <https://collection.sl.nsw.gov.au/record/74VKDwjor26X#viewer>)

Two 1891 maps (Figures 11 & 12), both show the triangular wharf and a substantial new wharf complex immediately to its north – both within the underwater component of the Bank Street Park project area. These may be associated with timber merchants such as J. E. Handcock, who is listed in the Sands Directory towards the northern end of the bay in 1891 (Sands Directory 1891:1). A second 1891 Parish map, (Figure 11), shows both the triangular structures, and a larger wharf complex to its north. An overlay has been drawn from this georeferenced 1891 map to show the relationship of the two structures to the underwater cultural heritage study area (Figure 12).

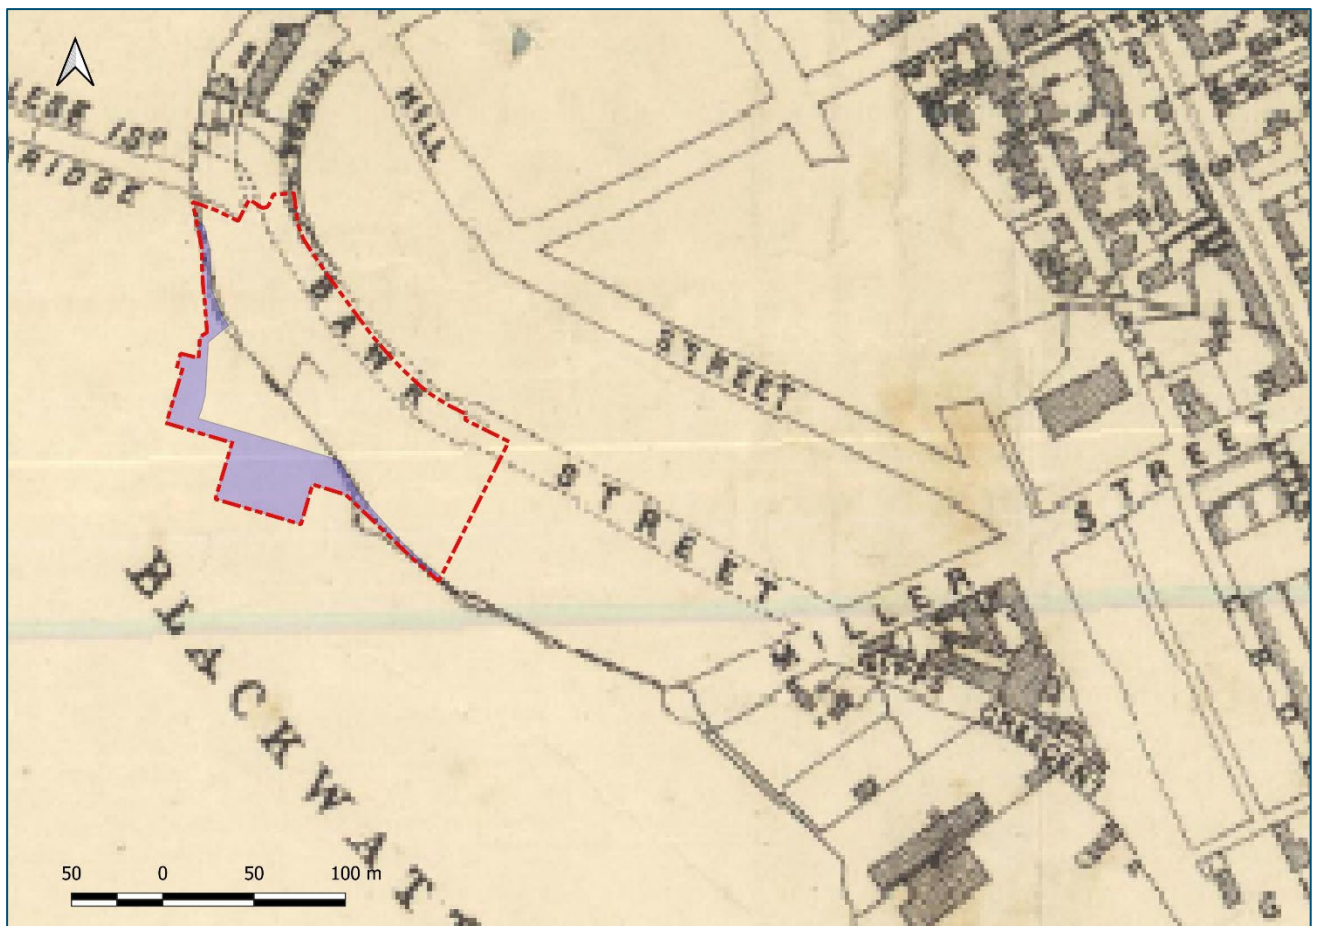
Figure 13: Port of Sydney 1903 map of the City of Sydney showing a shoreline feature, possibly a wharf, on the western side of Bank Street. This feature is not shown as extending into the bay. (Department of Lands, Sydney, NSW. <https://collection.sl.nsw.gov.au/record/74VMB0XRBBey#viewer>)
