Bank Street Park  
Blackwattle Bay / Tjerruing

## Geotechnical Assessment (JK Geotechnics)

FOR  
**PROPOSED BANK STREET PARK**

AT  
**1A-19 BANK STREET, PYRMONT, NSW**

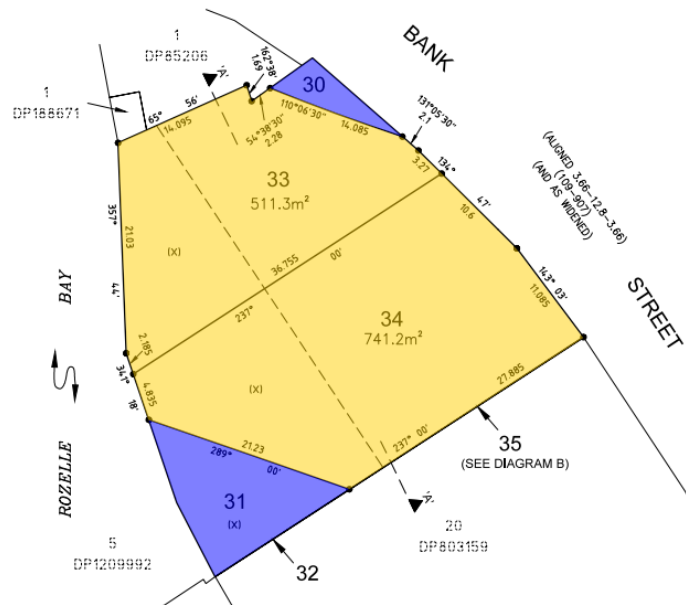
Plate 2 – Plan view of stratum acquisition for the Metro tunnel

The future Sydney Metro tunnel extending from Westmead to The Bays will extend below the subject site and approximately parallel with the northern side of Anzac Bridge, as shown on the attached Figure 2. Furthermore the extent of the Sydney Metro substratum acquisition is shown in Plates 2 and 3 below. The substratum acquisition extends across the majority of the site, as highlighted yellow in Plate 2 below, and extends up to RL-28.55m, as highlighted yellow in Plate 3 below.

Based on the available information, the first reserve extends to RL-28.55m, which is the extent of the Sydney Metro substratum above the tunnel crown. Furthermore, whilst the proposed tunnel diameter is unknown, the tunnel external diameter for previous Sydney Metro tunnels has typically been 7m. Based on this tunnel diameter, the second reserve extends for a distance of 21m. Therefore, in accordance with Technical Guidelines, the greater of the criteria is adopted, resulting in the second reserve extending approximately 25m beyond the first reserve, i.e. extends up to RL-3.55m.

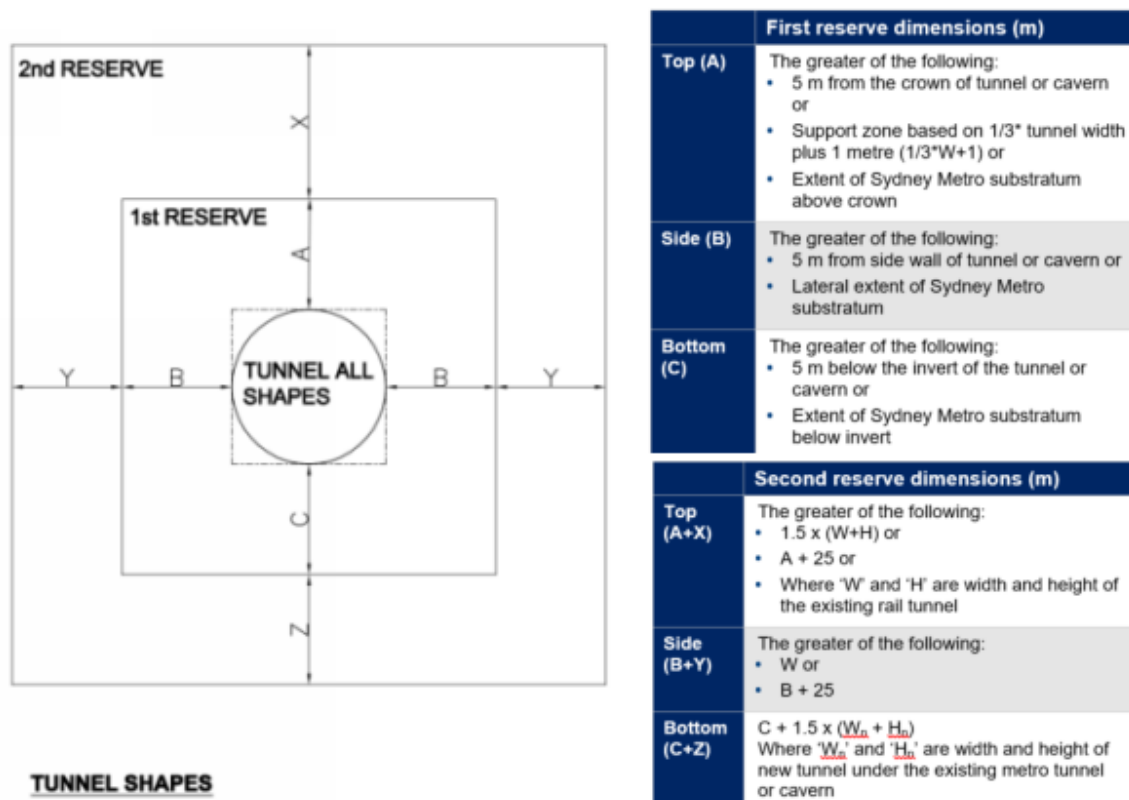
Plate 4 – Excerpt taken from Sydney Metro Underground Corridor Protection Technical Guidelines, pg. 8.

Based on the document “Sydney Metro Underground Corridor Protection Technical Guidelines” prepared by Sydney Metro dated April 2021, we understand the proposed Sydney Metro tunnel that will extend below the site likely consists of twin tunnels constructed using tunnel boring machines (TBM). The document provides the following to determine the first and second reserves of the tunnels, as shown in Plate 4.

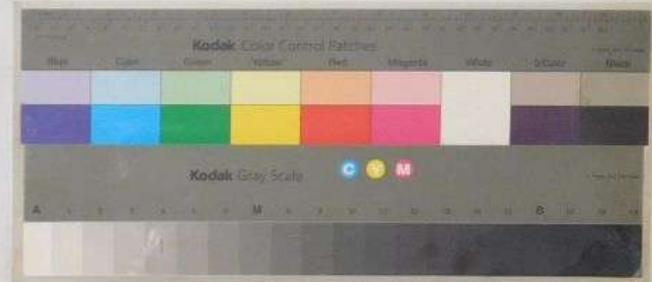
JOB No. 28974SP BH4 START CORING AT 1.63m

Client: UrbanGrowth NSW  
Project: Proposed Promenade Facility  
Location: Bank Street, Pyrmont, NSW  
Date: Drilled on 15 December 2015

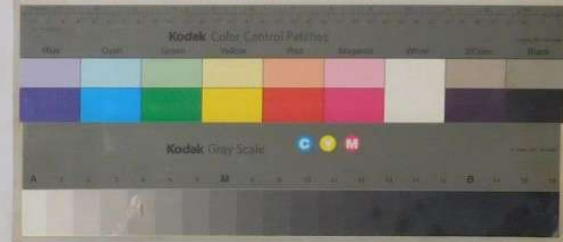
JOB NO. 28974SP BH5 START CORING AT 2.65m

Client: UrbanGrowth NSW  
Project: Proposed Promenade Facility  
Location: Bank Street, Pyrmont, NSW  
Date: Drilled on 11 December 2015

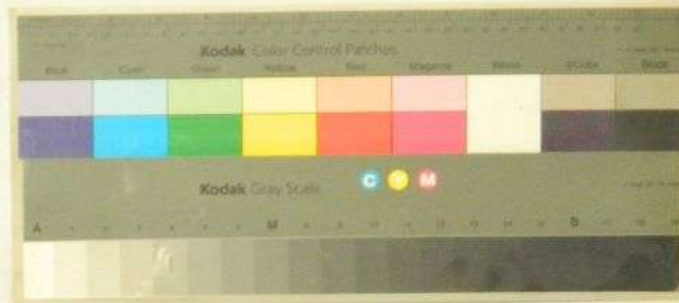
JOB NO. 28974SP BH8 START CORING AT 9.30m

Client: UrbanGrowth NSW  
Project: Proposed Promenade Facility  
Location: Bank Street, Pyrmont, NSW  
Date: 16 December 2015

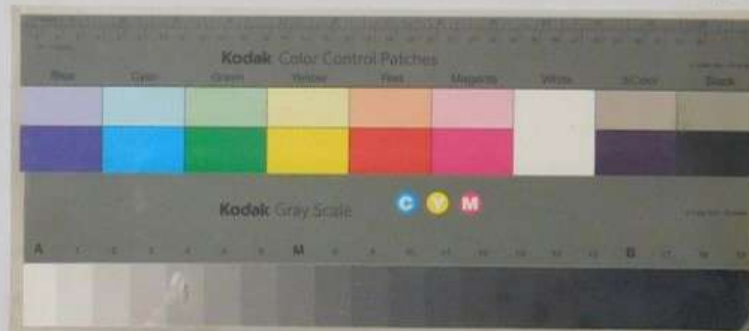
JOB NO. 28974SP BH11 START CORING AT 3.93m

Client: UrbanGrowth NSW  
Project: Proposed Promenade Facility  
Location: Bank Street, Pyrmont, NSW  
Date: 13 January 2016

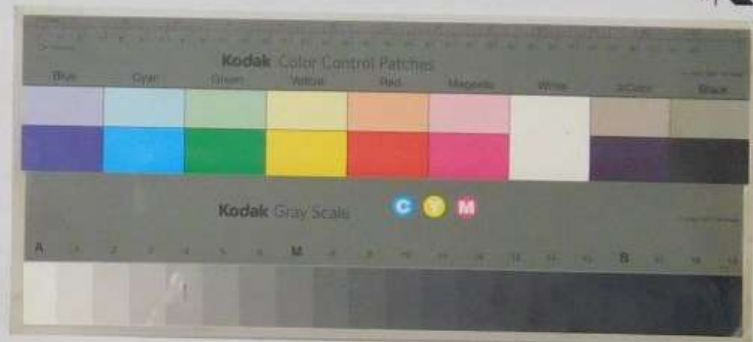
JOB NO. 28974SP      BH12      START CORING AT 8.51m

Client: UrbanGrowth NSW  
Project: Proposed Promenade Facility  
Location: Bank Street, Pyrmont, NSW  
Date: 11 January 2016

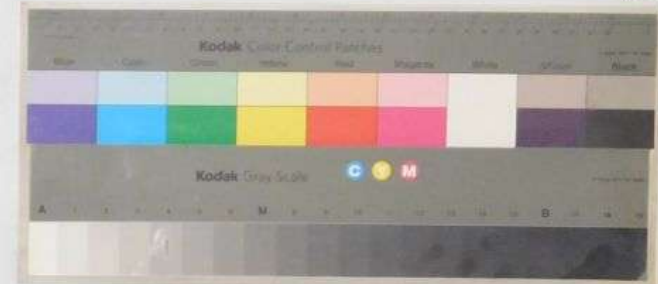
JOB NO. 28974SP BH15 START CORING AT 3.10m

Client: UrbanGrowth NSW  
Project: Proposed Promenade Facility  
Location: Bank Street, Pyrmont, NSW  
Date: Drilled on 15 December 2015

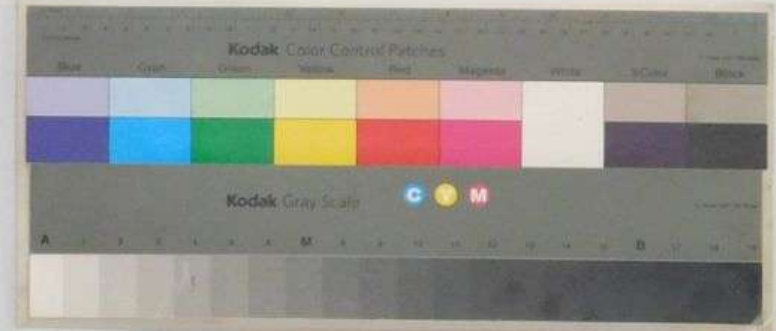
JOB NO. 28974SP      BH16      START CORING AT 25.95m

Client: UrbanGrowth NSW  
Project: Proposed Promenade Facility  
Location: Bank Street, Pyrmont, NSW  
Date: 22-23 December 2015
