# Non-Indigenous Archaeological Testing Results

## Combewood, North Penrith

Report to  
Landcom

October 2012

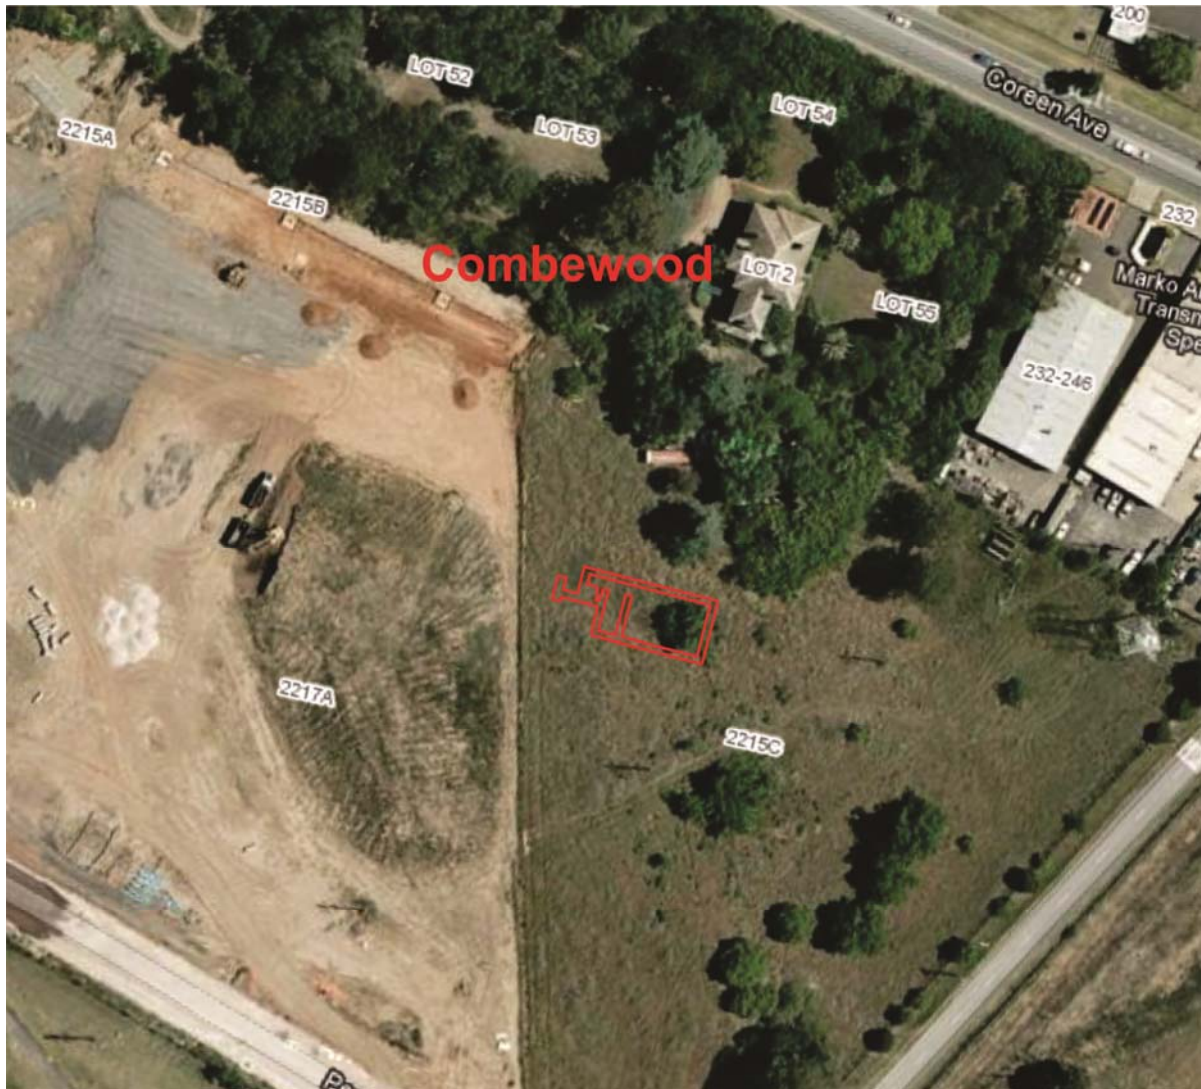
Figure 1.4: Location of trenches. Source: Google.

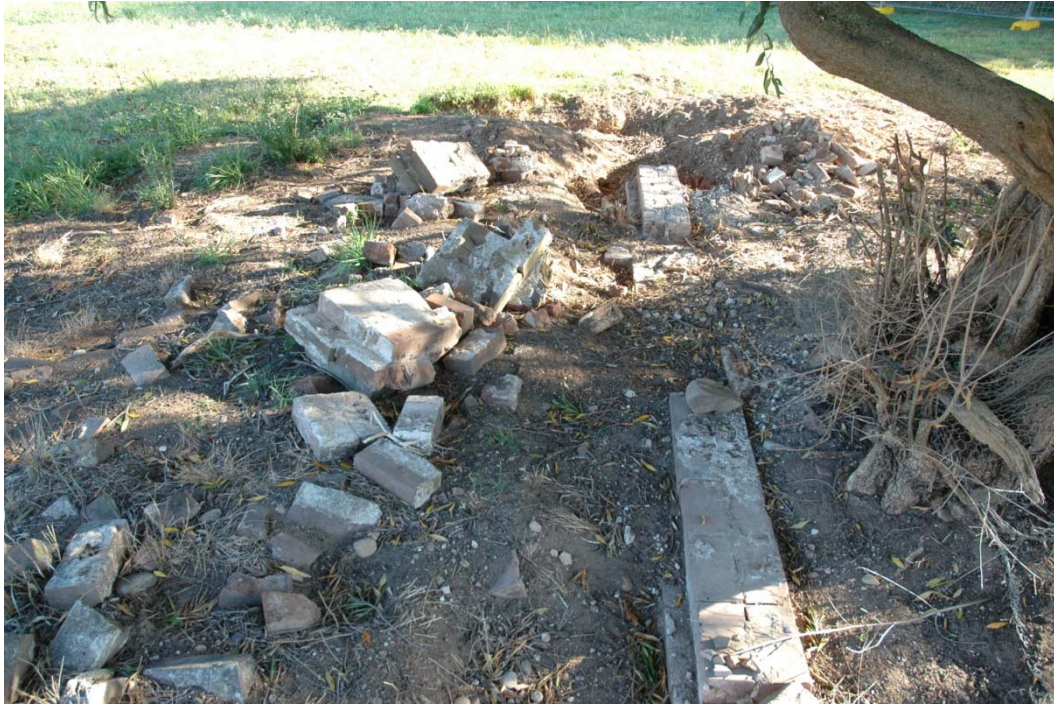
The site in question is located to the south of the extant 1890s Combewood house and is believed to contain the remains of a stables building. Recent disturbance of the site had revealed substantial brick footings (Fig. 1.5 – Fig. 1.8). These remains were not visible when the site was assessed in 2010 although some loose bricks had been noticed. The bricks are handmade sandstock bricks with a diamond frog (i.e. typically nineteenth century in date) and the alignment of the footings are of a rectangular building as seen in the 1943 aerial photograph (Fig. 1.2). It is believed that the remains have been exposed as part of a local historical society's training program. The site will be impacted by the development of a wetland in the area to the south of Combewood (Fig. 1.3).

**Figure 1.5: Sections of recently removed brick foundations. C&L 2012.**

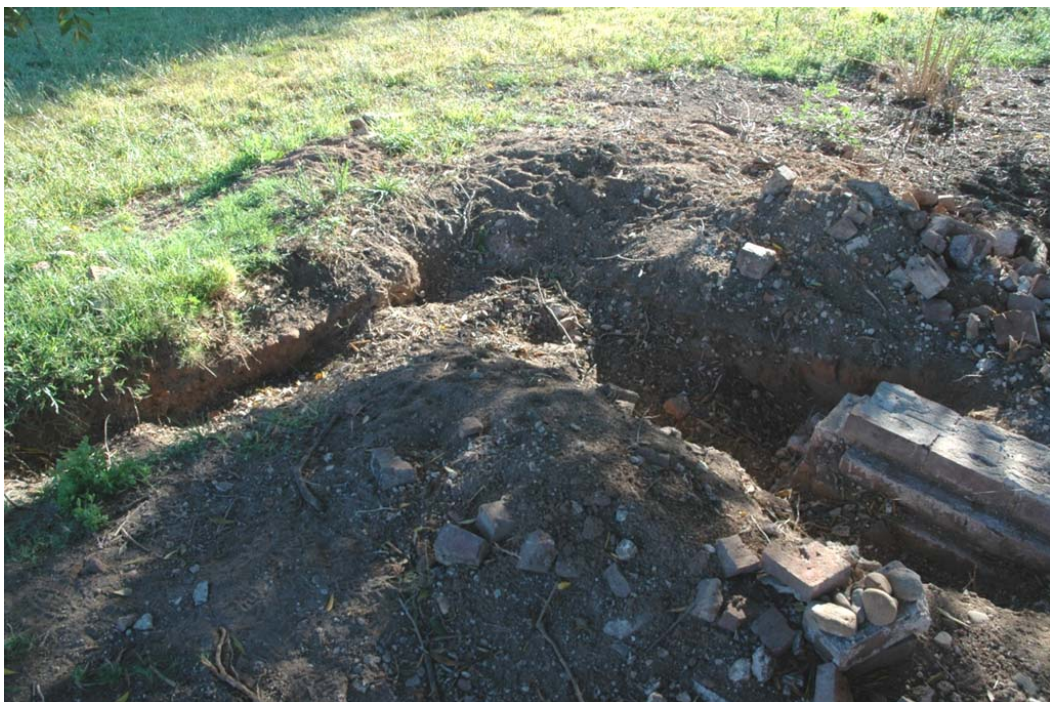
**Figure 1.6: Informal archaeological work had left deep trenches throughout the site, and removed potential archaeological evidence and artefacts. C&L 2012.**

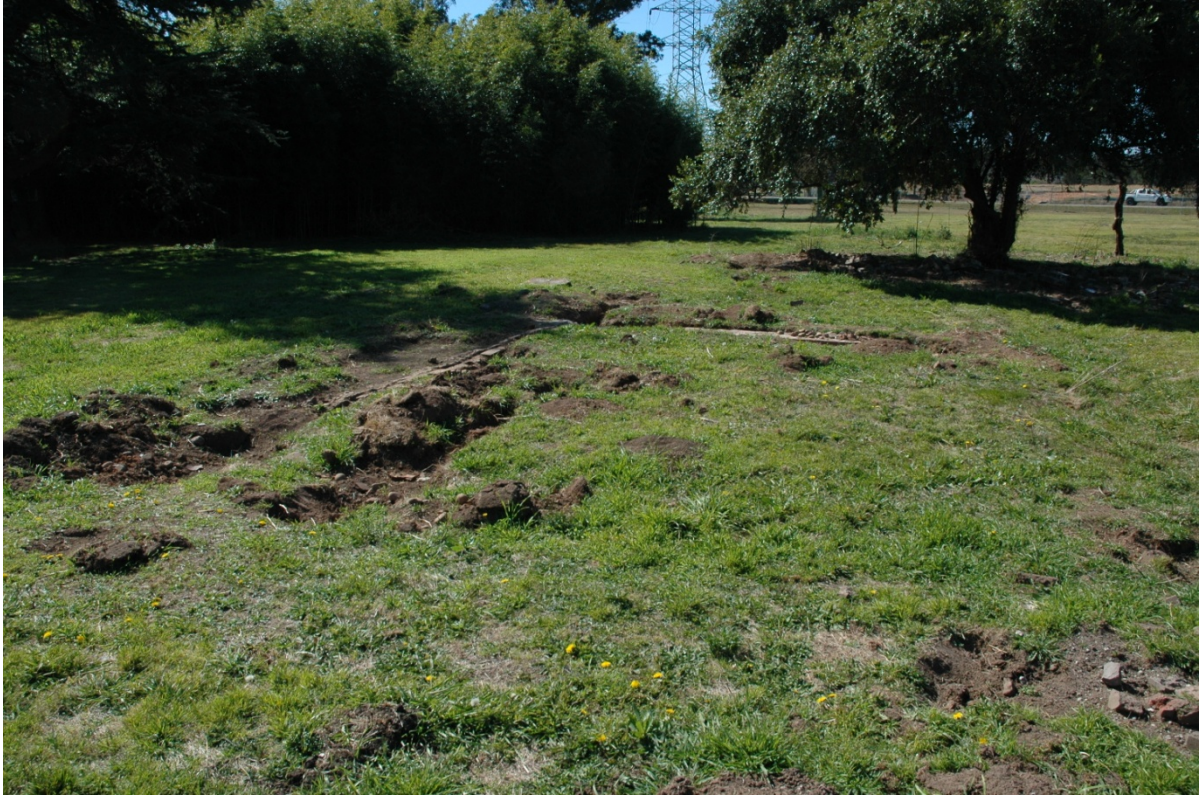
**Figure 1.7: Site showing recent disturbance, 6 September 2012.**

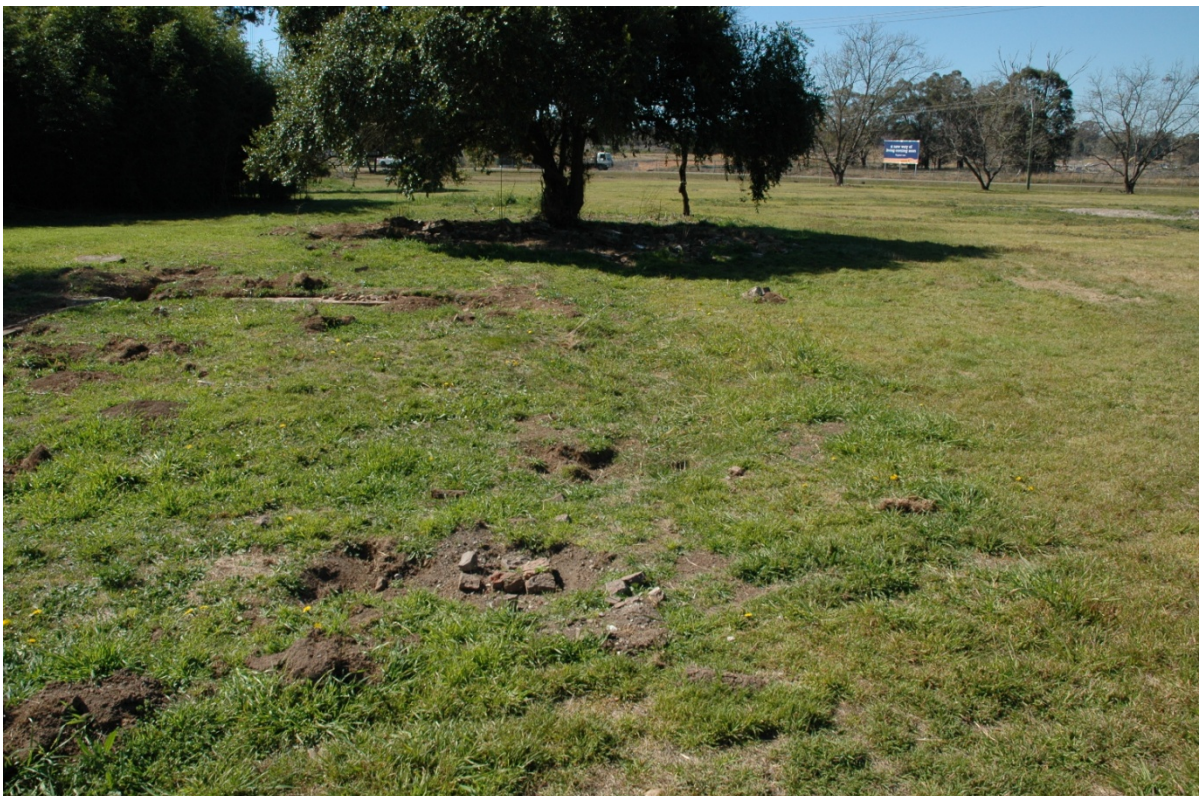
**Figure 1.8: Site looking east showing line of robbed out (southern) wall footing, 6 September 2012.**

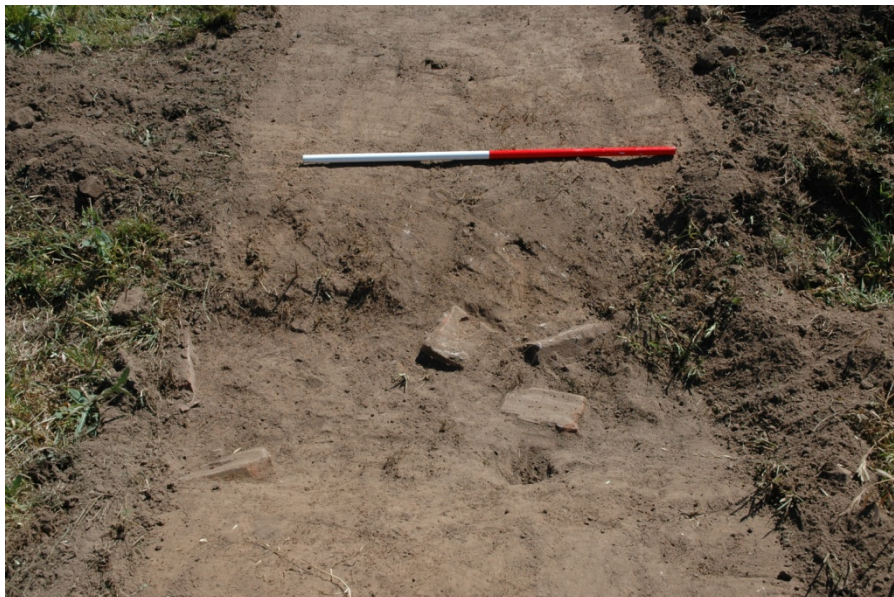
This trench was oriented north-south and located in the westernmost part of the former building. The trench included the modern disturbance along the northernmost footing. Dark silty staining was located in the central part of the trench. The southernmost end of the trench contained a robbed-out wall trench representing what had been the southern wall of the structure (Figure 2.2). A dark patch of soil containing mortar oriented east-west was located to the south of the trench, which may have been the remains of the base of a pathway along the side of the building.

Figure 2.2: The southern robbed-out wall trench in the south of Trench 1, looking north. Scale 1m. C&L 2012.

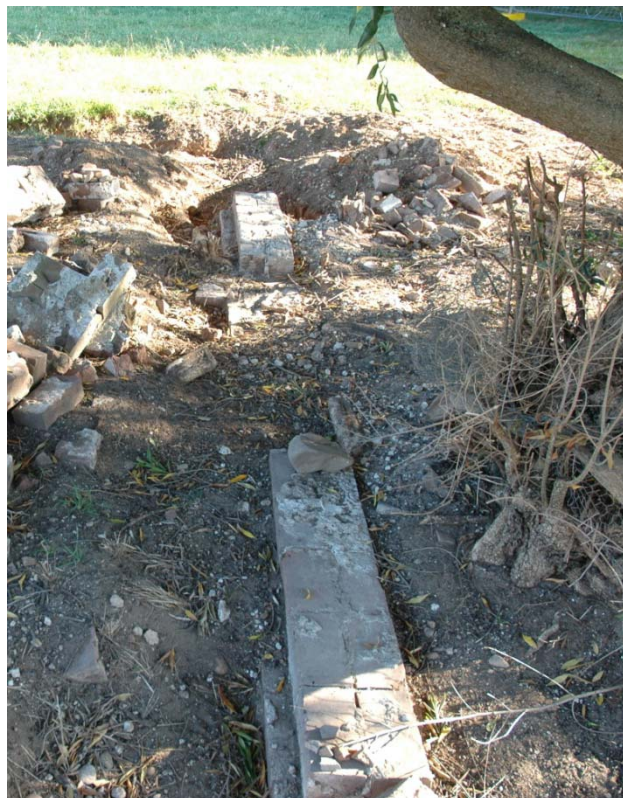
The footings were exposed (by previous informal excavation) to five stepped courses. The width of the footing is reduced by 100mm (50mm on each side) with each successive course. The top course of the easternmost wall remnant (Fig. 2.3) has been constructed of two rows of bricks laid head-to-head. These have been bonded with a coarse-grained but homogenous hard lime mortar. The sandstock bricks measure 230mm x 111mm x 74mm and have a diamond frog in the centre on the non-strike face. The frog measures 100mm in length and 54 mm in width. The bricks have been made from well-mixed clays with small black impurities.

**Figure 2.3: The easternmost wall footing adjacent to the olive tree, looking north. C&L 2012.**

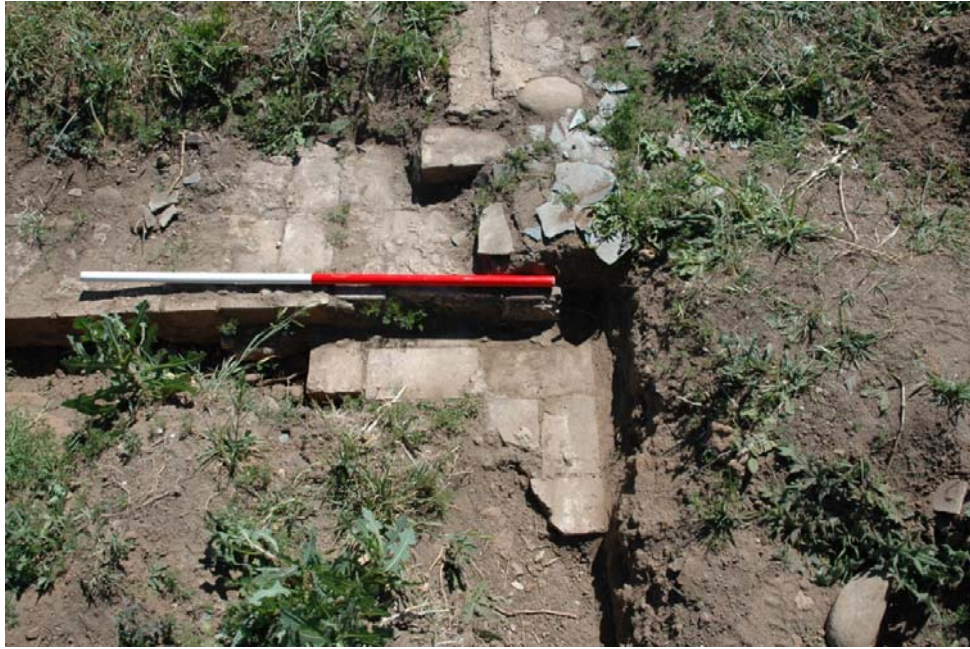
Bricks within the central dividing footing were not all standard in size (Fig. 2.5). Some of the bricks in the arrangement had been broken to fit the patterning required by the stepped nature of the footing.

**Figure 2.5:** The northern end of the central dividing wall, showing the head-to-head formation with the start of a return to the east (the northernmost footing). Looking west. Scale 1m. C&L 2012.

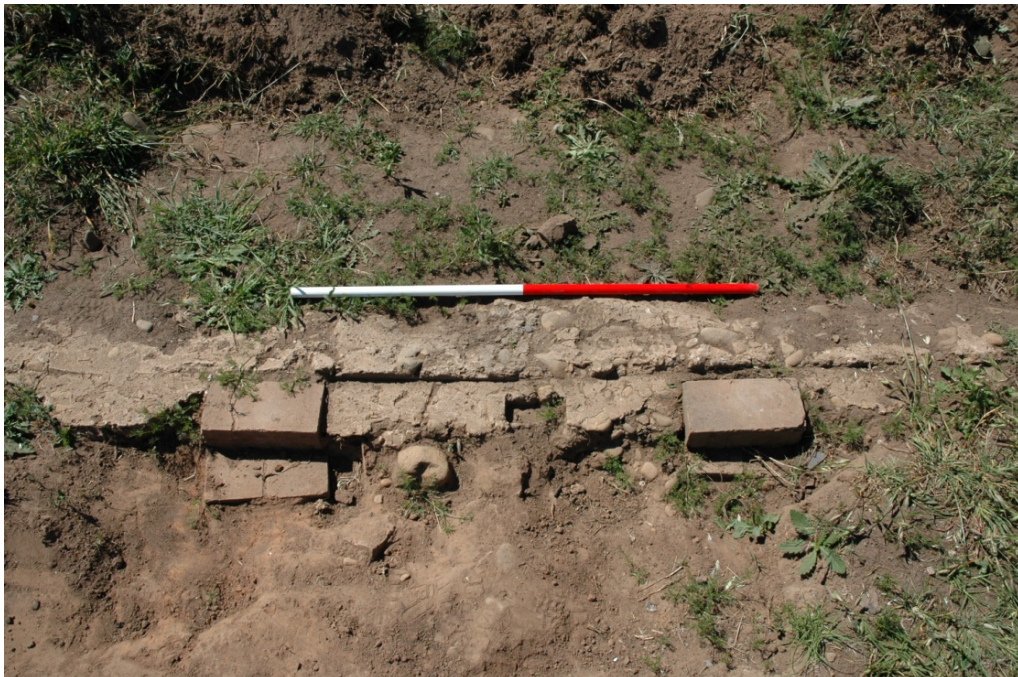
The northernmost footing is different from the others. The only remaining segment consists of 2 stepped brick pads within a concrete footing (Figure 2.6). The concrete is coarse-grained, poorly mixed and littered heavily with pebble aggregate. The upper surface of the concrete contains the impression of either a single row of bricks or a timber. The concrete footing is 350mm wide and has been poured directly into the cut. Whatever was laid on the concrete was placed there when the concrete was still wet. The brick pads have been set at an interval of 710mm.

**Figure 2.6:** The mixed concrete footing with two stepped brick pads. Scale 1m. C&L2012.

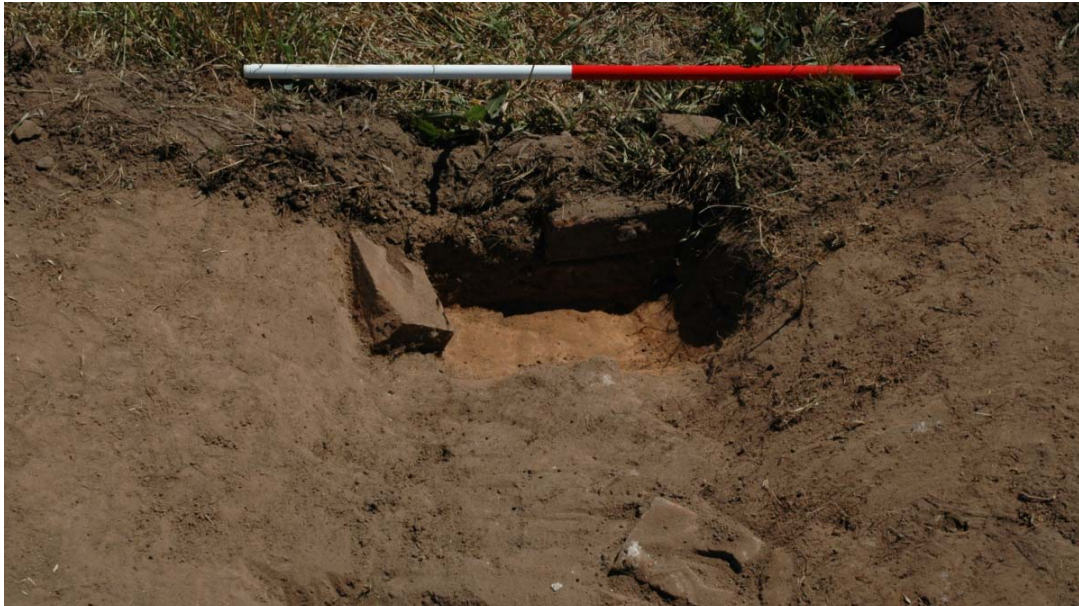
The southernmost wall of the building had been removed, leaving a backfilled trench (Figure 2.7). This trench measured 500mm in width and approximately 270mm in depth. It was poorly defined as it has been backfilled with redeposited local sandy clay loam (highly compacted, fine-grained, pale brown with some yellow content). The fill within the wall trench contained small pieces of degraded sandstone and displaced whole and partial bricks exhibiting the same characteristics as bricks found elsewhere on the site. The wall cut had a gentle break of top slope, with steep, near-vertical sides to a sharp break of base slope to a relatively flat base.

**Figure 2.7: The partially excavated robbed-wall cut for the southernmost wall of the structure. Scale 1m. Looking west.**

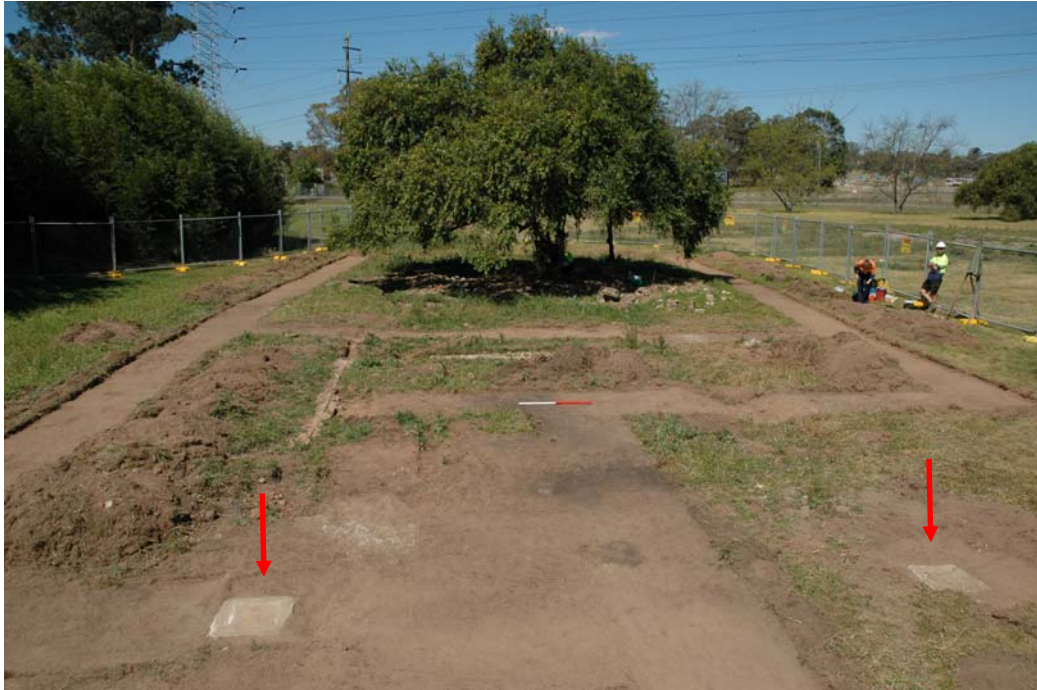
The western half of the structure was divided into two spaces. The largest part measured 5.9m by 5.6m and is delineated by the robbed-wall cut in the south, and the remaining brick and concrete footing. The smaller part measured 5.6m by 2.4m and was delineated by two concrete pads on the western side (Fig. 2.8). This probably represented a part of the structure that was able to be open on three sides. The concrete pads measured 480mm x 460mm with a square impression measuring 300mm x 260mm (Figure 2.9). These would have supported brick or timber columns.

Figure 2.8: The two concrete pads (arrowed). C&L 2012.

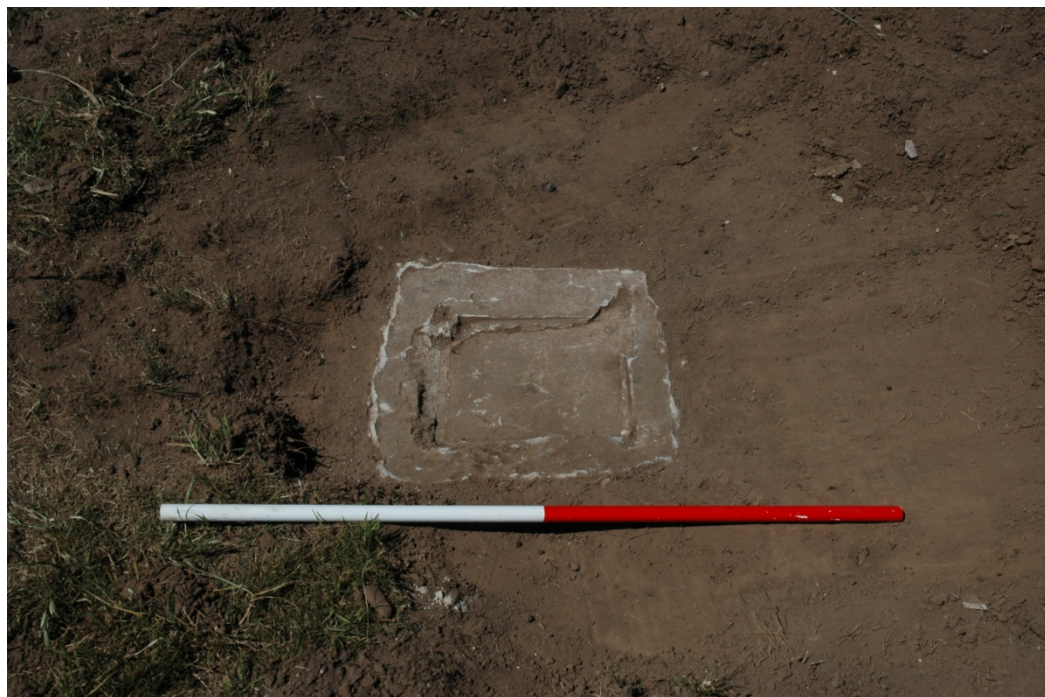
Figure 2.9: Detail of one of the concrete pads showing the square impression of a column base. Scale 1m. C&L 2012.

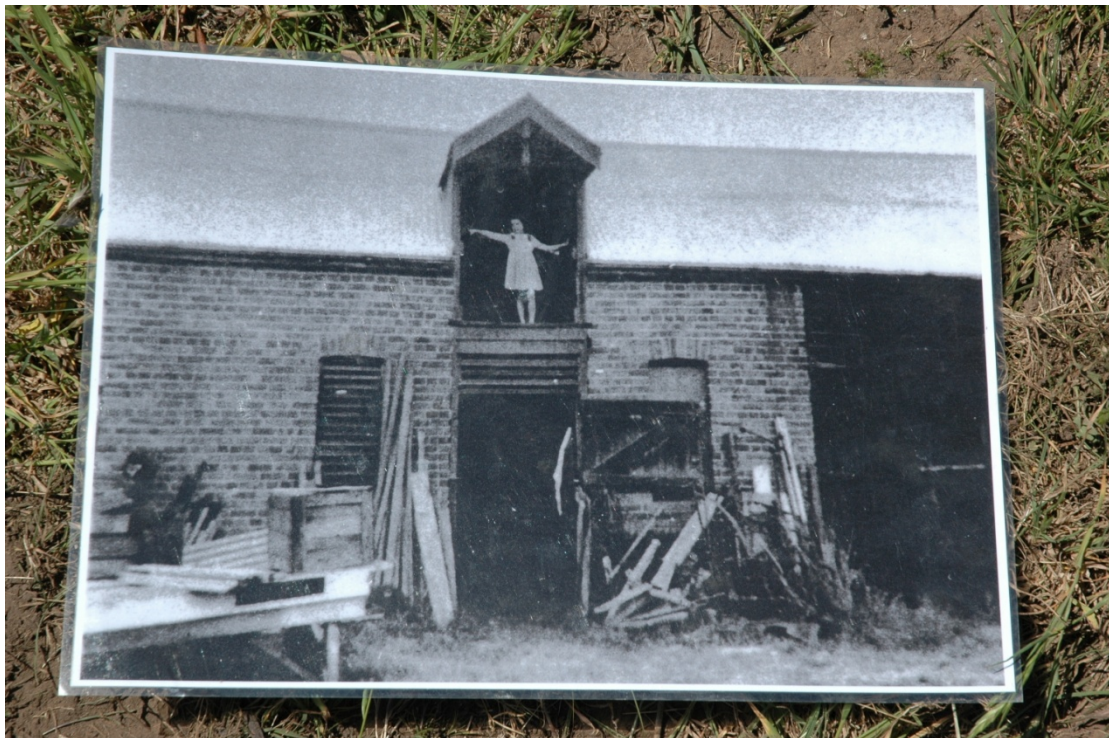
The brick in the northernmost wall foundation were probably in the location of the hayloft, visible on a photograph and painting of the building supplied by the current owner of Combewood, Mrs Margarite Scott (Figure 3.1, 3.2). Mrs Scott indicated that she had known the building as a child, knew its internal layout and confirmed that it had been used as a stable, grooms quarters, and hayloft.

Figure 3.1: Photograph of the building under investigation prior to its demolition in the 1960s. Courtesy of Mrs Margarite Scott, Combewood.

The archaeology, when considered in conjunction with the photograph and painting (Figure 3.1, 3.2), would suggest that the structure was indeed used as a stable or coach house dating to the 1890s.

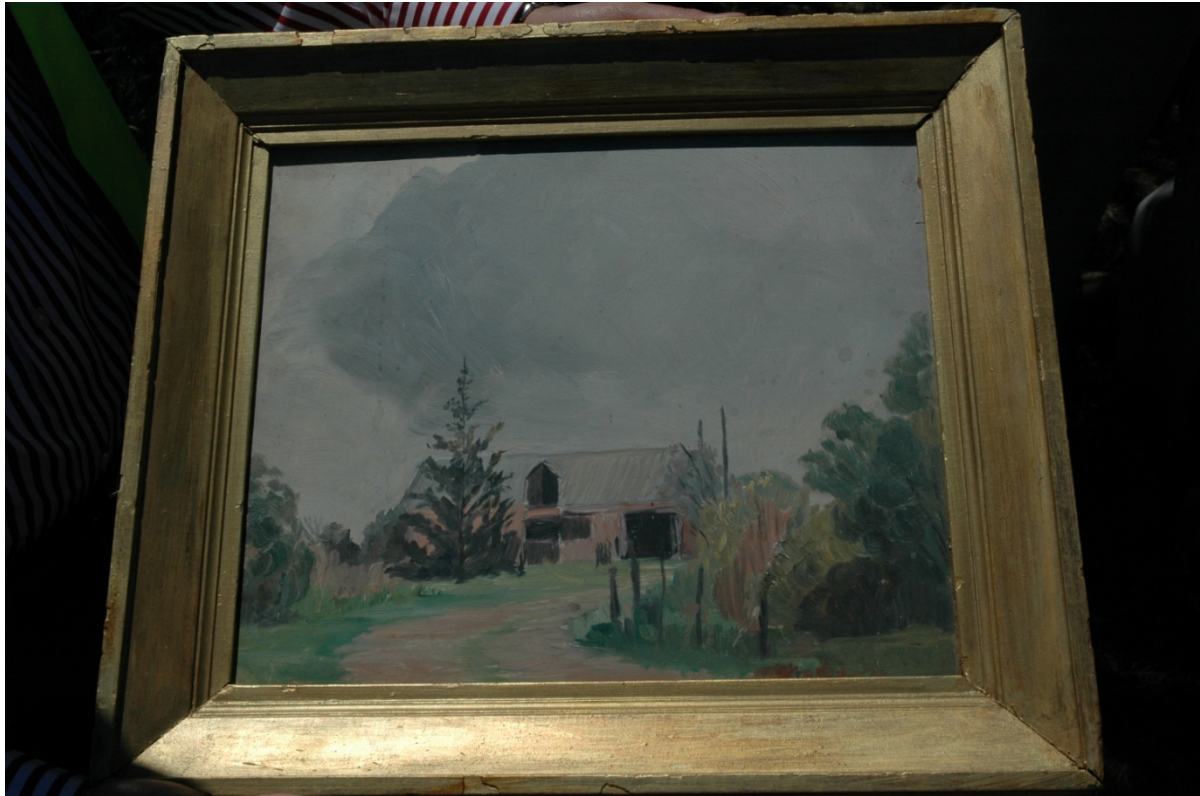
Figure 3.2: Painting of the stables looking from house. Courtesy of Mrs Margarite Scott, Combewood.
