PRELIMINARY ENVIRONMENTAL SITE ASSESSMENT

**Hornsby Ku-Ring-Gai Hospital
Derby Road and Burdett Street,
Hornsby NSW**

**Health Infrastructure
C/- Thinc Projects**

November 2011

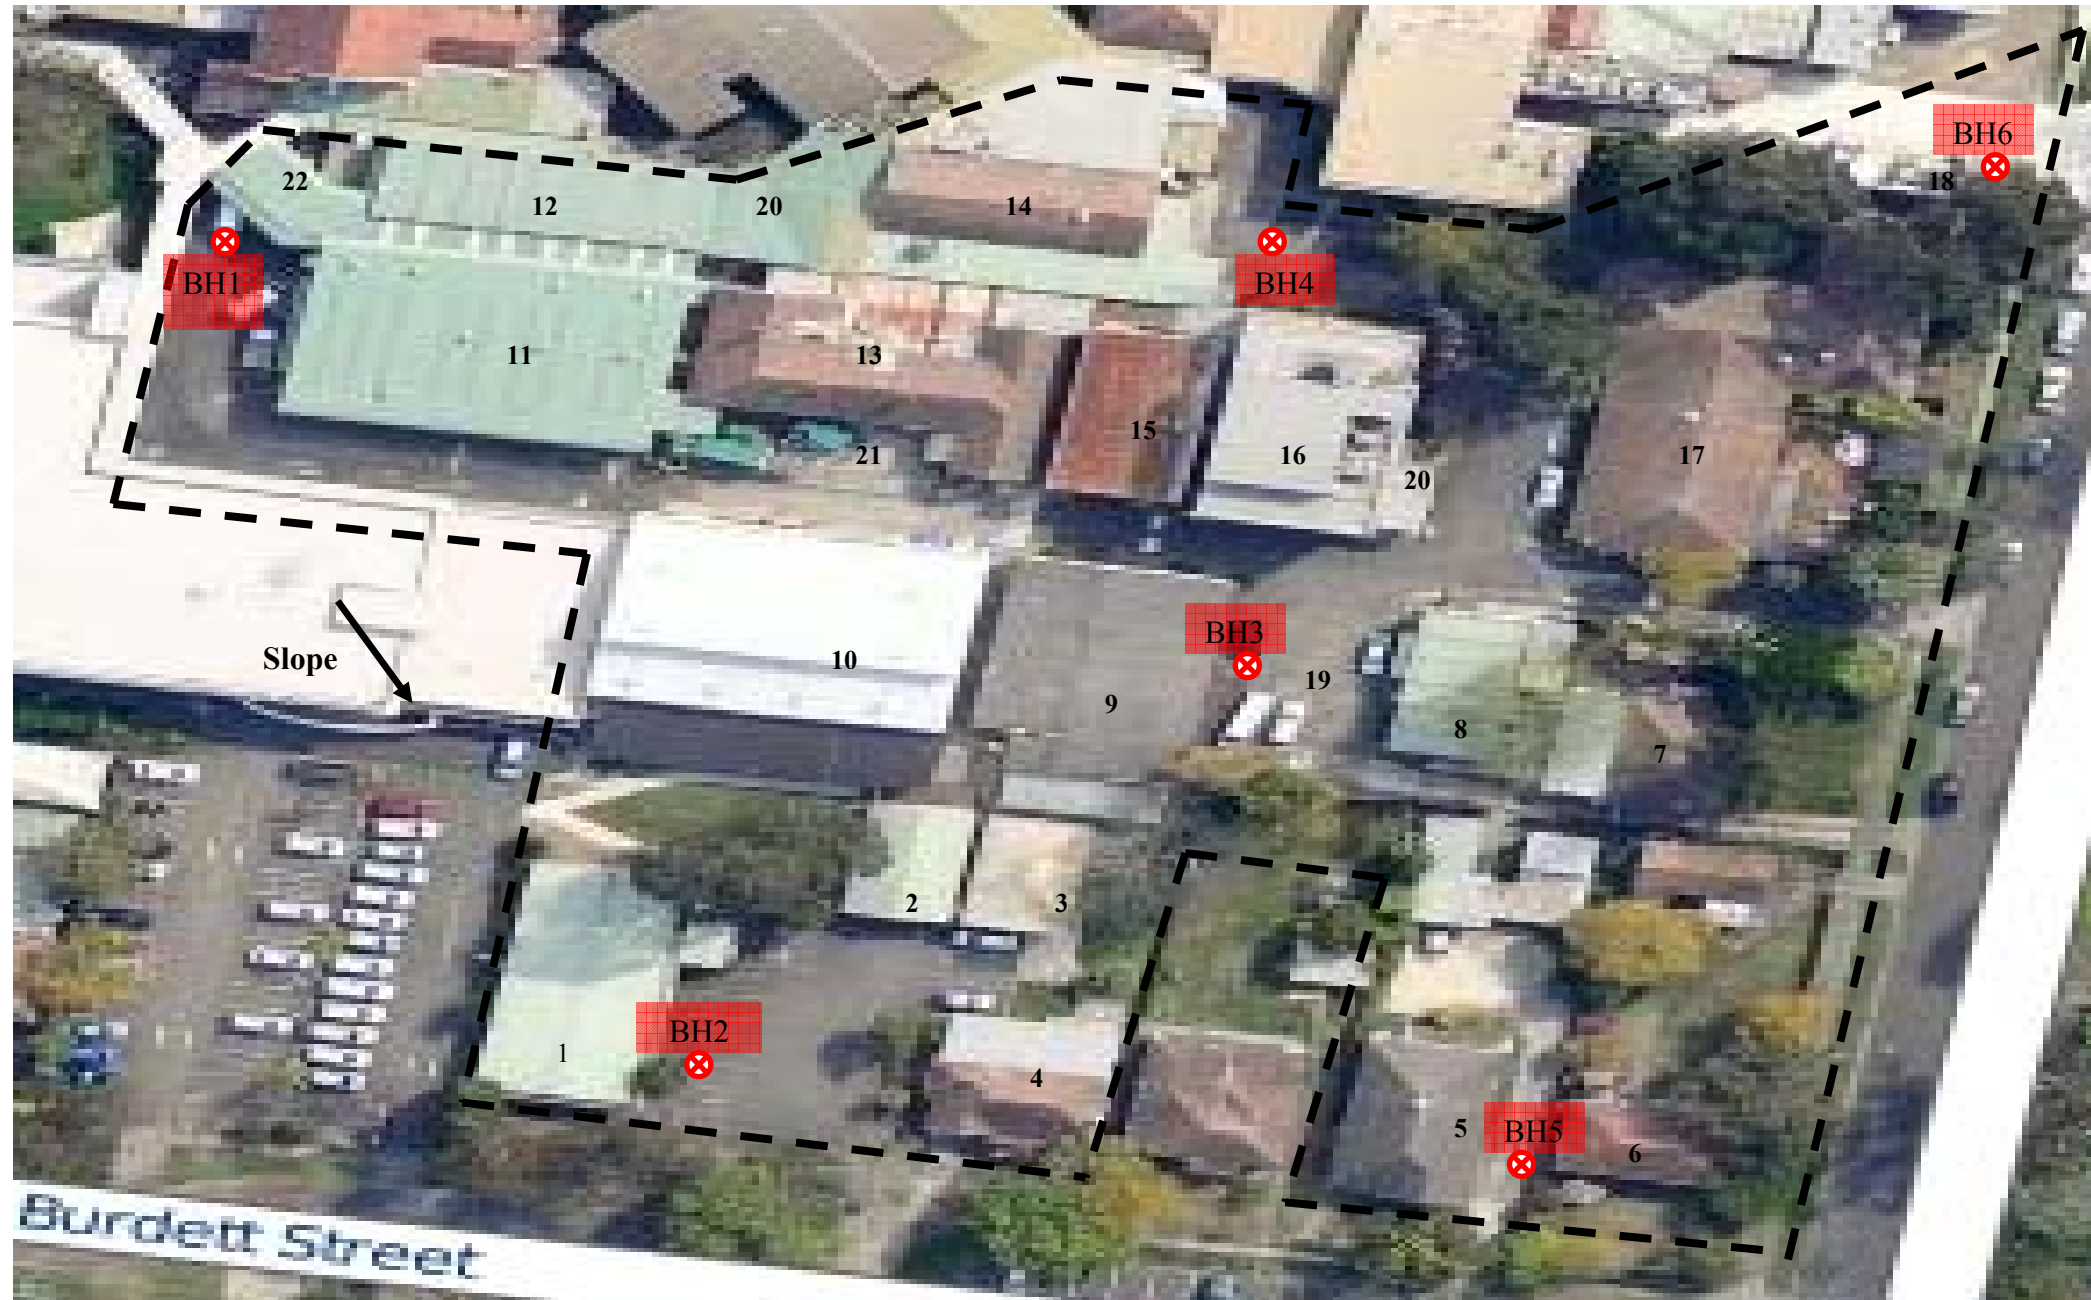
SITE PLAN

NUMBER	SITE FEATURES	NUMBER	SITE FEATURES	NUMBER	SITE FEATURES
1	Dietary Podiatry Building	9	Linen Building	17	Staff Cafeteria and Functions Building
2	P.A.D.P Building A	10	Store, Purchasing, Printing, Transport Building	18	Oxidising Gas Tanks
3	P.A.D.P Building B	11	Maintenance Workshop	19	Decommissioned UST
4	Family Cottage	12	Engineering Office Workshop	20	Power Generators
5	Health Administration Corporation Building	13	Central Plating Area Building	21	Waste Skip Bins Area
6	Workcover Staff Counseling Building	14	Kitchen	22	Gas Storage Area
7	No. 1 Derby Road (house)	15	Staff Amenities Building		
8	Physio Therapy Building	16	Pathology Mortuary Building

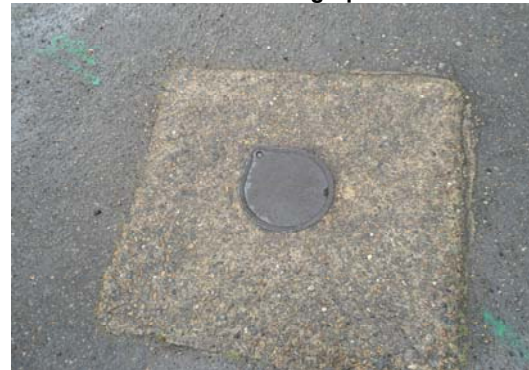
Photograph 8

Decommissioned UST

Whilst the above concerns are considered minimal, it is difficult to determine the extent (if any) of potential leaks occurring from the underground tank, pipes/lines and bowser unless sampling occurs. It is recommended that a Tank Validation report be undertaken to determine if contamination has occurred in the vicinity of the UST and associated features. Further samples would be warranted in and around the remaining of the site in order to provide classification of soils for disposal purposes as part of the proposed development.

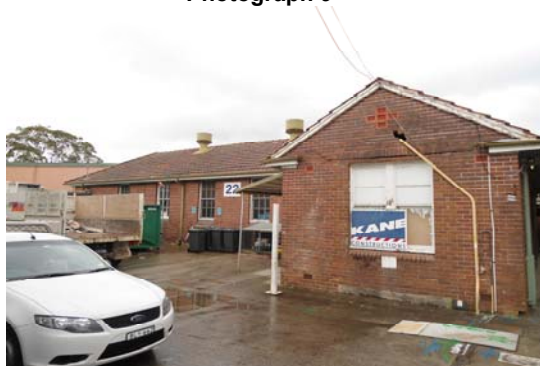
Photograph 9

Central Plating Area Building, Showing Skip Location

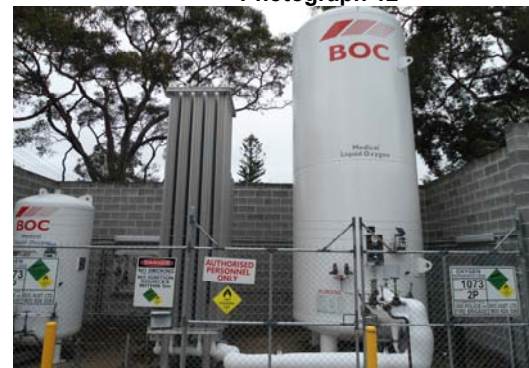
Photograph 12

Oxidising Gas Tanks Storage
