# Urunga Antimony Processing Plant Contaminated Site - Project Application & Preliminary Environmental Assessment

Prepared for: NSW Department of Planning

Department of  
Primary Industries  
Soil Conservation Service

On behalf of NSW Catchment & Lands  
– Crown Lands

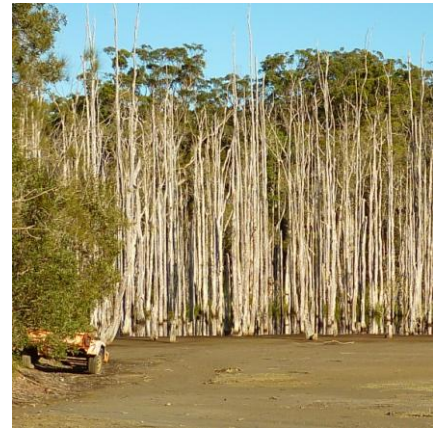
**Photo 2 Classic image of dead paperbarks in Swamp Scl. Forest**

Evidence of dead vegetation (*Melaleuca sp.*) occurs along the wetland periphery closest to the site.

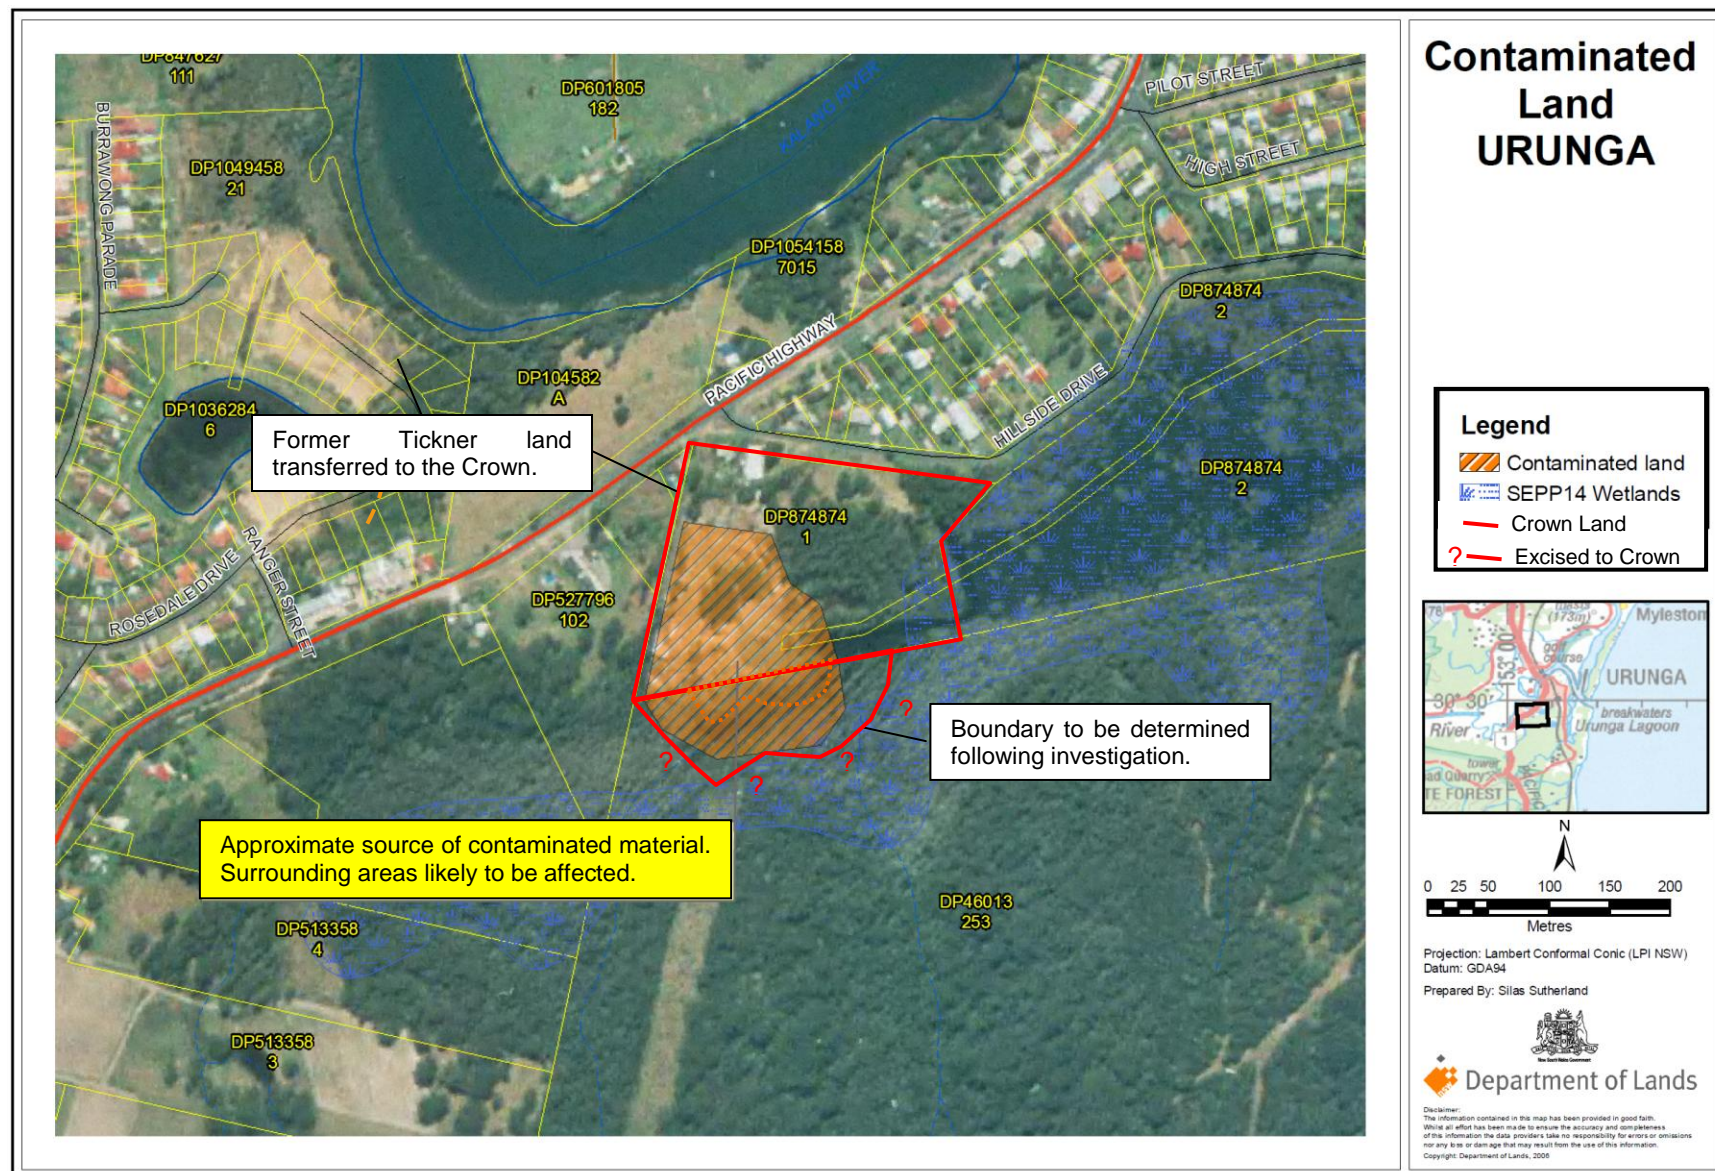
Figure 4 Site Location

The contamination is known to be located across several land parcels (see Figure 4) :

1. Lot 1 DP 874874 (Crown Land - former Tickner property)
2. Lot 2 DP 874874 (Crown Land - former Tickner property)
3. Lot 253 DP 46013 (Aboriginal Land with excised portion to Crown Land)

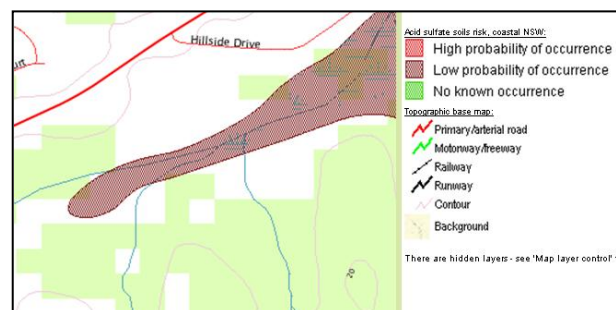
**Figure 6 Extract from ASS Risk Map**

As a complication to the site, there is a low risk of acid sulphate soil occurrence in the lower reaches of the site within the wetland peats, underlying grey clays and in the tailings. Where pyritic material is exposed to oxygen, acid generation will occur which would exacerbate the mobilisation of metal contaminants.

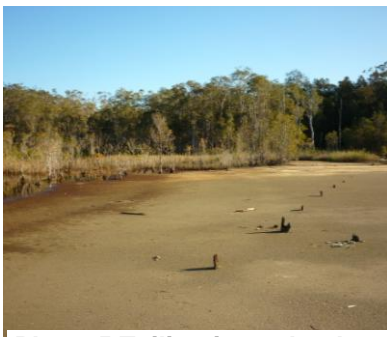
**Photo 5 Tailing in wetland**

The scale of excavation could require full removal of at least 9,000 m<sup>3</sup> of contaminated material from the edge and within the SEPP 14 wetland.

Any excavation from the wetland will require an appropriate barrier system to contain sediment and/or leachate derived from the excavation.
