# **Health Infrastructure NSW c/- Johnstaff Projects**

**Kempsey Hospital Redevelopment  
Remedial Action Plan**

July 2013

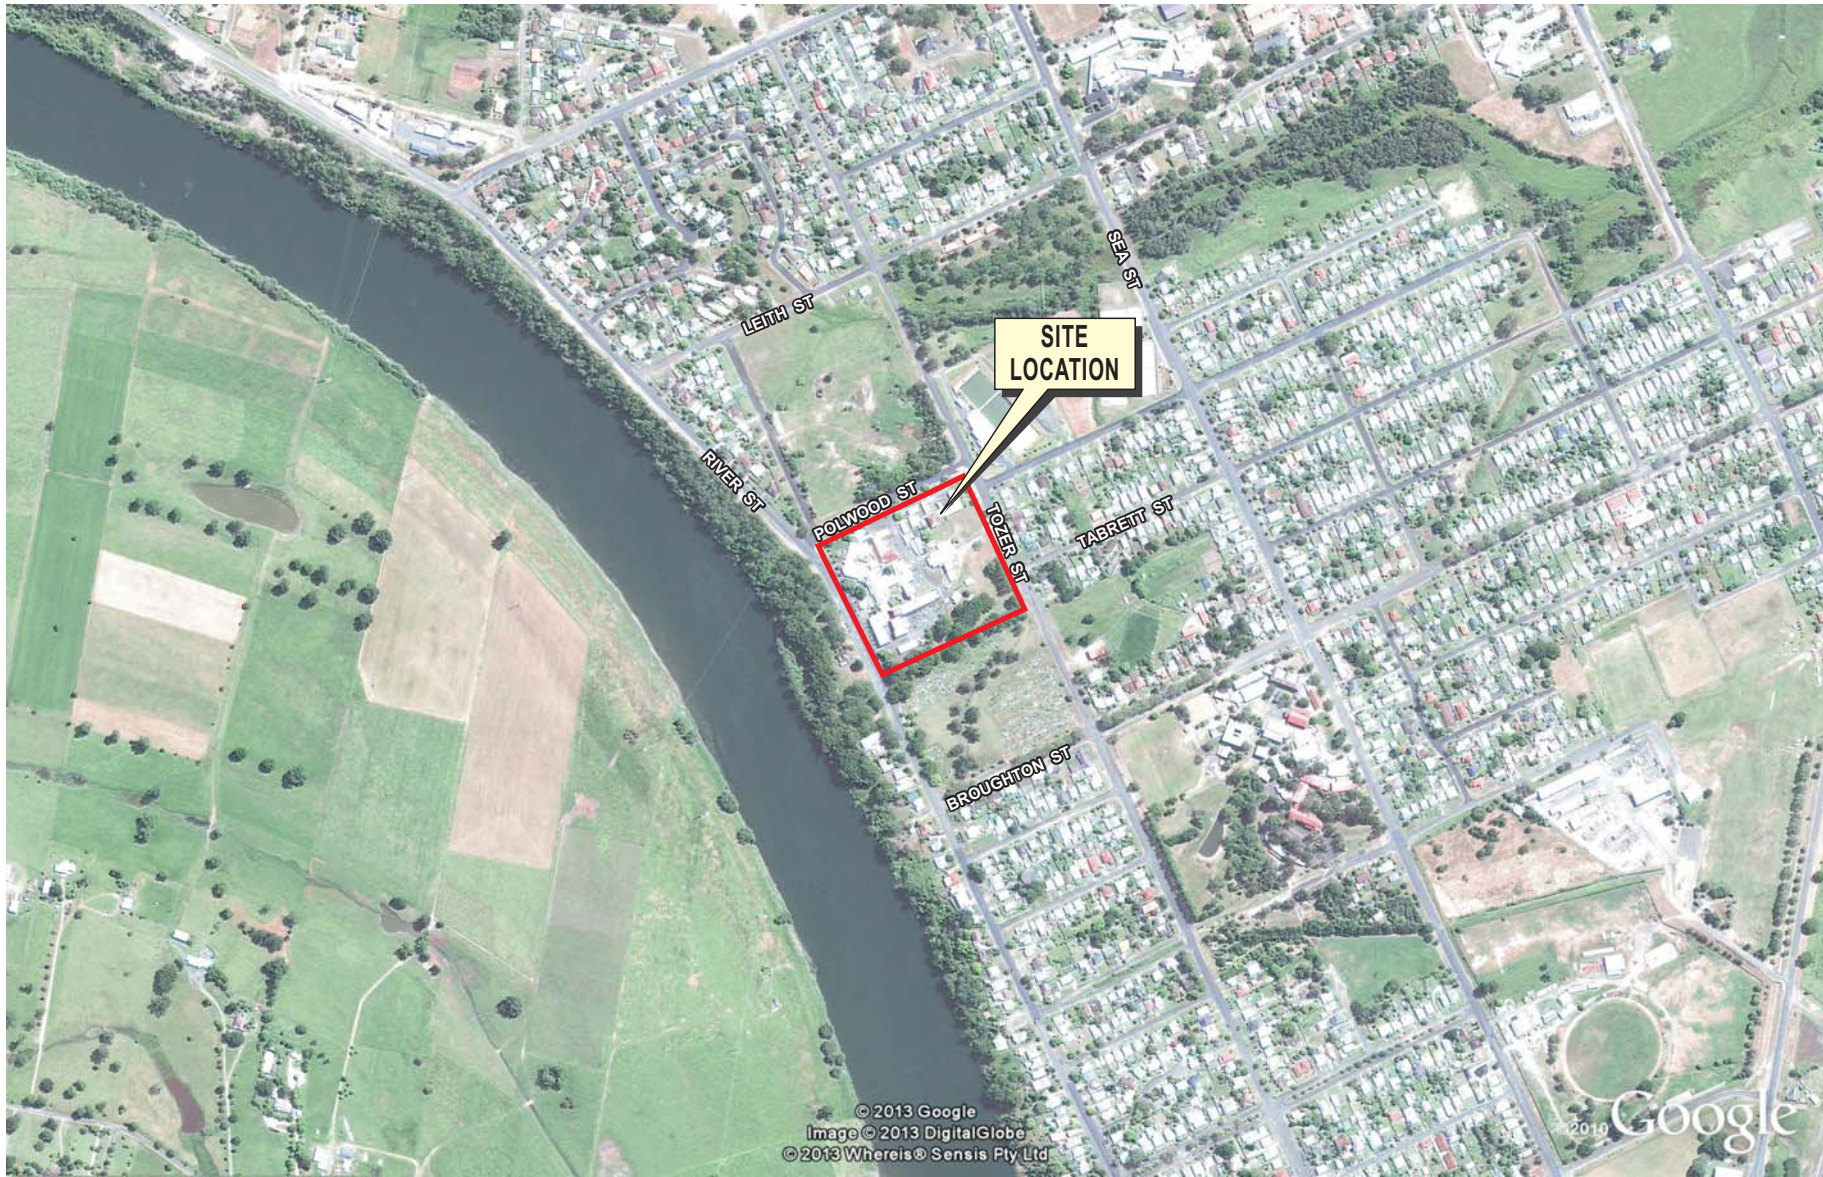
The extent of soil requiring removal was estimated by Coffs Harbour Demolitions as shown on enstruct Dwg 5027-ENS-CV-DWG-SA2-910 included in **Appendix A**. Further assessment by GHD was utilised to confirm and further assess the extent of asbestos impact identified.

As noted in **Section 3.2** contractors working on the site identified asbestos fragments, bottles and ash within fill material requiring removal for the construction of the proposed building illustrated on enstruct Dwg 5027-ENS-CV-DWG-SA2-910 included in **Appendix A**. On the 10<sup>th</sup> July 2013 GHD undertook further assessment to gain an appreciation as to the extent and degree of contamination in this area and to inform this RAP.

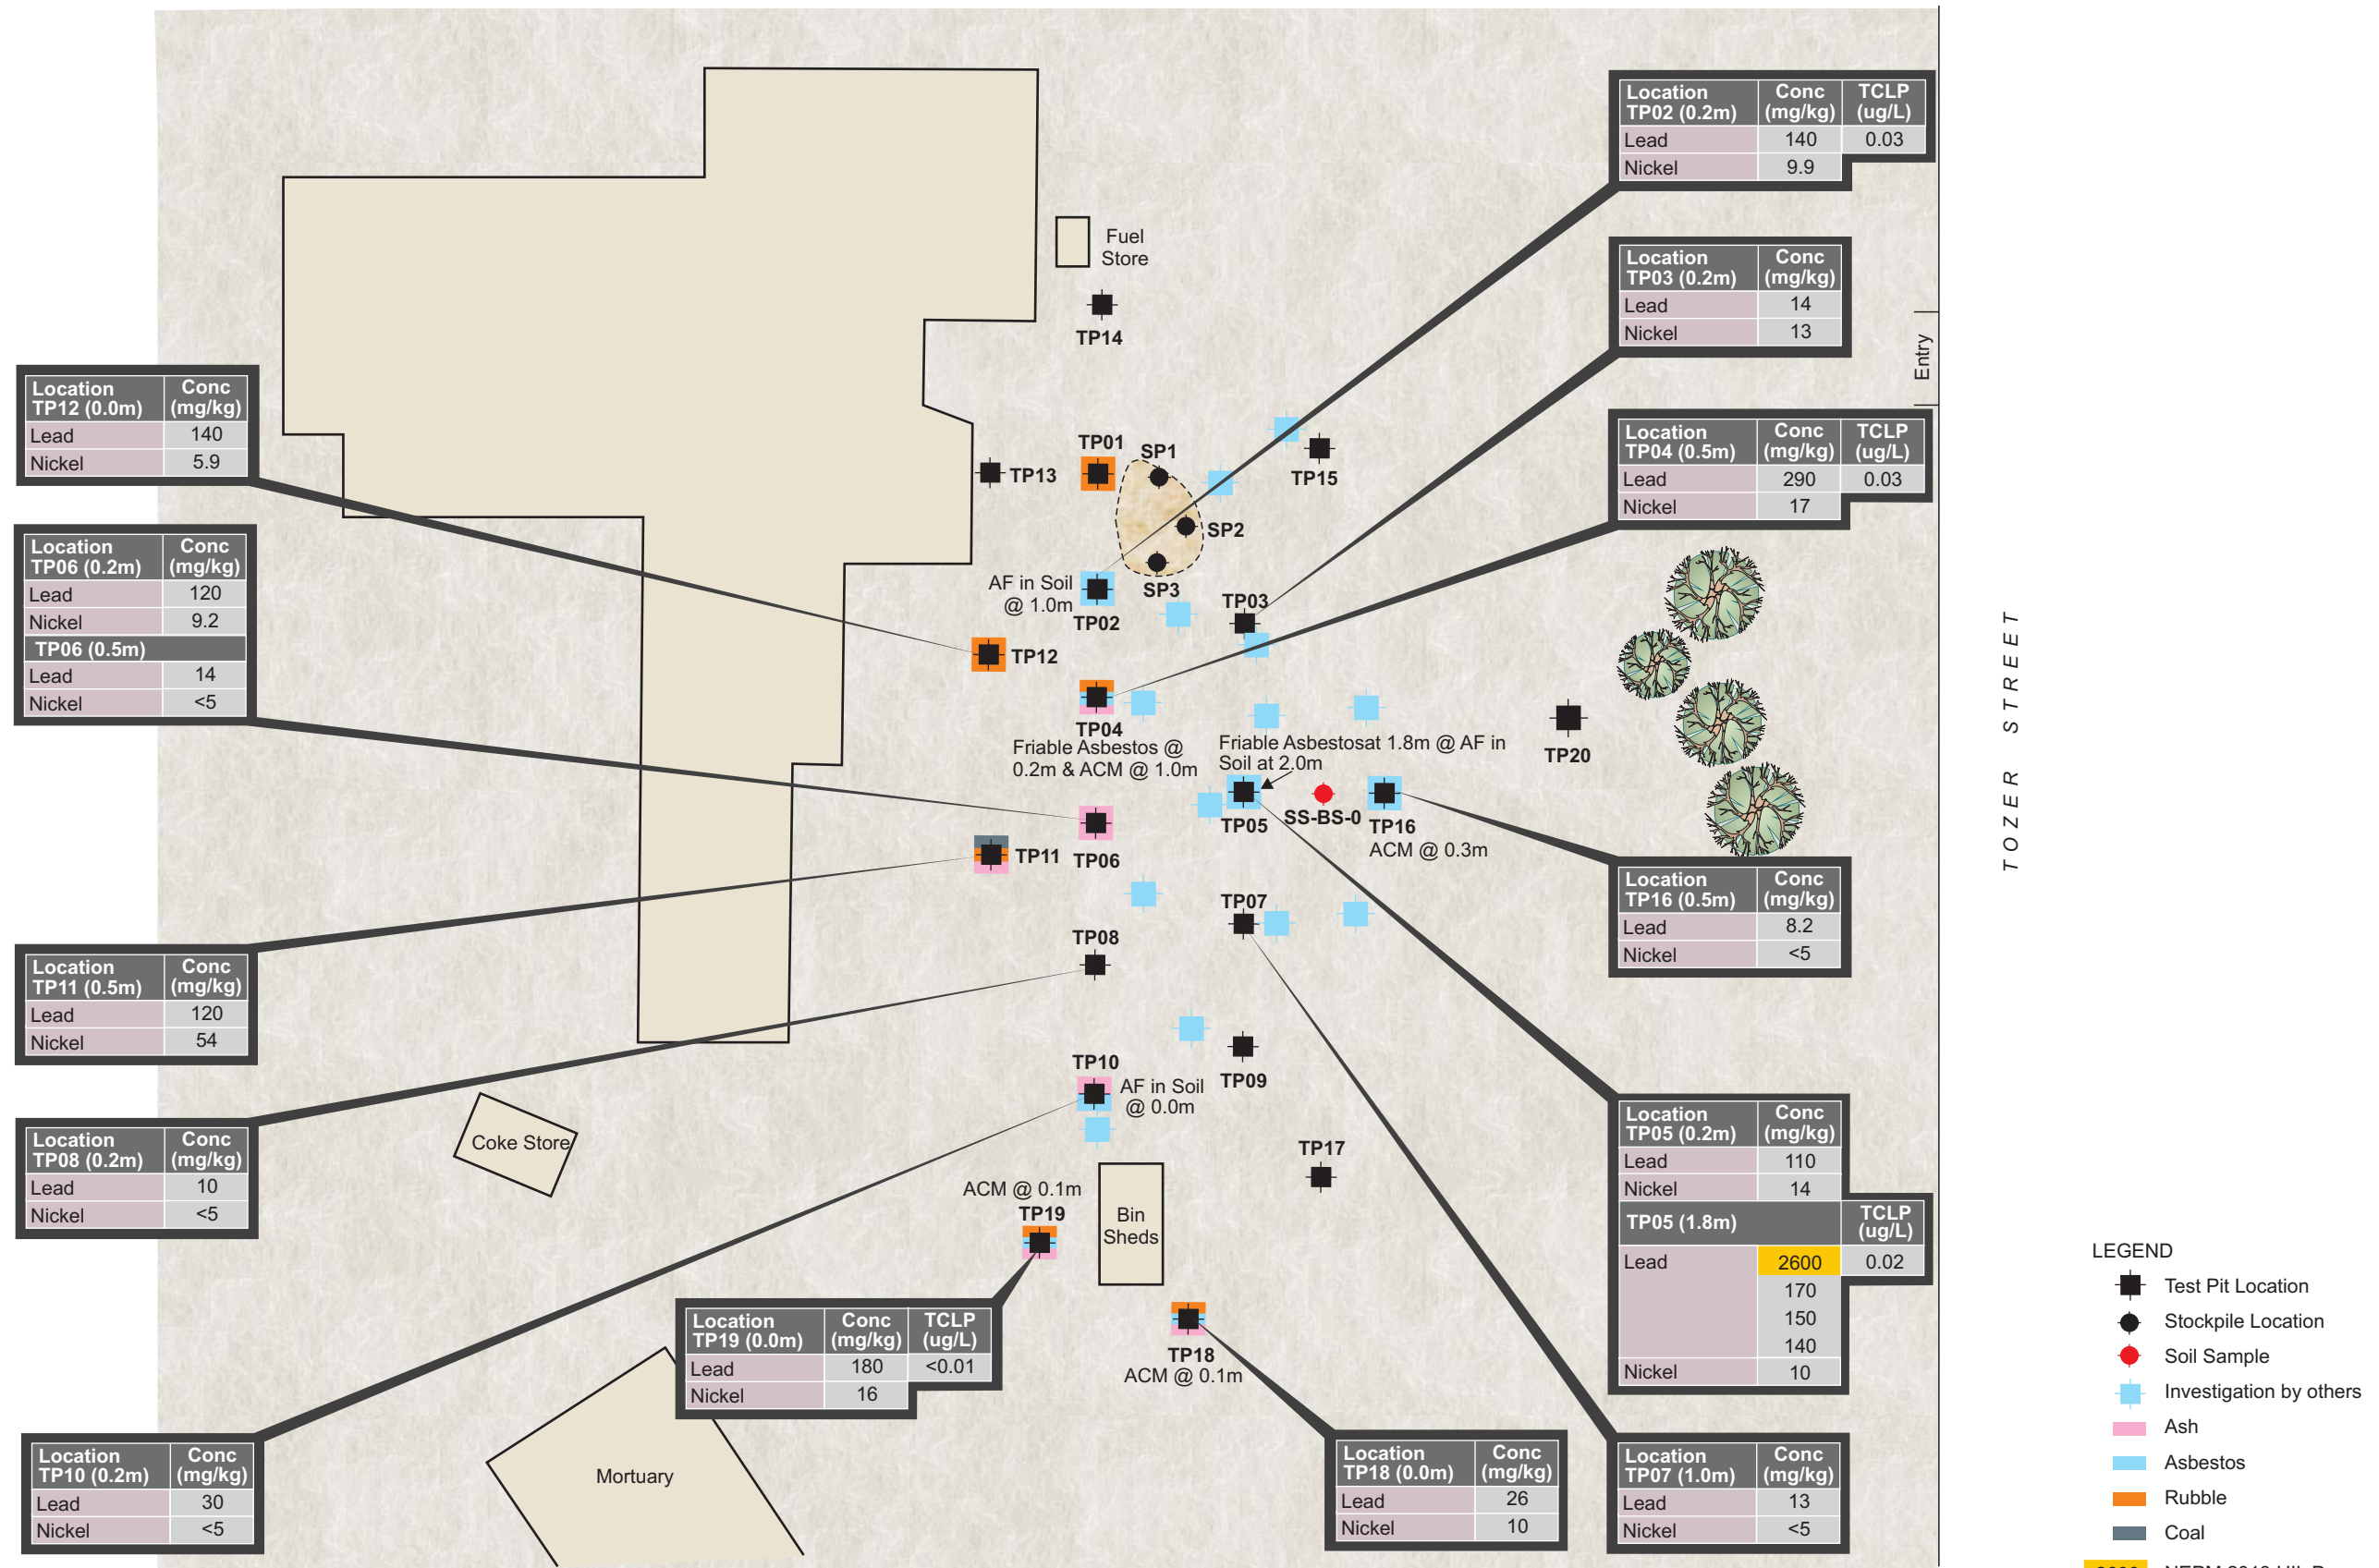
Figure 1

- LEGEND**
- Test Pit Location
  - Stockpile Location
  - Soil Sample
  - Investigation by others
  - Ash
  - Asbestos
  - Rubble
  - Coal
- 2600** NEPM 2013 HIL D

GHD Pty Ltd (GHD) was commissioned by Johnstaff Projects (Johnstaff) to undertake additional site assessment and to utilise the results to prepare a Remedial Action Plan (RAP) for contaminated soil requiring removal as part of the proposed redevelopment at Kempsey Hospital, Kempsey, NSW (the site). The site location and site layout are shown on **Figures 1 and Figure 2, Appendix A, respectively**.
