Report on  
Detailed Site Investigation

Proposed School Development  
Cnr Fox Valley Road & Comenarra Parkway  
Wahroonga, NSW

Project 73244.01 Rev 1  
August 2013

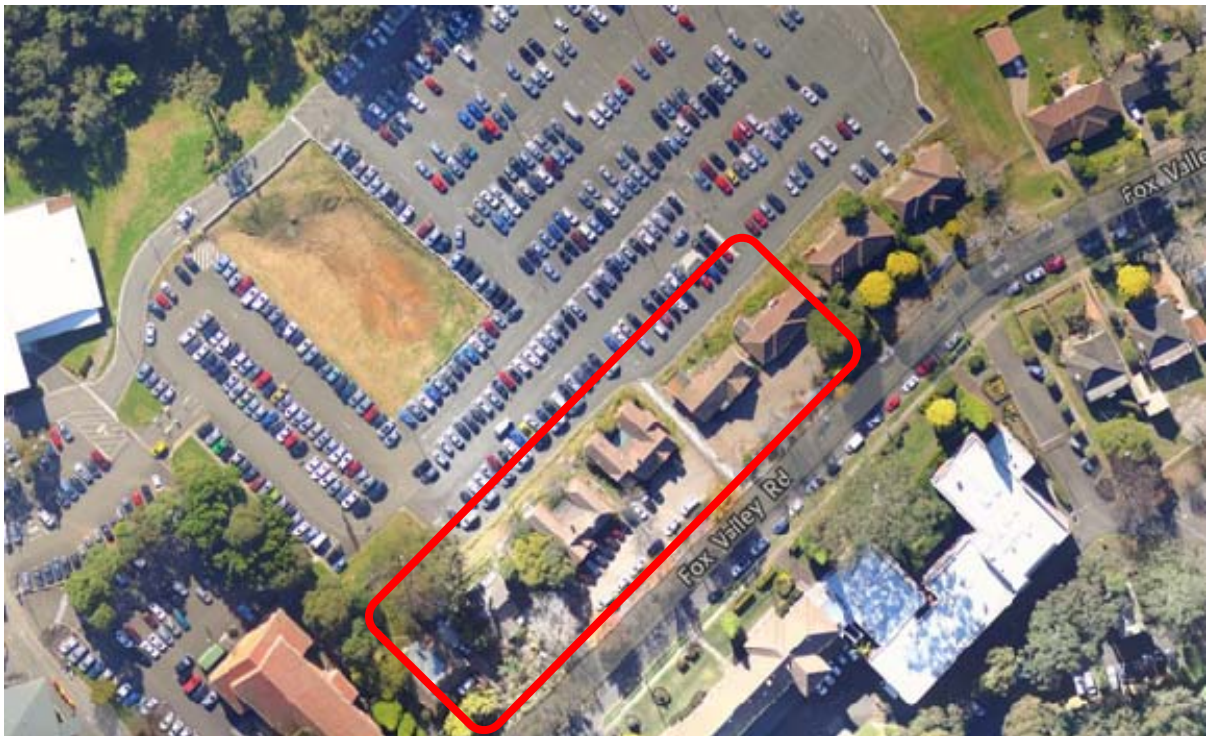
Figure 1: Area outlined in red shows former residential buildings situated in the proposed school campus. The aerial image was taken in June 2012 (Aerial image source: Nearmap)

A review of the most recent aerial photos - June and August 2012 aerial images in Figures 1 and 2, indicate a number of residential houses were demolished in August 2012. The recent demolition activities were also evident in the current field findings where greater depth of fill and heterogeneous fill materials were observed within the footprint of former residential buildings.

The former residential buildings appear to have been built *circa* 1930s – 1960s. Houses from this era which have been demolished would potentially have had asbestos-containing building materials contained within them. Thus, there is the potential for surficial contamination around the building footprint with asbestos-containing materials from demolition. This was observed during the current field investigation where a fragment of suspected bonded asbestos-containing material was observed in the fill layer of a test pit located in the former building footprint. Subsequent analytical results confirmed the presence of asbestos. Details of the current findings are outlined in Section 13.

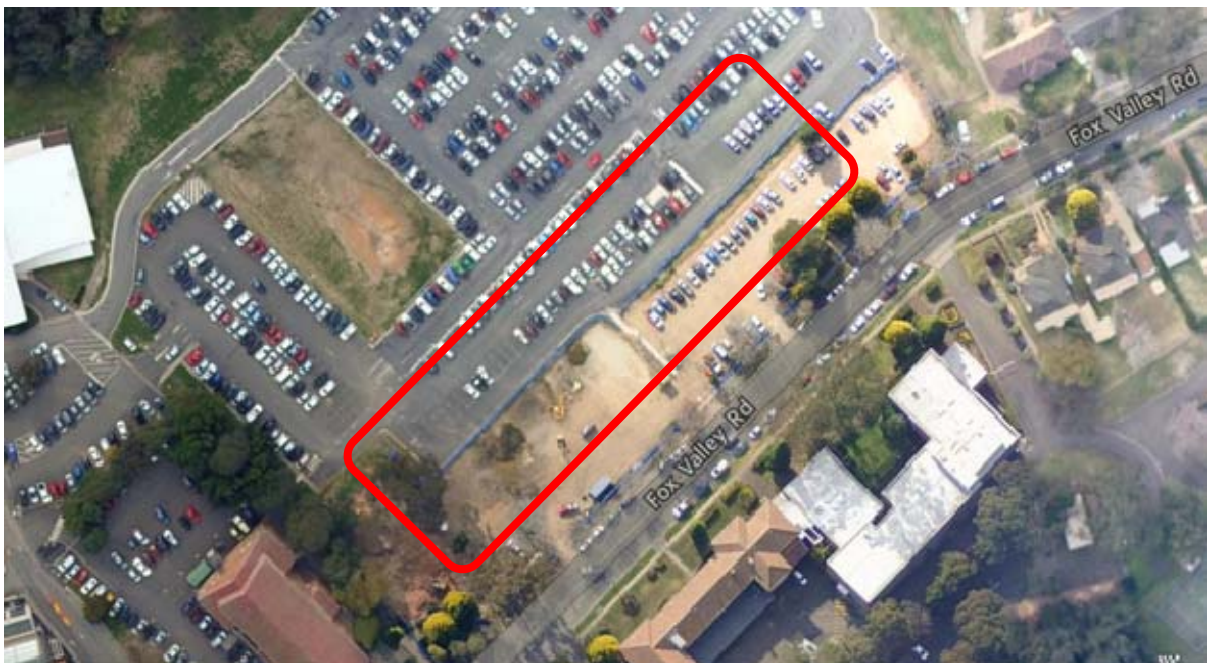
Figure 2: Area outlined in red shows post-demolition of former residential houses. The aerial image was taken in August 2012. (Aerial image source: Nearmap)

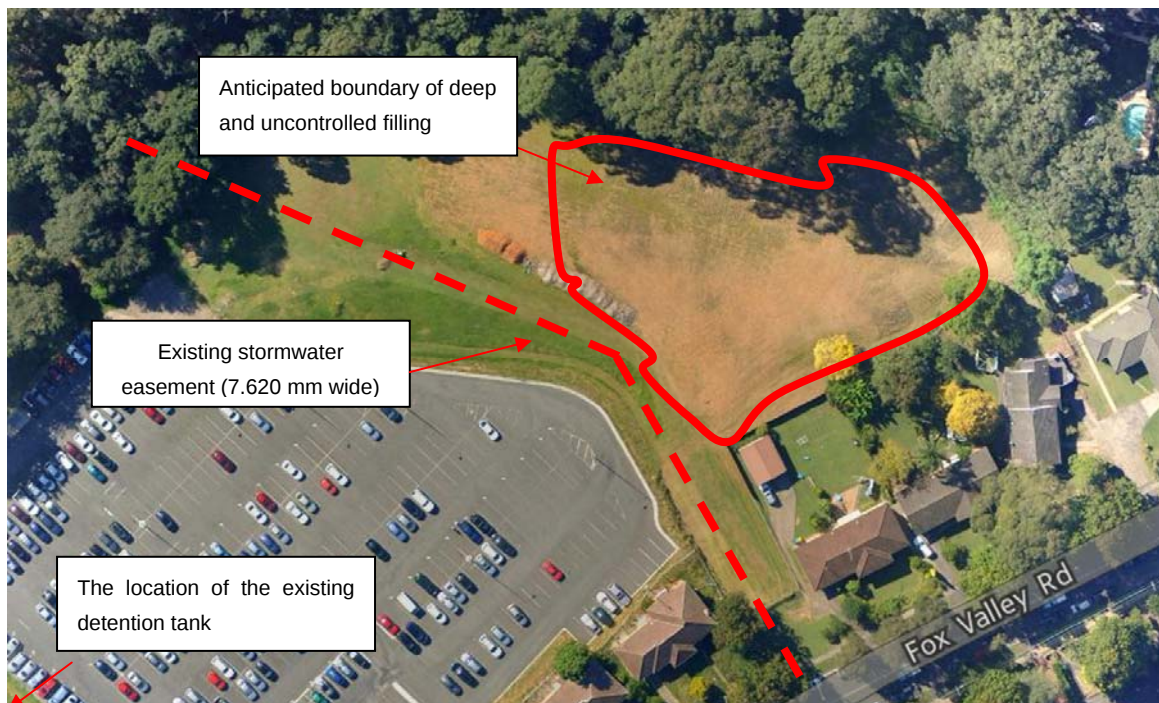
Figure 4: Area outlined in red marks the boundary of the anticipated boundary of deep and uncontrolled filling observed in the March 2012 aerial image. (Aerial image source: Nearmap)

A recent aerial image review indicates that cut and fill activities were undertaken *circa* September 2011 to level and establish the existing car park and possibly the existing detention tank and stormwater easement. This finding generally corresponds with DP's current field investigation where deep (greater than 4 m) and heterogeneous fill was observed within the boundary outlined in Figures 3 and 4.
