Aurora Projects Pty Ltd  
Upgrading of J17 & J18 Building, UNSW  
Geotechnical Investigation

# Contamination Assessment

School of Mechanical and Manufacturing  
Engineering,  
University of NSW,  
NSW

October 2012  
JBS 42248–51111 Rev 1  
JBS Environmental Pty Ltd

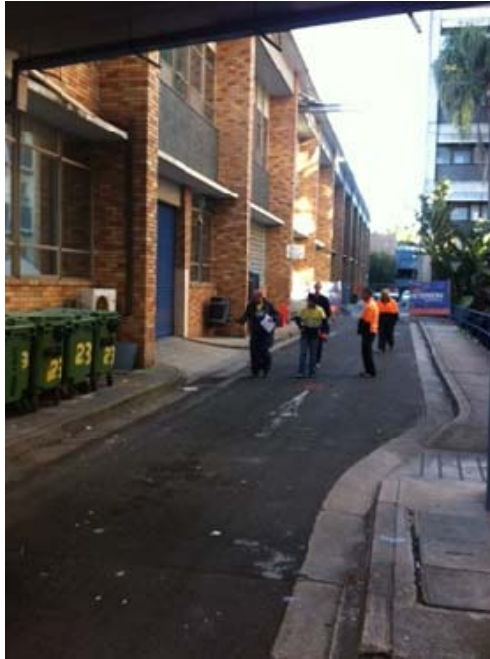
Photo 1: Willis Lane (the site) looking south from the northern end of the site

A site inspection was undertaken by one of JBS Environmental's trained and experienced field scientists on 3 July 2012. At the time of the inspection the site comprised two buildings utilised by the School of Mechanical and Manufacturing Engineering (**Photos 1 and 2, Appendix A**).

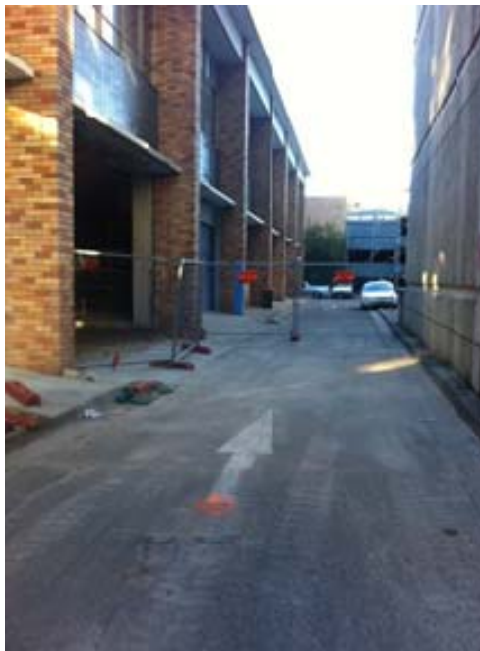
Photo 2: Willis lane (the site) looking south from the center of the site

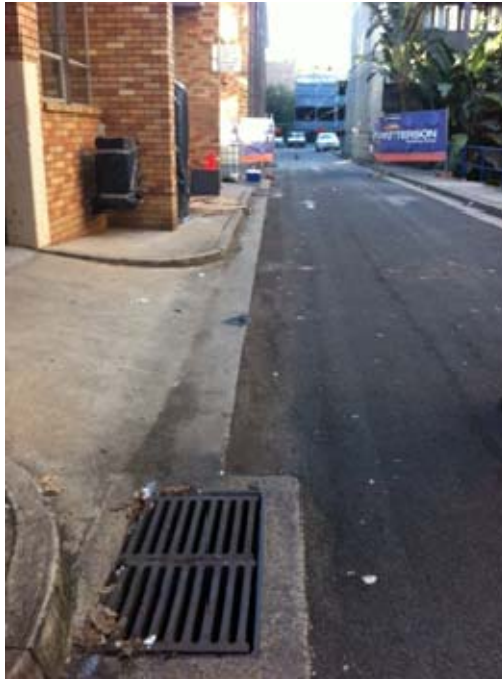
Photo 3: Storm water infrastructure along Willis Lane

The majority of the site comprised the two multi storey university buildings east and west of Willis Lane, with some small areas paved with bitumen or concrete both in relatively good condition. The building to the west was at a lower level than the eastern building, separated by a 3m to 4m retaining wall, constructed of open concrete block. (**Photos 5 and 6, Appendix A**). The remainder of the site was relatively level with a slight slope towards Willis Lane into the storm water infrastructure on either side of the lane (**Photo 3, Appendix A**).

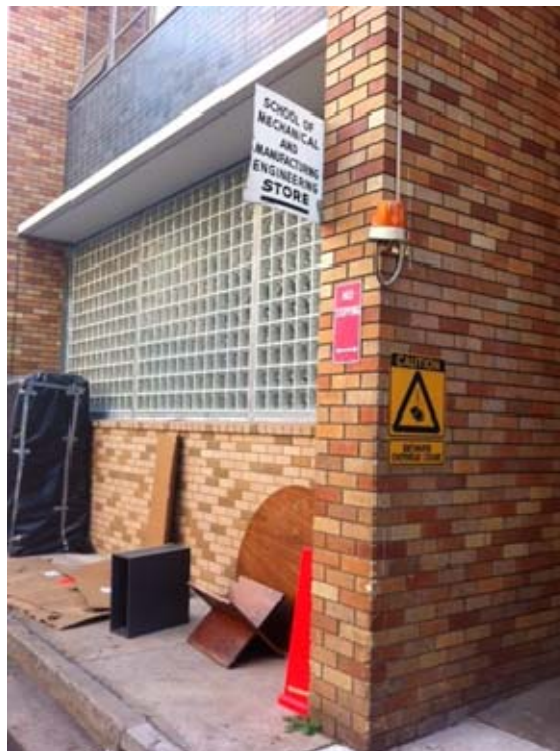
Photo 4: The mechanical and manufacturing engineering store located on the eastern side of Willis Lane.

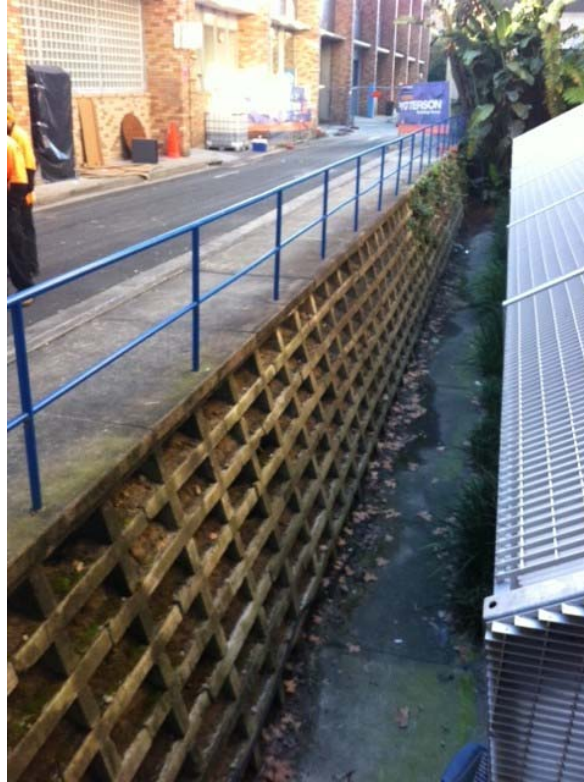
Photo 5: The retaining wall along the western side of the site, looking south

The majority of the site comprised the two multi storey university buildings, with some small areas paved with bitumen or concrete both in relatively good condition. The building to the west was at a lower level than the eastern building, separated by a 3m to 4m retaining wall, constructed of open concrete block.

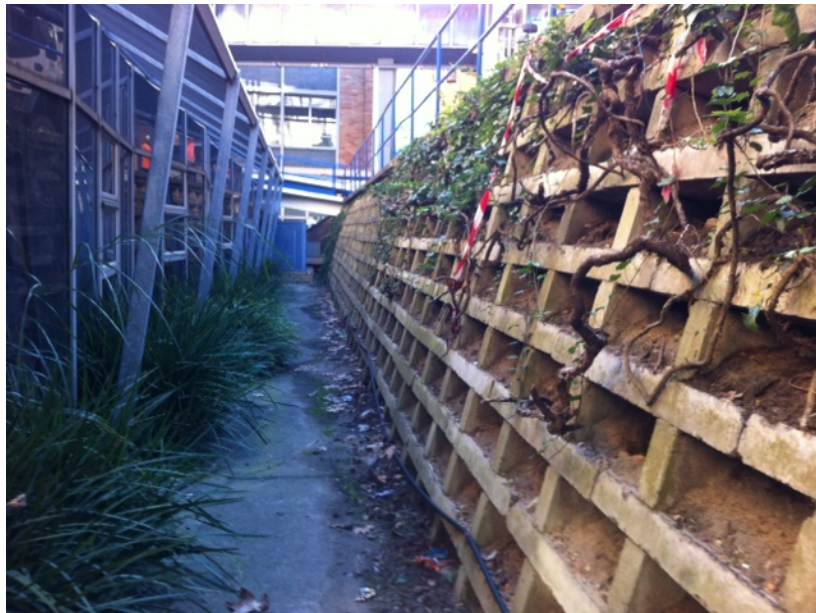
Photo 6: The retaining wall along the western side of the site.
