ENVIRONMENTAL IMPACT ASSESSMENT

FOR A PROPOSED TEMPORARY FERRY WHARF

AT GLEBE ISLAND TERMINAL BERTH 3

- AQUATIC ECOLOGY ASSESSMENT

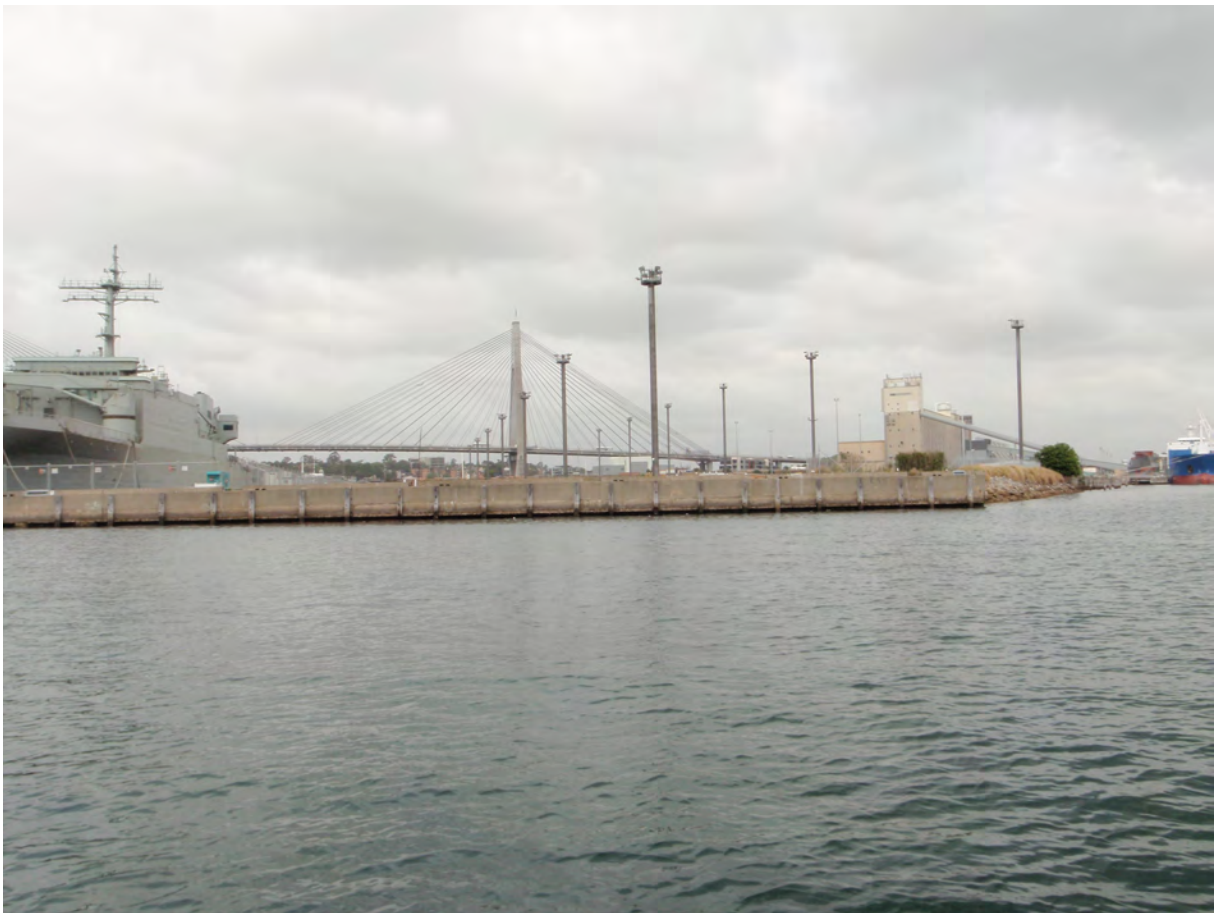
Figure 1 View of Berth 3 at the northern end of the Glebe Island Terminal, Johnson Bay.

Berth 3 is located at the northern end of the Glebe Island Terminal. Figure 1 shows a view of the existing Berth 3 from the water and Figure 2 provides an aerial view of a portion of Sydney Harbour around the Pyrmont peninsular, showing the site location in context with other marine facilities in this part of the harbour. Figure 3 provides a close up view of the existing berthing facility and Figures 4 and 5 show the western side of the berth and the rip-rap revetment wall to the south-west of Berth 3.

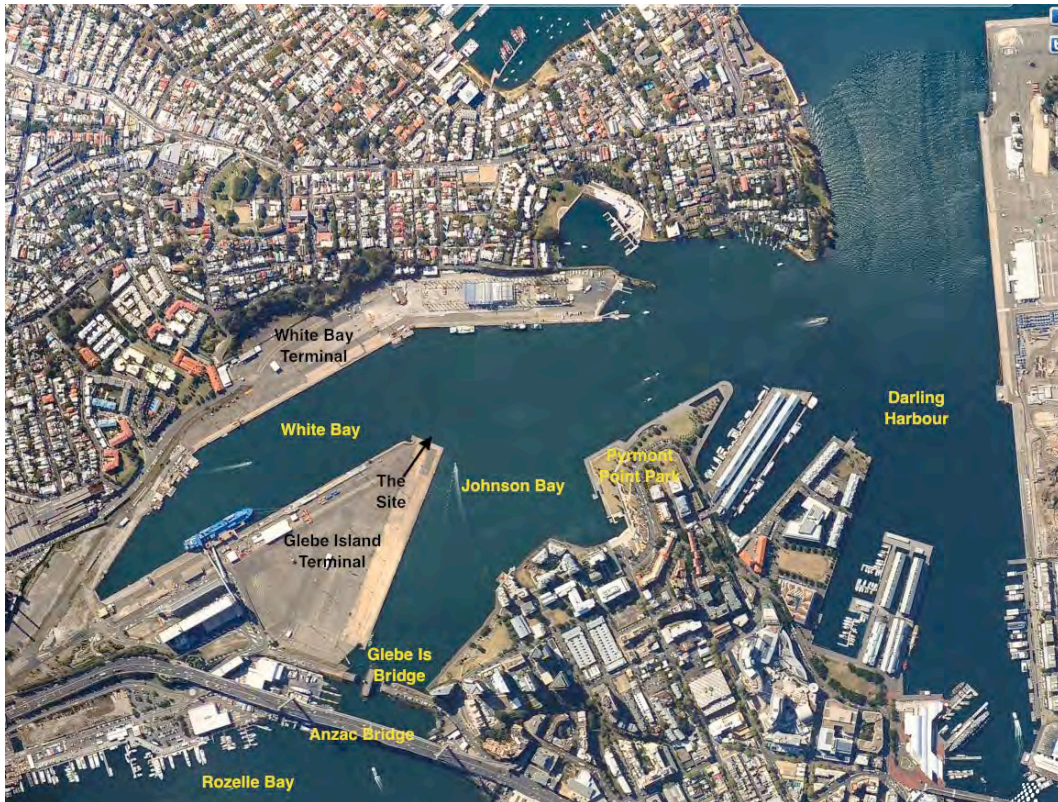
Figure 2 Aerial view of Pyrmont showing the location of the proposed ferry wharf at the northern end of the Glebe Island Terminal in relation to other marine facilities in this part of Sydney Harbour (Nearmap.com photo 8 Sep 2012).

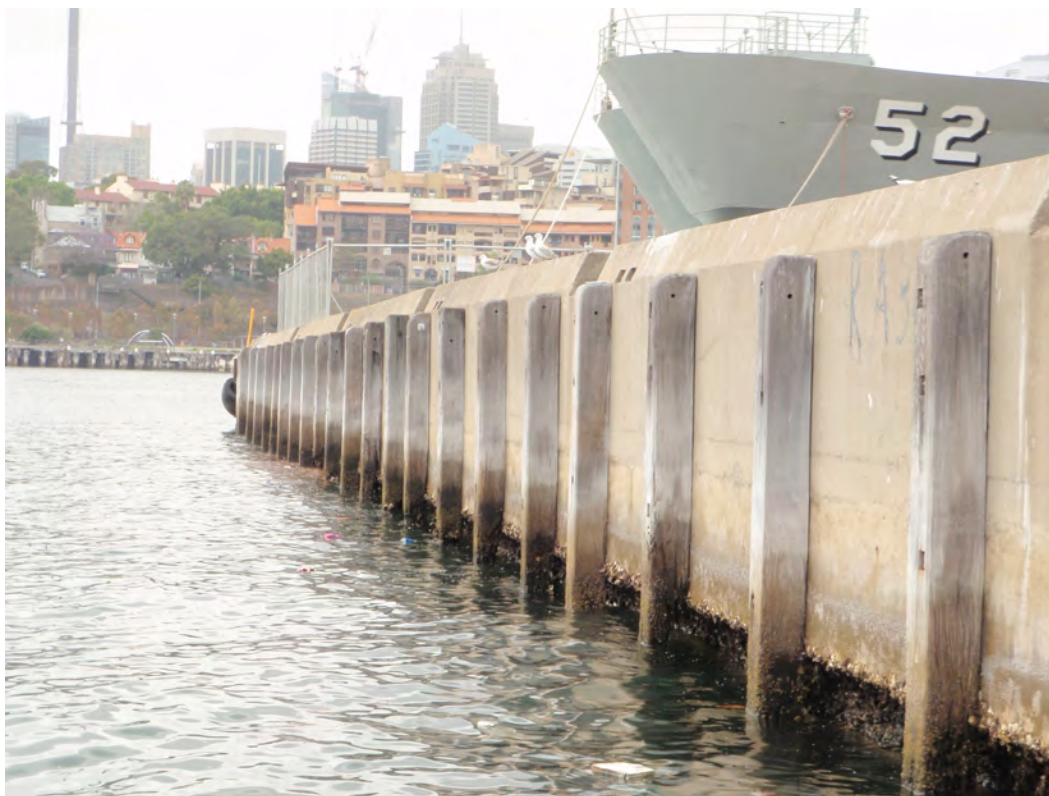
Figure 3 Close up view of existing berthing facility at Berth 3 Glebe Island Terminal. Berths 1 and 2 facilities along the eastern side of the terminal are similar to those of Berth 3 as shown here.

There are three main areas of aquatic habitat in the locality; (i) the wetted surface areas of the concrete faced berth (Figure 3), (ii) the mixed rock rubble intertidal and shallow subtidal rip-rap revetment habitat (Figure 4) and (iii) soft sediment habitat offshore from the wharf and the revetment. The revetment rip-rap rock is predominantly irregular sandstone with block sizes of around 400 to 600 mm diameter in the intertidal and immediate shallow subtidal and progressively larger block sizes in the subtidal to the muddy seabed. Bottom block sizes are up to 2 m diameter. The bare sediment seabed grades from silty-sand to mud with depth.

- The riparian shore comprises a concrete slab at Berth 3 (Figure 3) and the upper riparian part of the rip-rap revetment adjacent to Berth 4. The latter riparian habitat supports a cover of planted grasses plus a mix of herbs and weeds (Figure 5). This habitat provides suitable nesting habitat for seabirds, and at the time of survey was well utilised by nesting Silver gulls (Figure 10). The upper intertidal comprises bare concrete or bare rock with no aquatic biota (Figures 3 and 4).

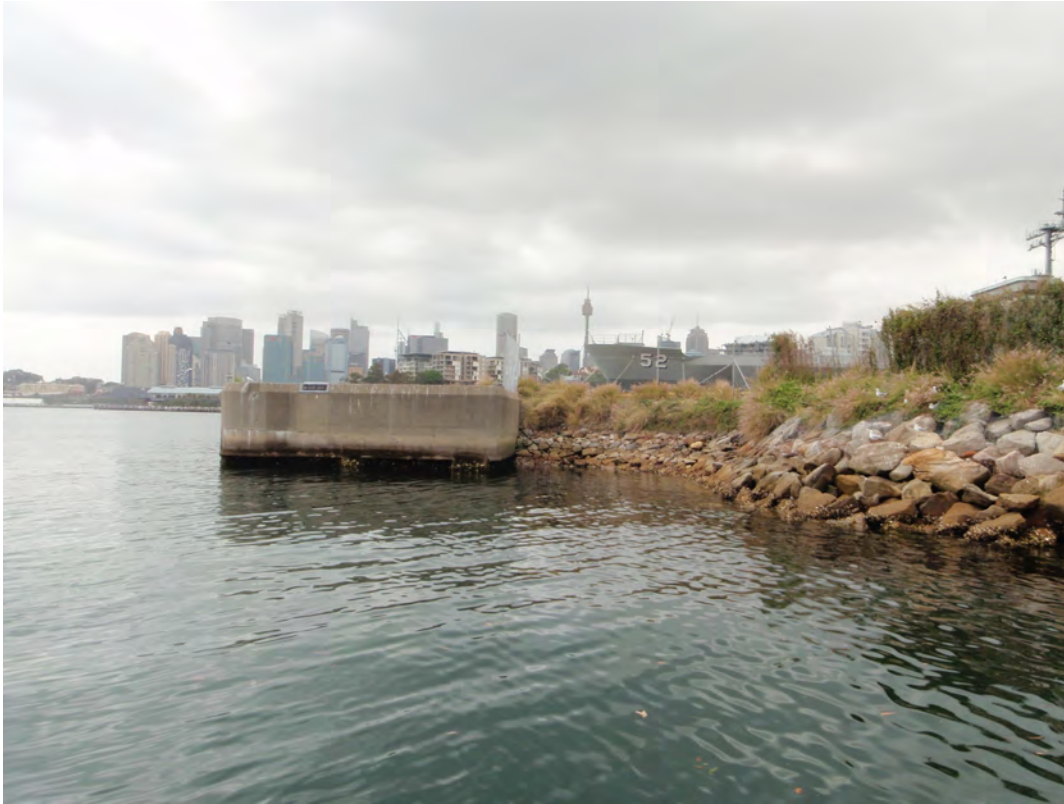
Figure 4 View of western side of Berth 3 looking east from off-shore of the rip-rap revetment (unused Berth 4).

The Glebe Island terminal is built on a reclamation that is held in place by a sloping rip-rap revetment wall along the north-western side (at the disused Berth 4 - Figure 4). This rip-rap extends north to Berth 3, and Berth 3 comprises a rectangular concrete structure that is built out over the end of the revetment (Figure 4). The rip-rap revetment wall also extends south towards the disused Berth 5 piles (see Figure 5).

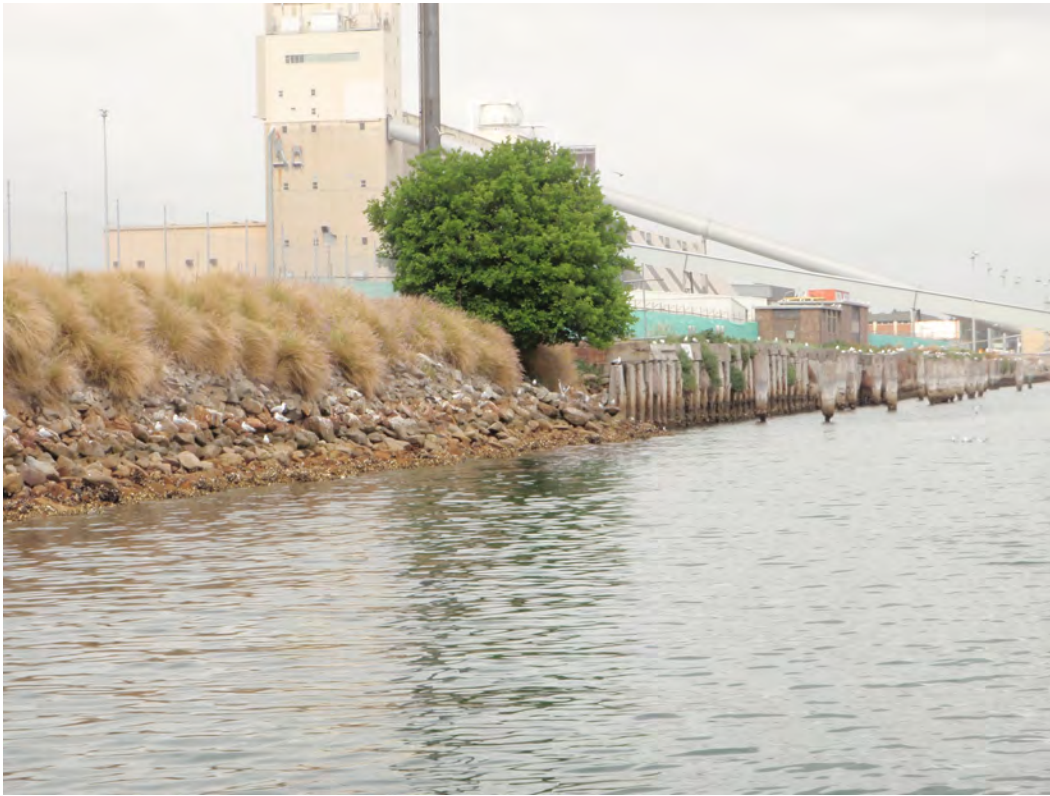
Figure 5 View of rip-rap revetment wall looking south towards the disused Berth 5 piles. The Cement and Sugar Terminals are located further south at Berths 6 and 7.

Depths along the front of Berth 3 and to the immediate west and east of the berth are all greater than - 11m LAT (Lowest Astronomical Tide). The rip-rap revetment depth varies from well above HAT at the top of the slope to around -10m LAT at the bottom (see Figure 5).

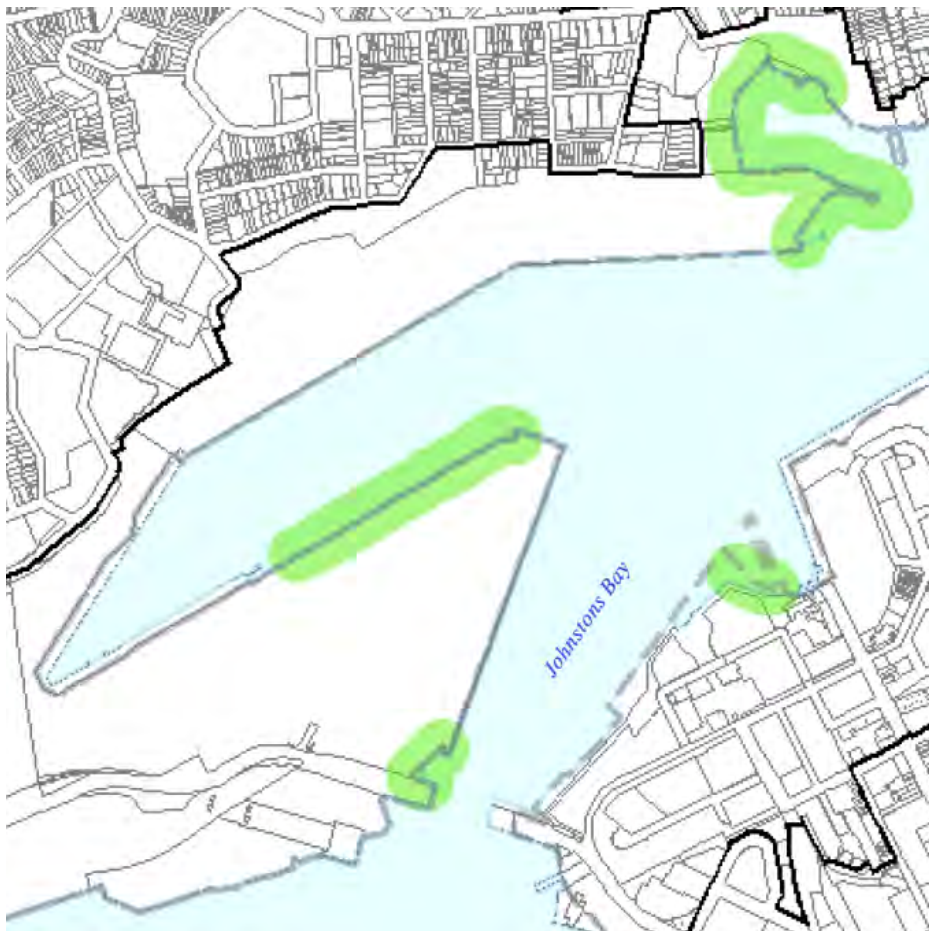
Figure 8 Portion of SREP (Sydney Harbour Catchment) Wetlands Protection Area Sheet 4 showing designated 'wetland' areas around Whites and Johnston Bays.

A portion of Sheet 4 for the Sydney Regional Environmental Plan (Sydney Harbour Catchment) 2005) is shown as Figure 8 below and it indicates 'wetlands' in Camerons Cove and around White Bay Terminal that coincide with the dark purple "rocky intertidal and rock platform" habitat shown in Figure 7.

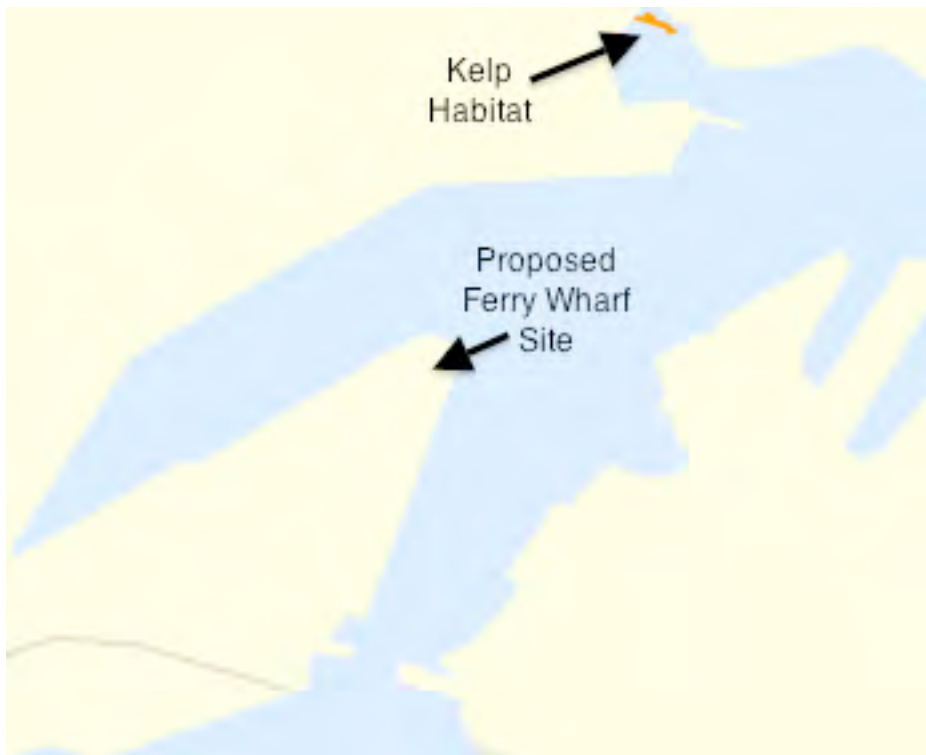
Figure 9 Detail of NSW DPI (Fisheries) estuarine vegetation map 39a showing kelp habitat in Cameron Cove, that coincides with the SREP Sheet 4 'wetland' designations.

Recent mapping by NSW Department of Primary Industries Fisheries Branch (DPI Fisheries) indicates *Kelp habitat* in the near-shore shallows of Camerons Cove (Figure 9). This location also matches up with the SREP ‘wetland’ designation shown in Figure 7, and it is concluded that all the SREP wetland areas shown in Figure 8 are intertidal to subtidal rip rap rock revetments that support macroalgae (kelp) habitats.

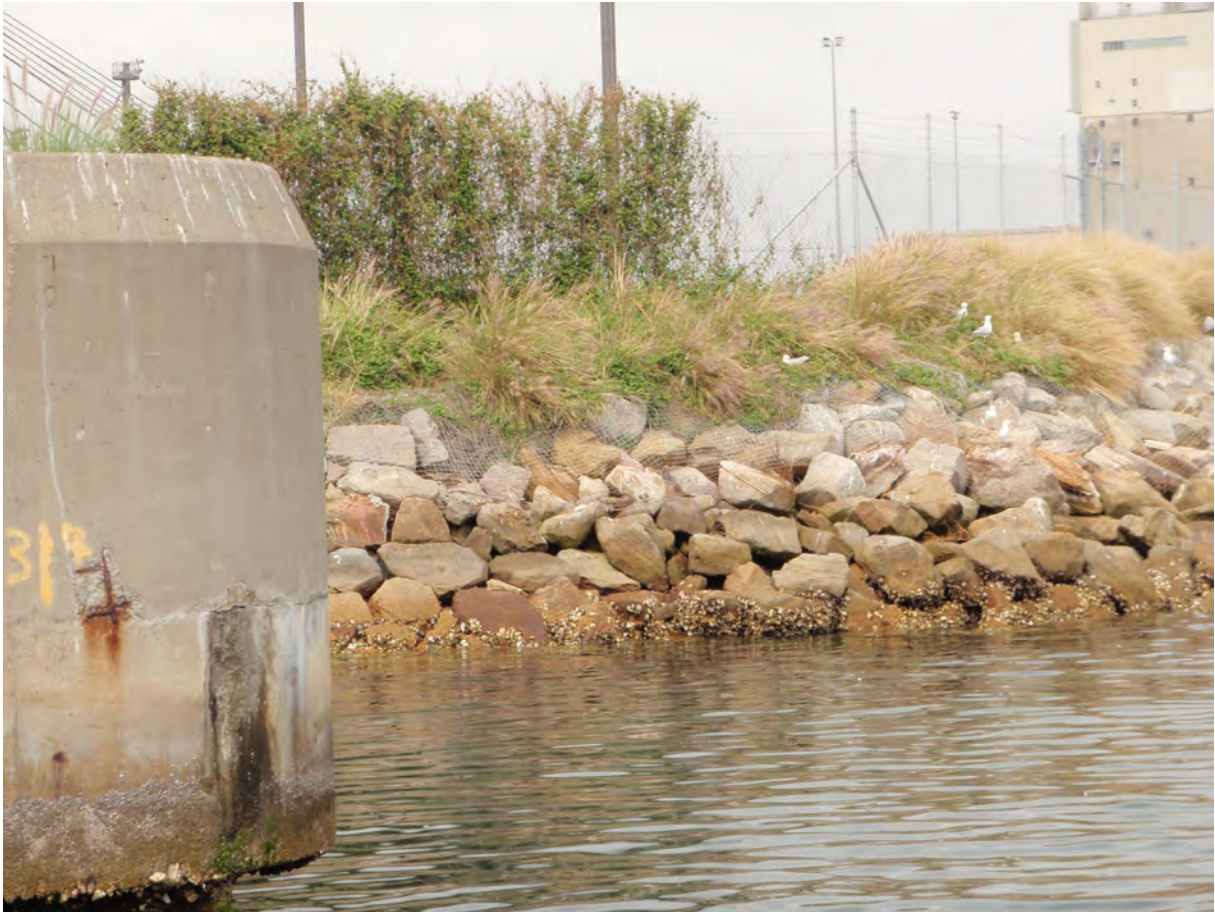
Figure 10 Riparian top of bank vegetation on riprap revetment supports nesting Silver gulls. There is a distinct depth zonation of aquatic biota on the concrete walls and rock revetment. This zonation and the biota of each of the zones are described as follows:

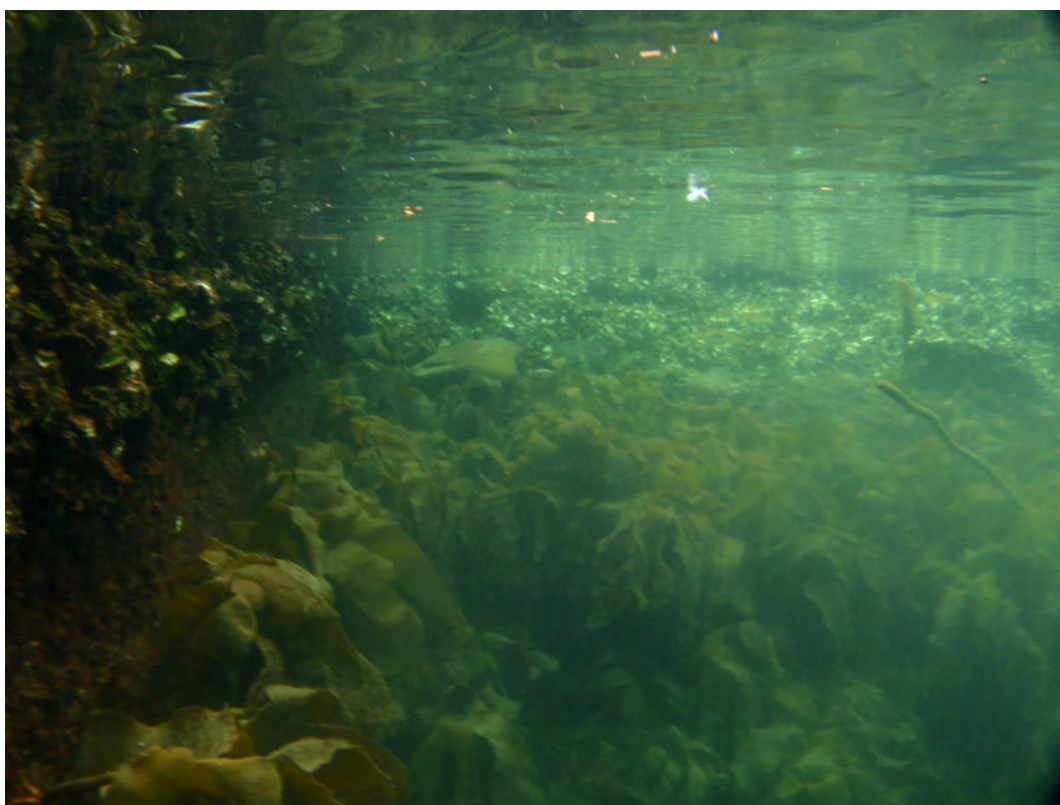
Figure 12 View of intertidal to shallow subtidal fringe on rock revetment with oyster band at the top and a kelp and *Sargassum* band in the shallow subtidal.

tramoserica and *Montfortula sp.*). There is a distinct oyster band from the lower intertidal into the shallow subtidal (Figures 11 and 12) comprising two species, the native Sydney Rock Oyster plus the introduced declared pest species the Pacific Oyster.

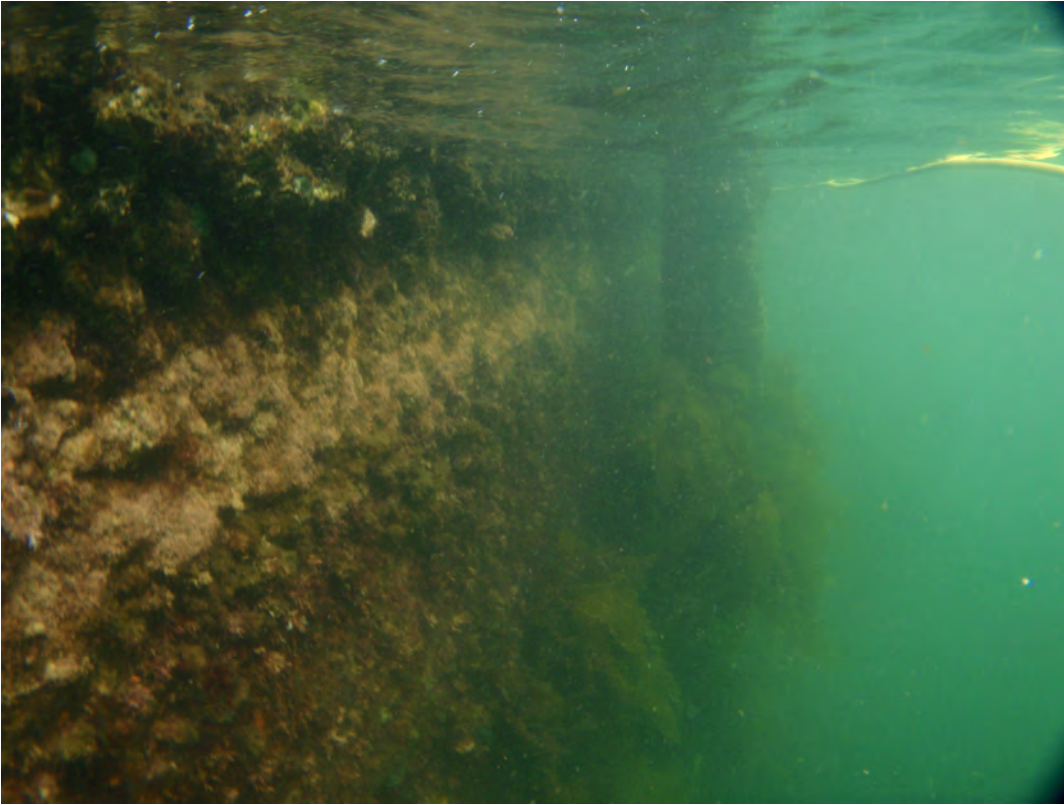
Figure 13 Close up view of subtidal fringe on concrete wall showing band of red coralline algae below oysters plus fringing algae plus tunicate band below.

- The intertidal fringe plus shallow sub-tidal fringes of the concrete berth wall, the wood berth fenders and of the revetment rocks all support a patchy cover of encrusting red coralline algae plus a variety of short frondose brown algae species including *Dictyota dichotoma* plus *Sargassum sp.* Overall cover is good (Figures 13 and 14).

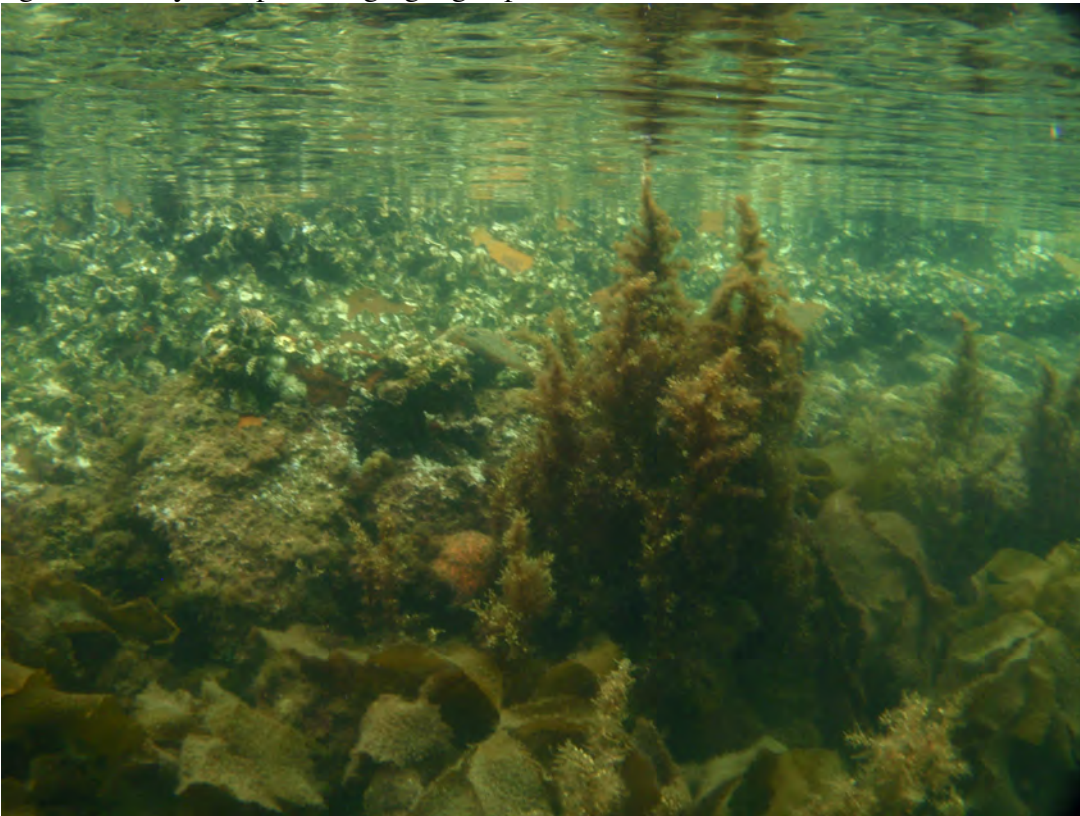
Figure 14 Close up view of subtidal fringe on revetment rocks showing sparse fringe of frondose algae between oyster band and kelp plus *Sargassum* zone below.

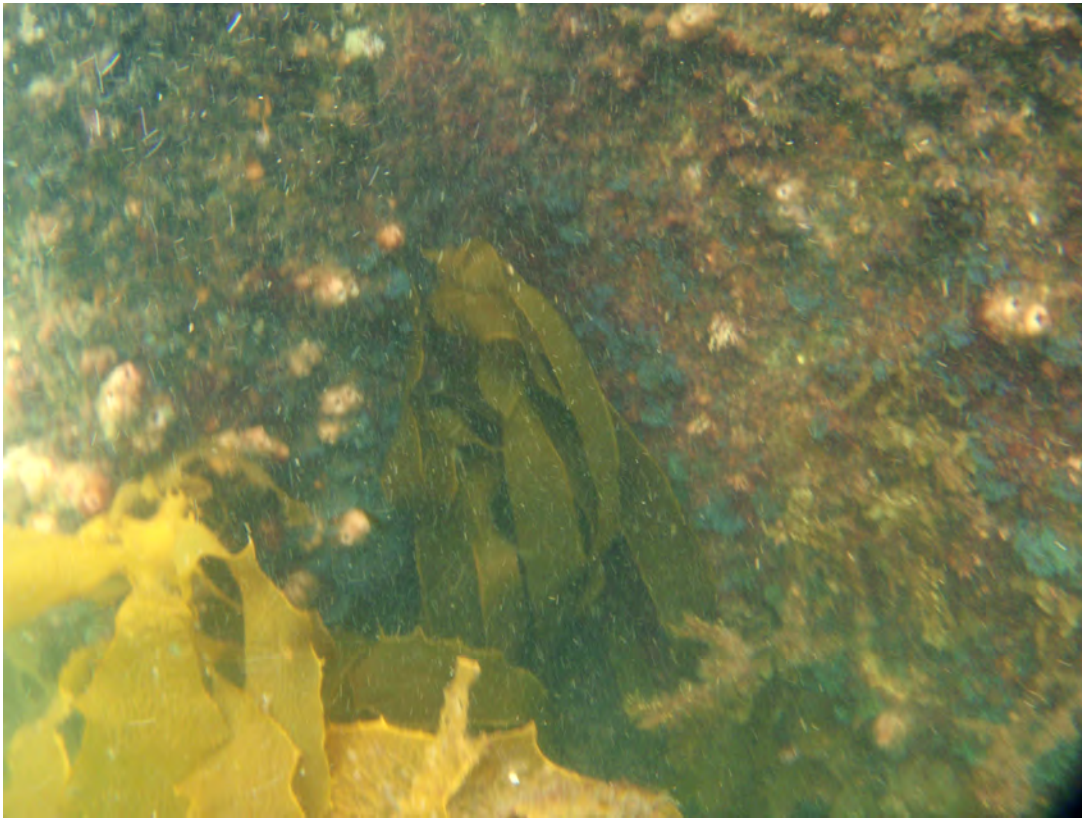
Figure 15 Mixed kelp, frondose algae and tunicate zone in deeper sub-tidal below subtidal fringe on concrete wall.

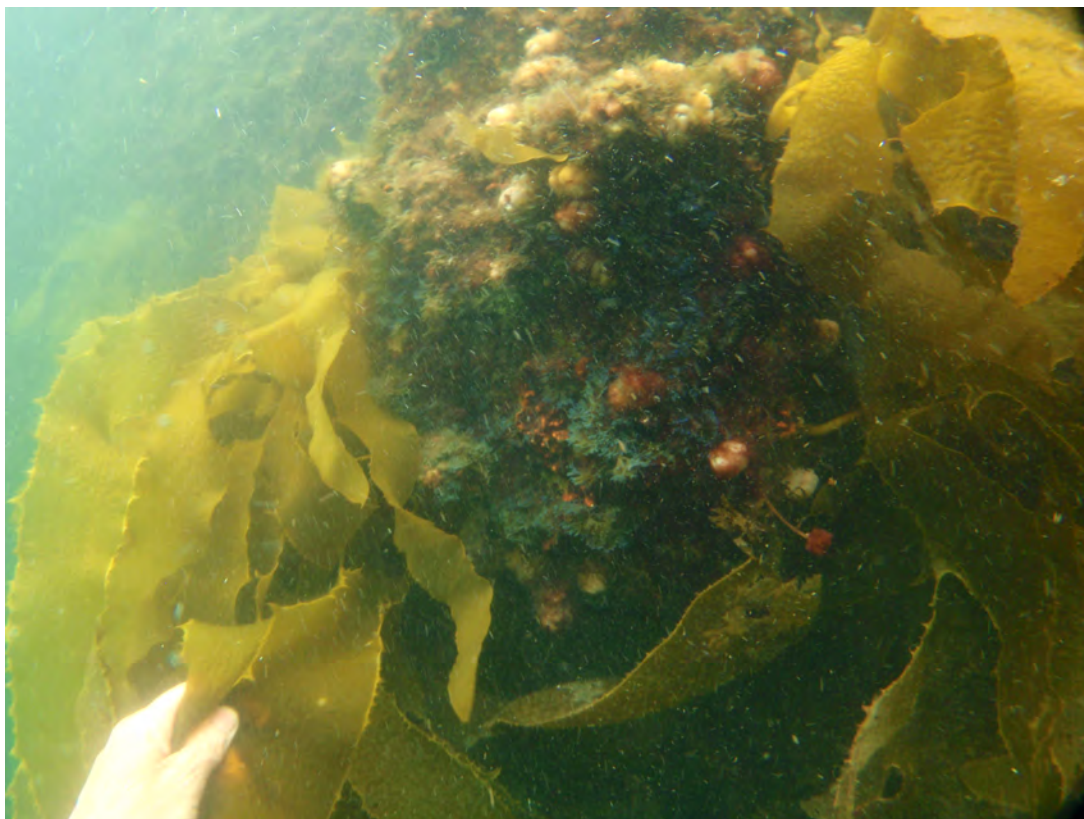
Figure 16 The wooden fenders on the concrete wall support a similar but more dense assemblage of biota in the sub-tidal zone than the concrete wall as shown in Figure 15.

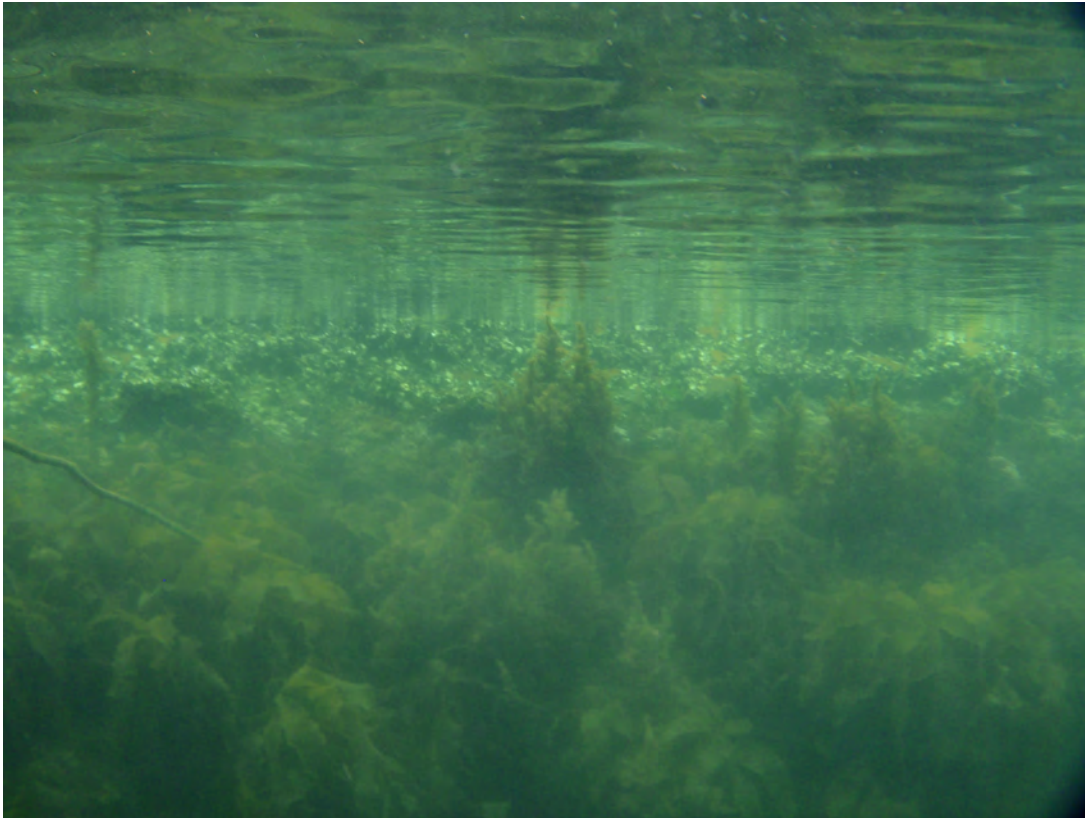
Figure 17. The revetment rocks support a mixed macro-algae zone comprising kelp and *Sargassum*, with an understory of frondose algae plus tunicates.

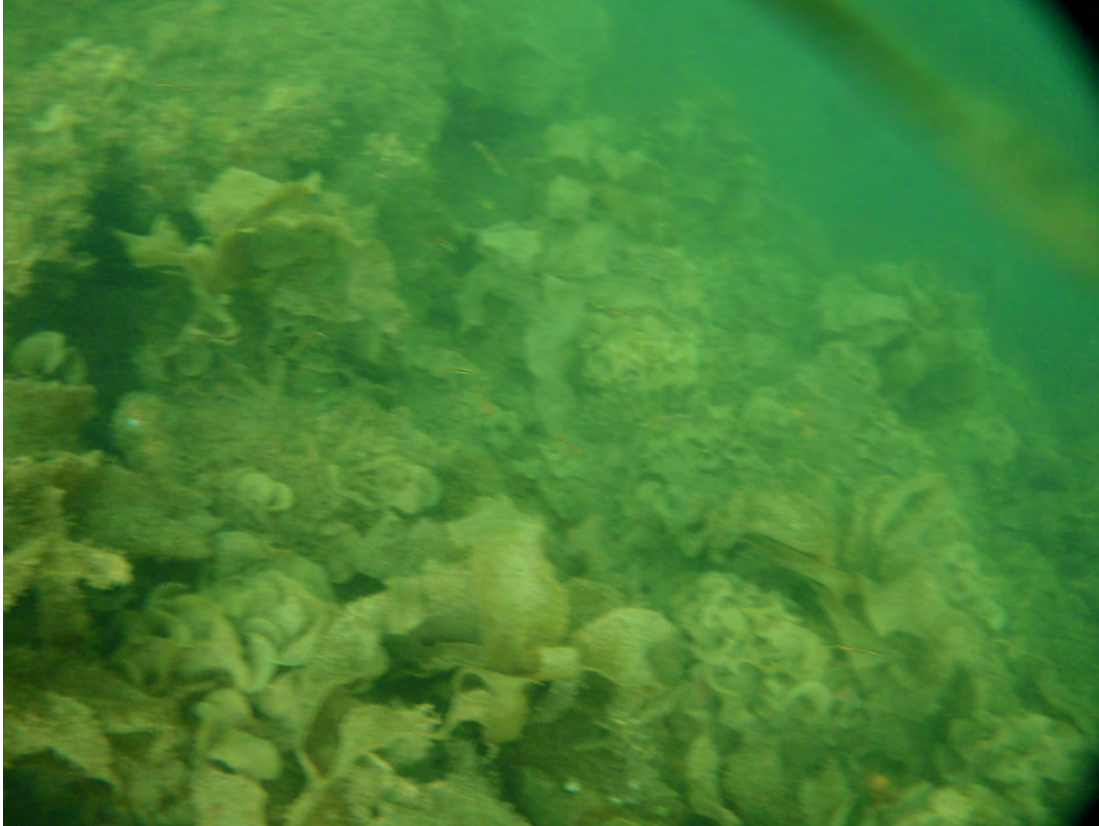
Figure 19. The lower limit of algae growth on the revetment is shallower than that on the concrete wall by around 1m due to the prevalence of smothering silt on the algae.

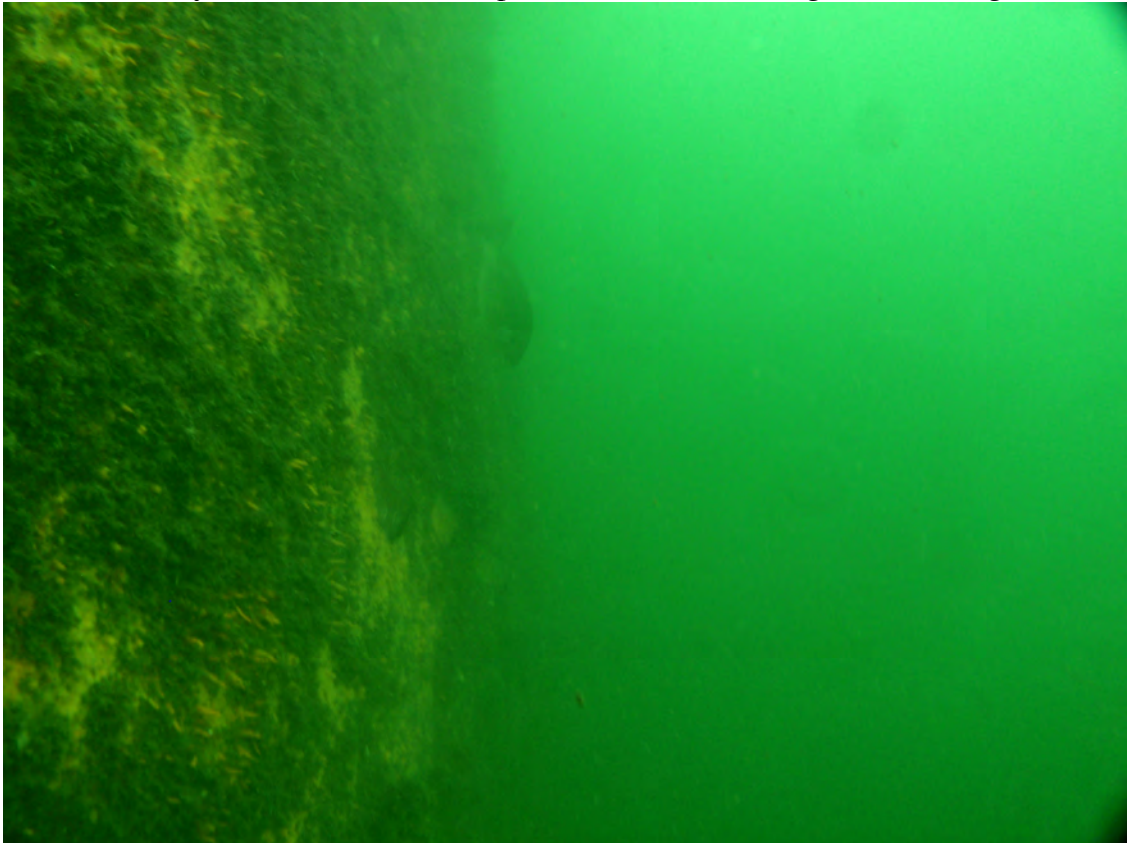
Figure 20. The extent of coverage by sponges decreases with depth on the concrete wall. Note blackfish swimming vertically along wall face in the background.

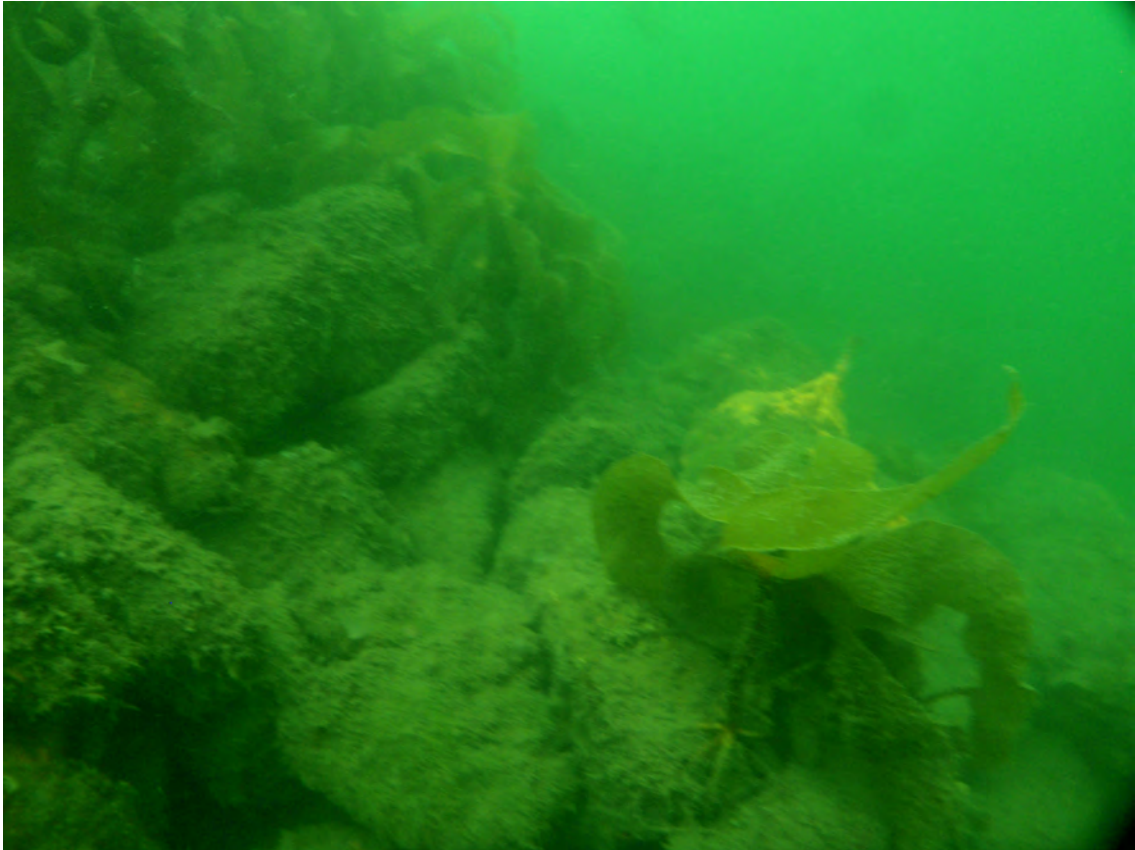
Figure 21. Silt smothers most encrusting growth and aquatic plants on the revetment rocks from about 3m depth down.

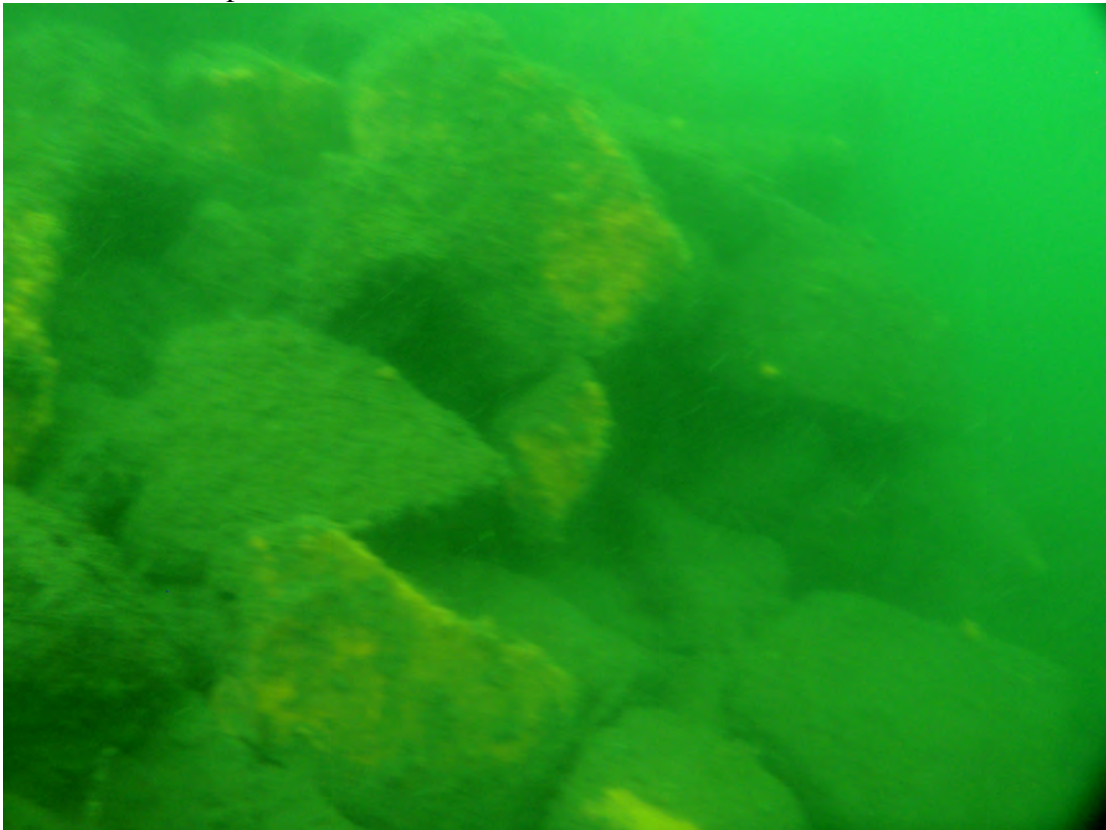
Figure 22. By 4m depth there are only isolated sponges found on the revetment rocks and then only around edges where silt cover is slightly less.

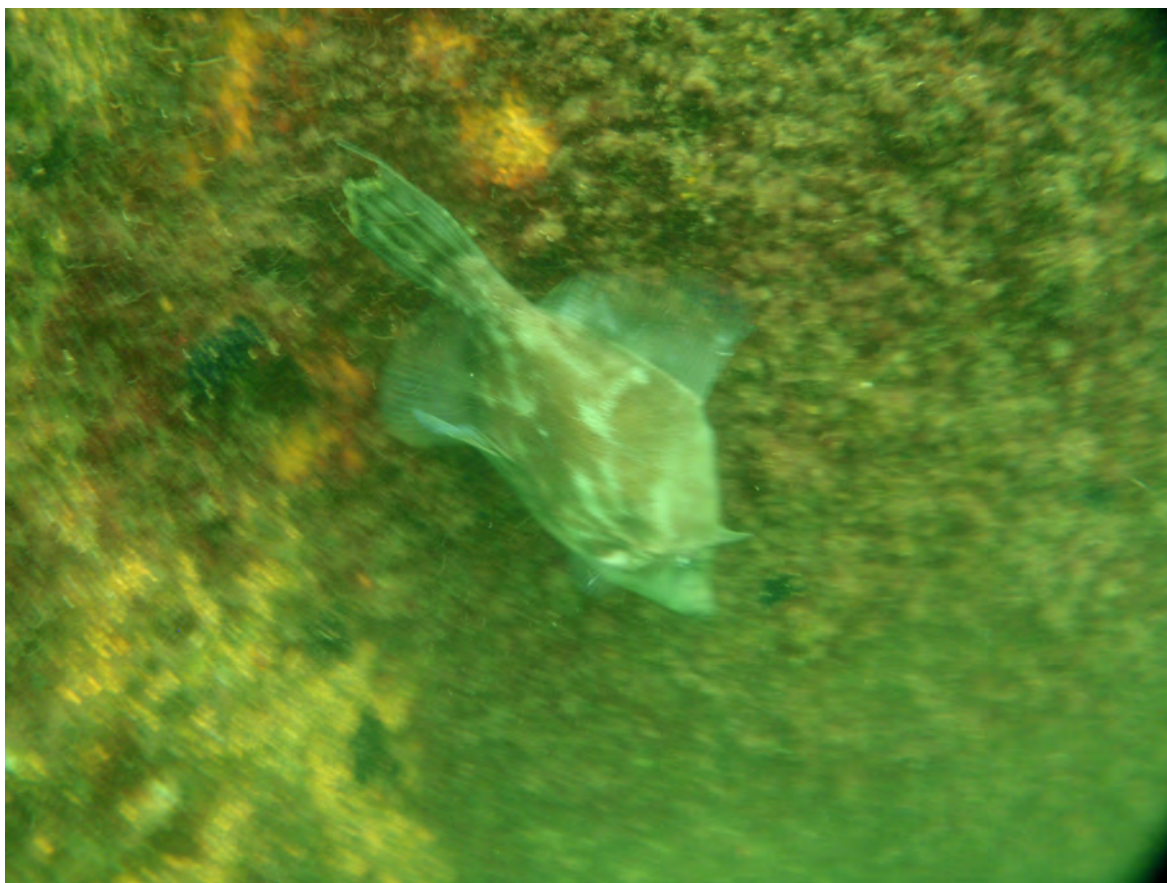
Figure 24 Fan bellied leatherjacket pressed against the concrete wall to camouflage itself from the potential predatory diver.

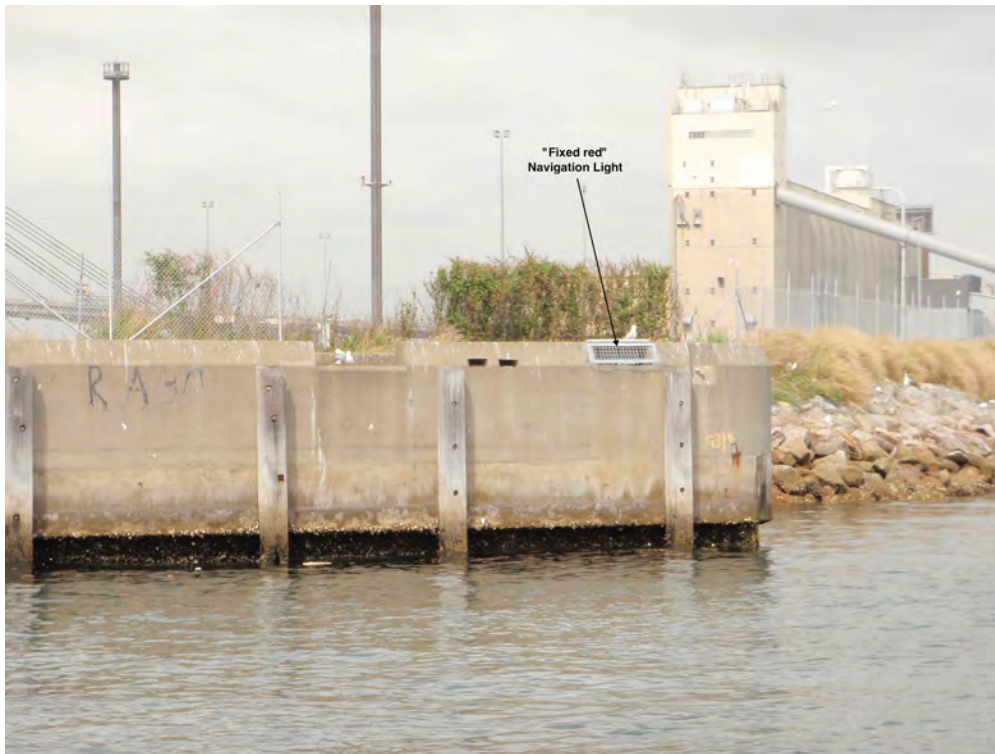
Figure 25 North-west side of Glebe Island berth 3 showing north facing “fixed red” navigation light. There is a similar light on the west facing side and two others at the north-eastern and east sides of the berth.

- Currently there are two sets of fixed red navigation lights, one on each corner of the Glebe Island Berth 3 concrete structure (Figure 6). The lights are set into the upper part of the concrete structure at each of the two corners (four lights in all - see Figures 4 and 25). There is potential for the proposed temporary structure to physically obscure these lights and there is also the potential for making the lights less visible via interference from ferry wharf lighting. Both these aspects will need to be taken into account and resolved during detailed wharf design.
