**SSD-5594 Schedule 3 Condition 10(h)(vii)**  
**Request for Alternative Compliance Approach - Heritage Management Plan**

# Springvale Longwalls 501-503 Extraction Plan Support

## Aboriginal Due Diligence Assessment

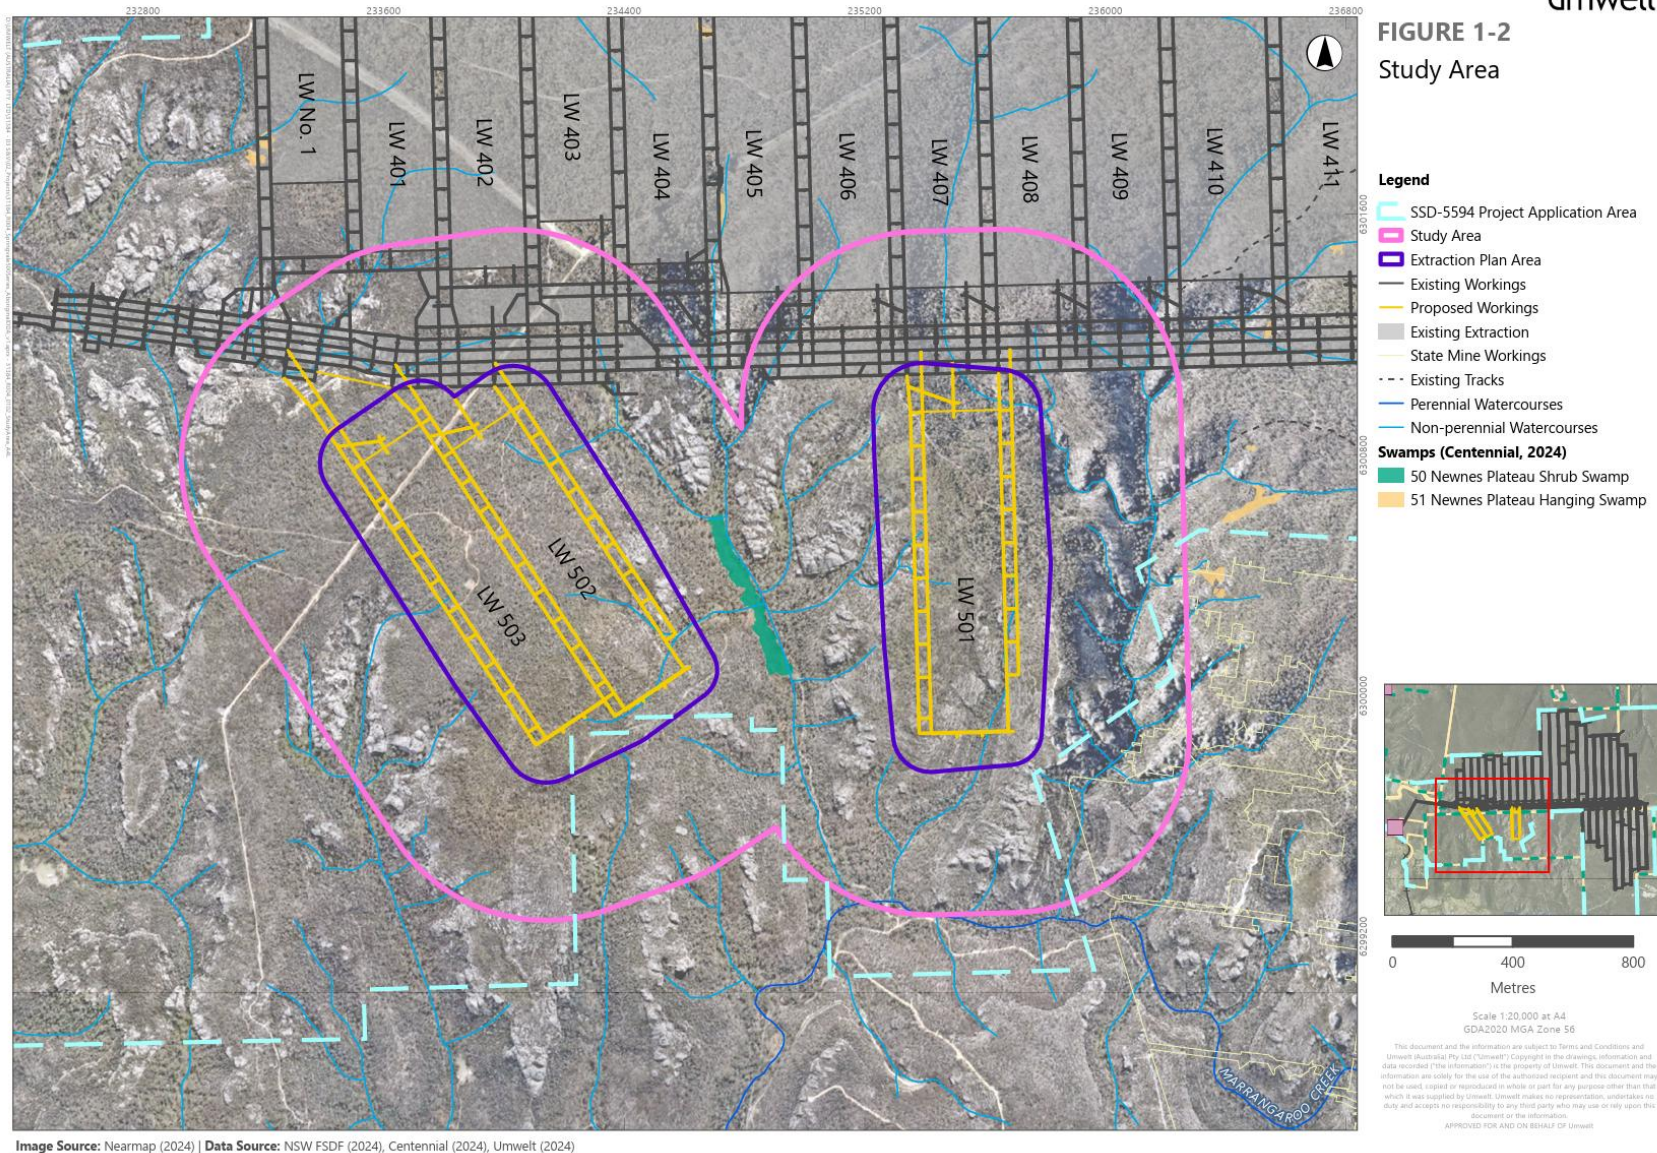
The Study Area for the Aboriginal Due Diligence Assessment extends 600 m from the proposed extraction of Longwalls 501–503 (refer to Figure 1-2). This buffer zone ensures that potential impacts from subsidence and related surface changes are adequately considered.

**Figure 1-2 Study Area**

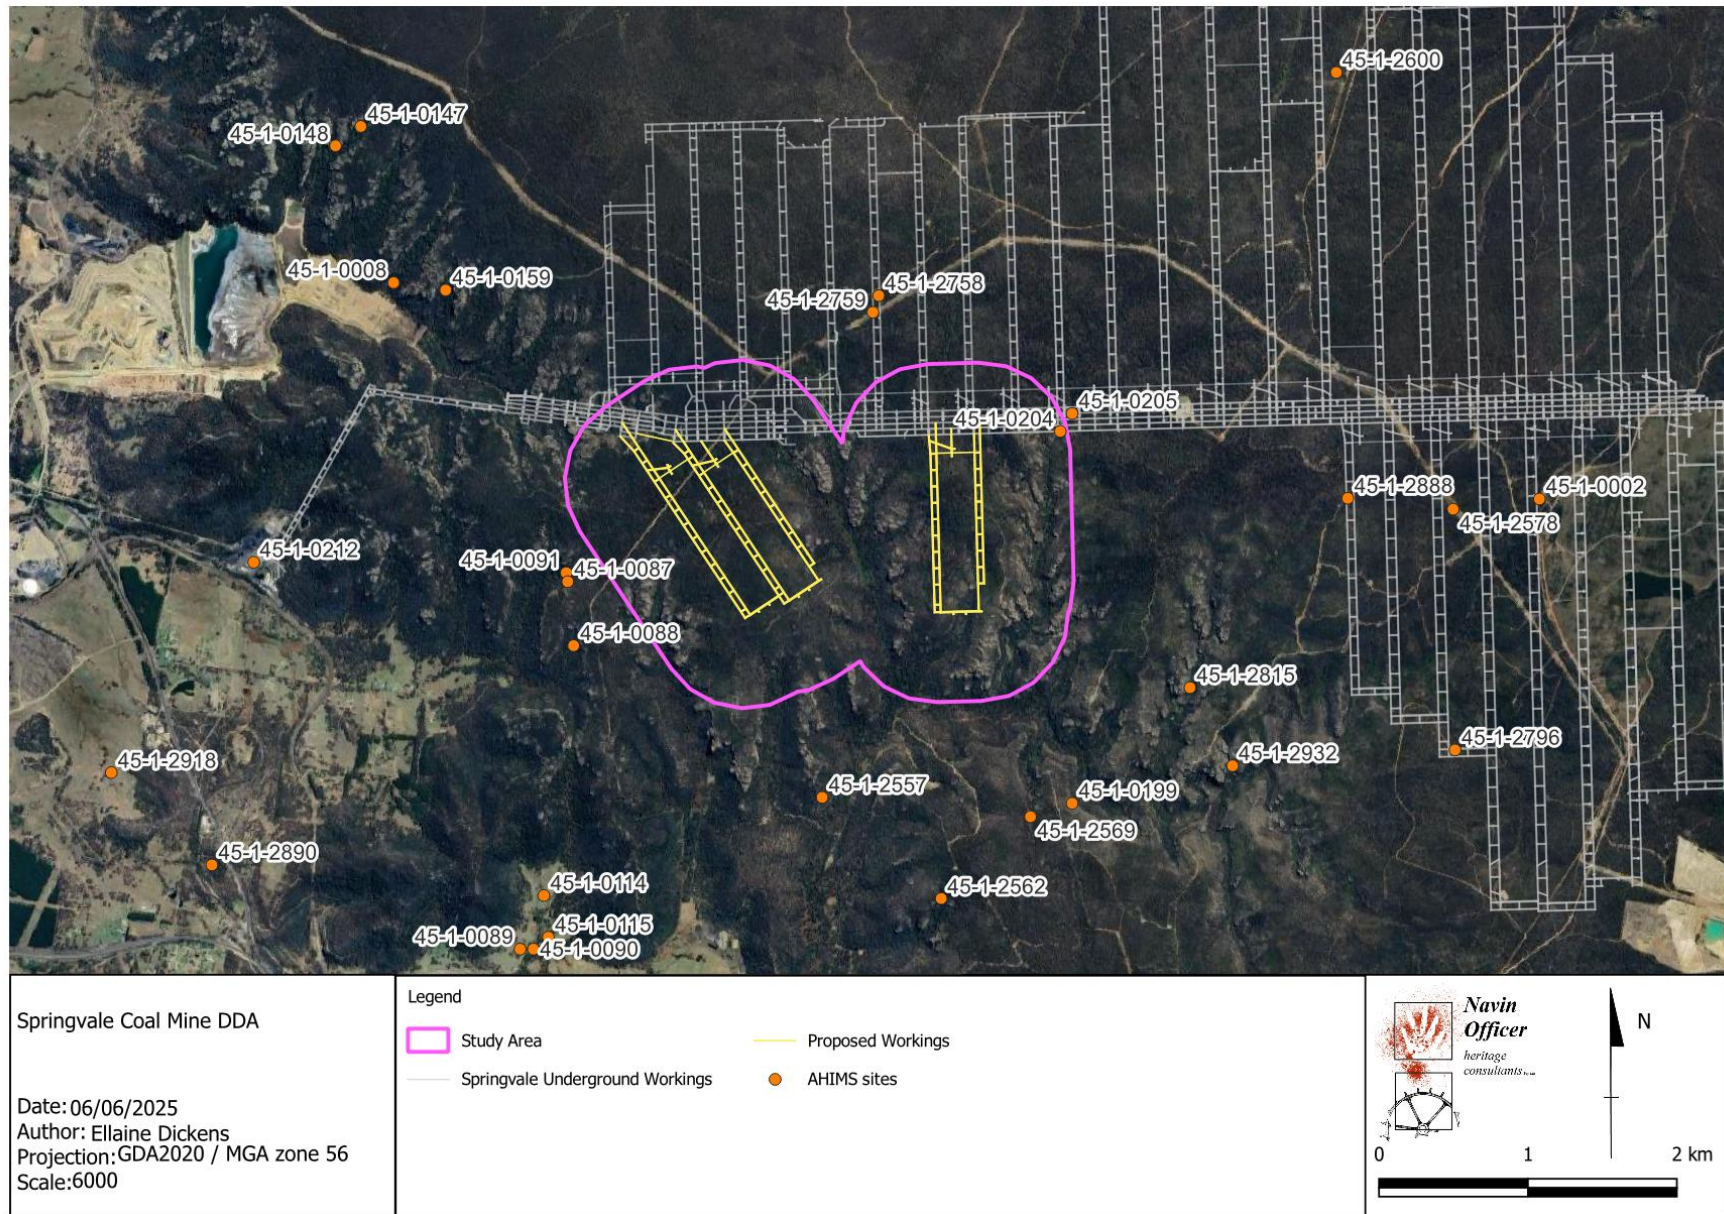
**Figure 2-1 AHIMS sites near the Study Area**

It should also be noted Site AHIMS #45-1-2557 (M-OS-1) was incorrectly recorded in AHIMS as an Aboriginal Ceremony and Dreaming site. The original report refers to this site as an open artefact scatter (CWAS, 2000). The site is located approximately 730 m south of the Study Area.

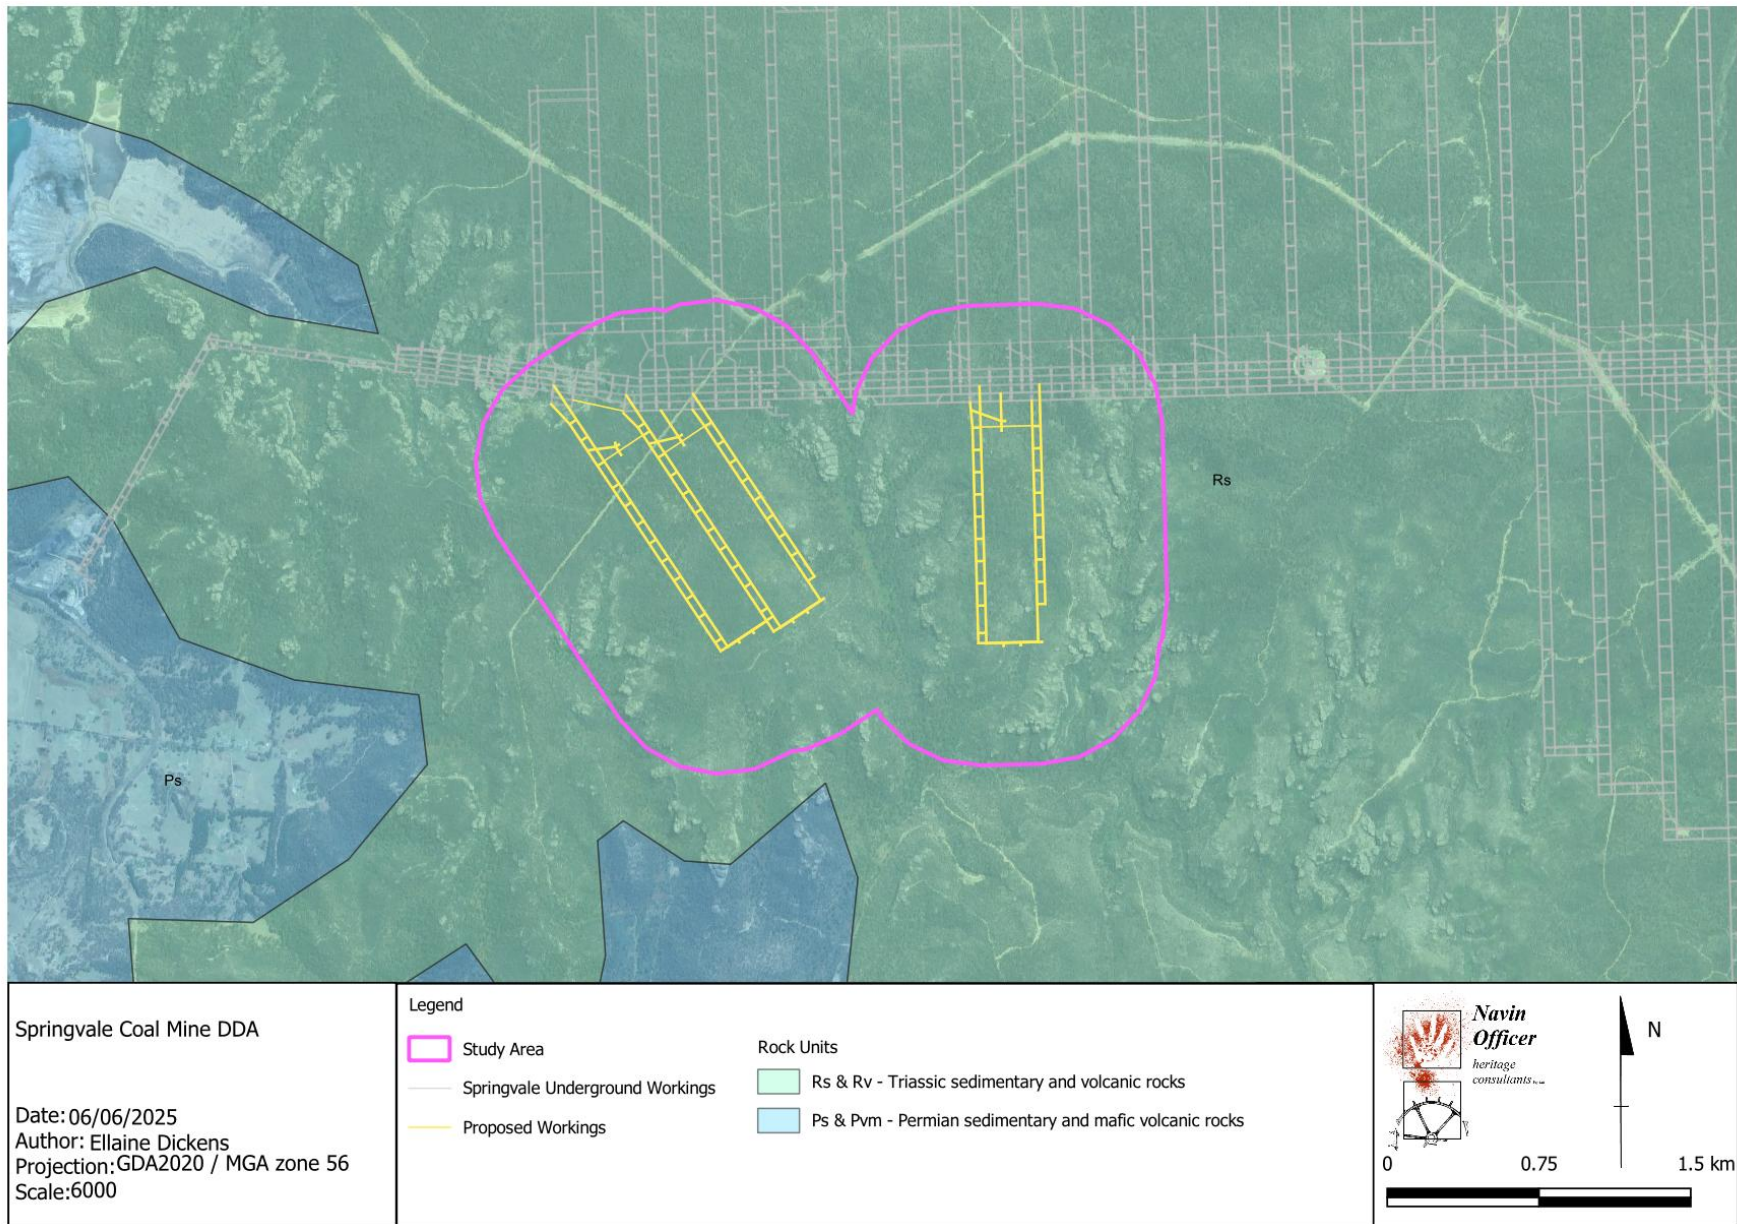
**Figure 2-2 Geology units within the Study Area**

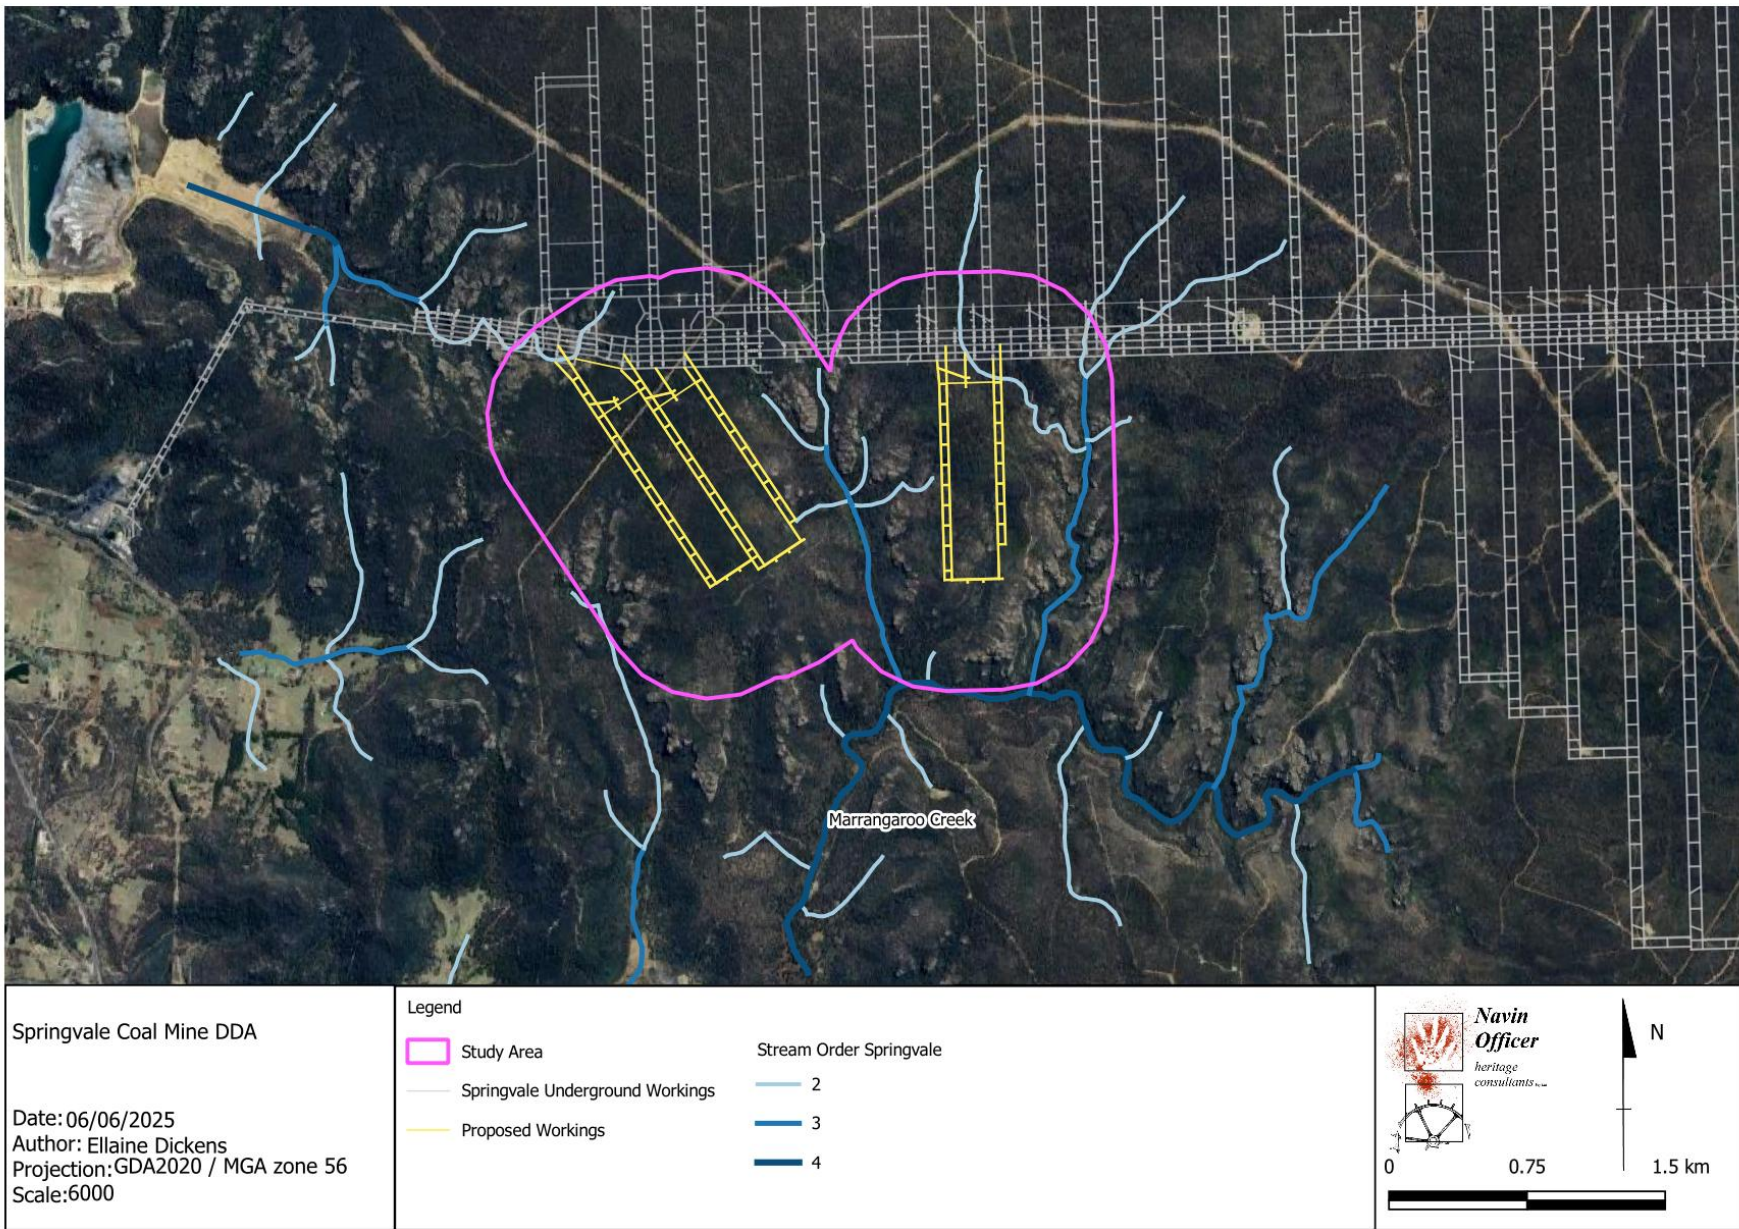
Water sources are considered a key resource in the development of predictive modelling for Aboriginal archaeology. There are three unnamed second order streams in the vicinity of the Study Area that run north-south in the valleys surrounded by escarpments (Figure 2-4). The third order streams join a fourth order stream (Marrangaroo Creek) that runs east-west to the south of the Study Area. Marrangaroo Creek joins Coxs River that runs into Lake Wallace to the west of the Study Area.

Figure 2-4 Hydrology within the Study Area

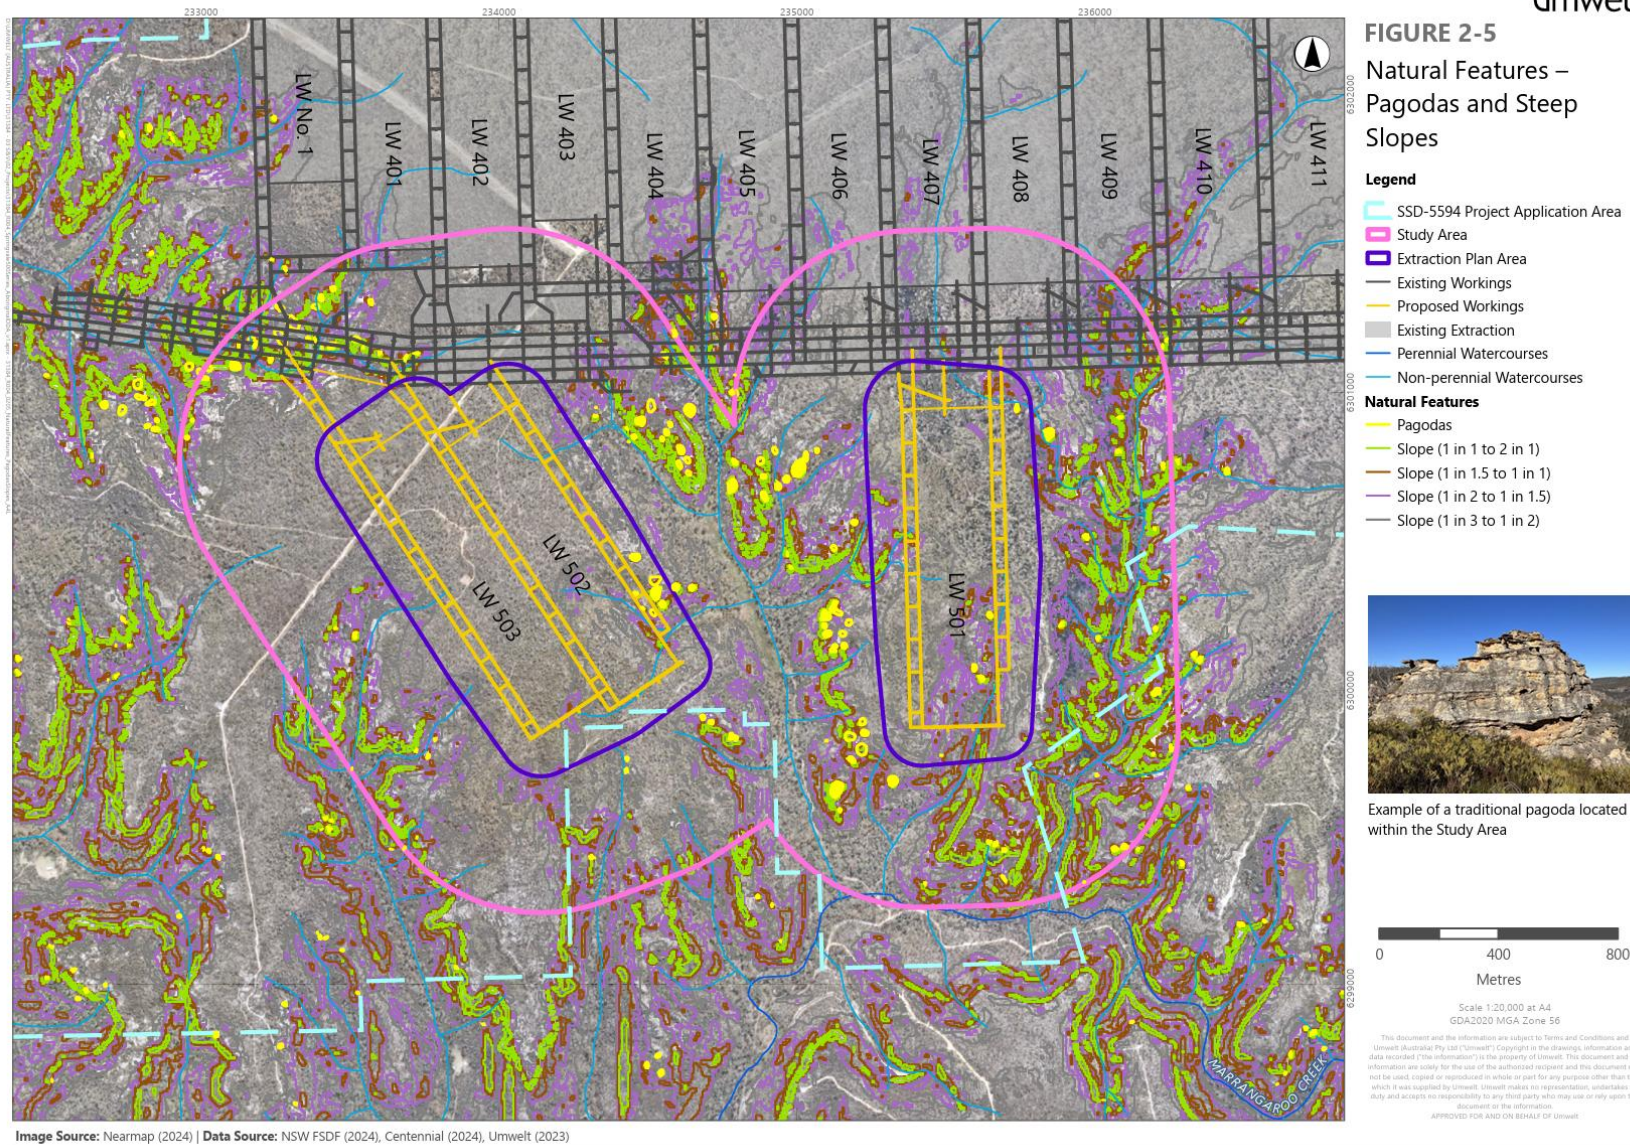
Figure 2-5 and Figure 2-6 depicts the landform features surrounding proposed Longwalls 501-503.

**Figure 2-5 Natural Features – Pagodas and Steep Slopes**

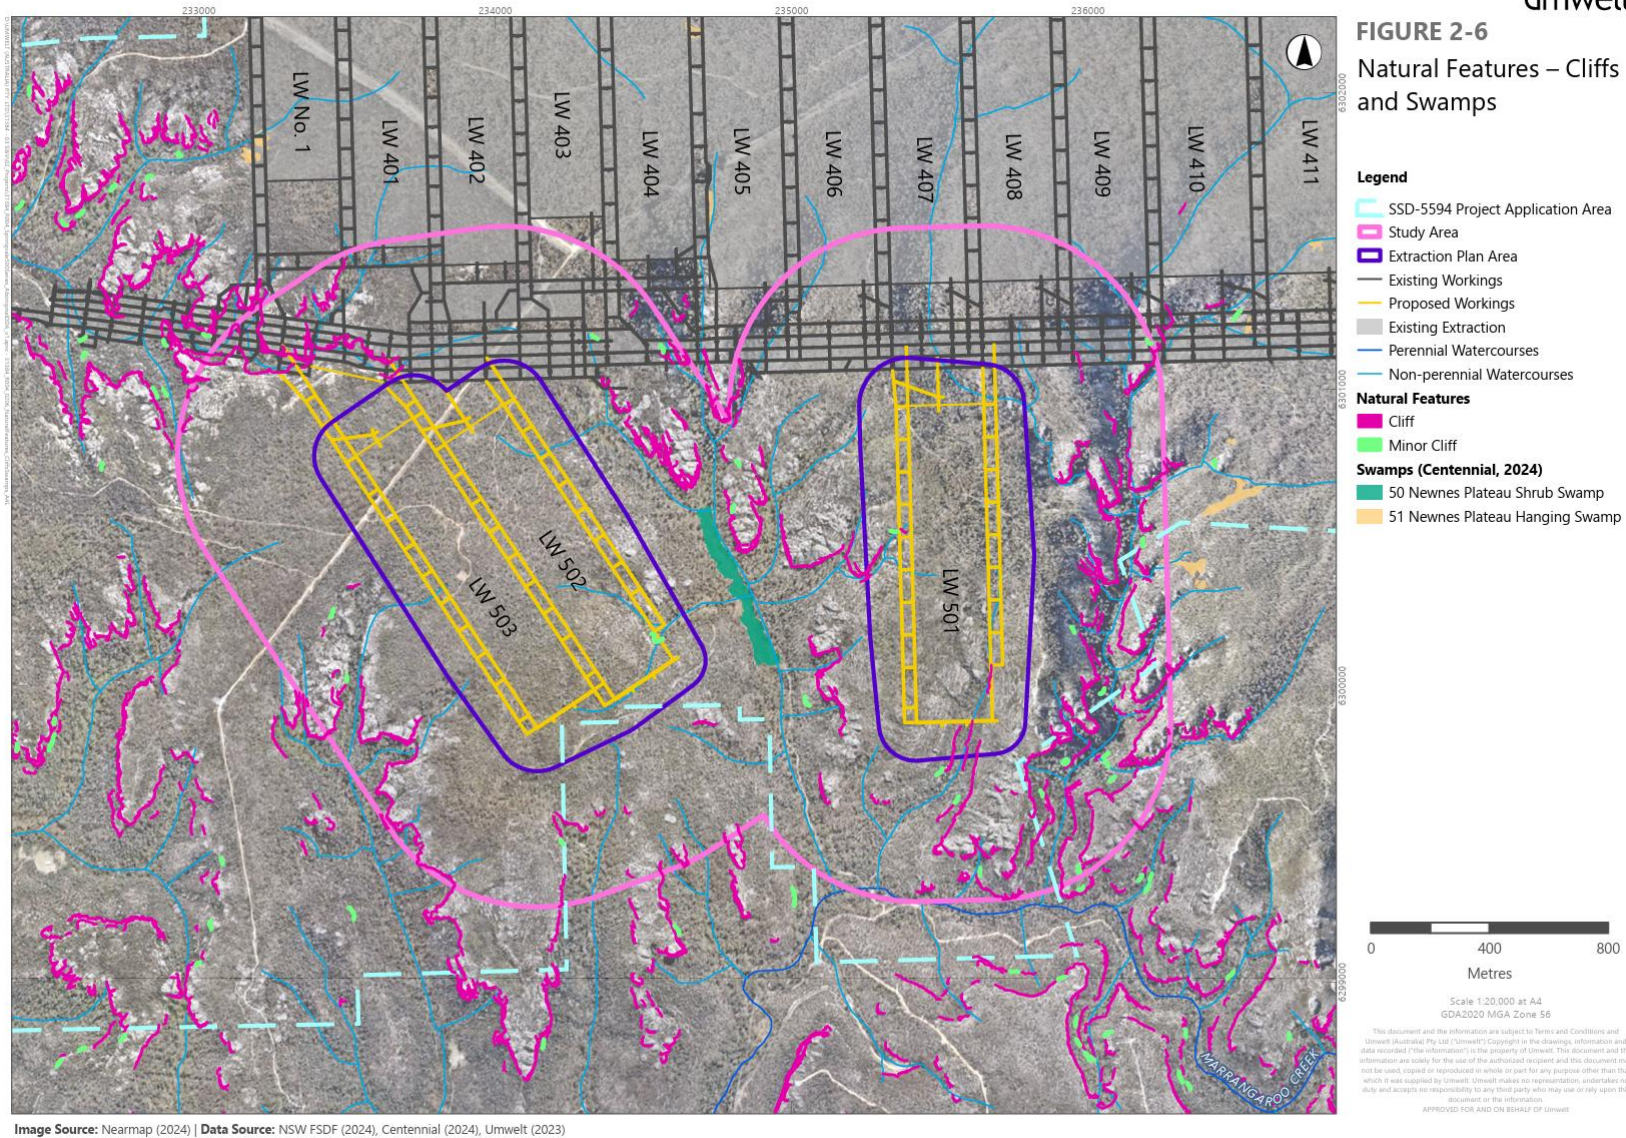
**Figure 2-6 Natural Features – Cliffs and Swamps**

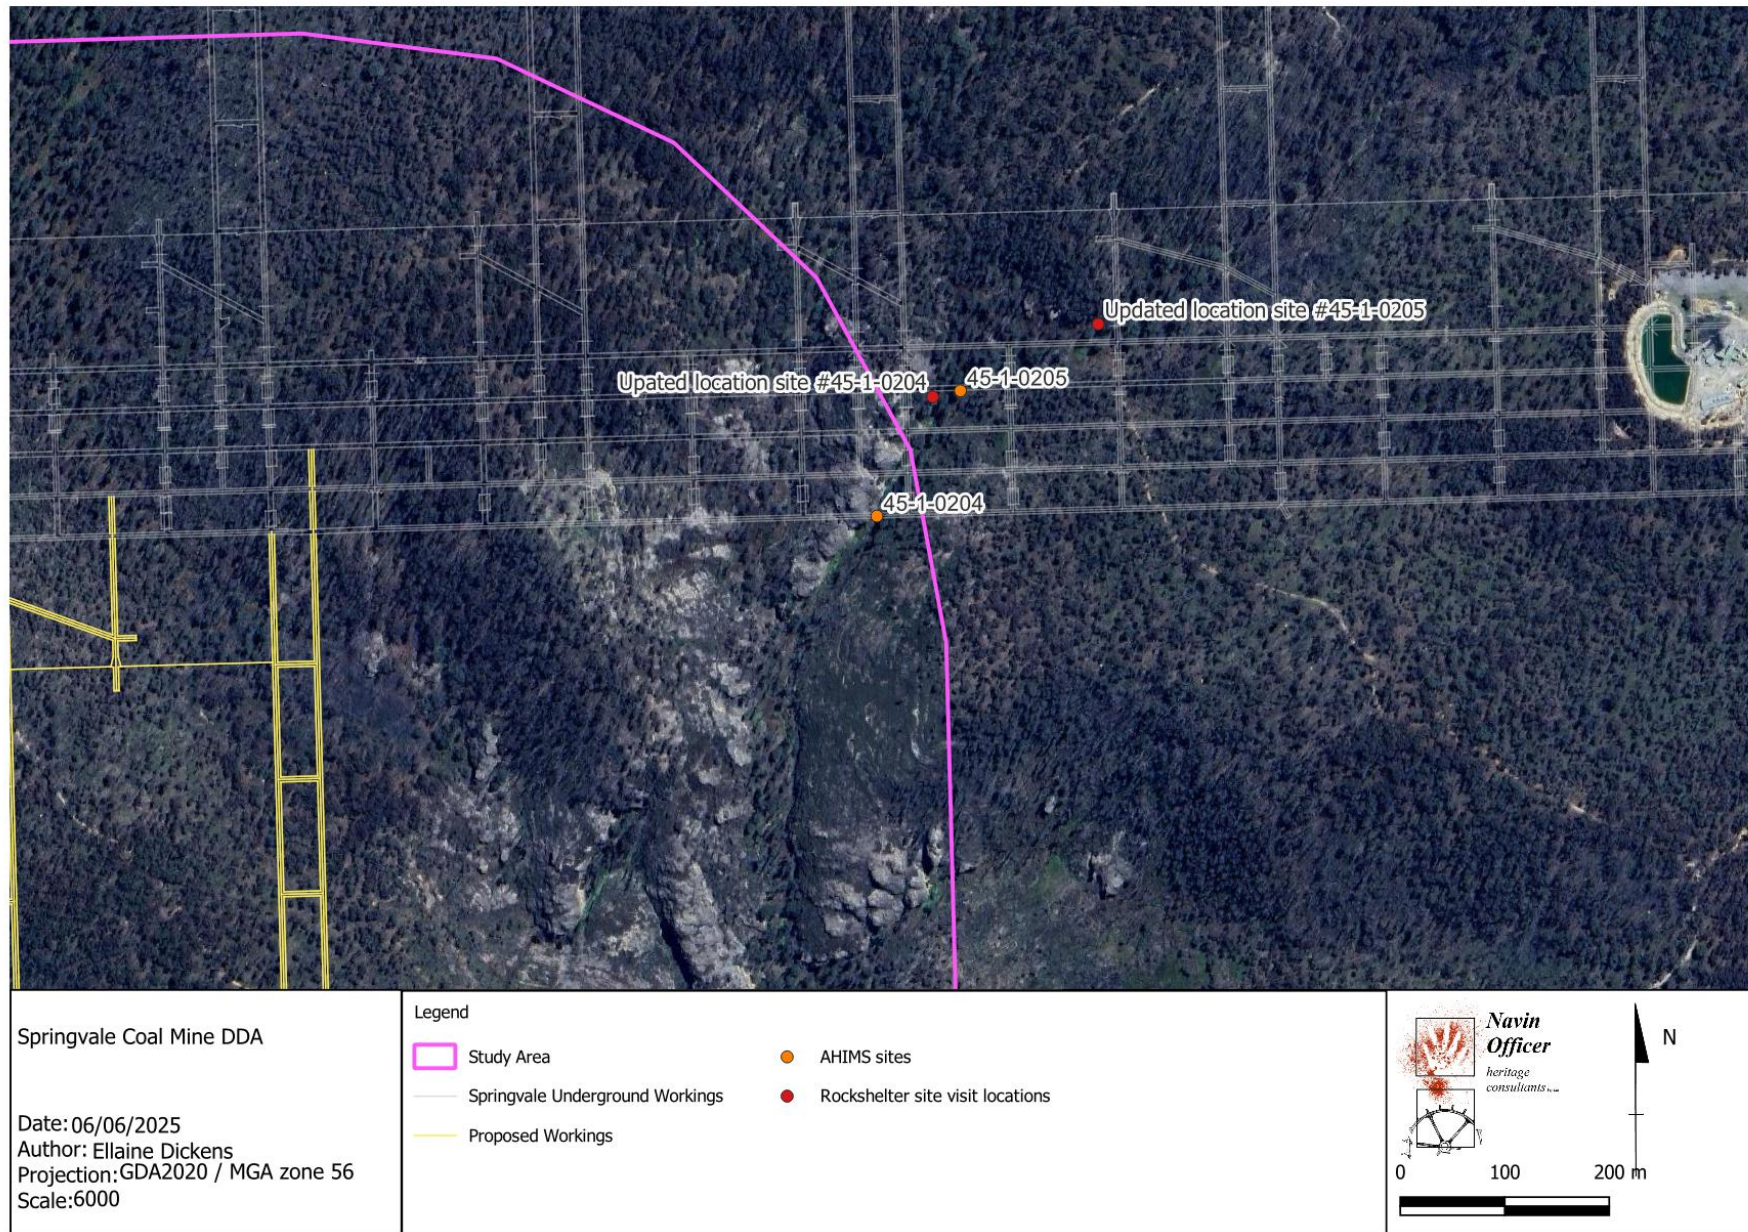
During the survey it was found that the original GPS points from 1992 for AHIMS sites #45-1-0204 and #45-1-0205 were recorded incorrectly due to the progression of modern GPS technologies. As such NOHC has updated the points for each of the sites (Figure 3-1). The updated site locations now place AHIMS #45-1-0204 outside of the Study Area.

**Figure 3-1 Updated AHIMS site locations**

Visual inspection of #45-1-0204 found that the site is situated on a stream bank within the Gardens Stone State Conservation Area. The original 1992 site recording placed this site within the Study Area, however following the survey it was found that the site is instead correctly located 42 m outside of the Study Area.

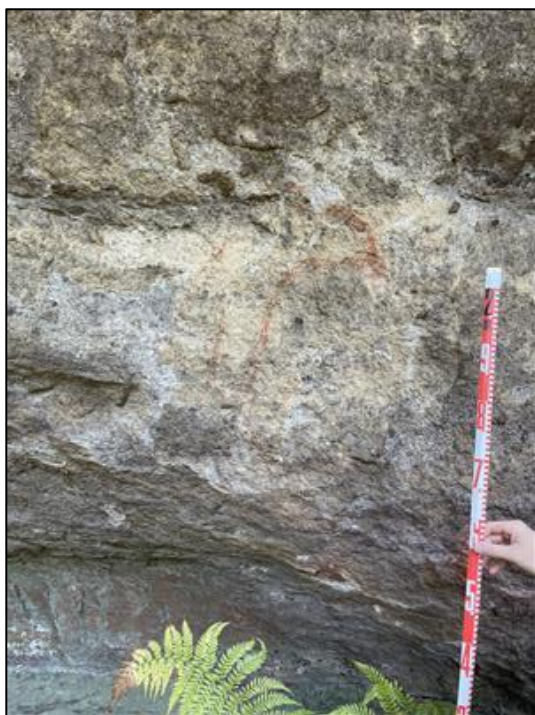
The surrounding vegetation was predominantly scrub, over grey sandy silts. Visibility within the site was strong at 80% and the exposure incidence was at 100%. The rock art motif within the site was still in good condition (Figure 3-2). Photos of the rock art panels were run through a rock art tool programme known as *DStretch* by RAP Brad Bliss and the subsequent images revealed several handprints stencils. These images highlighted in Figure 3-3. Figure 3-3 and Figure 3-4 demonstrate three handprint stencils which are likely to be from adults and children. These stencils are a new addition to what is known about AHIMS #45-1-0204 and were not observable for the 1992 recording of the site.

**Figure 3-2 Rock art at AHIMS #45-1-0204**

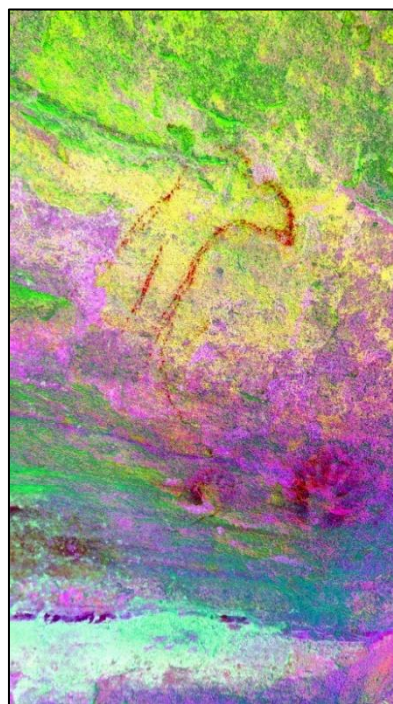
**Figure 3-3 DStretch Image of rock art motif and hand stencils from B. Bliss**

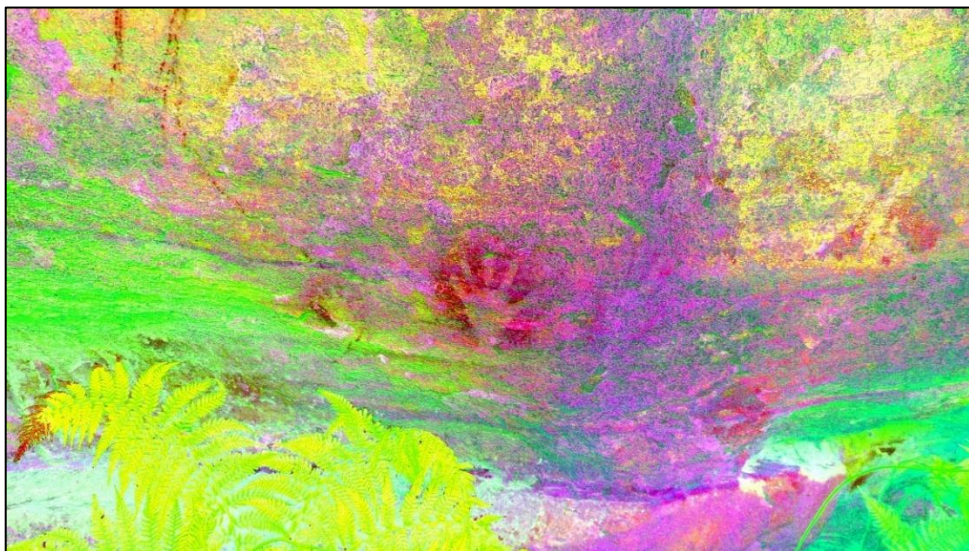
**Figure 3-4 DStretch Image of three hand stencils from B. Bliss**

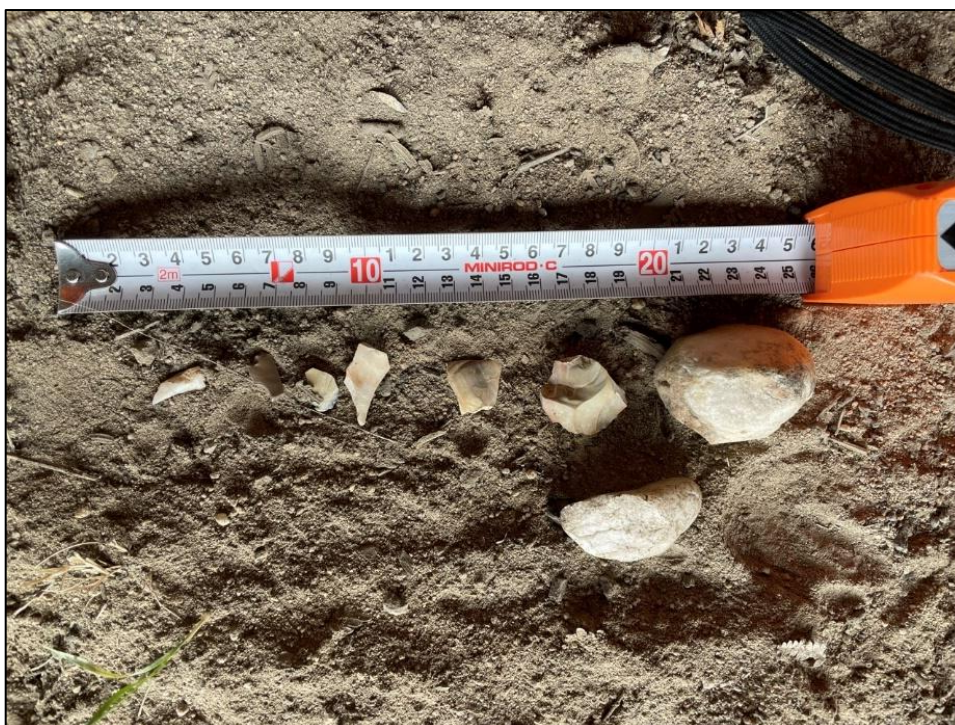
The presence of lithic artefacts (Figure 3-5) at the site was also confirmed with the below artefacts documented during the survey.

- Quartzite hammerstone measuring 55 x 40 mm.
- Broken quartzite hammerstone. measuring 47 x 24 mm.
- Red and grey IMT multidirectional core measuring 27 x 25 mm.
- Brown IMT complete flake measuring 17 x 15 mm.
- Brown IMT proximal flake measuring 27 x 14 mm.
- Grey/brown, IMT complete flake measuring 12 x 10 mm.
- Brown IMT proximal flake measuring 18 x 10 mm.
- Milky quartz proximal flake measuring 14 x 6 mm.

**Figure 3-5 Lithic Artefacts at AHIMS #45-1-0204**

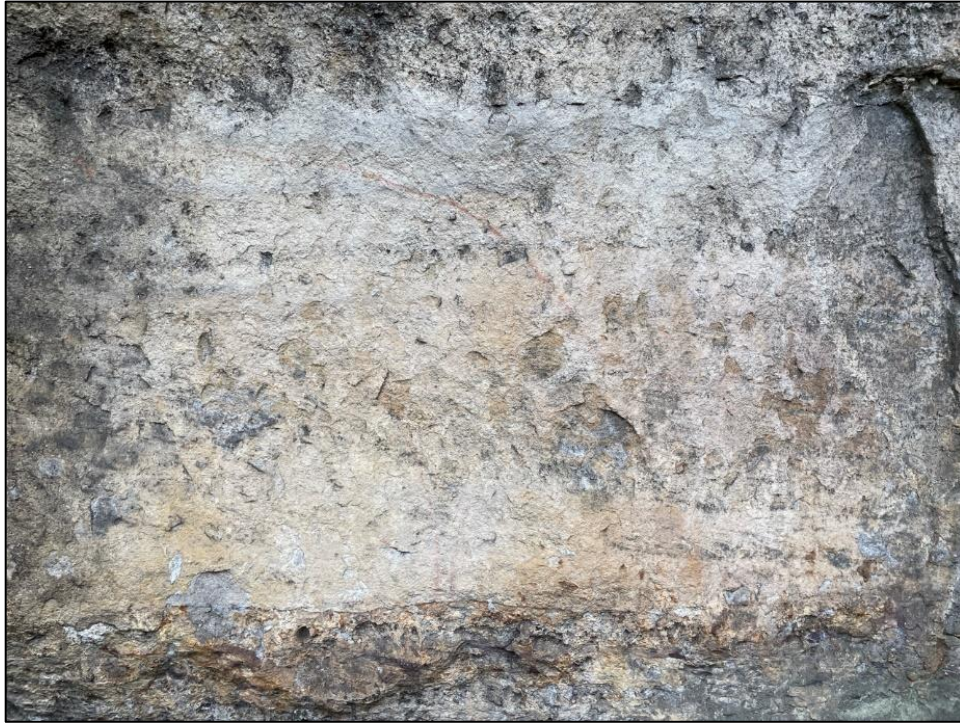
The surrounding vegetation was prominently scrub, over grey silty sand. Visibility within the site was strong at 80% and the exposure incidence was at 100%. Observations of the rock art at the site appear similar to those of Rich (1993), although some additional observations were made by RAPs and archaeologist at the site. Onsite discussions lead to the revision of the motif featured in Figure 3-6 and Figure 3-7 to that of a wallaby rather than a kangaroo. Moreover, the faint grey line above wallaby/kangaroo motif (see blue highlight in Figure 3-8) was discussed and it was found that it is likely to be a fault within the sandstone panel rather anthropomorphic in nature. Three lithic artefacts were found at the site during the February survey, and they are listed below (see Figure 3-9).

**Figure 3-6 Faint wallaby motif at AHIMS #45-1-0205**

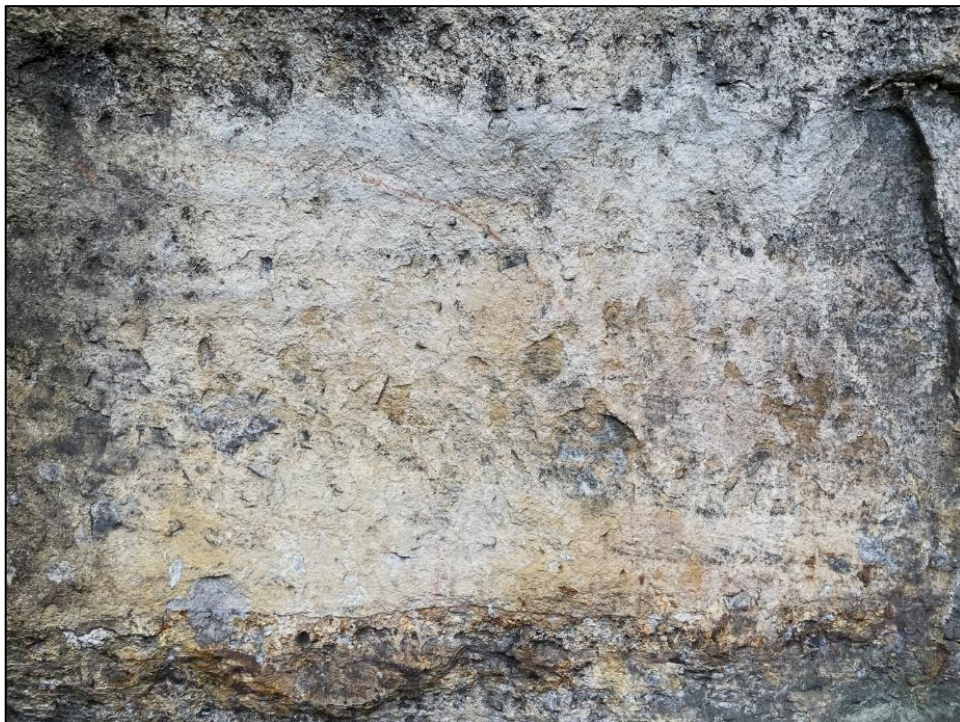
**Figure 3-7 Edited Image of Faint Wallaby motif at AHIMS #45-1-0205 to best highlight artwork**

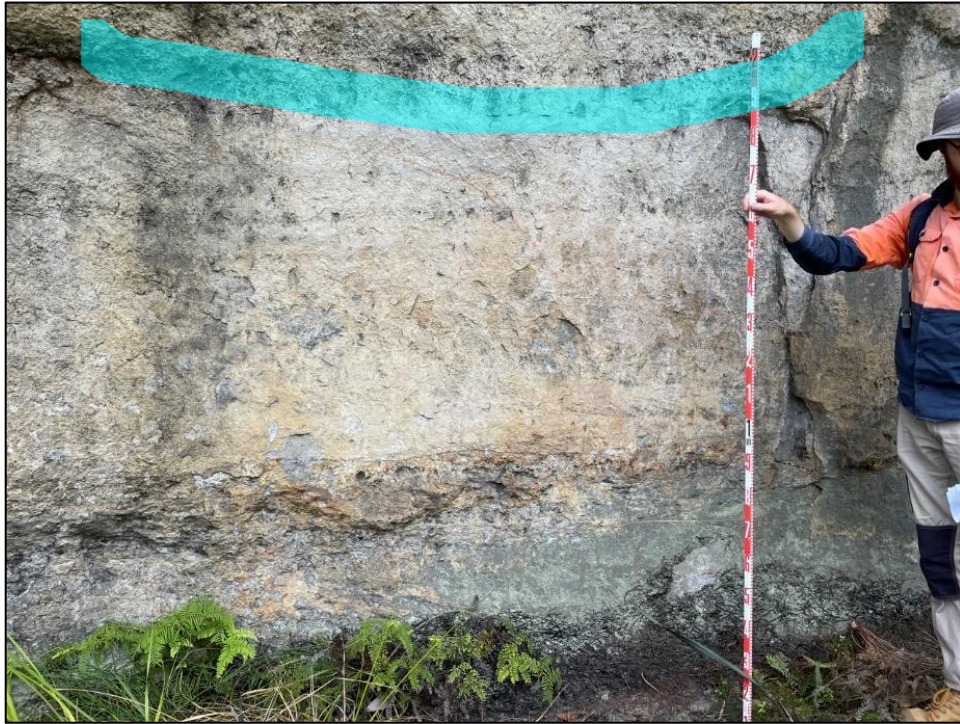
Visual inspection of #45-1-0205 found that the site is situated on basal slope within the Gardens of Stone State Conservation Area. The original 1992 recording for this site placed it 72 m outside of the Study Area. During the survey it was found that this site is actually located 220 m east of the Study Area.

**Figure 3-8 AHIMS site #45-1-0205 with sandstone fault highlighted in blue**

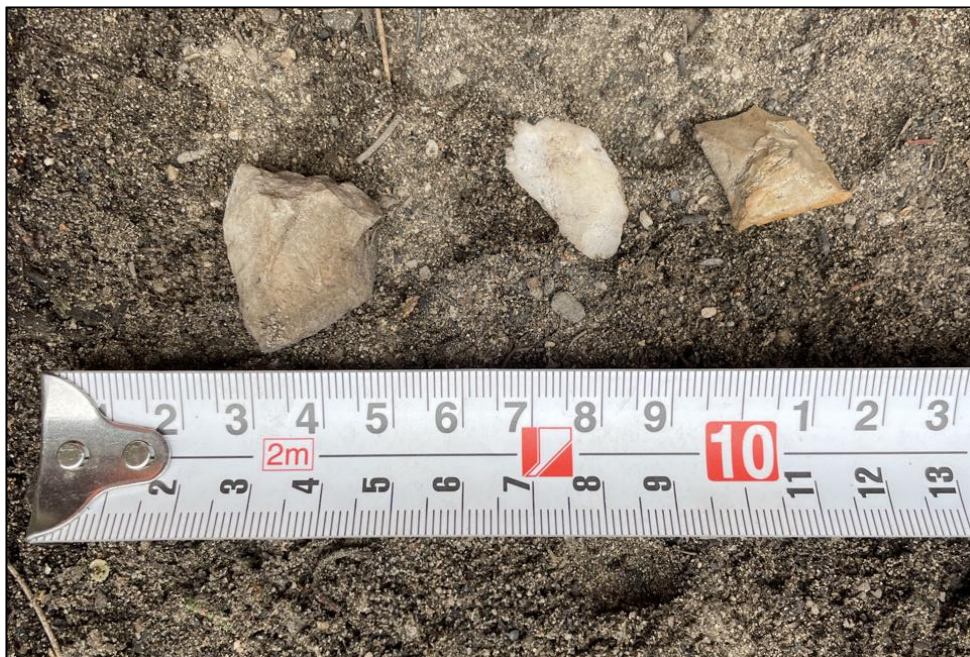
- Grey quartzite complete flake measuring 30 x 24 mm.
- Milky quartz complete flake measuring 25 x 10 mm.
- Brown IMT distal flake measuring 25 x 19 mm.

**Figure 3-9 Lithic Artefacts at AHIMS #45-1-0205**

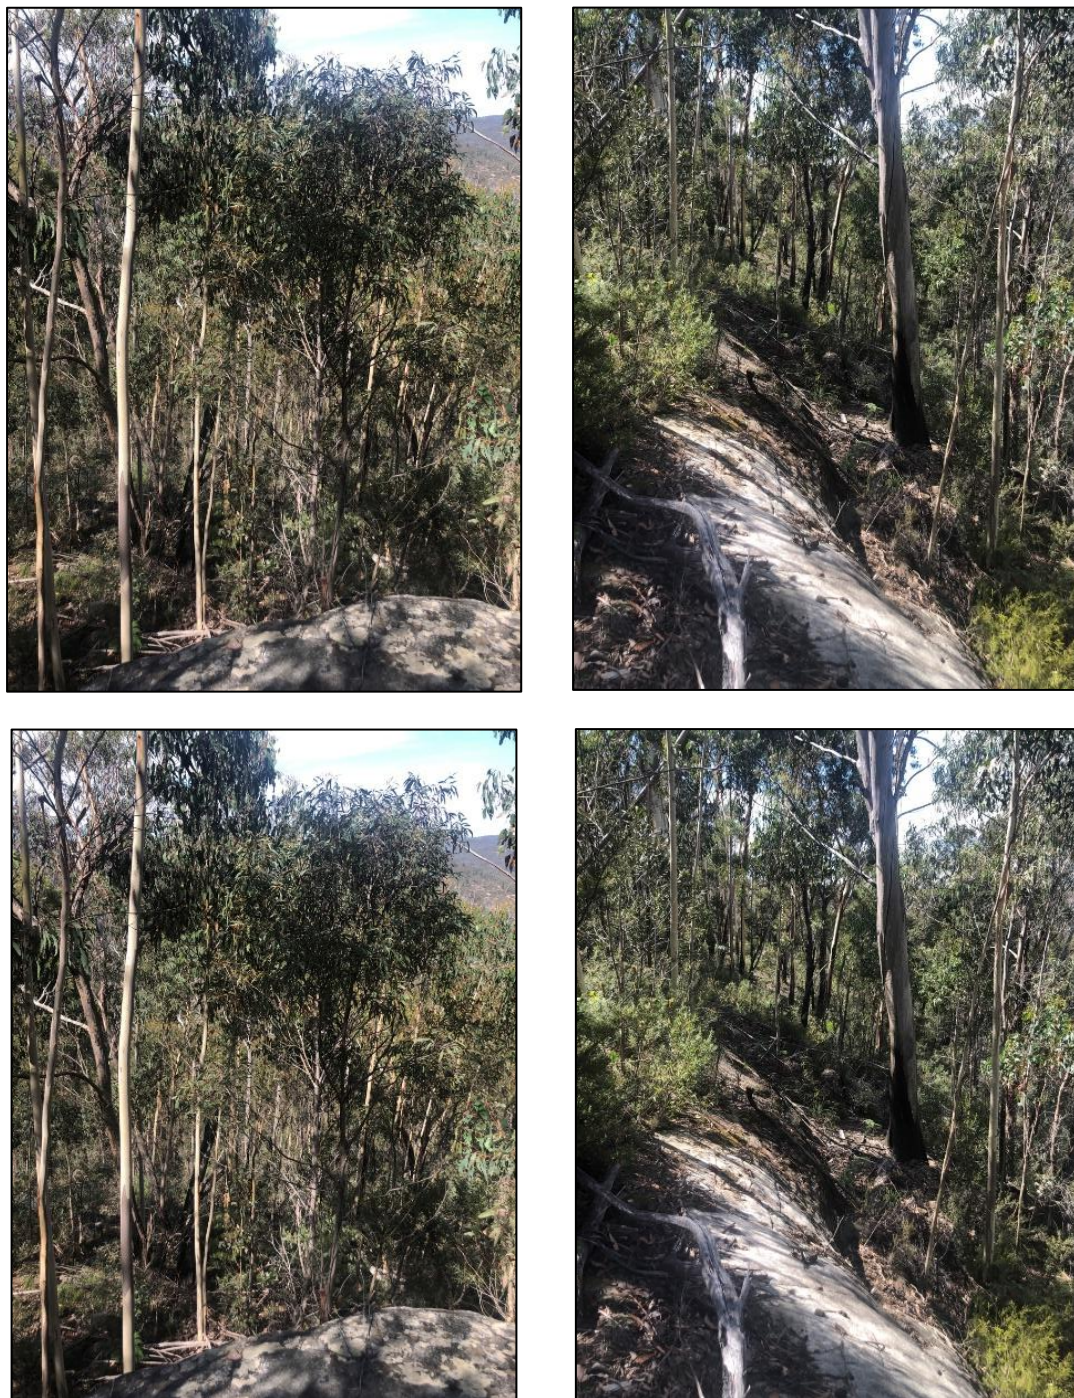
The surveys conducted on March 19<sup>th</sup> investigated the ridgelines and water courses within the west of the Study Area. NOHC sought to gain access through the powerline easement but upon passing through, encountered steep terrain and dense overgrowth within an open conservation forest. As a result, access to the Study Area was severely restricted as demonstrated in Figure 3-10. At the furthest accessible point, it was documented that ground soils were sandy loams with an exposure incidence of 10% and a visibility was 20%.

**Figure 3-10 Survey terrain on March 19<sup>th</sup> 2025**

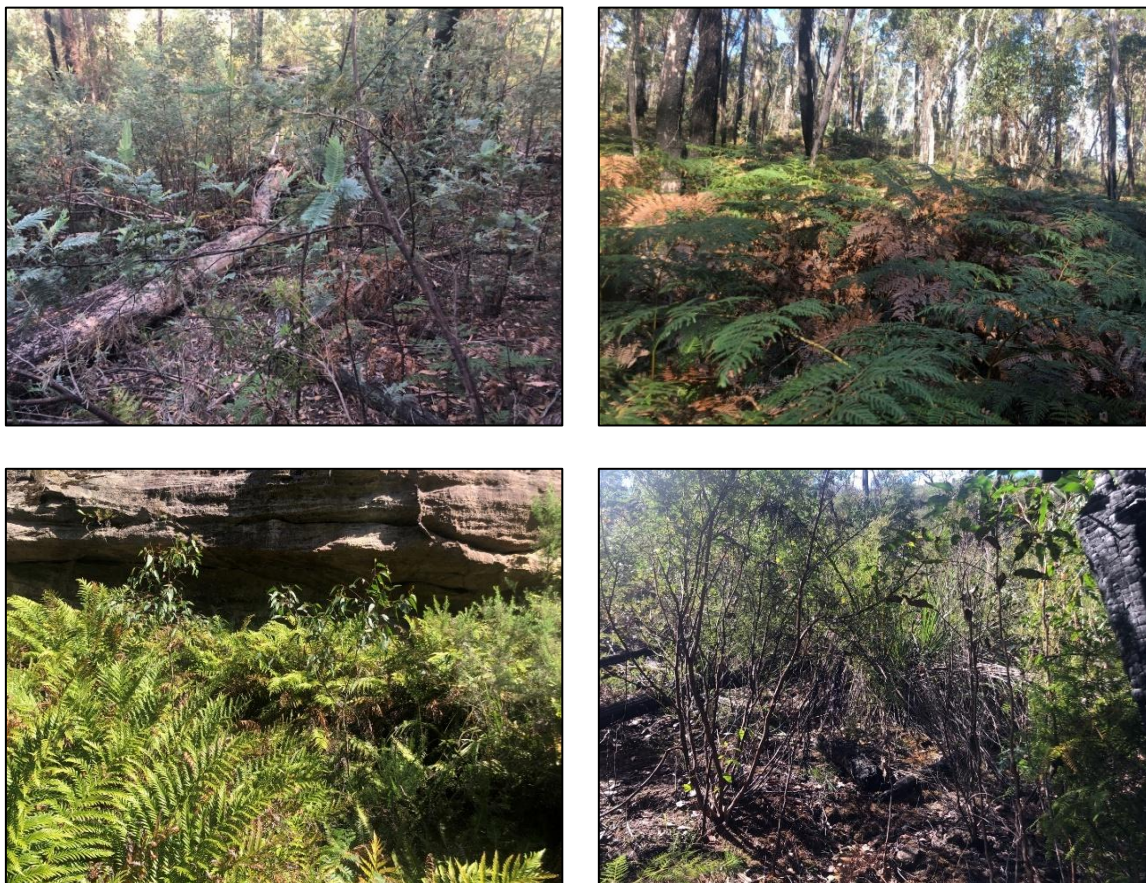
The surveys conducted on March 20<sup>th</sup> investigated the ridgelines and water courses within the eastern aspect of the Study Area. Using established tracks within the Study Area NOHC personnel sought to gain access to locations of interest as discussed with RAPs. Several short foot surveys sought to gain access to the watercourse mentioned above, however these were all ceased due to steep and abrupt terminating ridgelines as well as overgrowth forest floors. Figure 3-11 below demonstrates the steep terrains, shoulder and waist height undergrowth as well as the inclines of the ridgelines and watercourses. At the furthest points of access, it was recorded that ground exposure averaged 10% and visibility averaged 10% also. Soils at these points of furthest access were found to be loams or sandy loams within sand content increasing in proximity to stream channels.

**Figure 3-11 Imagery of surveyed terrain on March 20<sup>th</sup> 2025**
