**SSD-5594 Schedule 3 Condition 10(h)(vii)**  
**Request for Alternative Compliance Approach - Heritage Management Plan**

# Springvale Longwalls 501-503 Extraction Plan Support

## Aboriginal Due Diligence Assessment

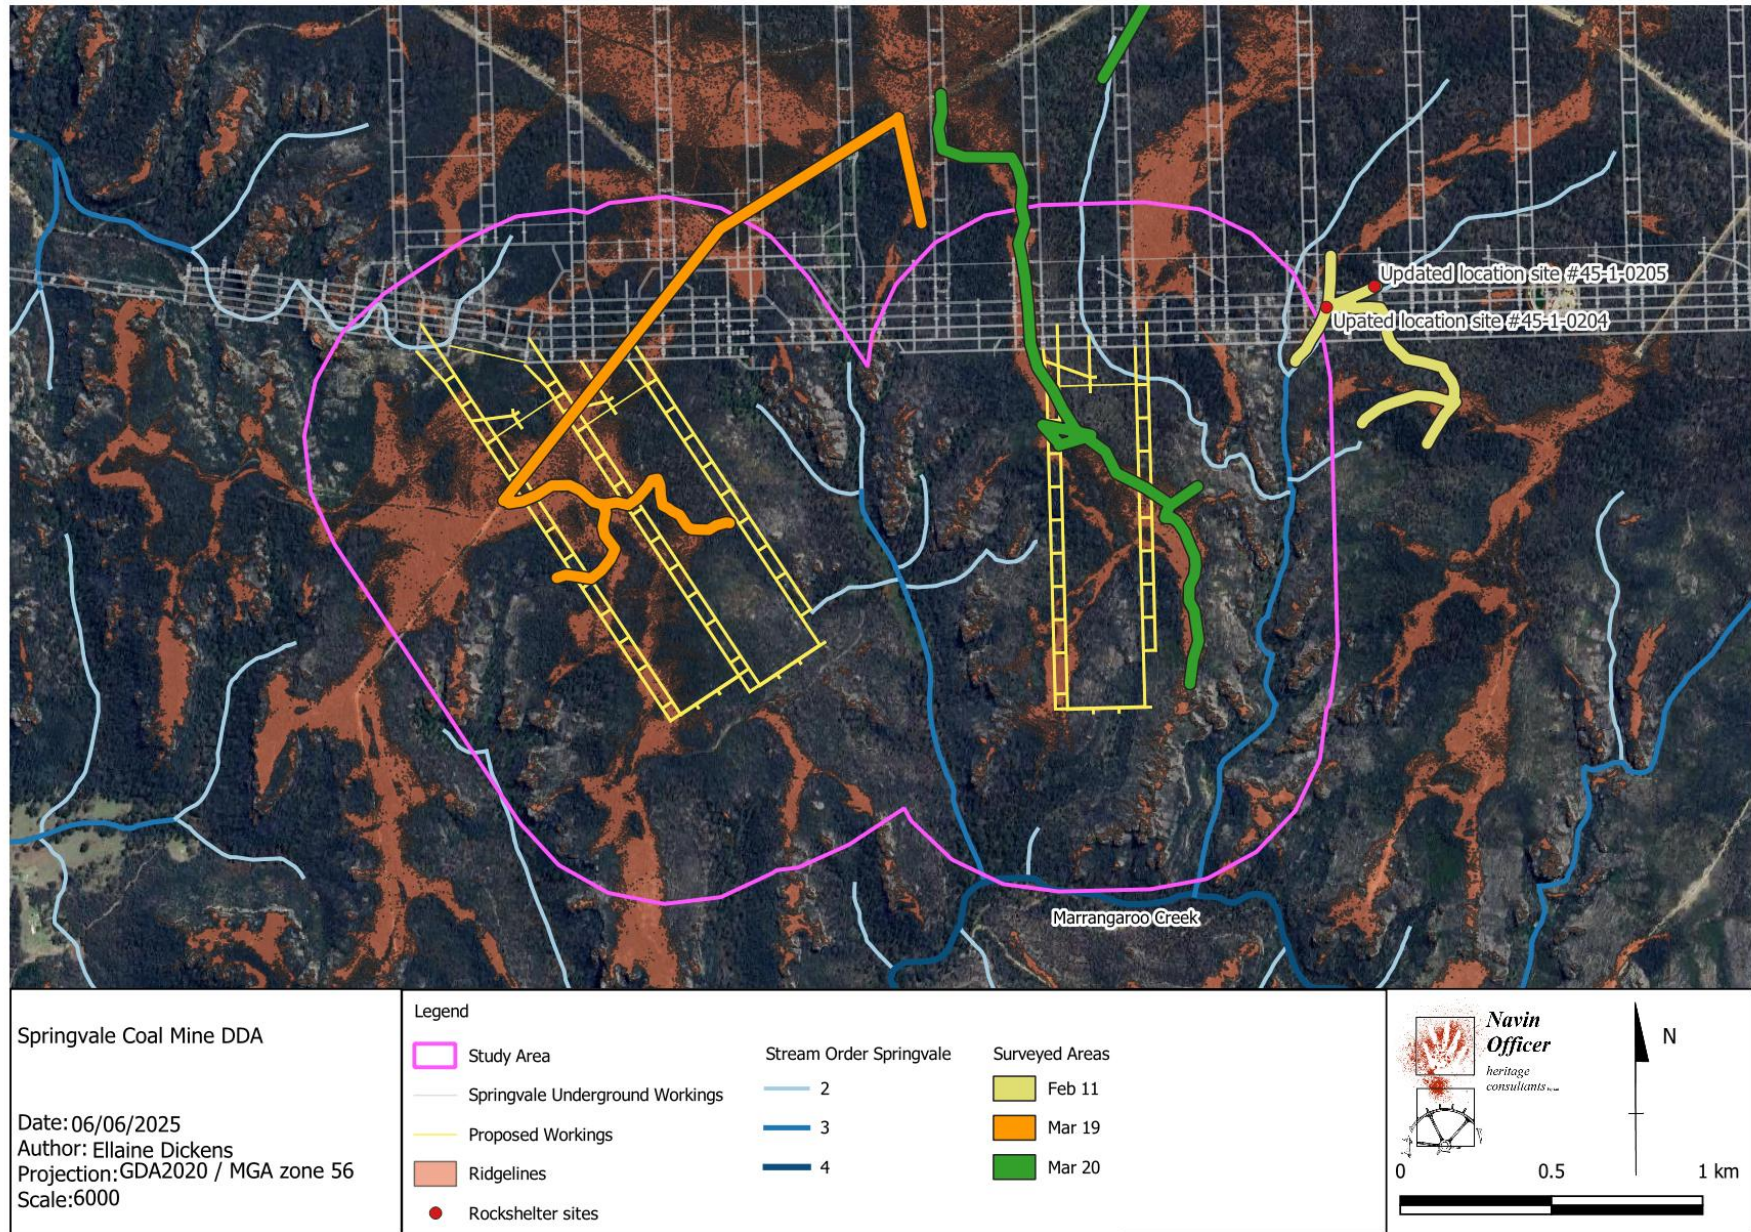
With permission from the RAPs, NOHC personnel Ricardo Servin (Senior Specialist/Heritage Consultant) and Lachlan Sharp (Heritage Consultant/Archaeologist) conducted foot surveys to access and survey watercourses and ridgelines within the Study Area. The surveys sought to identify areas or locations of Aboriginal heritage and archaeological potential. The surveys were undertaken within the highlighted aspects of Figure 3-12 Figure 3-12

**Figure 3-12 Map of surveyed terrain within Study Area**
