Stuarts Point Sewerage Scheme – Effluent Transfer and Disposal Design Concept Design Report

Kempsey Shire Council 31 January 2023

Project na	Project name SPSS - Effluent transfer and disposal design and investigations							
Documen	t title	Stuarts Point Sewer Report	rage Scheme – I	Effluent Transfer	and Disposal De	sign Concept D	esign	
Project nu	umber	12551313						
File name		12551313-REP_SPSS Effluent Transfer Design_Concept Design Report.docx						
Status	Revision	Author	Reviewer		Approved for issue			
Code				Name	Signature	Name	Signature	Date
S4	0	J. O'Donoghue	R Johnson	R. Johnson	A Fletcher	ALL	31/01/23

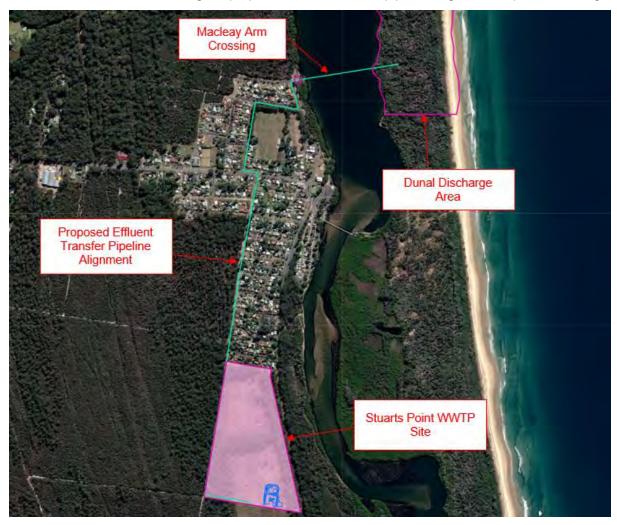
Figure 3.1 Site over-view plan

An overview of the site, including the proposed effluent transfer pipeline alignment, is provided in Figure 3.1.

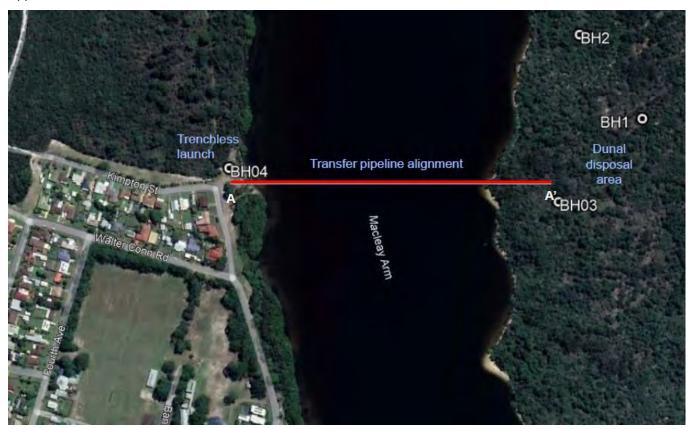
Figure 4.1 Geotechnical Investigation Locations

Geotechnical investigations were undertaken by GHD on 26-27 May 2022 and 7 June 2022. The geotechnical investigation sites are presented in Figure 4.1. The Geotechnical Report prepared by GHD is provided in Appendix A.

- BH01 loose to medium dense sand to 18 m depth, overlying very loose to loose sand
- BH02 loose sand to 0.8 m depth, overlying medium dense sand
- BH03 very loose to loose sand to 1.3 m depth, overlying medium dense sand

BH04 – loose to medium dense sand to a depth of 7.0 m, very dense sands below this.

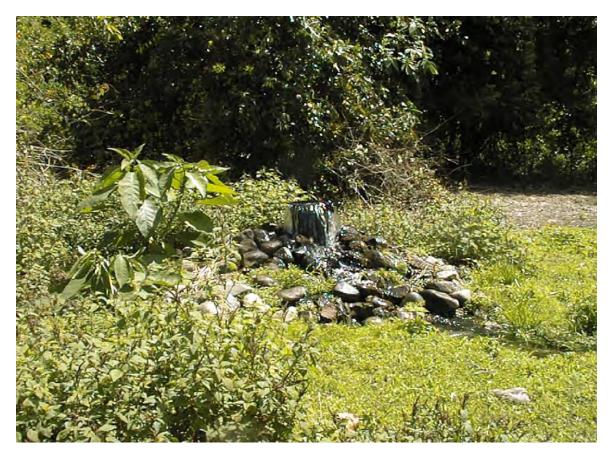
Figure 6.2 South West Rocks Effluent Discharge Pipe

A short section of riser pipe will bring effluent to the surface where it discharges directly on a small area of riprap before flowing onto the ground. This discharge system is similar to the nearby existing South West Rocks effluent discharge area. The South West Rocks effluent discharge system is shown in Figure 6.2.

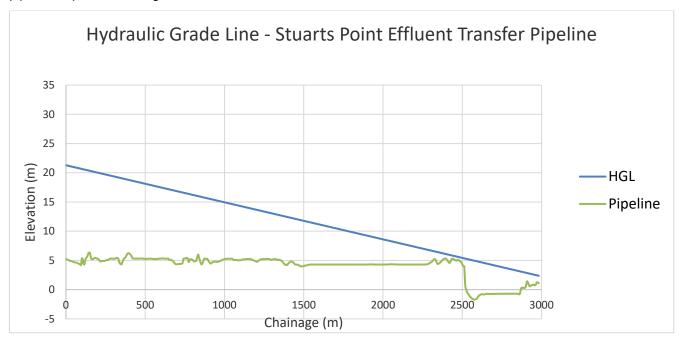
Figure 7.1 Hydraulic Grade Line

It is noted that the vertical alignment will not follow the surface level and minimum cover depth for the entire alignment however for the purpose of simplicity at the concept design level this profile has been adopted for the pipeline in the hydraulic calculations. Greater pipeline depths than are shown are likely required for the crossing of the Macleay arm however this has also not been considered for the hydraulic grade line development noting that this does not affect the elevation at the discharge location. The hydraulic grade line for the effluent transfer pipeline is provided in Figure 7.1.

It was calculated that to provide a flowrate of 74L/s, approximately 22 m head is required to overcome static head and friction losses throughout the pipeline. Pressure head requirements for the effluent transfer pipeline system are subject to minor changes depending on the final location of the dunal disposal point at the discharge end of the pipeline.

A hydraulic grade line was developed for the effluent transfer pipeline using the proposed pipeline alignment. For the purpose of this calculation, it was assumed the pipeline remains at the minimum 600 mm below the existing surface level along the entire alignment as per WSAA requirements for trafficable carriage ways and verges of sealed roads.

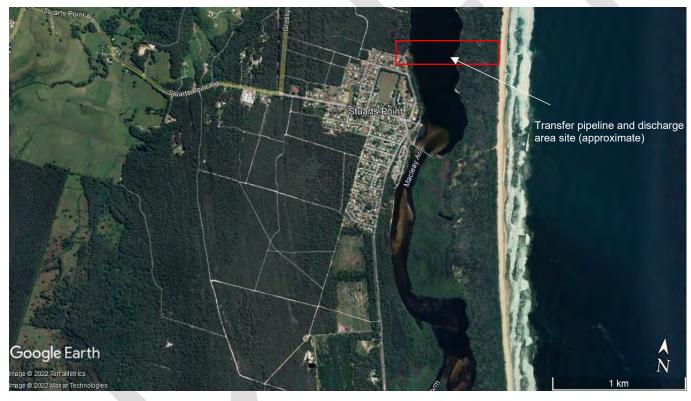
Figure 2.1 Site location (source: Google Earth)

Refer to Figure 2.1 below for the site location and Figure 1 in Appendix A for the proposed transfer pipeline alignment.

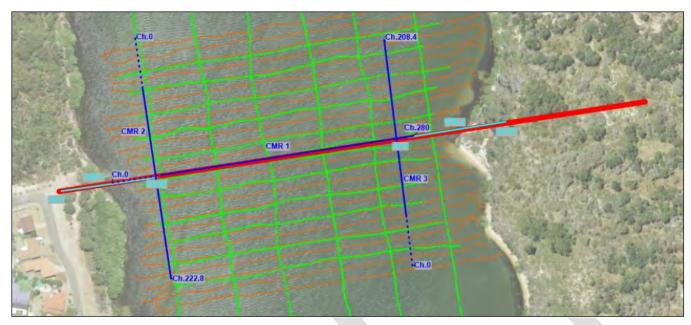
The coverage of the survey is shown in Figure 3.1.

Figure 3.1 Coverage of the geophysical survey comprising sub-bottom profiling (green), single beam echosounder bathymetry (orange), continuous marine refraction (blue) and transition zone refraction (light blue) techniques. The proposed pipeline alignment is shown in red.

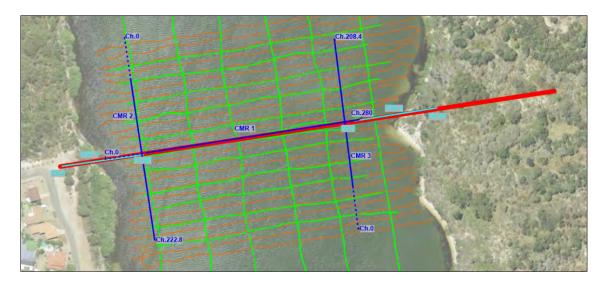
Figure 1. Satellite image with supplied HDD alignment (red) and data collection extents overlaid.

Figure 1 shows the alignment (red) overlaid on a satellite image. The other lines represent the extent of the data collection for the survey methodologies discussed further in this report. To the east, dense vegetation precluded data collection beyond what is shown by the cyan line. A detailed site plan can be found in Appendix A (GBGA2566_01 – Site Plan).

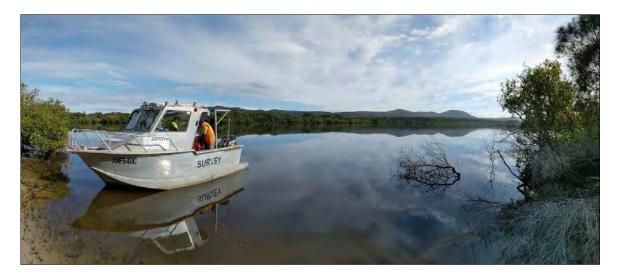
GBG engaged Astute Surveying Pty Ltd for the Single Beam Echosounder (SBES) survey and for vessel and operator hire. All methods utilised Astute's vessel, Coastal Explorer (Figure 2).

Figure 2. Coastal explorer on the east side of the HDD alignment. Picture taken looking west from the bank.

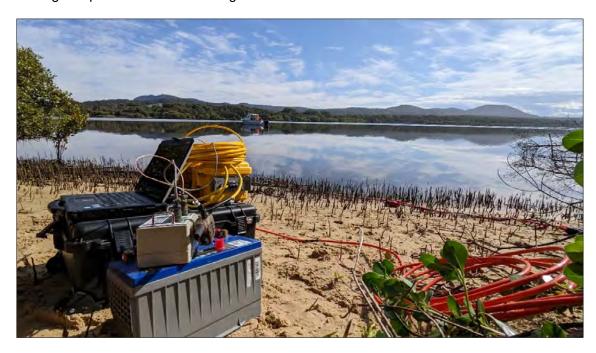
The receiving equipment was setup on the land side. The airgun was setup on Coastal Explorer. Figure 4 shows the land equipment setup on the east side. Coastal Explorer is moving into position for the first air gun shot.

Figure 4. Seismic receiving equipment setup on the east side of the alignment. Picture taken looking west.

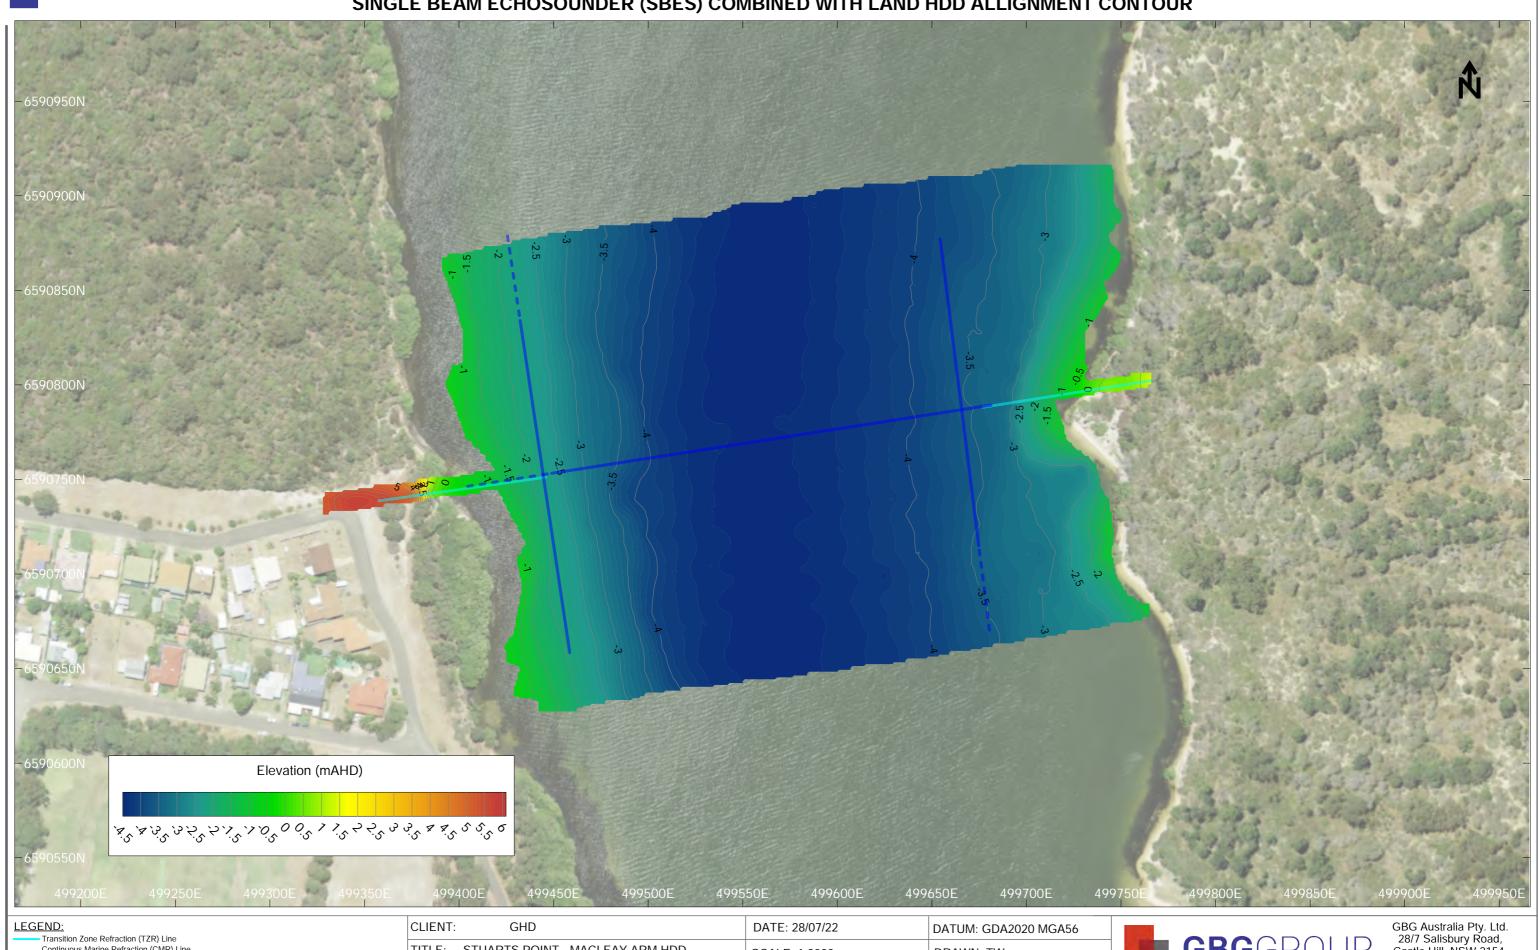
SINGLE BEAM ECHOSOUNDER (SBES) COMBINED WITH LAND HDD ALLIGNMENT CONTOUR

Continuous Marine Refraction (CMR) Line (Data Extents)

Continuous Marine Refraction (CMR) Line (Collection Extents)

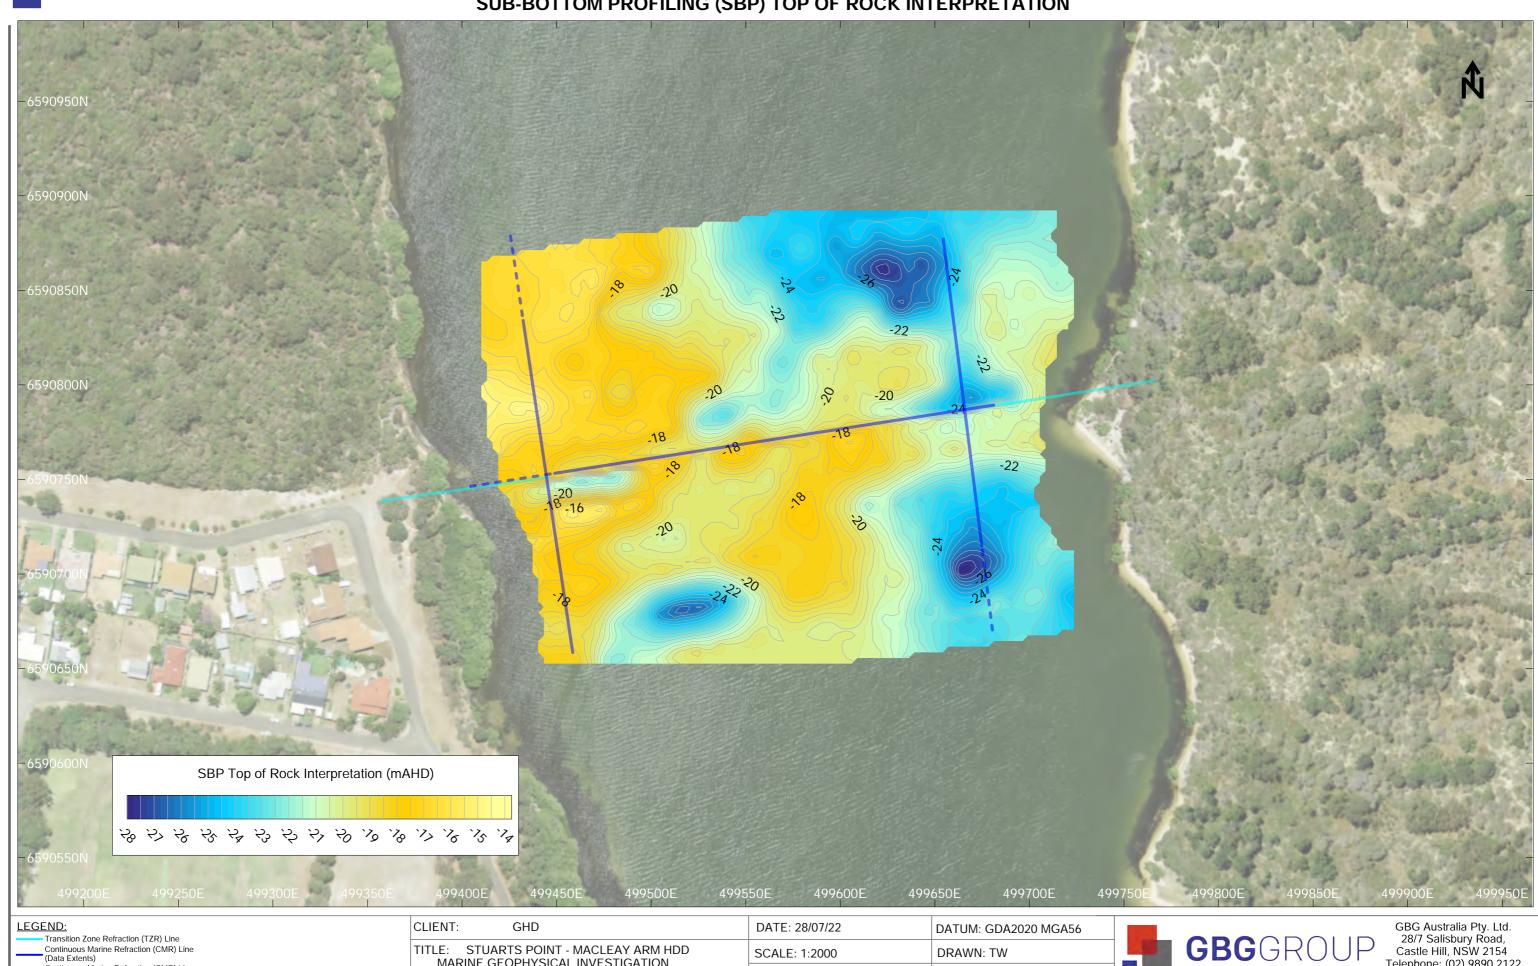
SUB-BOTTOM PROFILING (SBP) TOP OF ROCK INTERPRETATION

DRG No: GBGA2566_03

Based on geophysical sub-bottom profiling (SBP) survey, a reflector was noted between RL -18 m and -24 m AHD (approximately 23 m to 29 m below the ground surface of BH04), coinciding with seismic refraction velocities of 1800 m/s to 2200 m/s which are typically associated with rock materials. However, this seismic refraction velocity range reduces in level to around RL -11 m AHD (about 16 m depth below the ground surface at BH04) near the proposed launch site and based on the logged BH04 profile, both the seismic reflector and high velocities are inferred to correlate with very dense sand.

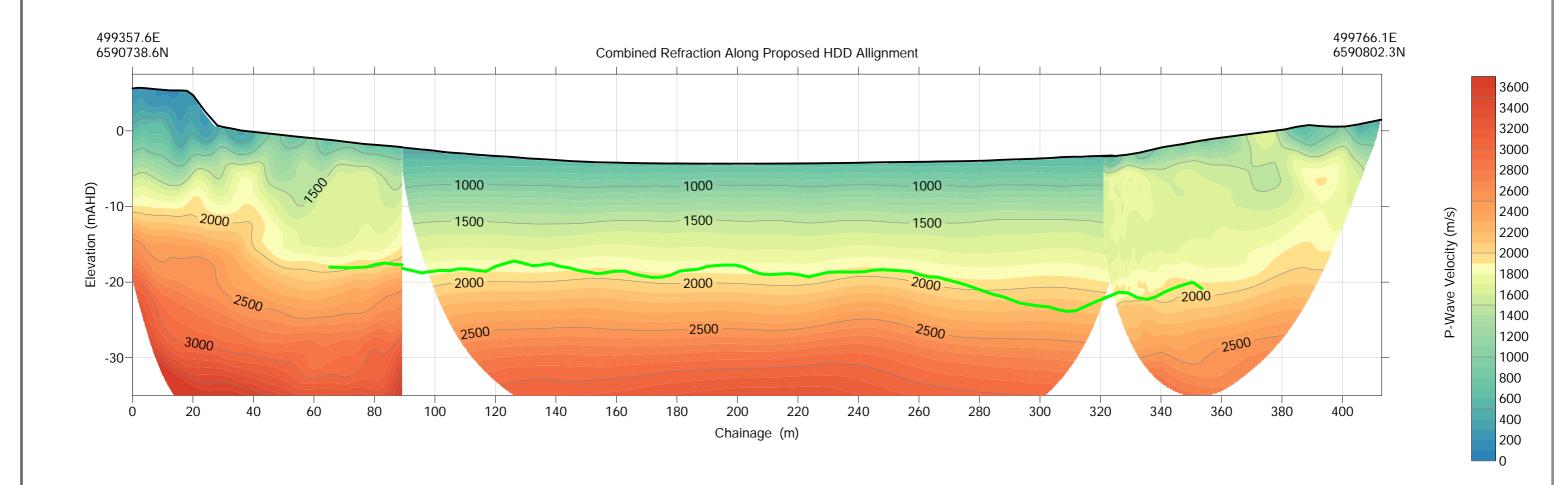
COMBINED TZR AND CMR REFRACTION PROFILES ALONG HDD ALLIGNMENT

SBP 'Slice'

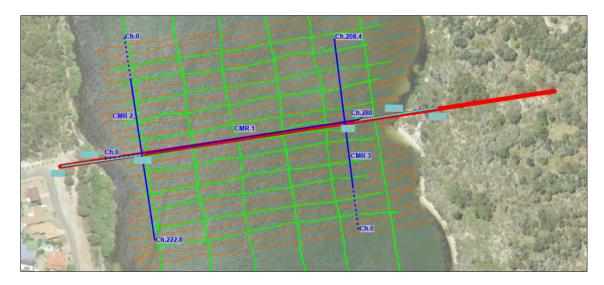
Figure 1. Satellite image with supplied HDD alignment (red) and data collection extents overlaid.

Figure 1 shows the alignment (red) overlaid on a satellite image. The other lines represent the extent of the data collection for the survey methodologies discussed further in this report. To the east, dense vegetation precluded data collection beyond what is shown by the cyan line. A detailed site plan can be found in Appendix A (GBGA2566_01 – Site Plan).

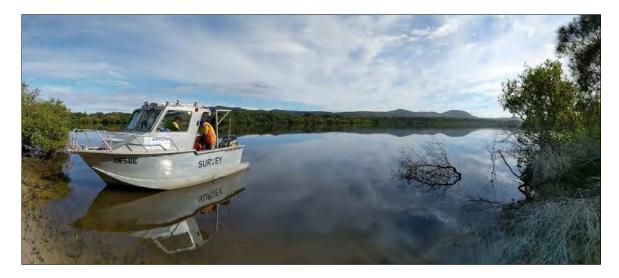
GBG engaged Astute Surveying Pty Ltd for the Single Beam Echosounder (SBES) survey and for vessel and operator hire. All methods utilised Astute's vessel, Coastal Explorer (Figure 2).

Figure 2. Coastal explorer on the east side of the HDD alignment. Picture taken looking west from the bank.

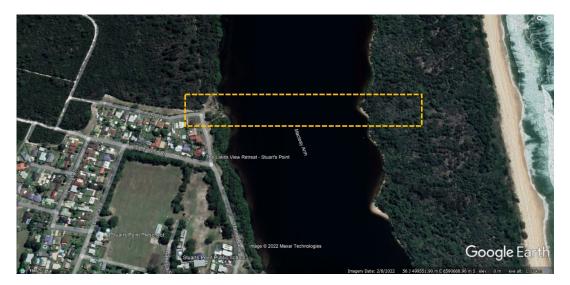
Location: The location of the Macleay Arm crossing is from the corner of Kimpton St and Marine Pde at the northern end Stuarts Point. The proposed underbore crossing is located to the northern side of the roadway and runs east across the Macleay Arm River to the Dunal release point between the river and the ocean.

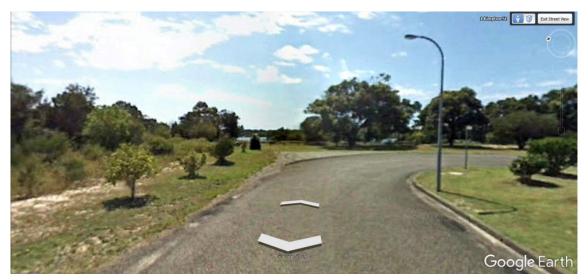
The area in Kimpton St is fairly flat and best sited as the site for setup of the drilling equipment whilst the exit site is currently covered in vegetation which will need some site modification for equipment and pipe string on the eastern Dune side.

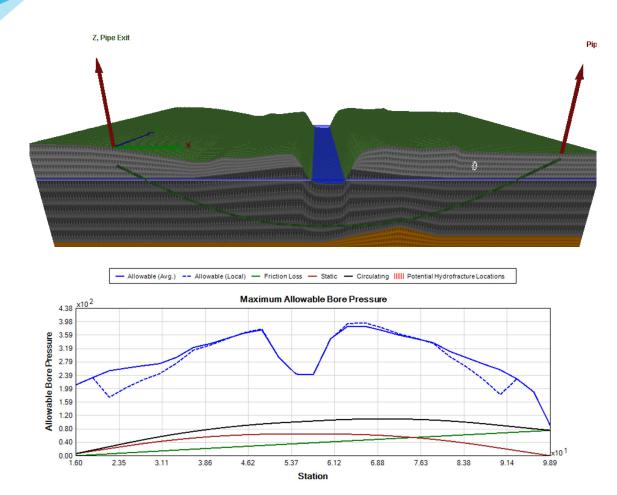
Below is a preliminary soil profile with underbore profile through the sands and further below a preliminary hydrofracture analysis which indicates that an underbore within the sands at 10m+m below the riverbed is possible at this location though an experienced contractor with previous history drilling below waterways within these soil conditions is a must to limit the risk and be confident in achieving the underbore.

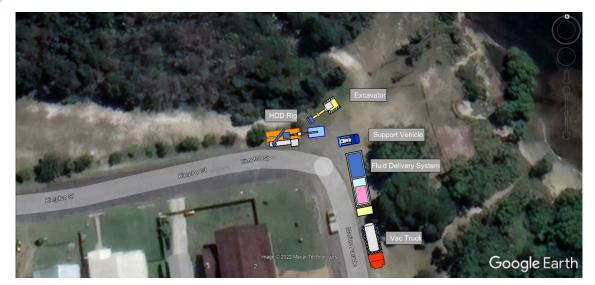
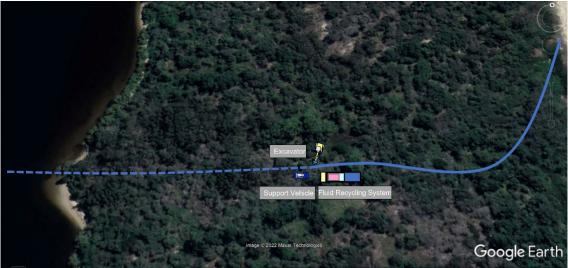
Indicative Setup and Exit Area

Site Setup: The HDD Rig and equipment set up for the underbore of Macleay Arm at Kimpton St as this best suited using the access to Stuarts Point for the Heavier Vehicles and using the flatter area to the northern side of the Kimpton Road Surface. For the entry location the space on the side of the road is suitable to house the HDD Rig and the ancillary equipment removing the impact on the traffic at this location, though some vehicles may make use of the road surface in this area. The exit location in the dunes would need to have some ground modifications to allow access and house the excavator and vacuum truck along with the pipe string for installation. An area approx. 40x20 is required at the entry whilst 20x20 plus the pipe string area is required at the release location.

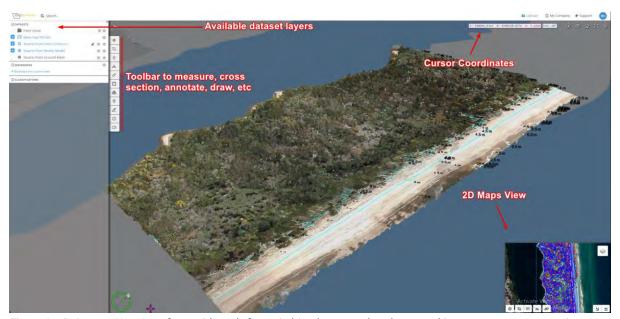
Figure 2 – Pointerra User Interface, with tools for switching between data layers, taking measurements, cutting cross sections and adding Points of Interest.

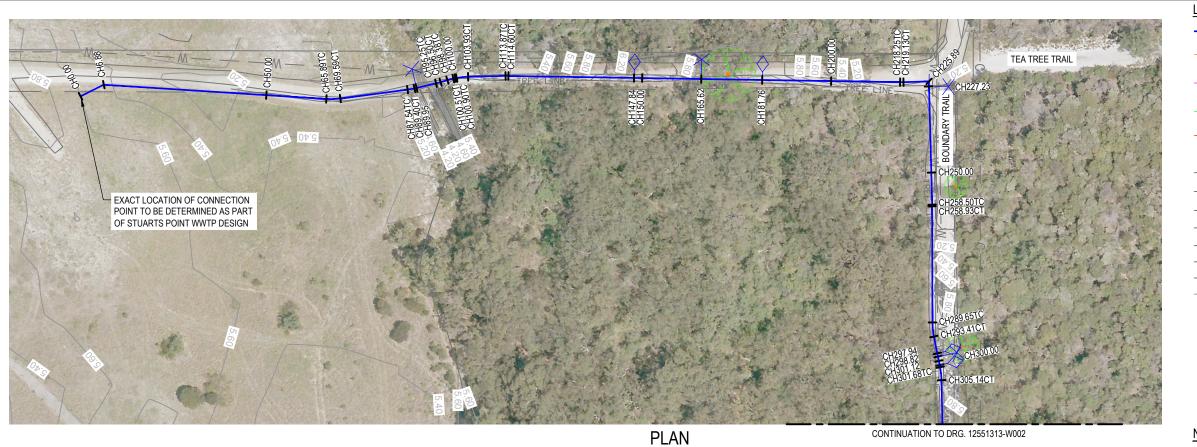
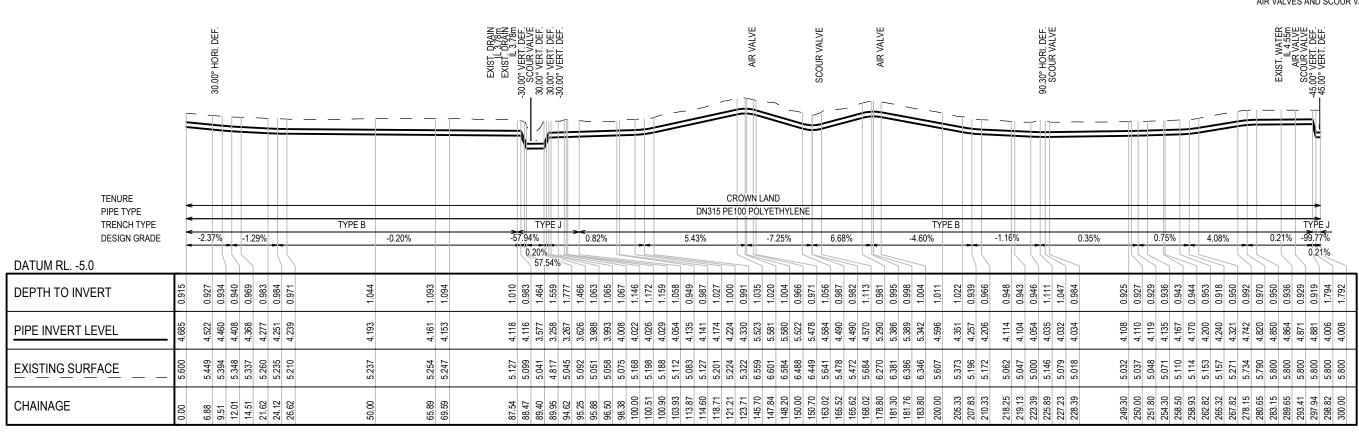
Drawing PLAN AND LONGITUDINAL SECTION - SHEET 1 OF 10

DEEPER TRENCH MAY BE POSSIBLE IF GEOTECHNICAL CONDITIONS ARE SUITABLE TO REDUCE NUMBER OF AIR VALVES AND SCOUR VALVES.

LONGITUDINAL SECTION
