Stage 3 - Proposed Residential Development

30-46 Auburn Road, Regents Park NSW 2143

Groundwater Impact Assessment (GIA)

Project number: IRP-01500

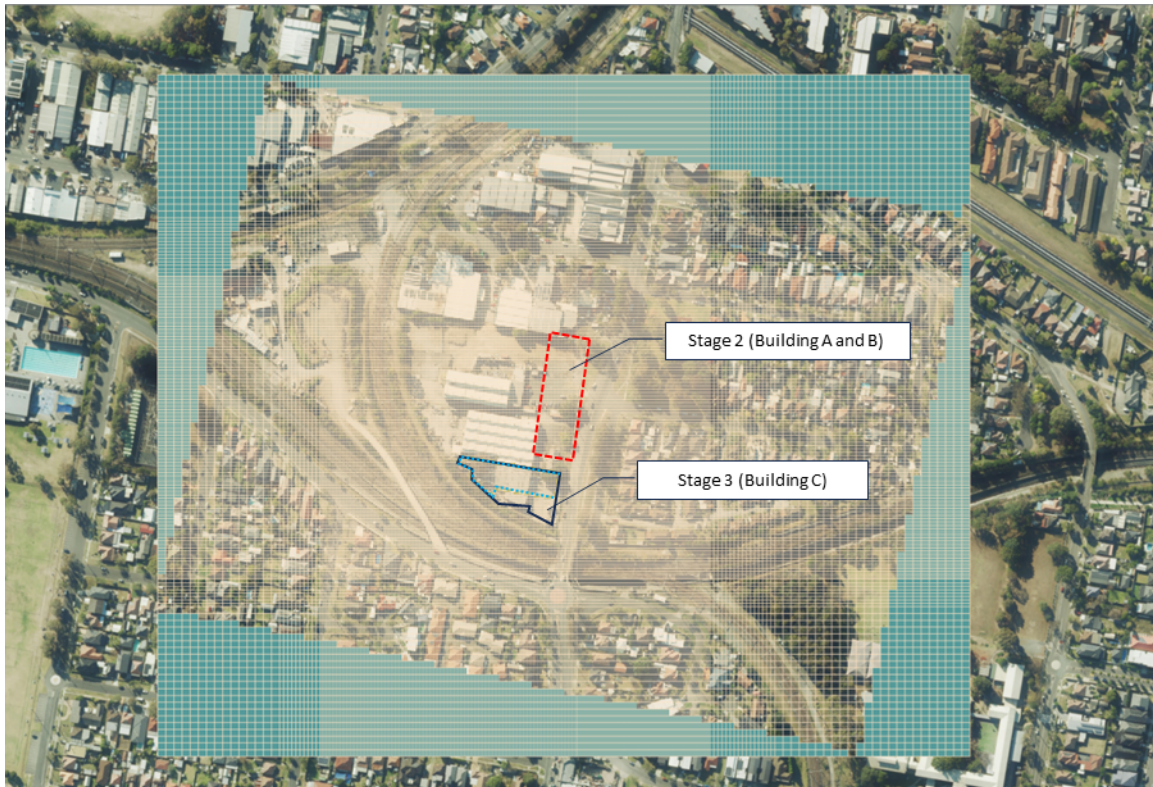
Figure 1 Model Scenario Stage 3, Building C

As part of the proposed Stage 3 construction plan, the construction of Building C was simulated in this report. During some of the model simulations, an excavation wall was simulated (as a groundwater inflow control) by applying a horizontal flow barrier (HFB) to the cells around the proposed Building C basement excavation. Modelled scenarios include soldier pile wall to lowest basement C3 with bulk excavation level (BEL) between 22.5 mRL with no shotcrete infill to 0.5 m below the BEL. Groundwater modelling results are included in the Appendix E. The Figure 1 below illustrates the Model Scenario: Soldier pile wall with shotcrete infill around the basement excavation for Stage 2 and Stage 3 basement construction.

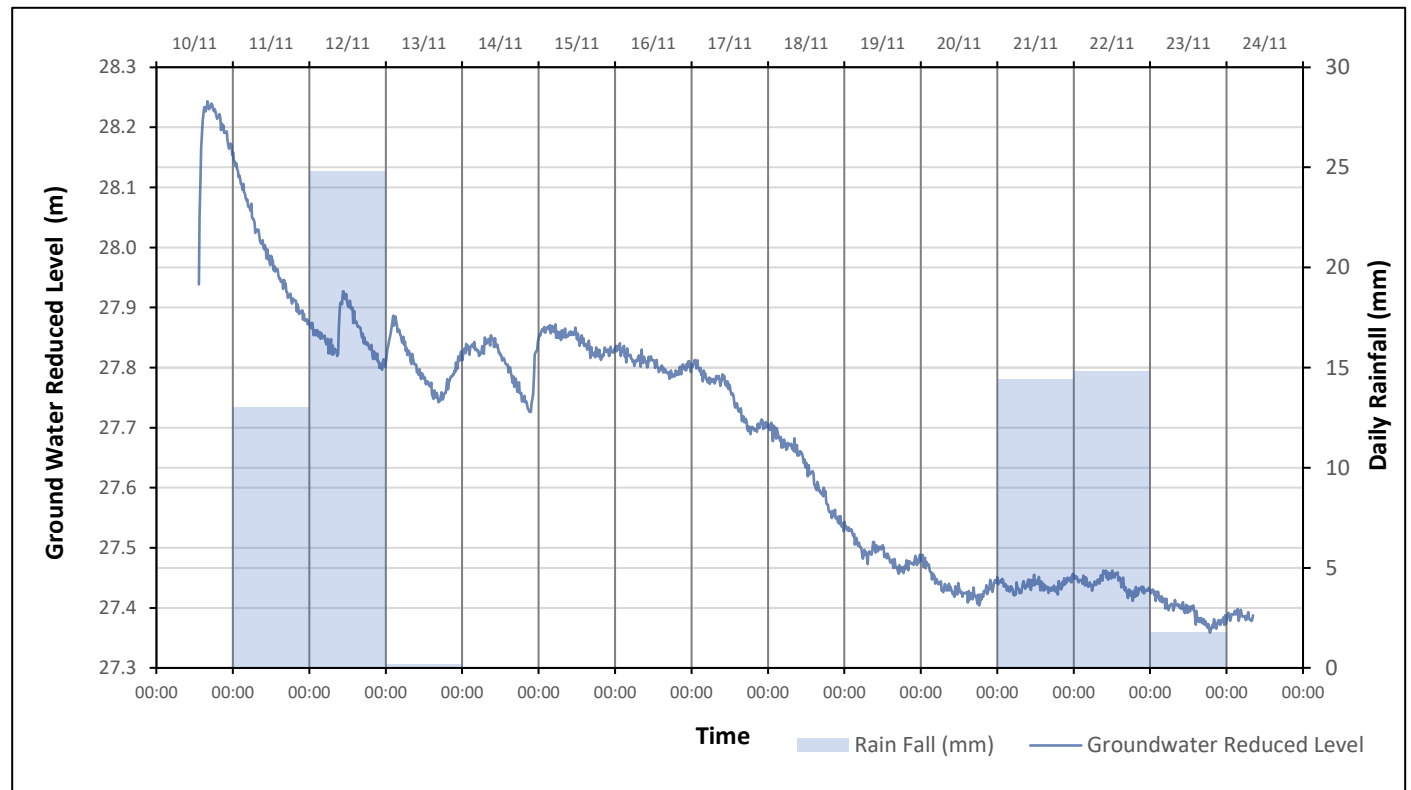
Scaled Well and Logger Details		
Ground RL	m	36
Solid Length	m	3
Slotted Length	m	6
Logger Install Depth	m	9
Initial Water Level	m	8.06
