1. INTRODUCTION

Sovereign Wynyard Centre Pty Limited is proposing a major new PCA Premium Grade commercial and retail development over and including the eastern access ways to the Wynyard Station concourse, from George Street through to Carrington Street.

8. ONE CARRINGTON STREET

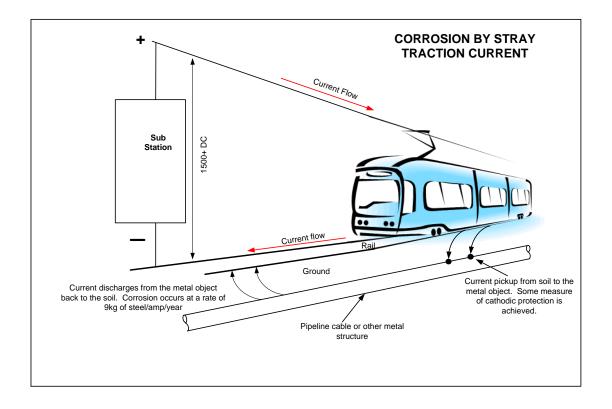
APPENDIX A

Where the "foreign" structure picks up the stray current a small measure of corrosion control or "cathodic protection" is achieved. However, where the current discharges from the foreign structure back to the soil, corrosion of the foreign structure occurs as shown on Sketch CP34.

Direct current as used by the traction system can cause serious corrosion to underground metallic services and the steel reinforcement of concrete. Stray traction current flowing in the ground can be picked up by the steel reinforcement one side of the development, flow along the steelwork and discharge back to the soil on the opposite side of the building. At the discharge point of the current, corrosion of the reinforcement will occur.

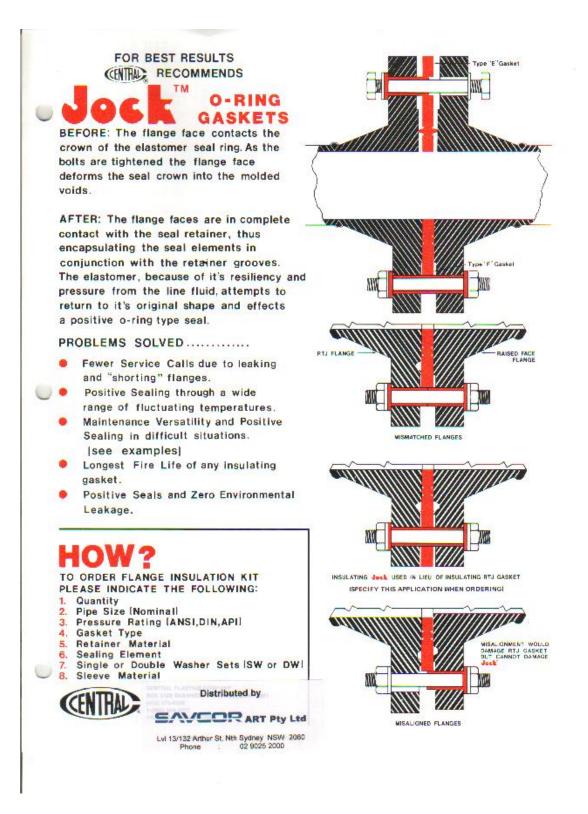
(Standard Gasket Width-1/8")

2.3 Corrosion of the water service or the electrical earth can be caused by stray traction current. Installation of an insulating fitting in the water service, or the use of a non metallic water meter, or PVC pipe eliminates this hazard.
