MGO MT OWEN/GLENDELL OPERATIONS GLENCORE

MT OWEN/GLENDELL OPERATIONS THE ANNUAL REVIEW APPENDICIES

1 January 2019 – 31 December 2019

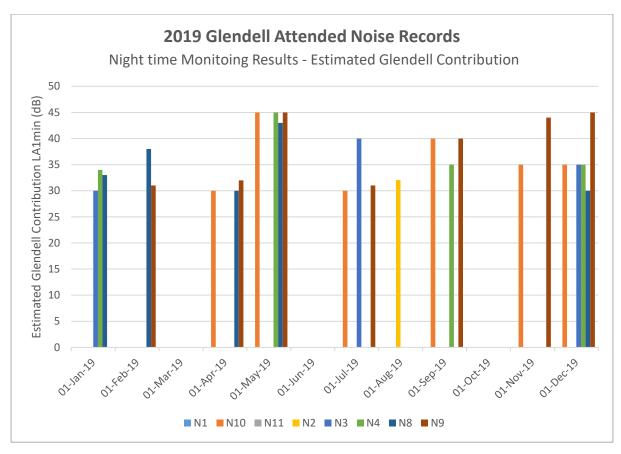
Figure 1: 2019 Attended Noise Records - Night time noise contribution - Glendell

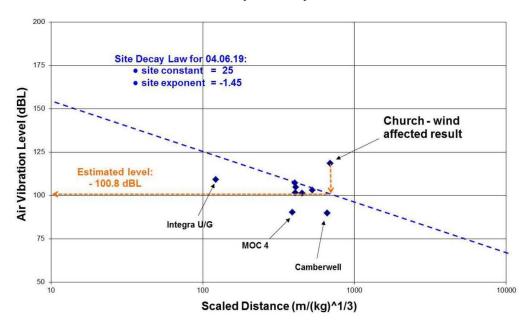
FIGURE 5 – Sonic Decay Law Analysis – 04.06.19 Blast

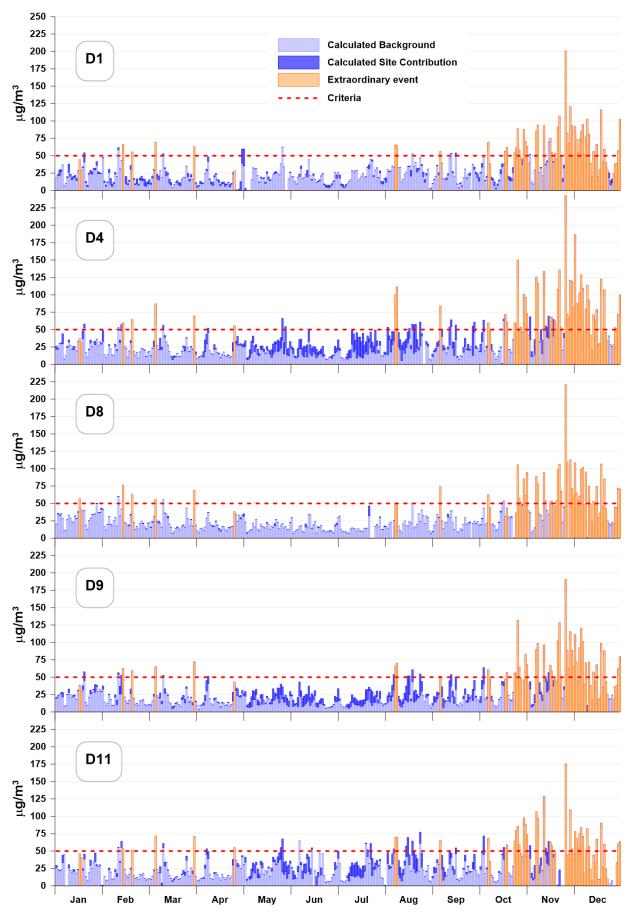
Figure 4 Measured 24-hour average PM₁₀ summary 2019.

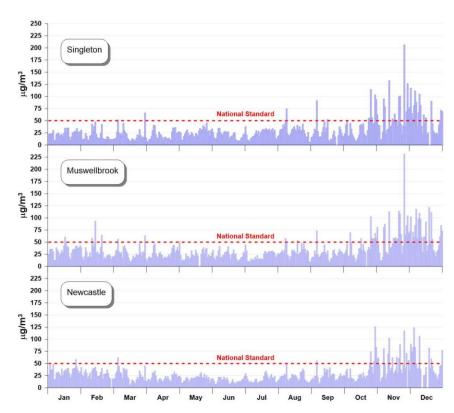
Figure 2 Measured 24-hour average PM_{10} concentrations in the Hunter Valley in 2019

These bushfire events adversely affected air quality across large parts of NSW including the Upper and Lower Hunter Valley. The adverse air quality conditions were evident from monitoring data collected by the Department of Planning, Industry and Environment (DPIE). Figure 2 shows the measured PM_{10} concentrations at the Singleton, Muswellbrook and Newcastle monitoring stations in 2019. These data clearly show the increased PM_{10} concentrations in November and December and, based on the documented bushfire activity and bushfire locations, it would not be unreasonable to classify most days in these two months as related to extraordinary events in the Hunter Valley.

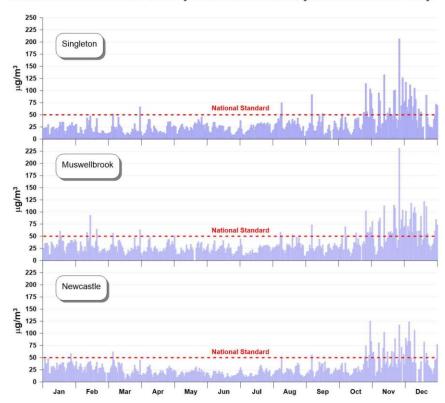
Figure 2 Measured 24-hour average PM₁₀ concentrations in the Hunter Valley in 2019

The bushfire events in late 2019 adversely affected air quality across large parts of NSW including the Upper and Lower Hunter Valley. The adverse air quality conditions were evident from monitoring data collected by the DPIE. Figure 2 shows the measured PM_{10} concentrations at the Singleton, Muswellbrook and Newcastle monitoring stations in 2019. These data clearly showed the increased PM_{10} concentrations in November and December and, as noted in Section 2.1, there were a total of 66 days declared as extraordinary events in the Hunter Valley.

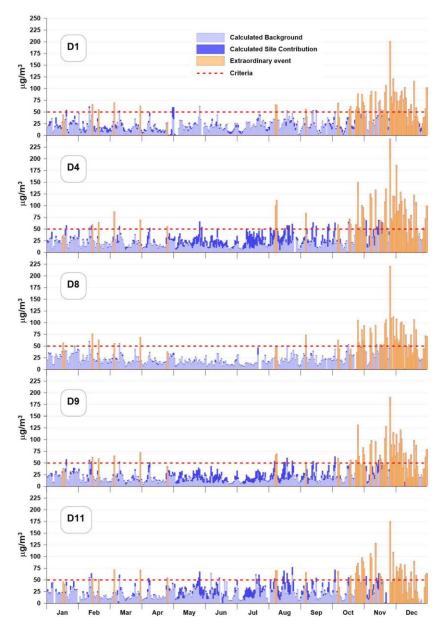
Figure 3 Measured 24-hour average PM_{10} concentrations at MGO monitoring sites in 2019 $\,$

The calculations from Table 7 show that, of all sites, the MGO was estimated to have contributed up to 5 μ g/m³; at SX13 D4. The basis for the calculated site contributions can be seen from Figure 3. This figure shows the measured 24-hour average PM₁₀ concentration from each monitoring site, broken down into calculated background and calculated site contributions for each day of the year. The calculated higher site contributions at SX13 D4 can be seen to occur in the winter months when winds from the northwest are more common. As noted in Section 1 Mt Owen reports compliance against their 24-hour average PM₁₀ criteria via a separate process established with the DPIE so these results are not discussed further.

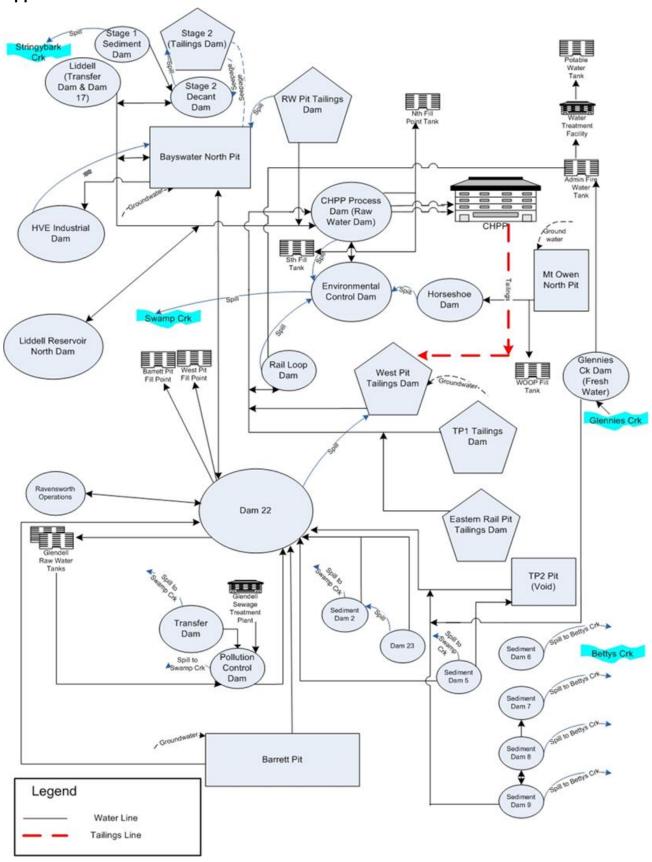
Figure 5: MGO Water Schematic
