MGO
MT OWEN/GLENDELL OPERATIONS
GLENCORE

ANNUAL REVIEW
1 January 2019 – 31 December 2019

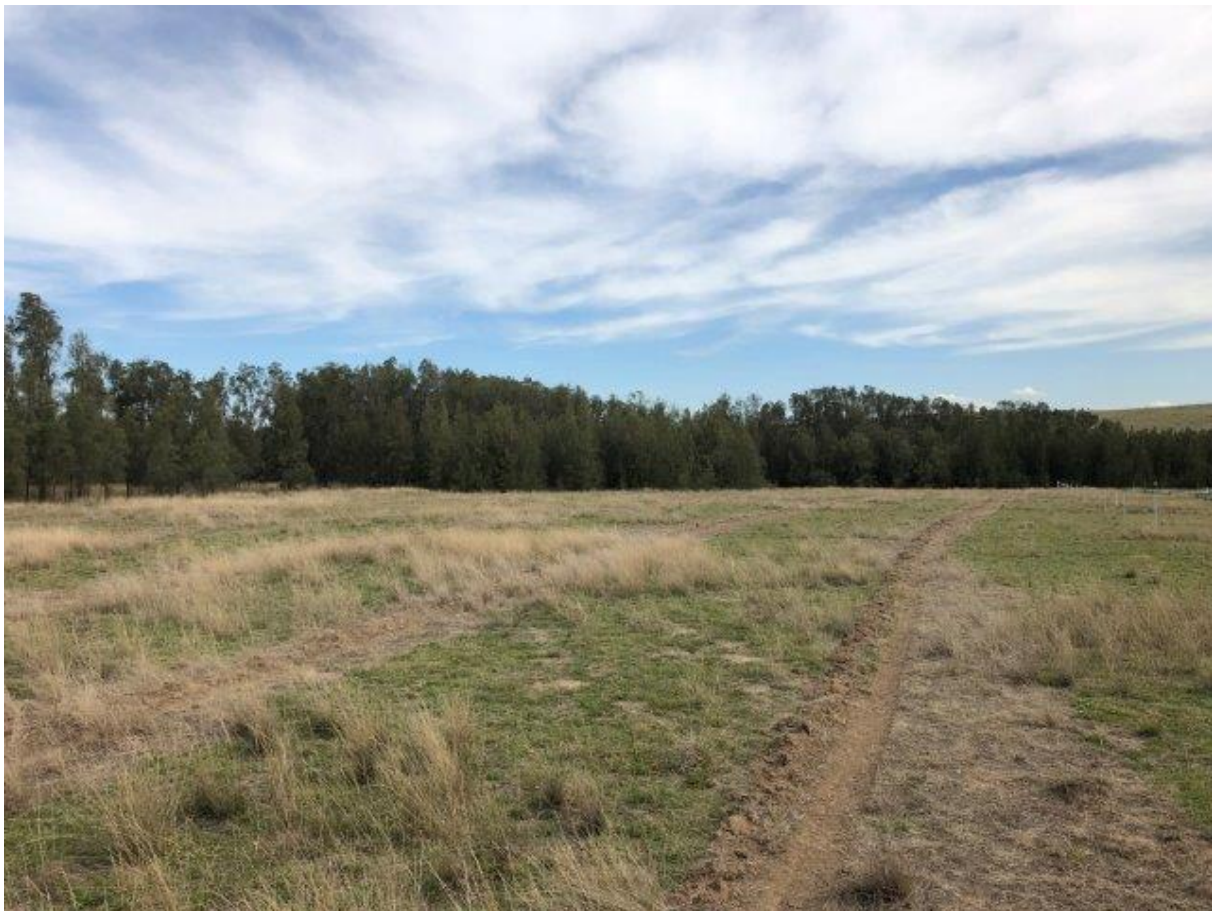
Figure 14 Example of direct seeding works completed at Bettys Creek (Glendell) Conservation Area

In 2019 MGO carried out direct seeding works across its Conservation Areas. A total of 31 hectares were direct seeded within the vegetation community 1602 - Spotted Gum - Narrow-leaved Ironbark Shrub - Grass Open Forest of the Central and Lower Hunter. A photo showing one seeded area is included in [Figure 14](#).

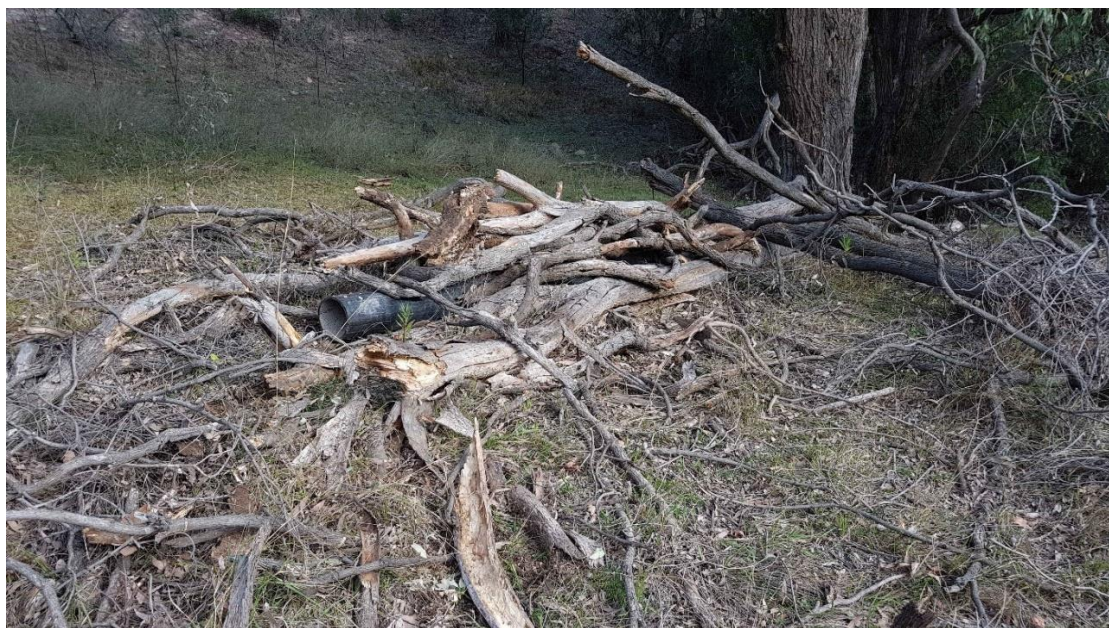
Figure 16 Spotted-tail Quoll habitat structure installed at Stringybark Creek BOA in 2019.

The BOMP (2018) details specific habitat creation for Spotted-tail Quolls in the Stringybark Creek BOA. In 2019, habitat enhancement works for fauna included the installation of structures for the threatened Spotted-tail Quoll and nest boxes for tree hollow-dependent fauna. The Spotted-tail Quoll structures installed consisted of 5m lengths x 30cm diameter disused polypipe utilised by MGO for water management (refer to [Figure 16](#)). These pipes were recycled and trialled at Stringybark Creek BOA as an alternative to installing natural ground logs from felled trees. Monitoring of the pipes over time will determine the effectiveness of this material in providing habitat for the Spotted-tail Quoll. If successful, additional structures will be installed throughout MGO rehabilitation and offset areas.

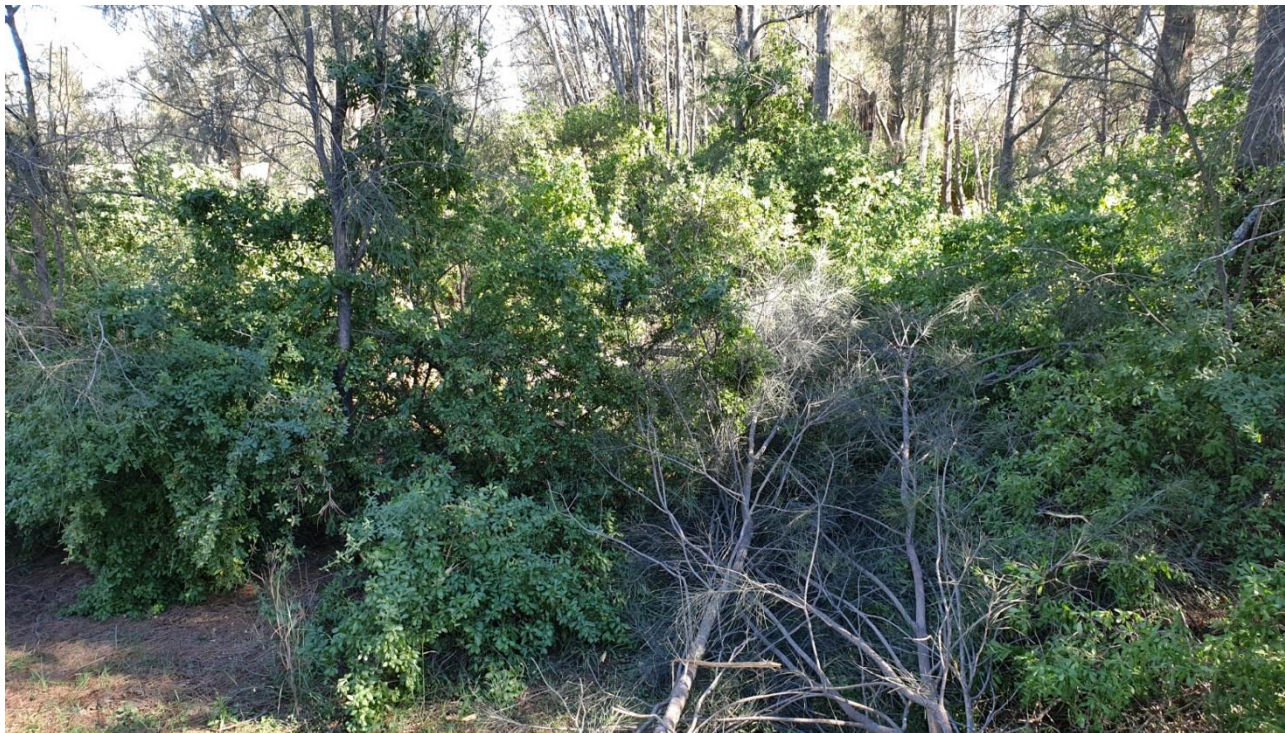
A summary of weed management works undertaken in MGO biodiversity offsets during the reporting period is included in [Table 33](#). During 2019 a successful mulching program was implemented targeting Acacia Saligna, African Boxthorn and Kia Apple in buffer land and rehabilitation areas. Before and after images can be viewed below (see [Figure 17](#) and [Figure 18](#)).

Figure 17: African Boxthron Infestation Main Creek before Mulching

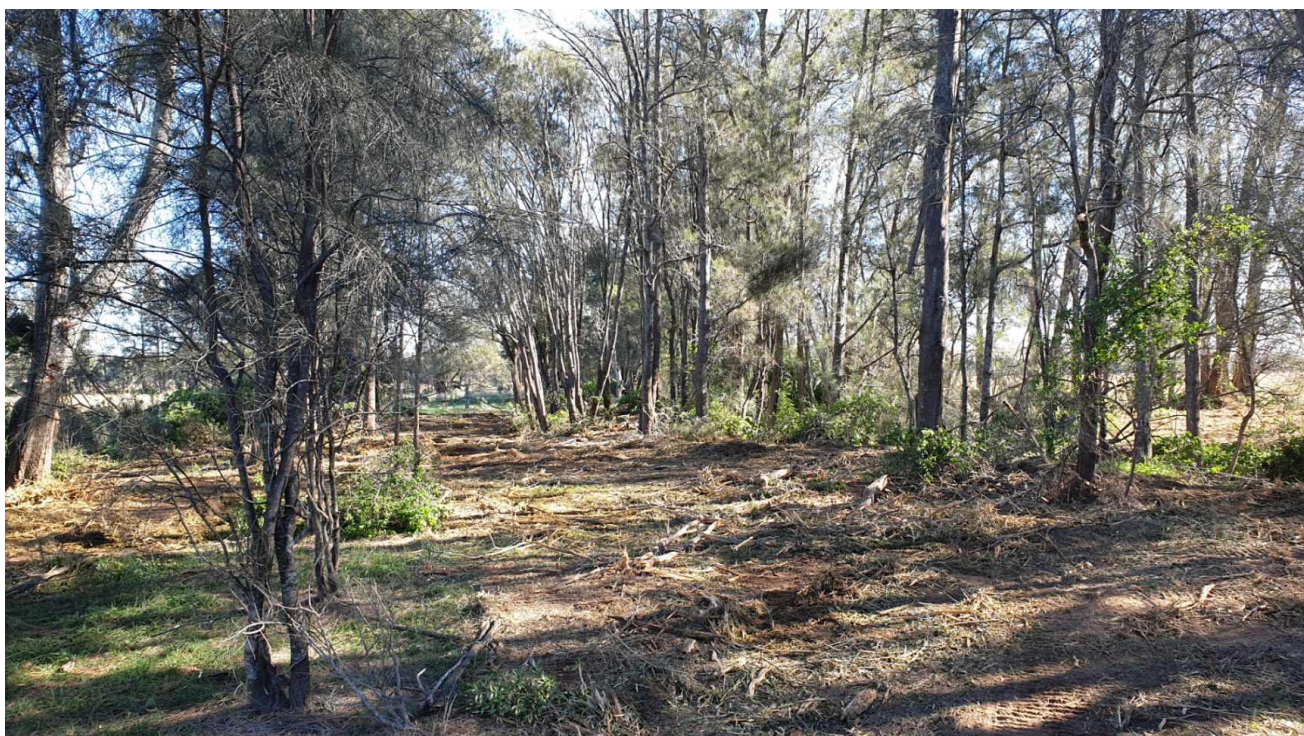
Figure 18 African Boxthron Infestation Main Creek after Mulching

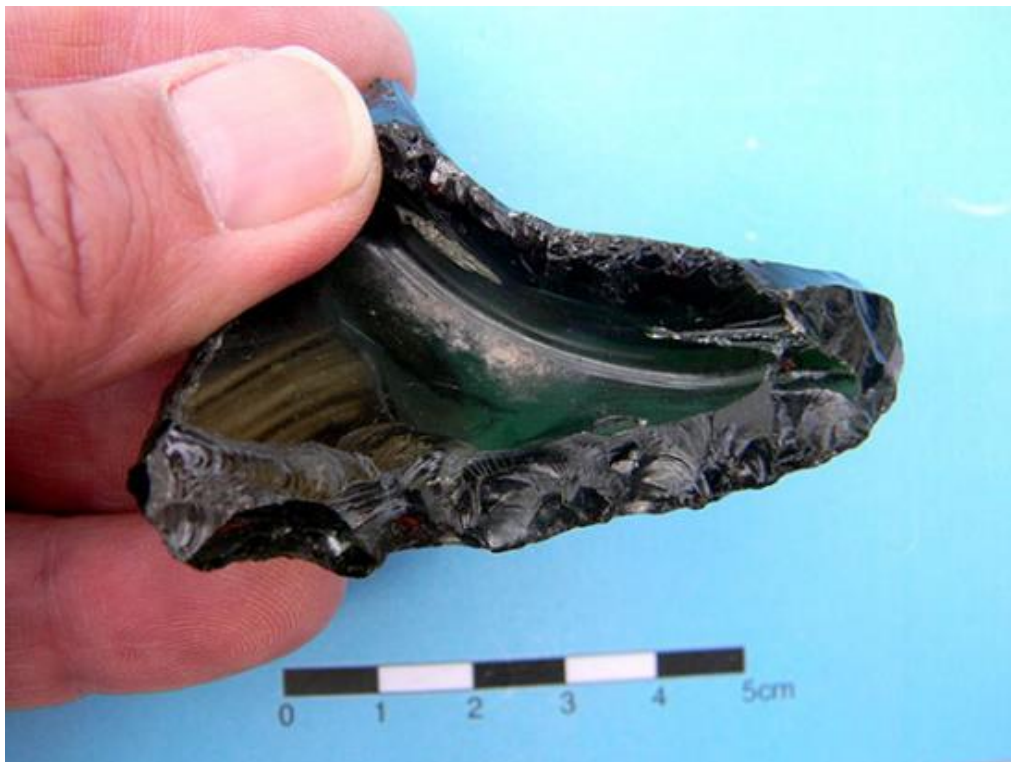
Figure 21: Knapped glass artefact monitored in 2019 in MGO's Buffer Lands

MGO monitored all four quadrants during 2019 with over 55 artefact sites visited. Artefacts were found to be well-preserved with minimal management recommendations required.

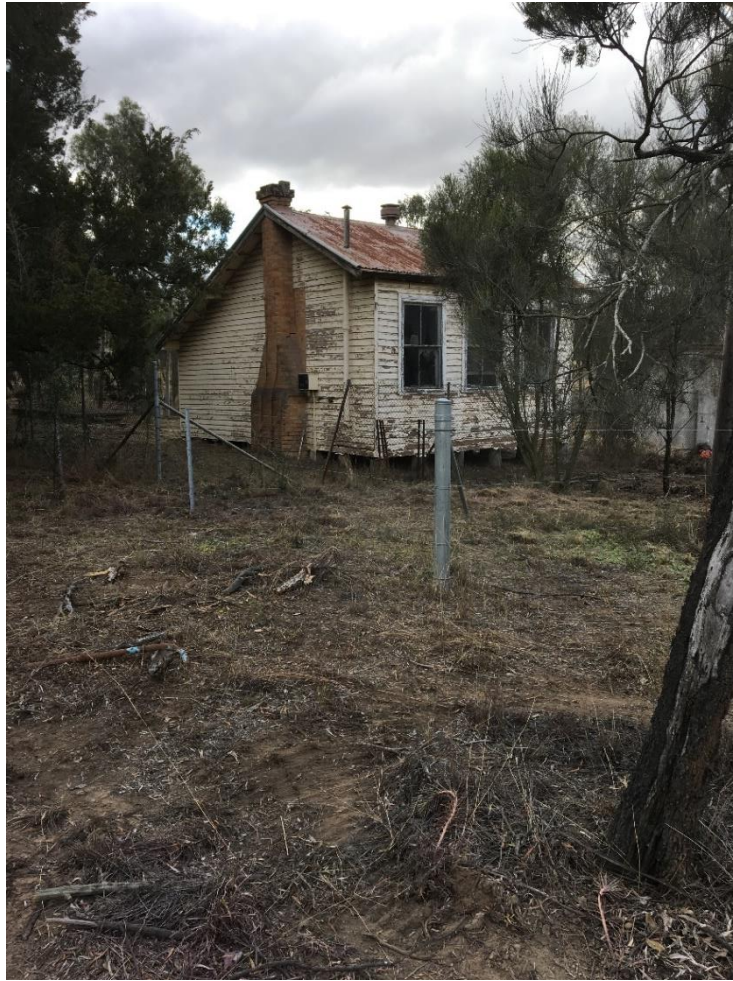
Figure 23: Former Hebden PS removal of rubbish and weed management

During 2019 the former Hebden Public School was removed of dumped rubbish and tidied up (see [Figure 23](#)). Monitoring during the reporting period found that sites are well-preserved with minimal management recommendations required, such as the timber loading ramps pictured below in [Figure 24](#).

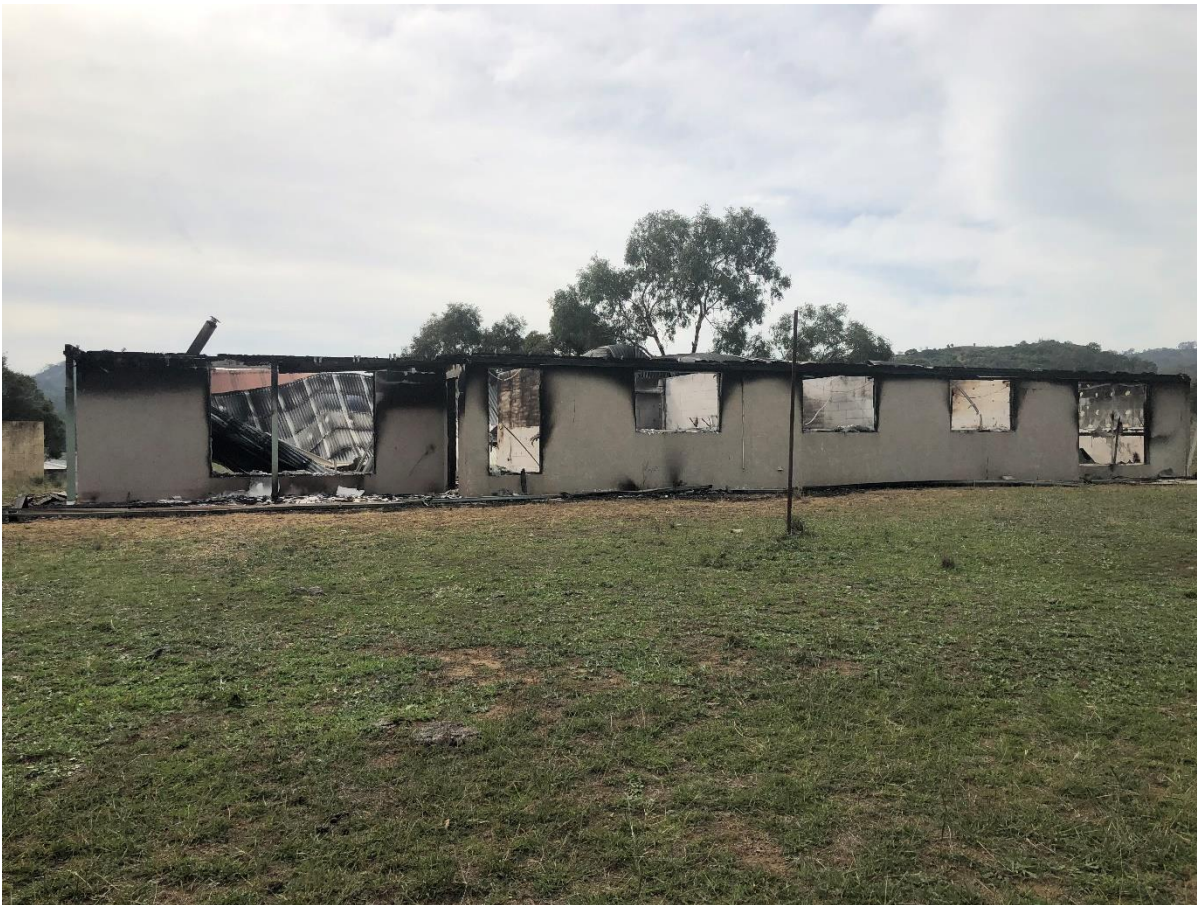
No asbestos was present at the property, as confirmed by a licensed independent certifier (EP Pty Ltd) who were engaged to undertake site monitoring and sampling. This inspection was undertaken on 9th of May 2019.

Figure 25: Demolition of fire effected Picton Lane property – before.

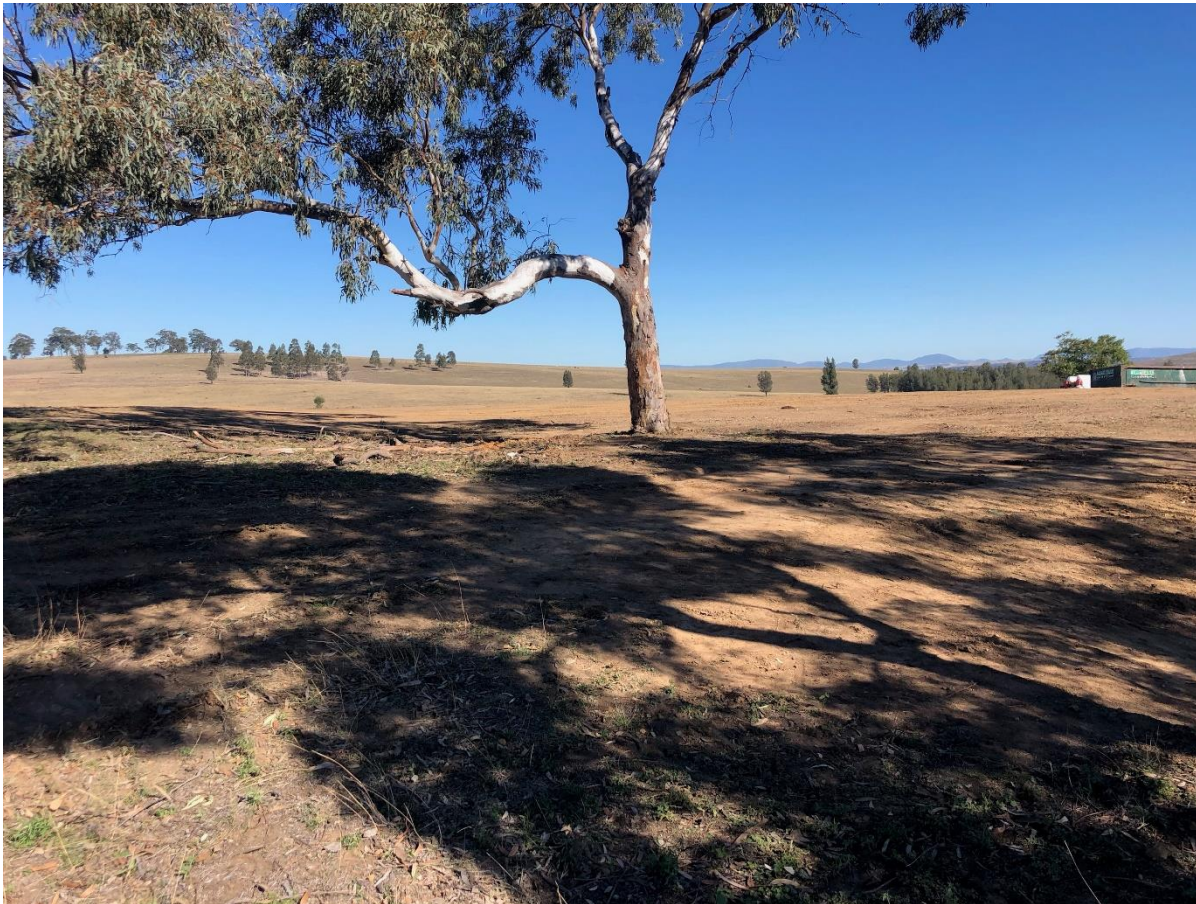
During the reporting period the fire damaged former property at 140 Picton Lane was dismantled and disposed of to improve local visual amenity and farming land. Approximately 188 tonnes of waste was removed from the site including 84.62 tonnes of mixed waste, 101.14 tonnes of concrete waste and 2.4 tonnes of steel.

Figure 26: Demolition of fire effected Picton Lane property – after

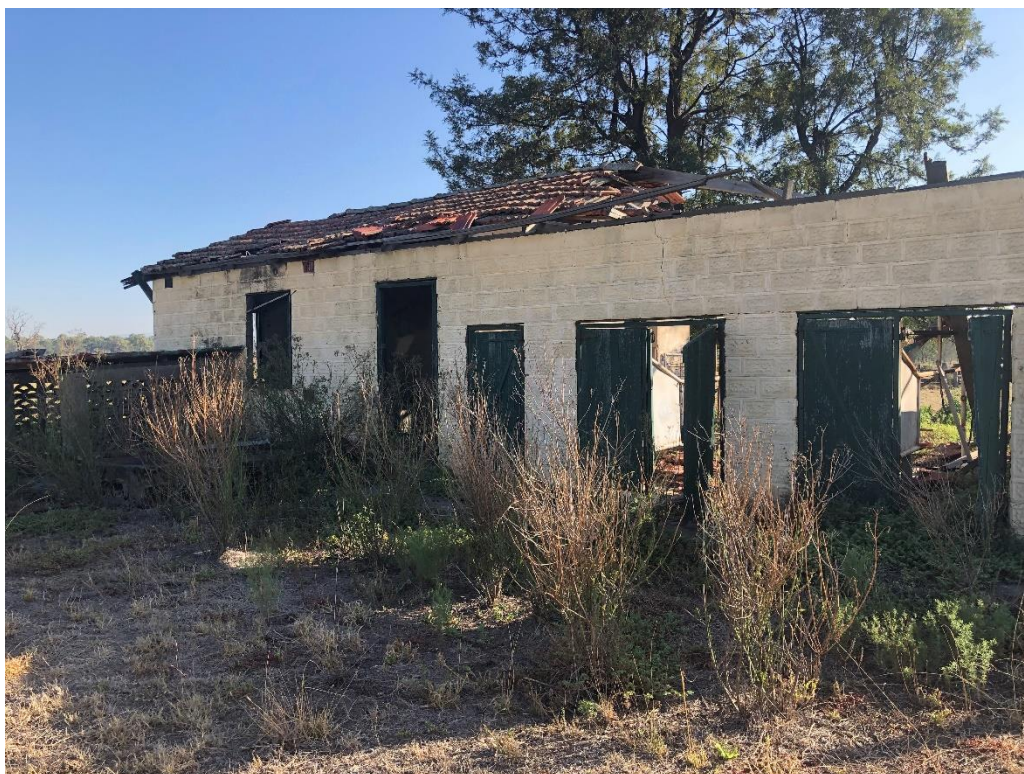
Asbestos removal work was undertaken by a licensed asbestos removal contractor – JR Richards - in accordance with the Safe Work NSW *Code of Practice – How to Safety Remove Asbestos* 2016 and the *NSW Work Health and Safety Regulation* 2017, Clauses 473, 474 and 482. An independent certifier (TMT Industries) was engaged to undertake a visual inspection of the site to confirm the removal of the asbestos. This inspection was undertaken on 8th of August 2019 and ESP confirmed that the potential risk to human health following removal of asbestos from the site is extremely low.

Figure 27: Demolition of dilapidated dairy Glennies Creek Road – before

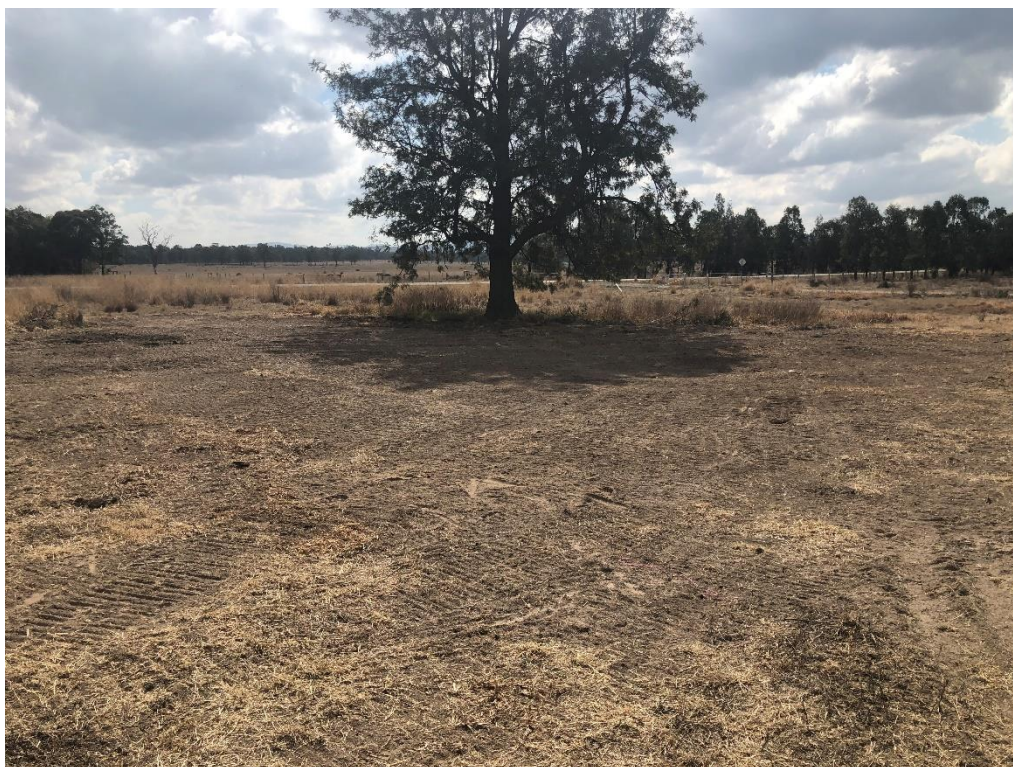
Figure 28: Demolition of dilapidated dairy Glennies Creek Road – after

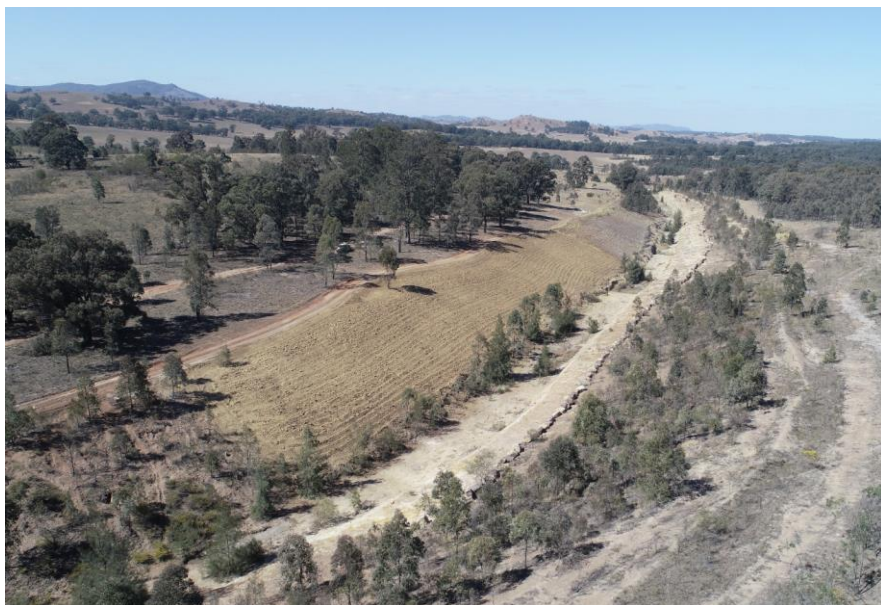
The Upper Bettys Creek Diversion Remediation Plan (requested by DPIE) was implemented in 2018 and is aimed at establishing a resilient vegetation layer to provide sustained protection from further erosion in and around the diversion. The remediation works in the plan will continue to be monitored for establishment in 2019 [Figure 32](#) shows remediation works undertaken in 2018 and additional works undertaken in 2019. Remedial works are planned for Upper Betty's Creek and Middle Betty's Creek in 2020 to repair areas of minor erosion in line with 2019 stream health monitoring. In-fill tree and reed planting is planned for Lower Betty's Creek diversion in 2020 for areas of limited success since establishment in 2014. Approximately 3000 tubestock and 500 reeds will be planted within this diversion.

Figure 32: Upper Bettys Creek remediation works completed in 2019.

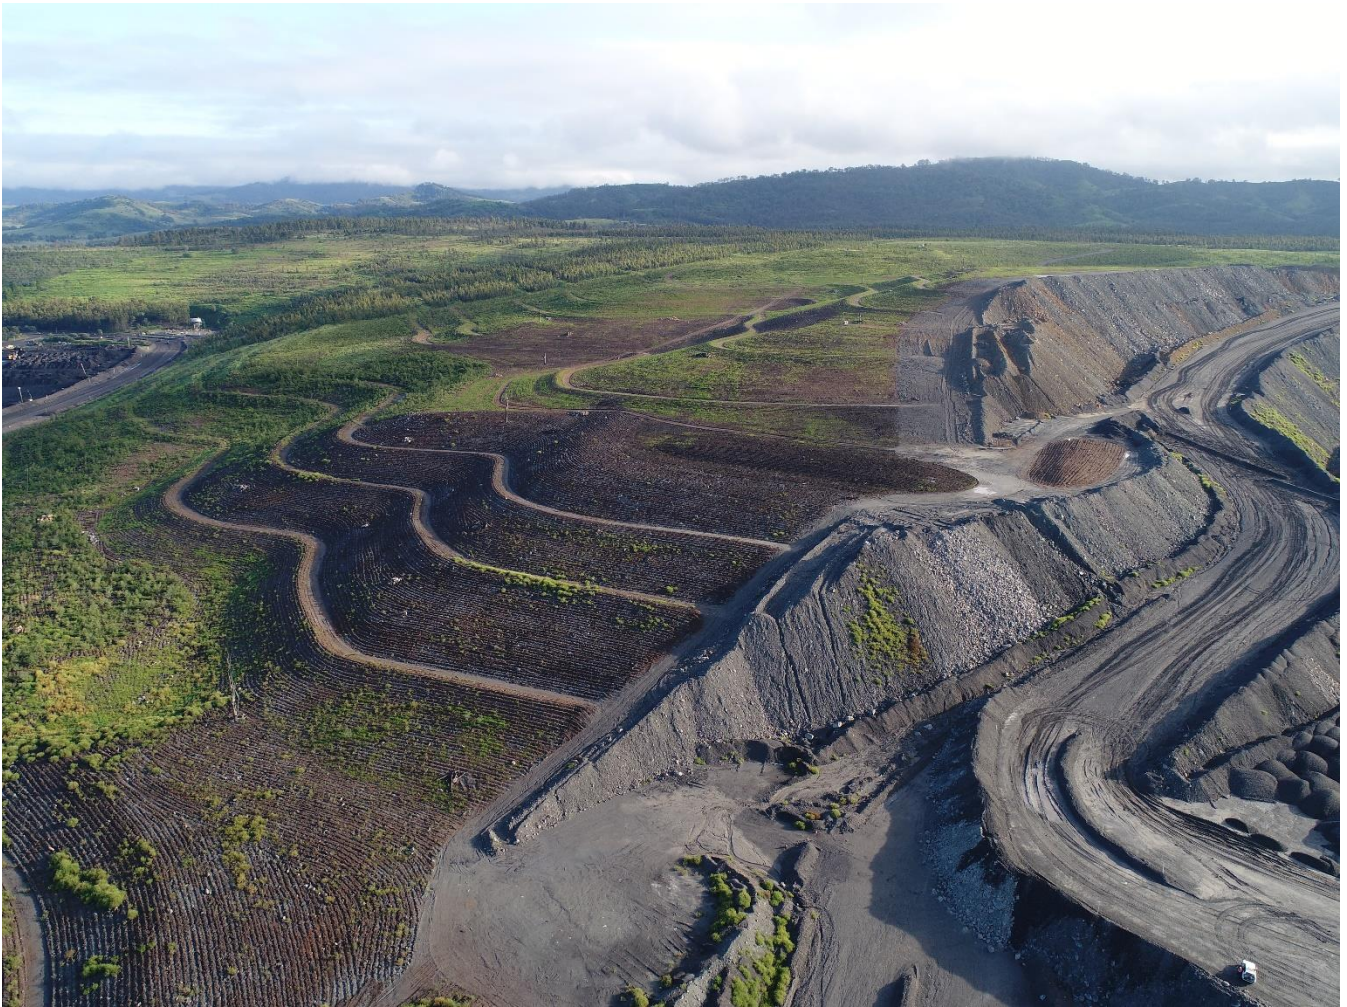
In 2019 MTO prepared and seeded 50 ha of open forest rehabilitation. Rehabilitation methodology remains largely unchanged at MTO with past success an indicator that processes are suitable for the conditions. Focus is placed on the use of direct place topsoil from pre-strip areas and the majority of 2019 rehabilitation was able to utilise this resource. The rest of the area was rehabilitated using subsoil with the addition of gypsum to counter any soil dispersion. 2019 was the first year natural landform design was incorporated into the rehabilitation process, with 27.5 ha was completed on the North Pit rehabilitation area (see [Figure 34](#)).

Figure 34: Newly completed rehabilitation at Mt Owen North Pit incorporating natural landform design. Note older rehabilitation areas in the background

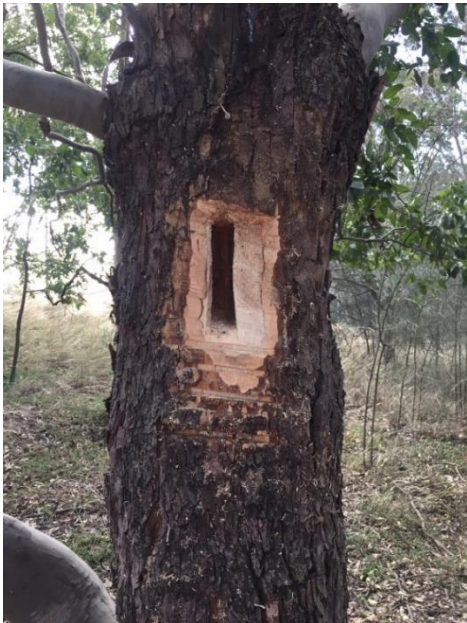
During 2019, MGO created supplementary habitat in older rehabilitation areas (approximately 30 years since establishment) at MTO North Void. This included chainsaw hollows being cut into mature natural tree's with a trunk diameter of 400-700mm. The 20 chainsaw hollows were installed to provide habitat for microbats and squirrel gliders in particular (see [Figure 37](#)). In comparison, 20 traditional nest boxes were installed in close proximity for comparison of effectiveness in providing habitat resources. It is believed the chainsaw hollows should have the thermal properties similar to that of natural tree hollows and be preferentially inhabited by target species. During 2020, monitoring will take place to review the success of this trial. Aside to this in 2019, there was an additional 76 nest boxes installed throughout rehabilitation areas suitable for species such as Spotted-quoll, antechinus, microbat, squirrel glider, ducks and small parrots in line with target species in MGO's approved Rehabilitation Strategy.

Figure 37: Example of chainsaw hollow installed for microbat habitat.

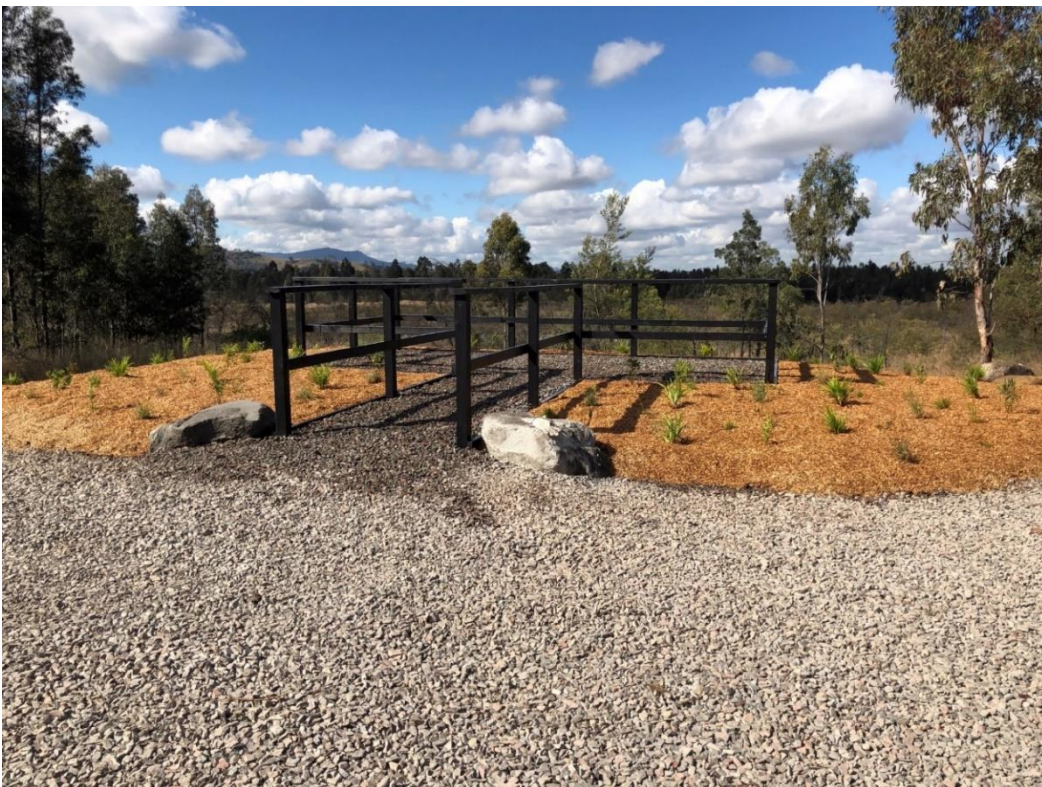
During 2019, a rehabilitation viewing platform was installed at MTO North Pit for site visitors to view an existing rehabilitation area (see [Figure 38](#)). This work also included a signage network that was installed along rehabilitation tracks similar to those found in National Parks. These tracks allow ongoing maintenance of the rehabilitation areas as well as access points for bushfire management.

Figure 38: Mt Owen North Pit rehabilitation viewing platform.
