MGO  
MTOWEN/GLENDELLOPERATIONS  
GLENCORE

**ANNUAL REVIEW**

**1 January 2020 – 31 December 2020**

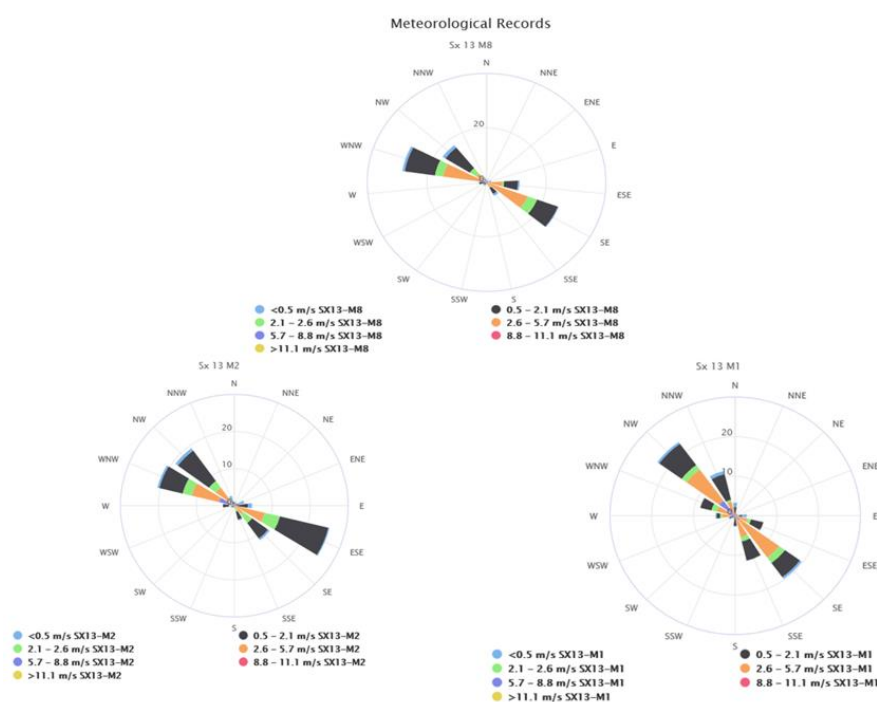
Figure 7: 2020 Annual Wind Roses for Sx13 M1, Sx13 M2 and Sx13 M8

Approximately 841mm of rainfall was recorded at MGO at Sx13 M2 during the reporting period. Due to faults in the SX13 M1 sample site in 2020, data from sample site SX13 M2 was used in the period. In the previous reporting period, approximately 397mm of rainfall was recorded, highlighting that 2020 was wetter than previous years.

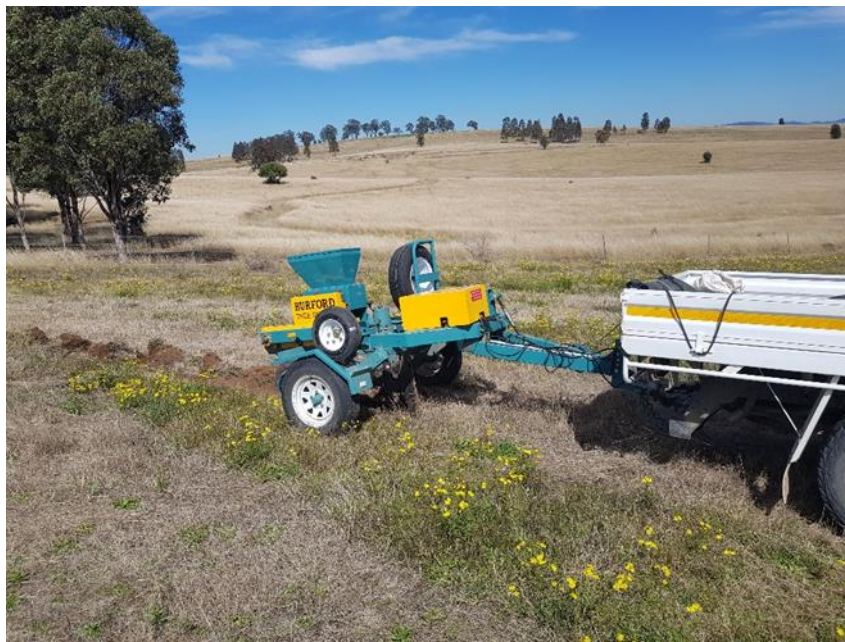
**Figure 13: Example of direct seeding works completed at Stringybark Offset Area**

In 2020 MGO carried out direct seeding works across its Offset Areas. A total of 23.5 hectares were direct seeded within the vegetation community 1602 - Spotted Gum - Narrow-leaved Ironbark Shrub - Grass Open Forest of the Central and Lower Hunter. A photo showing one seeded area is included in [Figure 13](#)<sup>Error! Reference source not found.</sup>. Further direct seeding works are planned for Autumn 2021.

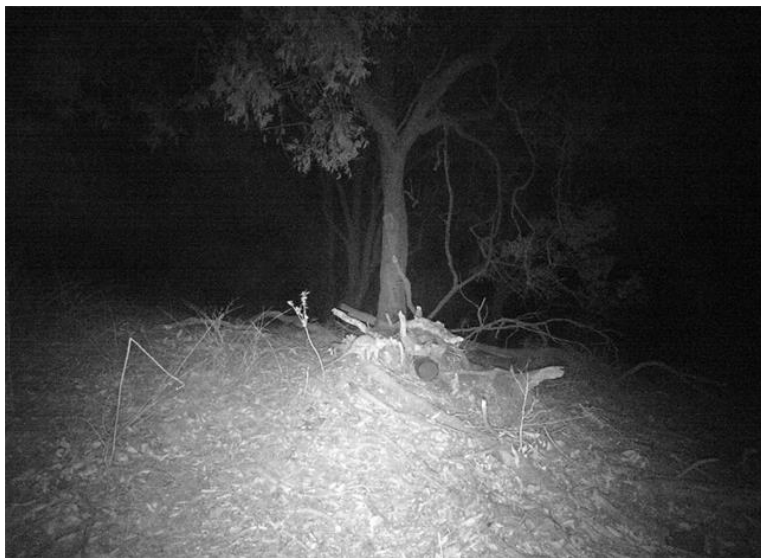
A: Evidence of Spotted-tail Quoll at polypipe structure, Stringybark Creek VCA, 2020

The BOMP (2018) details specific habitat creation for Spotted-tail Quolls in the Stringybark Creek BOA. These structures consisted of 5m lengths x 30cm diameter disused polypipe utilised by MGO for water management and were installed in 2019. In 2020, there was evidence of Spotted-tail Quolls utilising these structures across MGO (refer to [Figure 15](#)). Due to this success, additional structures were installed in the Cross Creek offset and the East West Corridor Management Area. These areas which have been identified as ideal locations to create habitats for the Spotted-tail Quoll. Branches and other small logs have been used to cover the poly-pipe to create the habitat feature (refer to [Figure 15](#)).

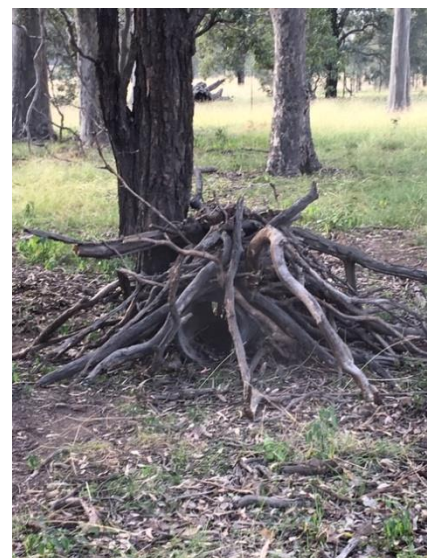
**Figure 15: Habitat Augmentation features installed within BOAs**

B: Log feature habitat installed in East-West Corridor

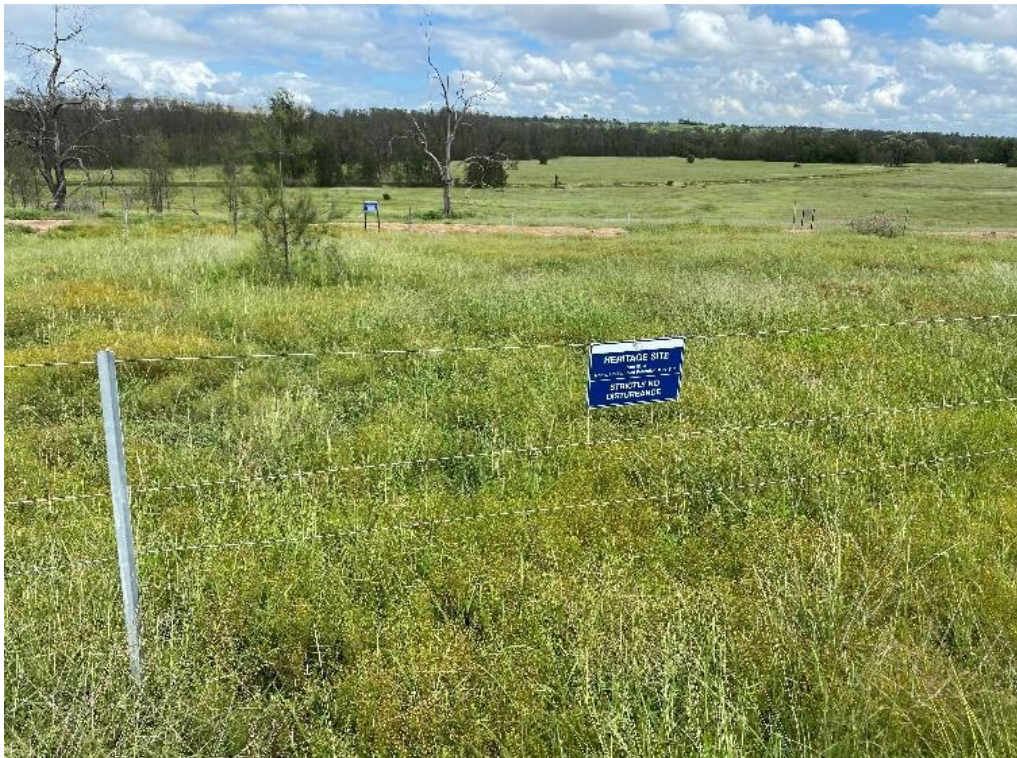
Figure 21: Fence at Marali Homestead

During 2020 the Marali House had the fence and signage fixed. (see [Figure 21](#)). Monitoring during the reporting period found that sites are well-preserved with minimal management recommendations required, such as the timber loading ramps pictured below in [Figure 22](#).

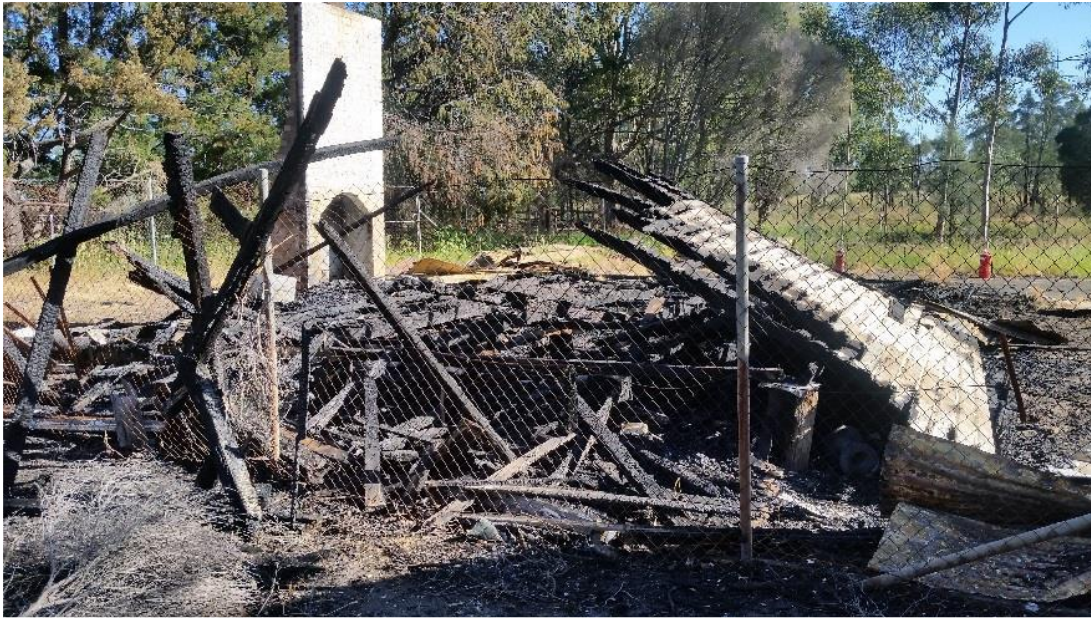
**Figure 23: Demolition of Hebden PS - before**

Hebden Public School was dismantled and disposed of due to a fire that burnt it down on the 15 April 2020 from a suspected arson attack. Demolition commenced on the 26 August 2020 and was completed with waste removed on the 17 September 2020. [Figure 23](#) and [Figure 24](#) shows before and after photos of the demolition. Approximately 20.84 tonnes of waste was removed from the site including 8.34 tonnes of mixed waste and 12.5 tonnes of Asbestos contaminated soil.

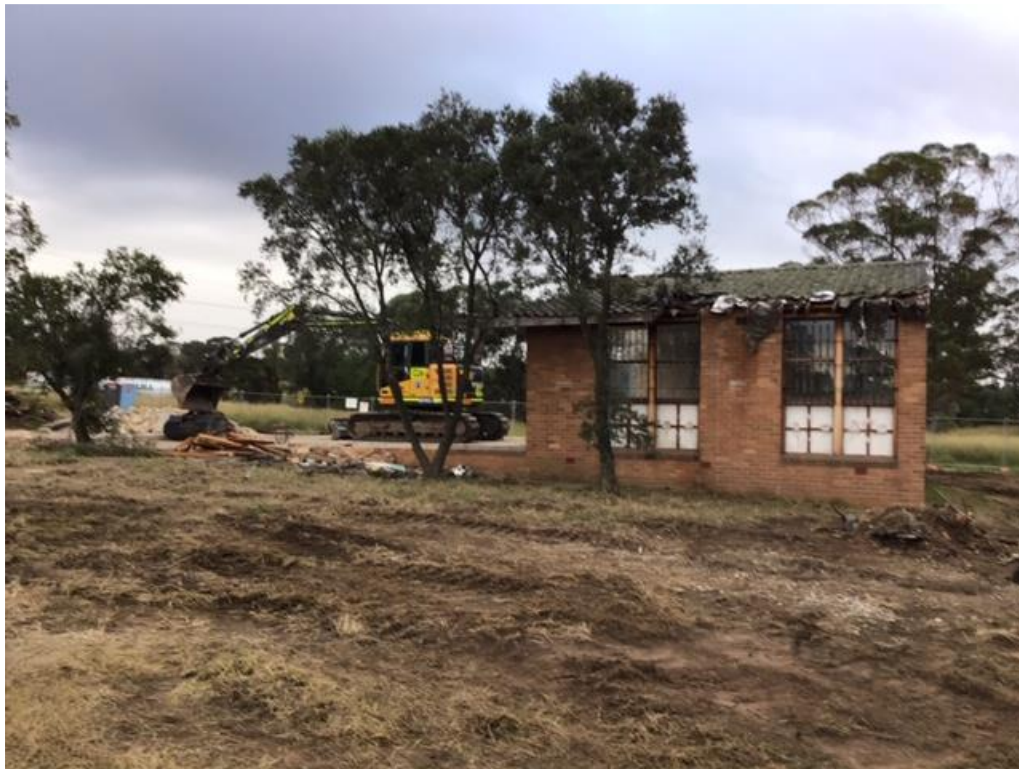
**Figure 25: Ravensworth Public School - before**

The former Ravensworth Public School was partially demolished as a result of it being set on fire by suspected vandals. Demolition commenced in June 2020 and was completed in September 2020. The demolition left parts of the public school as a heritage ruin site in line with community feedback. [Figure 25](#) and [Figure 26](#) shows before

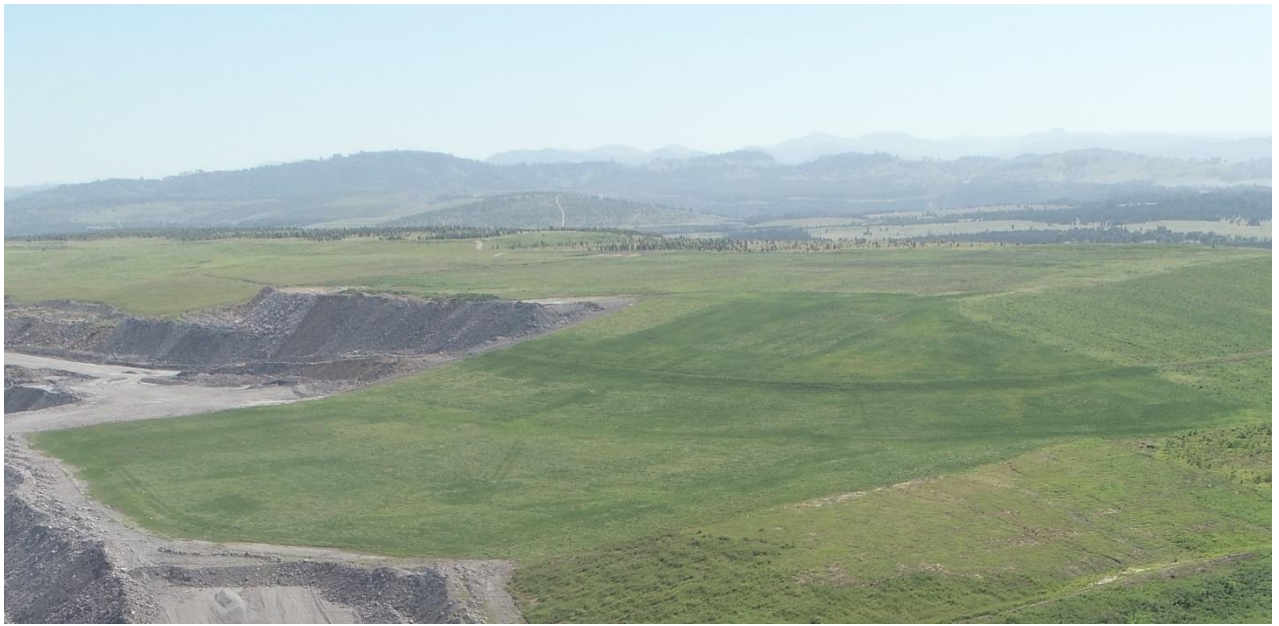
**Figure 31: Newly completed rehabilitation at Glendell**

In 2020 MTO rehabilitated 38ha of open forest rehabilitation. Rehabilitation methodology remains largely unchanged at MTO with past success an indicator that processes are suitable for the conditions. Focus is placed on the use of direct place topsoil from pre-strip areas and the majority of 2020 rehabilitation was able to utilise this resource. The rest of the area was rehabilitated using subsoil with the addition of gypsum to counter any soil dispersion. Natural landform design continued to be incorporated into the rehabilitation process during 2020, with 13.2 ha completed on the North Pit rehabilitation area.

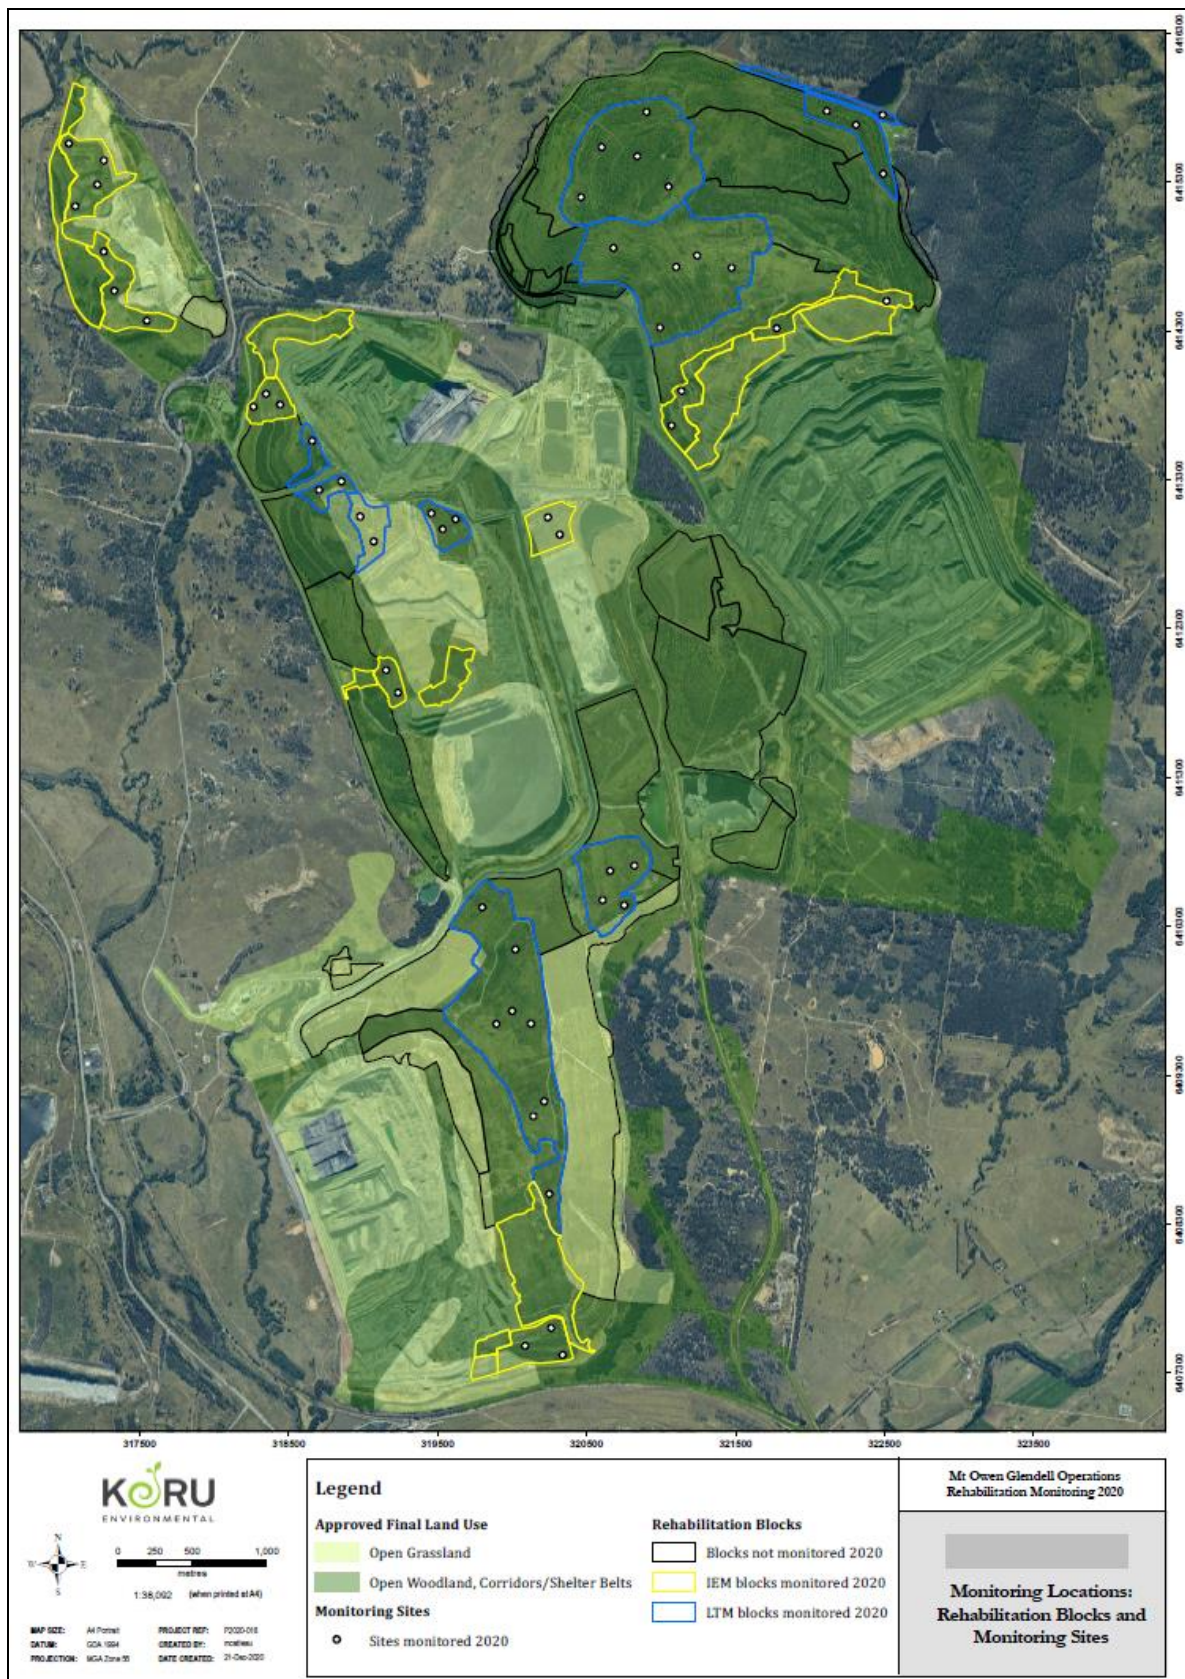
Figure 32: Rehabilitation Parameters Monitored

**Table 62:** Rehabilitation Parameters Monitored provides details of the rehabilitation blocks monitored in 2020 and **Figure 32** shows the locations.

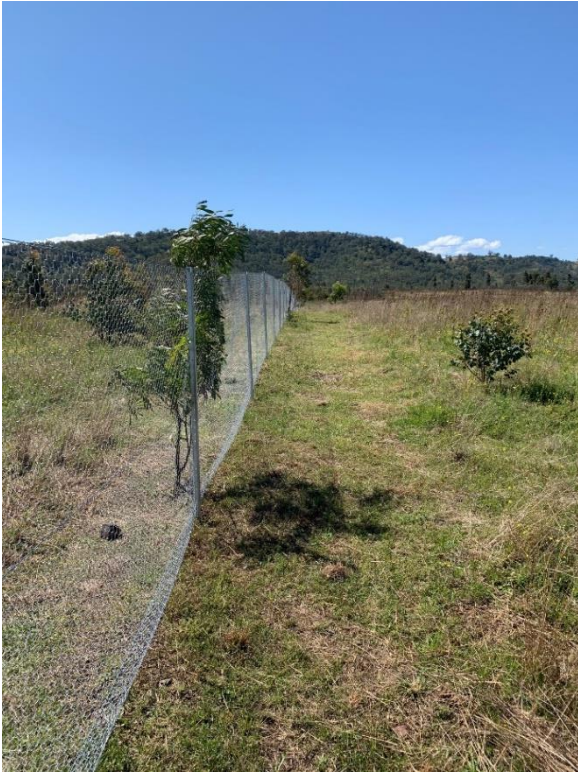
**Figure 34: Example of seed nursery development at Mt Owen**

It is envisaged that this program will be ongoing for a number of years and the success of this targeted and innovative approach to EEC rehabilitation at MGO will be reported on in future Annual Reviews. During 2020 MGO developed seed collection nurseries within the Mt Owen Rehab areas as part of this program.

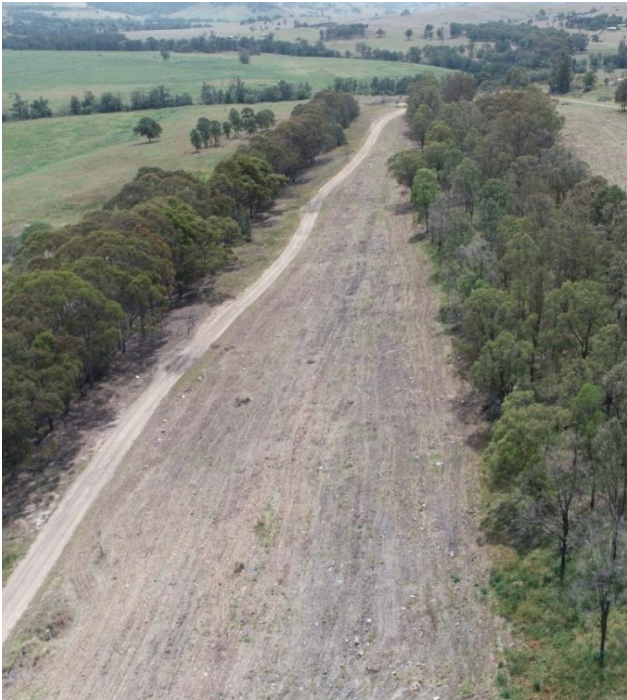
Figure 35: 7.5ha area of re-seeding to woodland in the North Void

- Ongoing weed and pest management;
- Planting of 500 native reeds in the North Void area;
- Re-seeding of 10 hectares of woodland species on Western Out of Pit (WOOP) dump;
- Re-seeding of 7.5 hectares of woodland species in the North Void Area ([Figure 35](#));
- Commencement of work to re-seed approximately 27 hectares to woodland species on the Barrett Pit RL150 rehabilitation area; and
- Installation of additional 12 nesting boxes in the Barrett Pit Rehabilitation area.
