TO: MARY WONG & SARA MADDISON

COMPANY: VEOLIA (AUSTRALIA) PTY LTD

JOB NO: N1906L.03

**SUBJECT: BANKSMEADOW WASTE TRANSFER TERMINAL FACILITY –
ON-GOING ODOUR AUDIT PROGRAM: OCTOBER 2019**

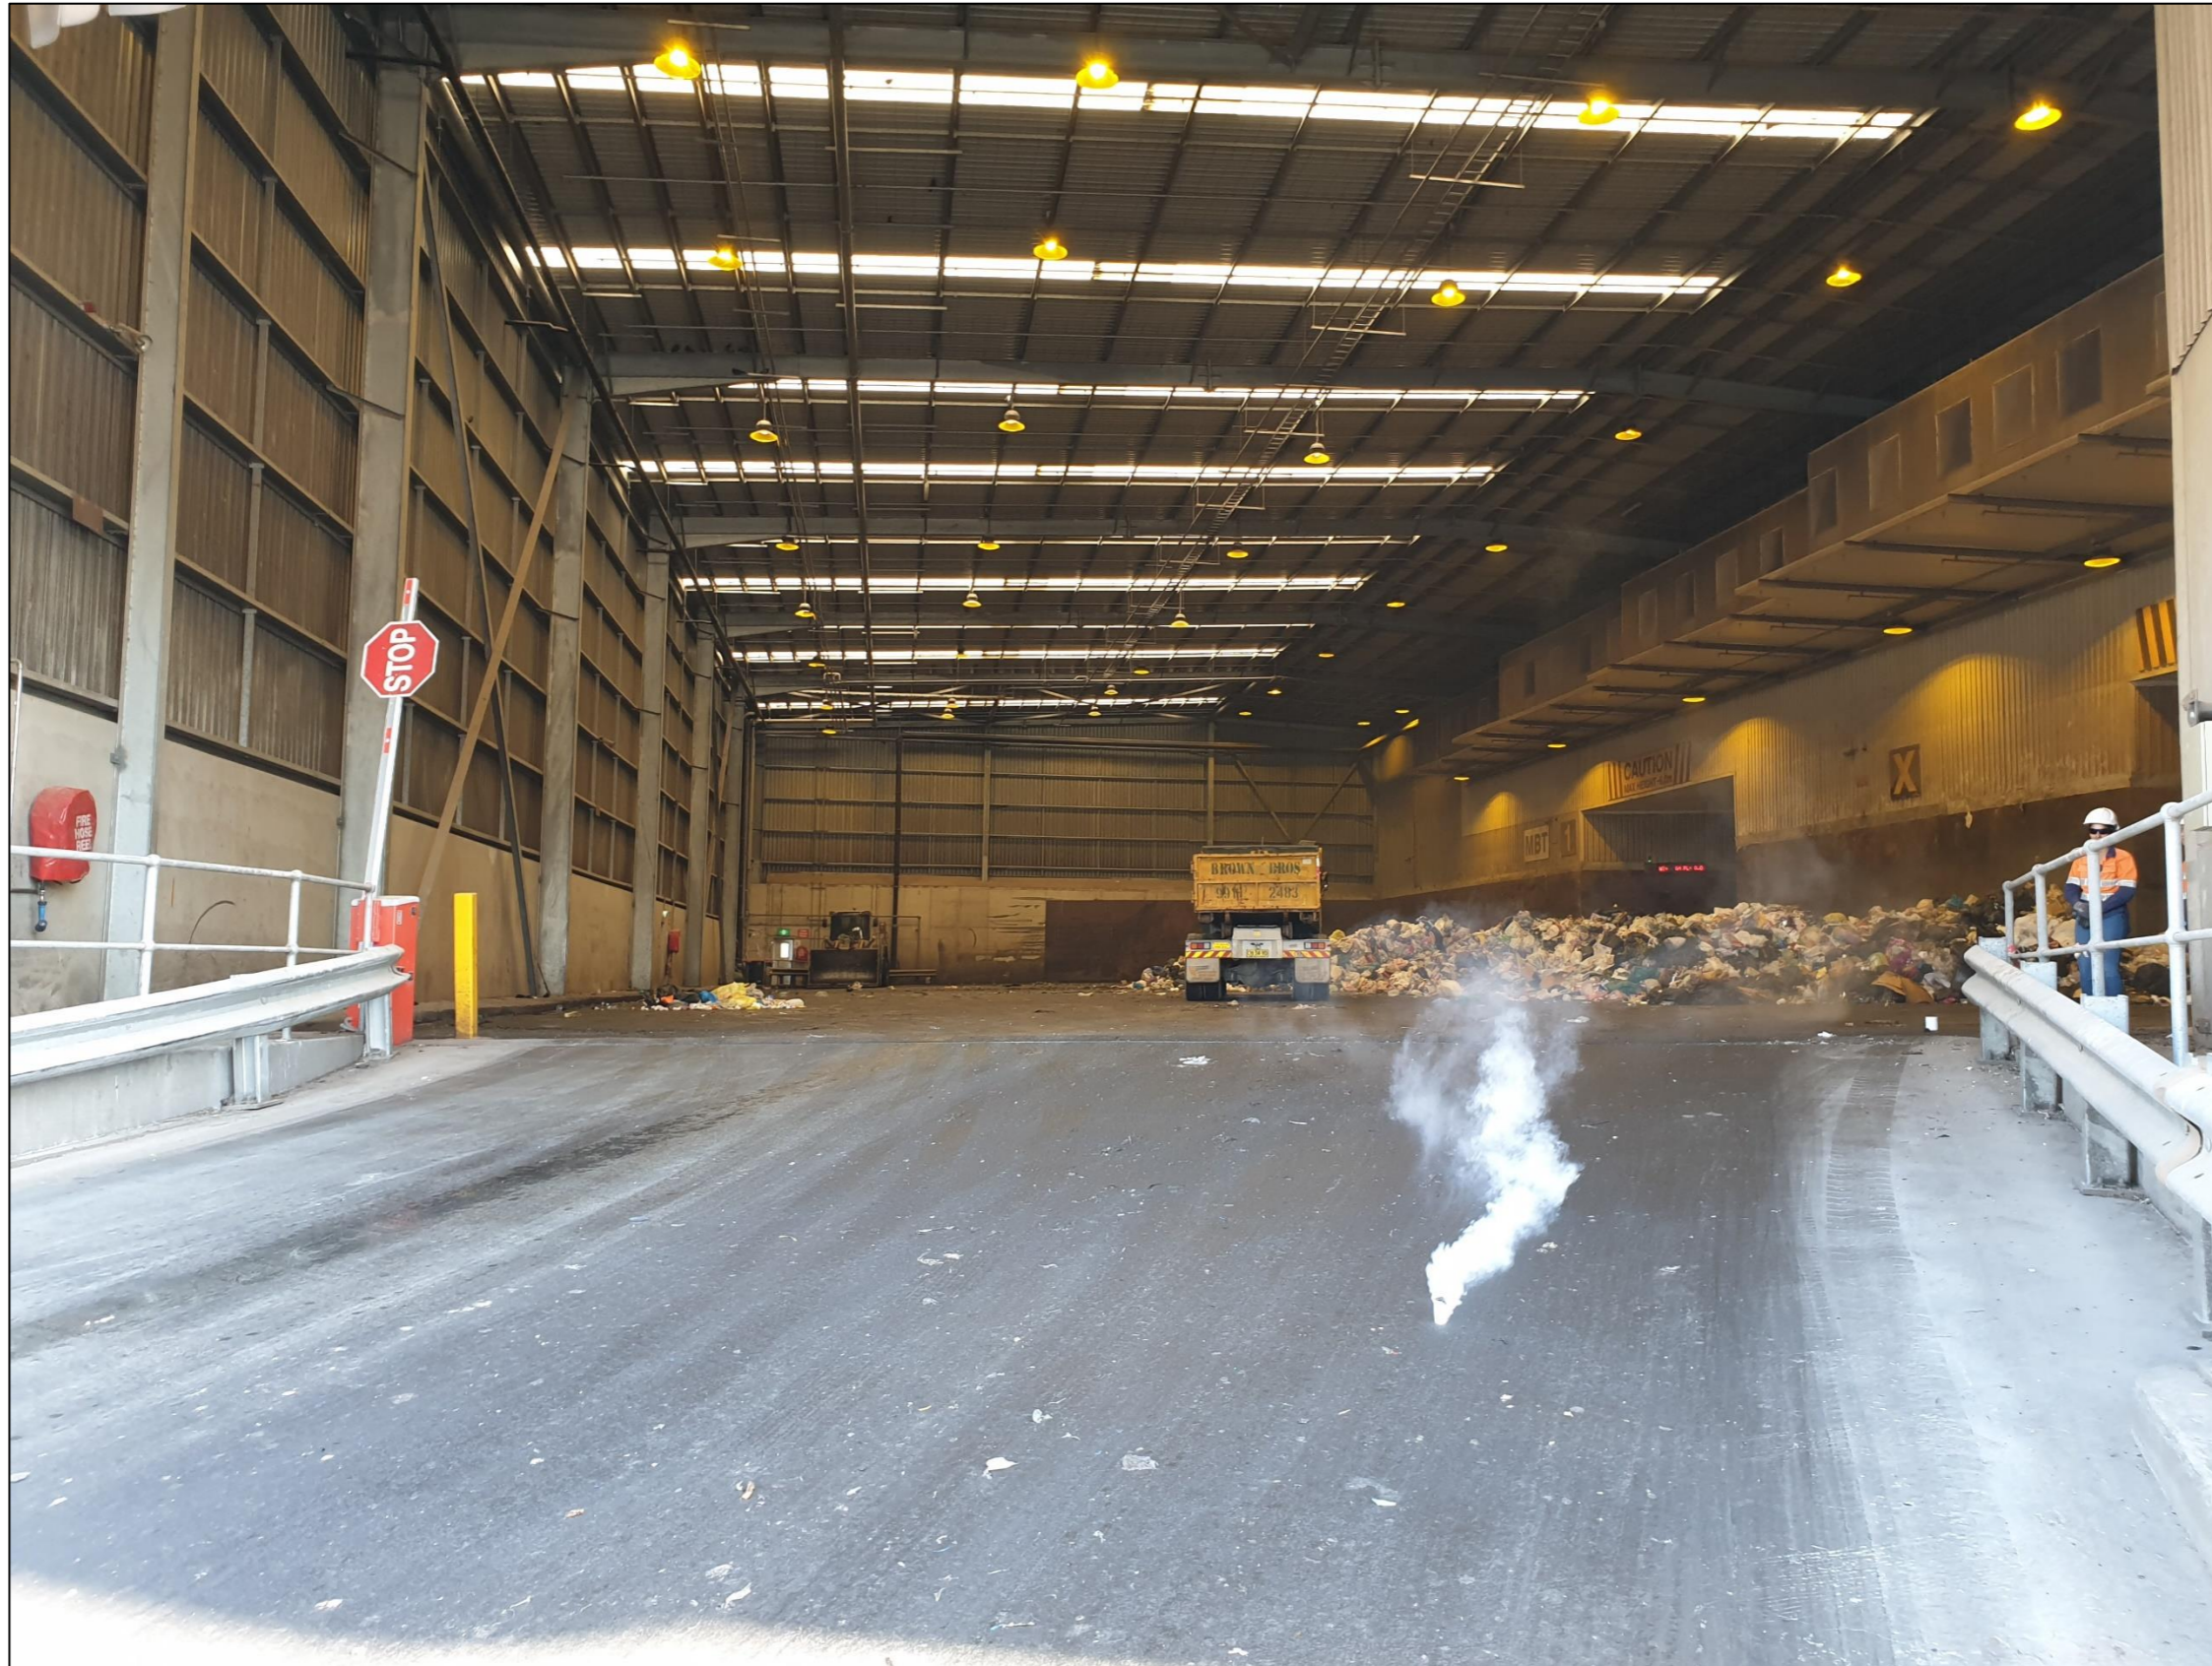
Several smoke release points were undertaken to evaluate airflow patterns and fugitive emission release within the BTT Facility building enclosure. The smoke release points included the northern, middle and southern areas of the BTT Facility building enclosure. A photo of a smoke testing point at the truck entry point of the BTT Facility building enclosure as occurred on 2 October 2019 is shown in **Photo 2**. The observations made during smoke testing are as follows:

- No smoke was found to be emanating from the sealed breezeways around the perimeter of the BTT Facility building;
- The released smoke was found to be well-contained within the BTT Facility building enclosure, suggesting that odour release at ground level is minimal; and
- The released smoke was found to gradually dissipate over time. This indicates that there is a very good level of air exchange turnover within the BTT Facility building enclosure.

Photo 2 – Smoke testing at the truck entry point of the BTT Facility building enclosure as occurred on 2 October 2019

- The smoke testing conducted within the BTT Facility building enclosure indicated positive results and suggests that the building ventilation air extraction system at the BTT Facility is operating in an optimum condition; and

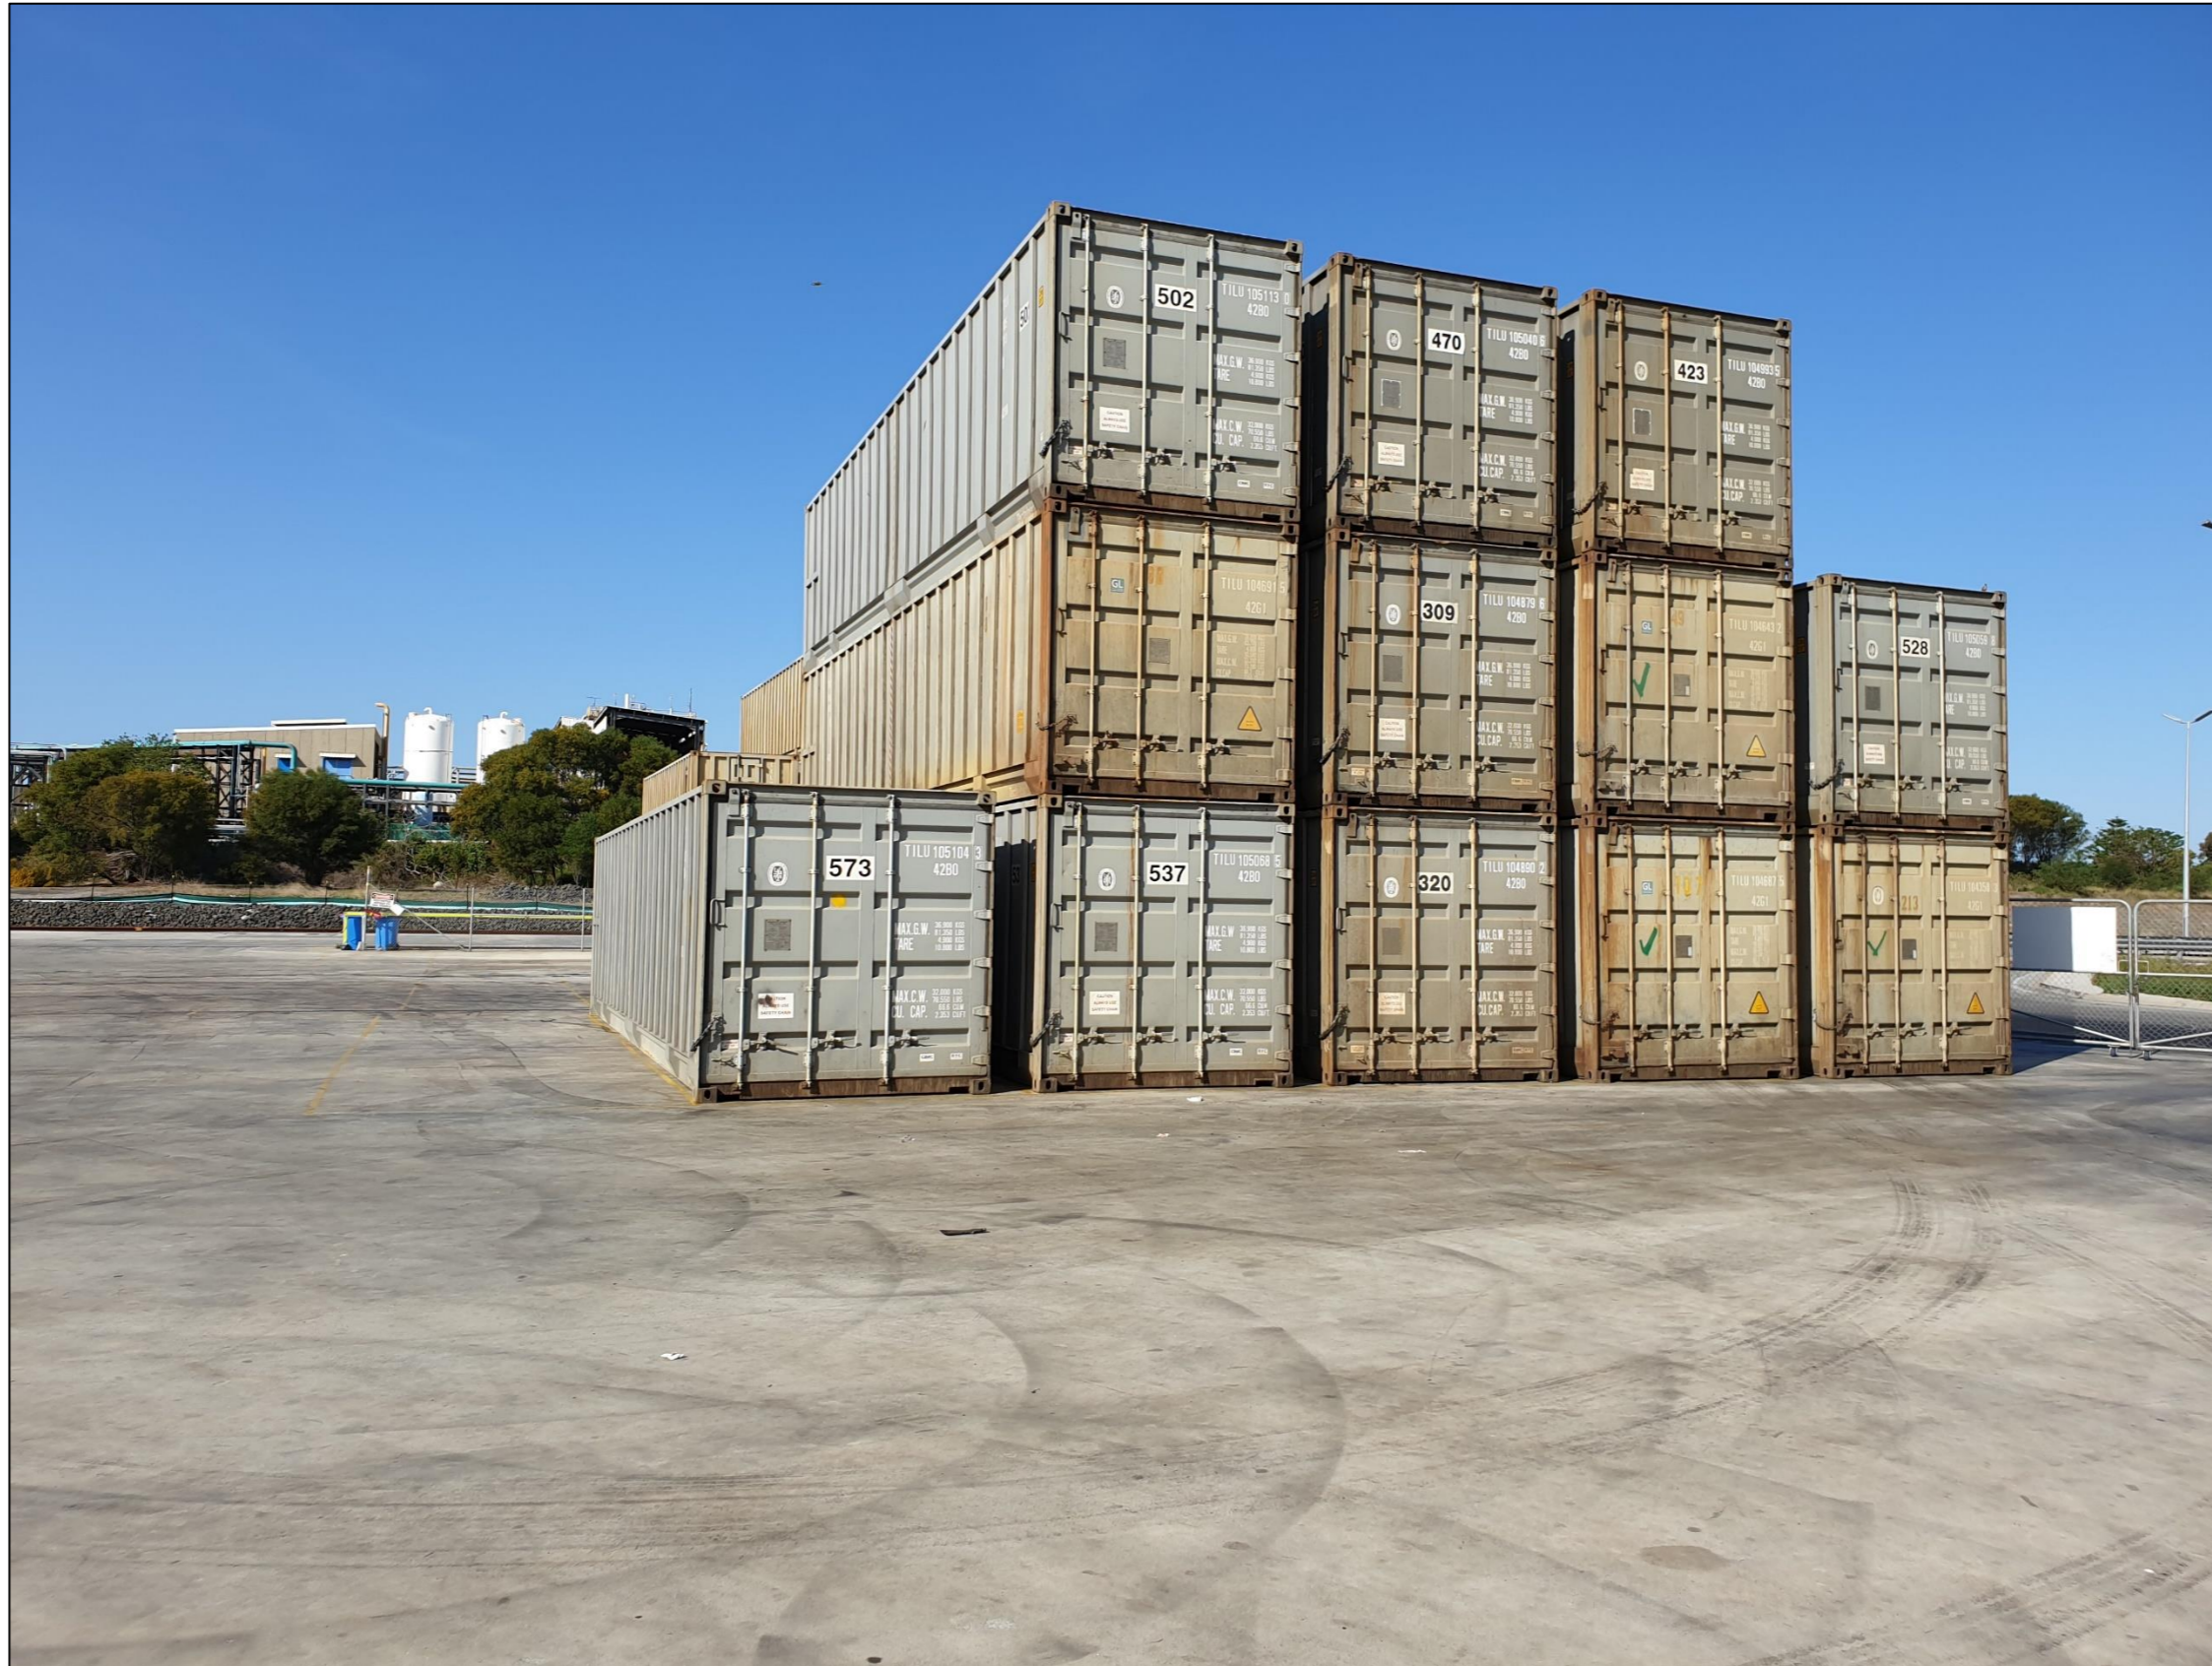
Photo 4 – A picture of the BTT Facility concrete pad facing north-east on 2 October 2019 at 1507 hrs

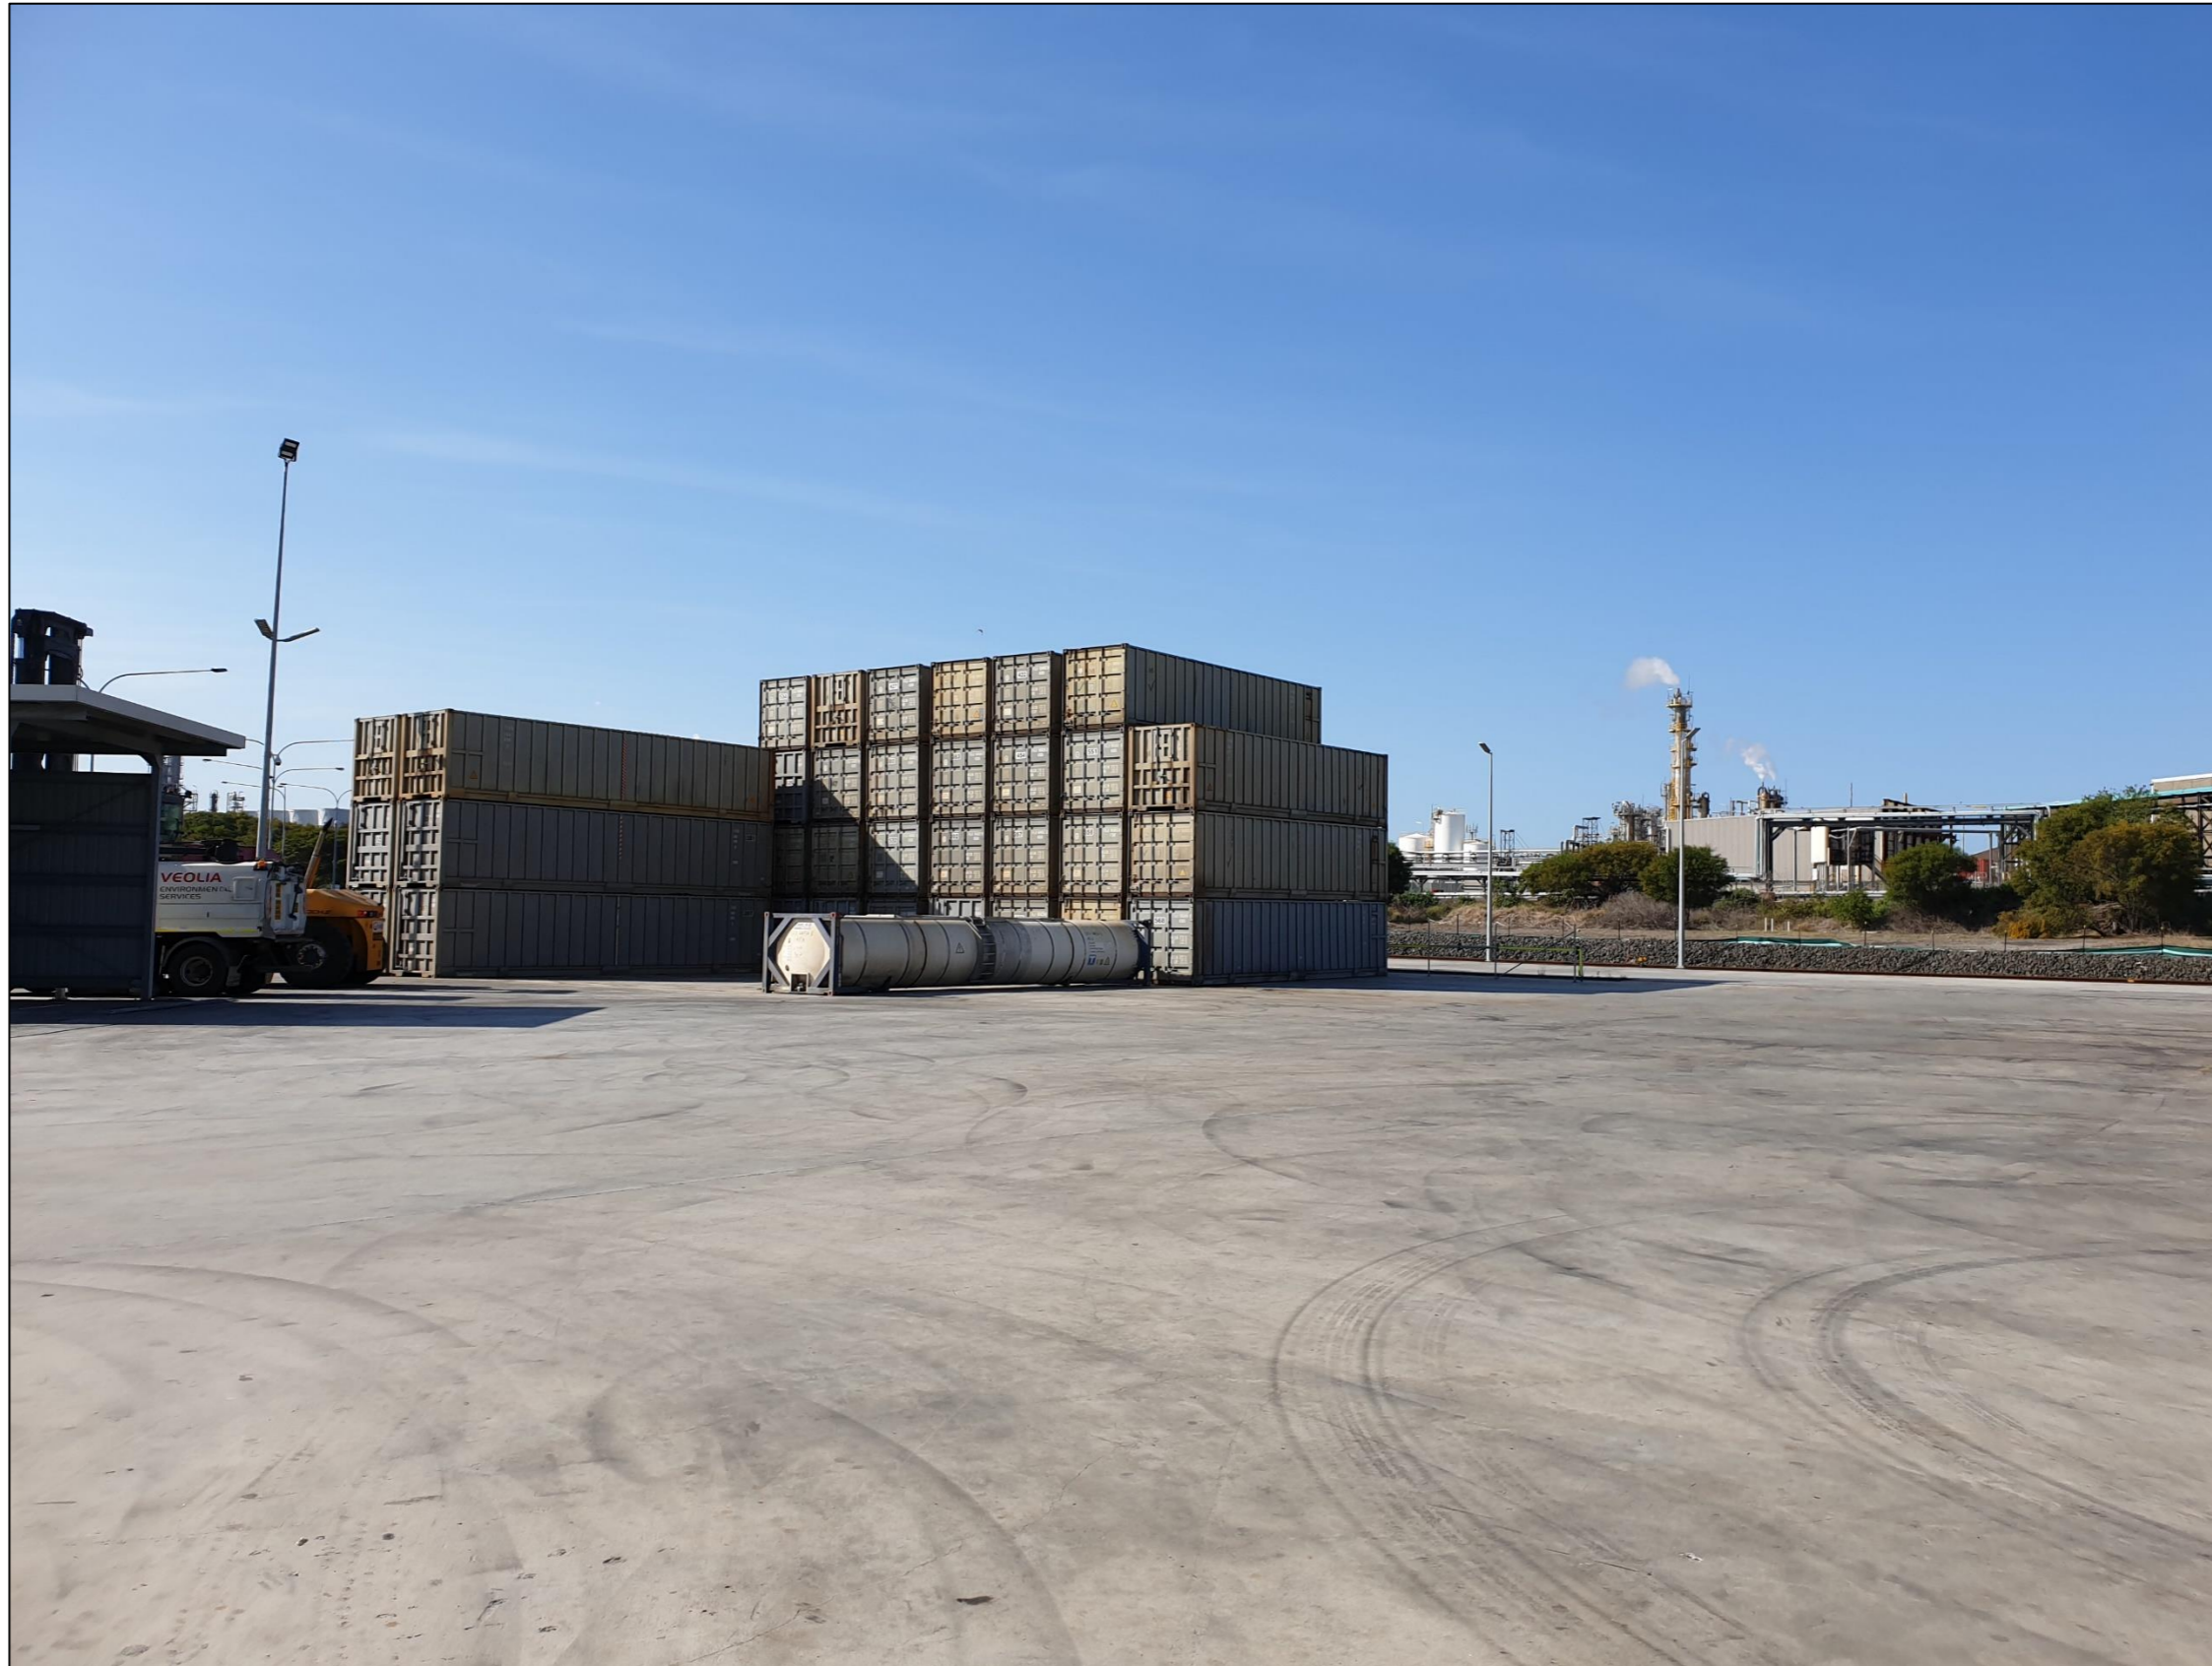
Photo 5 – A picture of the BTT Facility concrete pad facing north-east on 2 October 2019 at 1507 hrs

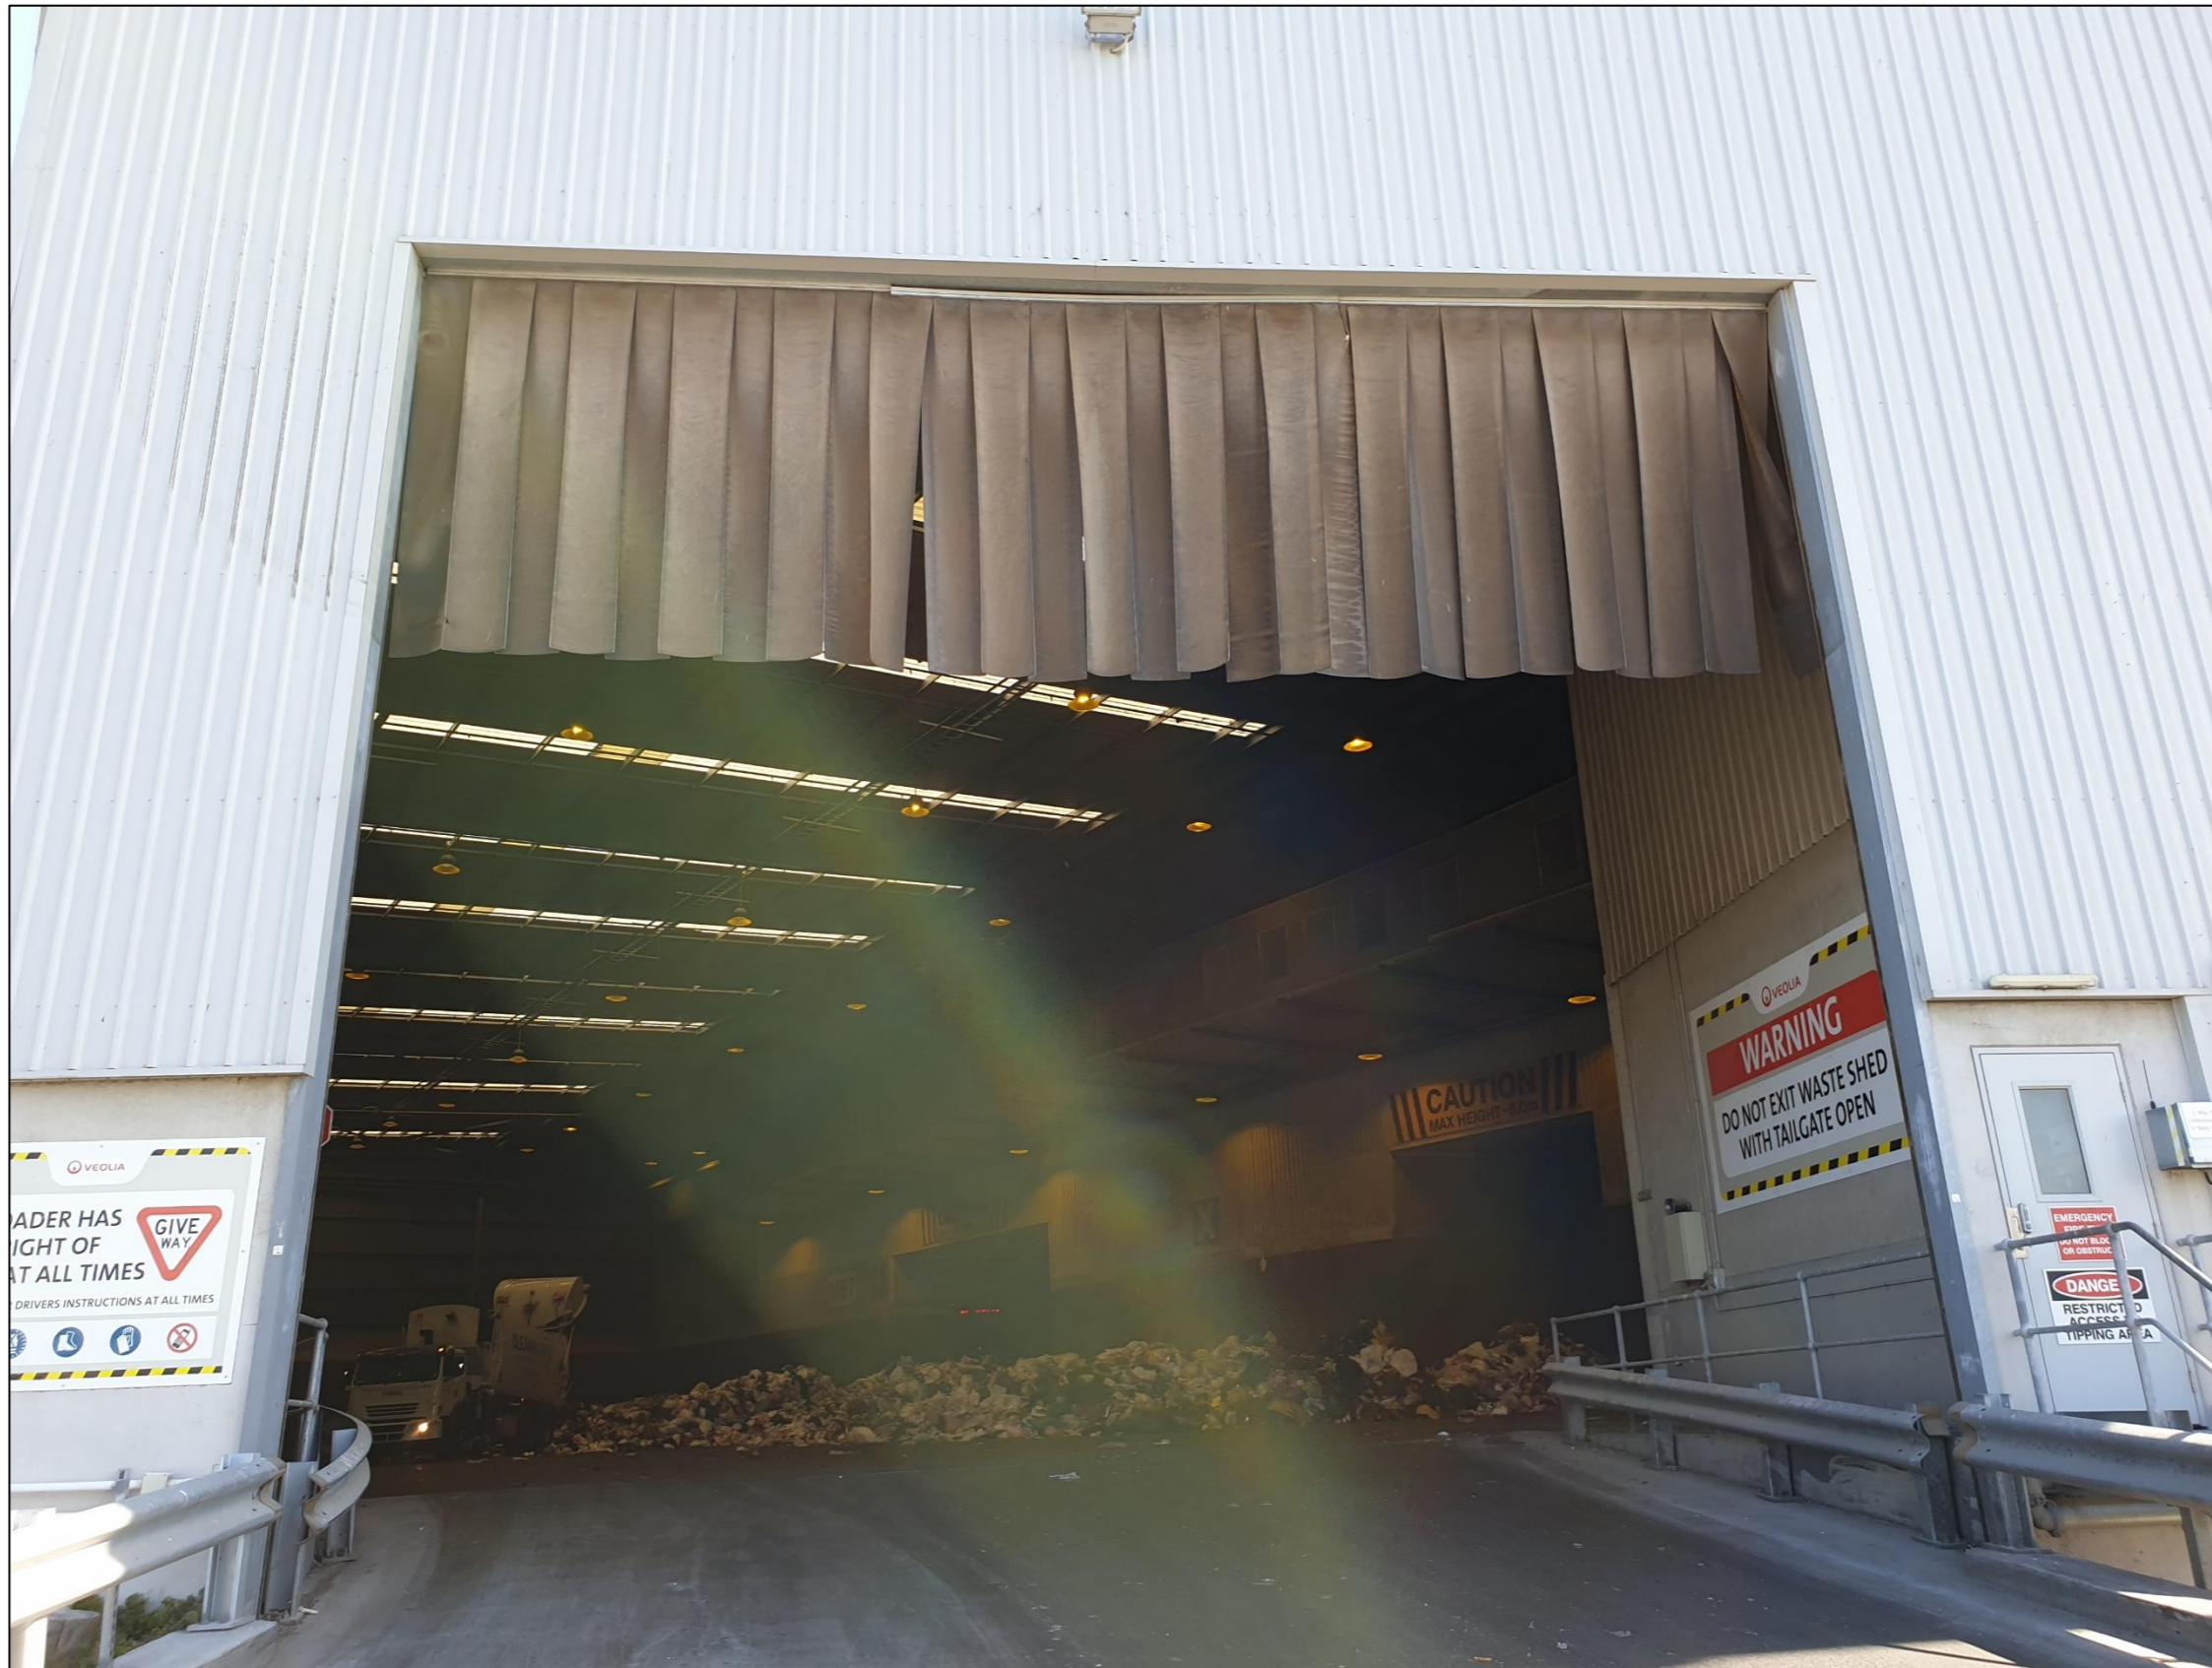
Photo 6 – A picture of the BTT Facility truck entry point as found on 2 October 2019. Note: The truck entrance plastics strips were found to be in good condition
