# Brandy Hill Quarry Annual Review – SSD 5899

9 July 2024 to 31 December 2024

| Document Title | Environmental Management Annual Review – Brandy Hill Quarry | | | |

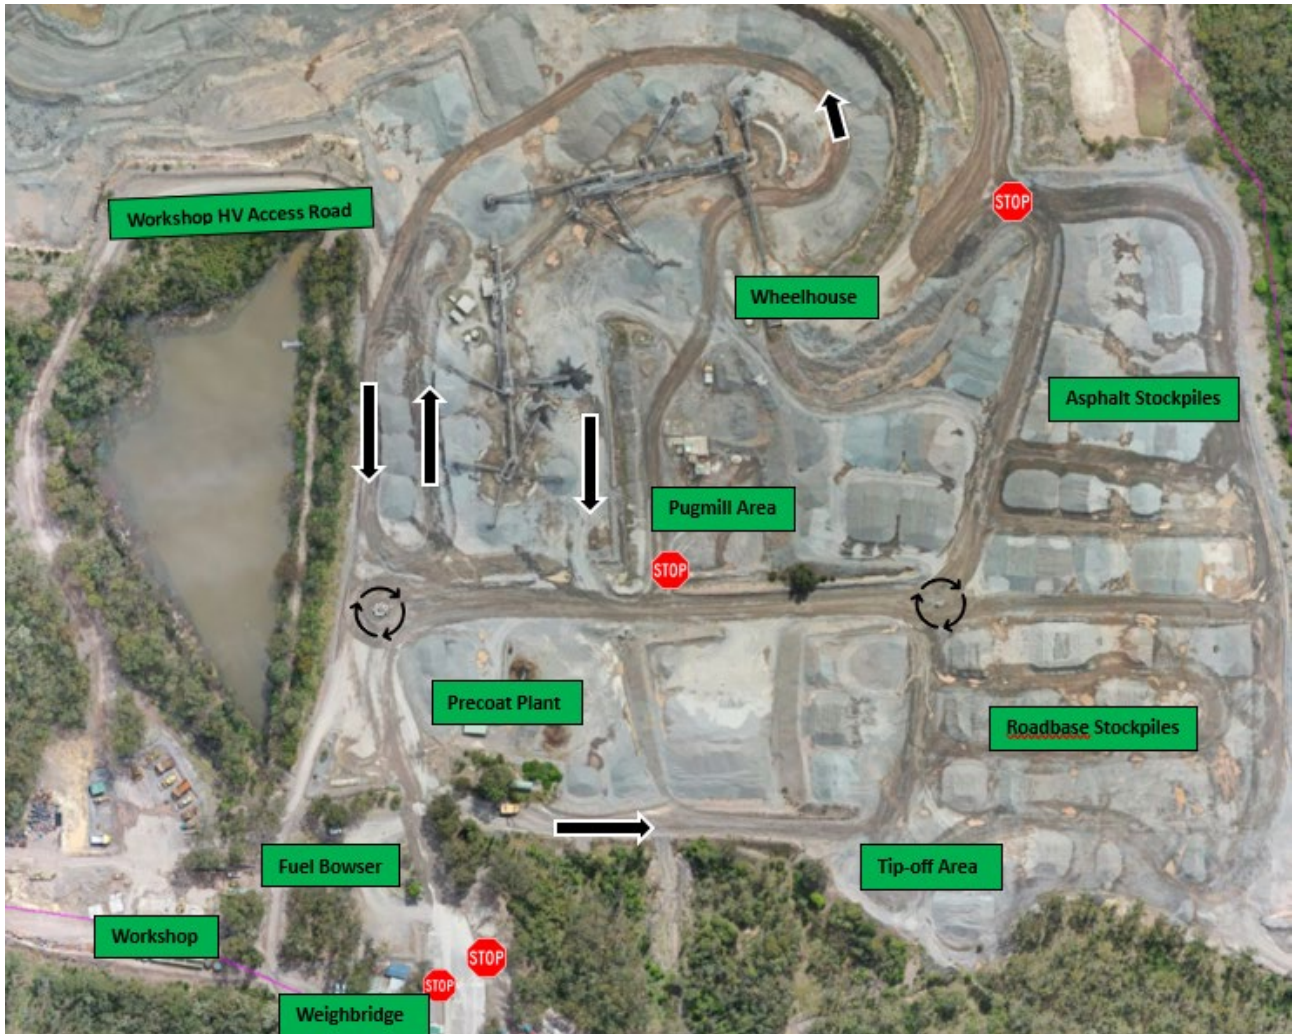
**Figure 2 : Construction Operations Locations**

Processing operations required the fixed processing plant and pre-coat plant during the reporting period (see **Figure 2**).

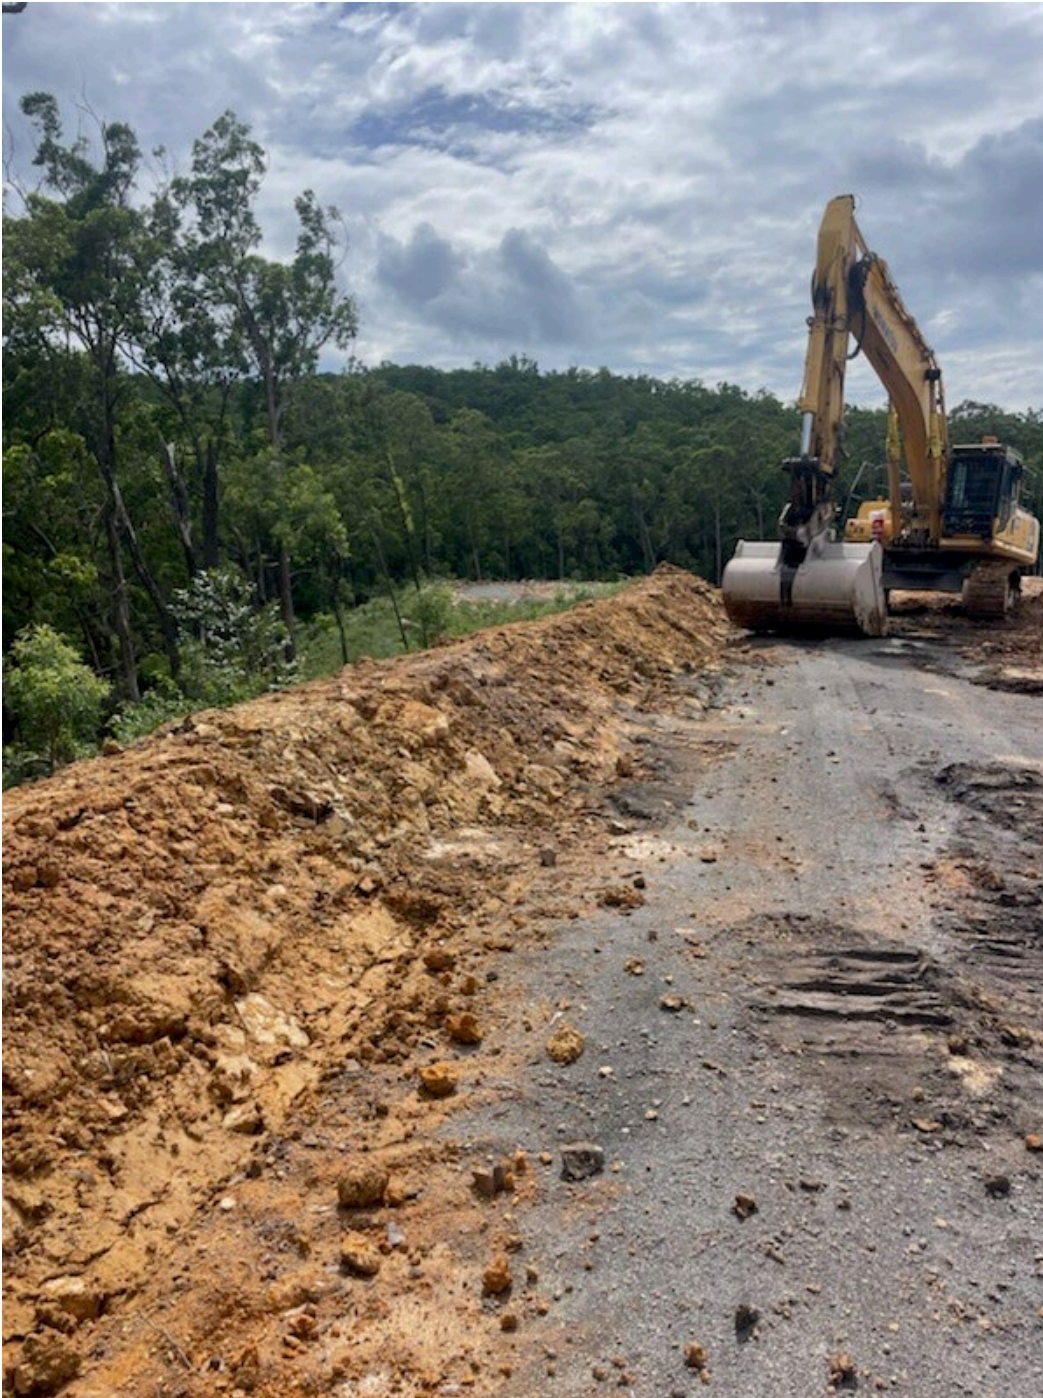
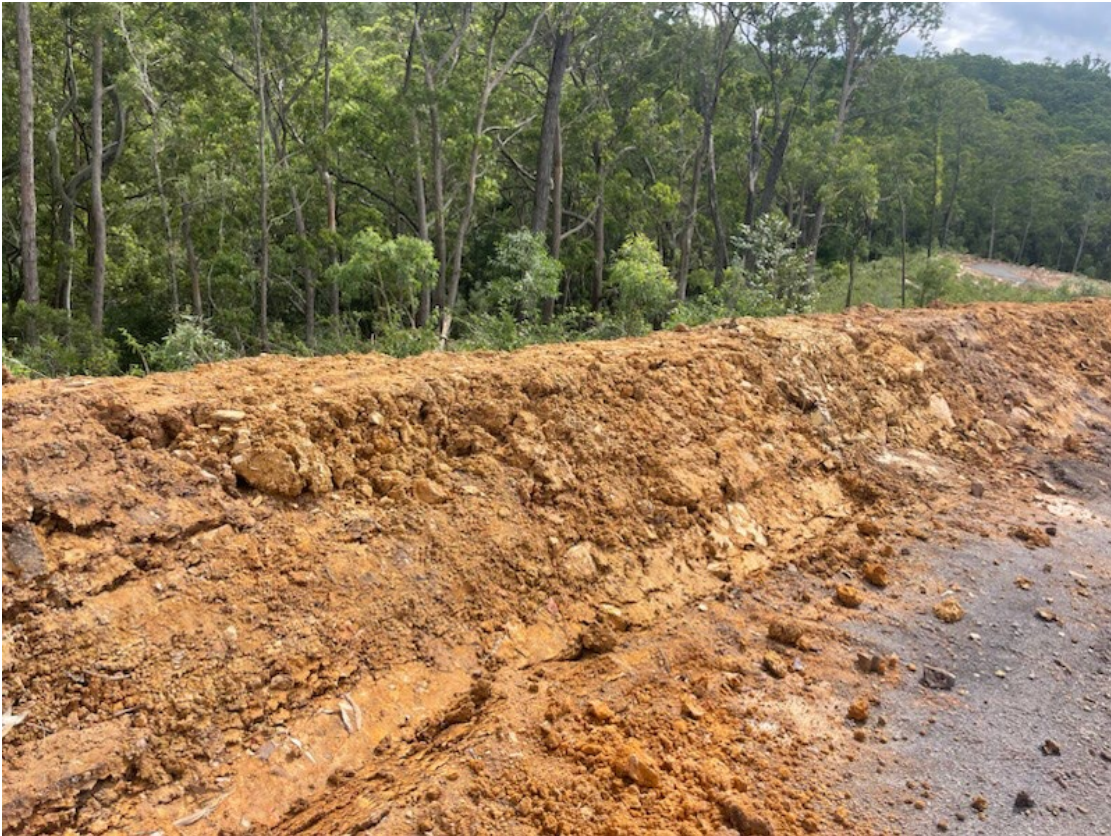
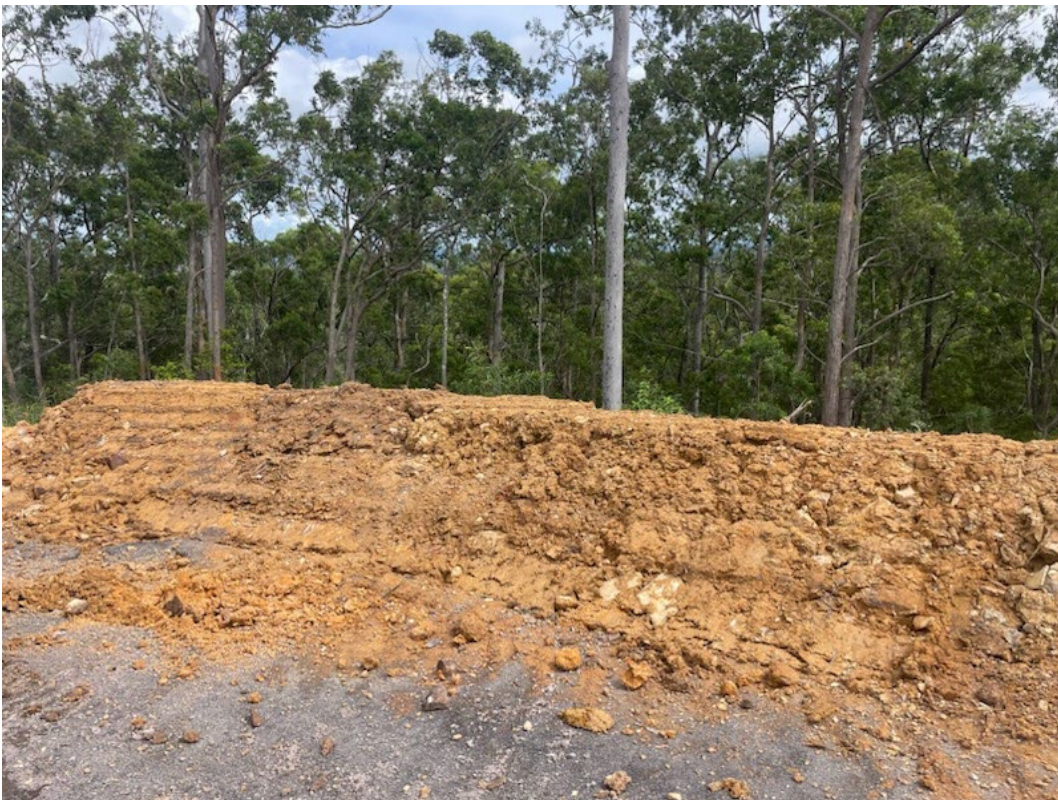
Clean Water Division Bund – Southern Side of Stage 1.

- Water Management Plan, Condition B39 of *SSD 5899*  
The installation of clean water diversion bunds and drains were required in the stage 1 expansion area. Bunding has now been installed along the northern perimeter of the extraction area to efficiently redirect clean water away from Stage 1. Additionally, a drainage system has been established within Stage 1 to direct water towards the lowest point, allowing for subsequent removal from the area. Please refer to **Appendix 2** for photographic evidence of the completed clean water diversion bunds.
- Liquid Storage, Condition B62 of *SSD 5899*
