**SITE SPECIFIC REMEDIAL ACTION PLAN  
FOR THE HAYMARKET PLANNING  
APPLICATION,**

**HAYMARKET, SYDNEY NSW**

Report Date: 18 December 2013  
Project Ref: ENAURHOD04498AA

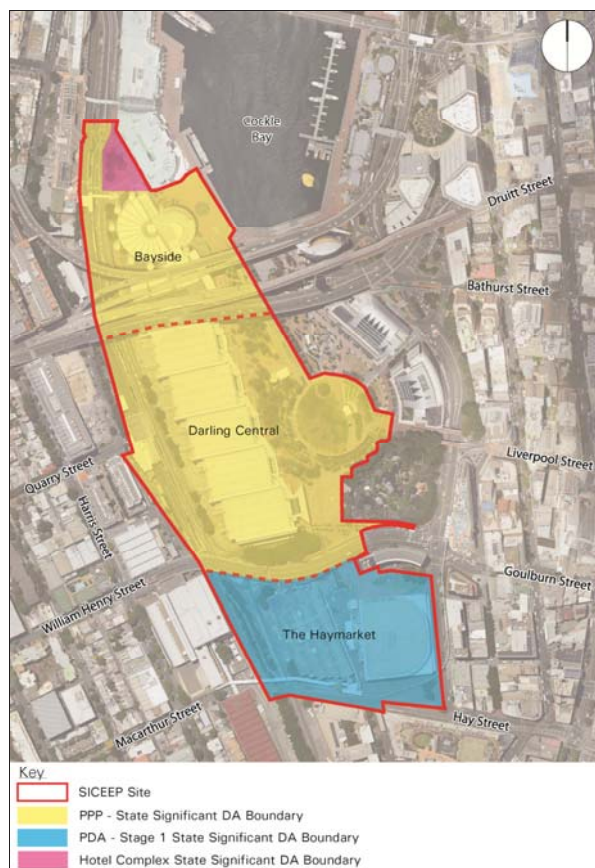
**Figure 1.1: Overview illustrating the location of The Haymarket relative to other areas within SICEEP**

The SICEEP Site has been divided into three distinct redevelopment areas – Bayside, Darling Central and The Haymarket. This document relates to The Haymarket as shown in the figure below.

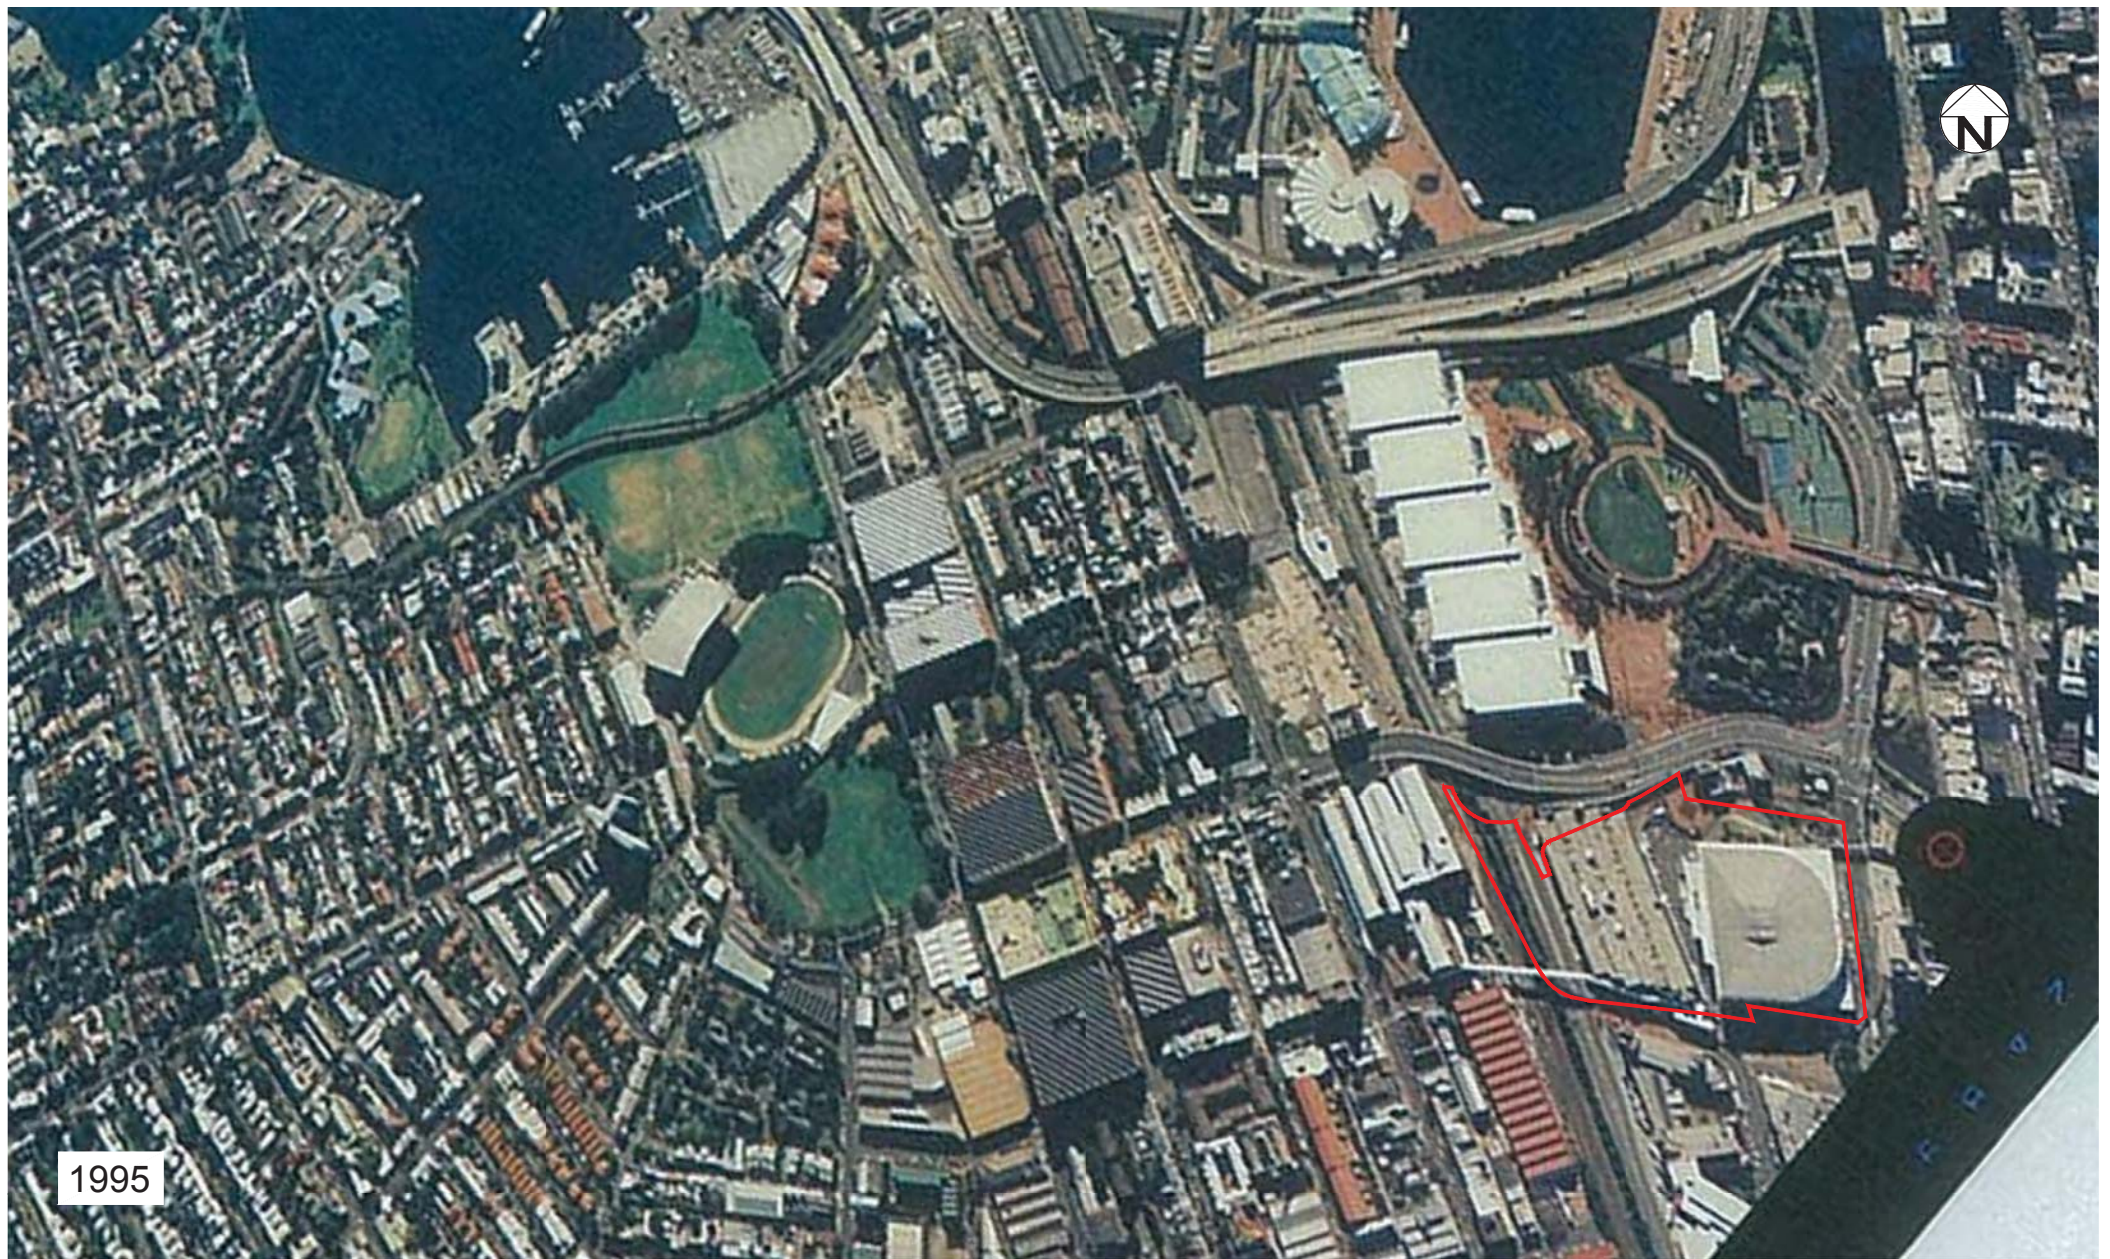
| | | | | | | scale | NTS | | title: 1995 AERIAL PHOTOGRAPH | |

| Period | Description of Land Uses |
|---|---|
| 1990s | <p>Aerial photograph (Figure 11) indicates that no significant change to site features is noted.</p> <p>The Market City building and University of Technology campus were constructed to the south of the site beyond Hay Street. The Novotel Rockford Hotel is established to the northeast of the site in 1999. The hydraulic pumping station (the 'Pumphouse') structure remains and has been converted to a restaurant and bar.</p> <p>The Powerhouse Museum is established in the former Ultimo Power Station structure. The monorail is visible to the south of the SEC and car park.</p> |
