Response to Submissions – SSD 6078

Oakdale Central – Horsley Park

Vegetation Management Plan

Oakdale Central VMP - Addendum

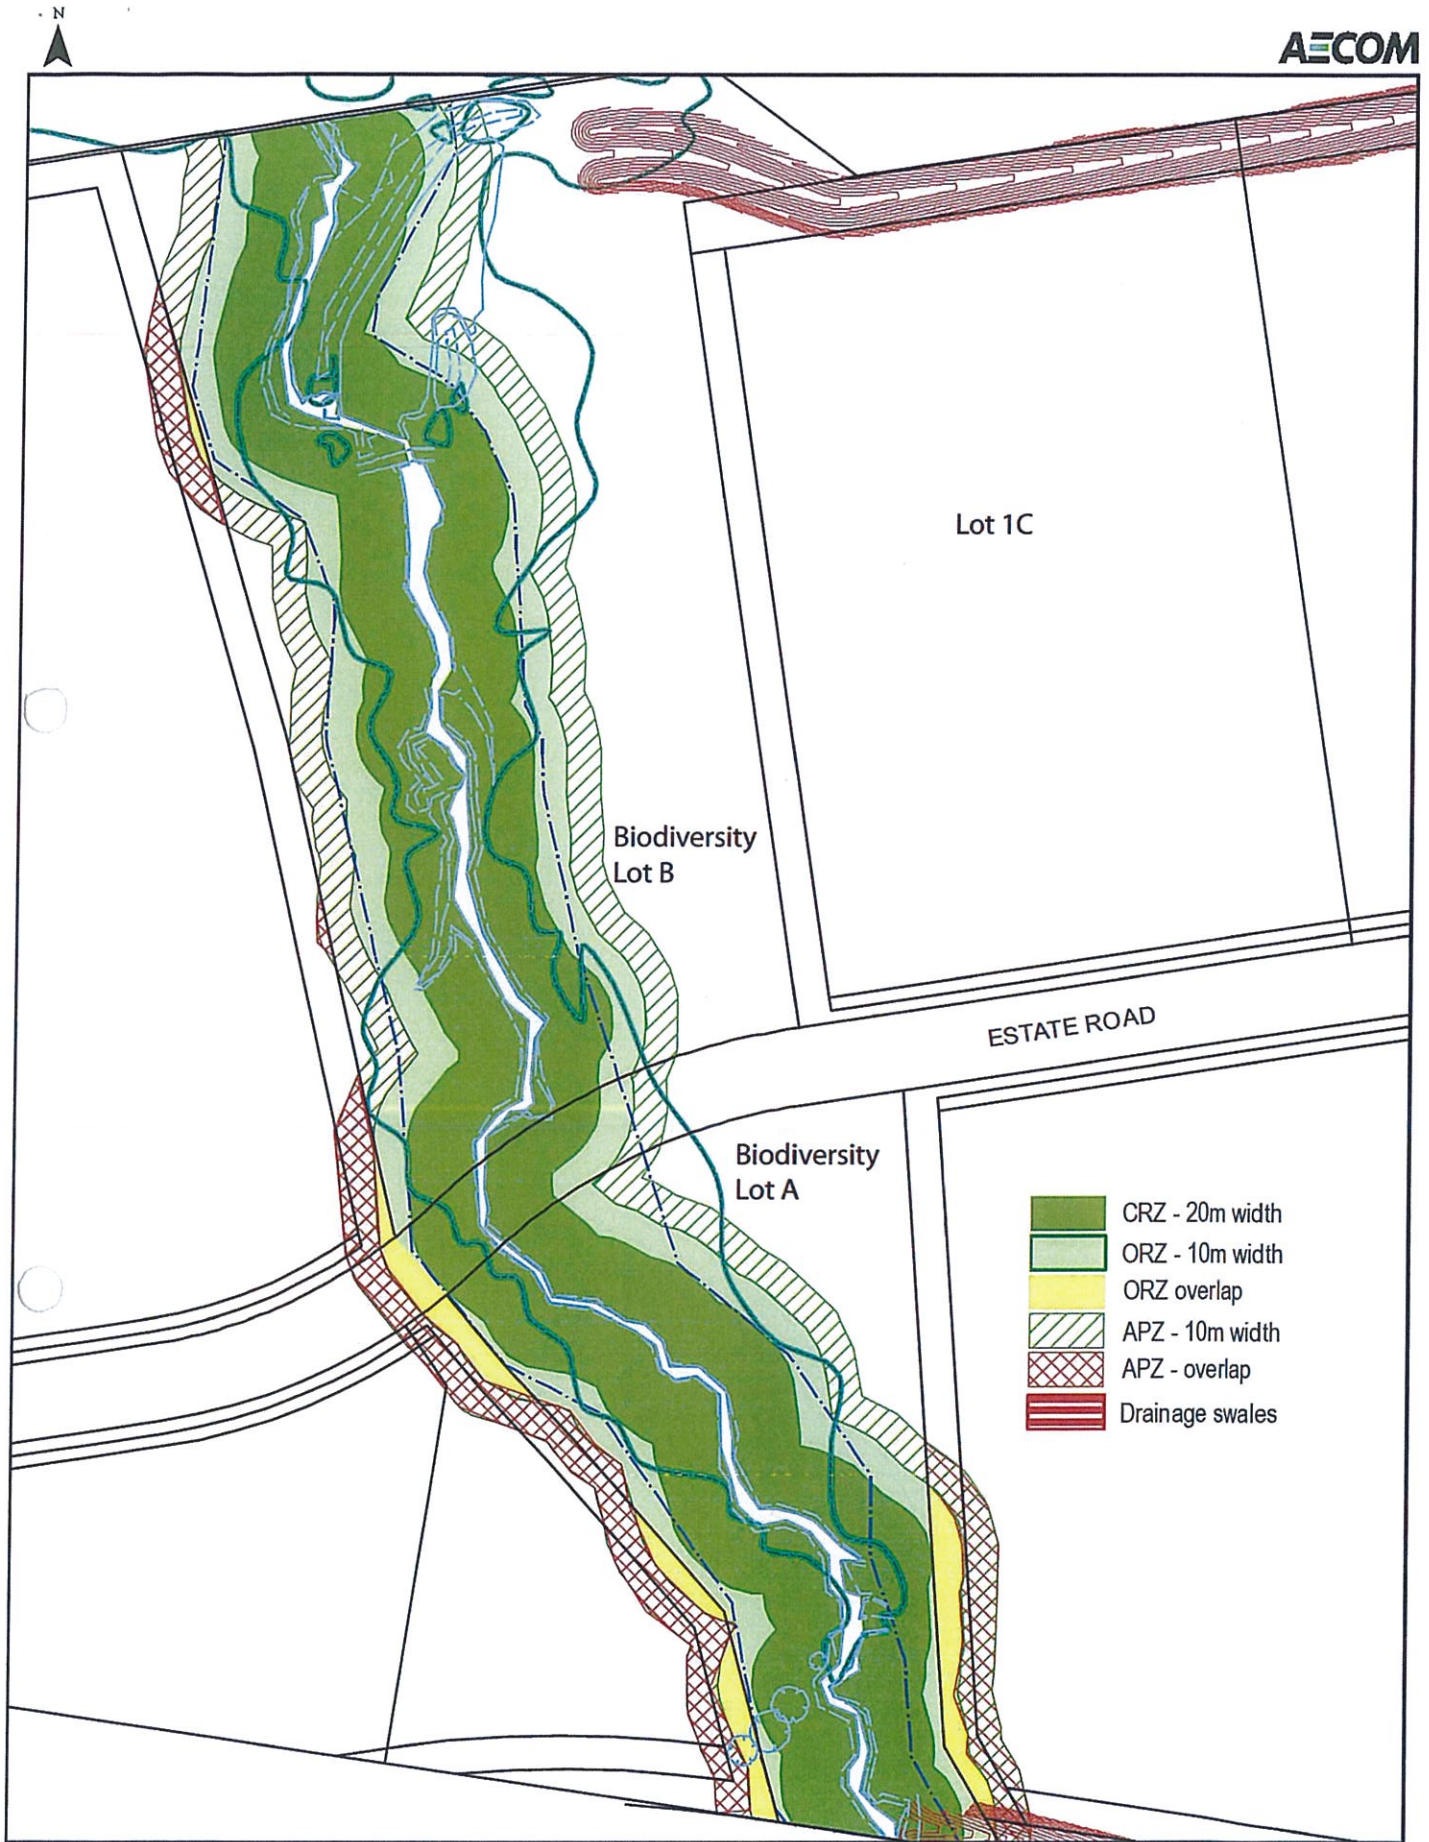
VMP Excerpt - Figure 2.2 (modified²)

OAKDALE CENTRAL VEGETATION MANAGEMENT PLAN
Tributary Riparian Zones

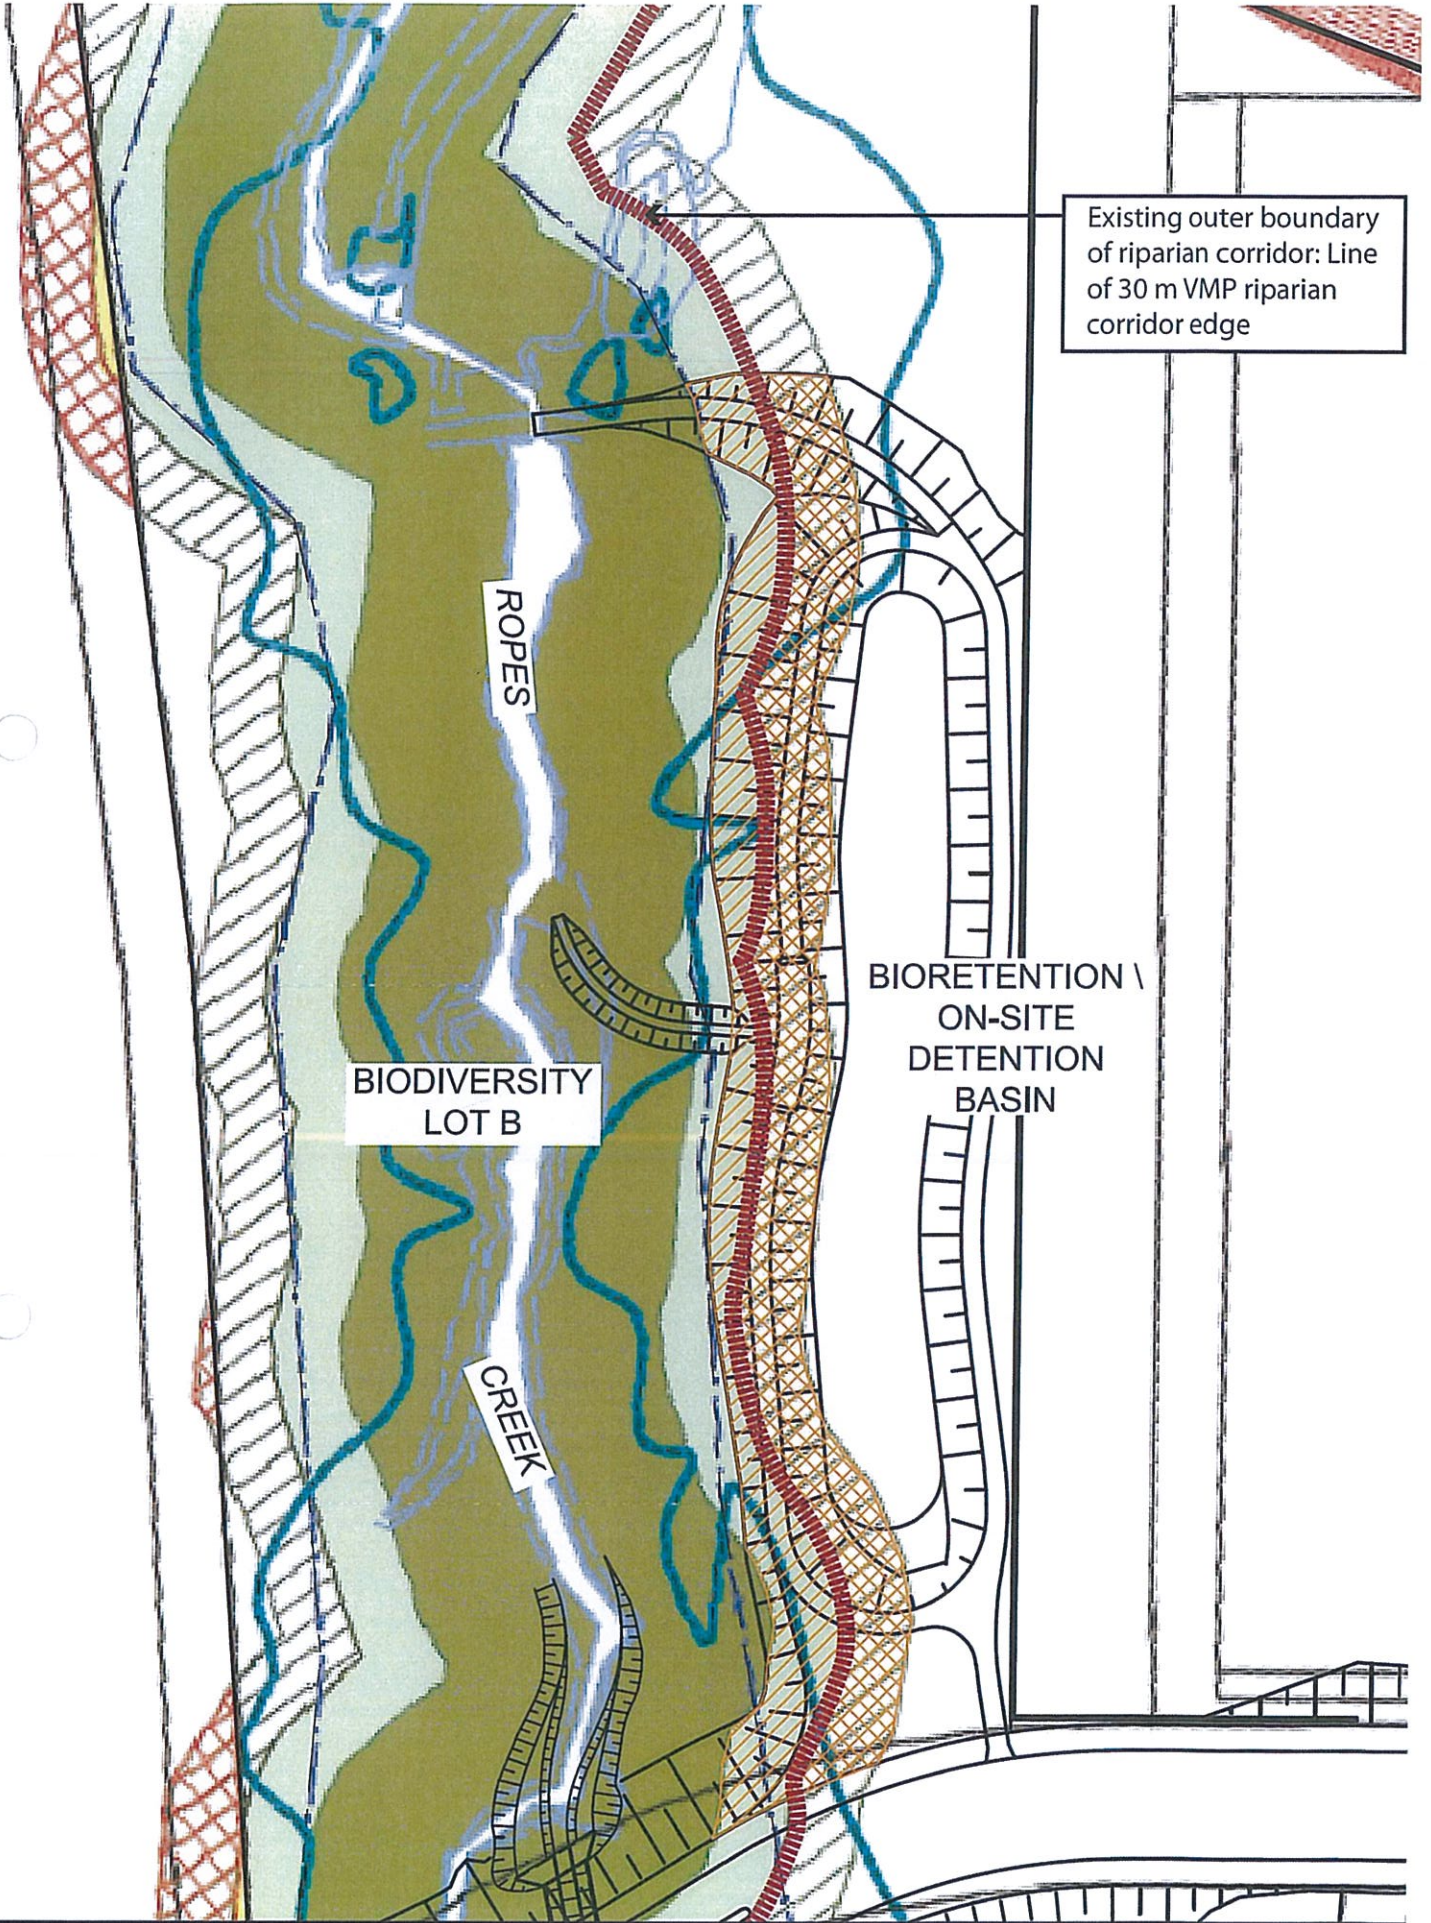
Drawing No. SKC118 - Detail

Existing outer boundary of riparian corridor: Line of 30 m VMP riparian corridor edge

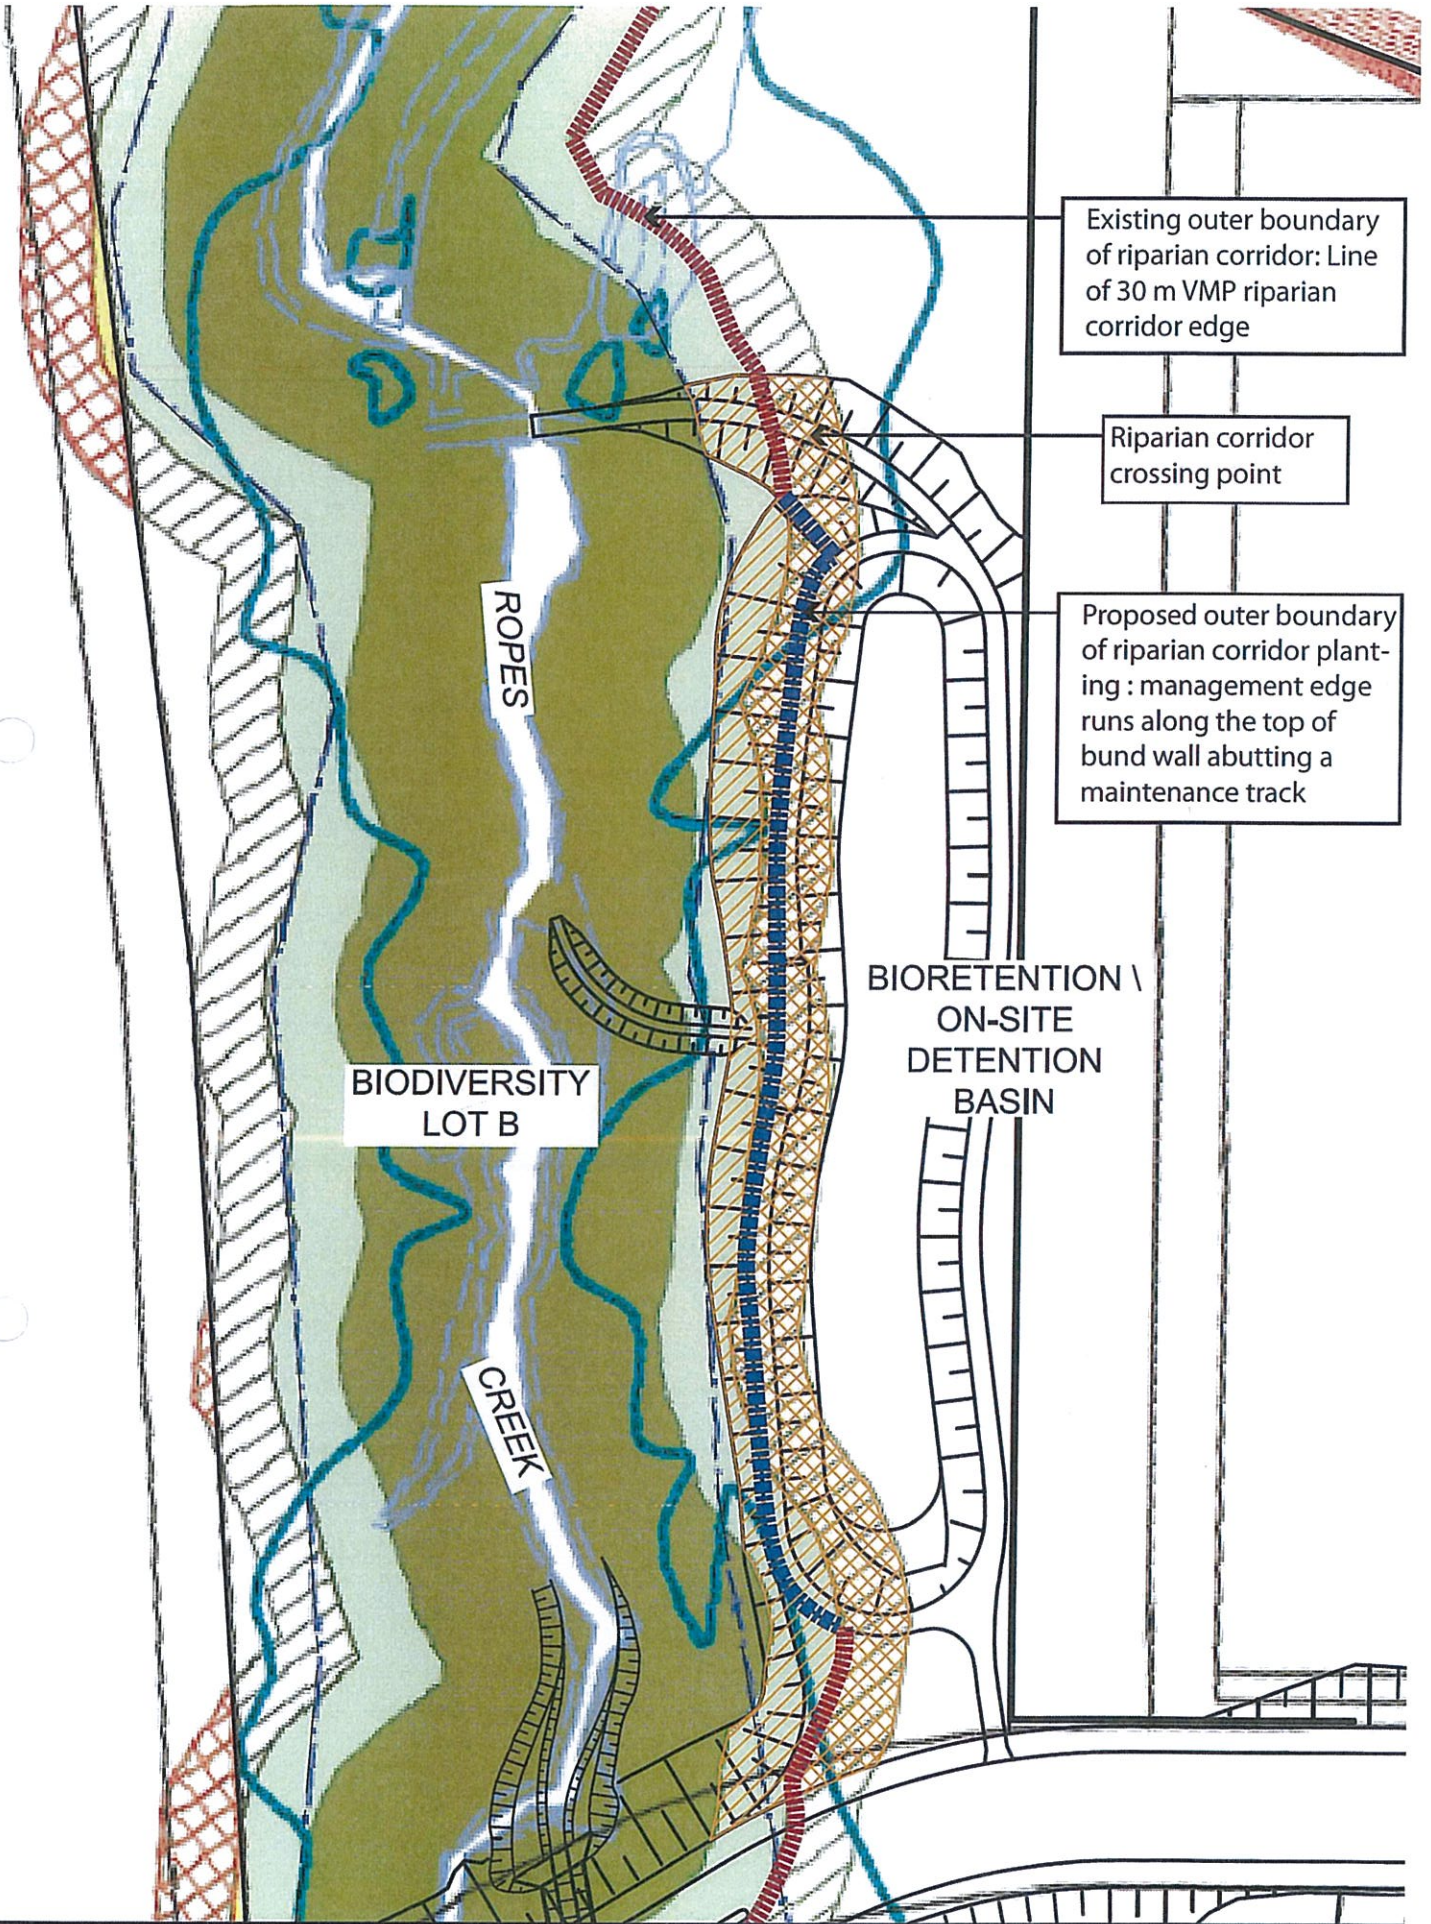
Drawing No. Sketch 01

Existing outer boundary of riparian corridor: Line of 30 m VMP riparian corridor edge

Riparian corridor crossing point

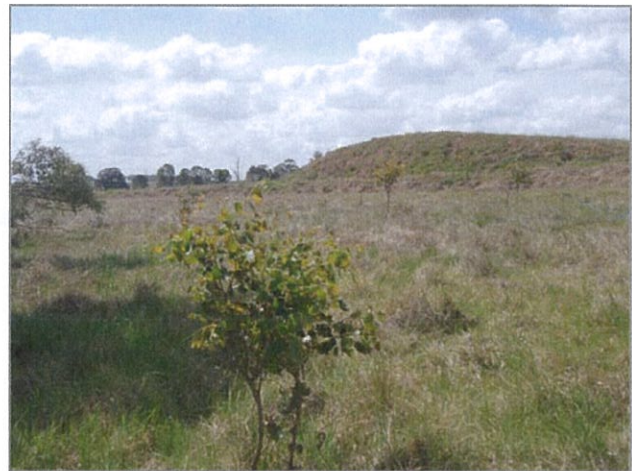
Above: regenerating Eucalypts adjacent tributary to the east

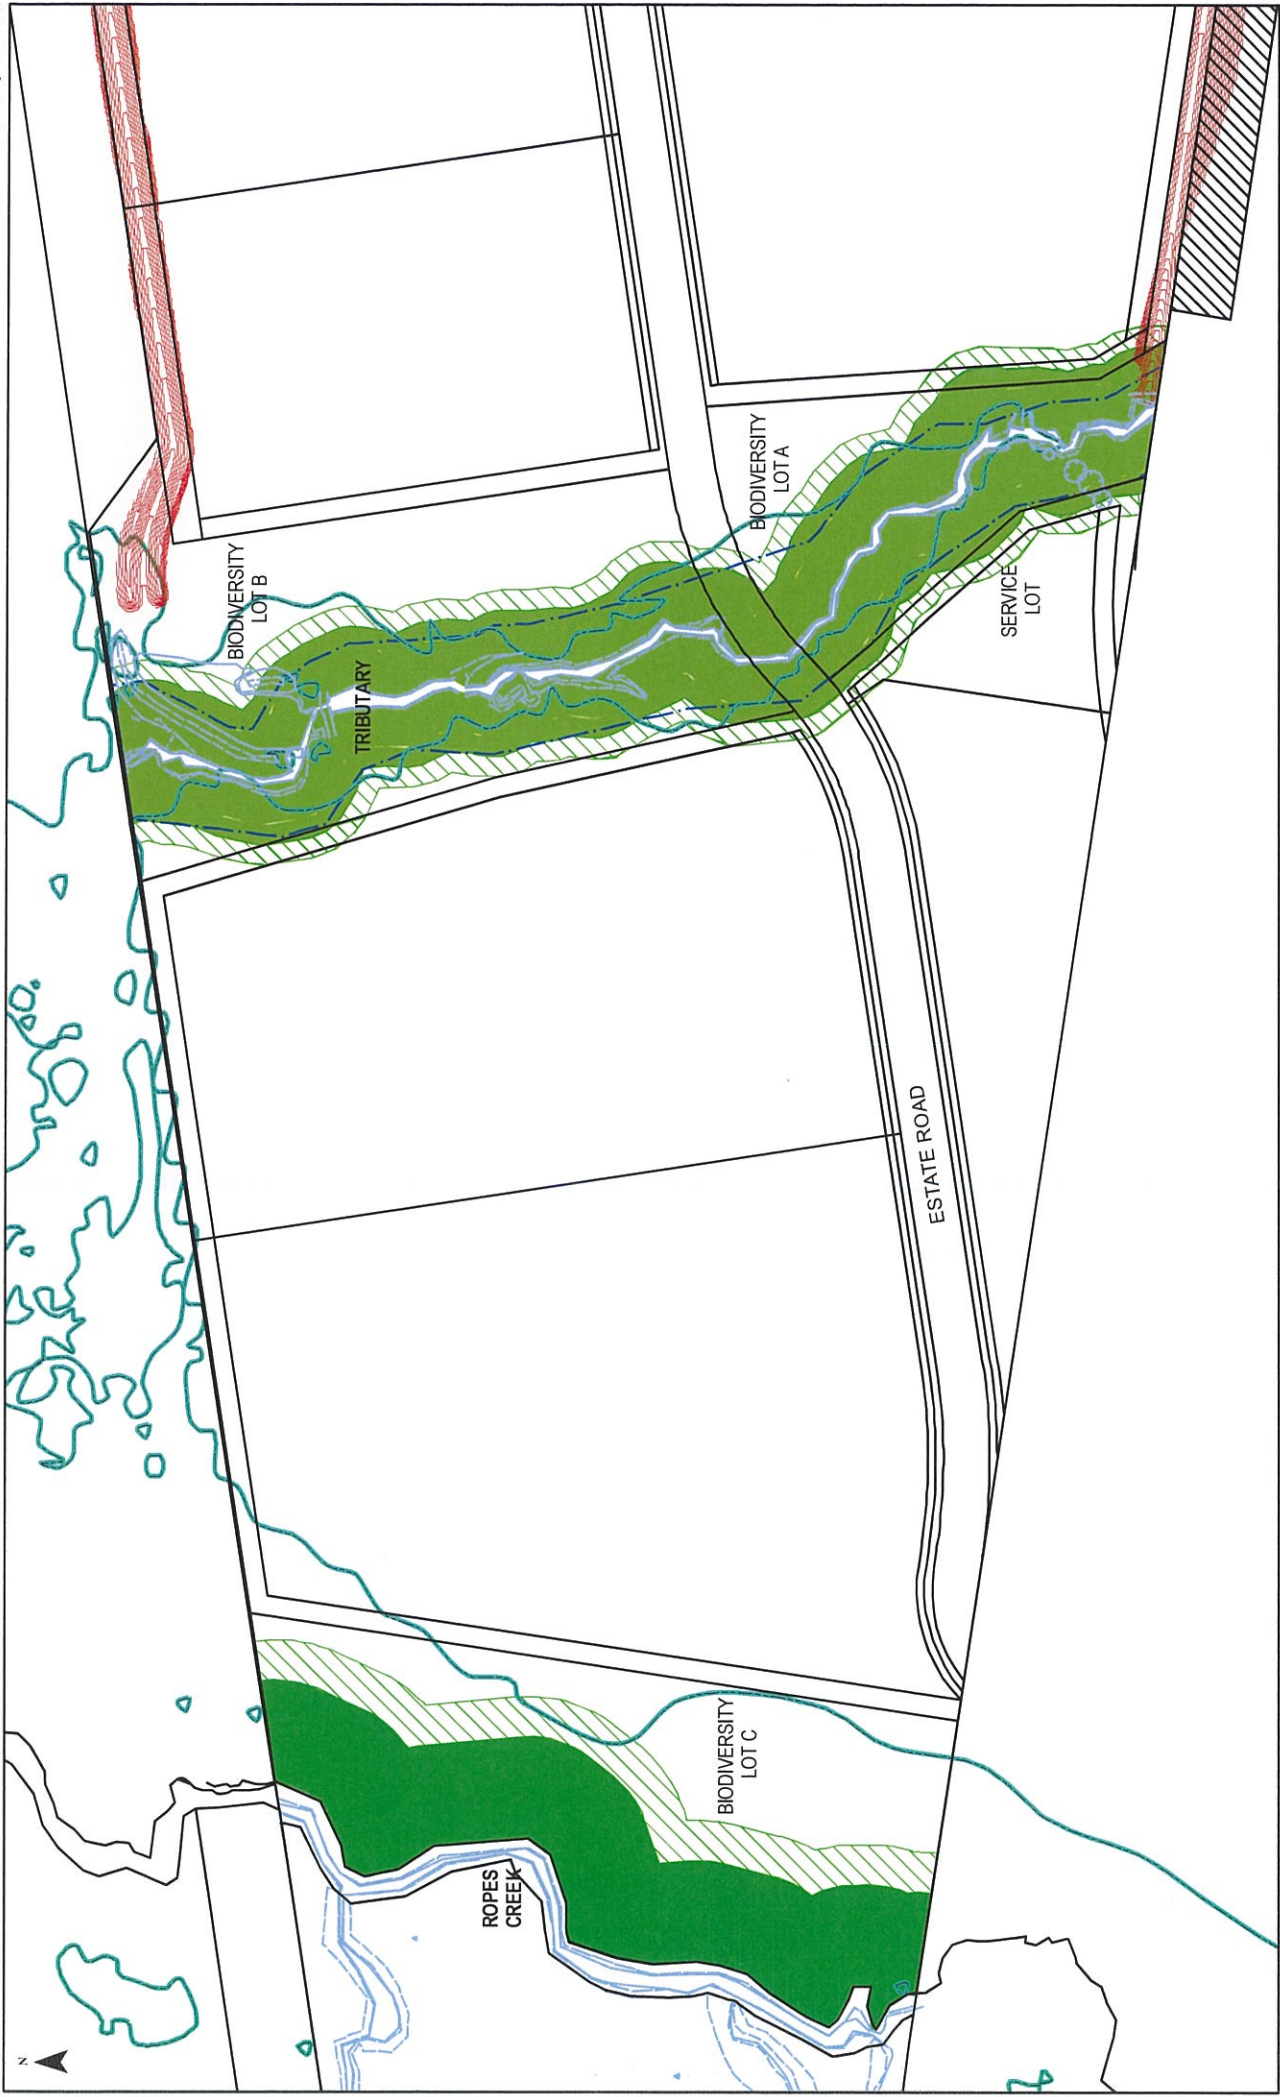
- Core Riparian Zone
- APZ - 10m width
- Drainage swales
- Flood_extent

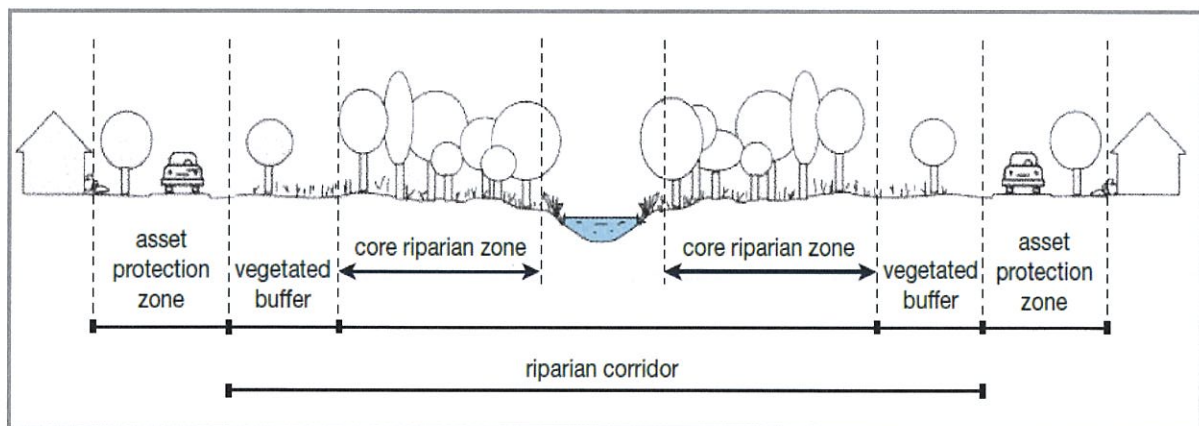
Figure 2-1. Riparian zonation schematic sourced from Riparian Corridor Guidelines (NOW 2011)

The NSW Office of Water (NOW) requires that the following three zones be designed for within the VMP as illustrated in Figure 2-1 and summarised below:

1. The core riparian zone (CRZ) which should be retained, or revegetated with fully structured native vegetation (including groundcovers, shrubs and trees),
2. An outer riparian zone (ORZ) shown as a vegetated buffer in Figure 2-1 which protects the environmental integrity of the CRZ and should be wide enough to protect the CRZ from weed invasion, micro-climate changes, litter, trampling and pollution (usually 10 metres is recommended), and
3. An asset protection zone (APZ) as a requirement of the NSW Rural Fire Service for the protection of assets (houses, buildings, etc.) from potential bushfire damage.

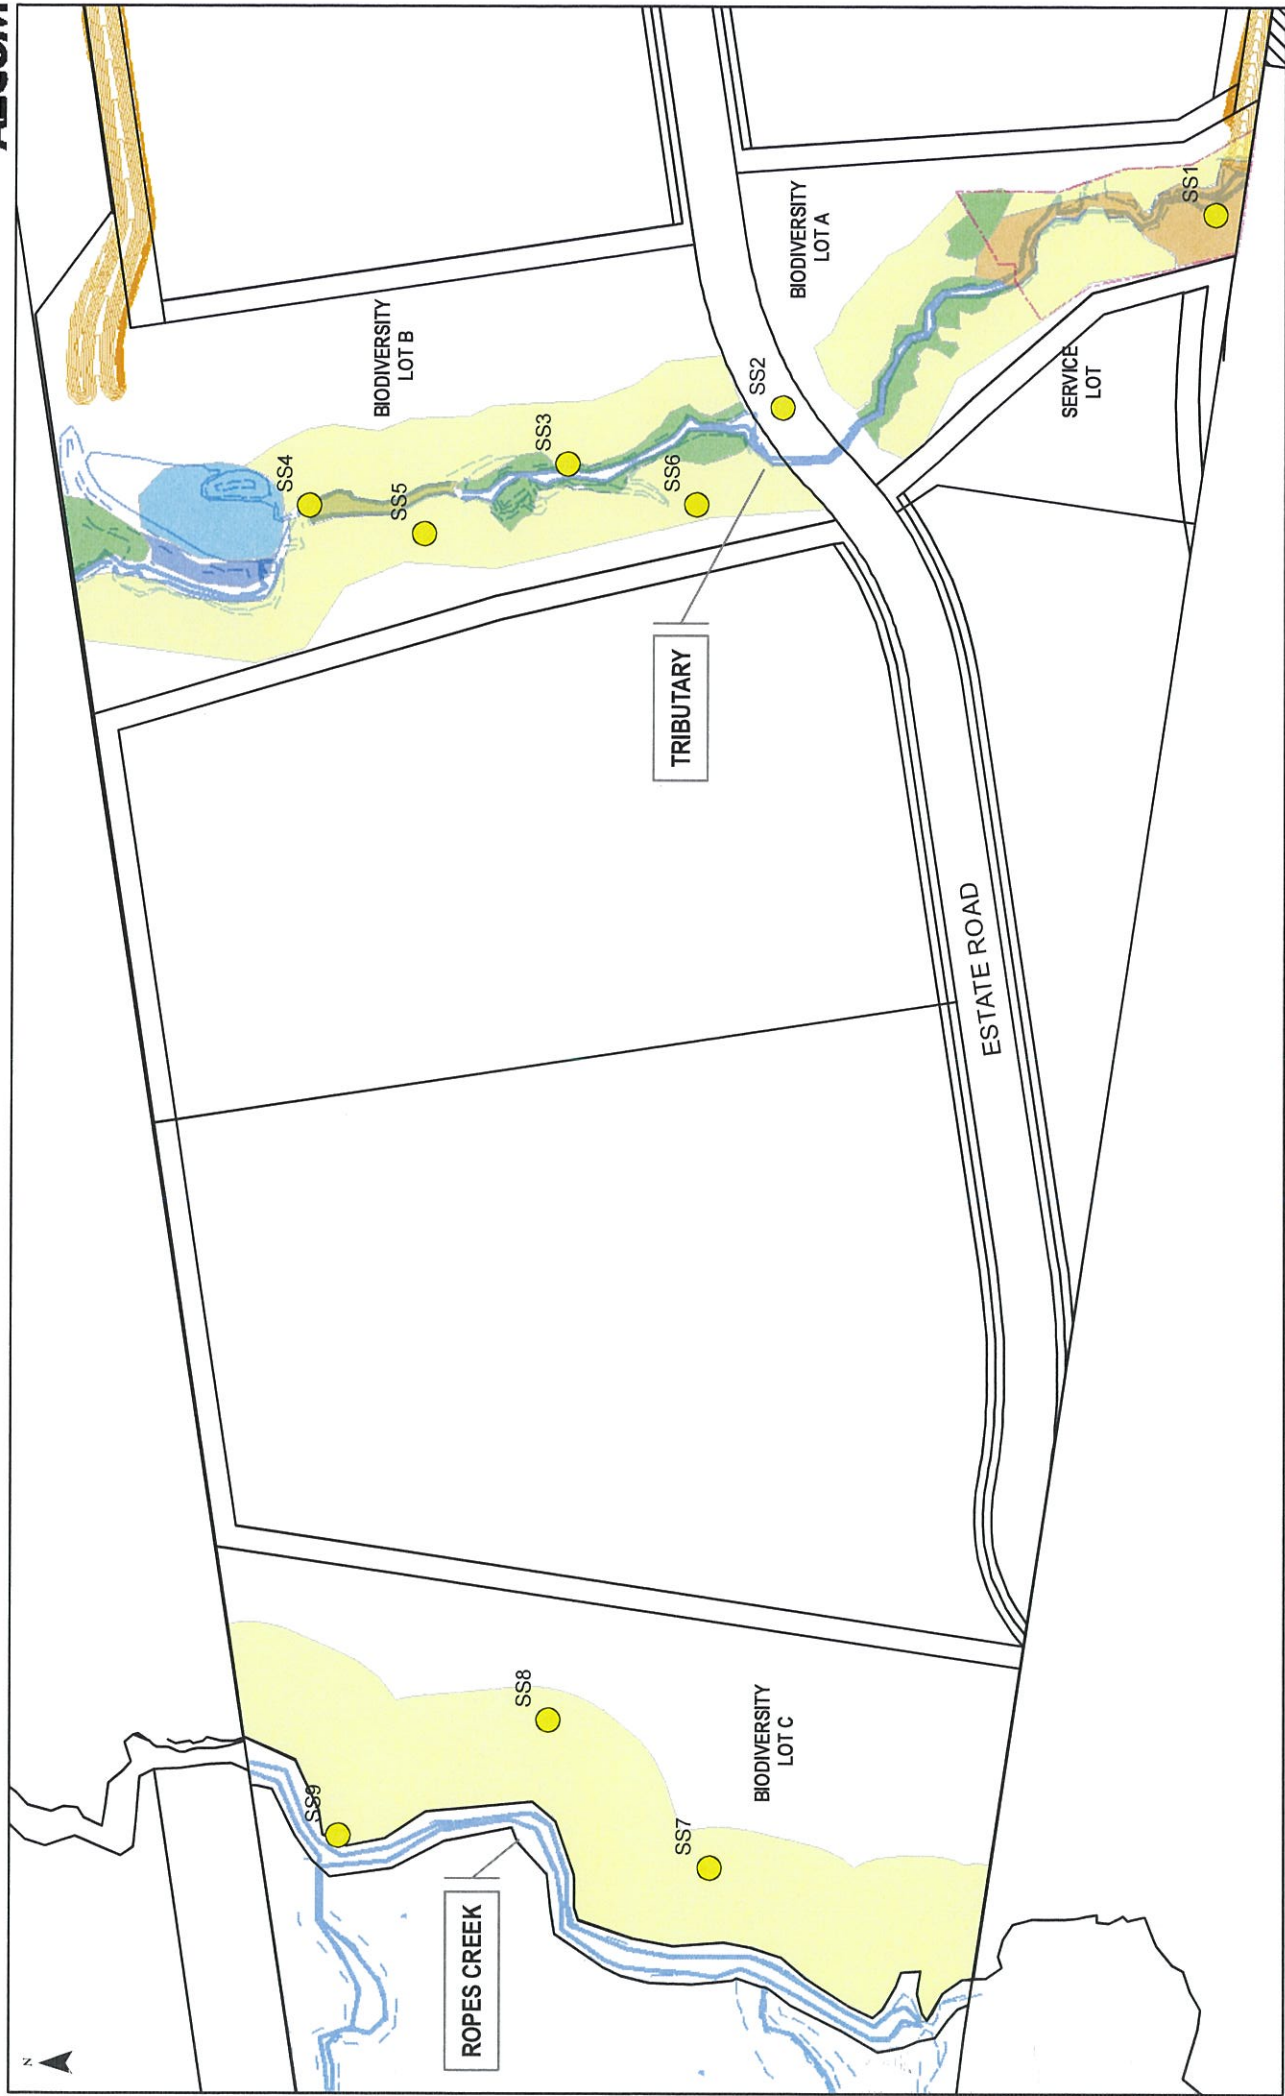
OAKDALE CENTRAL VEGETATION MANAGEMENT PLAN
Riparian Management Zones

The varying landscape settings, structural and floristic associations of the remnant native vegetation and degraded areas supporting naturalised plant associations at the subject site were classified into four zones for management purposes, as follows:

Table 2-2. Restoration Approach Summary Table

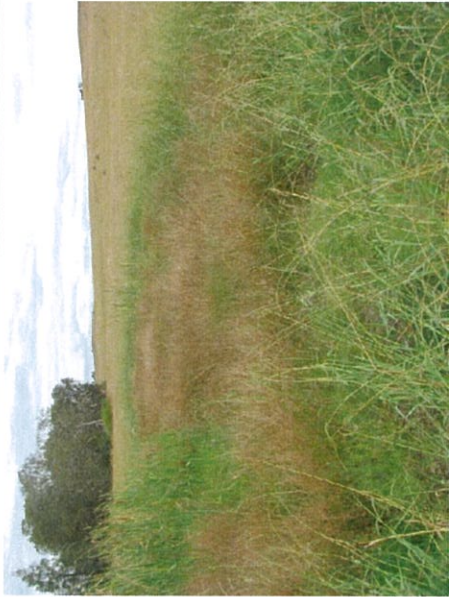
Creekline areas dominated by exotic sedge species in particular <i>Juncus acutus</i> .	All creekline channel areas dominated by exotic wetland plant species and therefore not included within zone 1 or 2 areas described above.	Despite the main characteristic of this management zone being the dominance of exotic vegetation, <i>Phragmites australis</i> is present amongst the dominating exotic <i>Juncus acutus</i> . Populations of <i>Microlaena stipoides</i> and <i>Imperata cylindrica</i> are present along the outer extent of this zone however their coverage represents < 5% of the total 3b zone area.	As the zone description outlines, <i>Juncus acutus</i> is the dominate naturalised plant species within this zone forming a dense coverage over in excess of 90% of the total zone area. A single mature <i>Pampas Grass</i> is also present within the adjoining road easement at the southern extent of the upper tributary within biodiversity lot A.	Soil tests have identified the area within zone 3b as having high levels of salinity. The high salt levels combined with the density of the <i>Juncus acutus</i> (a prolific seeder), has limited the ability for native vegetation to re-establish and compete.

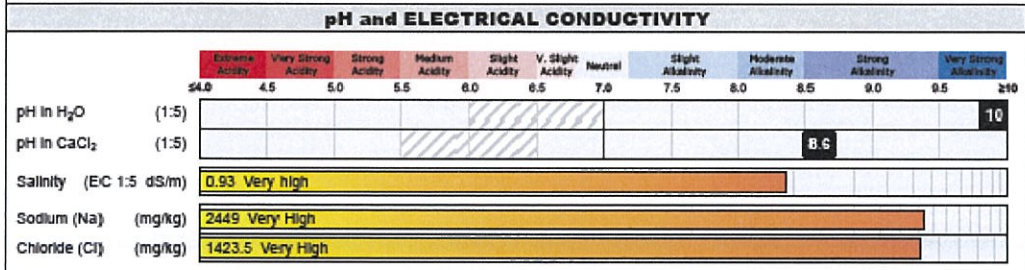
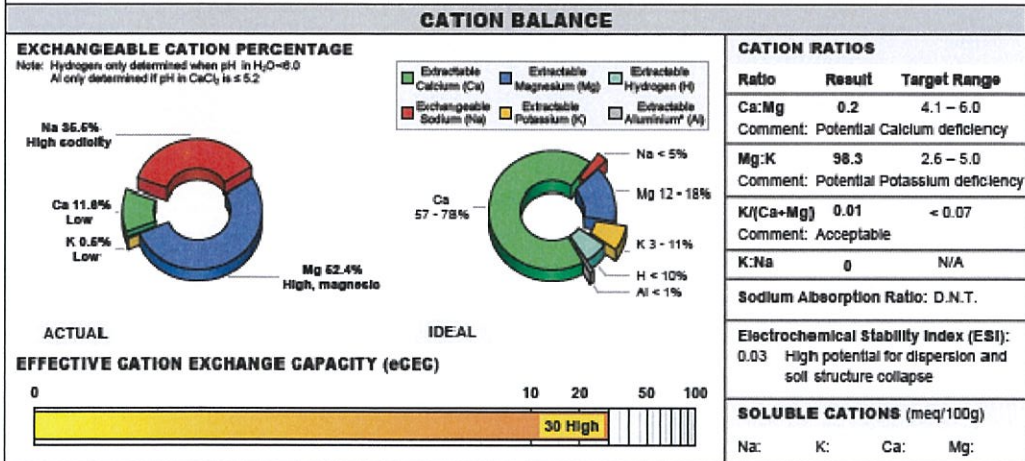
This area has severe alkalinity, salinity and sodicity and will not be suitable for planting, it is suggested to either bury this layer at least 1m deep or remove and replace.

SOIL SAMPLE DEPTH (mm): 100 150 200 FERTILITY RATING: Low Moderate High

- **Soil sample SS1:** Soils are severely alkaline, saline and sodic, and not suitable for planting. Recommendations include:
 - burying this area with appropriate soils to a minimum depth of one metre,

- excavate to a depth of one metre and replace with appropriate soils, or
 - revegetate with salt tolerant plant species.
- **Soil sample SS2:** Soils have a low effective cation exchange capacity indicating a poor ability to hold and retain nutrients. Recommendations include:

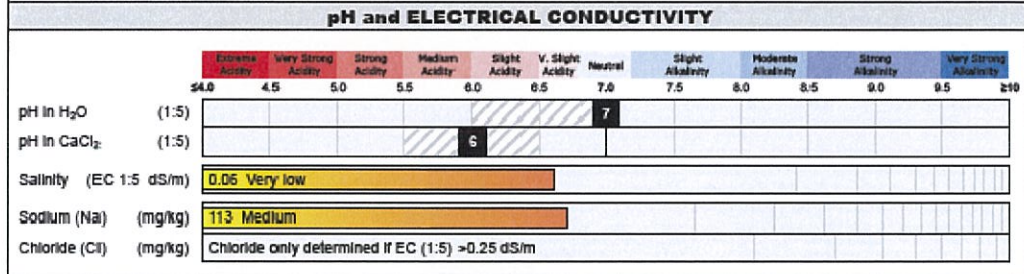
The addition of a well balanced NPK fertiliser (e.g. N: 10.5, P:3.5, K:5.5) at 50 g/sqm will help improve nutrients for revegetation. Gypsum at 300g/sqm will bring up the calcium levels and additional organic matter will create a better structured soil and increase water holding capacity. This can be done by using compost, biosolids or green manure.

SOIL SAMPLE DEPTH (mm): 100 150 200 FERTILITY RATING: Low Moderate High

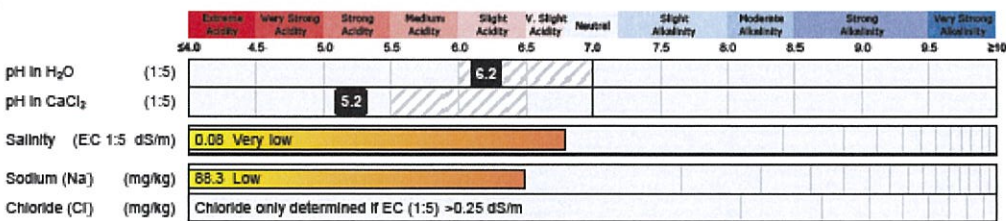
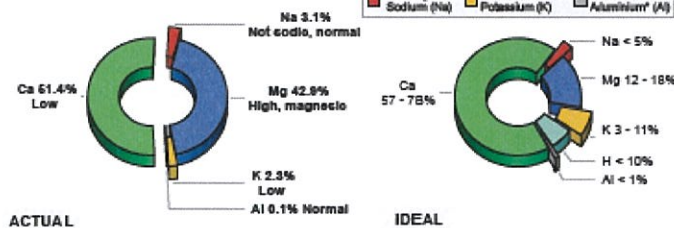
pH and ELECTRICAL CONDUCTIVITY

CATION BALANCE

Ratio	Result	Target Range
Ca:Mg	1.2	4.1 - 6.0
Comment: Calcium low		
Mg:K	18.9	2.6 - 5.0
Comment: Potential Potassium deficiency		
K/(Ca+Mg)	0.02	< 0.07
Comment: Acceptable		
K:Na	0.7	N/A

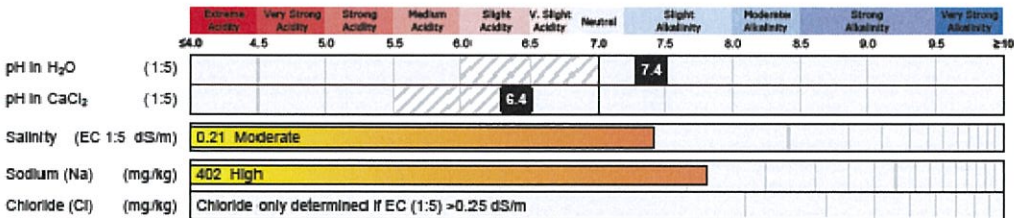
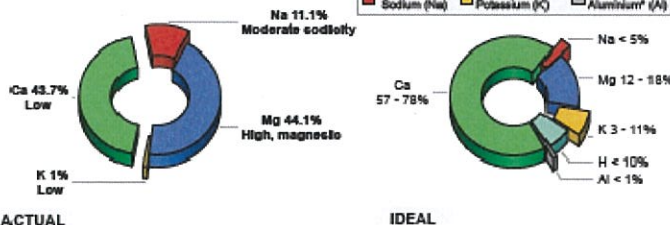
pH and ELECTRICAL CONDUCTIVITY

CATION BALANCE

Ratio	Result	Target Range
Ca:Mg	1	4.1 – 6.0
Comment: Calcium low		
Mg:K	46.2	2.6 – 5.0
Comment: Potential Potassium deficiency		
K/(Ca+Mg)	0.01	< 0.07
Comment: Acceptable		
K:Na	0.1	N/A
Sodium Absorption Ratio: D.N.T.		
Electrochemical Stability Index (ESI): 0.02 High potential for dispersion and soil structure collapse		
SOLUBLE CATIONS (meq/100g)		
Na:	K:	Ca: Mg:

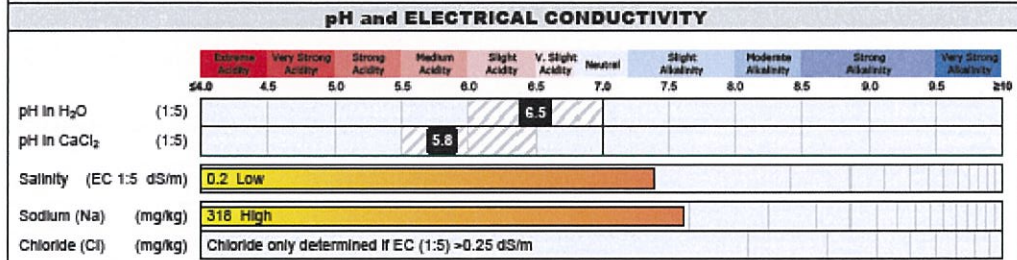
The addition of a well balanced NPK fertiliser (e.g. N: 10.5, P:3.5, K:5.5) at 50 g/sqm and will help improve nutrients for revegetation. Organic matter needs to be increased by the addition of compost, biosolids or green manure to bring up the levels and improve structure. Gypsum at 200g/sqm will improve calcium levels and displace sodium levels.

SOIL SAMPLE DEPTH (mm): 100 150 200 FERTILITY RATING: Low Moderate High

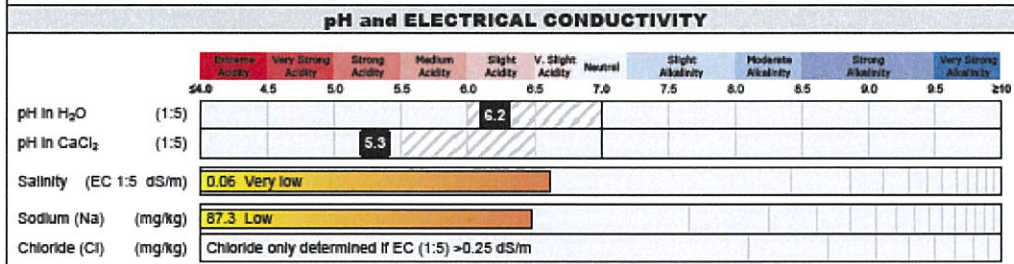
The addition of a well balanced NPK fertiliser (e.g. N: 10.5, P:3.5, K:5.5) at 50 g/sqm will help improve nutrients for revegetation. Gypsum at 200g/sqm and lime at 100g/sqm will improve calcium levels, neutralise aluminium and hydrogen and increase the pH. Organic matter needs to be increased by using a compost, biosolids or green manure.

SOIL SAMPLE DEPTH (mm): 100 150 200 FERTILITY RATING: Low Moderate High

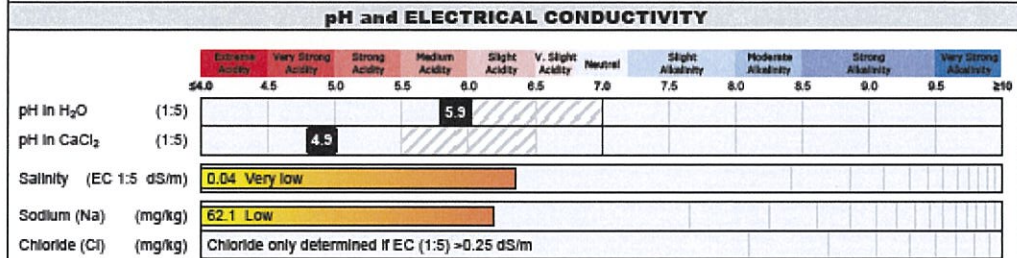
The addition of a well balanced NPK fertiliser (e.g. N: 10.5, P:3.5, K:5.5) at 50 g/sqm will help improve nutrients for revegetation. Gypsum at 300g/sqm and lime at 200g/sqm will improve calcium levels, neutralise aluminium and hydrogen, displace sodium levels and increase the pH. Organic matter needs to be increased to bring up the levels and improve structure. This can be done by using compost, biosolids or green manure.

SOIL SAMPLE DEPTH (mm): 100 150 200 FERTILITY RATING: Low Moderate High

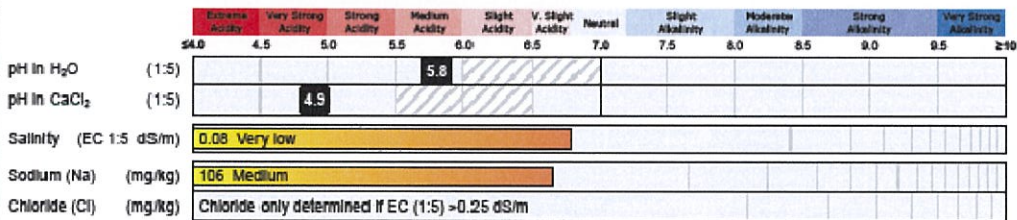
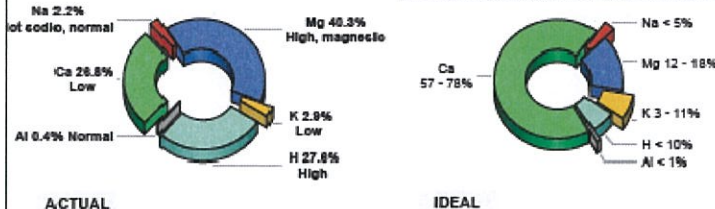
pH and ELECTRICAL CONDUCTIVITY

CATION BALANCE

Ratio	Result	Target Range
Ca:Mg	0.7	4.1 - 6.0
Comment: Potential Calcium deficiency		
Mg:K	14.2	2.6 - 5.0
Comment: Potential Potassium deficiency		
K/(Ca+Mg)	0.04	< 0.07
Comment: Acceptable		
K:Na	1.3	N/A
Sodium Absorption Ratio: D.N.T.

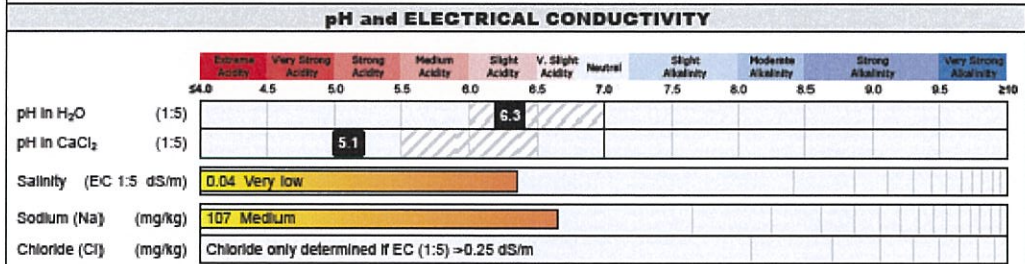
The addition of a well balanced NPK fertiliser (e.g. N: 10.5, P:3.5, K:5.5) at 50 g/sqm will help improve nutrients for revegetation. Gypsum at 200g/sqm will improve calcium levels and displace sodium levels. Organic matter needs to be increased by the addition of compost, biosolids or a green manure to bring up the levels and improve structure.

SOIL SAMPLE DEPTH (mm): 100 150 200 FERTILITY RATING: Low Moderate High
