**OLD WALLGROVE ROAD UPGRADE, AUSTRAL ACCESS WORKS -
FLORA AND FAUNA ADDENDUM ASSESSMENT**

This letter presents a flora and fauna assessment of the proposed Austral road access works along Old Wallgrove Road, which is an extension of the Old Wallgrove Road Upgrade project.

**OLD WALLGROVE ROAD
UPGRADE
AUSTRAL ACCESS**

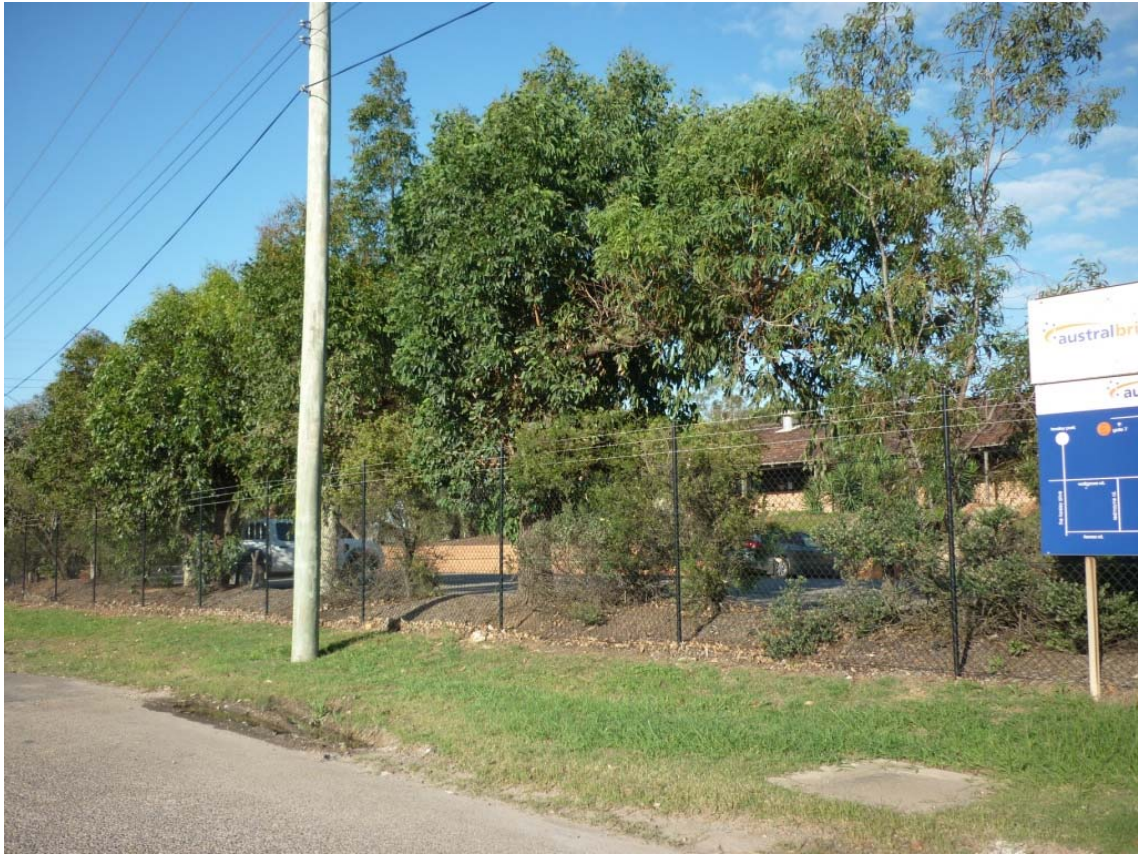
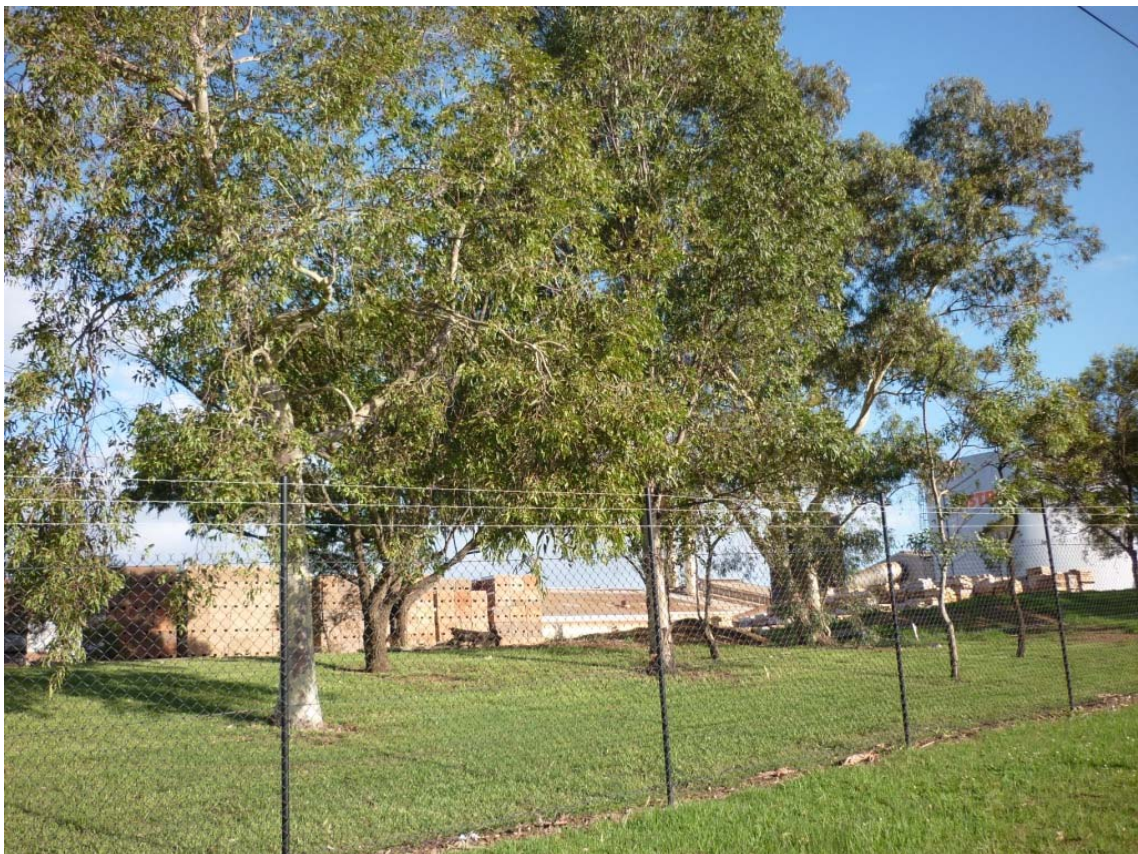
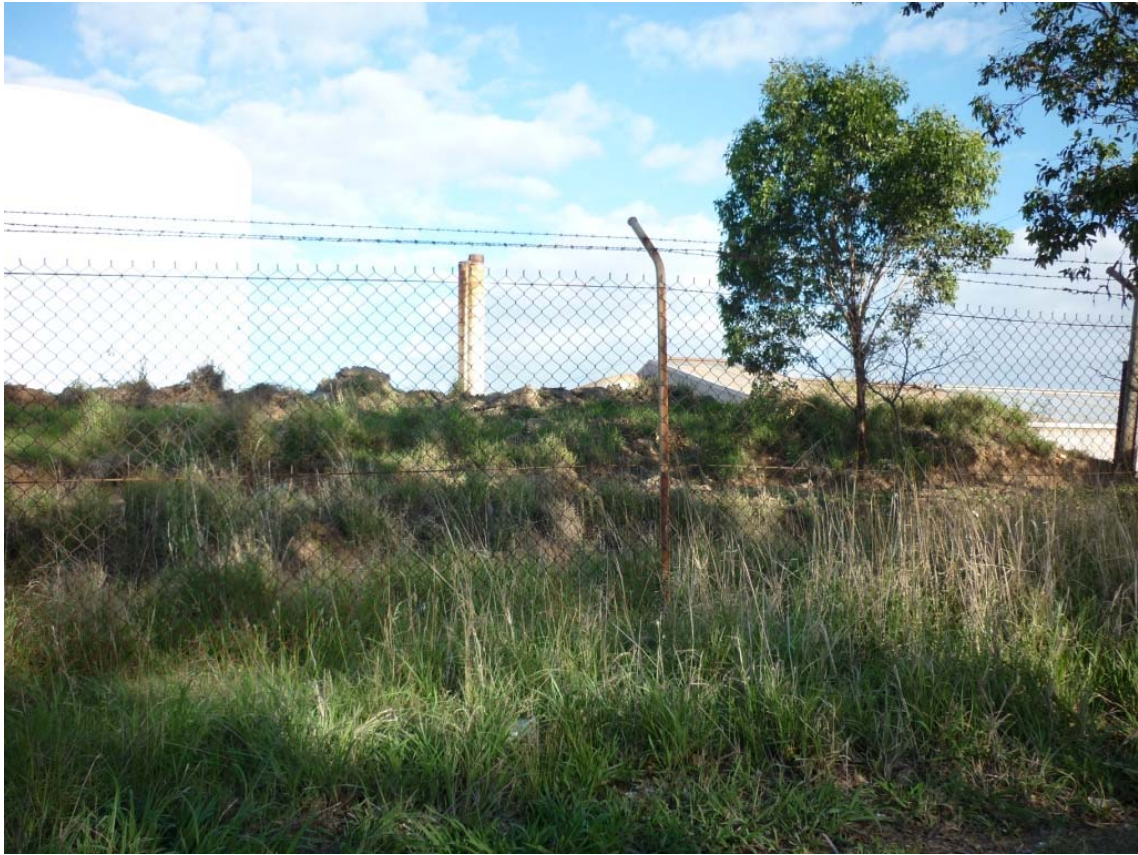
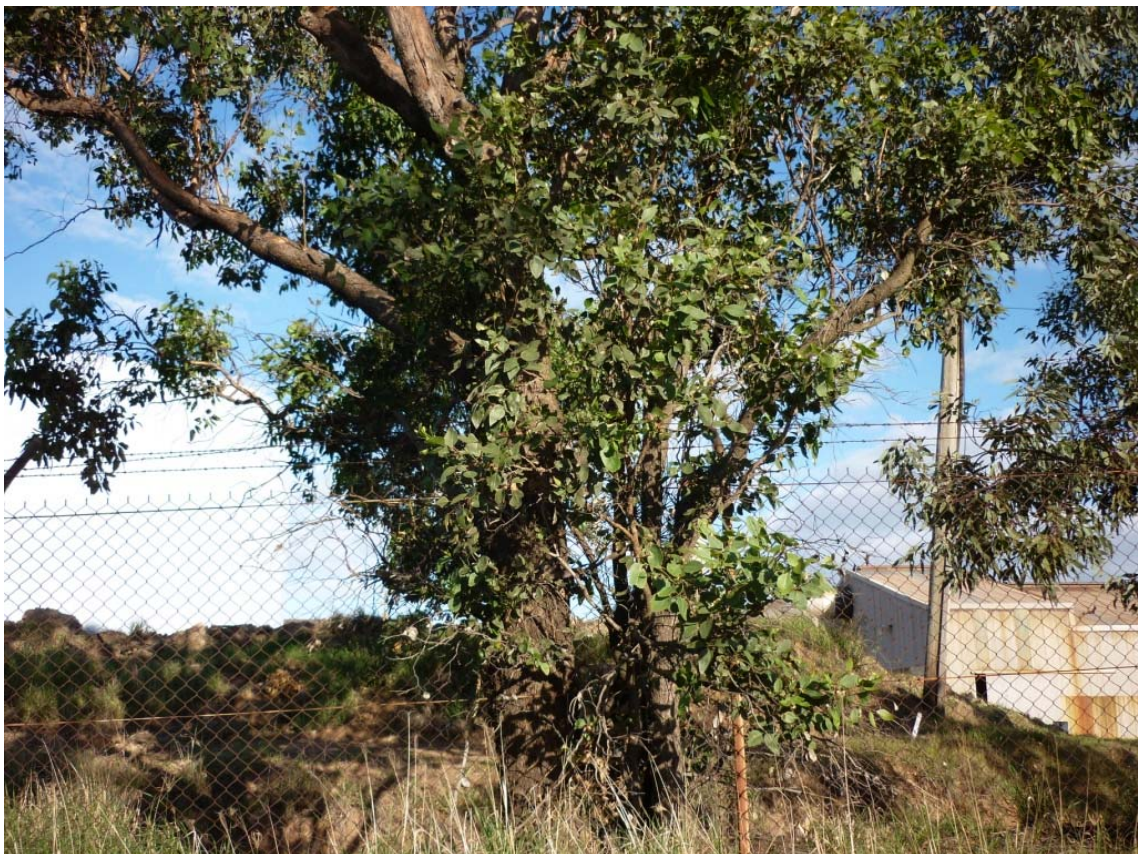
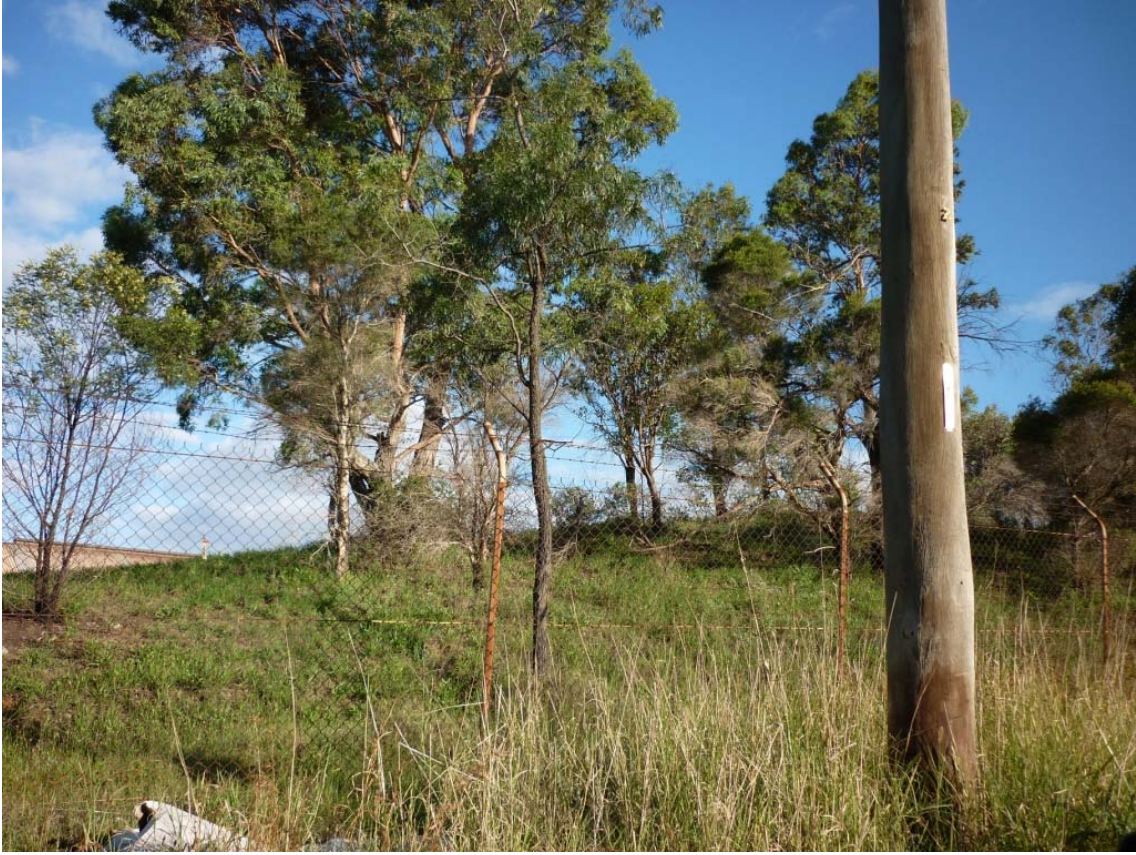
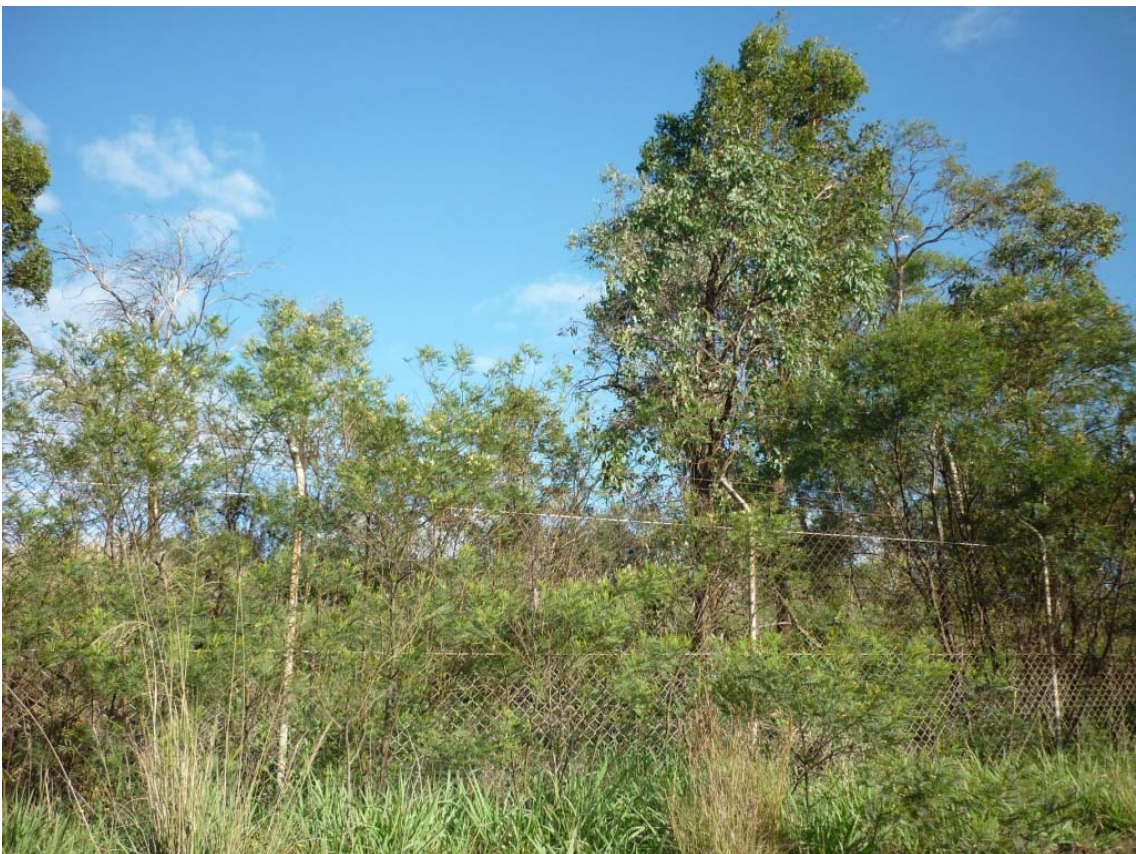
Photographs - Bund Vegetation

At the Old Wallgrove Road frontage, there is a strip of woody vegetation along the site fence line that extends from the existing gateway in the north and continues past the Millner Ave intersection. This woody vegetation is artificial (i.e. planted vegetation and not naturally occurring) and is comprised of native local species planted on a grassed bund. The bunding was established in the past from loose fill material to comply with noise conditions. The trees on the bund are relatively young; no mature trees were observed.

Trees species that have been planted include *Casuarina glauca* (Swamp Oak), *Eucalyptus moluccana* (Grey Box), *Acacia implexa* (Lightwood) and *Melaleuca styphelioides* (Prickly-leaved Tea Tree). The understorey is dominated by soil-stabilising perennial exotic grasses (including *Chloris gayana* Rhodes Grass, *Bromus catharticus* Prairie Grass, *Paspalum dilatatum* Paspalum, *Cynodon dactylon* Couch Grass) that would have been sown at the time the bund was established. Other abundant species recorded on the bund include *Plantago lanceolata* (Lamb's Tongue) and *Sida rhombifolia* (Farmer's Friend), which are both common exotic pasture species.

Some native woody species that were not originally planted but which were recorded occurring on the bund (i.e. have established voluntarily) include *Eucalyptus baueriana* (Blue Box) and *Bursaria spinosa* (Blackthorn). The native grass, *Themeda australis* (Kangaroo Grass) was also observed growing on the margins of the bund.

The planted bund does not represent native remnant woodland or forest vegetation. It has not been recognised in regional mapping data sets as a native remnant woodland or forest (NSW NPWS, 2002). No threatened ecological communities, such as Cumberland Plain Woodland, are represented by the bund vegetation. Photographs depicting the bund vegetation are provided in **Appendix B**.

The trees are young in age and do not feature hollows or generously decorticating bark that would provide habitat for native threatened fauna species. At the time of survey, the trees were not flowering, and were therefore not providing foraging resources for nectarivorous fauna. The structure of the bund vegetation is very simple and does not provide valuable refugia for native threatened fauna. The vegetation on the bund is not well connected to significant patches of native remnant woodland in the locality. Therefore, it is unlikely that the bund vegetation would support, or provide important threatened species habitat for threatened fauna species that have been recorded in the locality.
