Report on Geotechnical Investigation

**Proposed Mixed Use Build-To-Rent
Development**

146 Arthur Street, North Sydney NSW

Project 225758.00

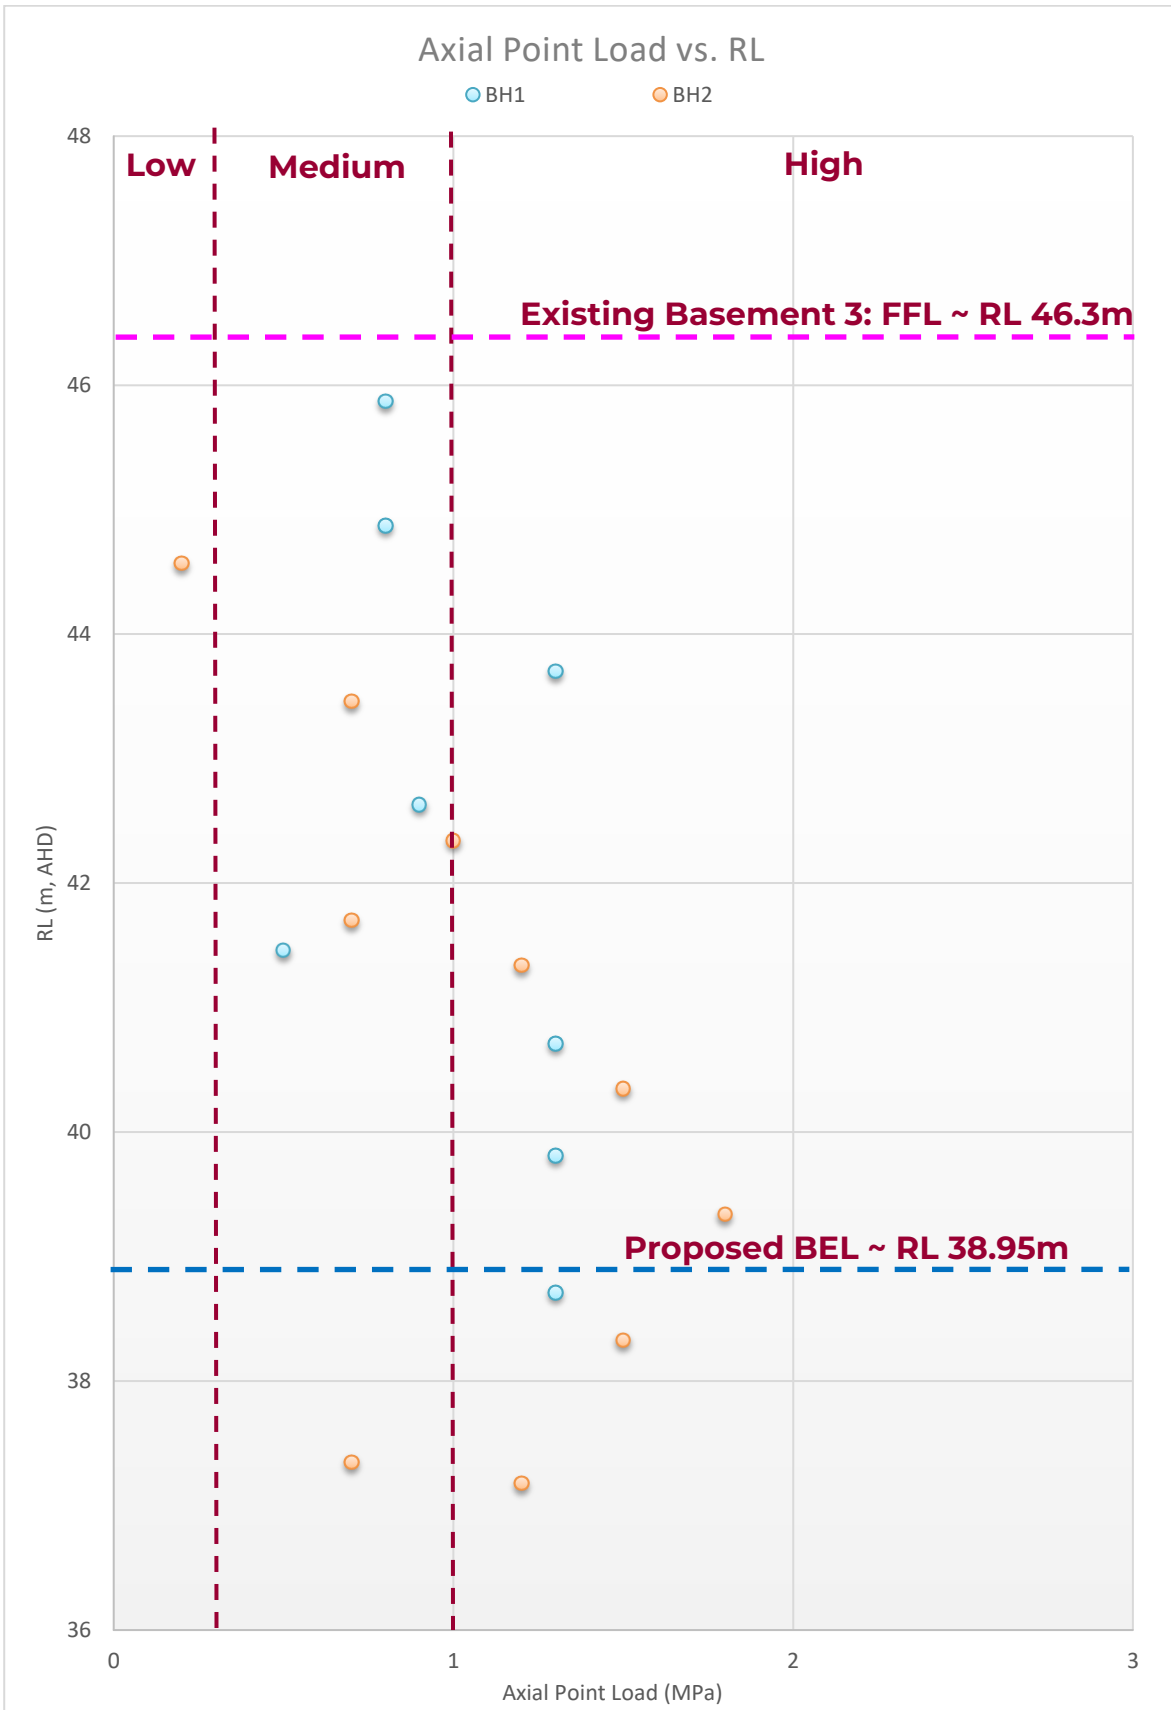
Figure 3: Axial Point Load Values Vs RL (m, AHD)

The results of point load index testing ($I_{s(50)}$), carried out at regular intervals on rock cores, are shown on the respective borehole logs in Appendix F. The results show $I_{s(50)}$ values in the range of 0.2 to 1.8 MPa, indicating that the rock tested ranged from low to high strength (refer figure 3 below). Note that point load testing can be inaccurate in weak rock.

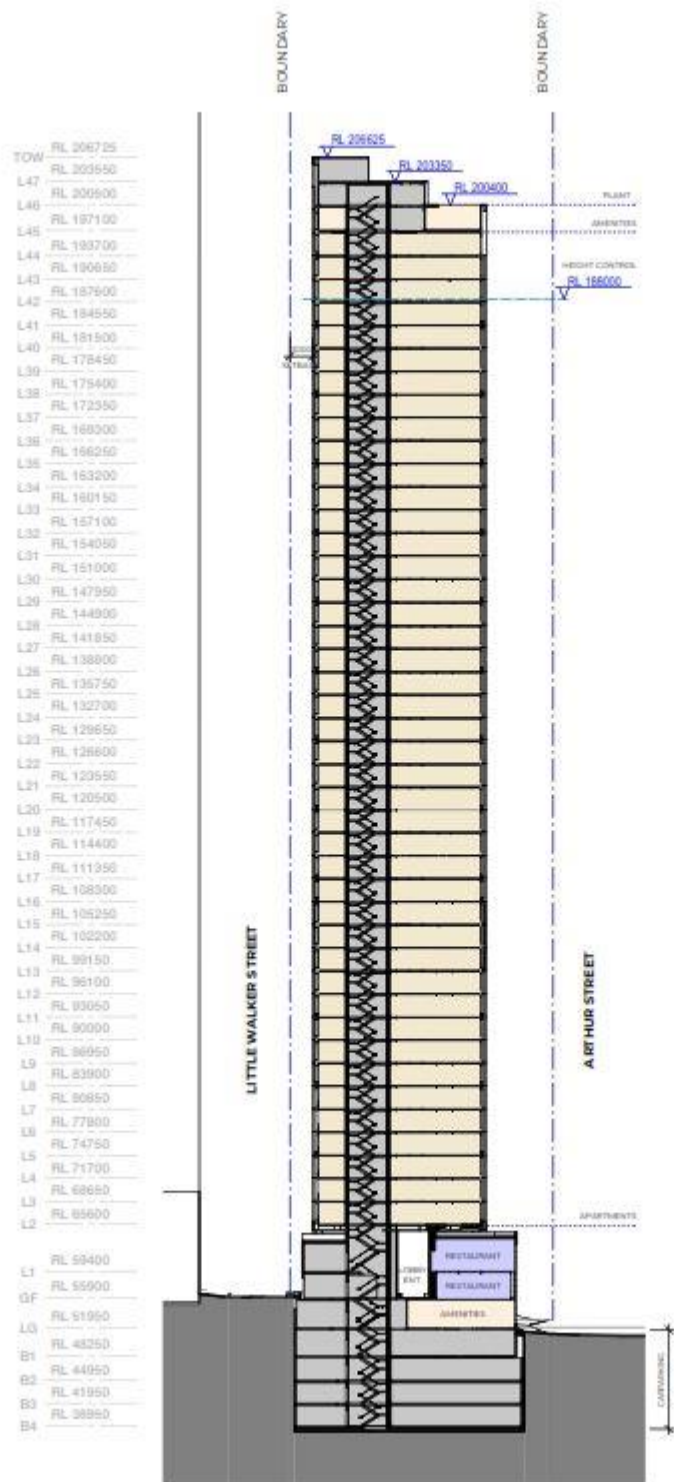
Figure 4: Woods Bagot Section East/West Drawing DA-1320 RevA (dated 05.03.2024).

It is understood that the proposed development includes the demolition of the existing structure and the construction of a high-rise 53-level residential, build-to-rent tower with four basement levels (see Figure 4 below). It is understood that the existing basement will be deepened from the existing FFL at RL 46.3 m down to BEL at RL 38.95 m.

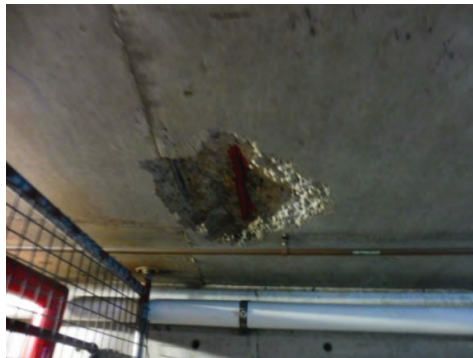
Spalling concrete to soffit B3

- Local carbonation of concrete and corrosion to reinforcements within the Level B3 carpark soffit evident by the cracked concrete and corroded reinforcements. These have been partially repaired and treated but the concrete still requires making good. Allow for local repairs in the short term;

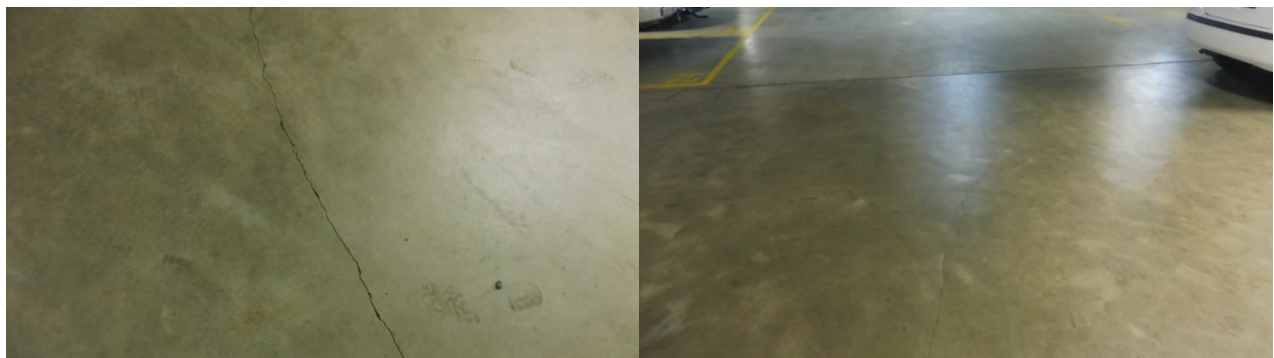
Local cracking to B2 floor

- Cracking circa 2-3mm was noted in one location to B2 floor slab. Although not a major structural concern we would recommend these be locally treated and repaired as required;

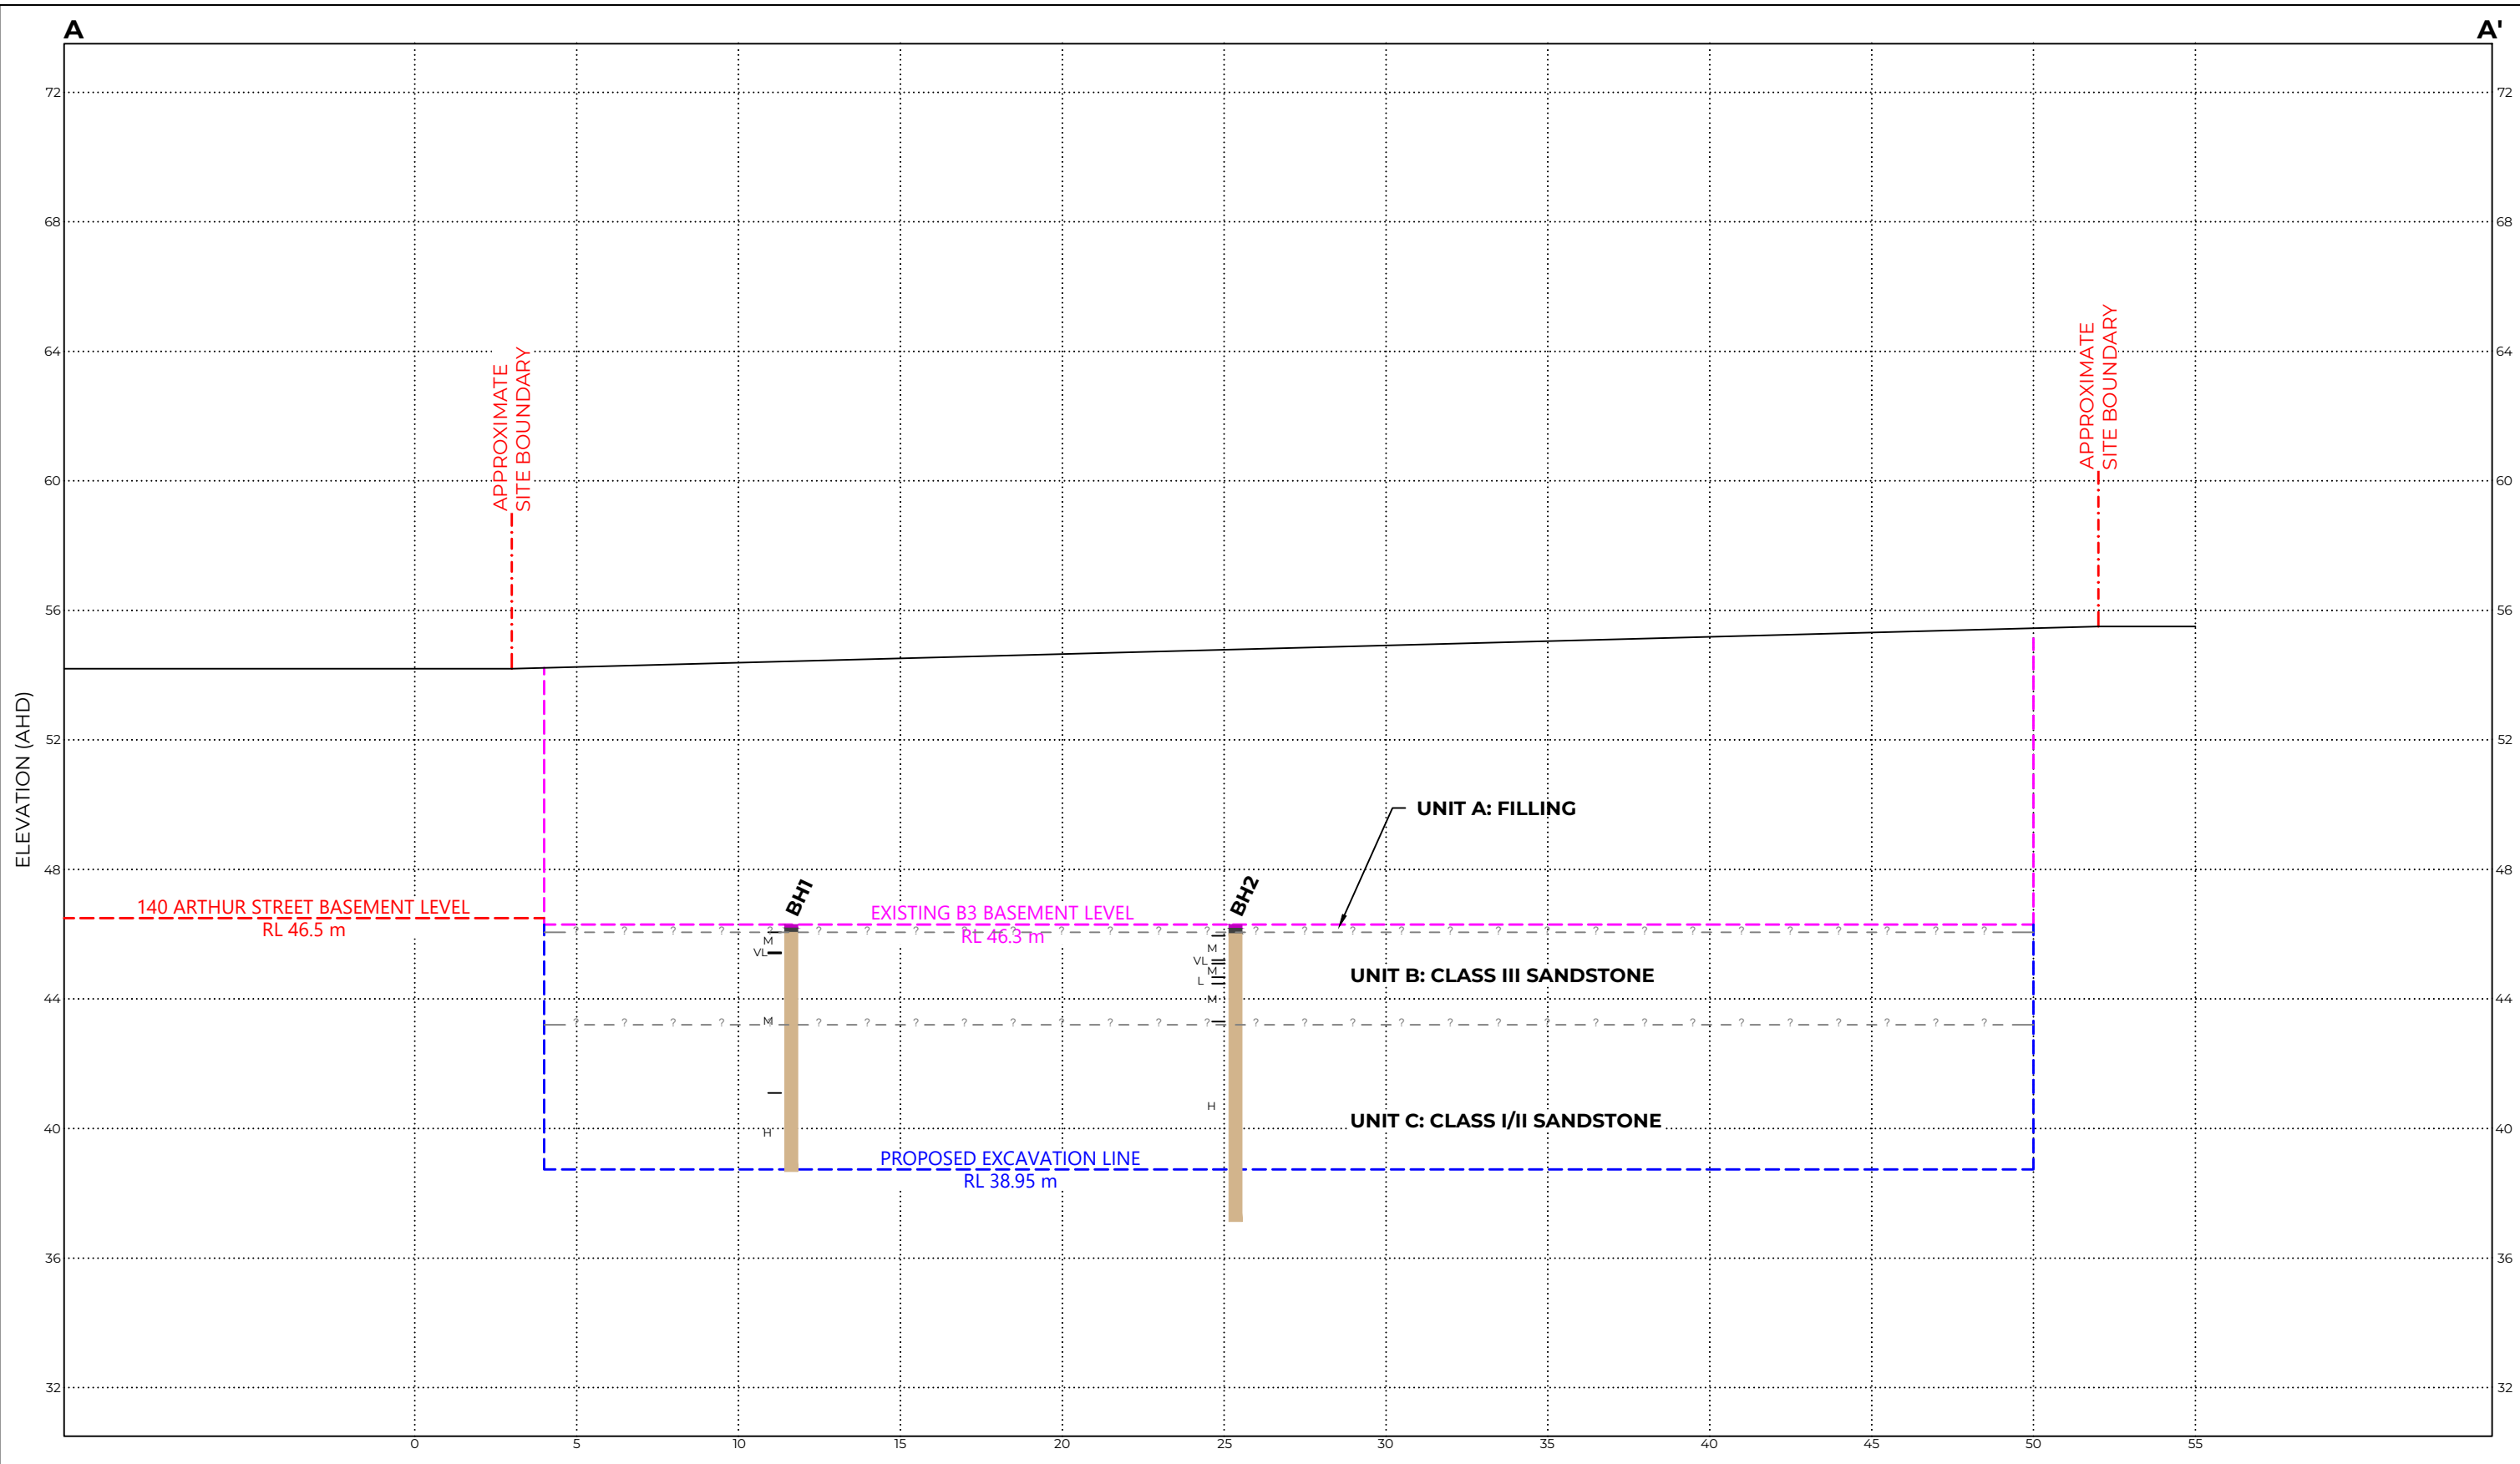
DRAWING TITLE:
INTERPRETED GEOTECHNICAL CROSS-SECTION A-A'

Geotechnical cross-sections are presented in Sections A-A’ and B-B’ in Drawings 2 and 3 in Appendix D. The interpreted geotechnical unit boundaries are shown between boreholes. It should be noted that the subsurface conditions are only accurate at the borehole locations. The ‘dashed’ lines representing the units are inferred from the borehole information, and therefore not necessarily correct.

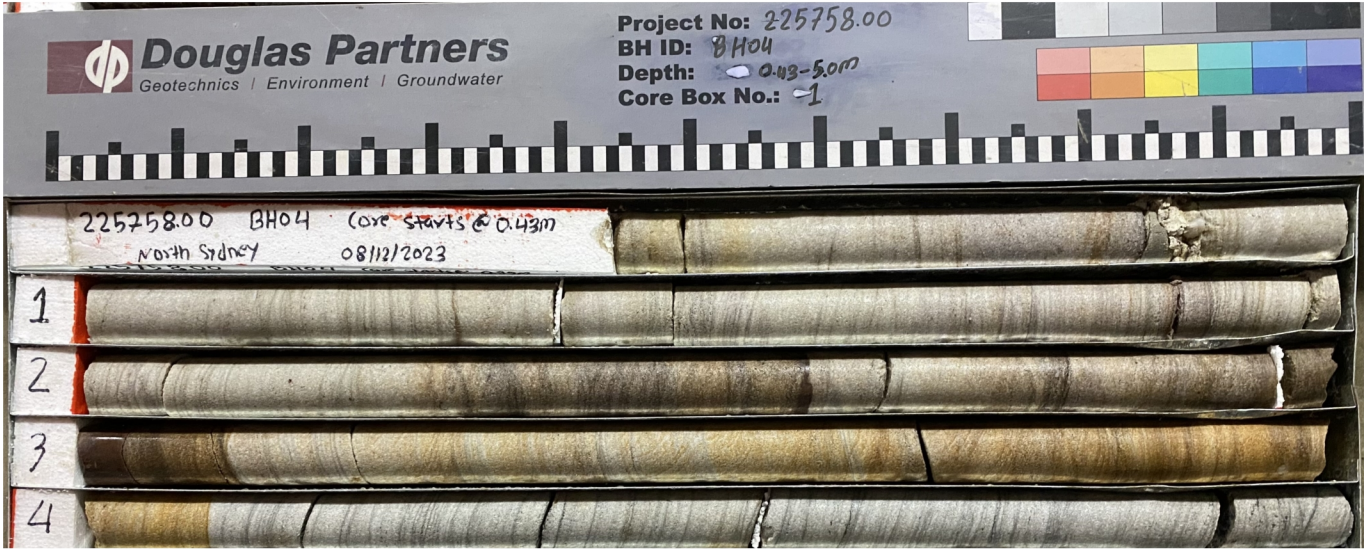
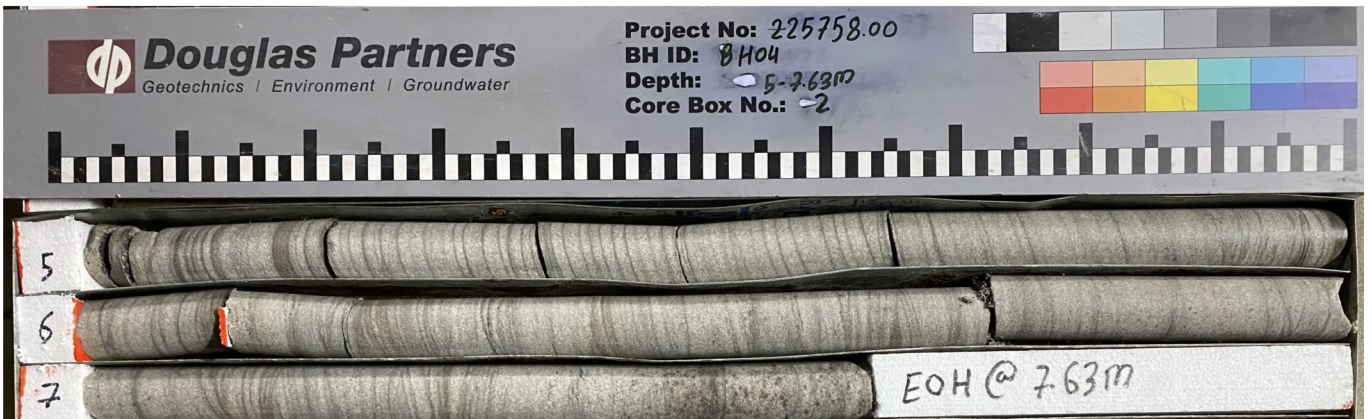
Details of the subsurface conditions encountered are given in the borehole logs included in Appendix F, with notes defining classification methods and descriptive terms. Photographs of the rock cores were taken and are presented with the relevant borehole logs.

Sandstone (Hawkesbury Sandstone): Medium and high strength with very low and low strength bands, slightly weathered with moderately weathered band then fresh, slightly fractured to unbroken sandstone.

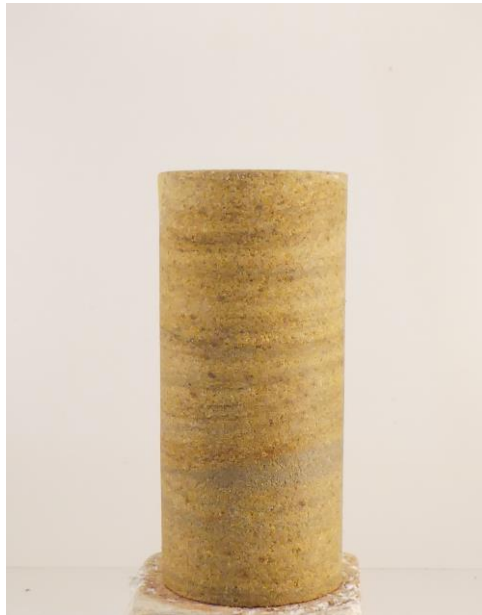
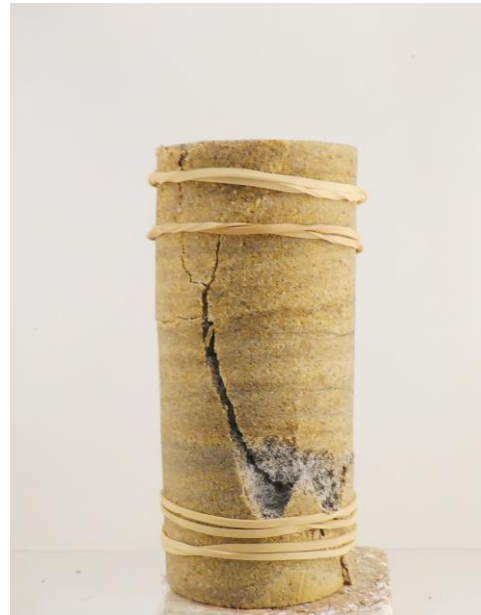
Uniaxial Compressive Strength		28	MPa
	<u>Young's Modulus</u>	<u>Poisson's Ratio</u>	
Tangent	5.9 GPa	0.14	from 42 % to 58 % of Max UCS
Secant	3.2 GPa	0.13	from 0 % to 50 % of Max UCS

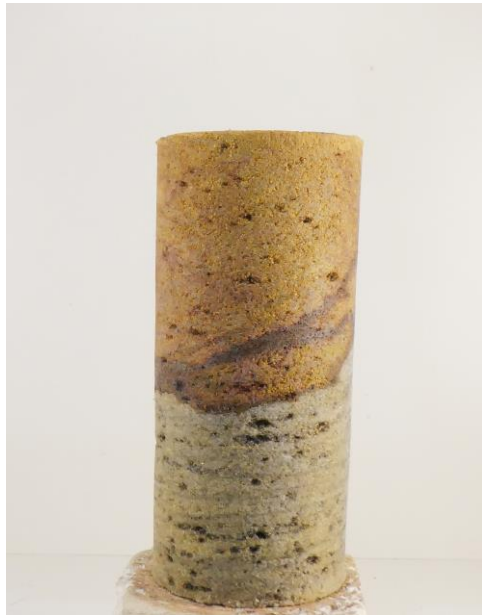
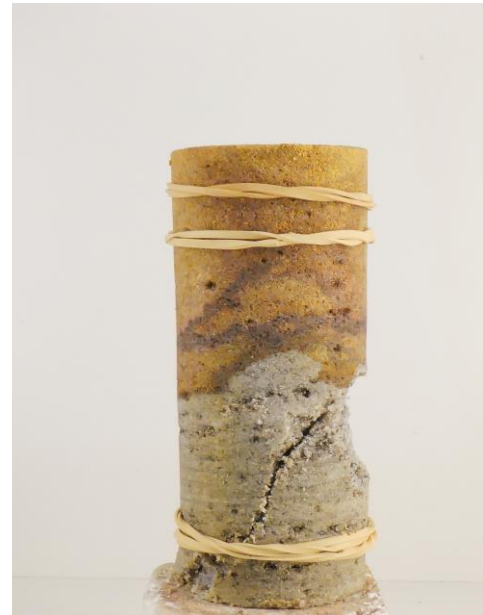
Uniaxial Compressive Strength		13	MPa
	<u>Young's Modulus</u>	<u>Poisson's Ratio</u>	
Tangent	6.0 GPa	0.11	from 60 % to 75 % of Max UCS
Secant	3.9 GPa	0.10	from 0 % to 68 % of Max UCS
