## 2.8 Ultimo Power House Cooling System

### 3.0 Archaeological Potential

#### 3.1 Archaeological Potential of the Study Area

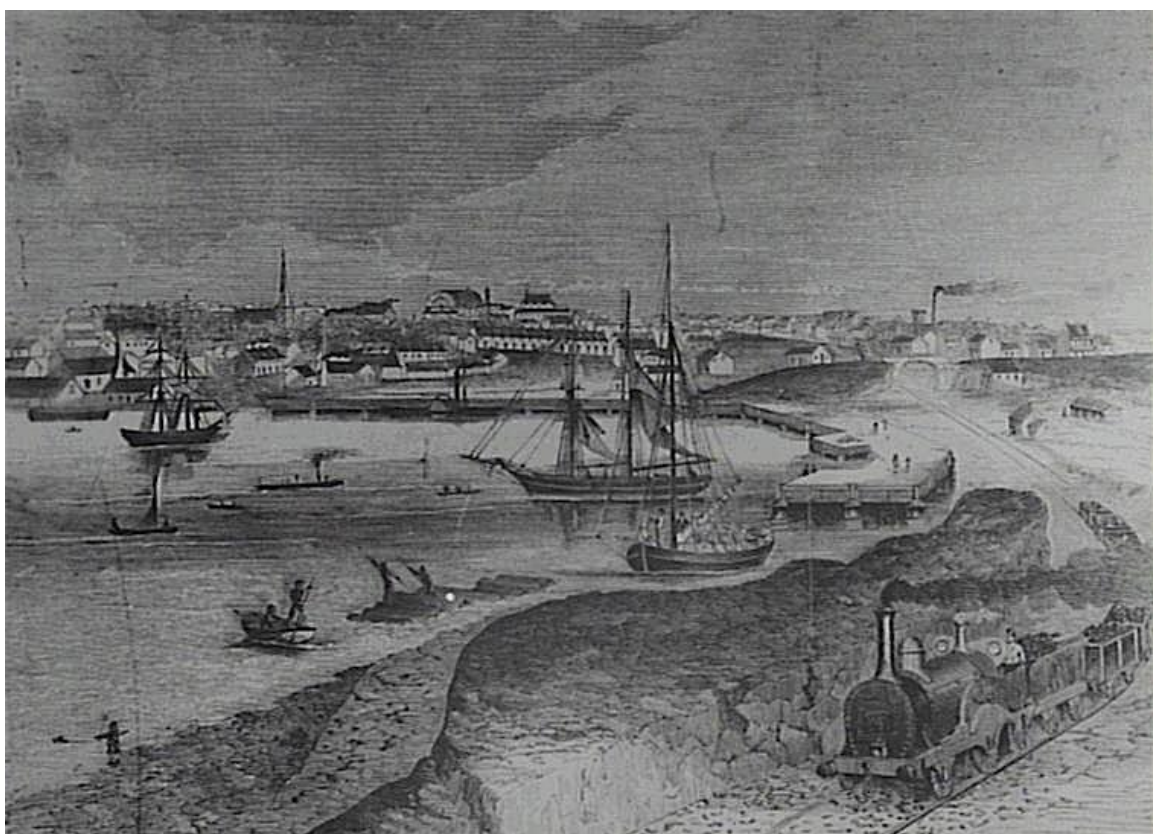
**Figure 2.23: Illustration of the Iron Wharf, Darling Harbour published in the *Illustrated Sydney News* on 30 January 1874. City of Sydney Archives, ArchivePix, SRC 1819.**

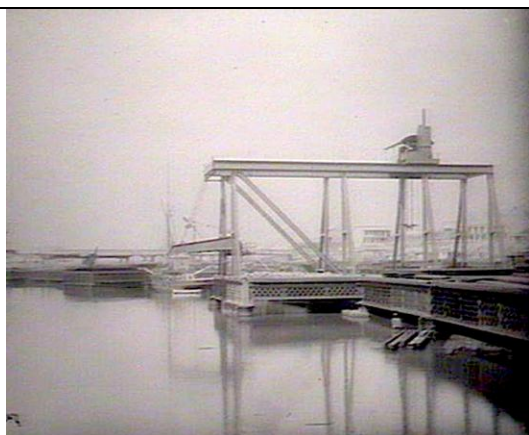
**Figure 2.24: The Iron Wharf with overhead crane, nd, c1880. SLNSW GPO 1 – 07062, digital order no. d1\_07062.**

The estimated expenditure for the construction of the Iron Wharf was raised in 1872 from £35,000 to £50,000 to include the stone retaining wall and infill (Figure 2.13). It is unclear if the final expenditure included the steam cranes installed on the wharves by 1880 (Figure 2.24, Figure 2.25). The steam-powered cranes associated with the wharf were installed between 1878 and 1885.<sup>48</sup>

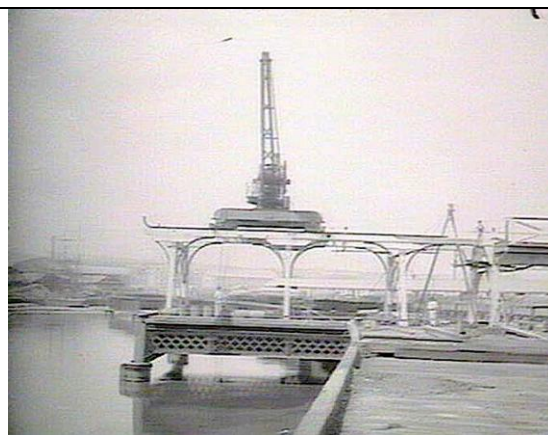
**Figure 2.25: The Iron Wharf with overhead travelling crane, nd, c1880. SLNSW GPO 1 – 07061, digital order no. d1\_07061.**

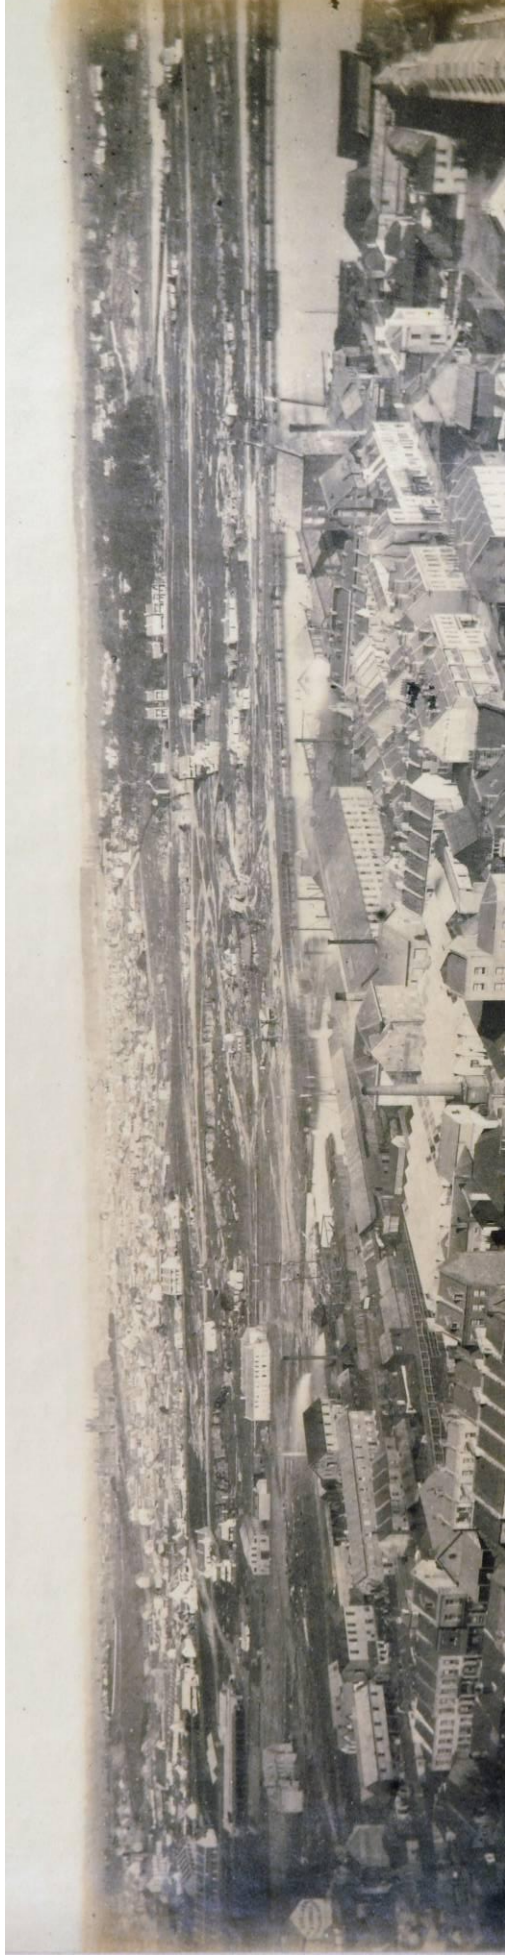
Figure 2.26: Panorama from Sydney Town Hall clock tower, c1873, looking west over the reclaimed land at the southern end of Darling Harbour with the Iron Wharf along the western foreshore. A number of railway buildings are in the left middle ground. The Darling Quarter (Darling Walk) site is in the middle ground. The part of the study area to the west of Darling Quarter was still harbour. There are a number of houses along the western foreshore of Ultimo and Pyrmont, some of which may be within the study area. City of Sydney Archives, SRC18062.

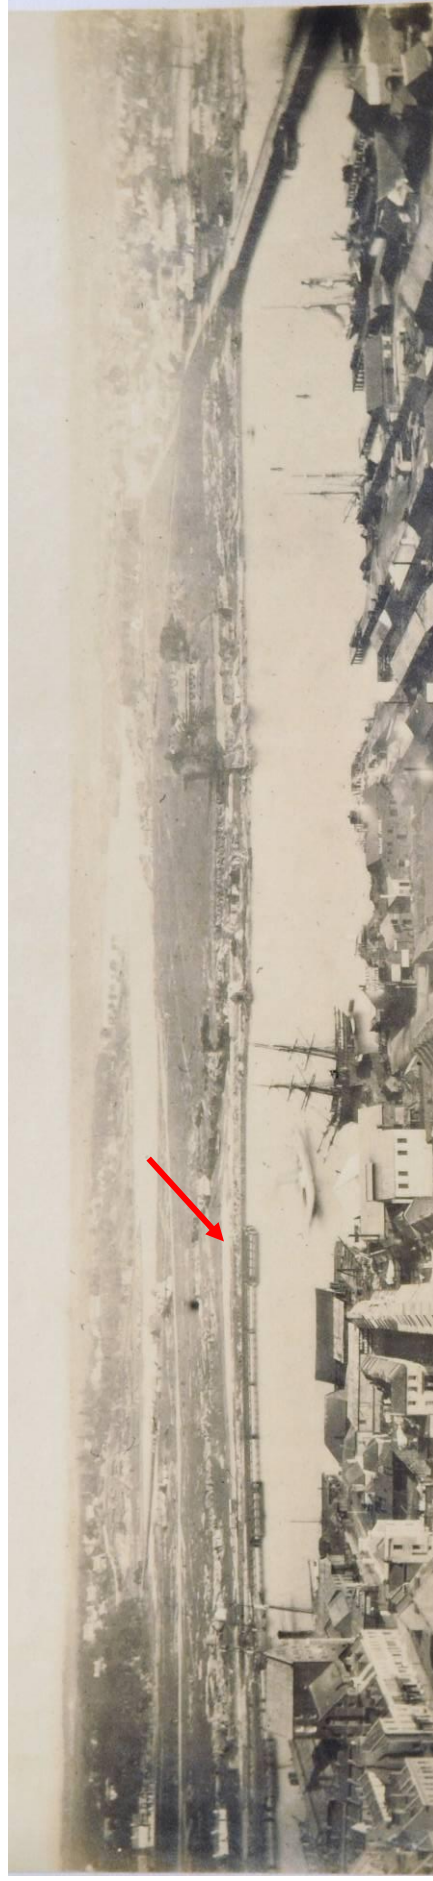
Figure 2.27: Panorama from Sydney Town Hall clock tower, c1873, looking west with the Iron Wharf along the western foreshore. There are only a few buildings along this part of the foreshore possibly within the study area. In the middle ground, behind the Iron Wharf, is the embankment built for the Darling Harbour goods line which leaves a body of water (red arrow) behind it which is yet to be reclaimed. There is boathouse on the foreshore. City of Sydney, SRC18063.

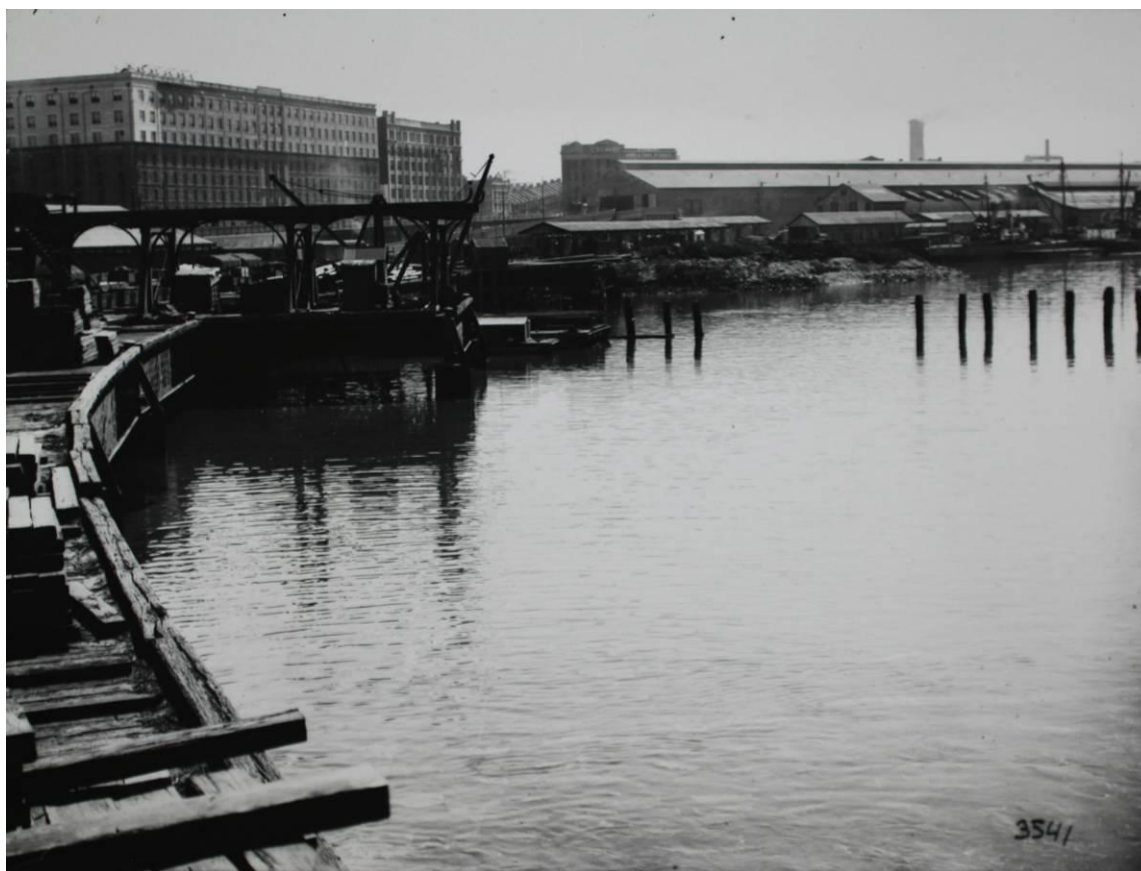
**Figure 2.29:** A photograph looking northwest at the Iron Wharf, Darling Harbour, c1920, at the beginning of demolition work. NRS 17420 Item 848/18 SRNSW.

By April 1917 improvements to Darling Harbour were underway to accommodate increased goods traffic. Reclamation was to be extended to Bathurst Street and one span of the Iron Wharf had already been removed. Sections of the wharf were cut and dropped into the harbour and subsequently buried.<sup>53</sup> A panorama of Darling Harbour in 1919 provides a record of the western shore at this time, and another c1920 photograph provides more details of the work being undertaken to expand and improve the outgrown goods facilities (Figure 2.28, Figure 2.29).

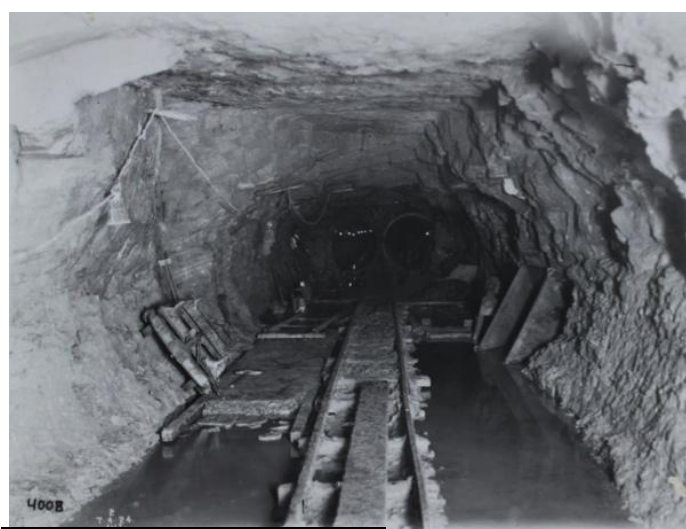
**Figure 2.32: Excavation under Darling Harbour for the installation of water conduits for Ultimo Power House. State Rail Photos Series: 17420 Item: 364/44 SRNSW.**

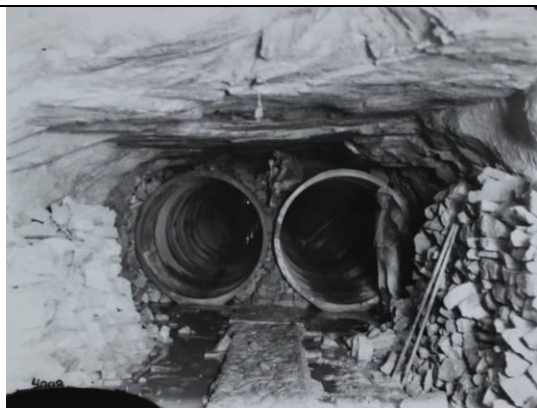
**Figure 2.33:** Pair of RC Monier conduits being installed in the sandstone tunnel under Darling Harbour. Rubble is stacked ready for packing around the 6 ft diameter pipes. State Rail Photos Series: 17420 Item: 364/45 SRNSW.

tunnelled through solid sandstone rock, a single tunnel being formed, and the Monier pipes laid side by side with the spaces around and between filled in with rubble.<sup>63</sup>

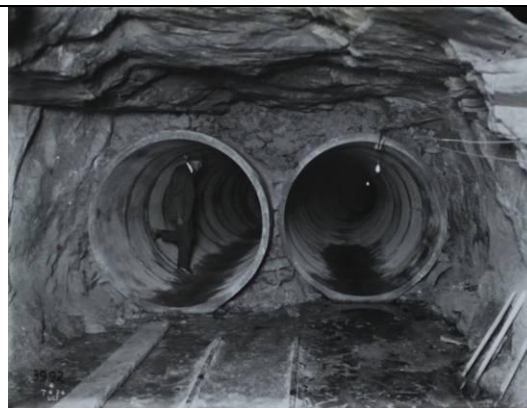
**Figure 2.34:** Rails in the foreground were used to cart rubble fill to the pipes. State Rail Photos Series: 17420 Item: 364/46 SRNSW.

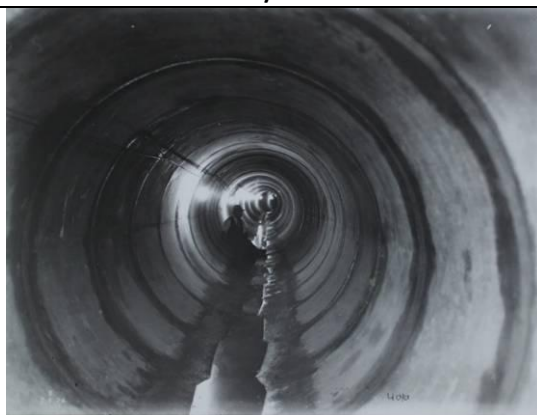
**Figure 2.35:** Joints between the sections of conduit are visible along the length of the water supply pipe. State Rail Photos Series: 17420 Item: 364/47 SRNSW.

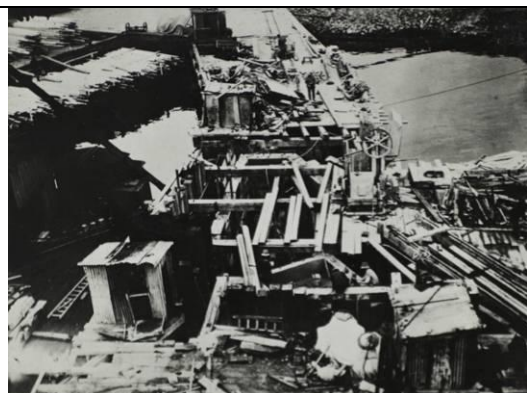
**Figure 2.36:** Cofferdam and formwork for the installation of conduits. State Rail Photos Series: 17420 Item: 364/48A SRNSW.

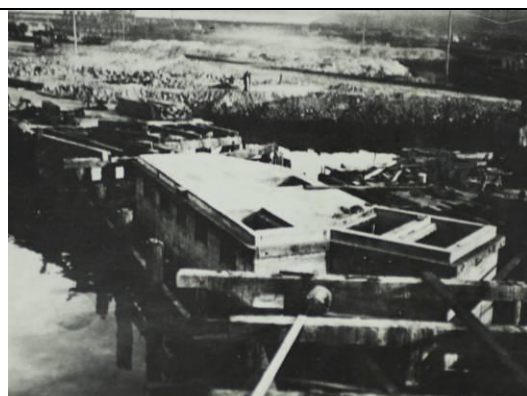
**Figure 2.38:** Work undertaken at the water's edge for installation of the inlet conduits for the Ultimo Power House. State Rail Photo Series: 17420 Item: 364/48C SRNSW.

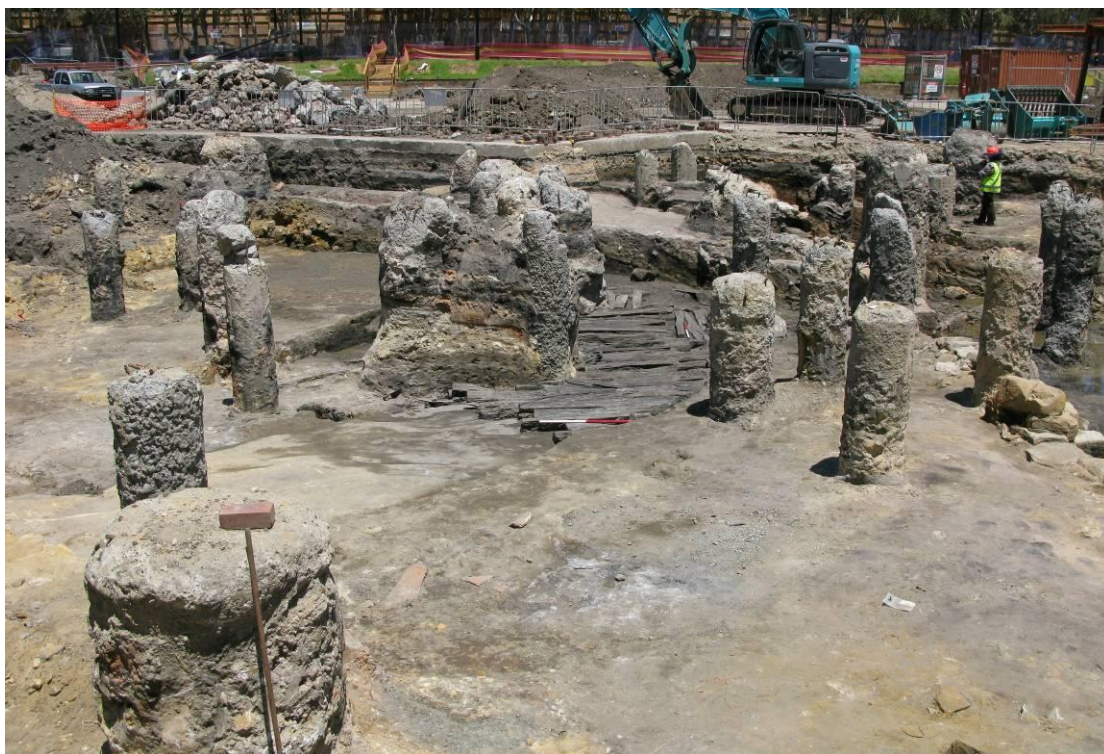
**Figure 3.1: Piles in the area of Barker's Jetty (c1826) and the early timber slip (1810s), Darling Quarter (Walk). This area was a focus of many piles. If there had been many more then the archaeology in this area would have been destroyed or become inaccessible. Looking west. Casey & Lowe 2009**

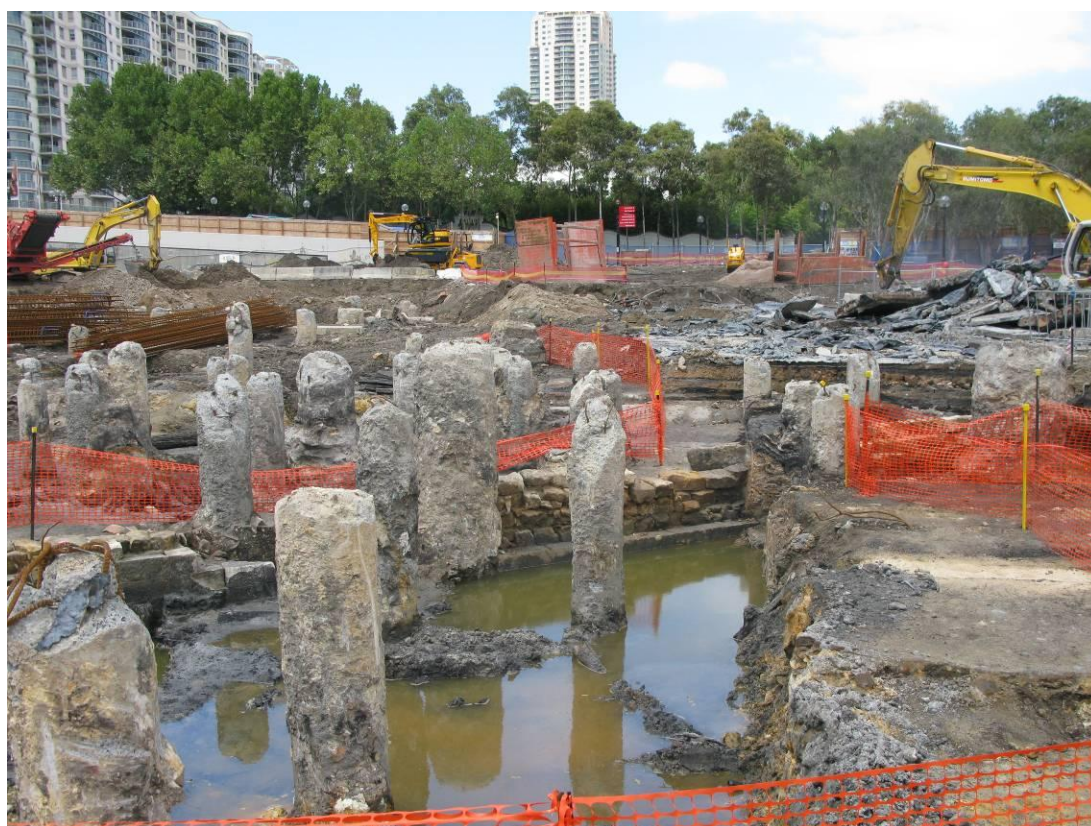
**Figure 3.2: View to south with the stone walling of Barker's Jetty (c1826) in the middle ground, Darling Quarter (Walk). There were many piles in this area from the two sets of building making access to the surviving remains quite difficult. Casey & Lowe 2009**

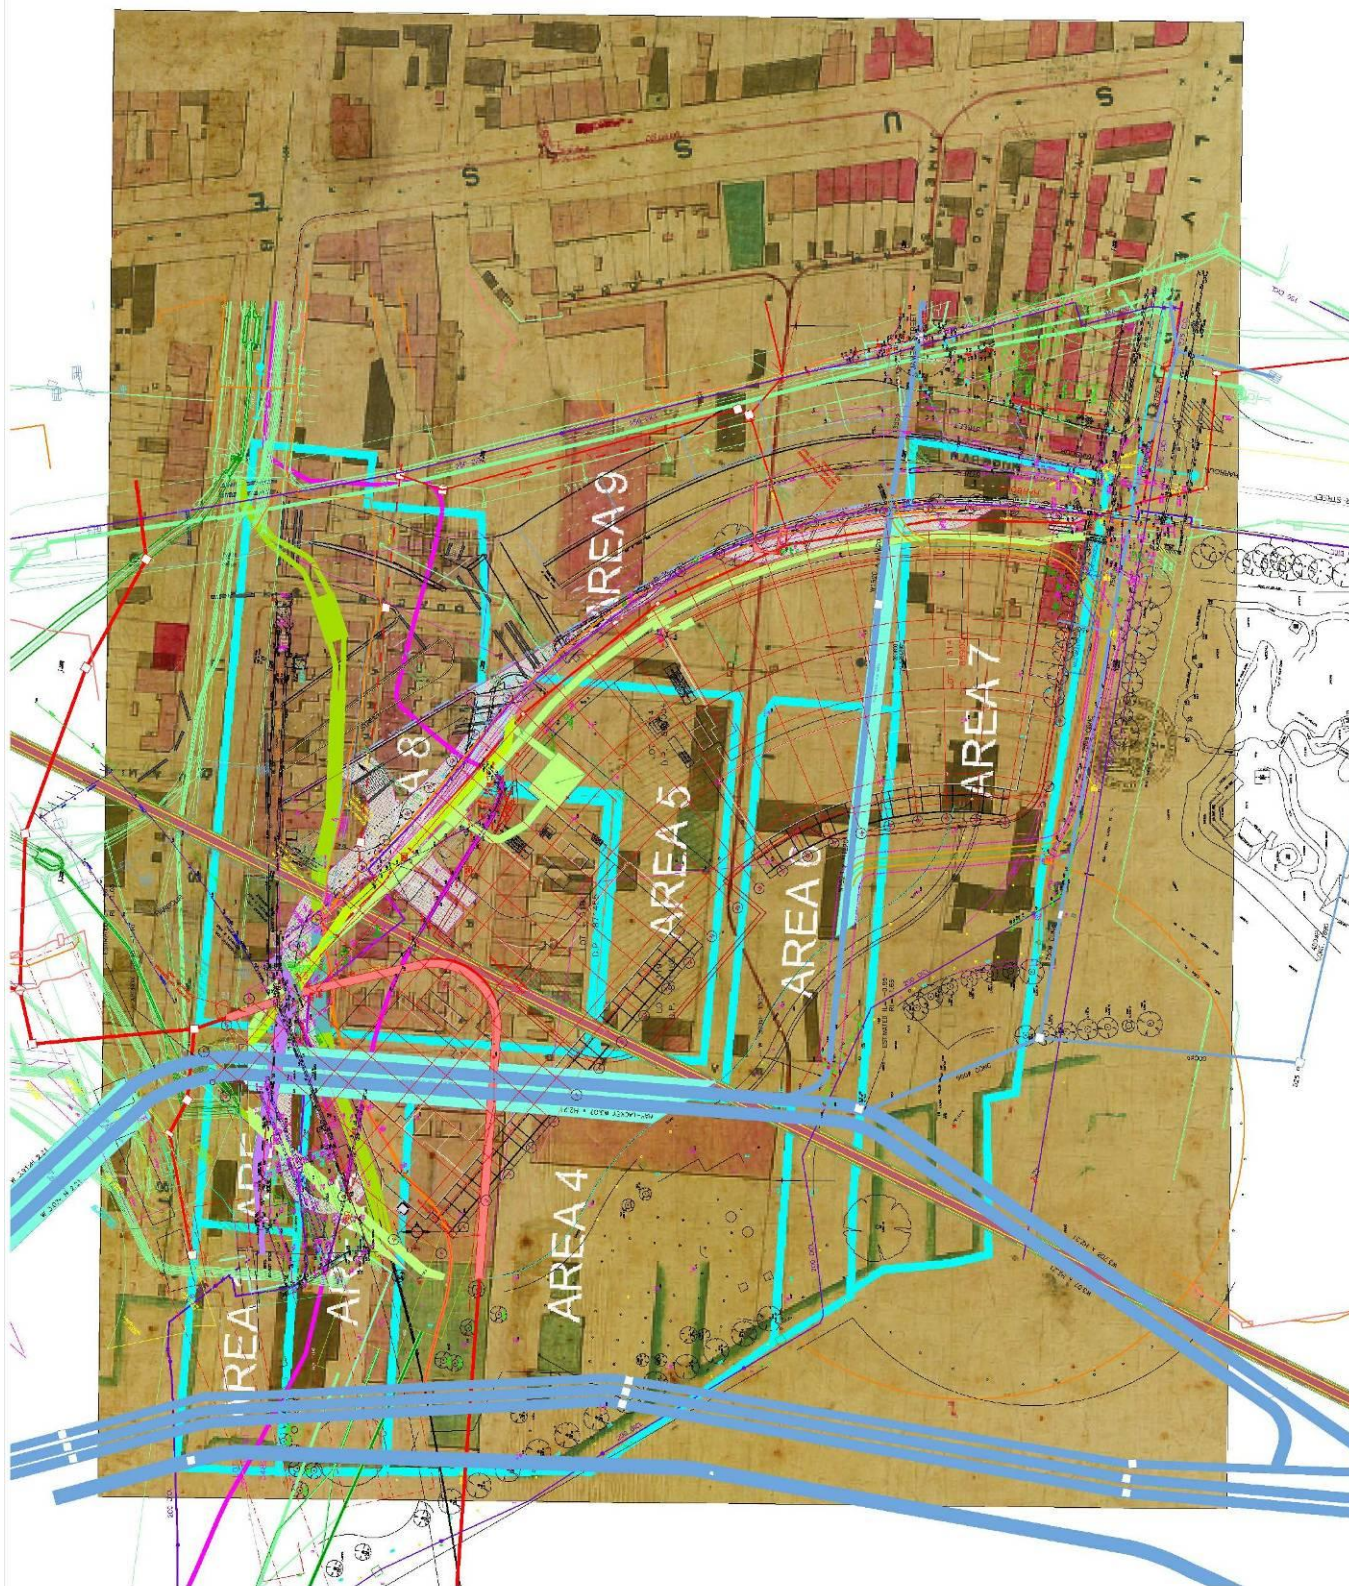
**Figure 3.3: Overlay of the Darling Quarter (Walk) Site with elements of the SICEEP public domain and existing stormwater culverts. This plan shows that archaeology from Area 7 extends into the public domain (beneath Tumbalong Park) area as well as part of Area 6. Area 6 includes the remains of Barker's Jetty. It also shows the impacts from major culverts (blue lines) running through this area. North is at the left. Rygate for Casey & Lowe 2008b.**

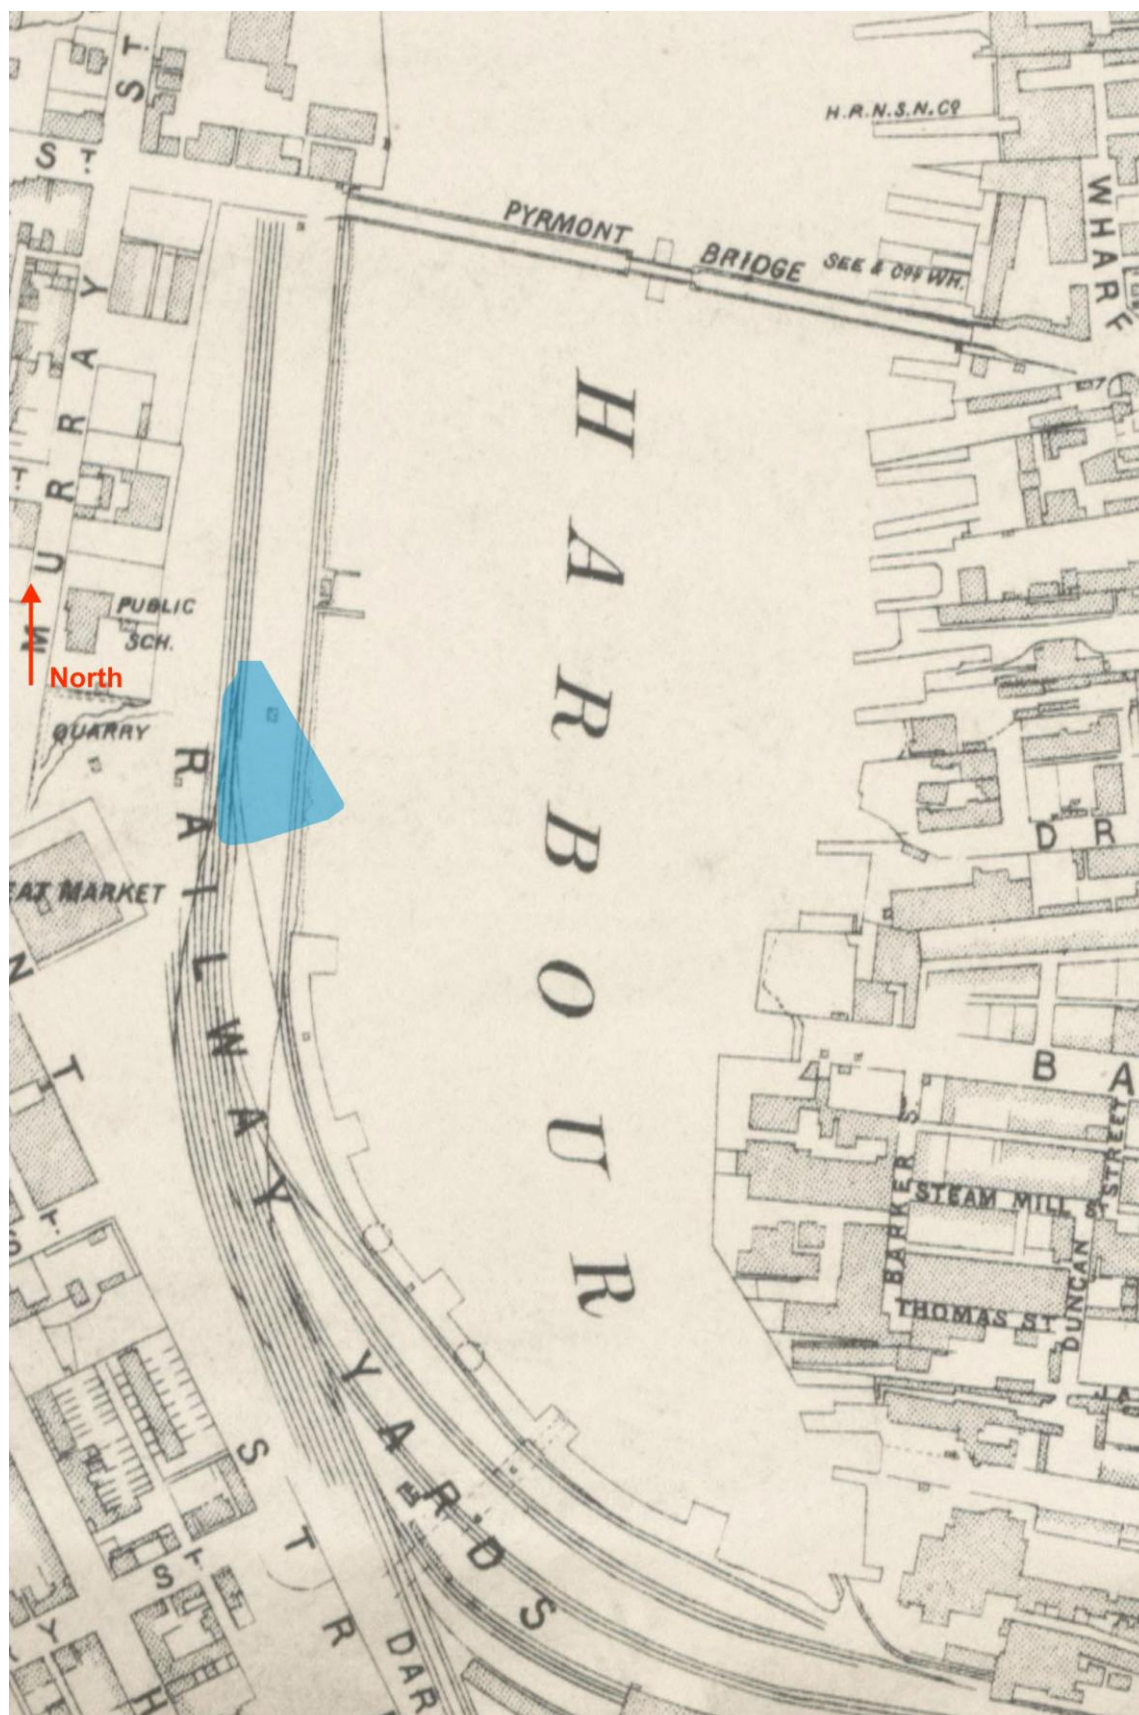
Figure 3.21: Overlay of ICC Hotel study area, shaded blue, on detail of Surveyor General's Office of NSW 1888. 'Map of the City of Sydney, New South Wales, 2<sup>nd</sup> edition'. NLA MAP RM 3448

Archaeological remains are also likely from both the first phase of the goods railway (c1853-1880s) and the associated process of filling in the harbour. The 1865 *Trigonometrical Survey of Sydney* shows the railway tracks crossing a culvert before terminating within the study area (Figure 3.18). Whether the first tracks still remain *in situ* is unclear. They may have been removed and replaced, as the line was repeatedly upgraded and expanded, although they also may have been simply buried by ballast as later tracks were laid and the railway line expanded. The pre-1865 culvert itself is likely to have been buried by all later works. Already by 1878, a plan of the railway line shows the culvert partially covered by a siding (Figure 2.14), and by the 1888 map, the culvert no longer appears (Figure 3.21). The actual fill material from the in-filling of Darling Harbour itself is a potential archaeological resource, whether it originated from deliberate human dumping or inadvertent silting due to changes in the harbour. Sampling this fill could provide information regarding how human activity transformed the landscape of Darling Harbour. The probable seawall or embankment shown on the 1888 map (Figure 3.21) is also an archaeological feature which is likely to still remain *in situ*.

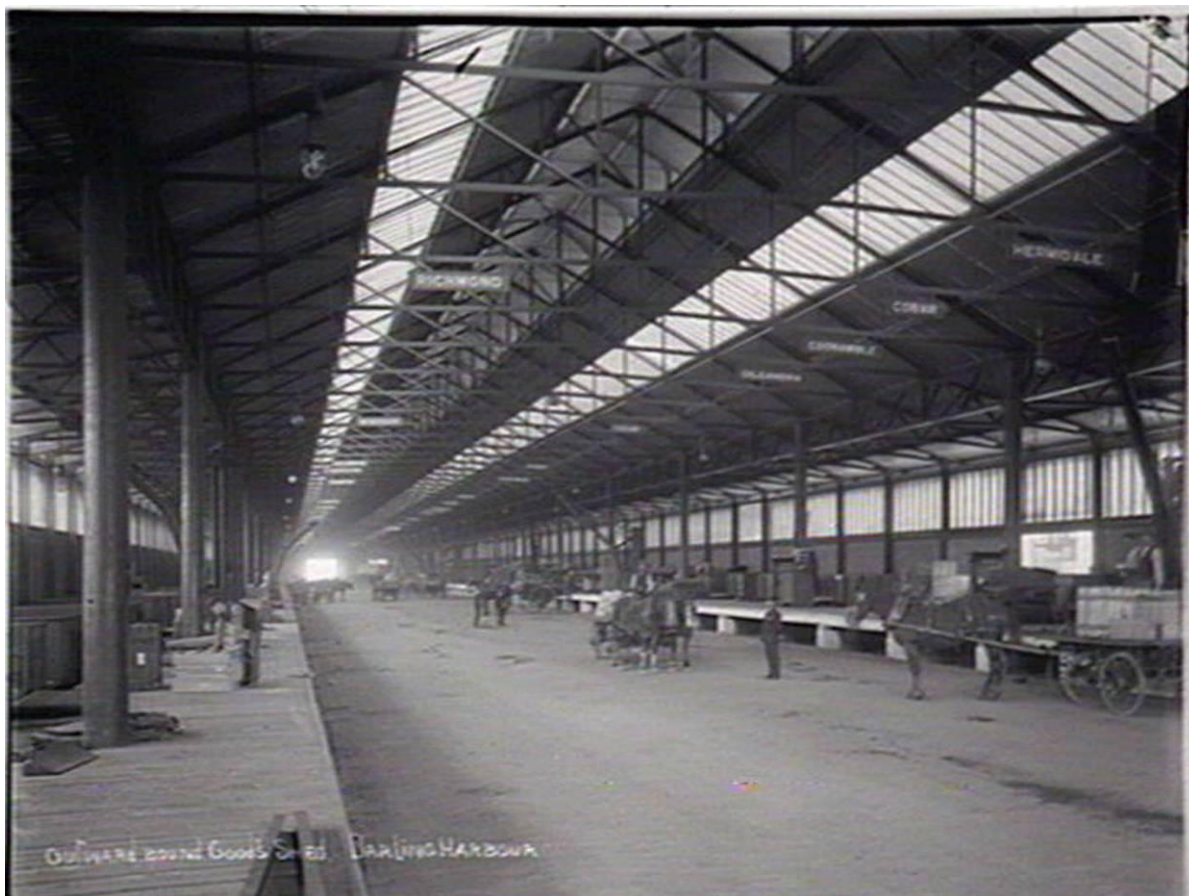
Figure 3.28: 'Outward bound Goods Shed, Darling Harbour' (no date). Interior view of one of the two sheds built in 1902. SLNSW Government Printing Office 2 – 52543, digital order no. d2\_52543.

The former railway goods yard continued to be used and occasionally changed until it was removed in the 1980s to make way for the Darling Harbour redevelopment. This continuous usage makes the survival of original railway tracks from the 1850s unlikely. One of the two Outward Goods Sheds built in 1902 were partially located in the study area (Figure 3.22, Figure 3.23, Figure 3.24, Figure 3.25, Figure 3.26, Figure 3.28, Figure 3.29).<sup>84</sup> The plans for these two sheds show that they

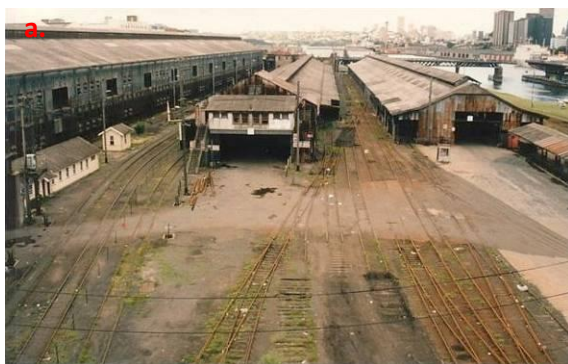
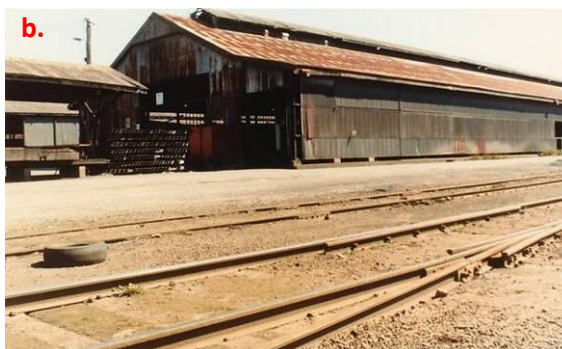
Figure 3.29: Two photos taken in 1984 by Geoff Allcock. a. – view showing (L-R) the Double Tier Goods Shed, the Outward Goods Shed and Outwards Goods Shed (west); b. – the southern end of the Outwards Goods Shed (west).

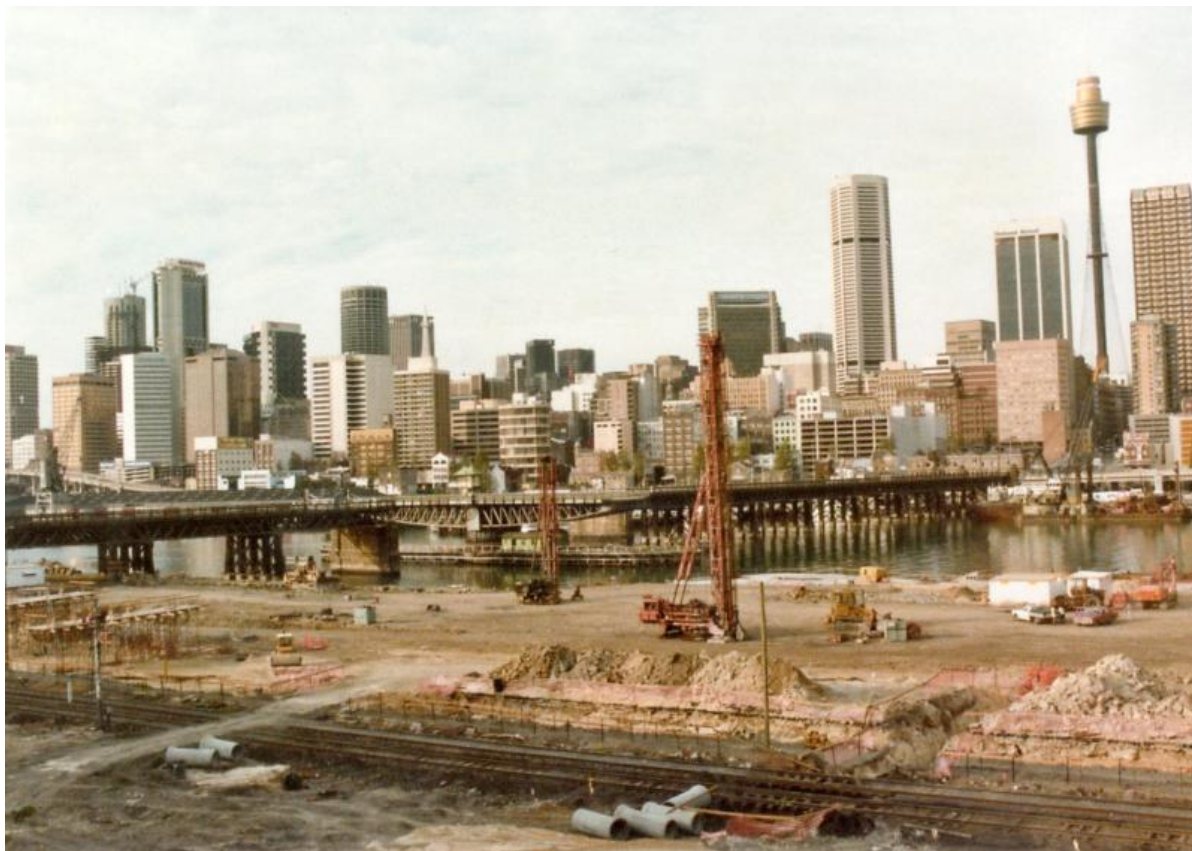
**Figure 3.30: View during 1980s Darling Harbour construction, looking northeast across what is now the Harbourside Shopping Centre. This view is probably slightly to the north of the ICC Hotel study area, but shows the kind of impact the 1980s construction would have had on archaeology associated with the Outwards Goods Shed, which previously had extended into the area shown in this photograph (Figure 3.24, Figure 3.26). Photo taken by Hilary Taylor. SHFA Collection.**

Piling associated with that part of the Sydney Convention Centre, which projects into the Hotel site, and possible piling associated with the awning joining the Harbourside Shopping Centre with other structures, is likely to have impacted on the potential archaeology but not destroyed it, based on our experience on other sites. The 1880s seawall or embankment is particularly likely to have been impacted by the 1980s redevelopment (Figure 3.30).
