Site Audit Report  
Extent of Contamination,  
Proposed International  
Convention Centre Hotel  
Development, Darling Harbour

Audit Number:  
**GN 477A**

**Re: Site Audit Report - Extent of Contamination, Proposed International  
Convention Centre Hotel Development, Darling Harbour**

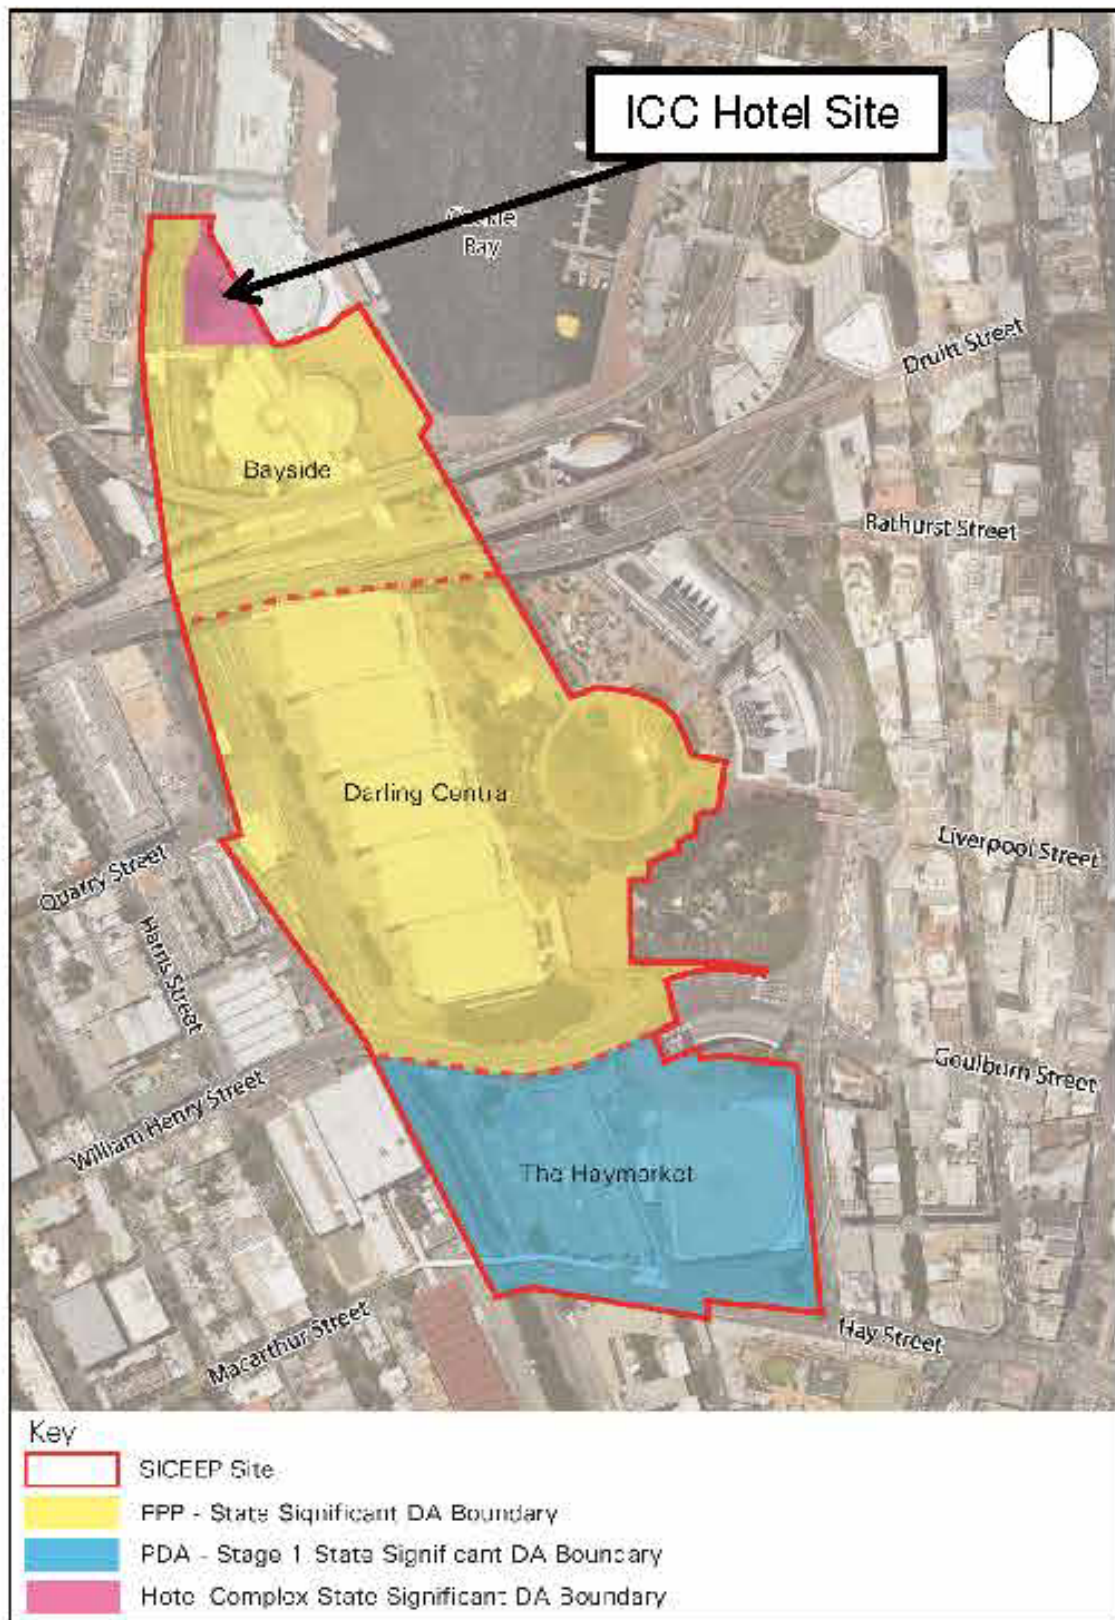
**Attachment 2: SICEEP Layout (Source: Figure 1.1  
within text Section 1.2 of Coffey 2013c)**

## SICEEP Layout
