| approved | | | project: | SICEEP - International Convention Centre (ICC) Hotel<br>Darling Harbour, Sydney | | |

# Engineering Log - Borehole

## Engineering Log - Cored Borehole

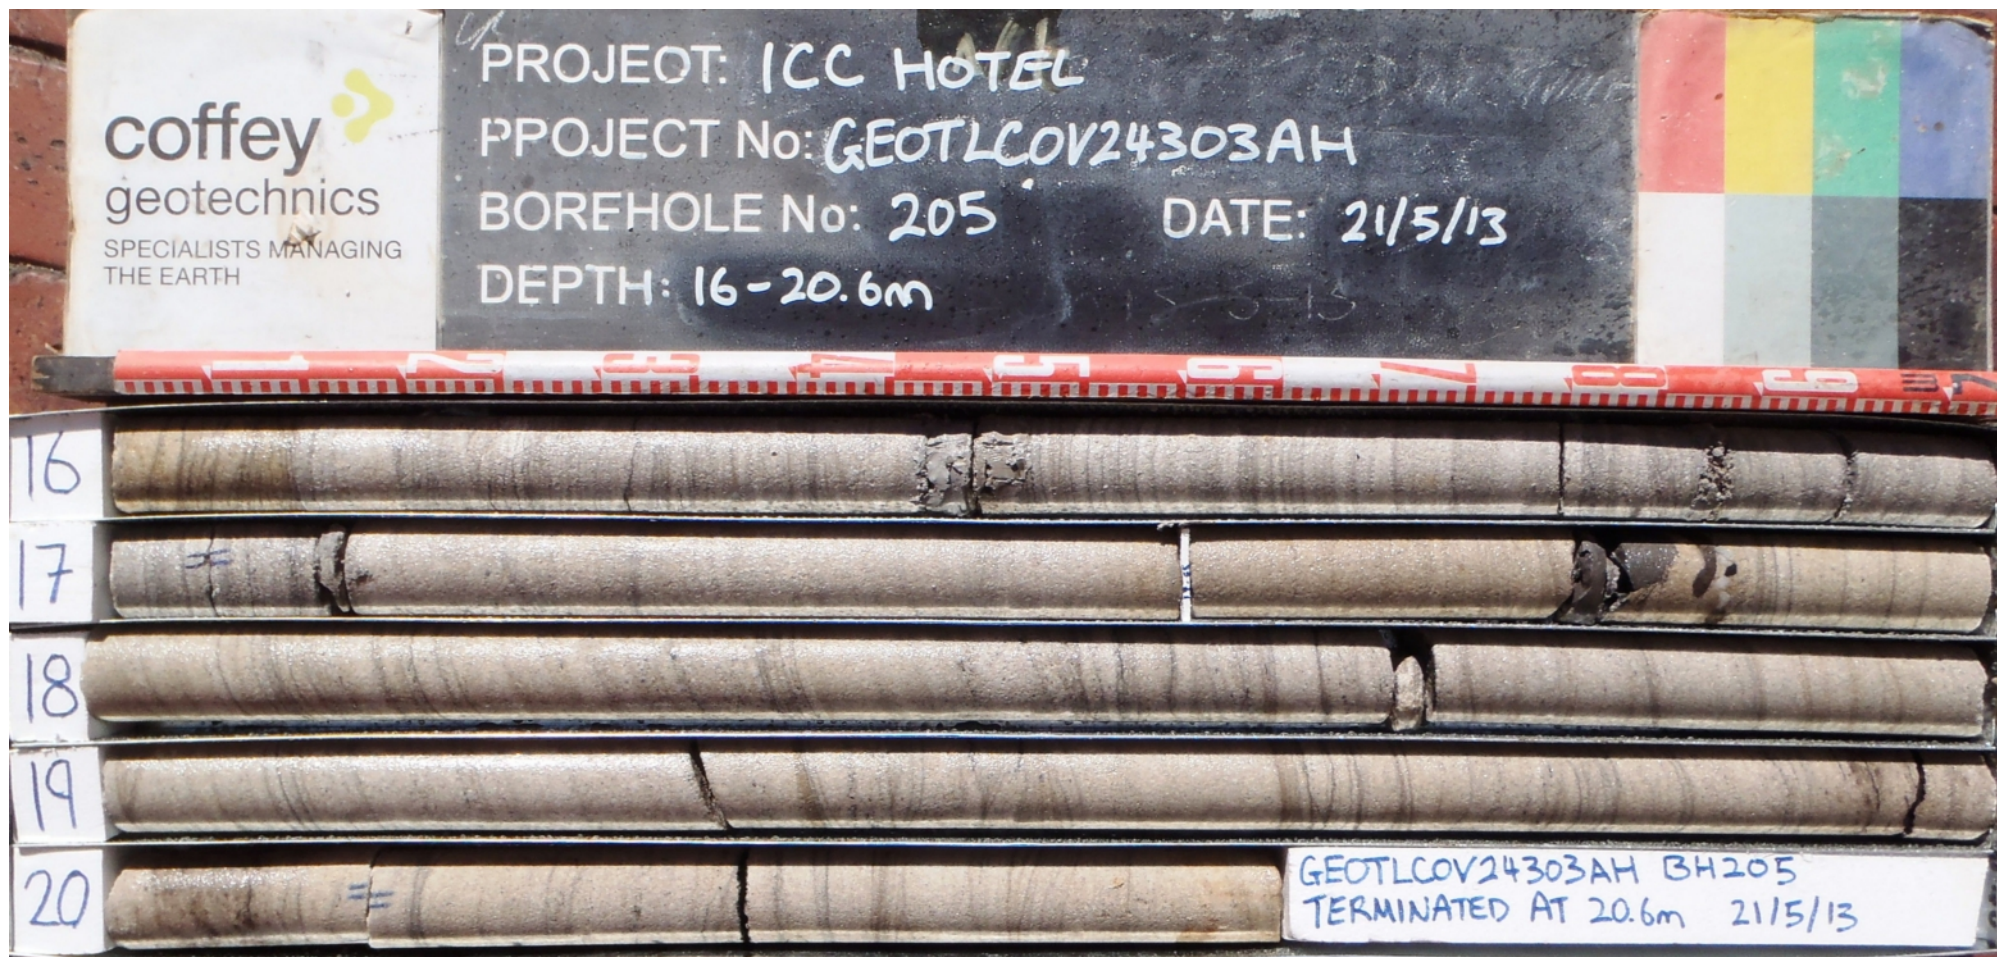
PointID : BH205 Depth Range: 16.00 - 20.60 m

| date | 07/06/2013 | | title: | <b>CORE PHOTOGRAPH<br/>BH205</b> | | |

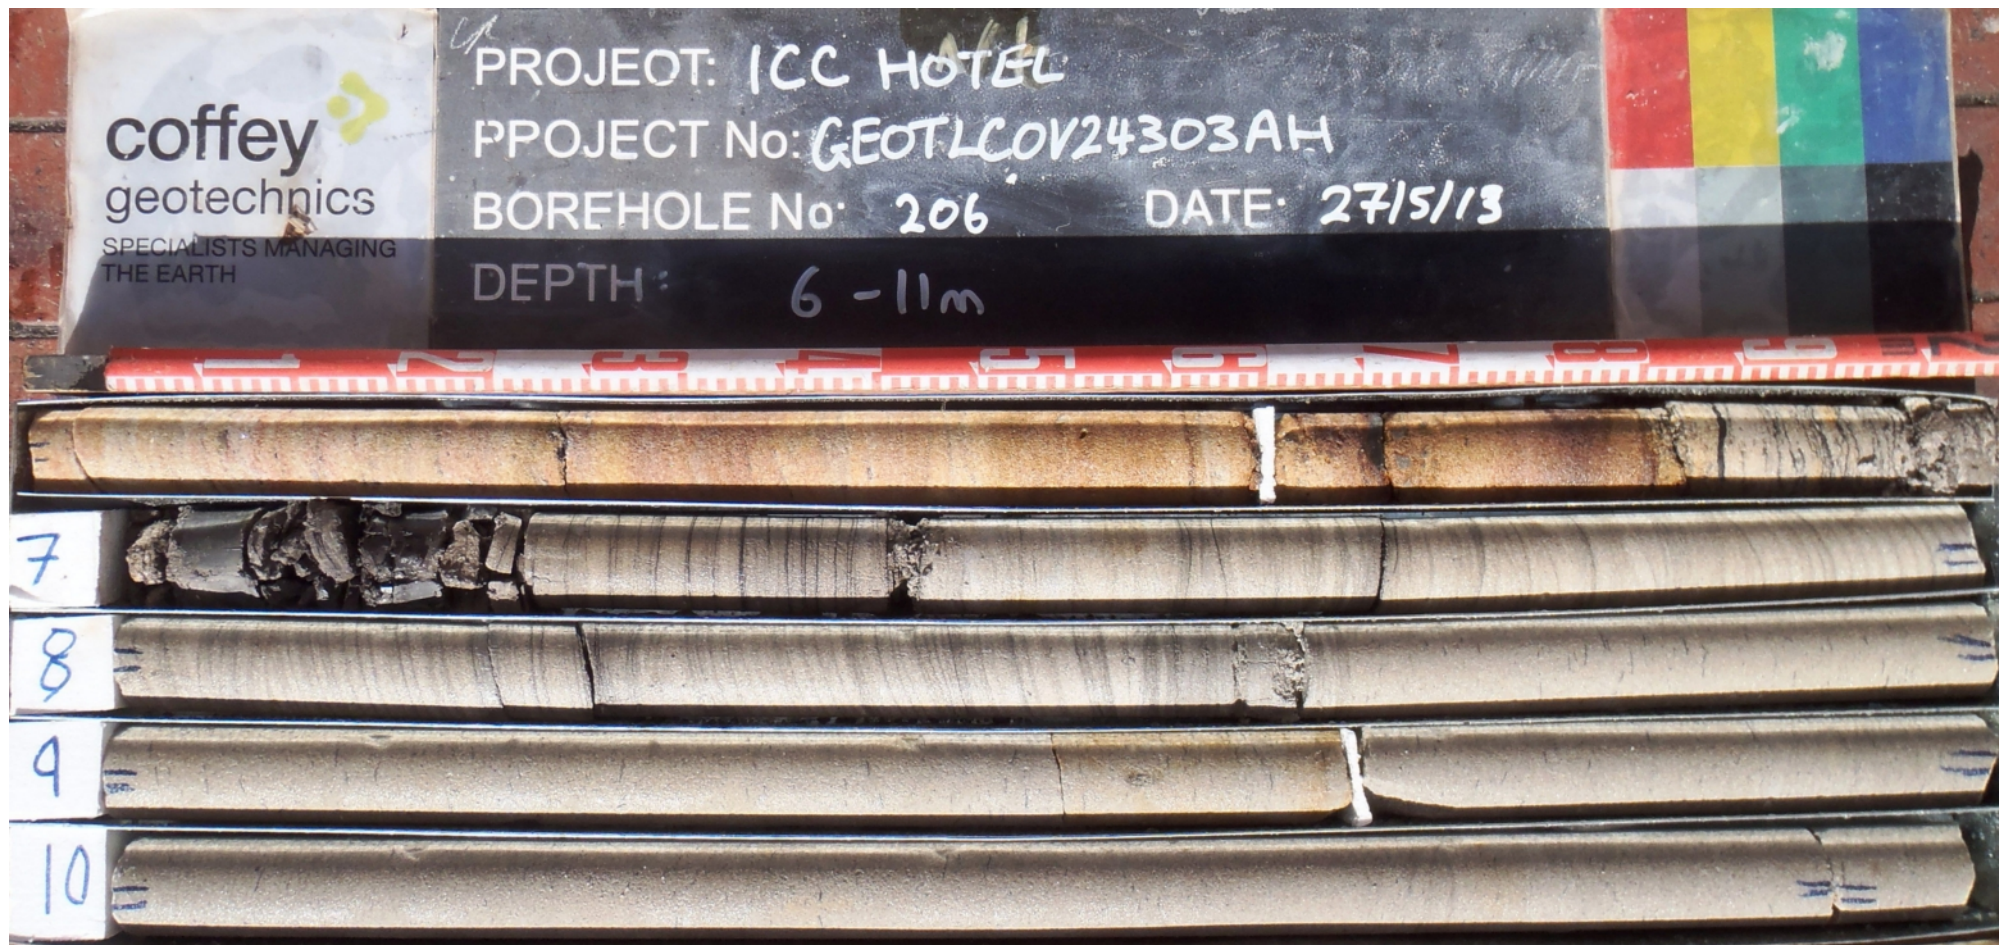
| scale | N.T.S. | | project no: | GEOTLCOV24303AH | fig no: | <b>FIGURE 20</b> |

PointID : BH206 Depth Range: 6.00 - 11.00 m

| date | 07/06/2013 | | title: | <b>CORE PHOTOGRAPH<br/>BH206</b> | | |

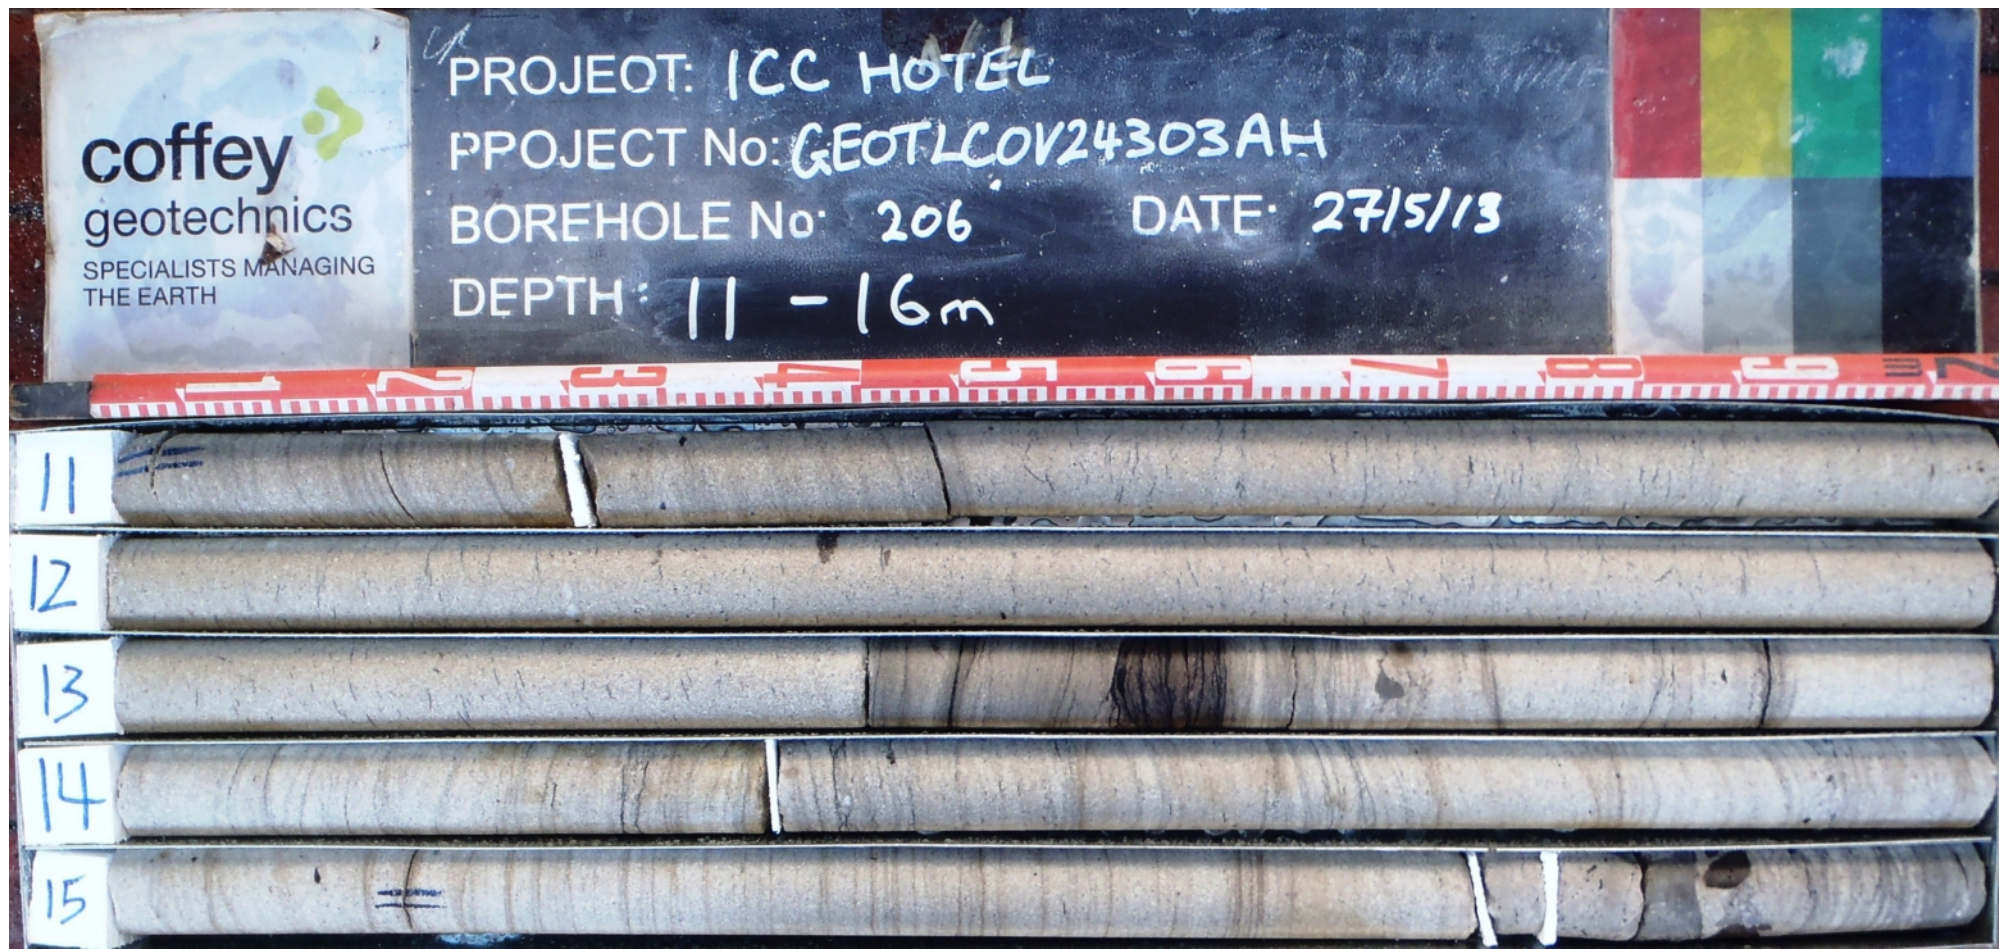
| scale | N.T.S. | | project no: | GEOTLCOV24303AH | fig no: | <b>FIGURE 21</b> |

PointID : BH206 Depth Range: 11.00 - 16.00 m

| date | 07/06/2013 | | title: | <b>CORE PHOTOGRAPH<br/>BH206</b> | | |

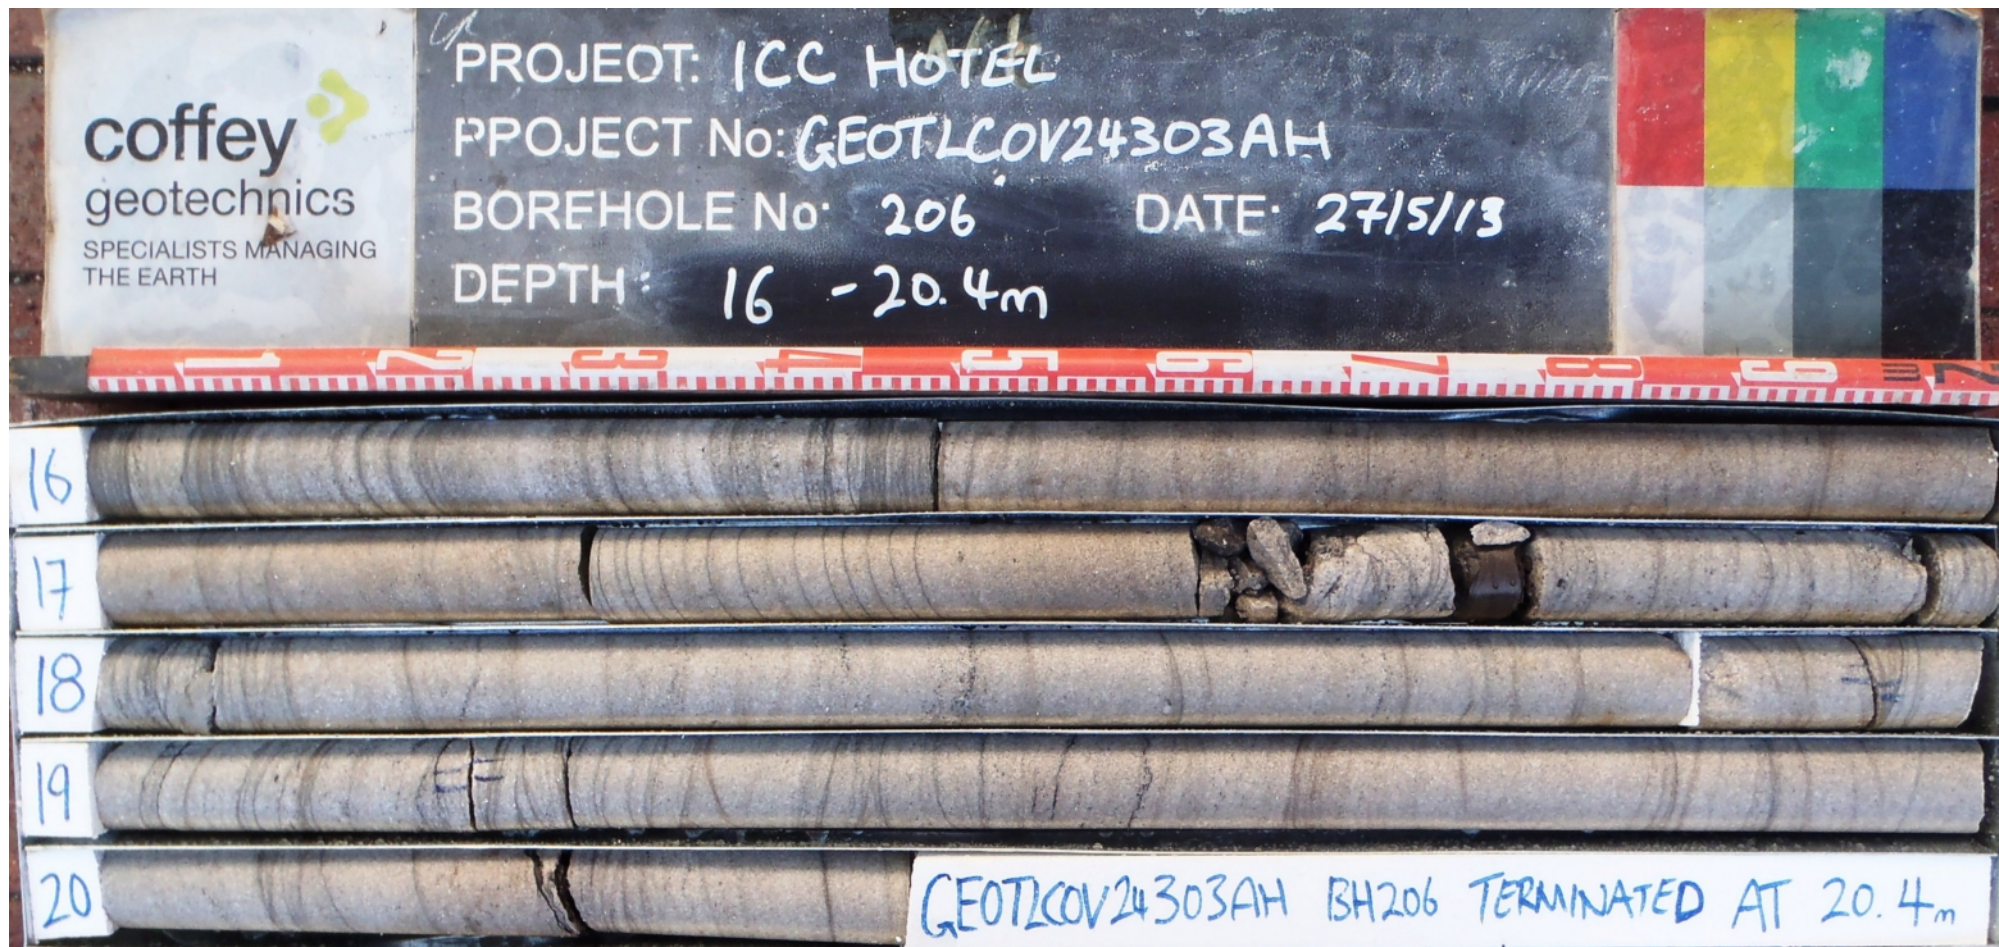
| scale | N.T.S. | | project no: | GEOTLCOV24303AH | fig no: | <b>FIGURE 22</b> |

PointID : BH206 Depth Range: 16.00 - 20.40 m

| date | 07/06/2013 | | title: | <b>CORE PHOTOGRAPH<br/>BH206</b> | | |
