Name of operation	Cabbage Tree Road Sand Quarry
Name of operator	Newcastle Sand
Development consent #	SSD-6125
Name of holder of development consent / project approval	Williamtown Sand Syndicate Pty Ltd
Mining lease #	Not applicable
Water licence #	Not applicable
MOP/RMP	Not applicable
Annual Review start date	1 January 2019
Annual Review end date	31 December 2019
<p>I, Darren Williams, certify that this audit report is a true and accurate record of the compliance status of the Cabbage Tree Road Sand Quarry for the period 1 January 2019 to 31 December 2019 and that I am authorised to make this statement on behalf of Newcastle Sand.</p> <p><i>Note.</i> a) The Annual Review is an 'environmental audit' for the purposes of section 122B(2) of the Environmental Planning and Assessment Act 1979. Section 122E provides that a person must not include false or misleading information (or provide information for inclusion in) an audit report produced to the Minister in connection with an environmental audit if the person knows that the information is false or misleading in a material respect. The maximum penalty is, in the case of a corporation, \$1 million and for an individual, \$250,000. b)

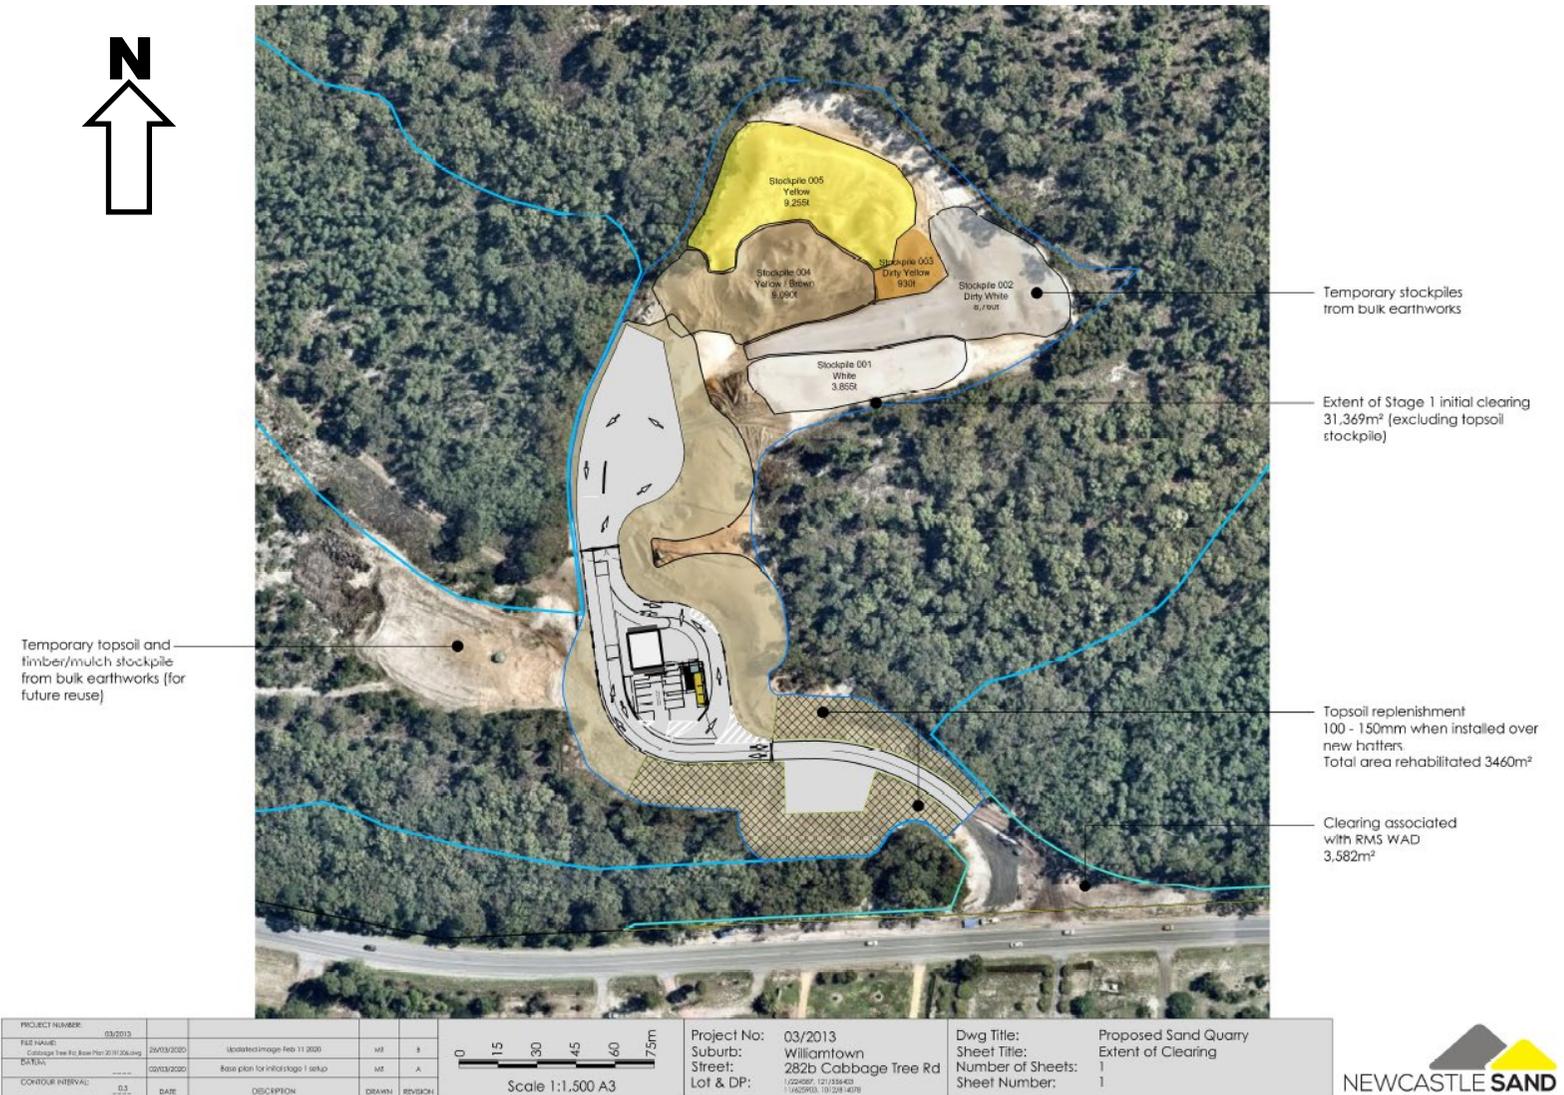
Figure 4: Progress at end of period, showing stockpiles and extent of clearing during the reporting period

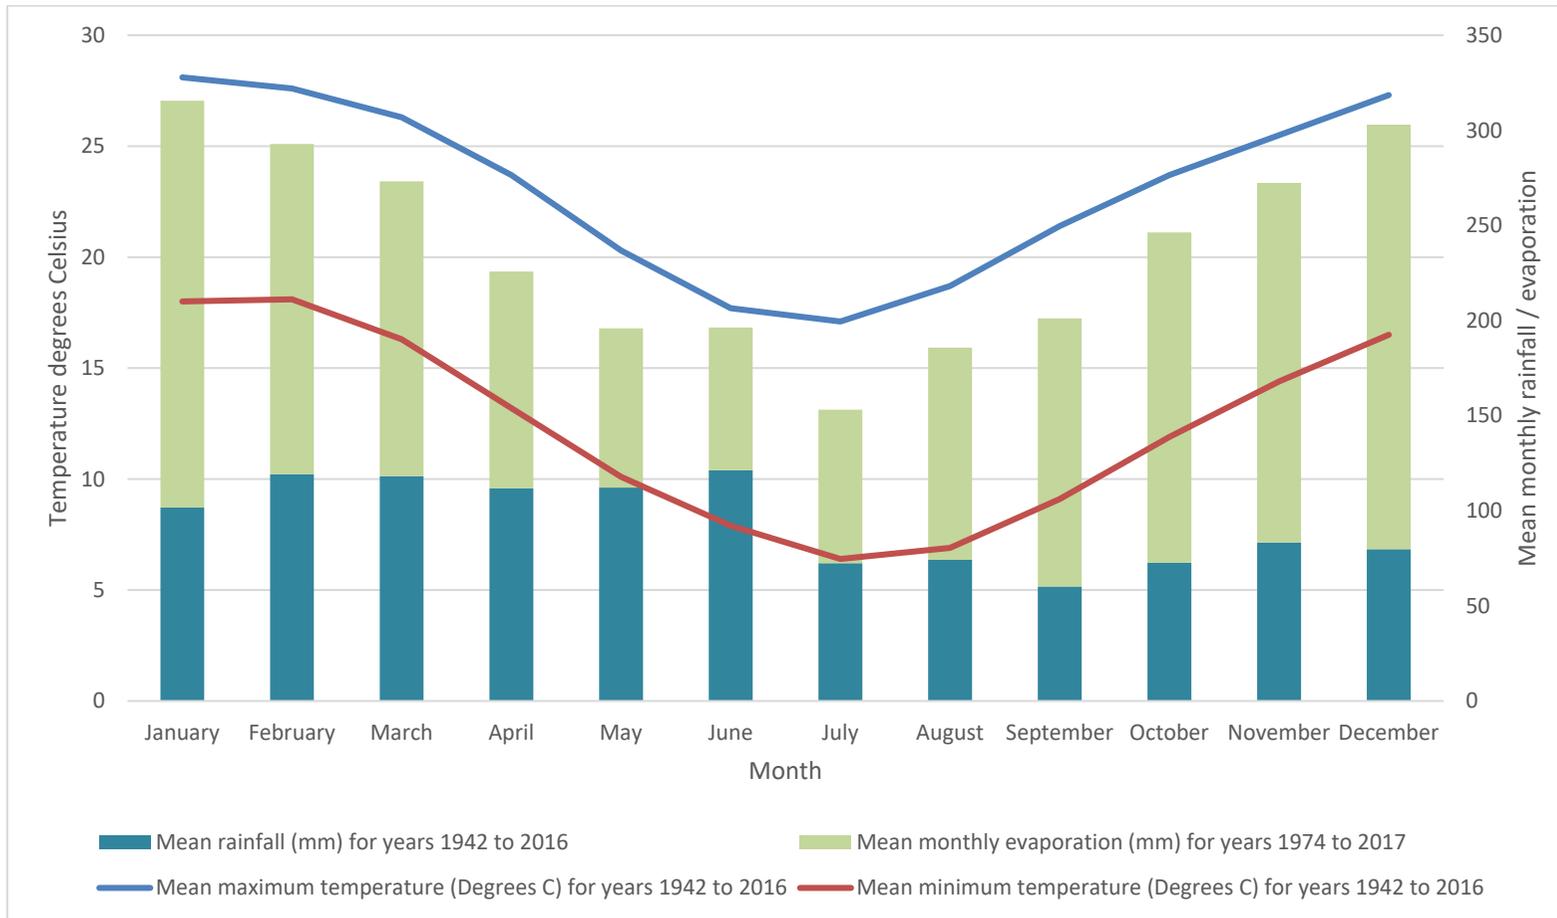
- The driest month on average is September, with the wettest in June.

Figure 5: Monthly average rainfall, evaporation, minimum and maximum temperatures recorded at Williamtown Airport weather station

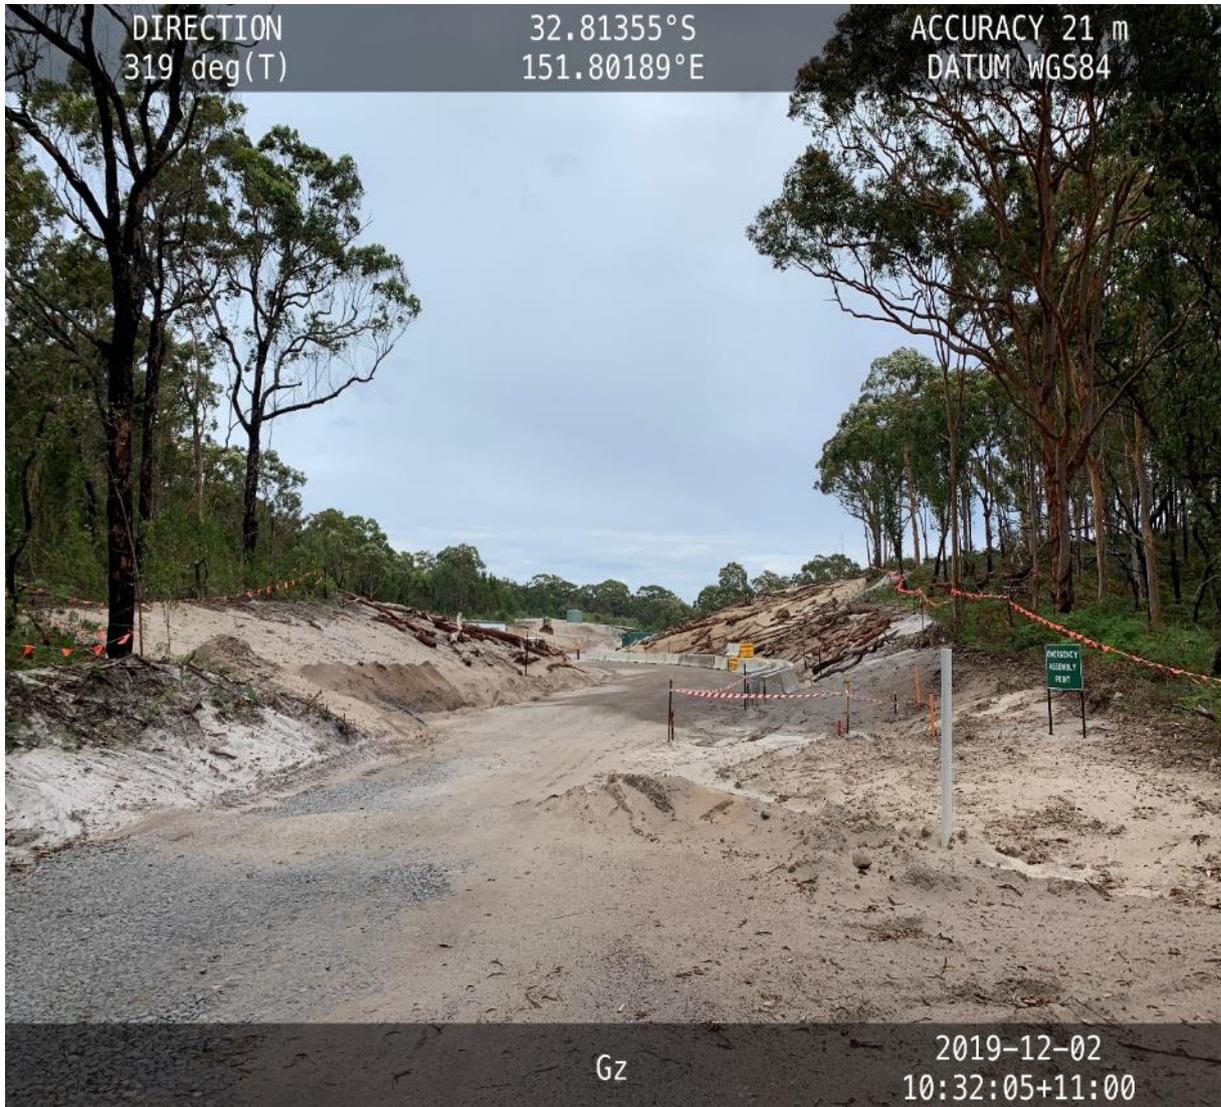
stabilisation (See **Photograph 1 / Photograph 2**) . As no 'Quarrying Operations' have yet commenced, progressive rehabilitation associated with such activity has not yet begun.

Photograph 1: Jersey Kerb awaiting installation on Cabbage Tree Road and Cleared Vegetation used for ground stabilisation looking into site

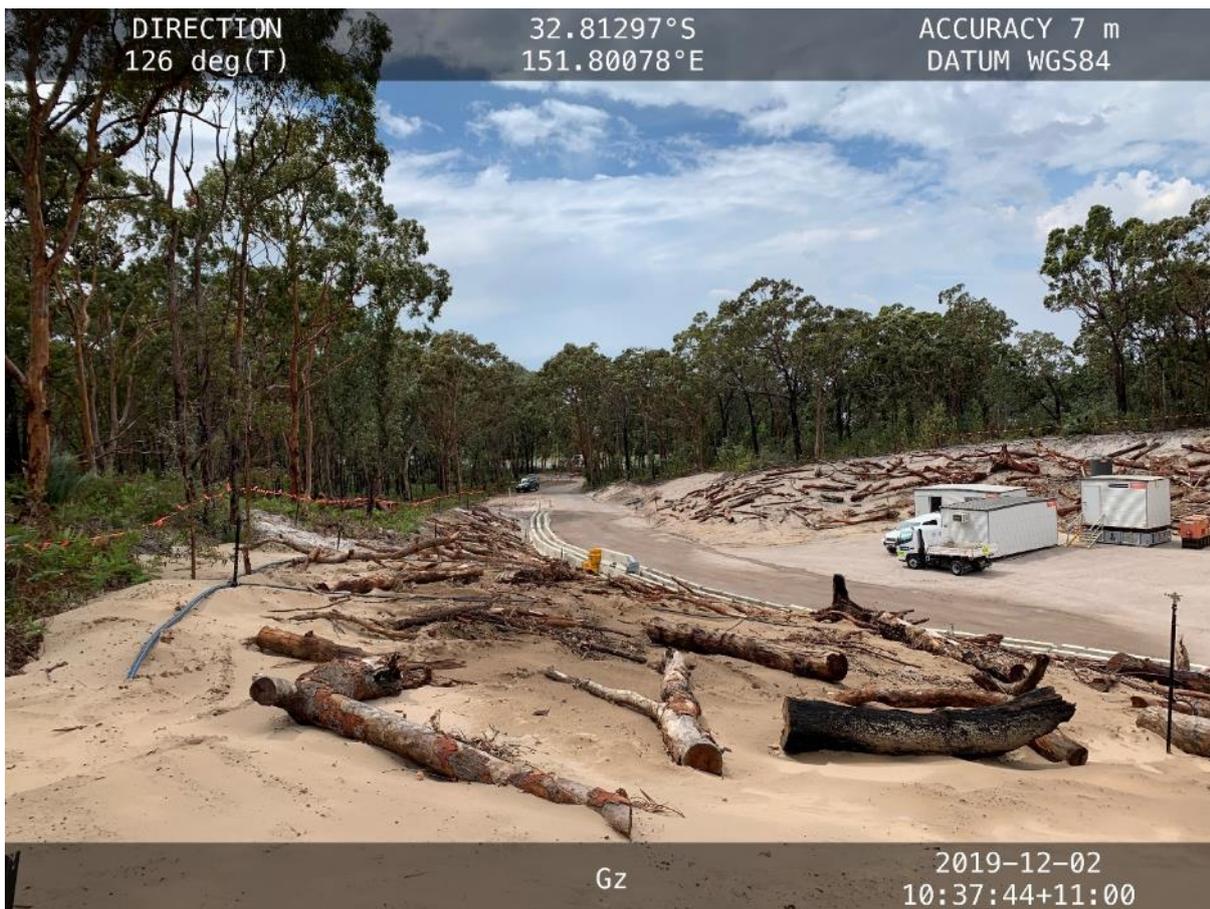
Photograph 2: Jersey Kerb Installation and Cleared Vegetation ground stabilisation looking from site to exit gate

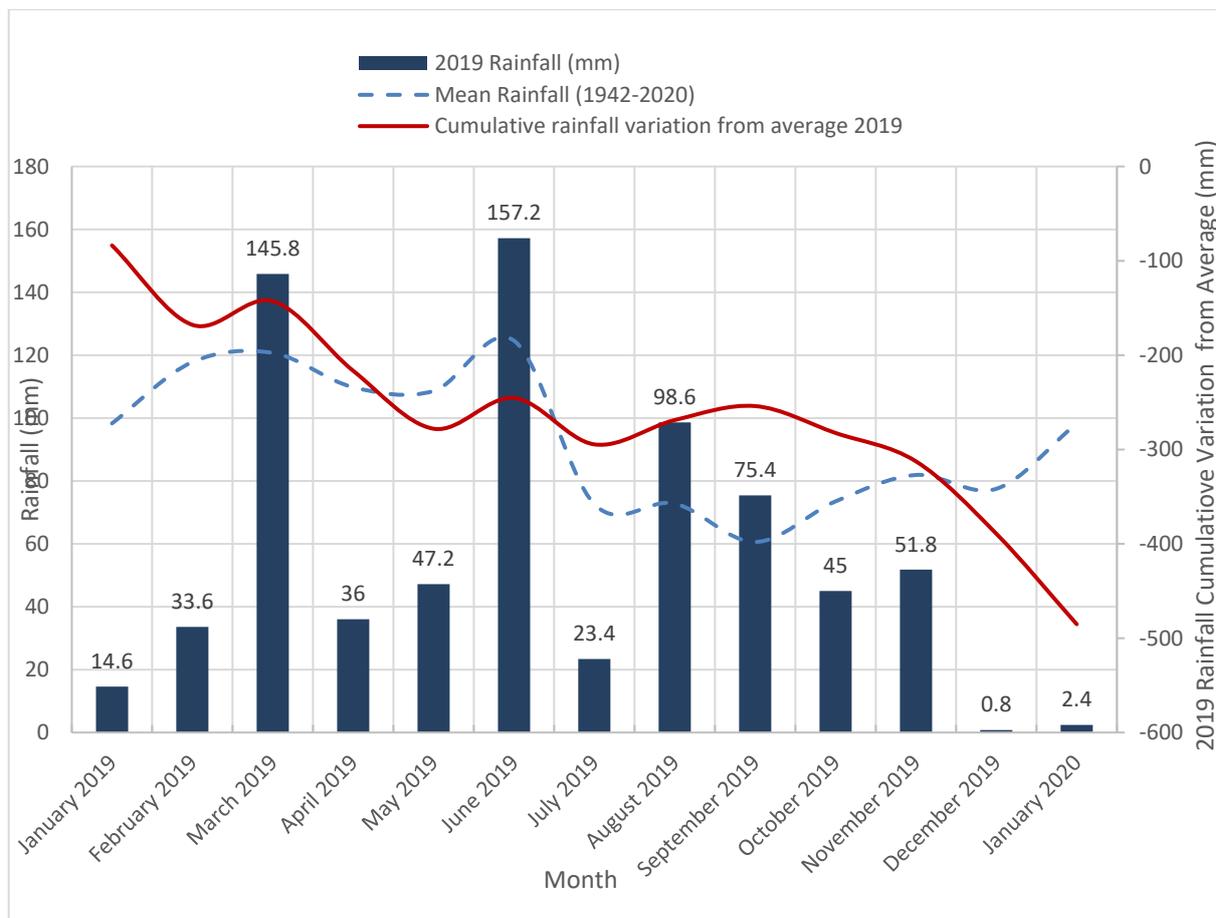
Figure 6: 2019 Monthly Rainfall Totals (Williamstown RAAF) and variation from average

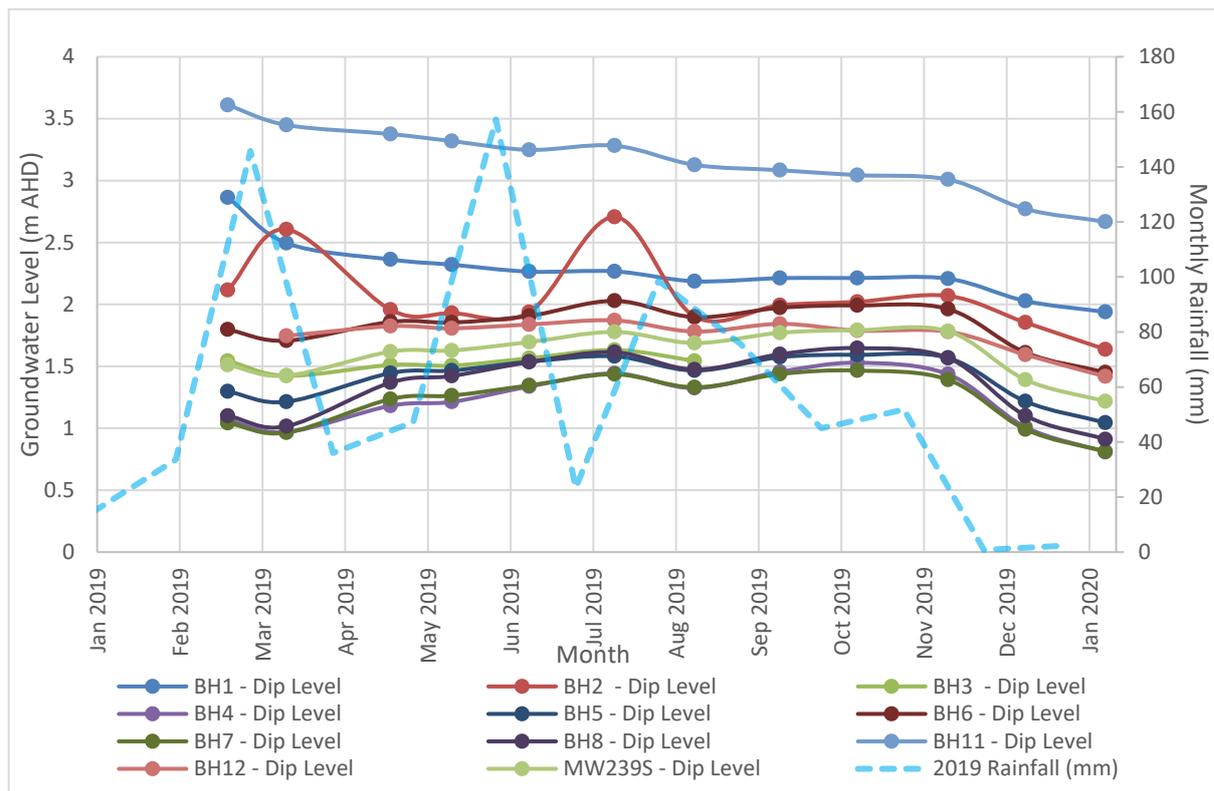
Groundwater throughout the sampling locations demonstrated a general decline in elevations throughout the 12-month period. Most notably the greatest decline in groundwater elevations was observed in the months following the November 2019 water monitoring event which correlates directly with a significant decrease in rainfall from the mean average and increase in temperatures with the onset of summer. presents the monthly rainfall recorded at Williamstown RAAF, and shows during 2019 there was 485mm less rainfall than average. **Figure 8** provides a graphical representation of groundwater elevation identified during gauging at each location.

Figure 8: Monthly groundwater elevation from manual gauging and 2019 monthly rainfall

Prior to the commencement of construction activities two anomalies were observed within BH2 for the manual gauging records. A review of the gauging records suggest these may be the result of sampling error, with the groundwater level logger showing negligible change during the same period. A chart for each of the wells with loggers installed is included as **Appendix 6**.

BH9 was dry during 2019. The monitoring network was developed based on the levels measured on seven occasions since monitoring wells were installed in 2014, BH9 appears to have been dry on two of these preceding monitoring events leading up to 2019. BH10 has been infiltrated by roots, making reliable measurement unfeasible.

The Maximum Extraction Depth report provides for a series of trigger action response plan (TARP) levels for each bore. Where monitoring shows groundwater levels are less than 0.5m from the maximum inferred groundwater level, additional monitoring is recommended. Owing to the low rainfall and low ground water levels, no monitoring well reached TARP Level 1 for groundwater levels.

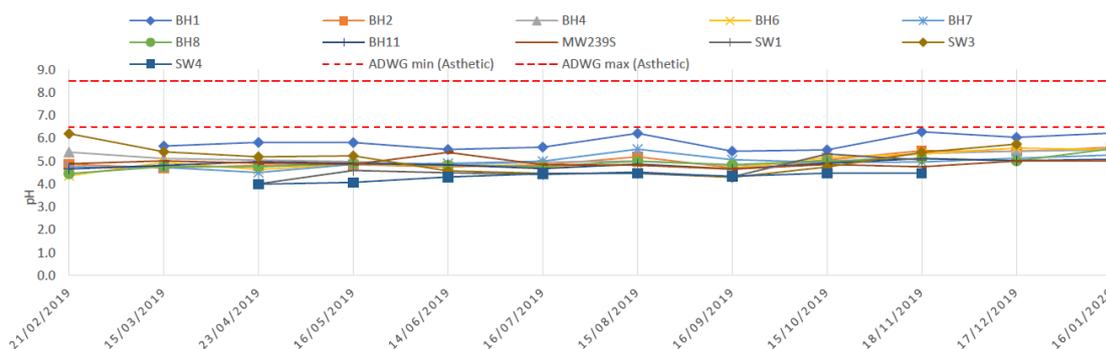
- pH: for the site is acidic, ranging between a pH of 4 and 7, BH1 is typically the highest, SW4 is typically the lowest.
- Electrical conductivity is generally relatively fresh and is typically below 1000 µS/cm, with the exception of SW1 adjacent to Cabbage Tree Road.
- Iron (Fe) is relatively low, with levels relative to the pH, BH1 has consistently the highest levels.
- Sulphate (SO₄) levels are relatively low and consistent, with SW1 showing the most variability.
- Manganese (Mn) is present, though at low levels across the site, the highest levels were found at SW1 and BH4.
- Arsenic (As) was on occasion detected above the laboratory detection levels at BH8 and SW3, however, in the majority no arsenic was measured in water across the site.
- Copper (Cu) was typically highest in BH4 and BH2, with levels starting to increase in June, possibly in response to the high June rainfall.

Figure 9: Laboratory pH

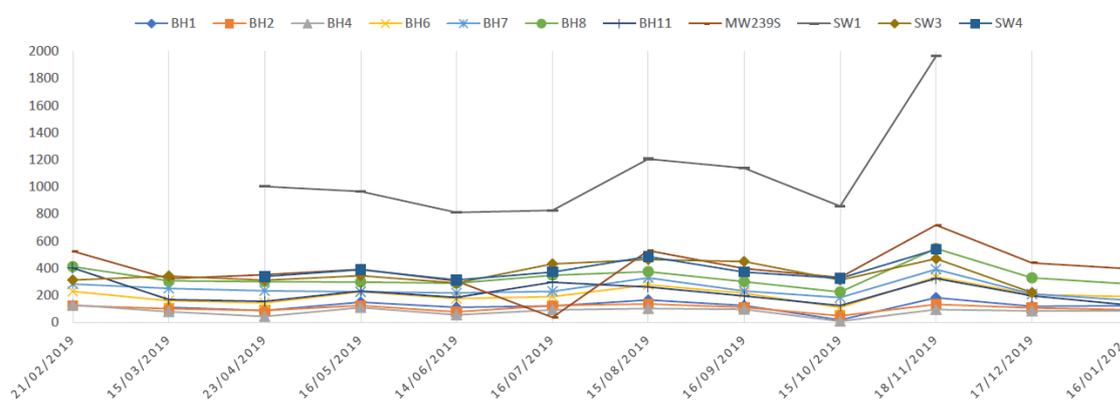
Figure 10: Field electrical conductivity (µS/cm)

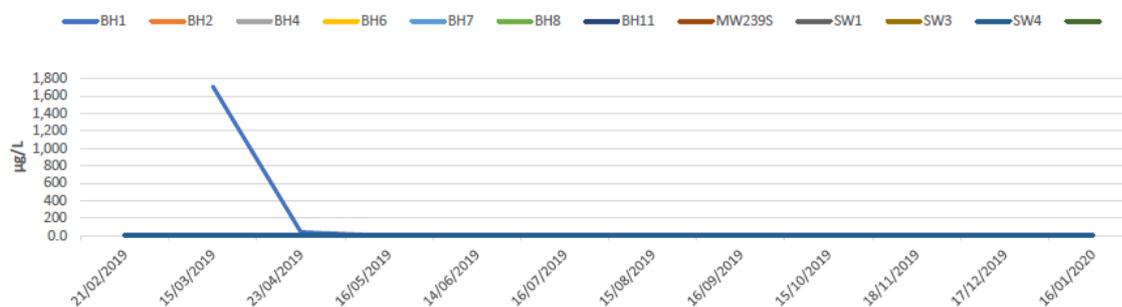
BTEXN, TPH and TRH were generally not detected across the majority of the Site with the exception of BH1 and BH4. At the initiation of the baseline sampling program in February 2019 BH1 was refitted with a PVC pipe to replace a previously fire damaged one. In the process an acrylic adhesive was applied to fuse the pipes together which likely initiated increased concentrations of TPH C6 - C9 (1,710µg/L) and TRH C6 - C10 (1,690µg/L) within the well. The subsequent months following reinstallation of the well concentrations of TPH and TRH fell to below LOR.

Figure 15: Total petroleum hydrocarbons (TPH) C₆ - C₉ in µg/L

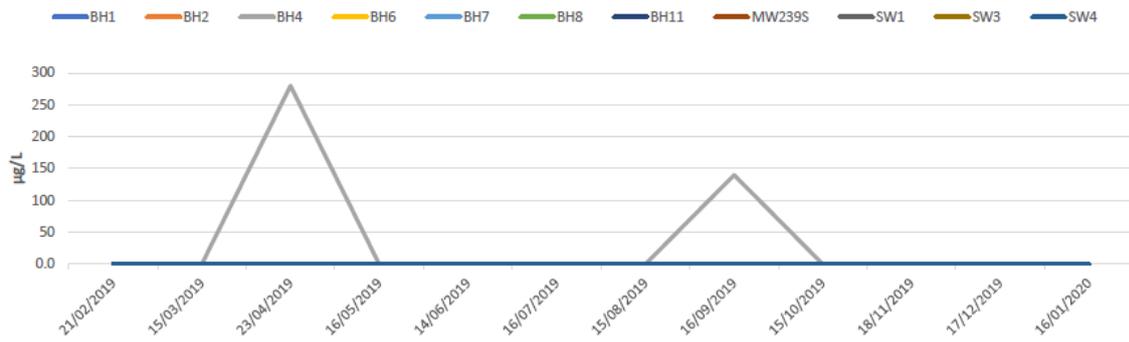
Concentration of hydrocarbons detected at BH4 are most likely influenced by the adjacent Cabbage Tree Road. Concentrations were detected following some form of rainfall in the region and ongoing detections are likely given the location of BH4 being in close proximity to a relatively busy carriageway. Ongoing monitoring of hydrocarbons is recommended, for due diligence purposes, given the potential likelihood for spills to occur from operational vehicles.

Figure 16: Total recoverable hydrocarbons (TRH) C₁₀-C₃₆ in µg/L

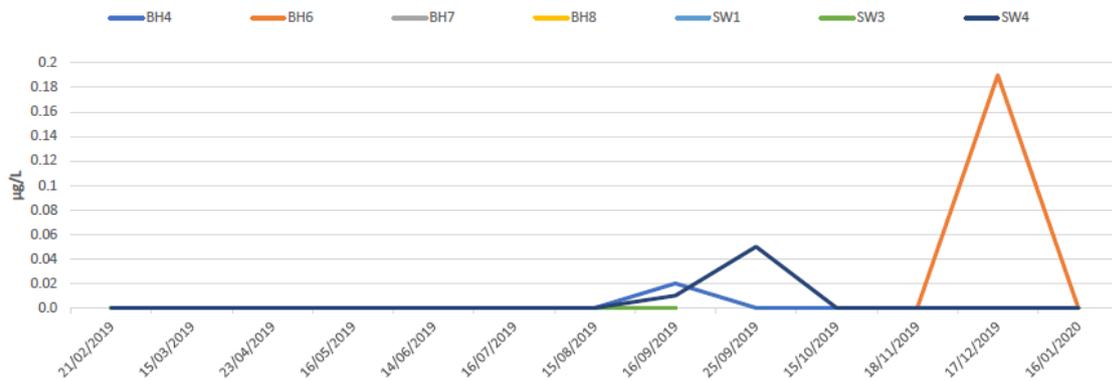
Figure 17: Sum of PFAS in µg/L

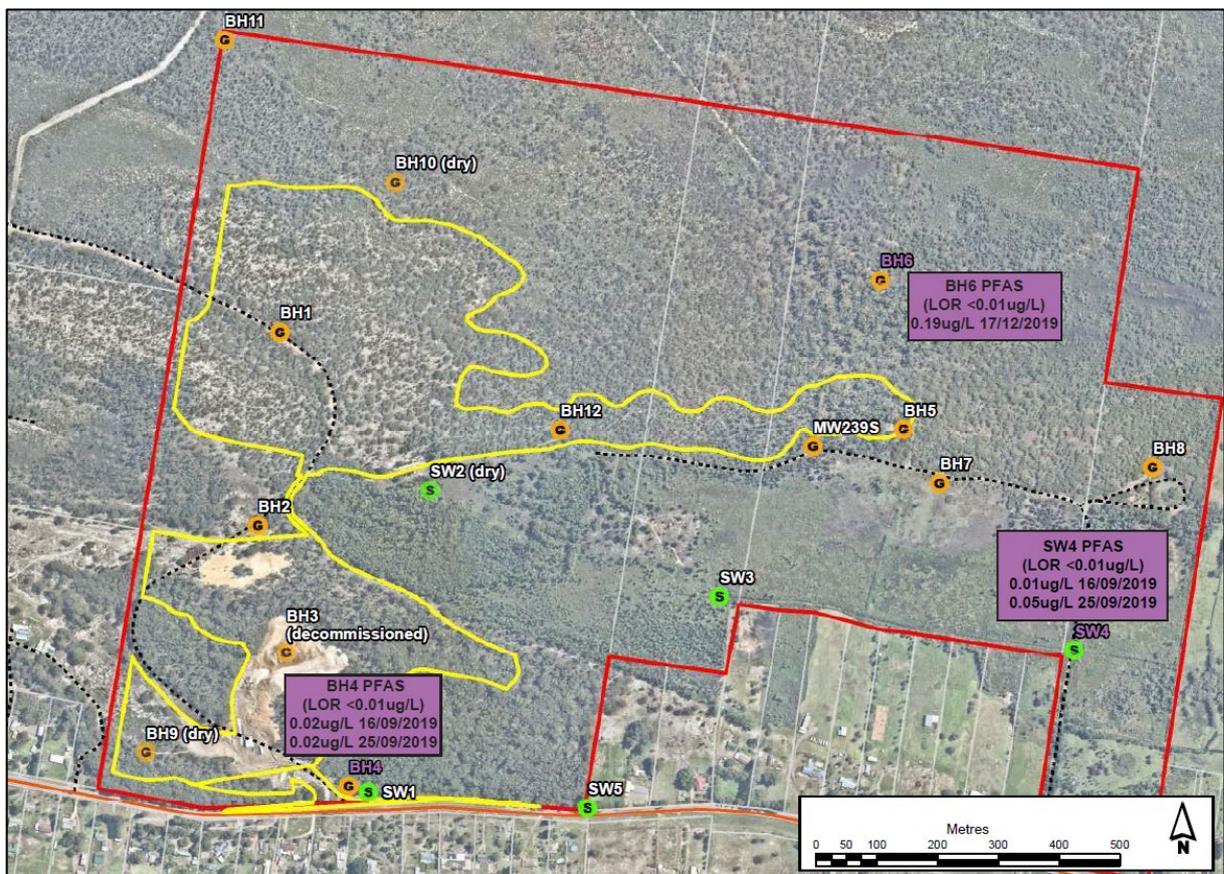
- A light fraction of total petroleum hydrocarbons (TPH), C₆-C₉ were found in BH1 associated with repairs to the piezometer. It is possible that the variability of several parameters in BH1 is the result of repairs (e.g. zinc, chromium, TPH, iron).
- Total recoverable hydrocarbons (TRH) C₁₀-C₃₆, characteristic of heavy hydrocarbons (e.g. diesel, grease and oil) were detected in BH4 on two occasions, likely due to proximity of Cabbage Tree Road.
- PFAS was detected above the limit of reporting at three sites, SW1 and SW4 and BH6. Levels at SW1 is consistent with Defence sampling of plume to the south, while SW4 is located on a drainage channel on the eastern side of property, and BH6 located to the north east as shown by **Figure 18**.

Figure 18: Locations where PFAS was detected during the period

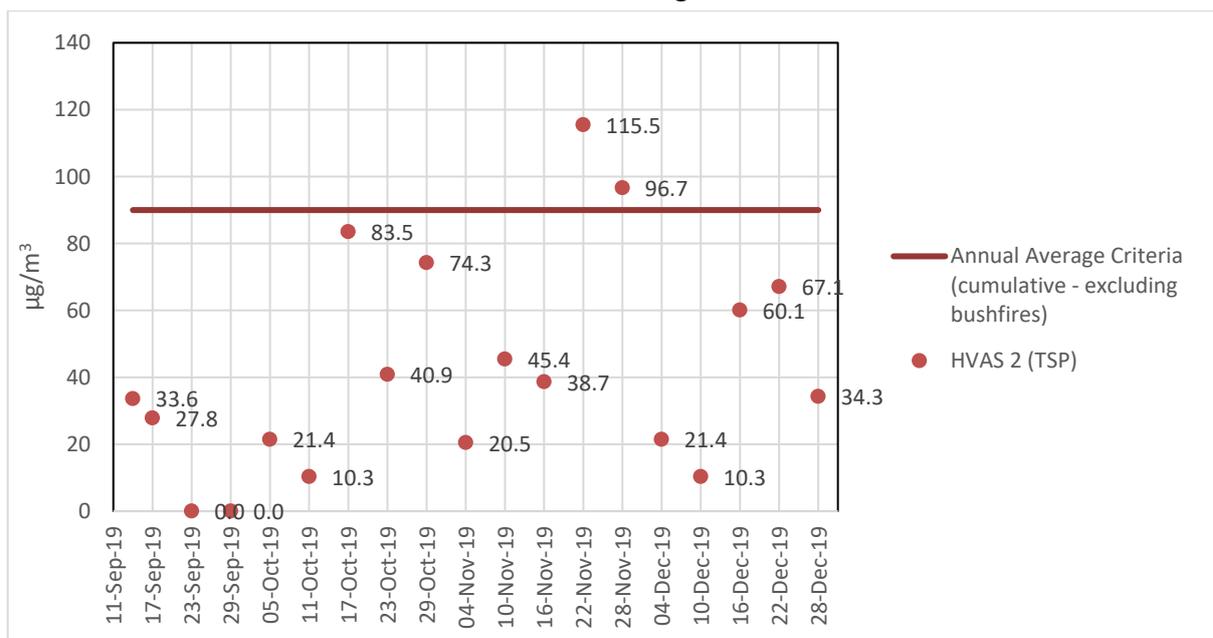
Figure 21: HVAS (TSP) sample results from 14 September to 31 December 2019

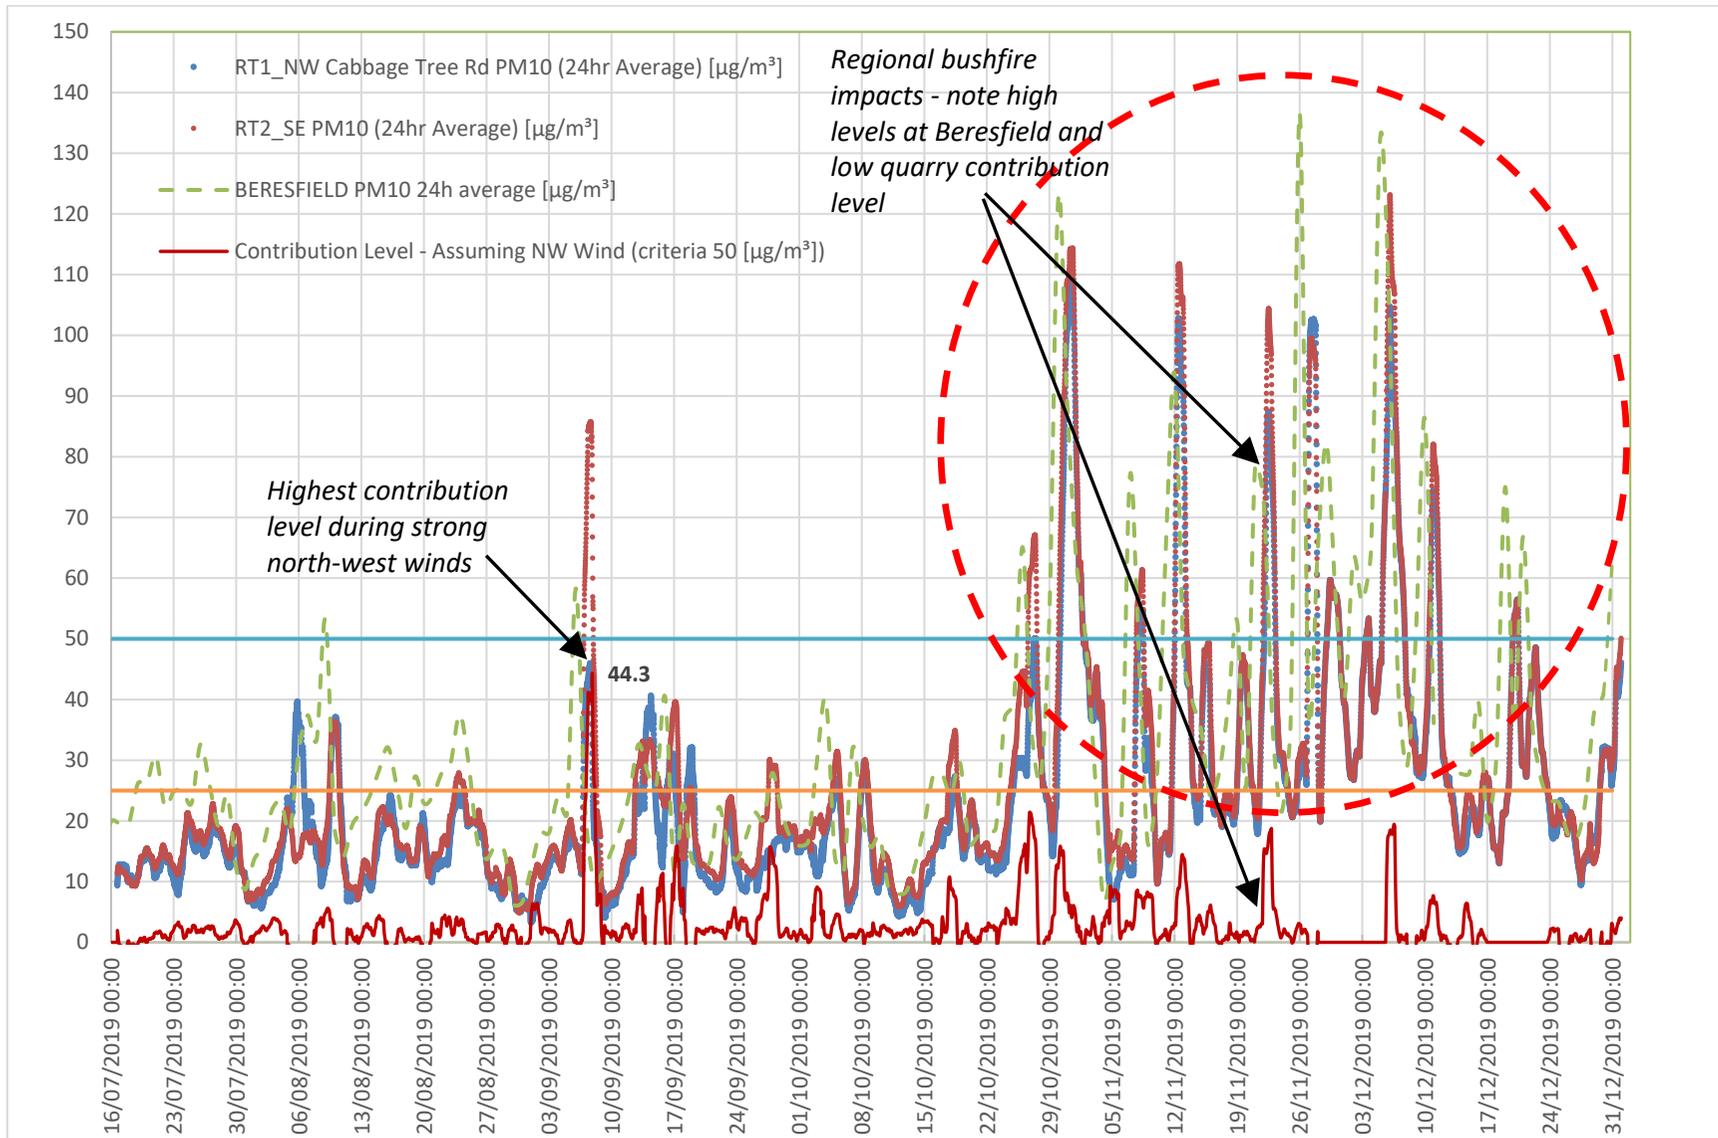
RT1 is located to the west of the quarry, while RT2 is to the south. RT1 enables the determination of reasonable background conditions during a north-westerly wind such that the contribution of the quarry to the dust measured at RT2 can be determined, and vice-versa during a south-easterly wind.

Over the period the strongest and most persistent winds occurred from the north west direction, and are considered to be the weather conditions onsite likely to have the greatest potential for air quality impacts at receptors south of the quarry.

Figure 22: Analysis of Real-Time Air quality data during the period, includes DPIE Beresfield station for context.

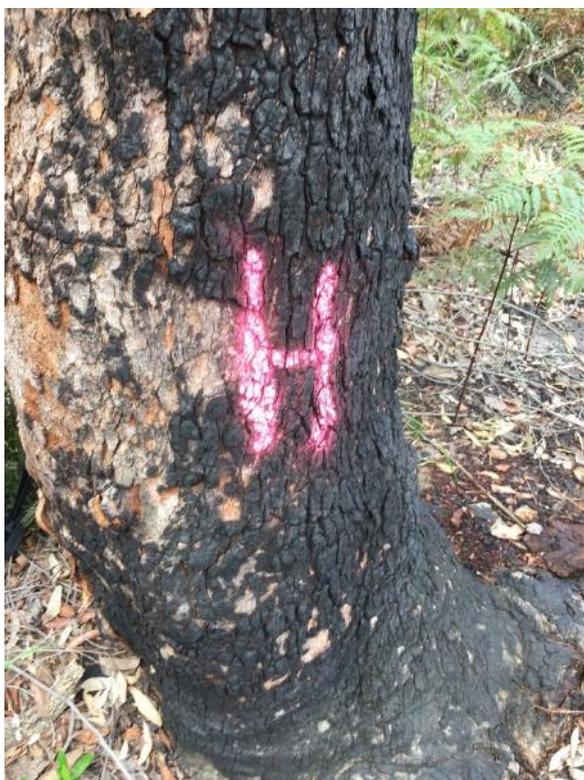
Clearing occurred under the supervision of an ecologist. Habitat trees were clearly marked prior to clearing using flagging or spray paint (see **Plate 3** and **Plate 4**). No fauna injuries were reported (see Section 7.10). A copy of the hollow bearing tree inspection

Plate 3: Habitat tree clearly marked with spray paint prior to clearing under supervision by an ecologist.

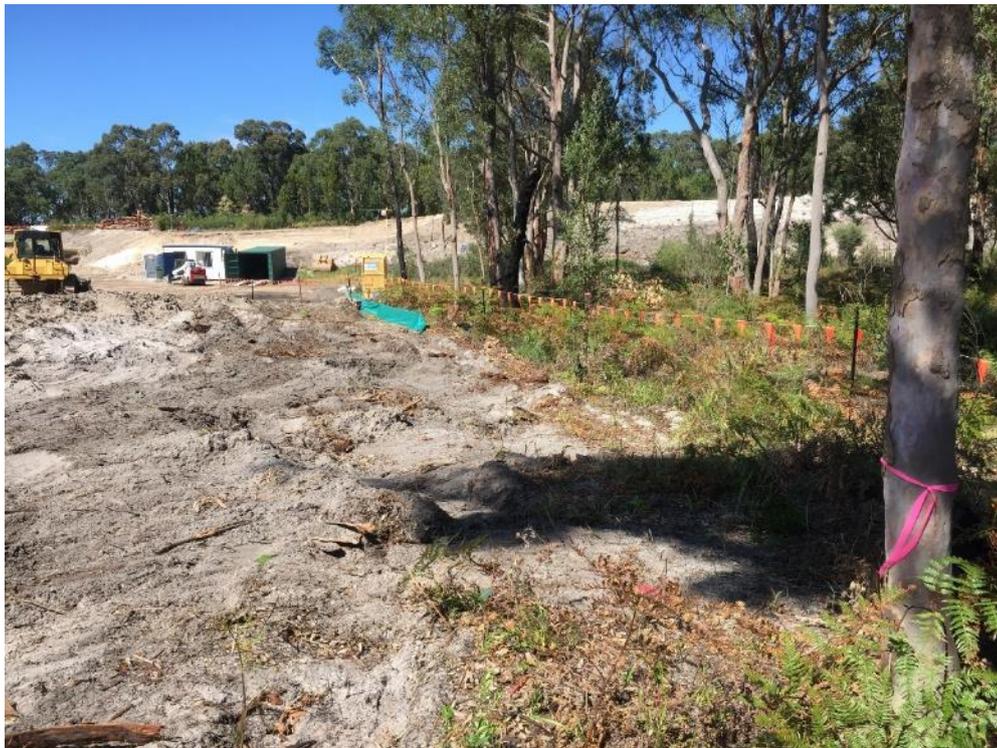
Plate 4: Habitat tree clearly marked with flagging tape prior to clearing under supervision by an ecologist.

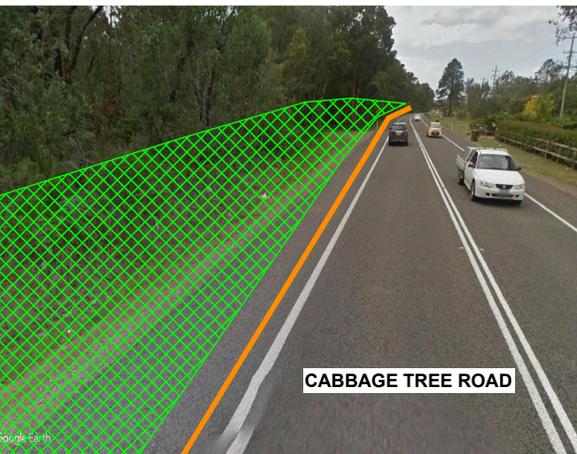
TCP 1 - Cabbage Tree Rd - Williamtown - Shoulder Closed - Long Term

- Property Boundry
- RMS Approved Jersey kerb
- Temporary Fence
- traffic controller
- Work Area

End Treatment - Absorb 350 crash cushion

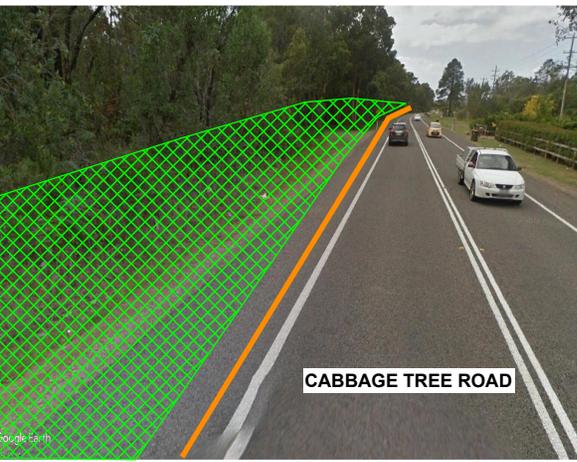
TCP 2 - Cabbage Tree Rd - Williamtown - Shoulder Closed - OUT OF HOURS

- Property Boundry
- RMS Approved Jersey kerb
- Temporary Fence
- Work Area

End Treatment - Absorb 350 crash cushion

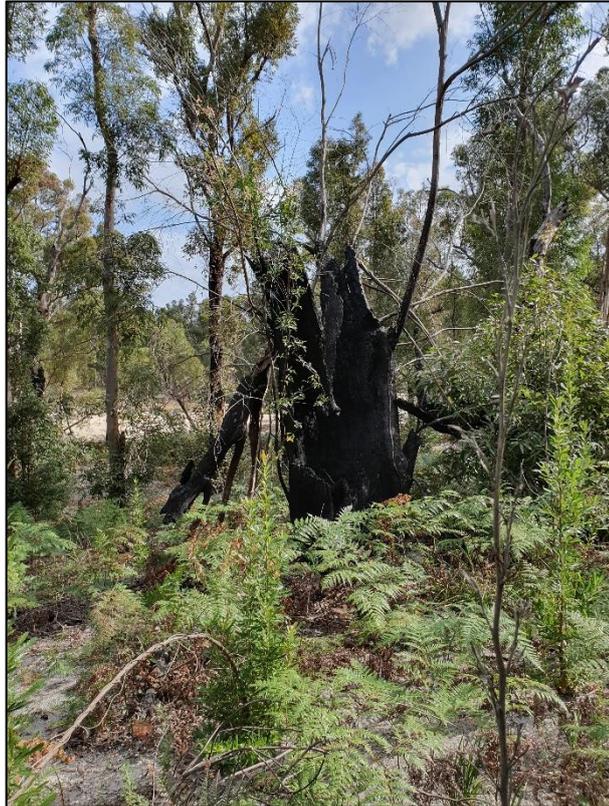
Photograph 1: Burnt out tree determined likely to constitute Tree 238

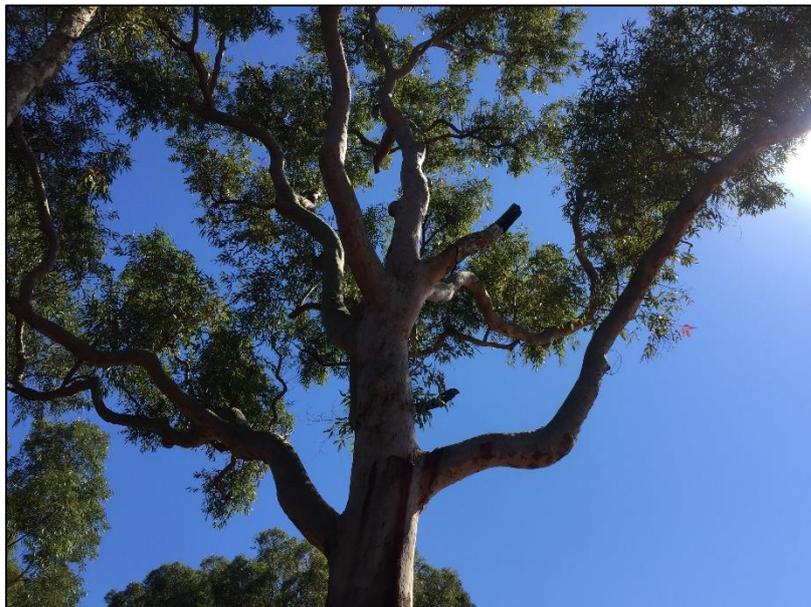
Photograph 2: Hollow limb within Tree 214

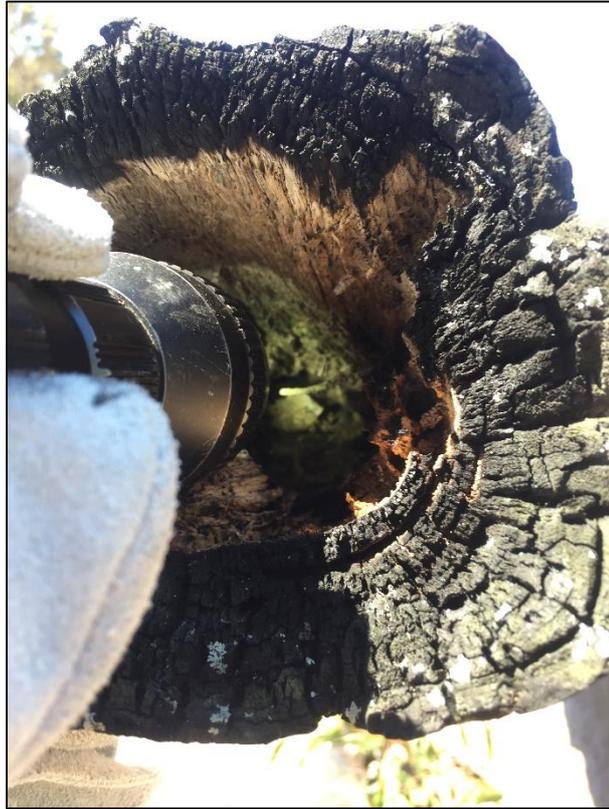
Photograph 3: Small hollow limb being inspected following felling of Tree 214

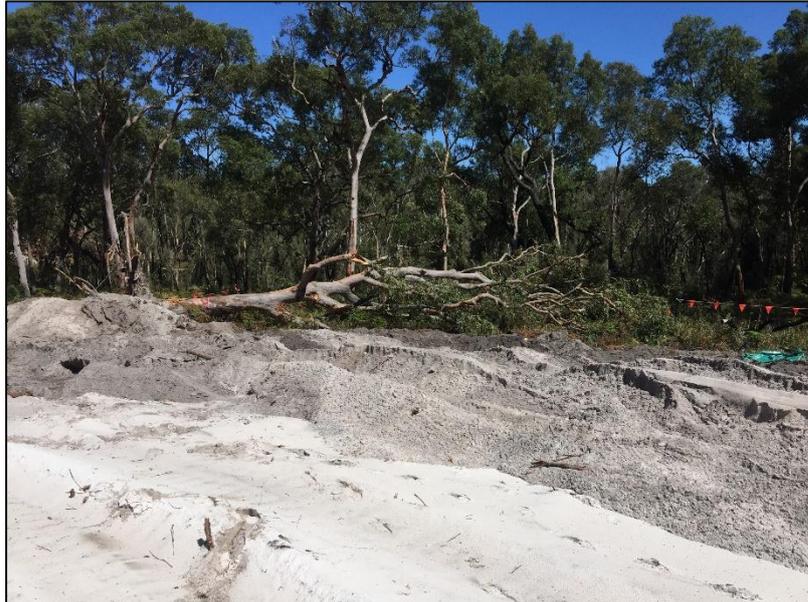
Photograph 4: Tree 214 on ground following felling

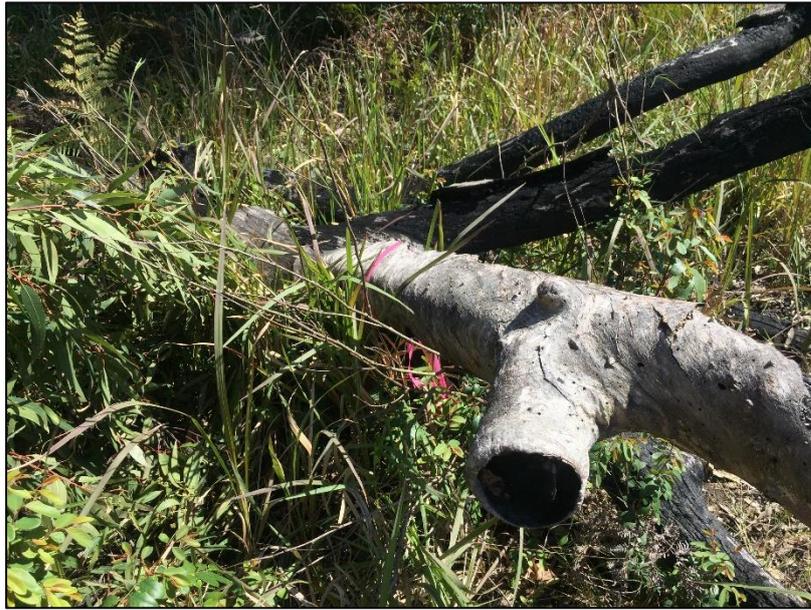
Photograph 5: Dead stag (Tree 215) on ground

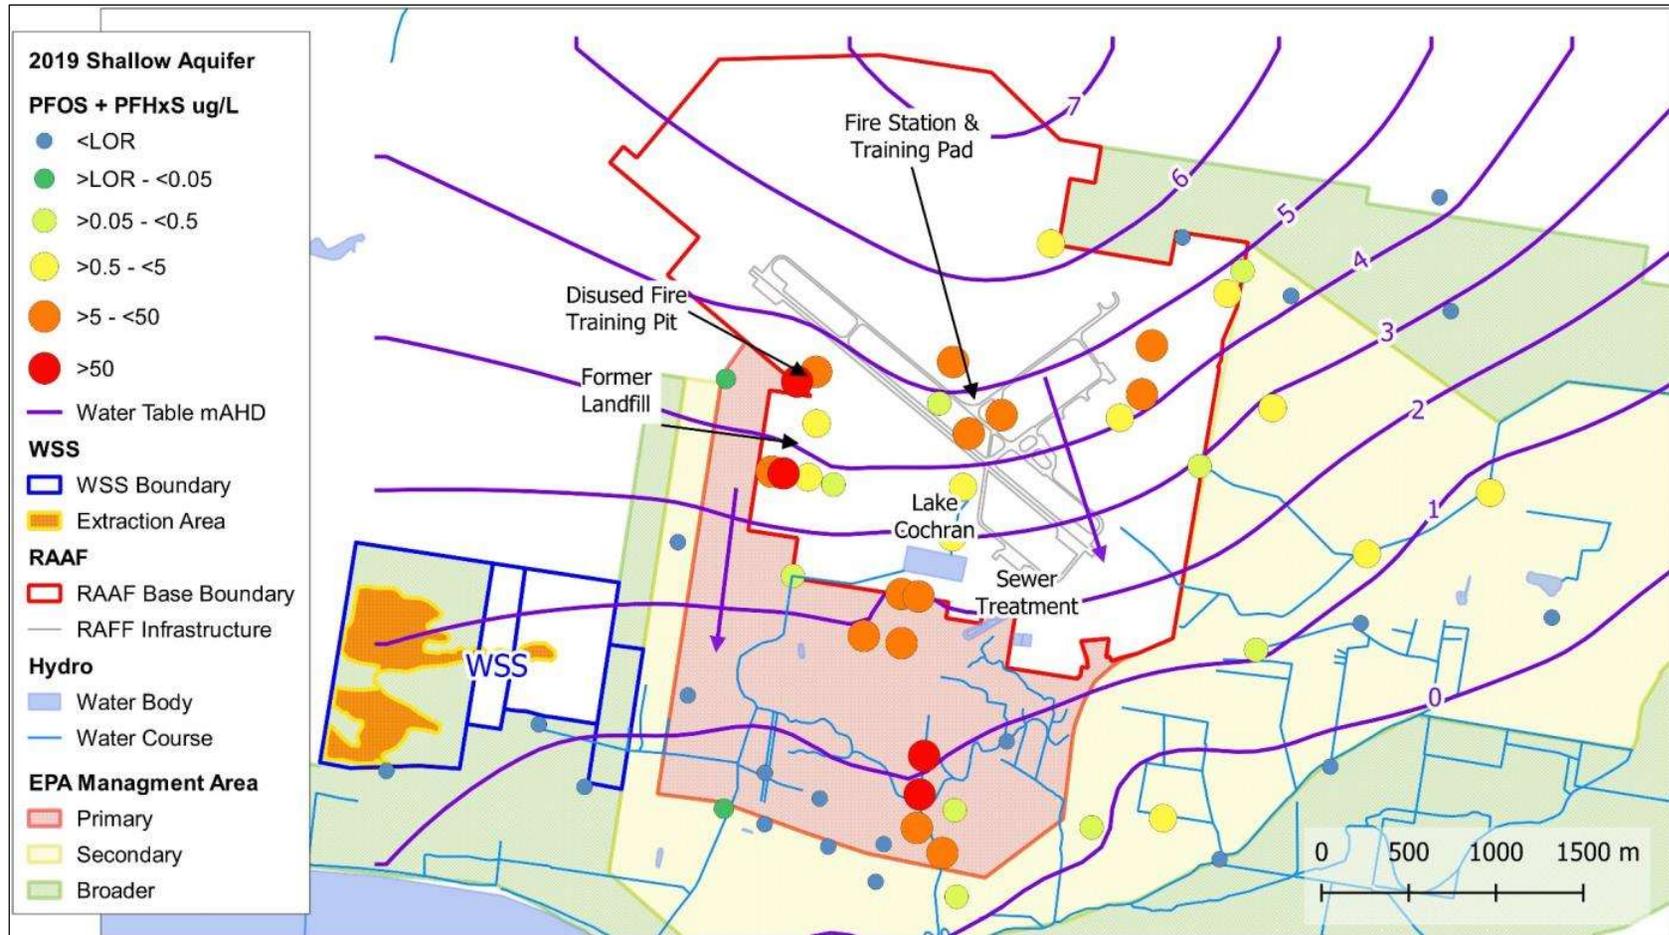
Figure 2. May 2019 water table elevations, potential groundwater flow direction and shallow groundwater sample PFOS + PFHxS concentrations
