Name of operation	Cabbage Tree Road Sand Quarry
Name of operator	Newcastle Sand
Development consent #	SSD-6125
Name of holder of development consent / project approval	Williamtown Sand Syndicate Pty Ltd
Mining lease #	Not applicable
Water licence #	Not applicable
MOP/RMP	Not applicable
Annual Review start date	1 January 2019
Annual Review end date	31 December 2019
<p>I, Darren Williams, certify that this audit report is a true and accurate record of the compliance status of the Cabbage Tree Road Sand Quarry for the period 1 January 2019 to 31 December 2019 and that I am authorised to make this statement on behalf of Newcastle Sand.</p> <p><i>Note.</i> a) The Annual Review is an 'environmental audit' for the purposes of section 122B(2) of the Environmental Planning and Assessment Act 1979. Section 122E provides that a person must not include false or misleading information (or provide information for inclusion in) an audit report produced to the Minister in connection with an environmental audit if the person knows that the information is false or misleading in a material respect. The maximum penalty is, in the case of a corporation, \$1 million and for an individual, \$250,000. b)

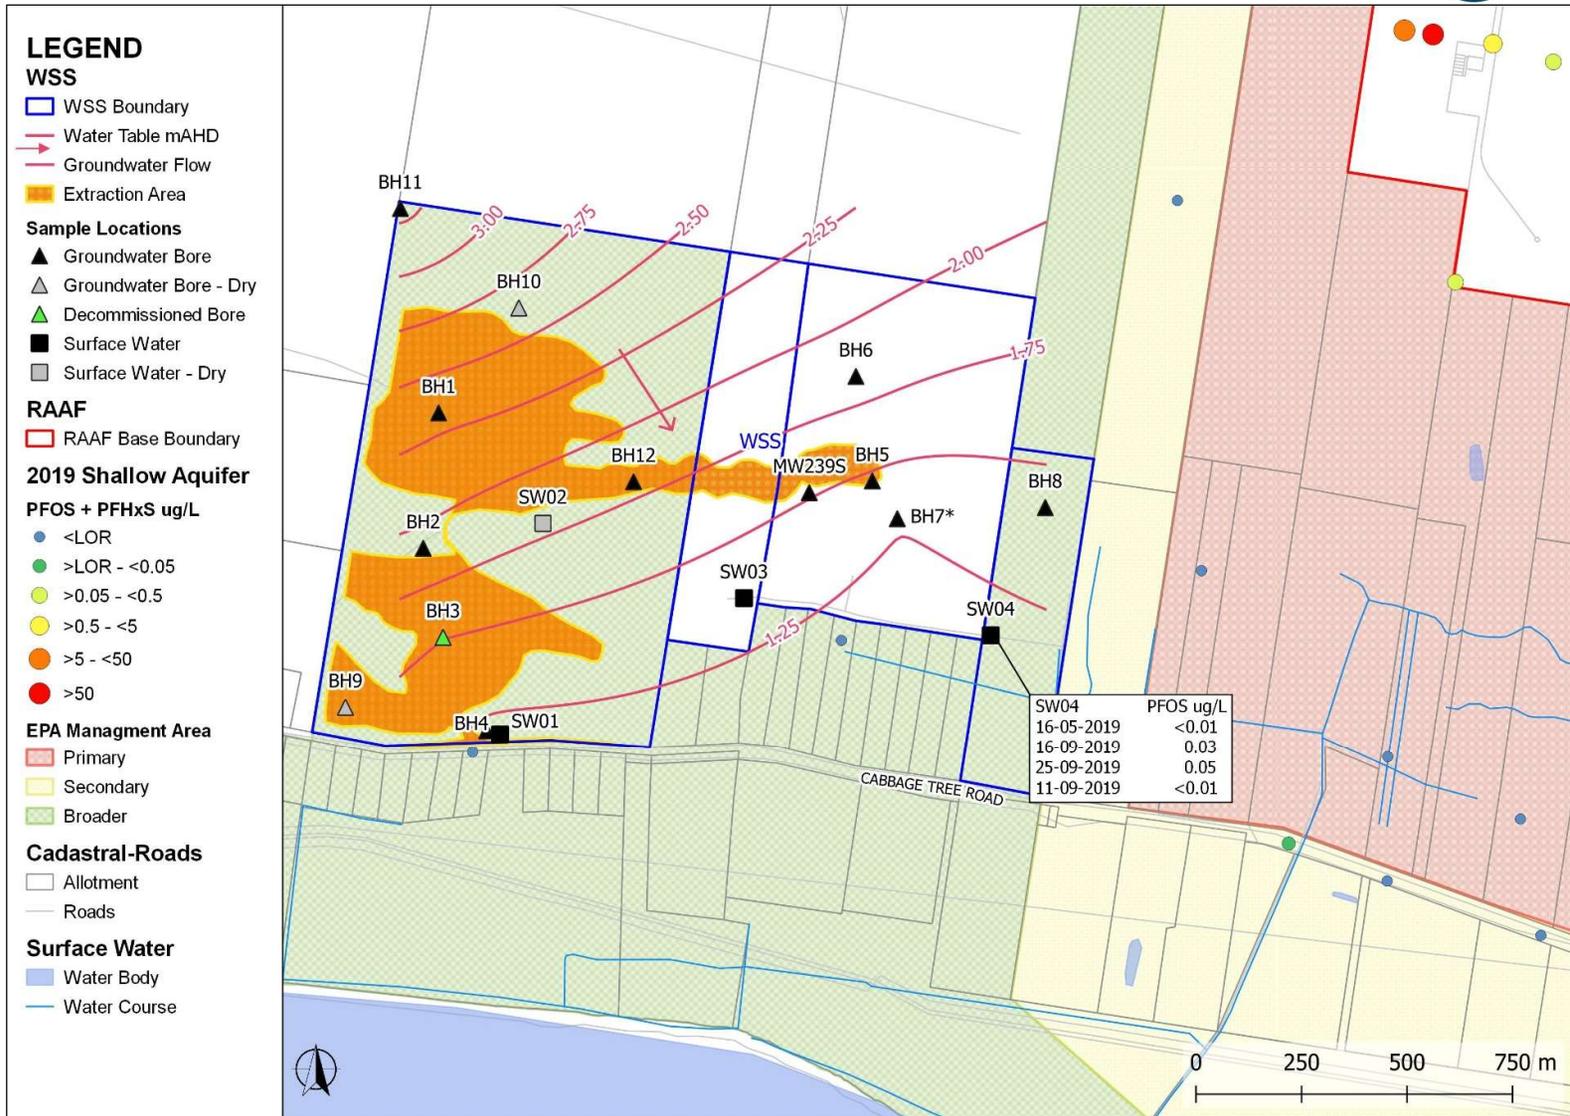
Figure 3. Site water table elevations and surface water and groundwater PHOS + PFHxS concentrations
