## **Groundwater Impact Assessment**

**Uniting War Memorial Hospital Waverley  
(Uniting Waverley)**

**Birrell Street, Bronte Road, Church Street  
and Carrington Road, Waverley NSW**

**Project 204088.03  
26 February 2025**

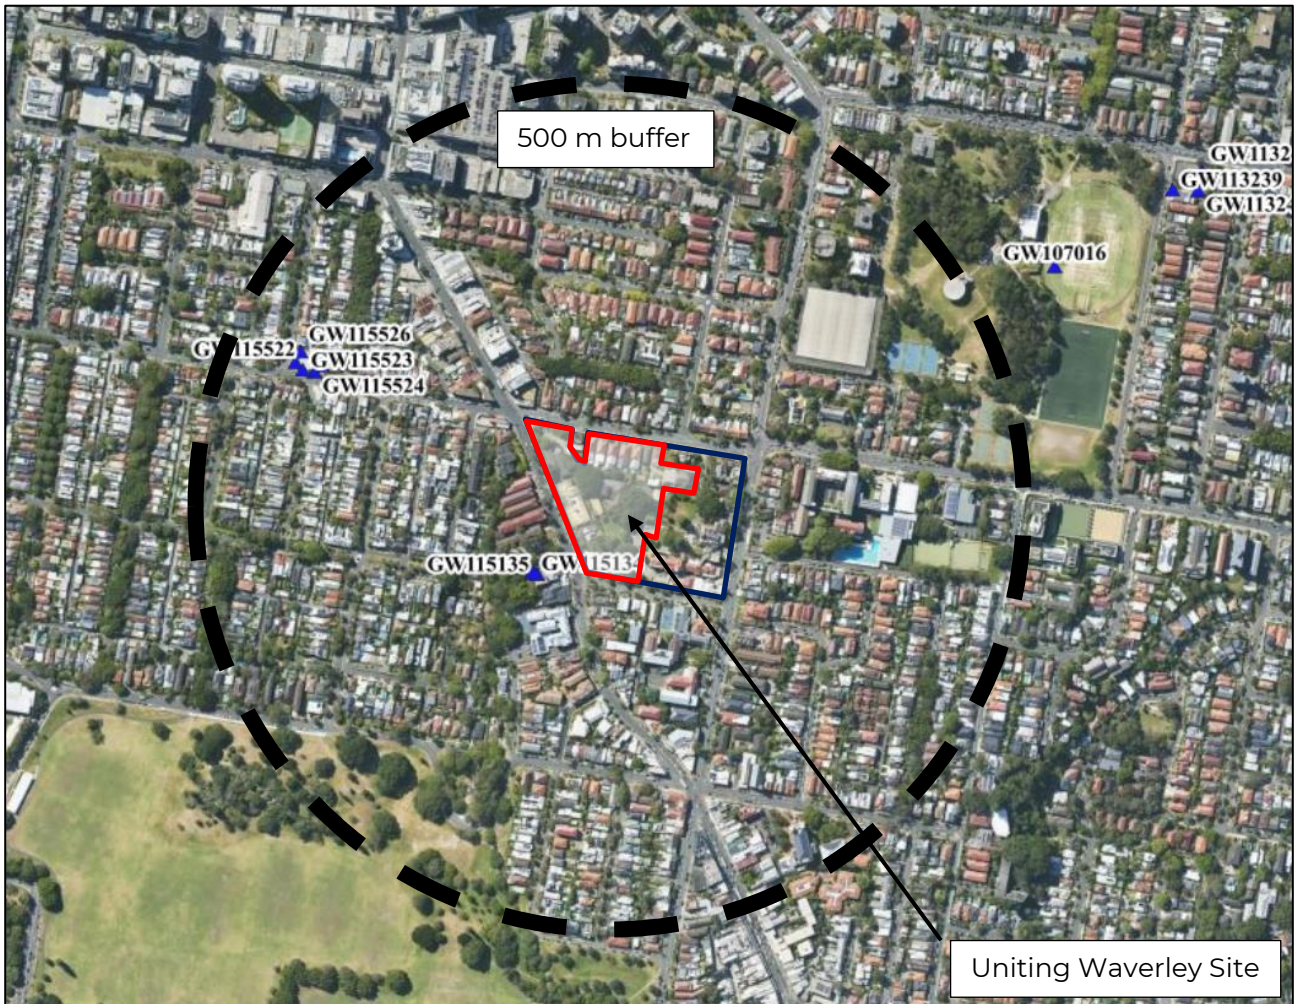
There are eight registered groundwater monitoring bores within 500 m of the site. None of these monitoring bores have recorded standing groundwater levels; however, a recreational use bore approximately 580 m northeast of the site has a recorded standing water level at 21.6 m depth. Given its distance from the site and its screens being deeper than the proposed basement, the recorded groundwater level may not be representative of groundwater conditions at the Uniting Waverley site. An aerial image showing the location of the registered groundwater bores is shown in Figure 3.

**Figure 3: Aerial image of registered groundwater bores, subject area in red)**

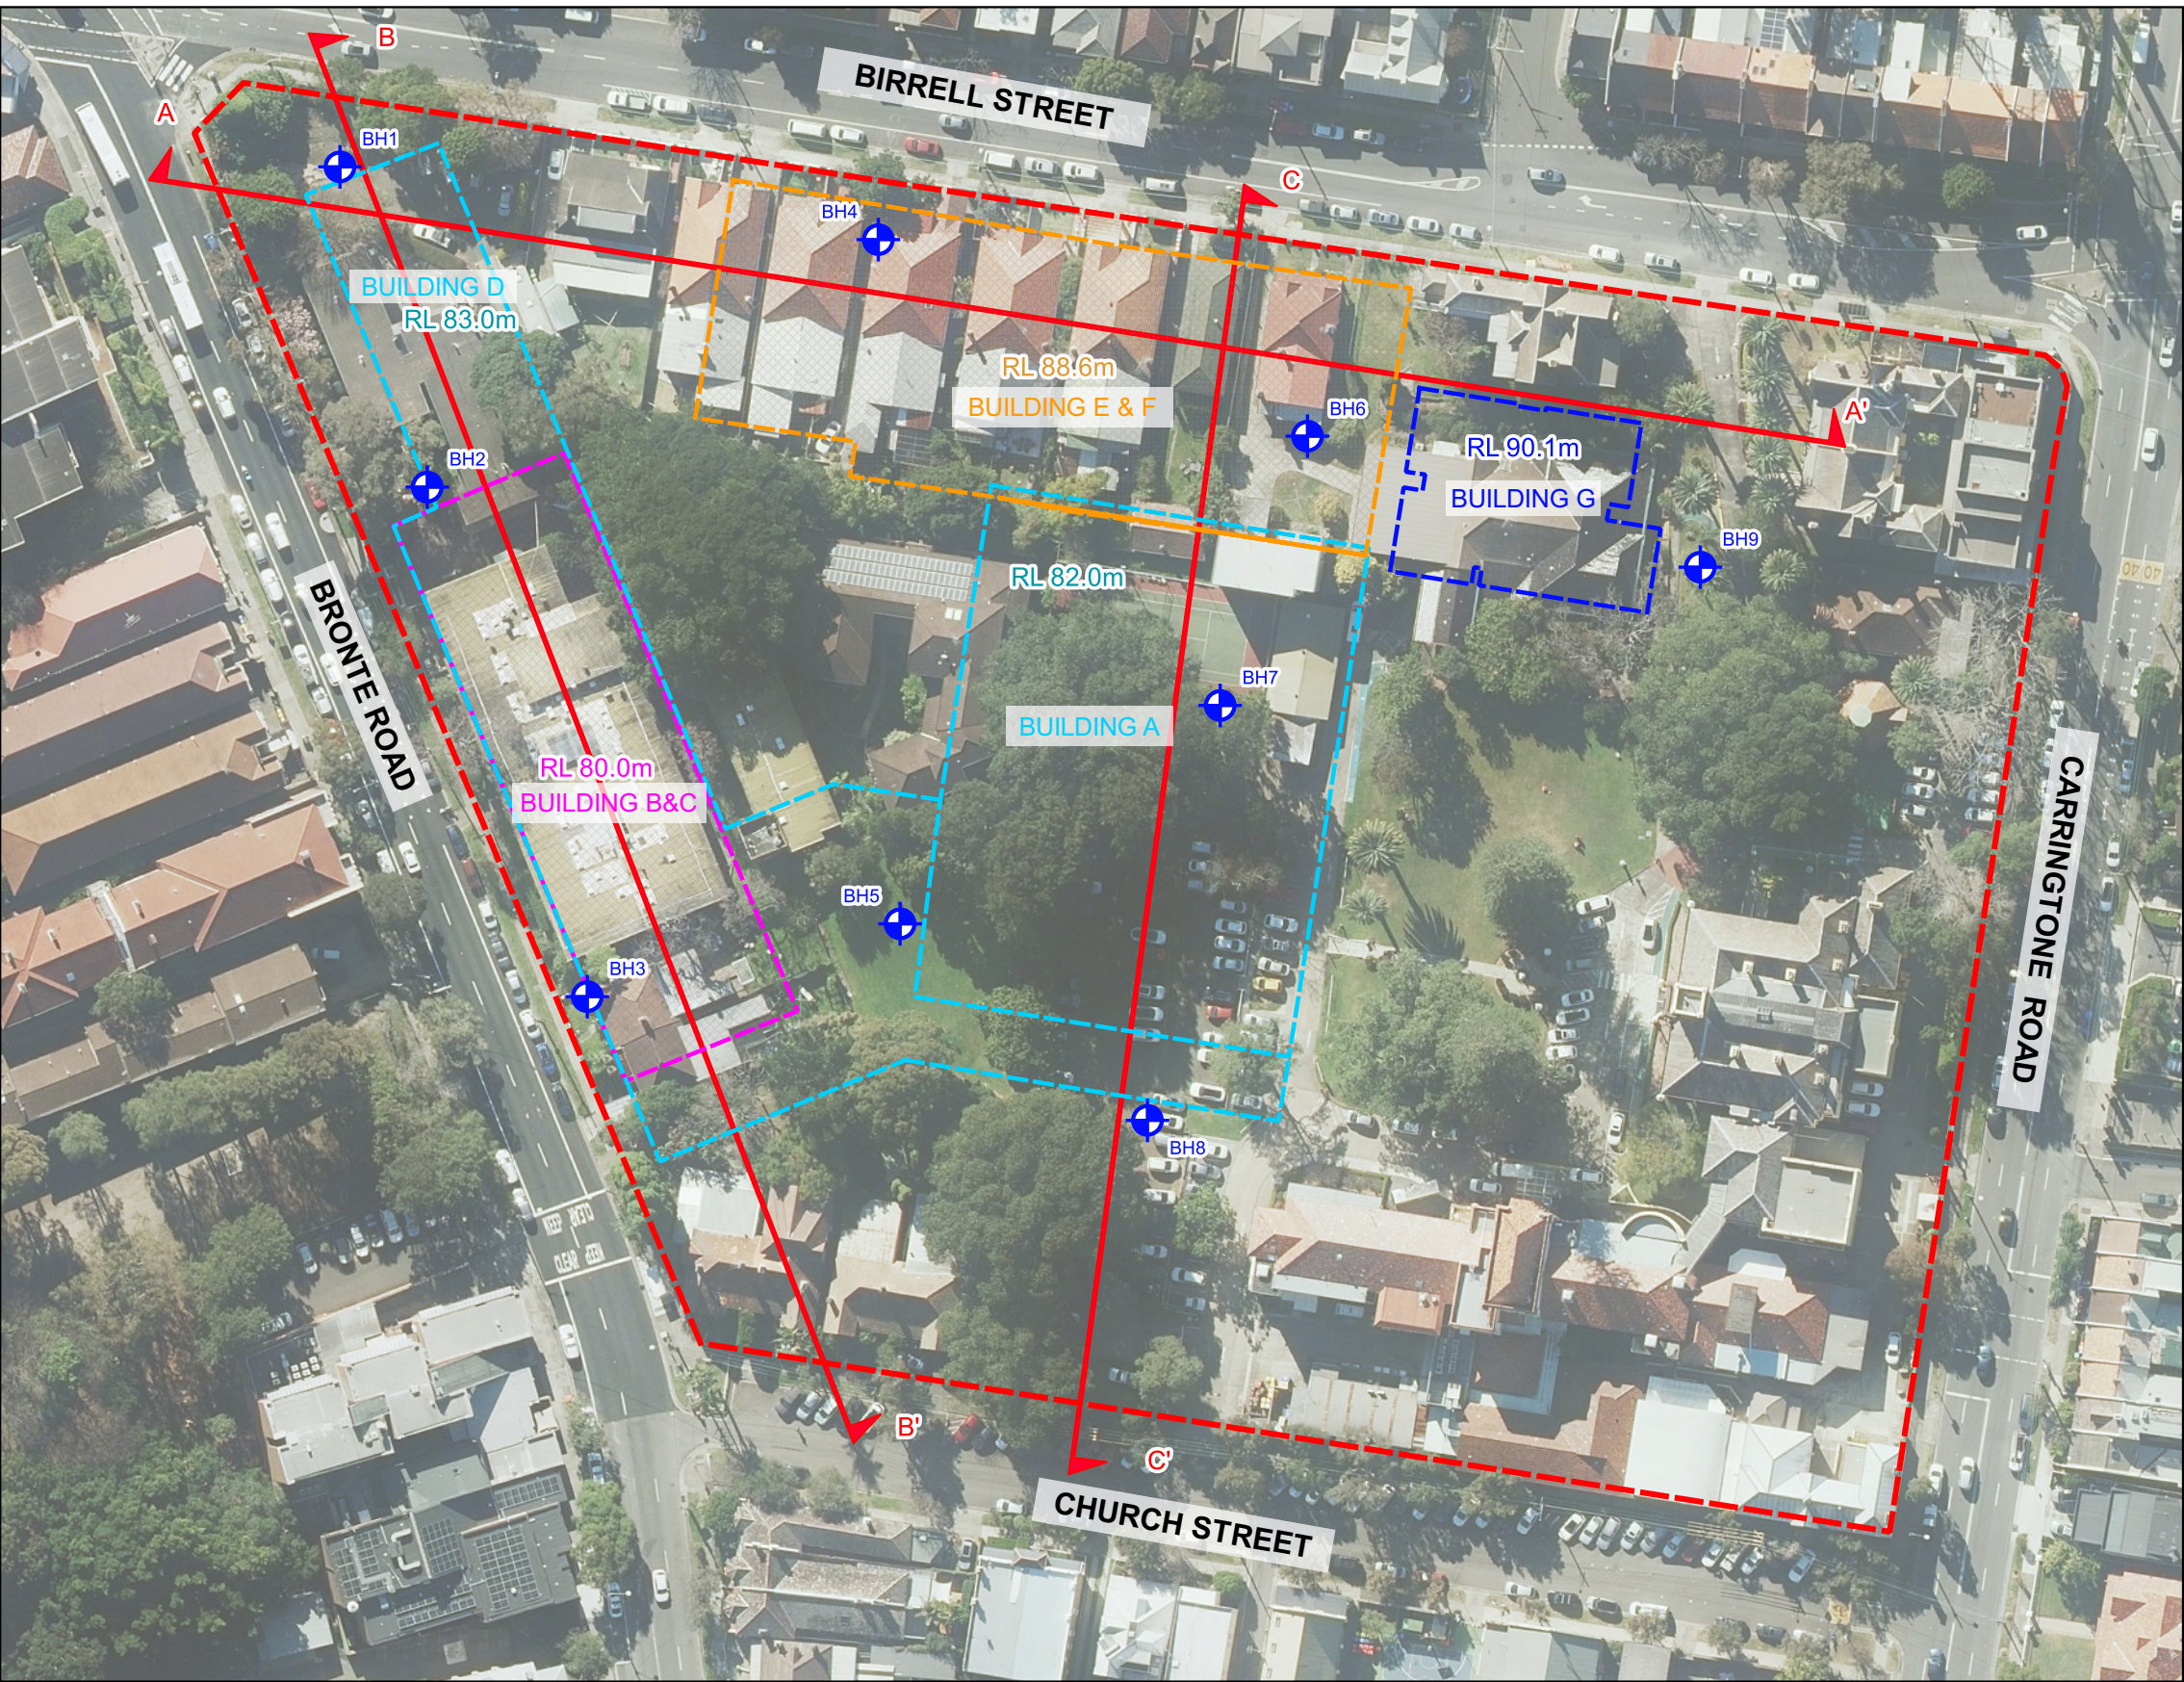
PROJECT No: 204088.00  
DRAWING No: 1  
REVISION: 0

Nine boreholes (BH1 to BH9) were drilled to depths of approximately of 8 m to 20 m between 24 July and 9 August 2023. Details of the subsurface conditions encountered are provided in the geotechnical investigation report (Douglas, 2024). The locations of the boreholes are shown in Drawing 1 (Appendix A).
