**RE: INTERIM AUDIT ADVICE LETTER NO. 1 - REVIEW OF REMEDIATION ACTION PLAN, 2-4 HALE STREET, BOTANY NSW**

Ref: 318002056

Audit Number: LW-057

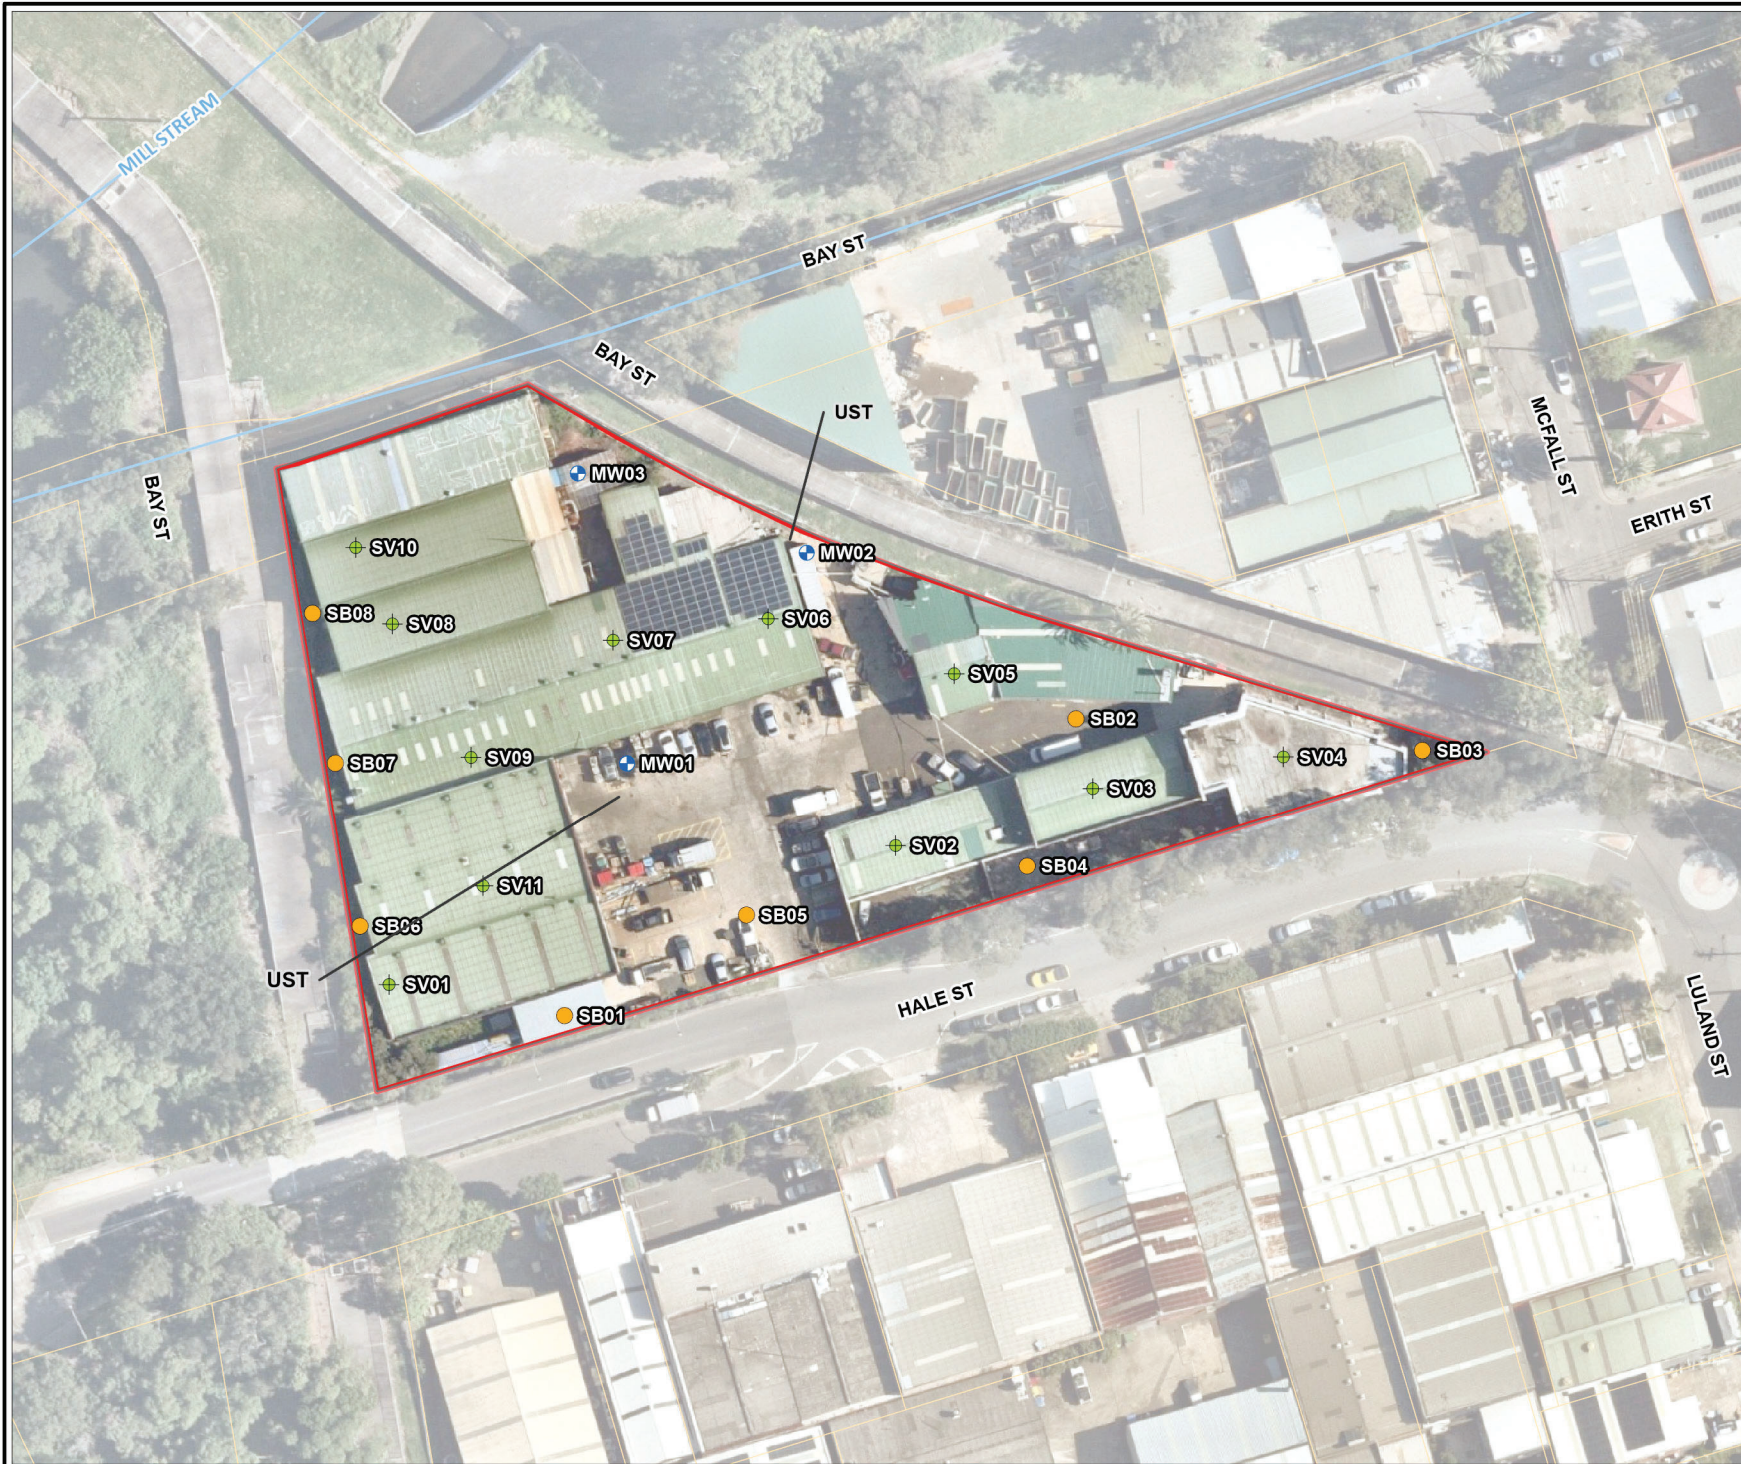
# Attachment 3: The DSI Investigation Locations

During the DSI, JBS&G completed 11 soil bores (MW01 to MW03 and SB01 to SB08) in accessible locations (i.e., outside the warehouse building footprints). A review of the relevant borehole logs indicated the subsurface profile typically consisted of fill to depths of between 0.2 and 1 m below ground level (mbgl), followed by natural sands and/or clayey sands to 6 mbgl (maximum depth of investigation). Thicker fill was noted in MW03 (3 m), SB06 (>1.3 m) and SB07 (1.9 m), noting that SB06 was terminated at 1.3 mbgl in fill soils due to refusal on large rock inclusions.

JBS&G installed three groundwater monitoring wells (MW01, MW02 and MW03) and undertook one groundwater monitoring event (GME) in the DSI. The groundwater monitoring locations are shown on **Attachment 3**.

The Auditor has assessed the overall quality of the data by review of the information presented in the DSI. The scope of works completed in the DSI are summarised in **Table 6.1**. The DSI sampling locations are shown on **Attachment 3**.

The DSI investigation locations are shown on **Attachment 3**.

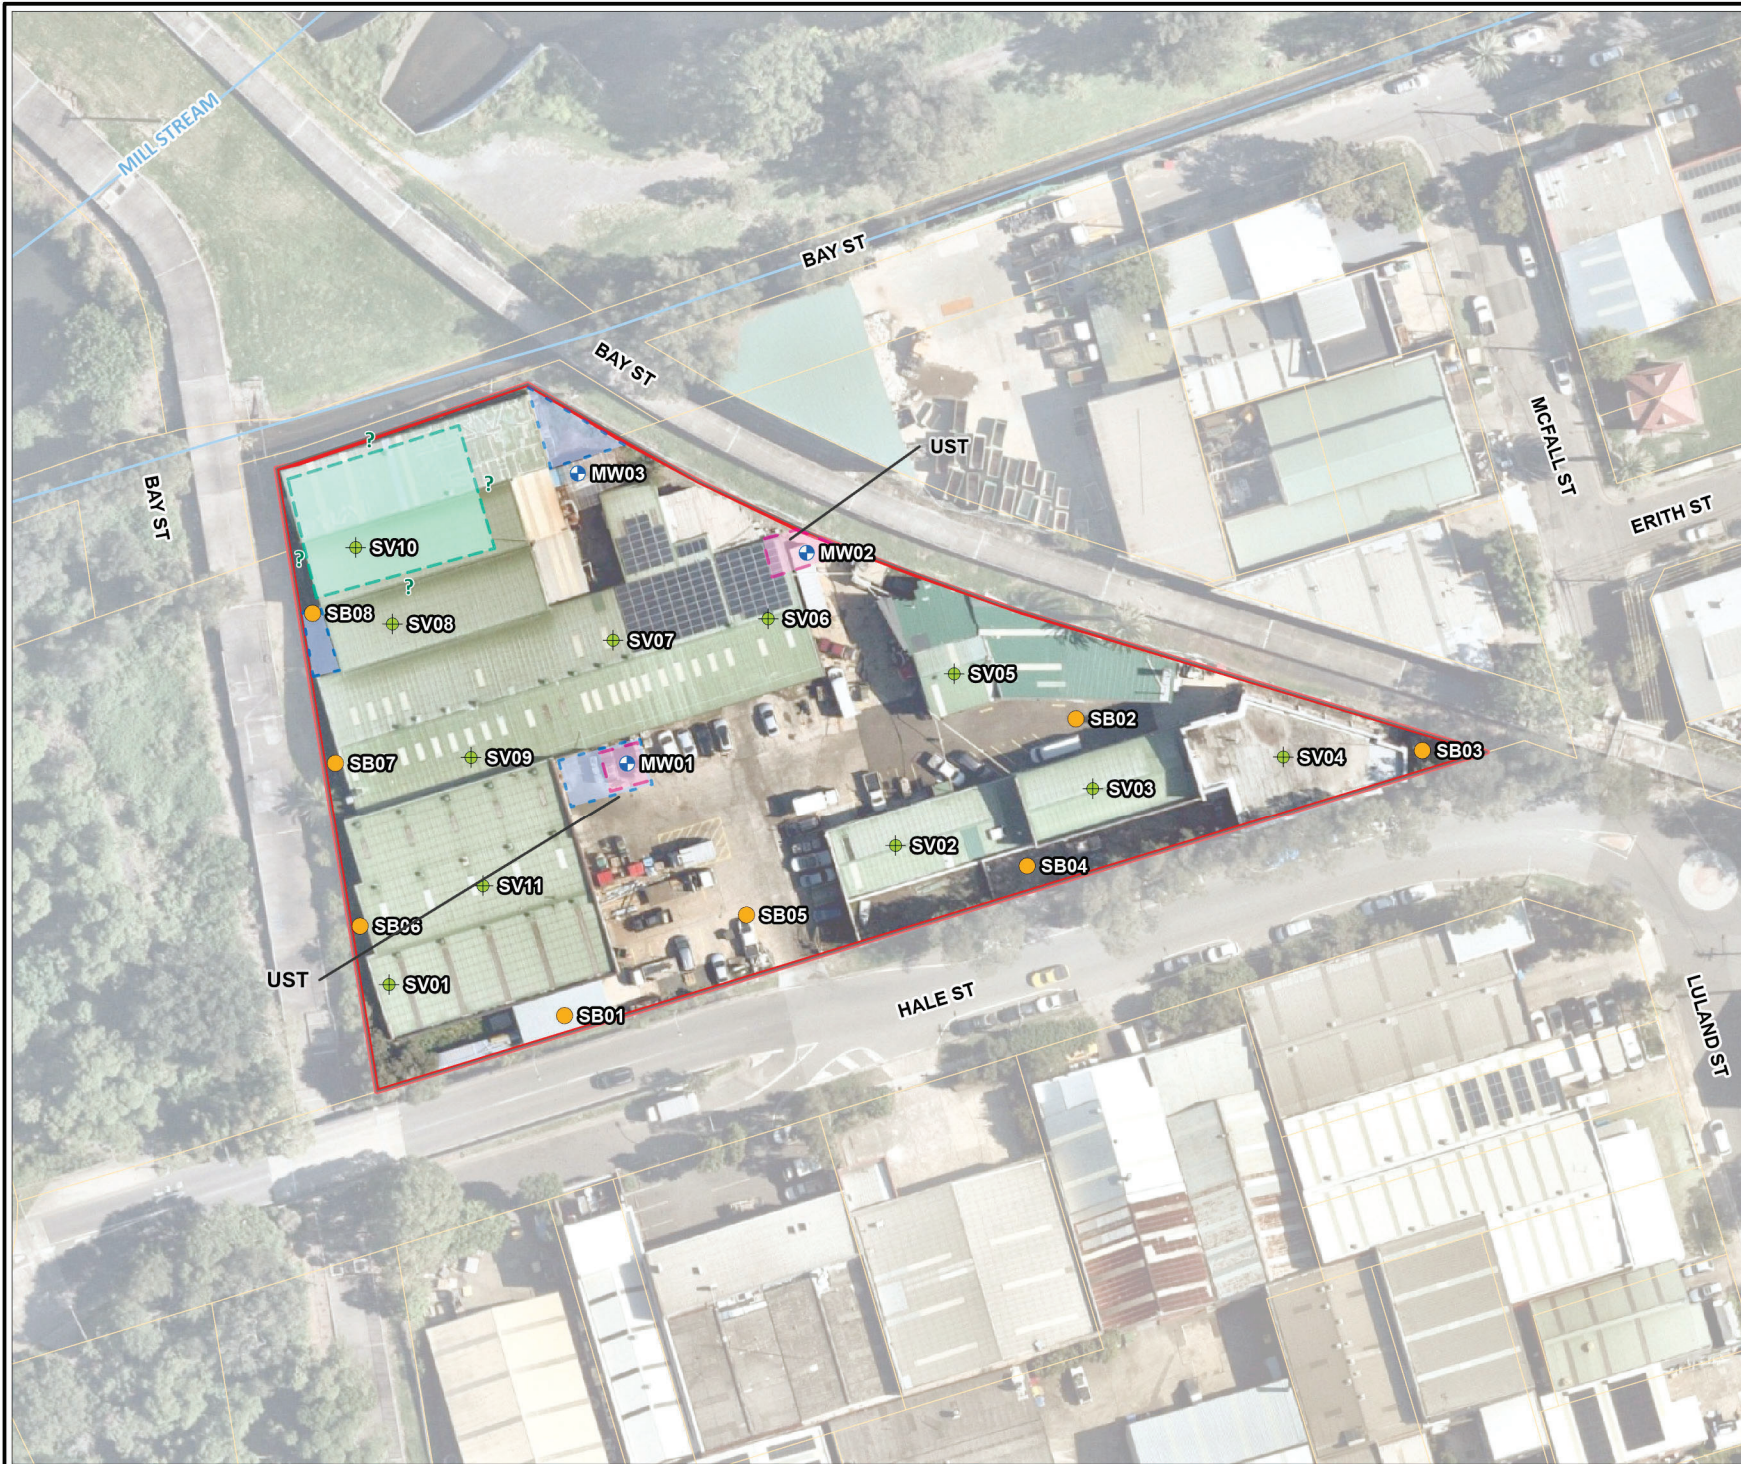
# Attachment 4: Anticipated Extents of Remediation

Fragments of asbestos containing materials (ACMs) were observed in fill at locations MW01 and MW02. These foreign inclusions were within the top metre of the fill layers. The DSI also noted that fragments of ACM were observed on unsealed ground surfaces along the western boundary and central portion garden bed (**Attachment 4**).

- Legend**
- Approximate Site Boundary
  - NSW Cadastre
- Sample Locations**
- Soil Bores, JBS&G 2022
  - ⊕ Monitoring Well (JBS&G 2022)
  - ⊕ Soil Vapour (JBS&G 2022)
- Remedial Extents**
- ACM Remedial Extent
  - UST Remedial Extent
  - TCE Remedial Extent
