## **Remediation Action Plan**

### **Proposed Research and Life Science Development**

**100 Botany Road, Alexandria NSW**

**Project 221233.03**

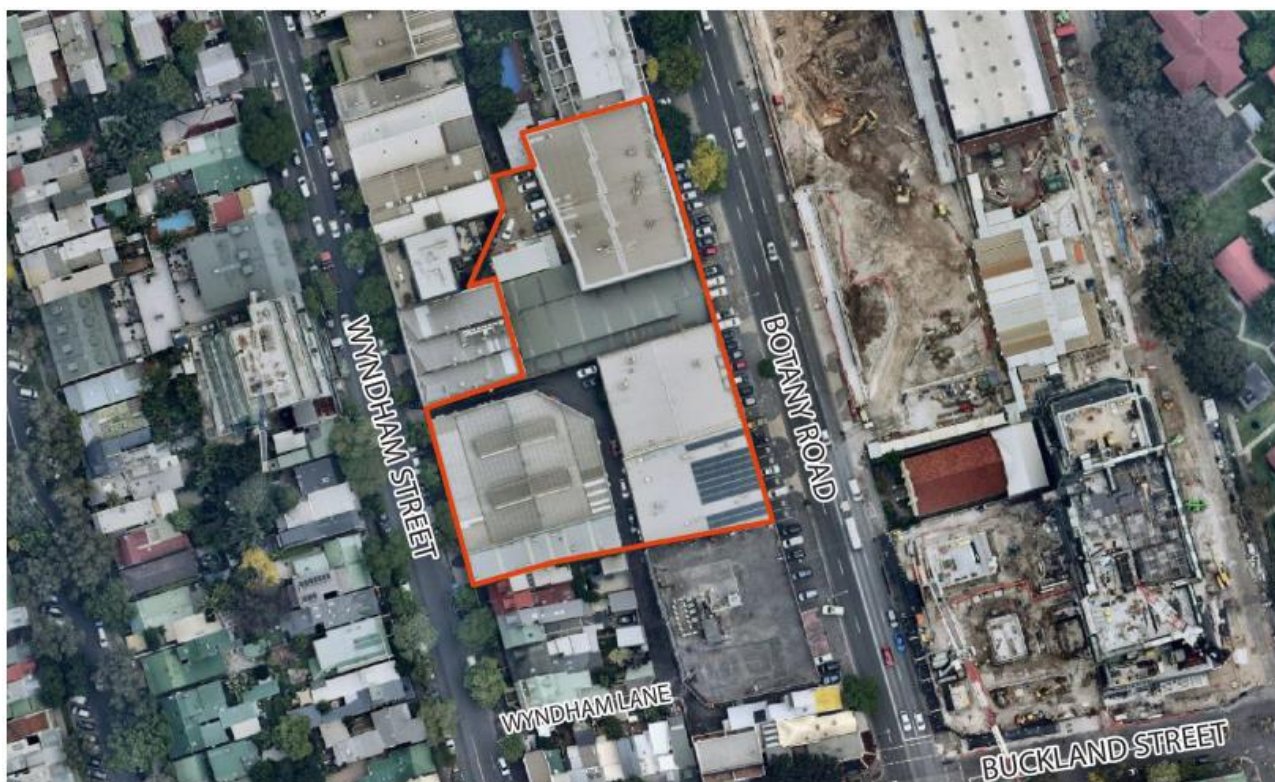
Site Boundaries

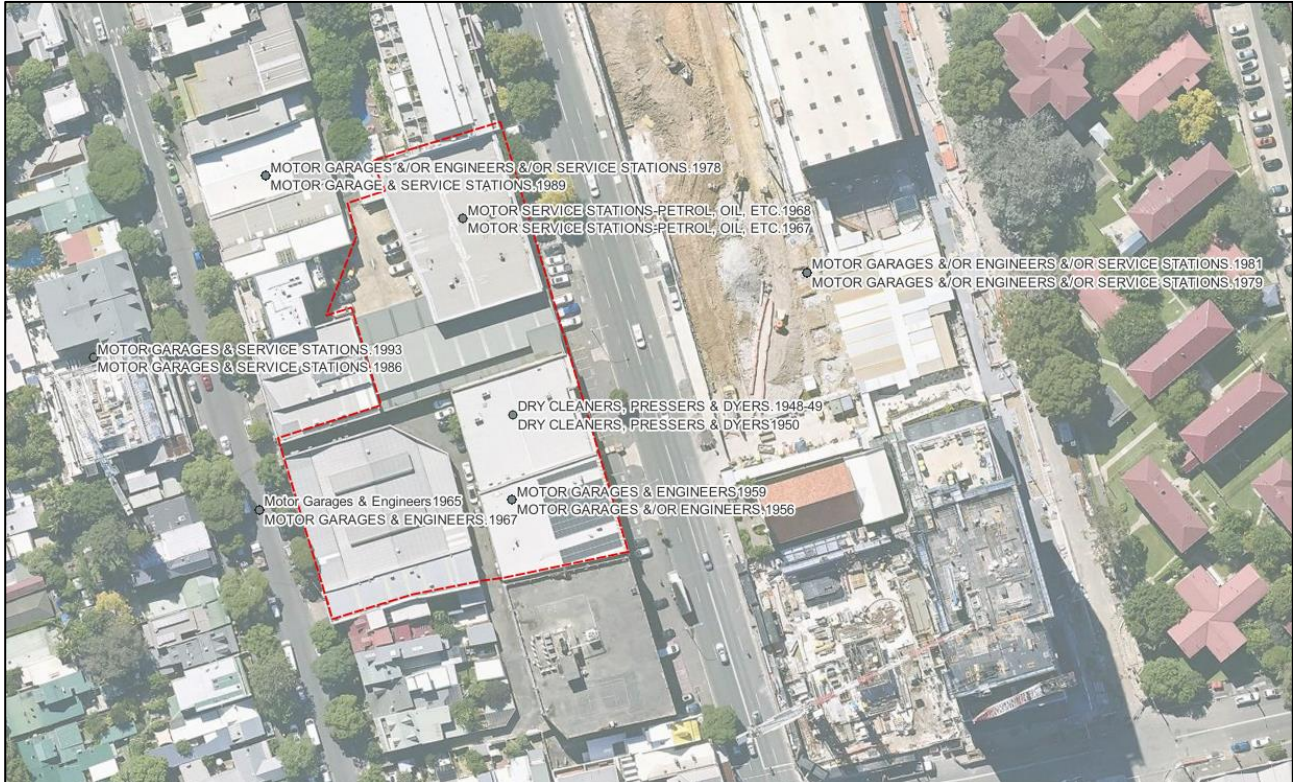
**Figure 2: On-site and nearby dry cleaners / service stations (showing current site boundary), adapted from DP (2023a)**

Off-site sources also included a dry cleaner to the east (within the now current Waterloo Station development site), and another motor garage / service station to the west and north-west.

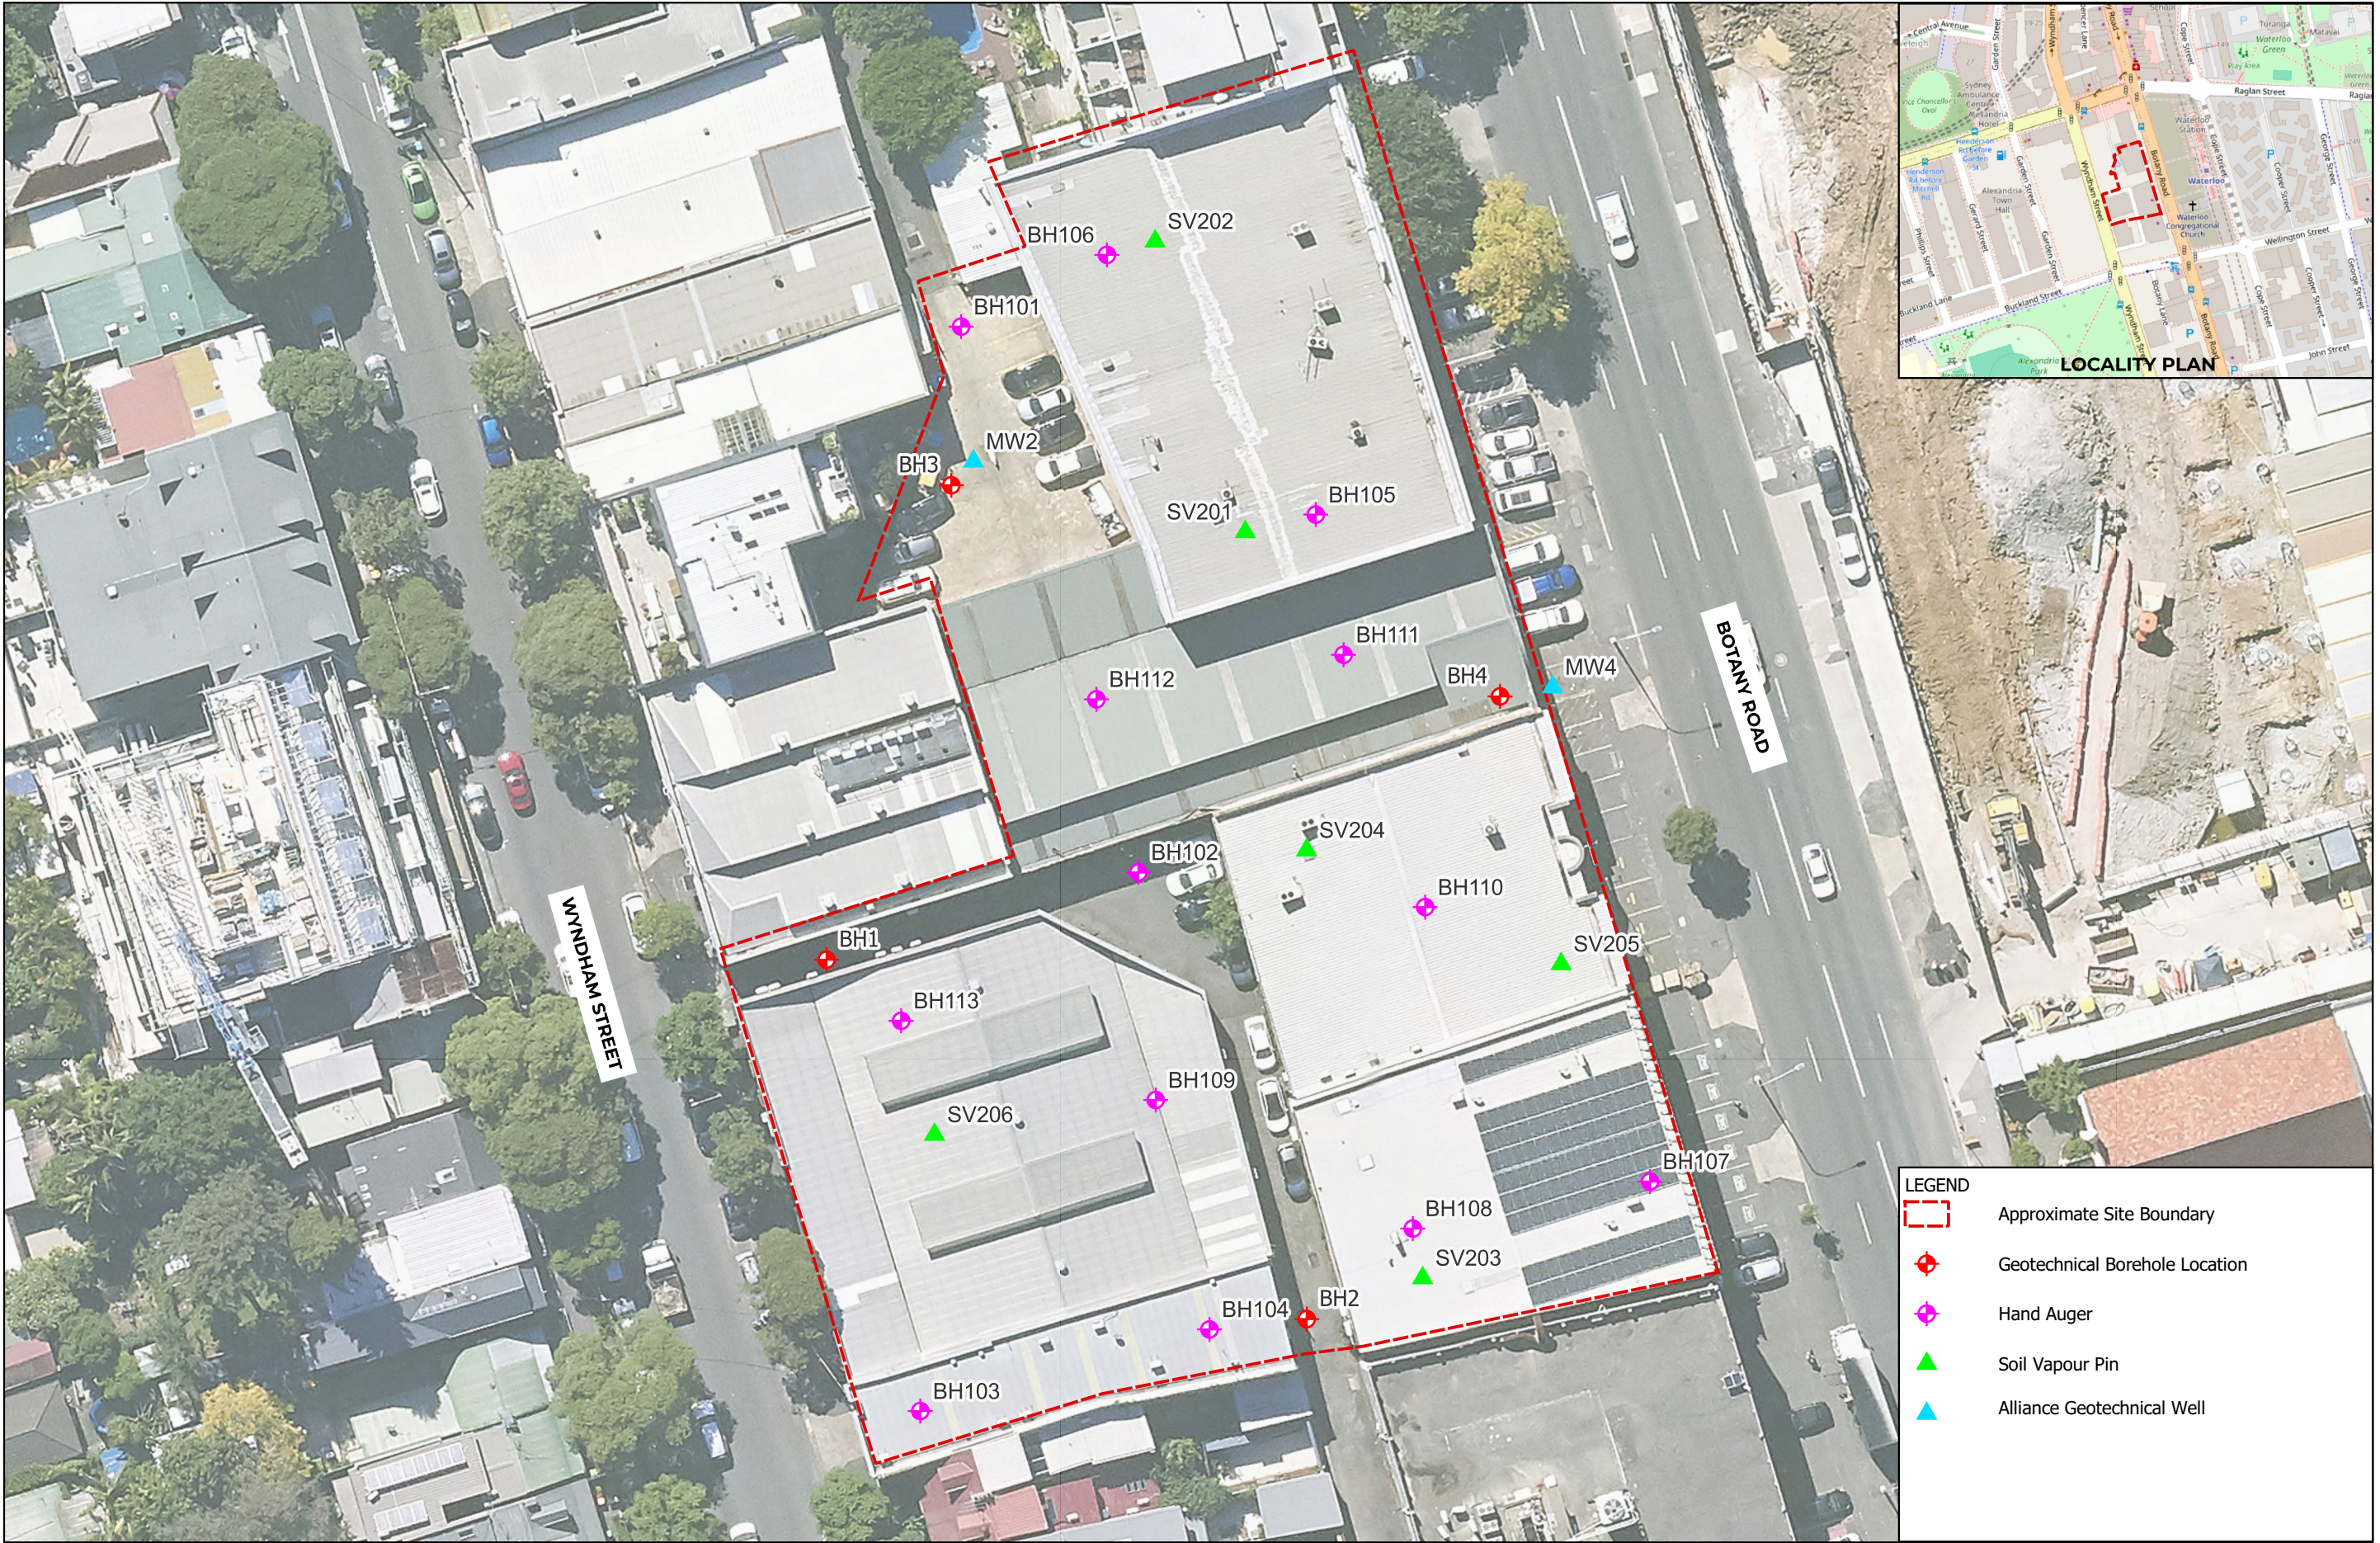
**Figure 3 – Sample Locations**

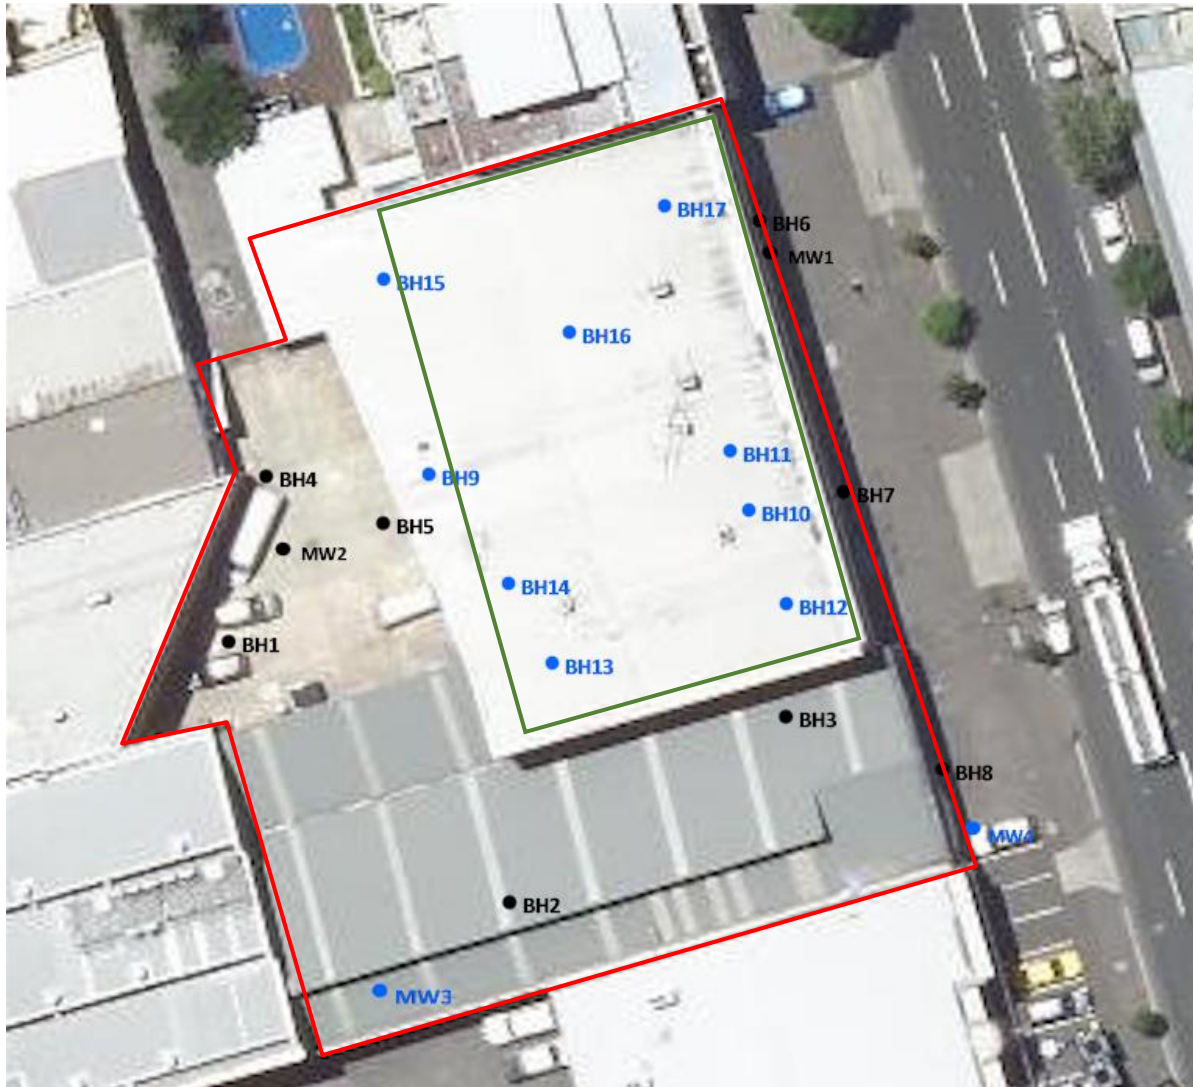
- BH1 Borehole Locations – Previous Investigations.
- BH9 Borehole Locations – Current Investigations.
- MW1 Monitoring Well- Previous Investigations.
- MW3 Monitoring Well- Current Investigations.
- Approximate Site Boundary
- Approximate Extent of Second Concrete Slab

**Figure 4 – Detailed Site Investigation Sample Criteria Exceedances**
