16 September 2024

**RE: INTERIM AUDIT ADVICE LETTER NO. 1 - REMEDIATION ACTION  
PLAN, 100 BOTANY ROAD, ALEXANDRIA**

Audit Number: TO-134

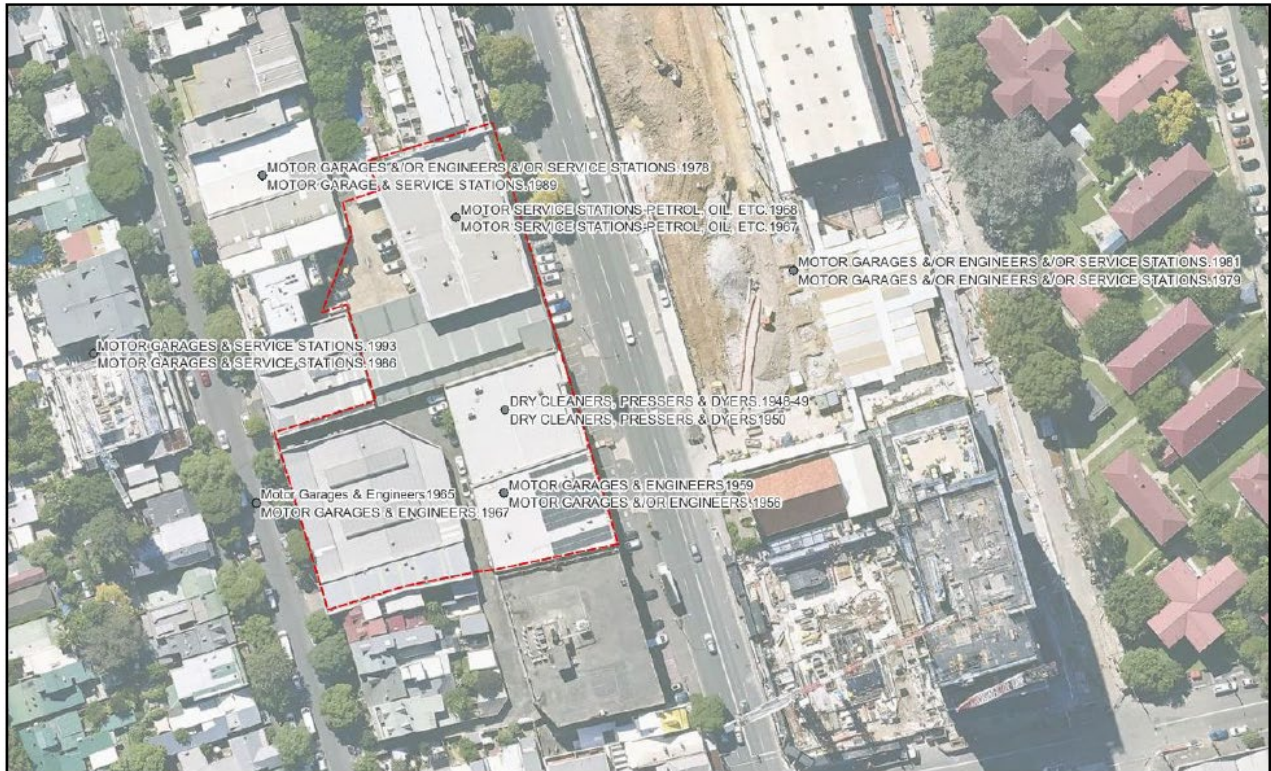
**Figure 2.1: Onsite and Nearby Former Dry Cleaners/Service Stations**

The RAP states that offsite (and onsite) former potential sources of contamination included a dry cleaner to the east, and a motor garage/service station to the west and northwest. The motor garage/service stations (and the onsite dry cleaner) are shown on **Figure 2.1** extracted from the RAP. The offsite dry cleaner is understood to be to the east of Botany Road within the now current Waterloo Station development site.

Subsequently, DP prepared the PSI for 100-108 Botany Road and 86-100 Wyndham Street (Lot 11 DP135914, Lot 2 DP659166, Lot 1 DP510091, Lot 3 DP1146614), which is the southern portion of the site. This was supplemented by the DSI, which considered the site history of the entire site based on a review of previous reports, historical aerial photographs and review of business directory records which indicated the following activities present within the site (refer also **Figure 2.1**):

- Manufacturing and wholesale/retail: (including *inter alia*) tools, pumps, furniture, boat/ship accessories, motor exhaust/mufflers, metals, and welding.
- Motor body repairs/painting.
- Motor garage (circa 1950-60).
- Service station (circa 1960), including potential USTs.
- Dry cleaners (circa 1950).

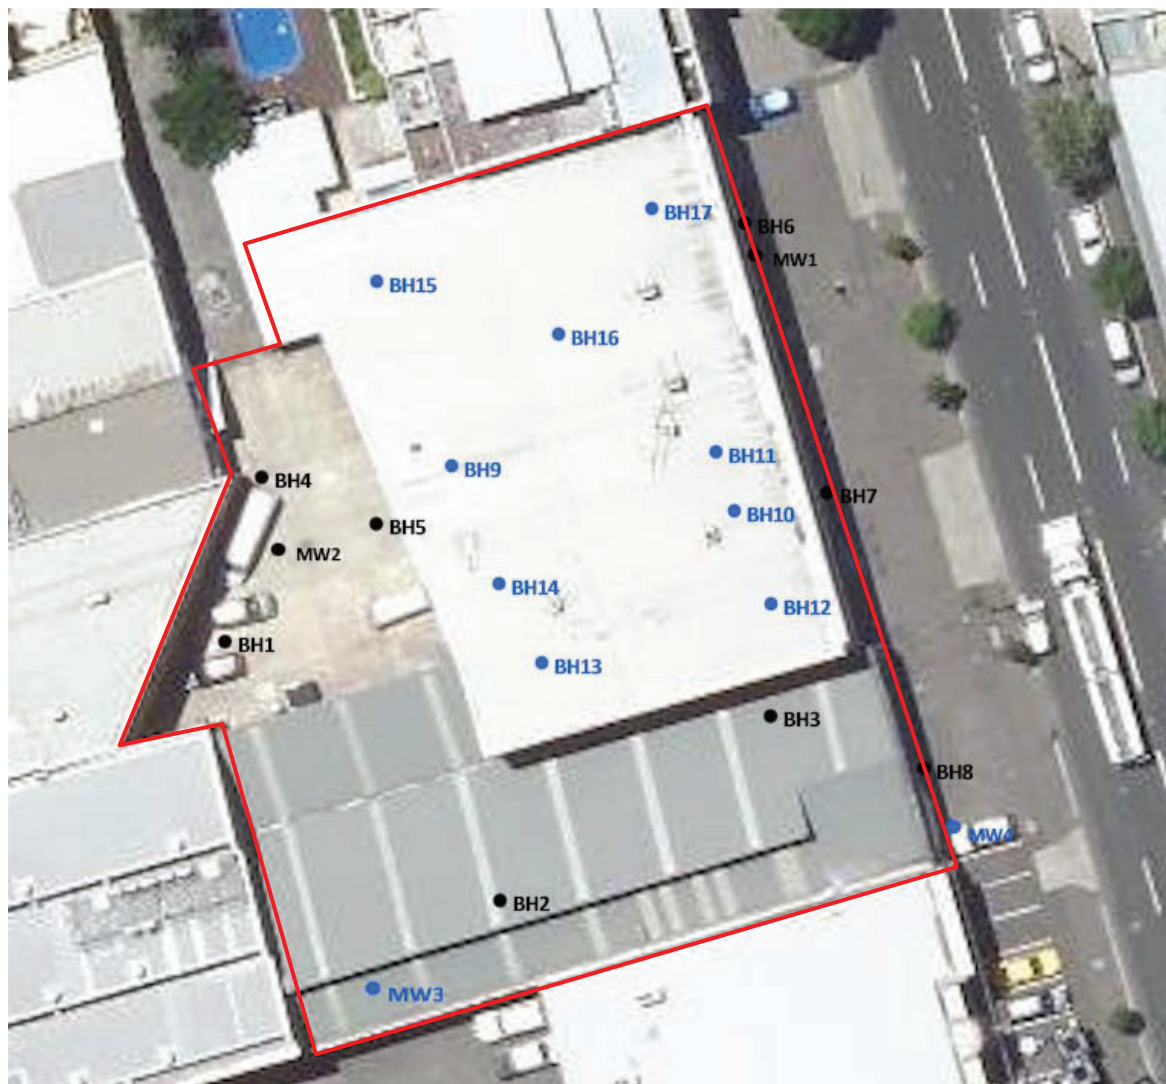
Figure 3 – Sample Locations

- BH1 Borehole Locations – Previous Investigations.
- BH9 Borehole Locations – Current Investigations.
- MW1 Monitoring Well- Previous Investigations.
- MW3 Monitoring Well- Current Investigations.
- Approximate Site Boundary
