## **Report on Geotechnical Investigation**

**MPark Talavera Road Data Centre**

**Part of 1-5 Khartoum Road, Macquarie  
Park**

**Project 99657.09**

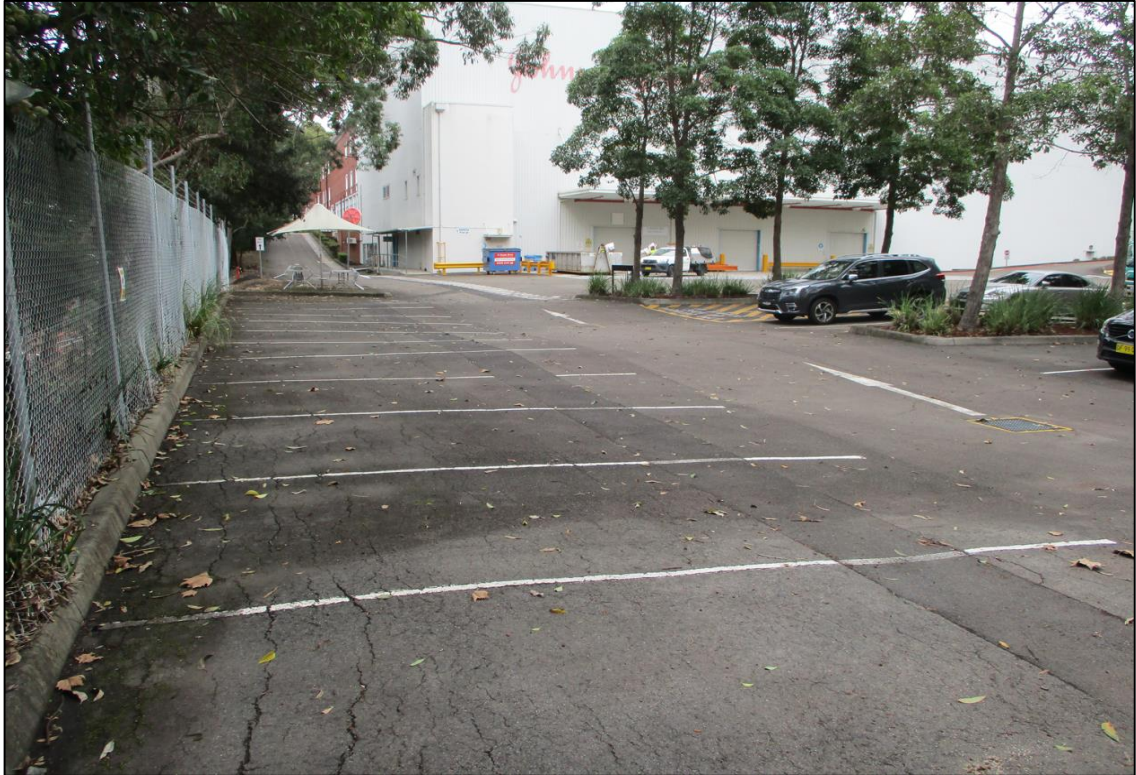
Photo 1: South western end of site, asphalt car park on-grade.

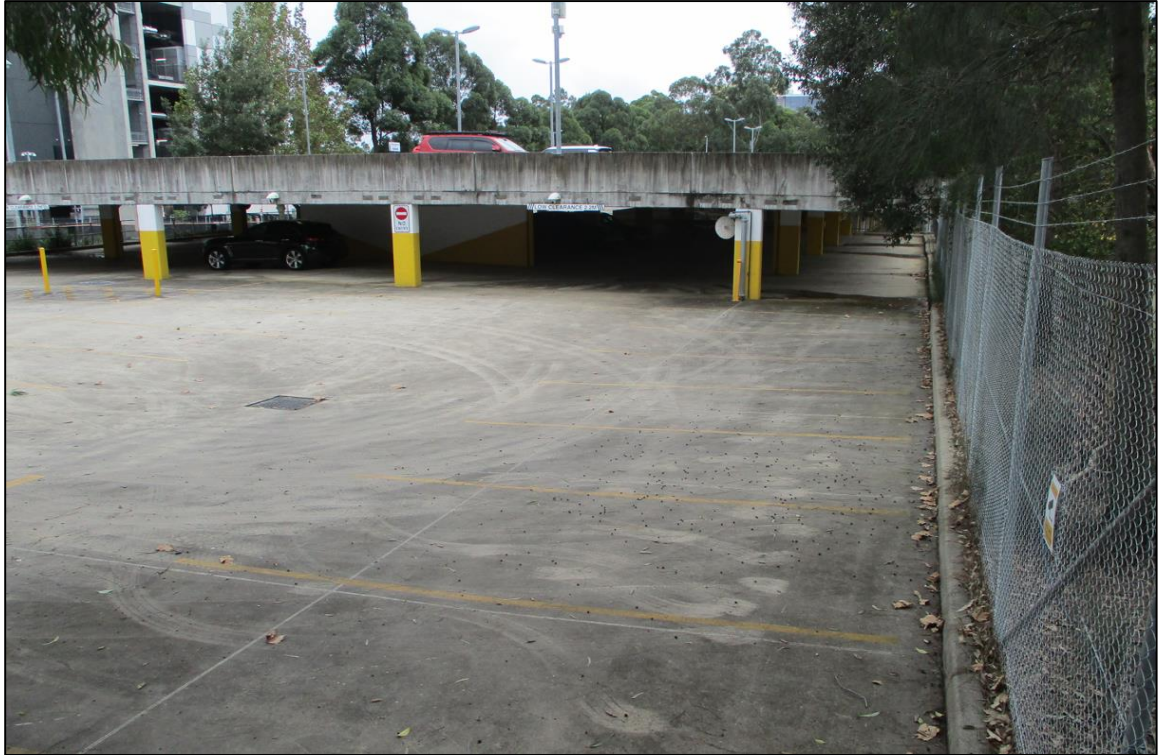
Photo 3: Central part of site, concrete carpark structure.

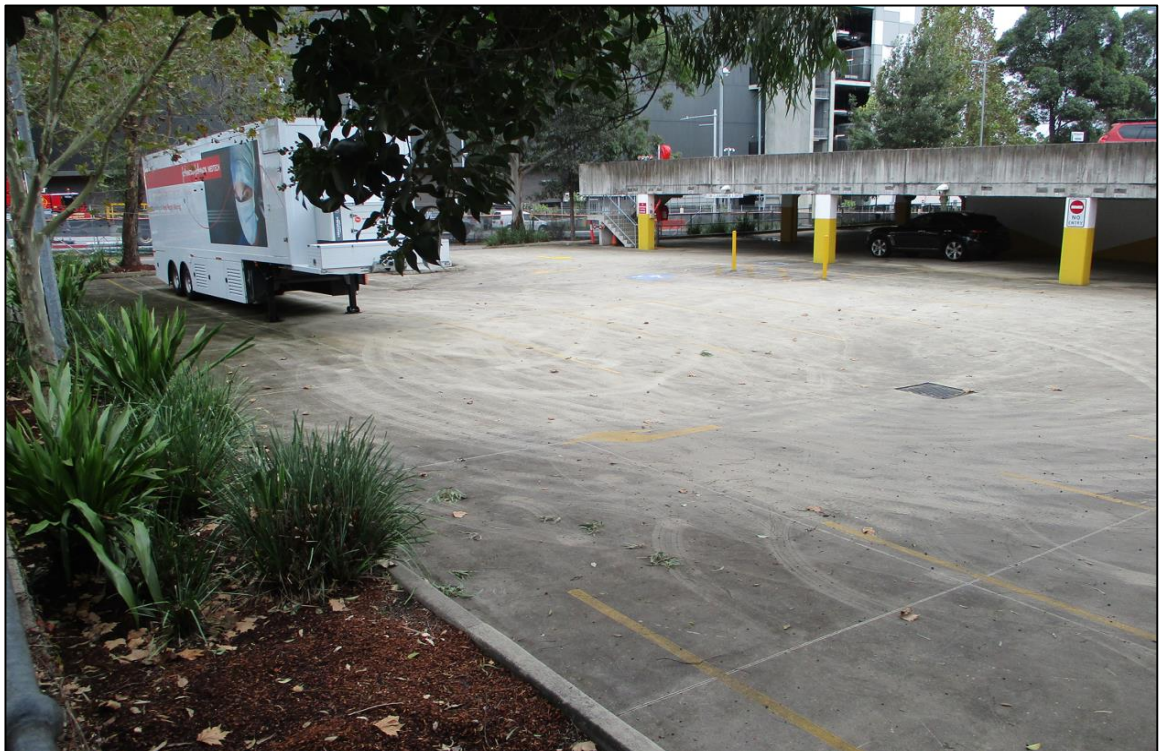
Photo 4: Central part of site, concrete hardstand.

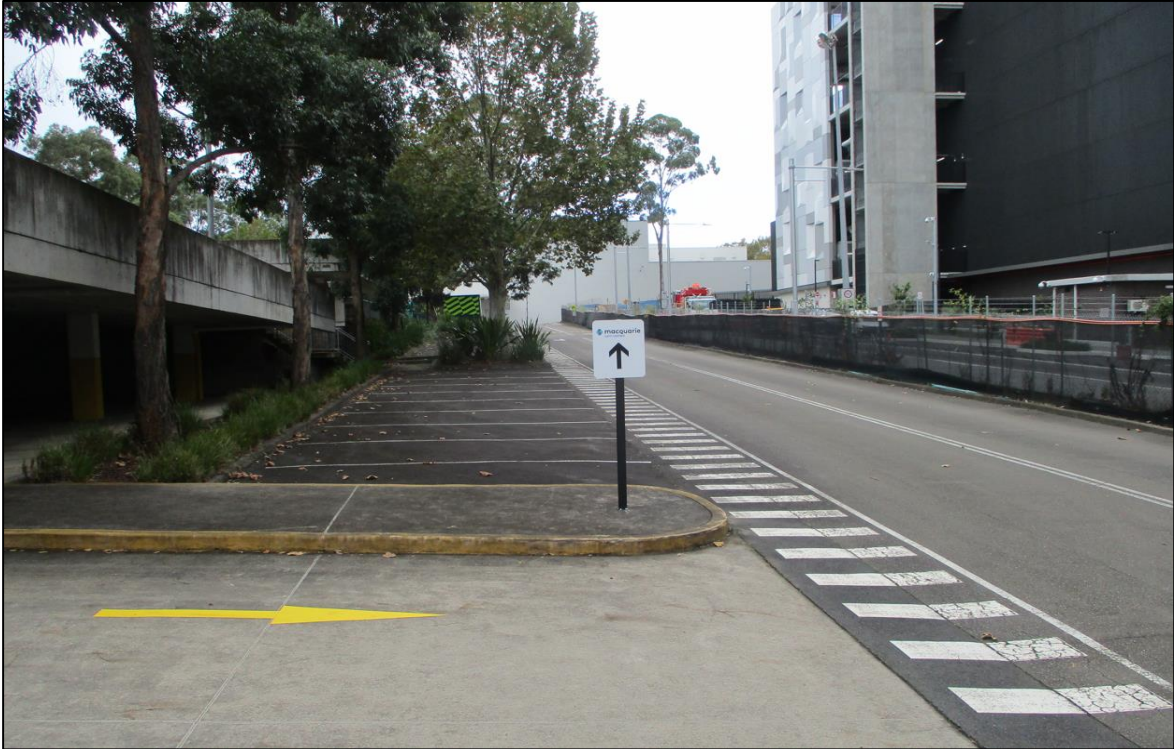
Photo 5: Asphalt access road, western boundary of site.

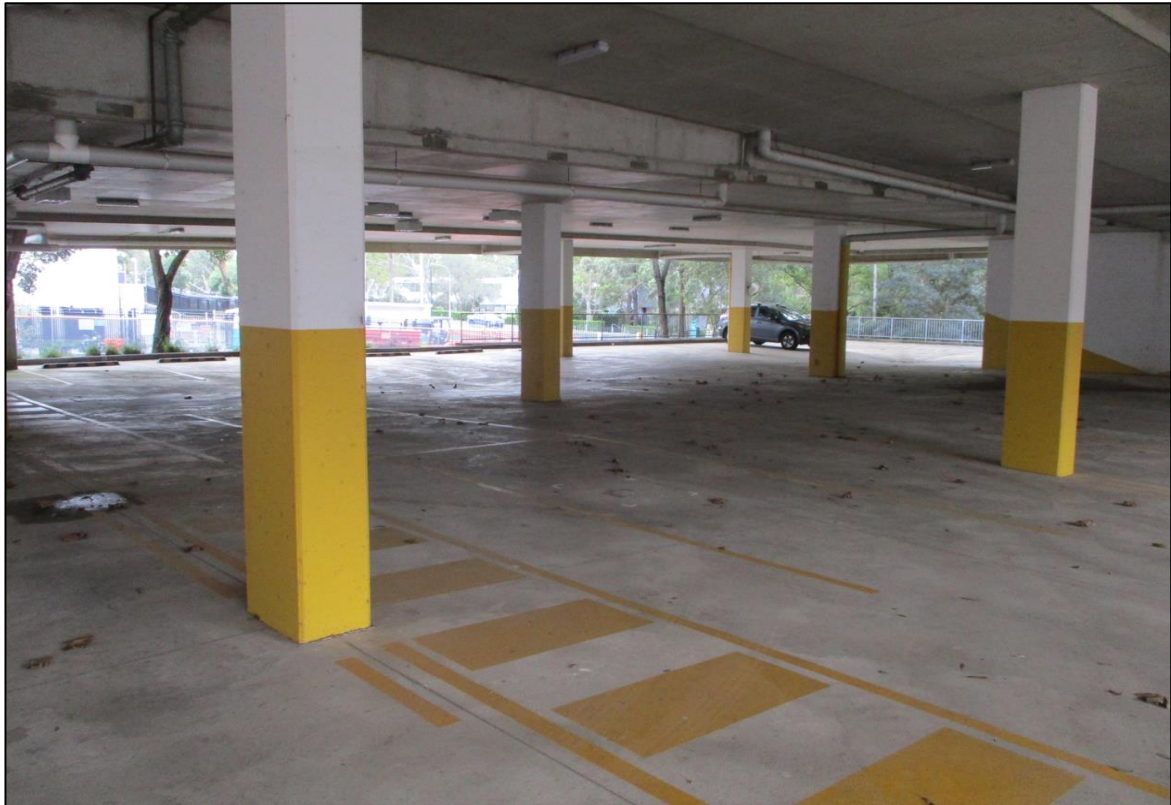
Photo 6: Concrete car park structure, central and northern end of site.

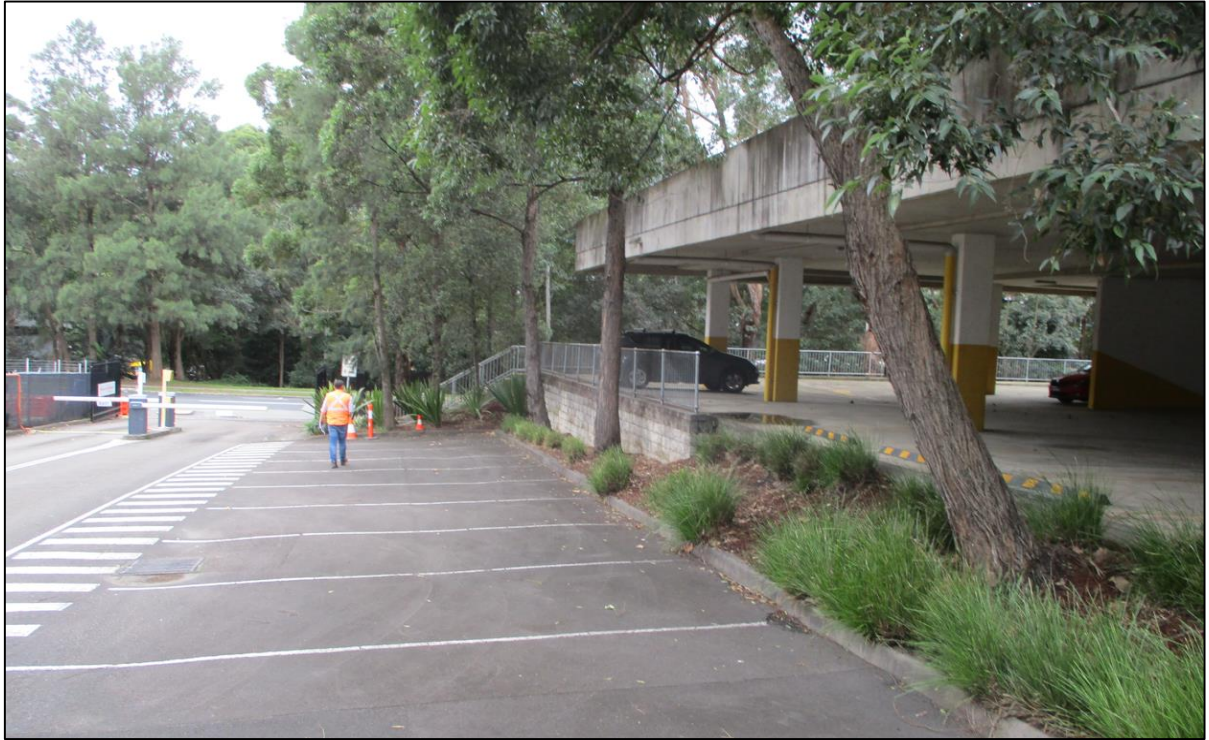
Photo 7: Access from Talavera Road, northern boundary of site.

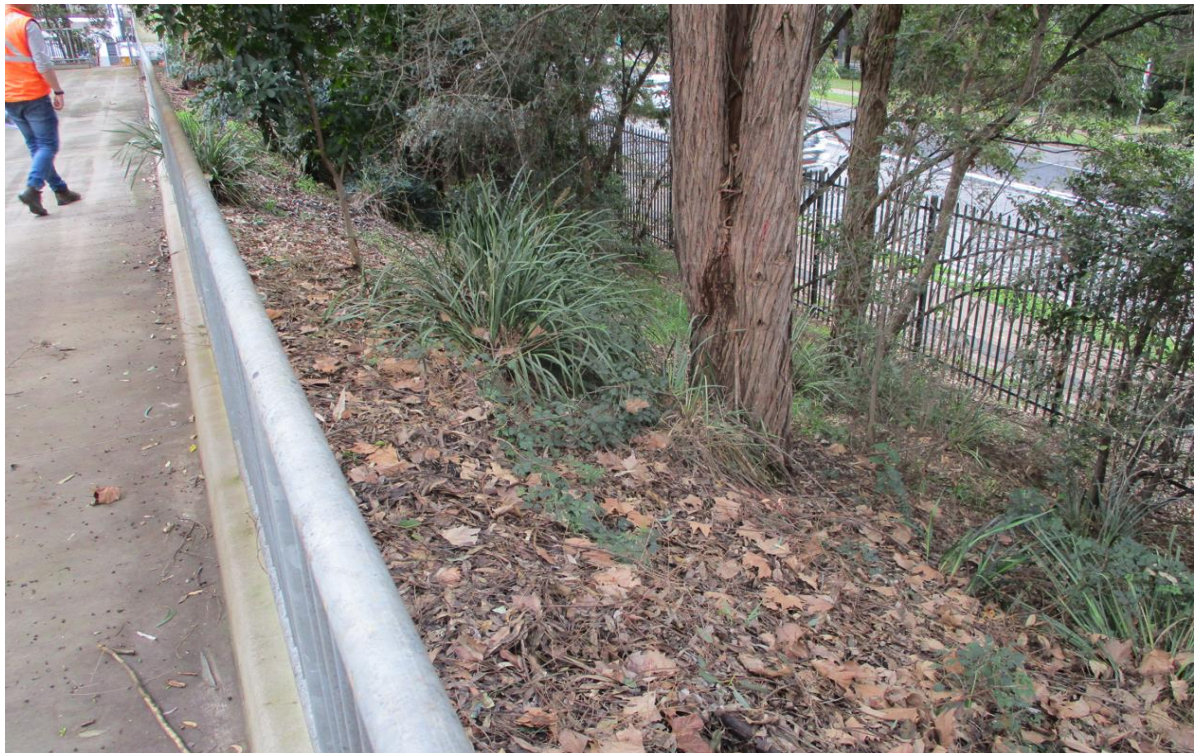
Photo 8: Batter slope frontage along Talavera Road.
