Maules Creek Continuation Project

Environmental Impact Statement

Appendix D
Aquatic Ecology Assessment

Maules Creek Continuation Project Aquatic Ecology Assessment

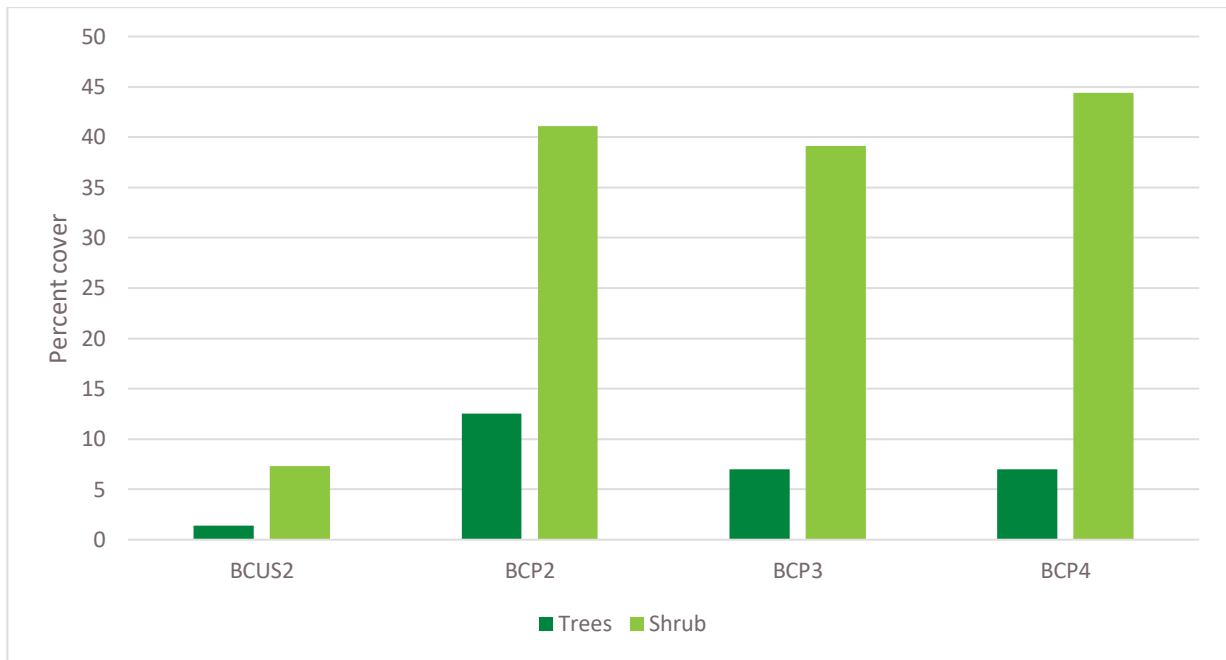
Figure 12: Tree and shrub cover in the riparian zone of Back Creek during autumn 2024.

Average tree cover across the four monitoring sites was 19.5% in summer 2022 (Figure 11) compared to 6.6% in autumn 2024 (Figure 12). Tree cover was highest at the two upstream sites (BCUS2, BCP2) and lowest at the downstream sites (Figure 11) in summer 2022. Tree cover in autumn 2024 was highest at BCP2 and lowest at BCUS2. In summer 2022, average shrub cover across the four monitoring sites was 27.2%, but cover varied considerably between upstream and downstream sites. BCP3 and BCP4 each had more than four times the shrub cover than the other two upstream sites. *Melaleuca bracteata* (Black Tea-tree) dominated the shrub layer at all sites except BCUS2, where it was absent in the plot during summer 2022. Average shrub cover had increased to 40.6% for the autumn 2024 survey. BCP3 had the highest shrub cover of 60.1%. Black Tea-tree dominated the shrub layer at all sites except BCUS2. Site BCUS2 has the lowest shrub cover of 7.3% of the entire plot in autumn 2024.

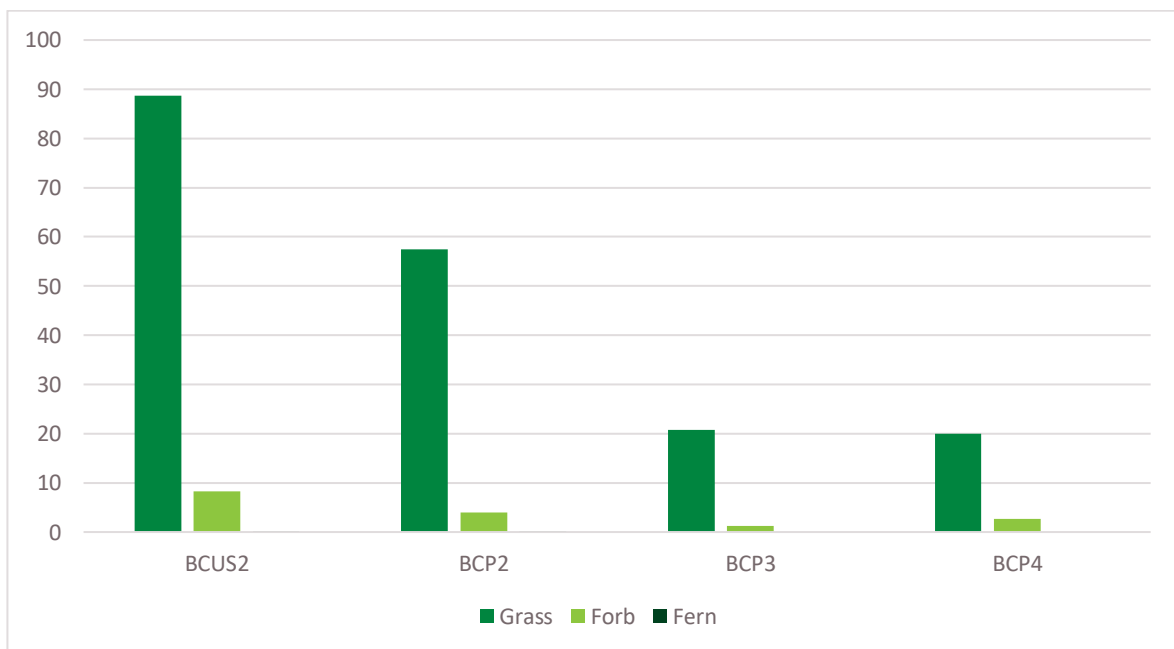
Figure 14: Ground cover (Grass, forbs, ferns) in the riparian zone of Back Creek during autumn 2024. Ferns present at BCUS2 and BCP2 but make up less than 0.1% cover at each site.

Grass cover was higher at downstream sites than upstream sites. Forb cover was between 2.6 and 6.7%, while ferns occurred only at BCUS2 with a cover 0.1% (not visible in Figure 14). In autumn 2024, two sites were dominated by groundcover, ranging from 29.7% to 87%, the other two sites were dominated by shrub cover. Ferns only occurred at BCUS2 and BCP4 with a cover 0.1% in autumn 2024 (not visible in Figure 14).

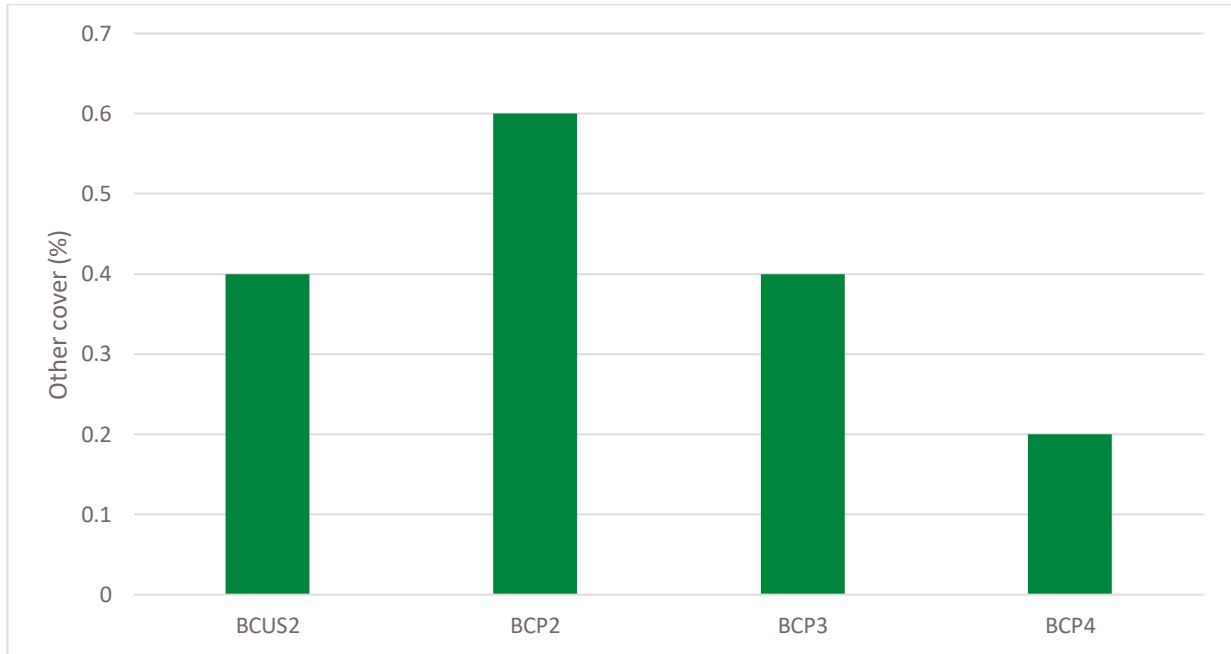
Figure 15: 'Other' cover in the riparian zone of Back Creek in summer 2022

Native species included in the 'other' growth form group category include vines such as *Desmodium varians* and *Glycine tabacina*, in both surveys, and *Clematis microphylla* in autumn 2024. The average 'other' cover across the four sites was 0.4 in summer 2022 (Figure 15) and 0.5 in autumn 2024 (Figure 16).

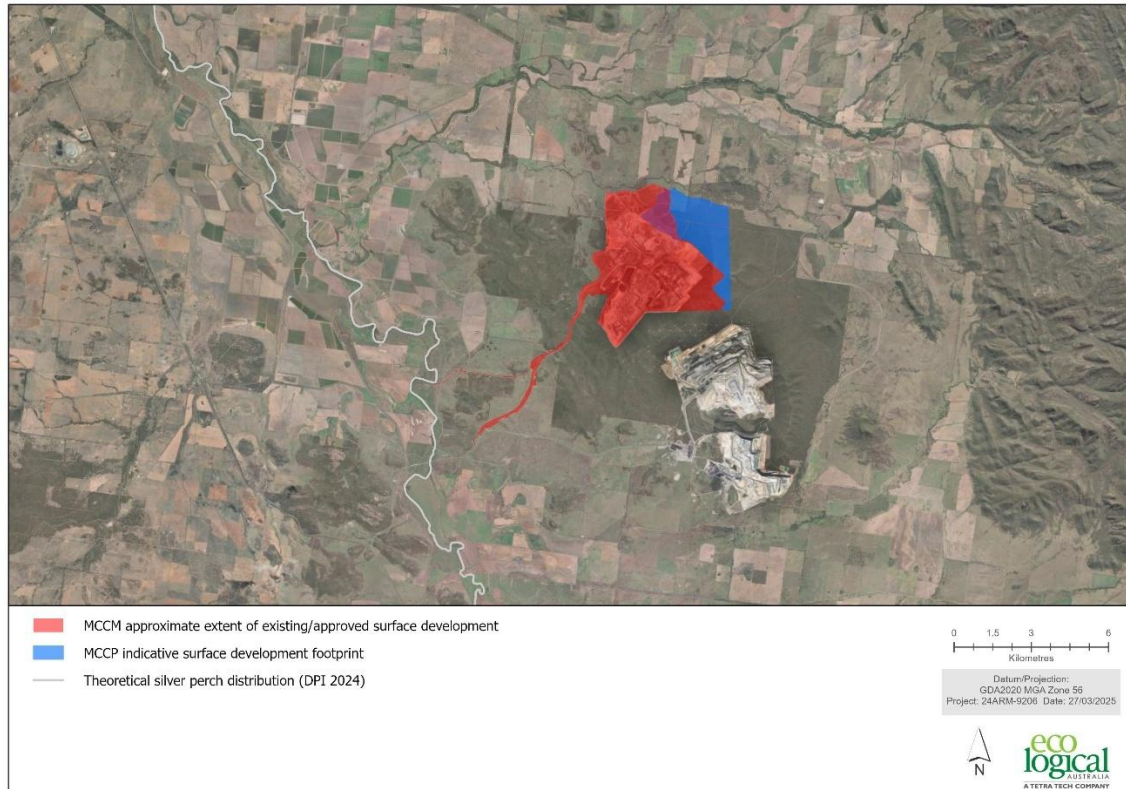
Figure 22: Theoretical distribution of silver perch (grey line) from Fisheries NSW Spatial Data Portal (DPI 2024b).

Eel-tailed catfish and silver perch occur in the Namoi River (Figure 19, Figure 22), with populations boosted by stocking (DPI 2024a).

As described above, the silver perch are mapped on the DPI Spatial Portal (2024) as potentially occurring in Namoi River (Figure 22). The Namoi River would not be impacted by the Project (refer to Section 5).

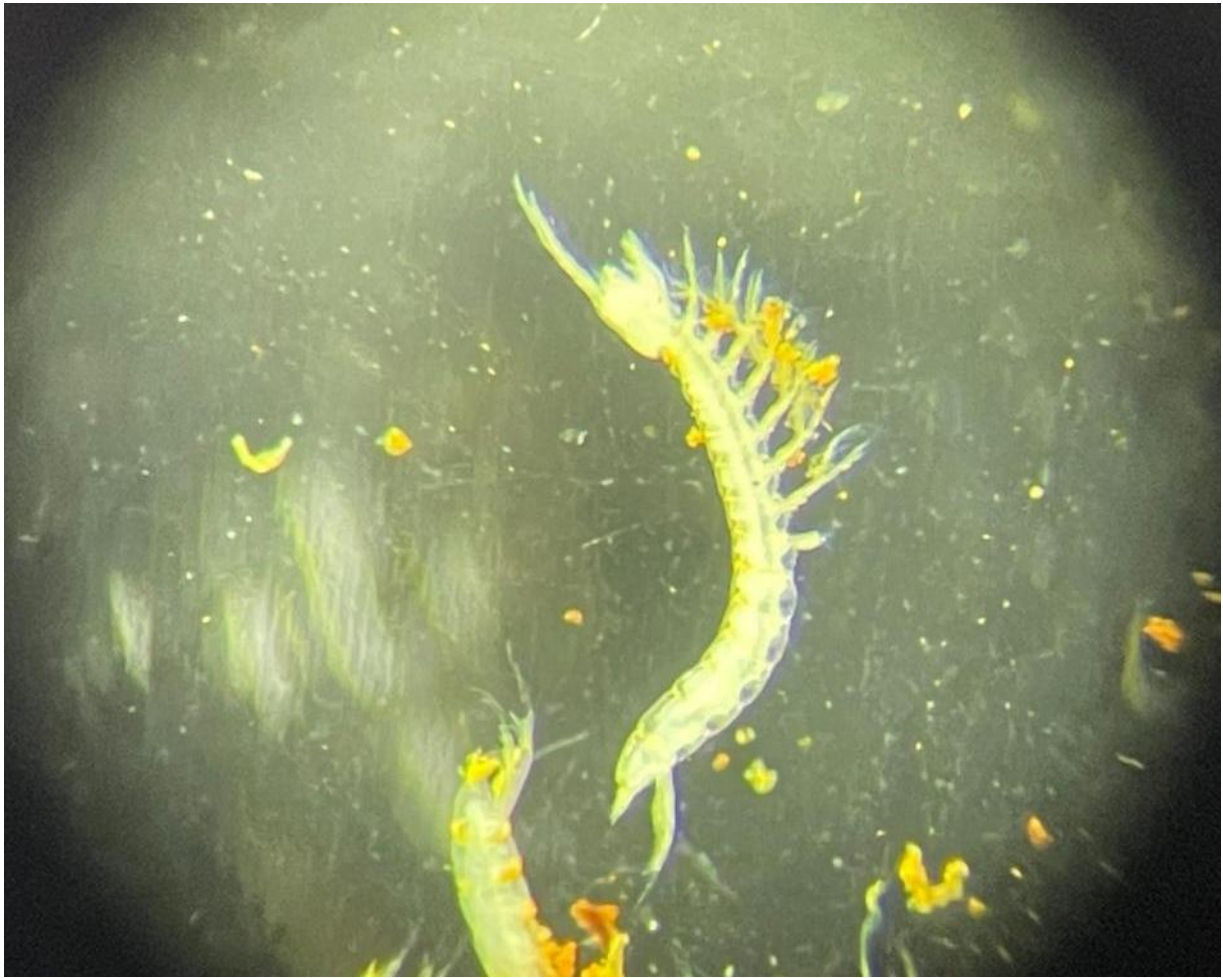
Figure 24: *Notobathynella* sp. collected from MOR2

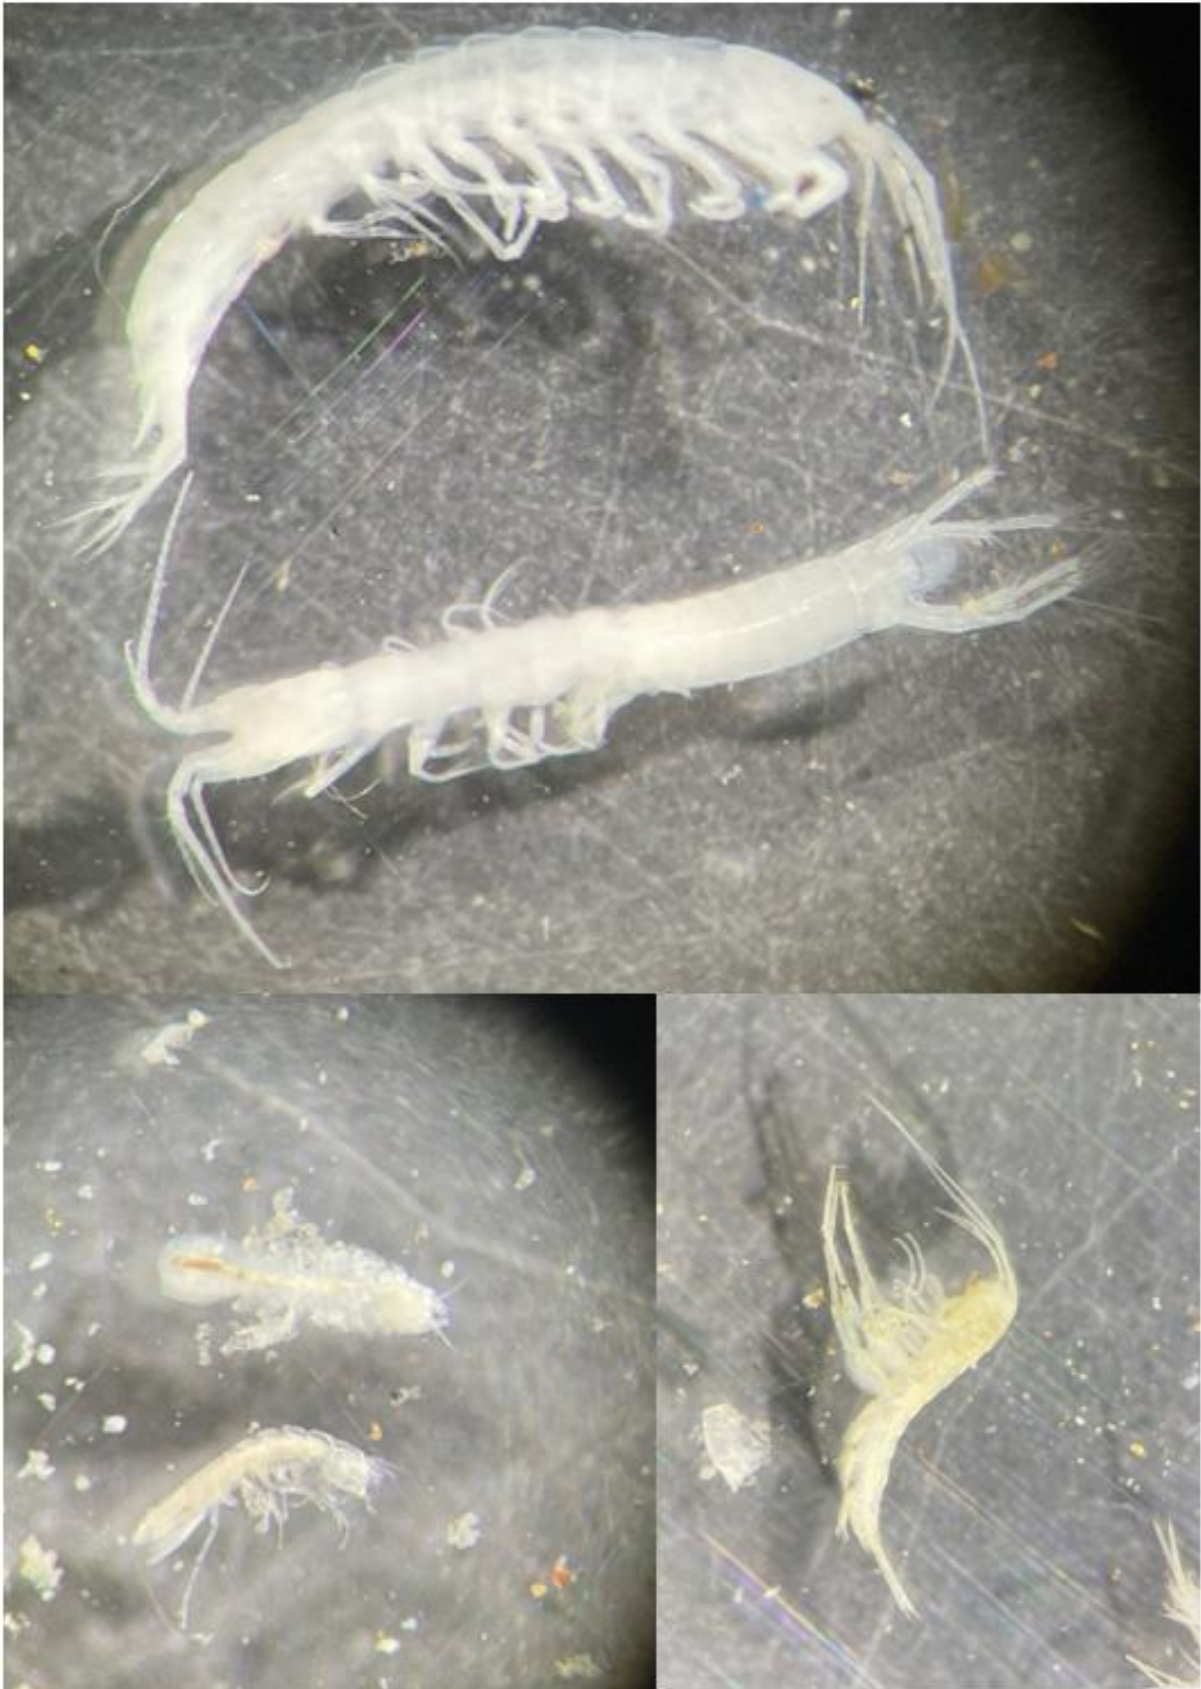
Figure 25: Stygofauna collected from REG16. Top: Syncarida, Psammaspidae; lower left: Isopoda, Janiridae; lower right: Amphipoda.

Bore REG16 is located approximately 40 m south of Maules Creek off Harparary Road (Figure 23). Bore REG16 contained another syncarida, this time from the family Psammaspidae (3 individuals). It also had Copepoda (69 individuals), Isopoda (Janiridae) (5 individuals) and Amphipoda (4 individuals) (Figure 25 and Table 17).

The four stygofauna taxa collected from REG16 are also known from the Maules Creek and Namoi River alluvial aquifers (Kath Korbelt, *pers comm.*). This bore was completed in March 2023 and is screened from 24 to 30 m below ground. The drill log for this bore shows that the aquifer here is deeper than 37 m, and that it consists of mixed alluvial sand, gravel and cobble down to 31 m. Below this depth, clay content increases to 50 %. When developed, water level in the bore was 2.6 m below ground level, pH was 7.5, EC was 3097 $\mu\text{S}/\text{cm}$, and temperature was 19.7 °C.
