Maules Creek Continuation Project

Appendix L
Land Contamination Assessment

**RE: MAULES CREEK CONTINUATION PROJECT,
PRELIMINARY SITE INVESTIGATIONS**

**Maules Creek Continuation Project
Mine Site
Preliminary Site Investigation**

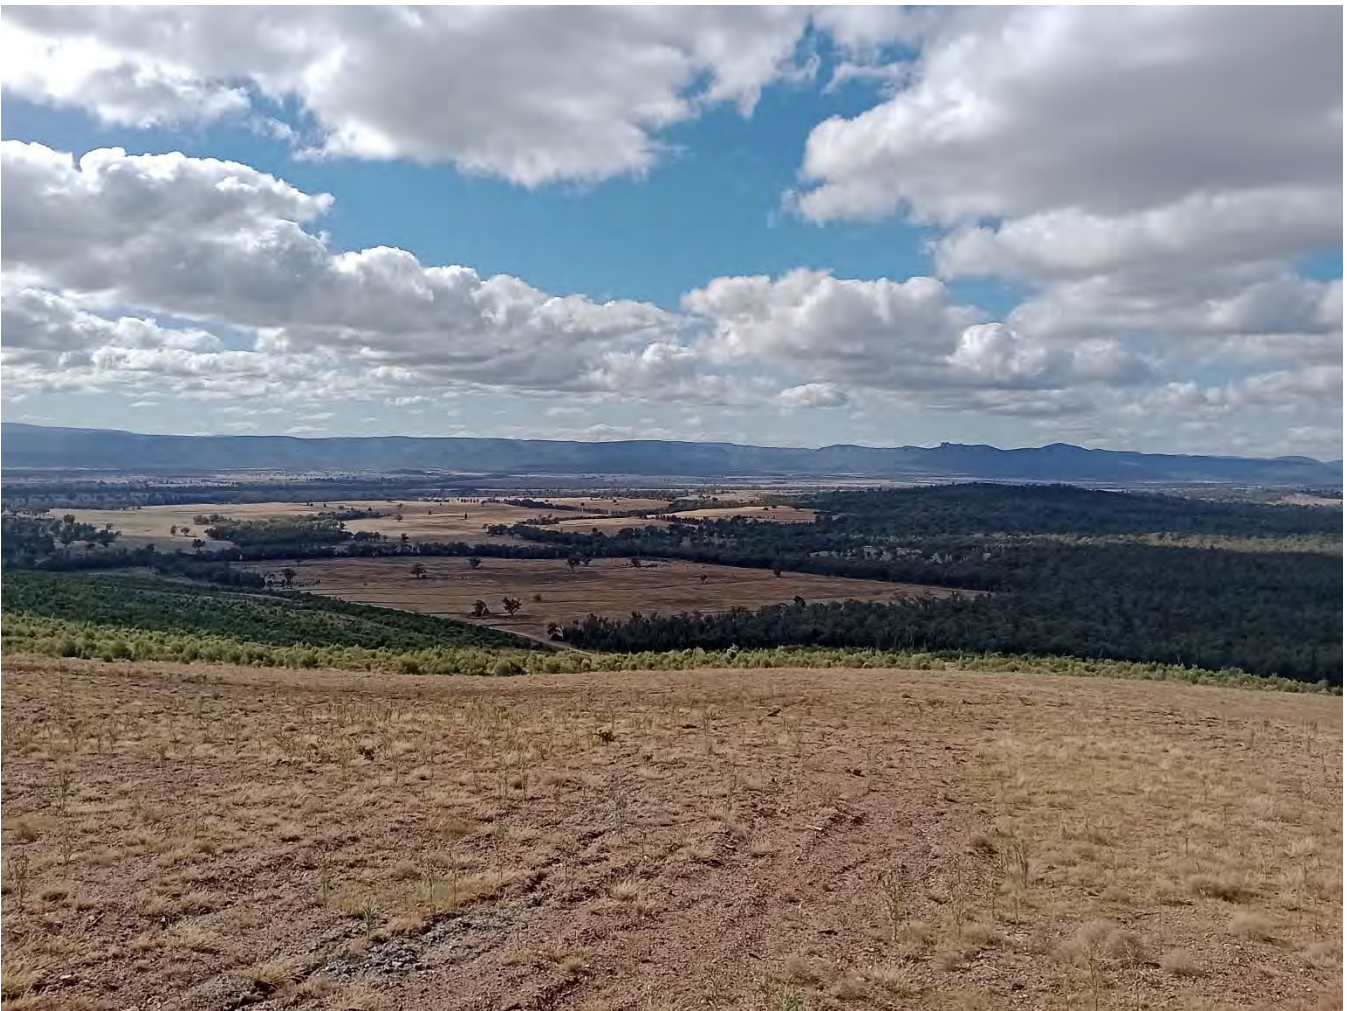
Looking in a north easterly direction over the Study Area from the waste rock emplacement located adjacent to the north west corner of the Study Area. The photo shows the north west corner of the Study Area as a cleared paddock formerly used for cropping. The Leard State Forest occupies the majority of the Study Area.

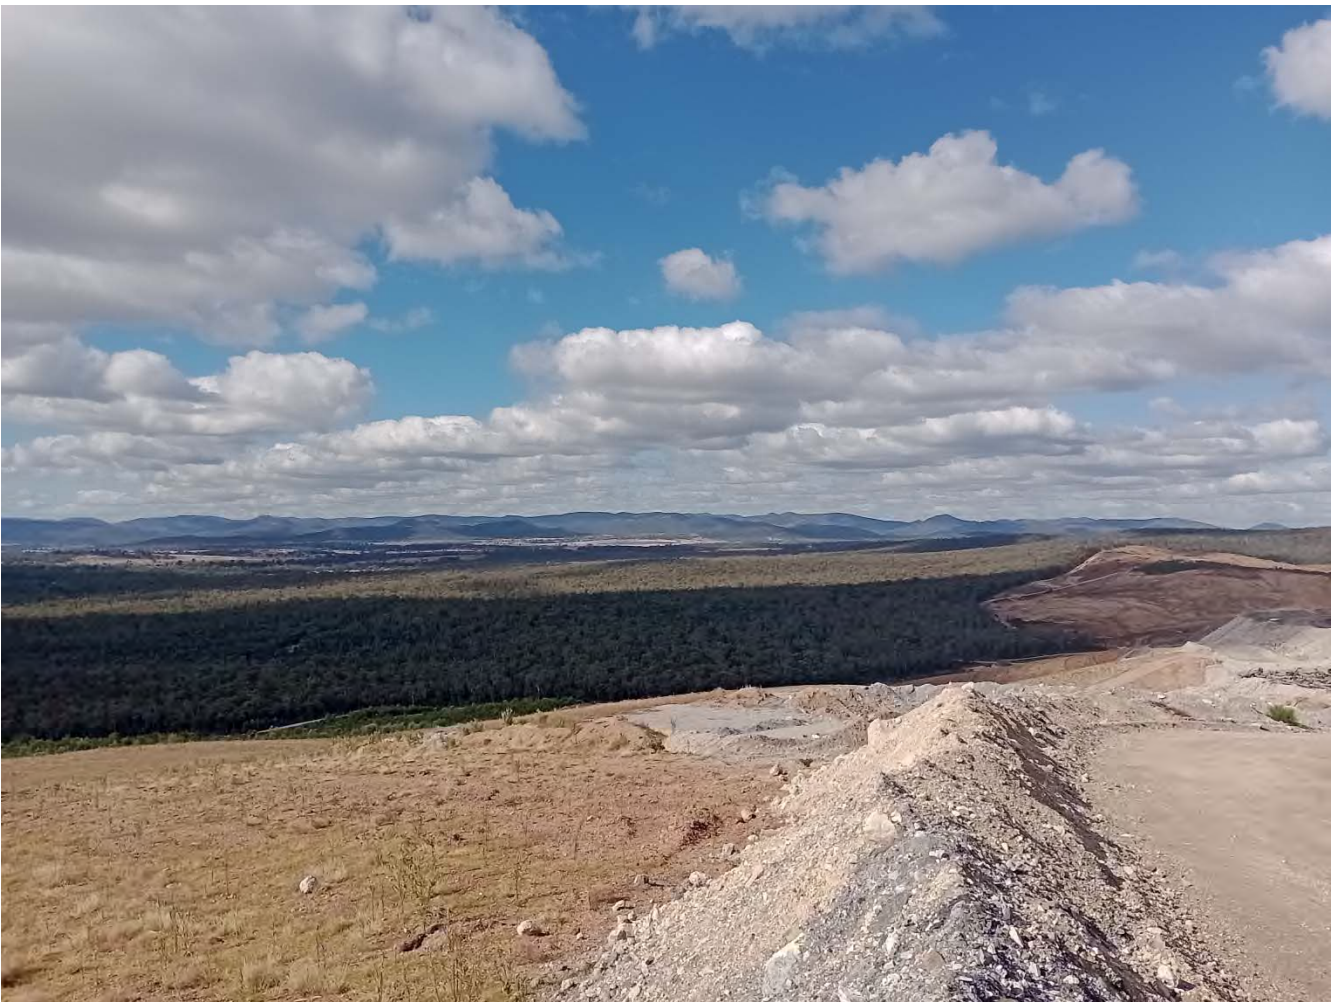
Looking in an easterly direction over the Study Area from the waste rock emplacement located adjacent to the north west corner of the Study Area. The majority of the Study Area is part of the Leard State Forest.

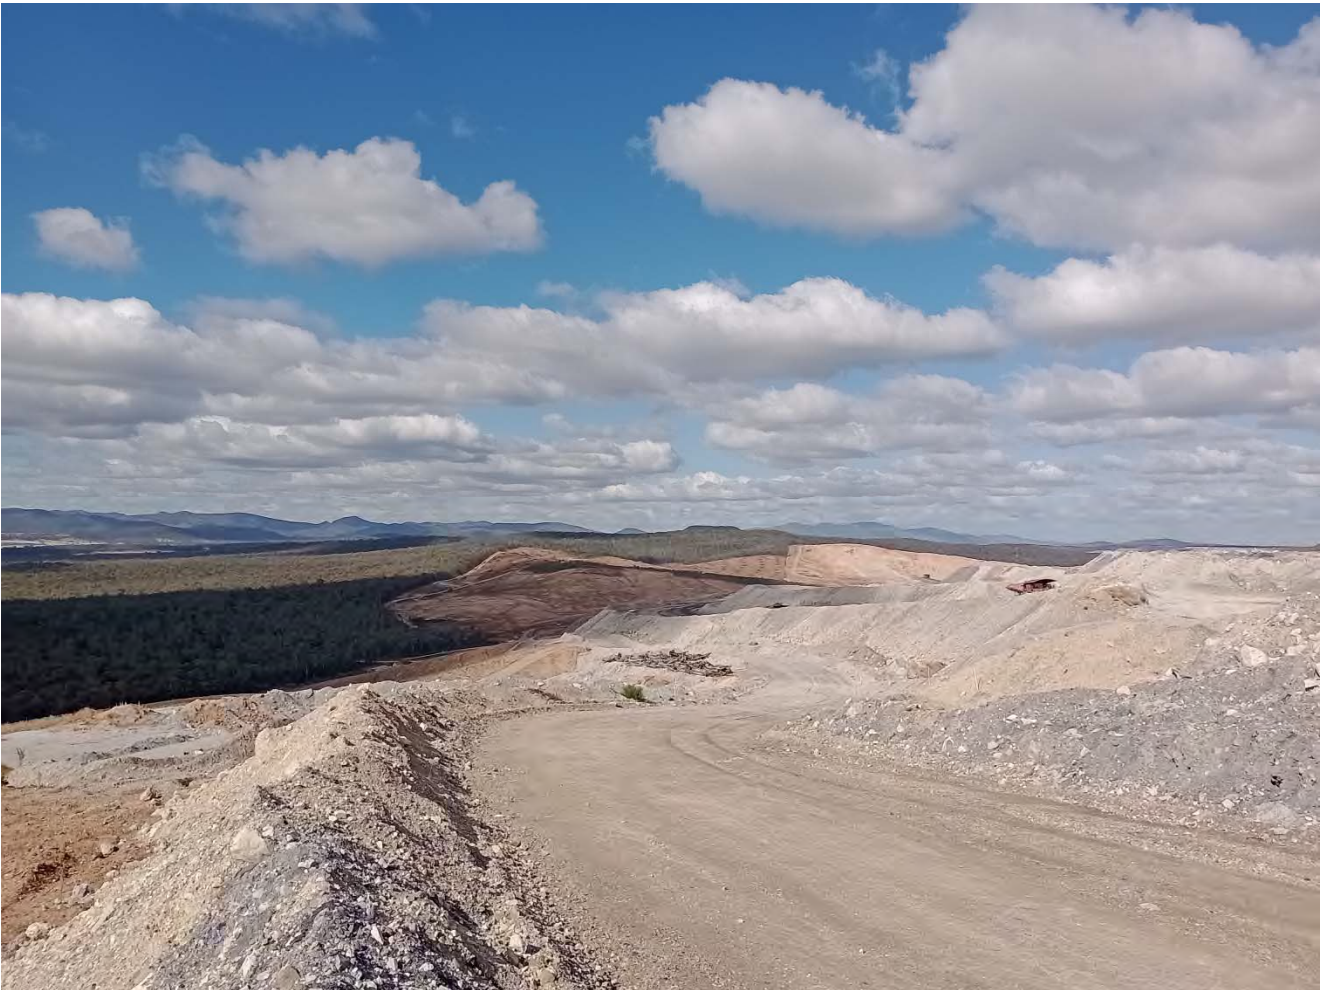
The most elevated part of the Study Area is visible in the distance in this photograph looking in a south easterly direction from the waste rock emplacement located adjacent to the north west corner of the Study Area.

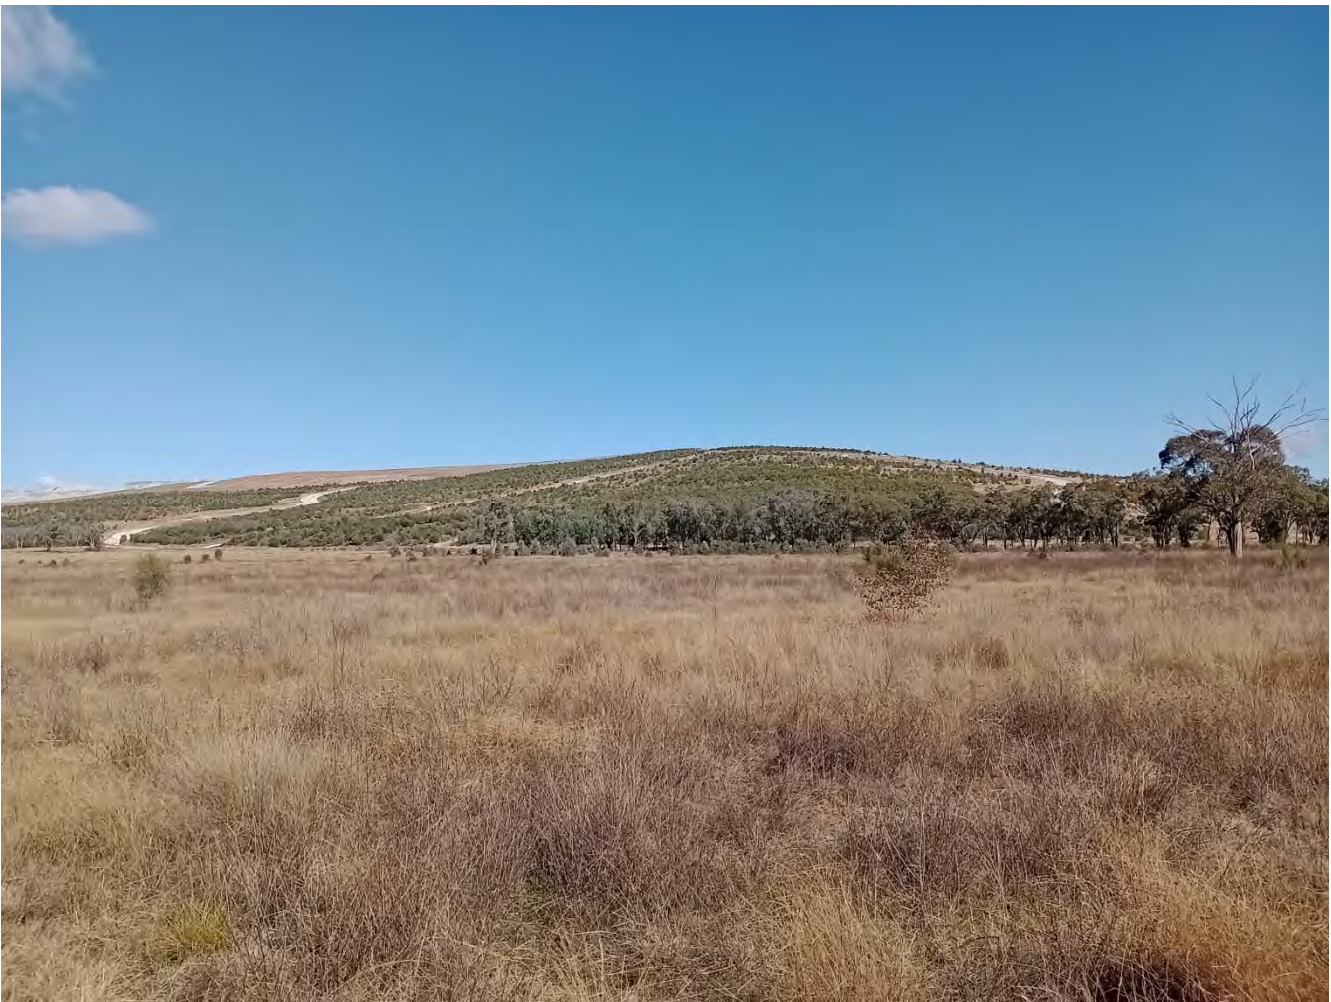
Looking across cleared land in the north west of the Study Area. This area was formerly used for dryland cropping. The hill in the background is the waste rock emplacement on the adjacent MCCM site.

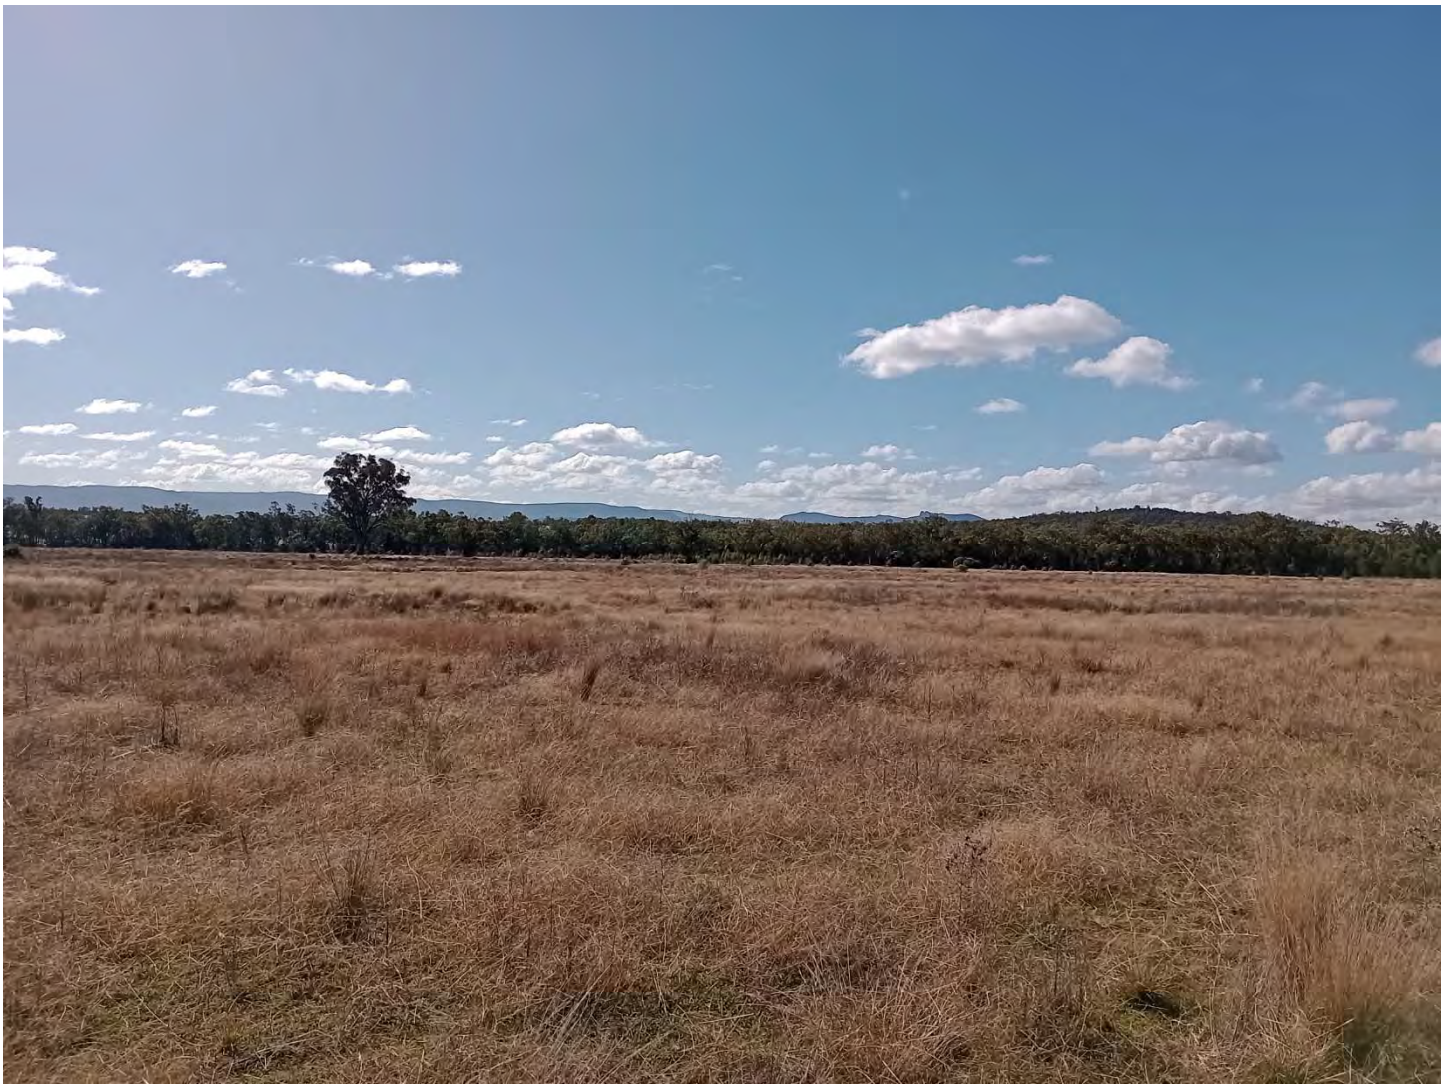
Looking northwards across the former cropping area. Back Creek is situated in the stand of trees north of the cleared paddock.

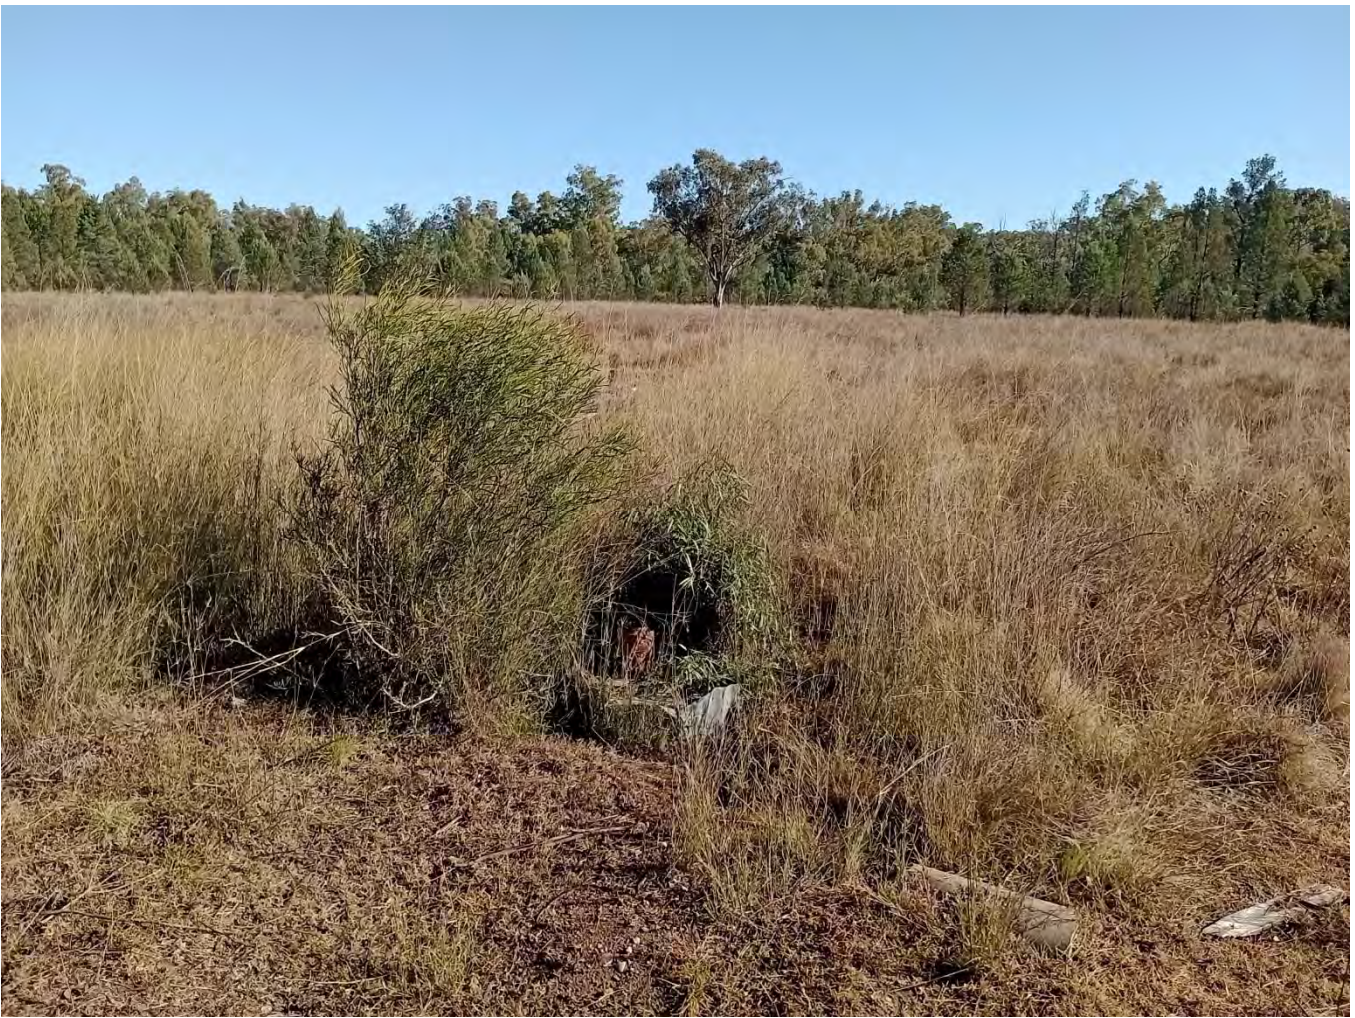
The top of a groundwater bore identified immediately adjacent to the north east corner of the Study Area. A pile of timber was identified nearby. These were the only signs of built infrastructure identified within former agricultural land within or immediately adjacent to the Study Area.

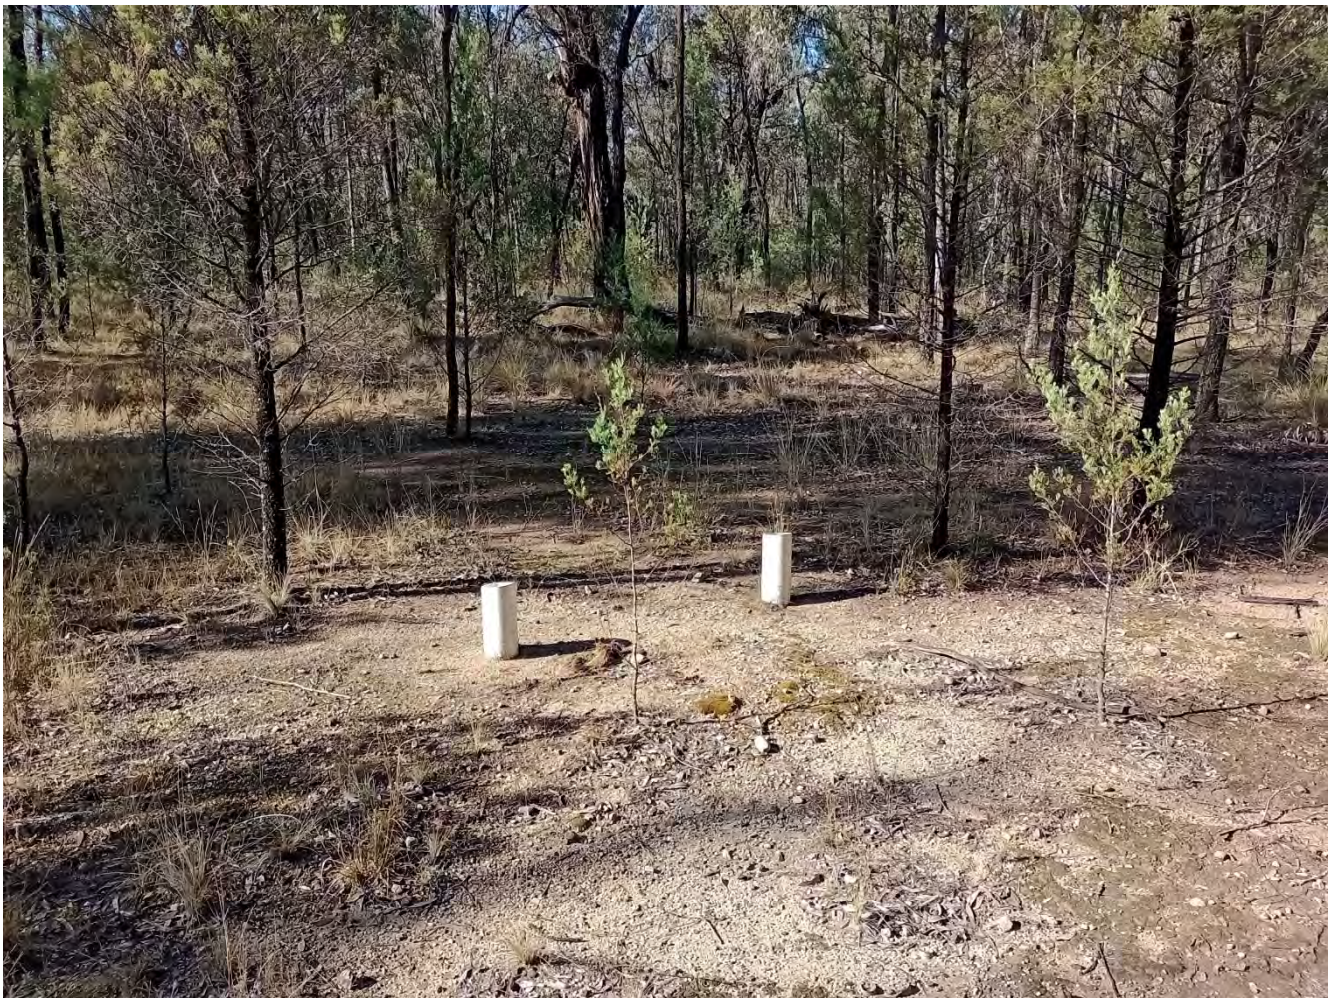
PVC borehole collars were identified at former exploration drilling sites within Leard State Forest. The former drill sites were tidy and vegetation was reestablishing in the drill sites and associated access tracks.

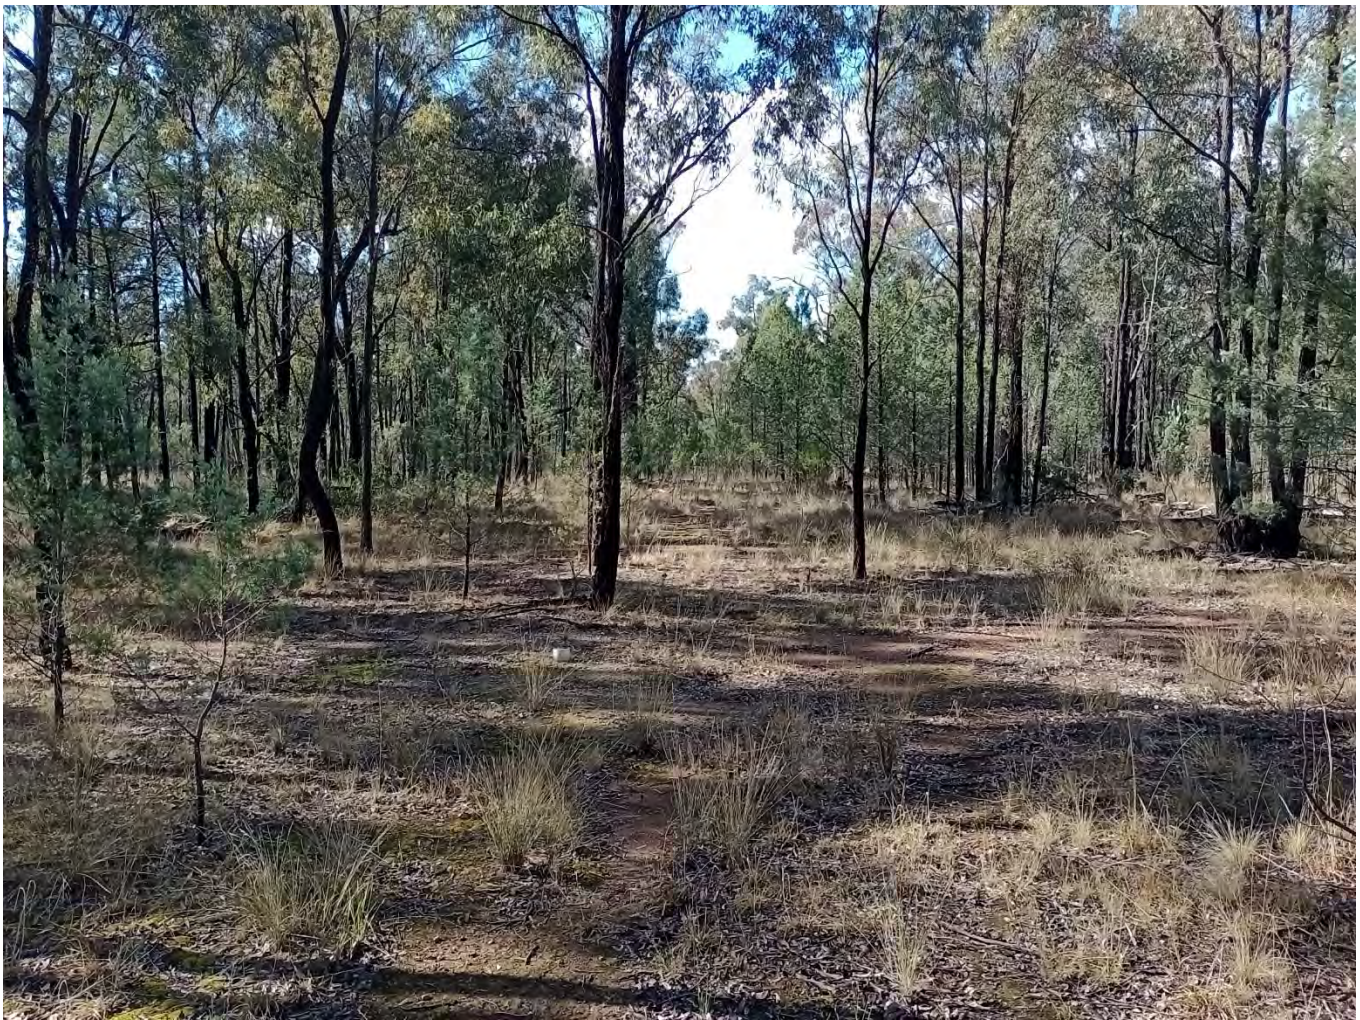
PVC borehole collars were identified at former exploration drilling sites within Leard State Forest. The former drill sites were tidy and vegetation was reestablishing in the drill sites and associated access tracks.

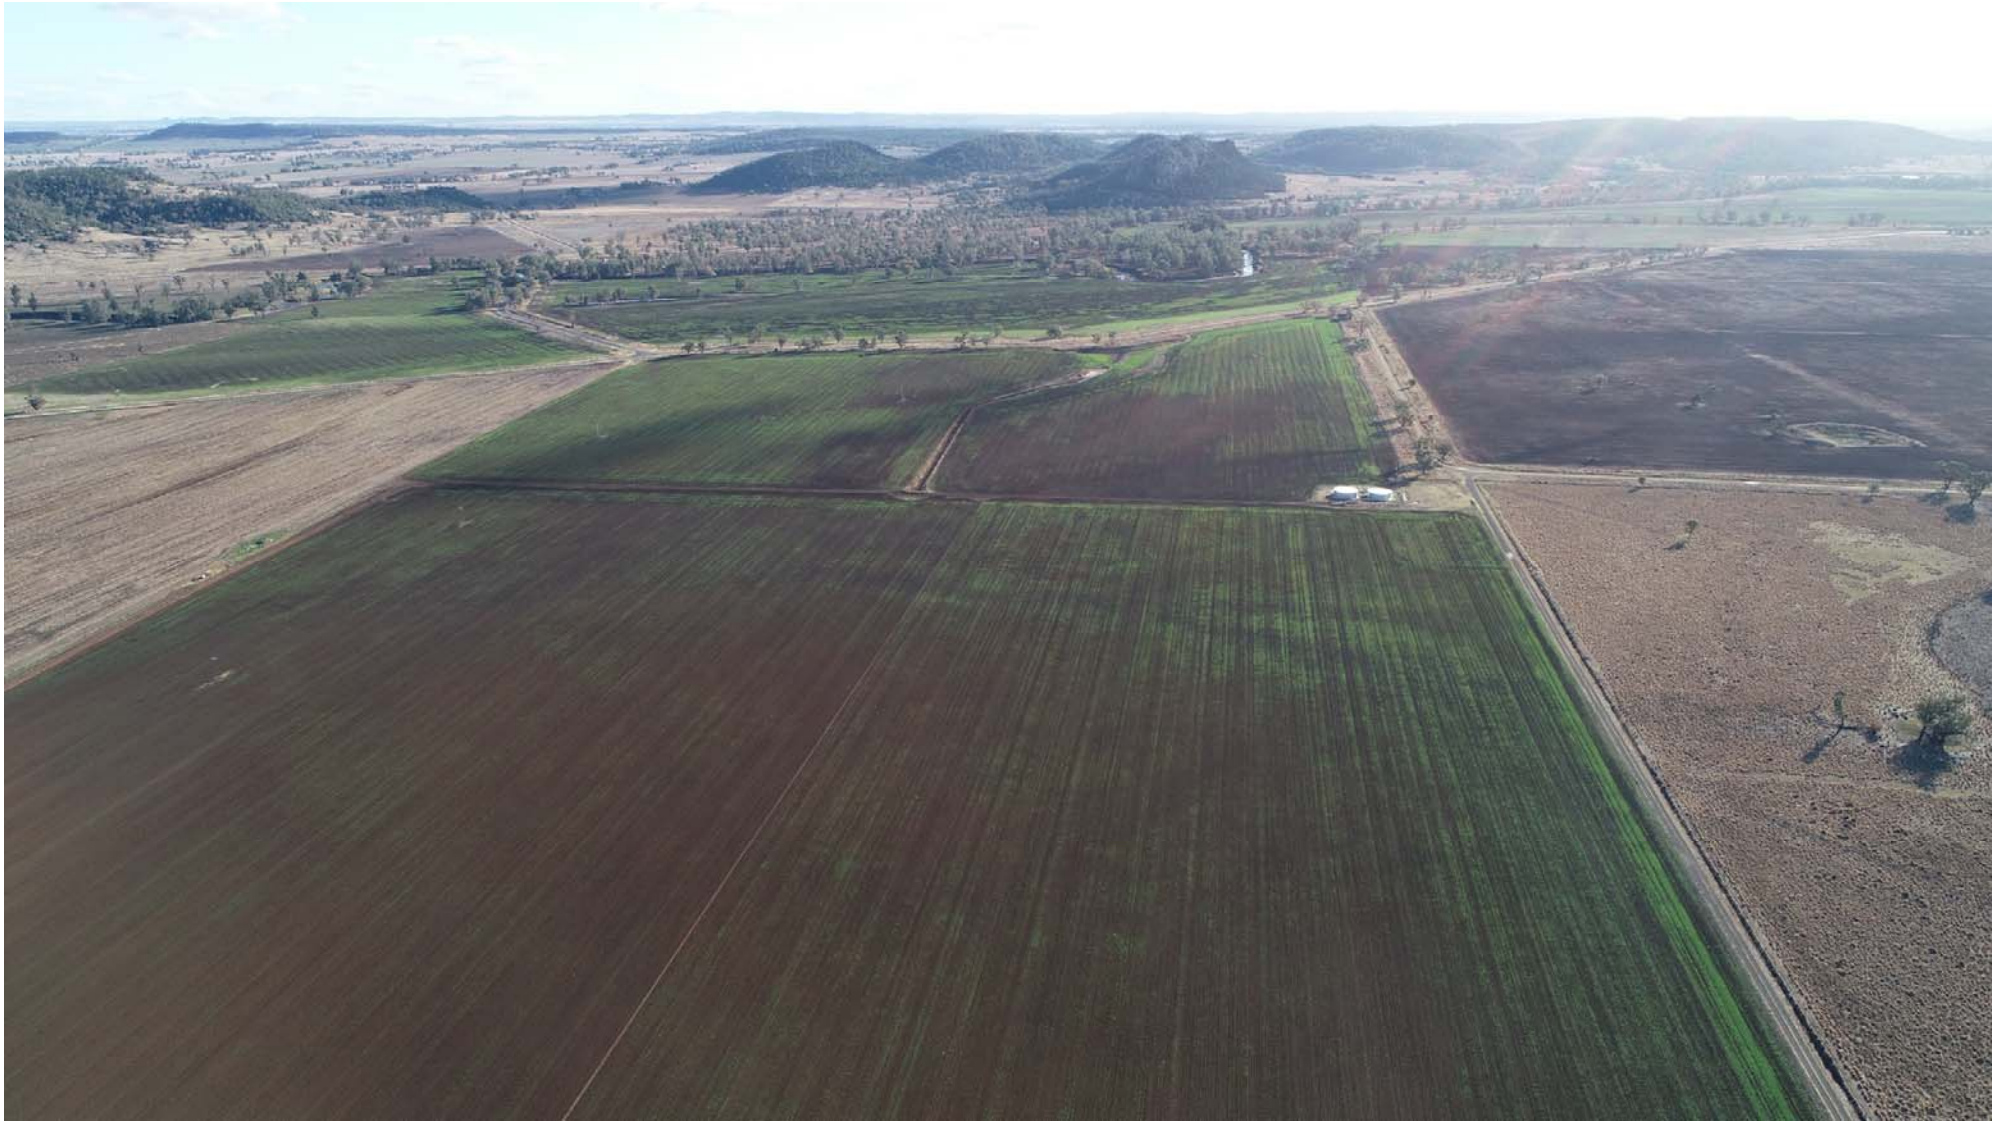
Looking in a westerly direction from above Brighton homestead toward Namoi River. The two white circular tanks middle right are the header tanks for the pipeline. A water supply bore is located close to the tanks. This part of the WSPC is situated on alluvial floodplain of the Namoi River.

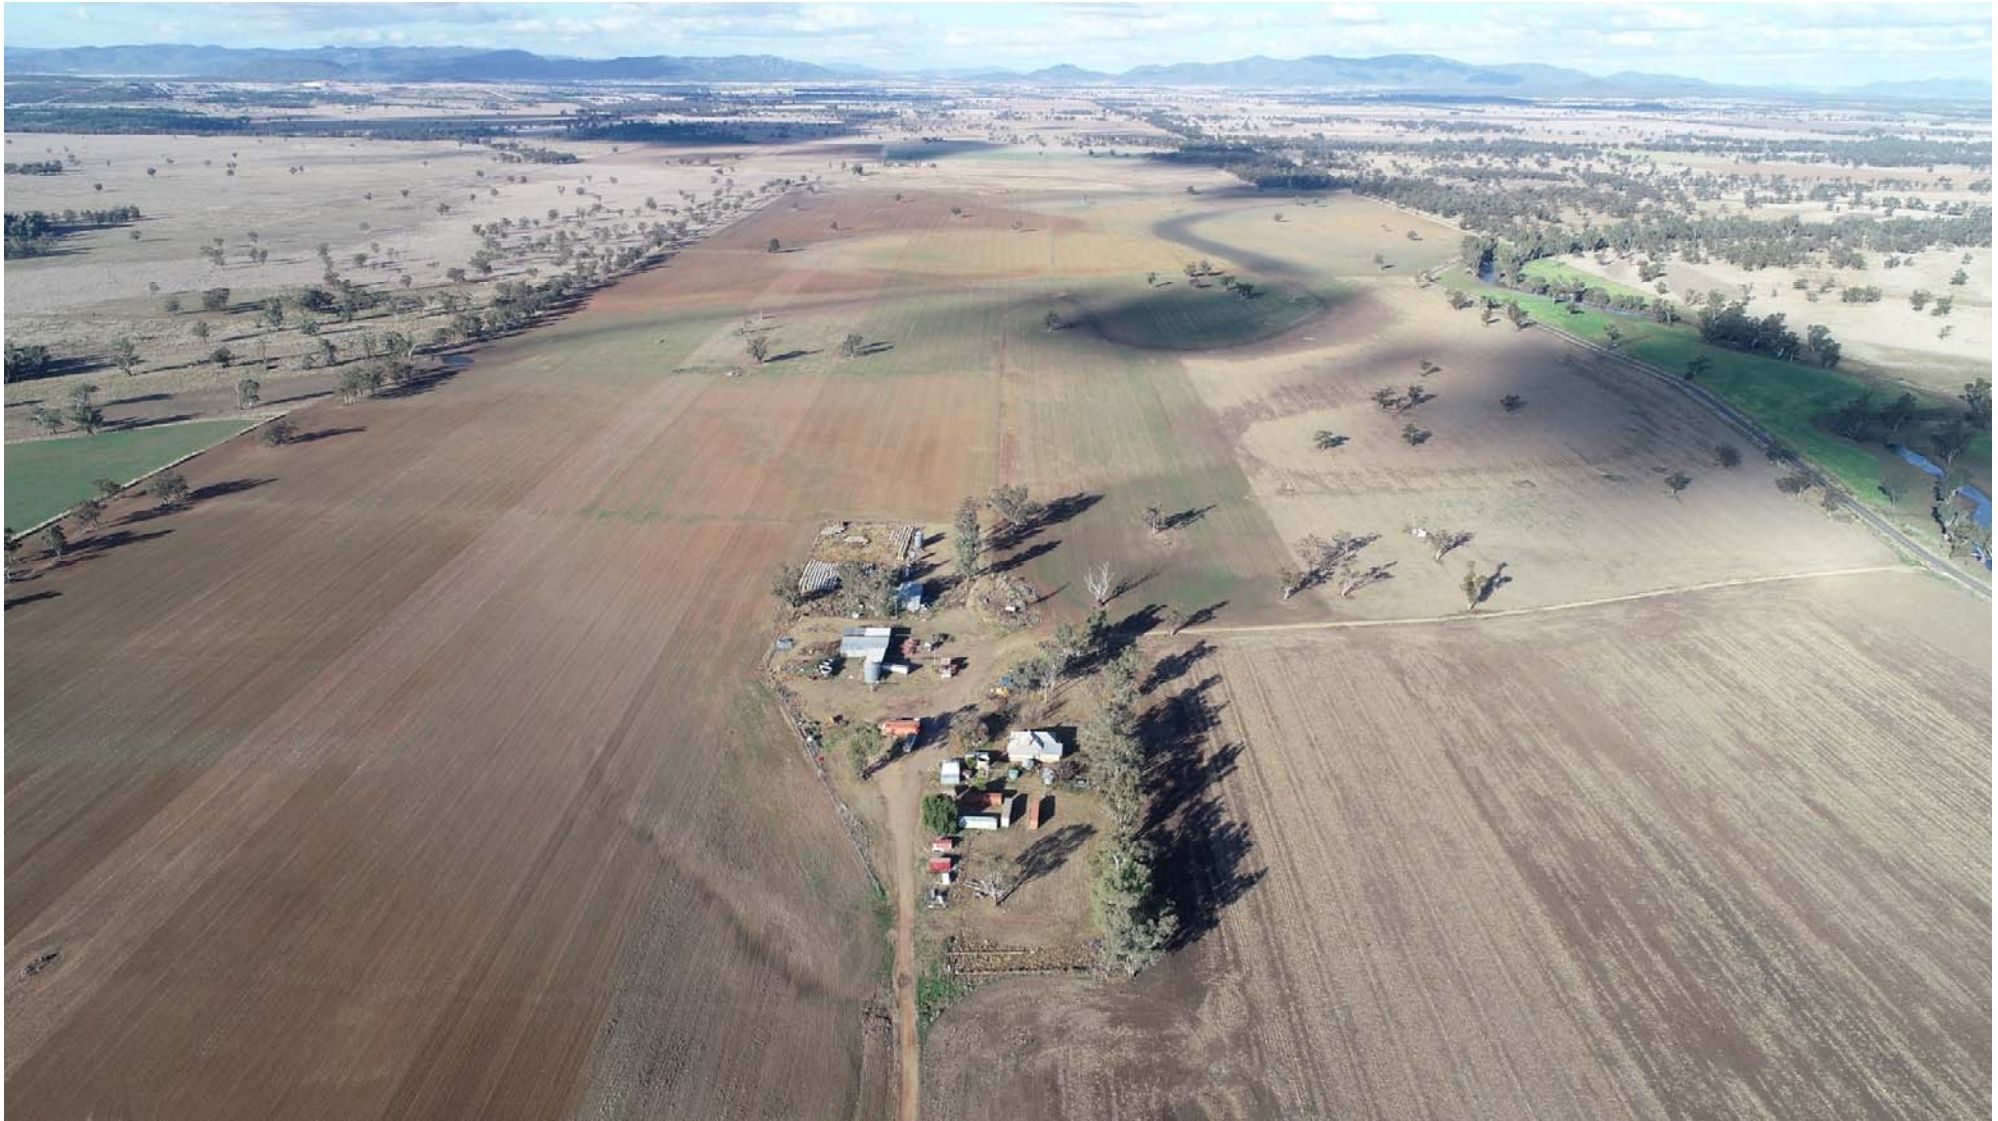
Looking in a westerly direction from above Brighton homestead. Barbers Lagoon is the waterway visible in the right side of the photo. Rangari Road is visible close to barbers lagoon and follows the tree line to the distant centre of the photo.

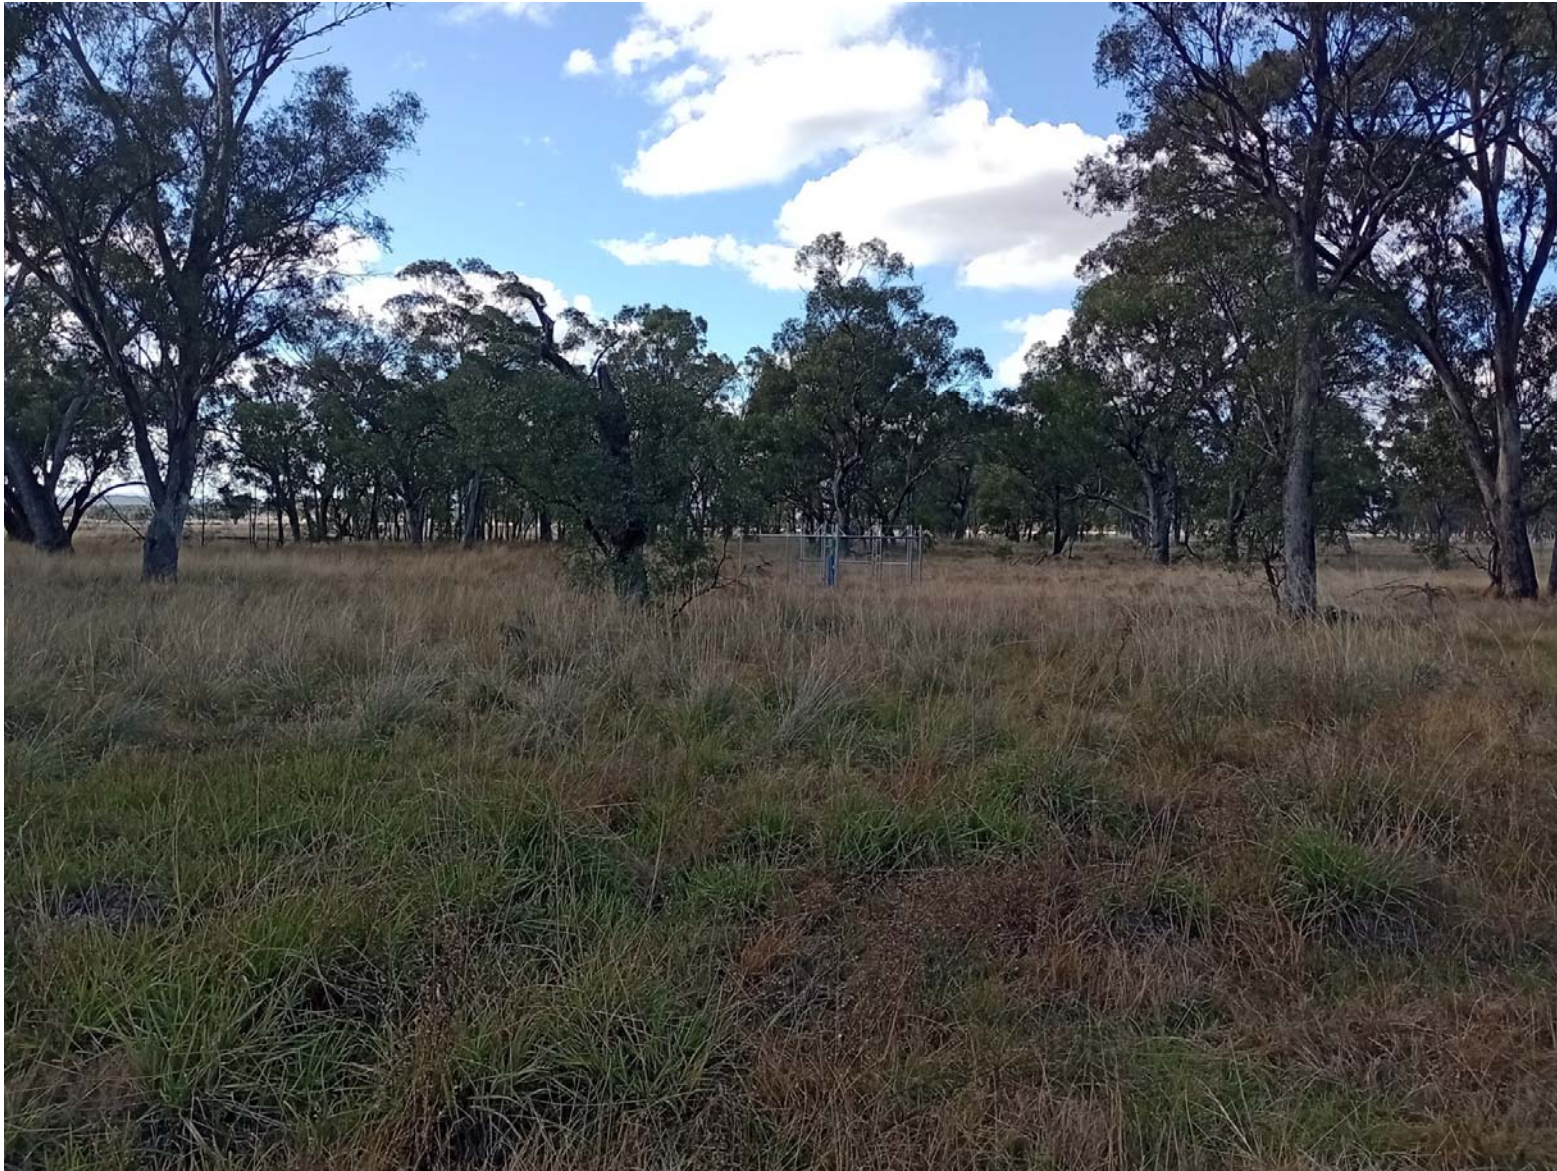
A groundwater monitoring bore was the only infrastructure identified within the travelling stock reserve.

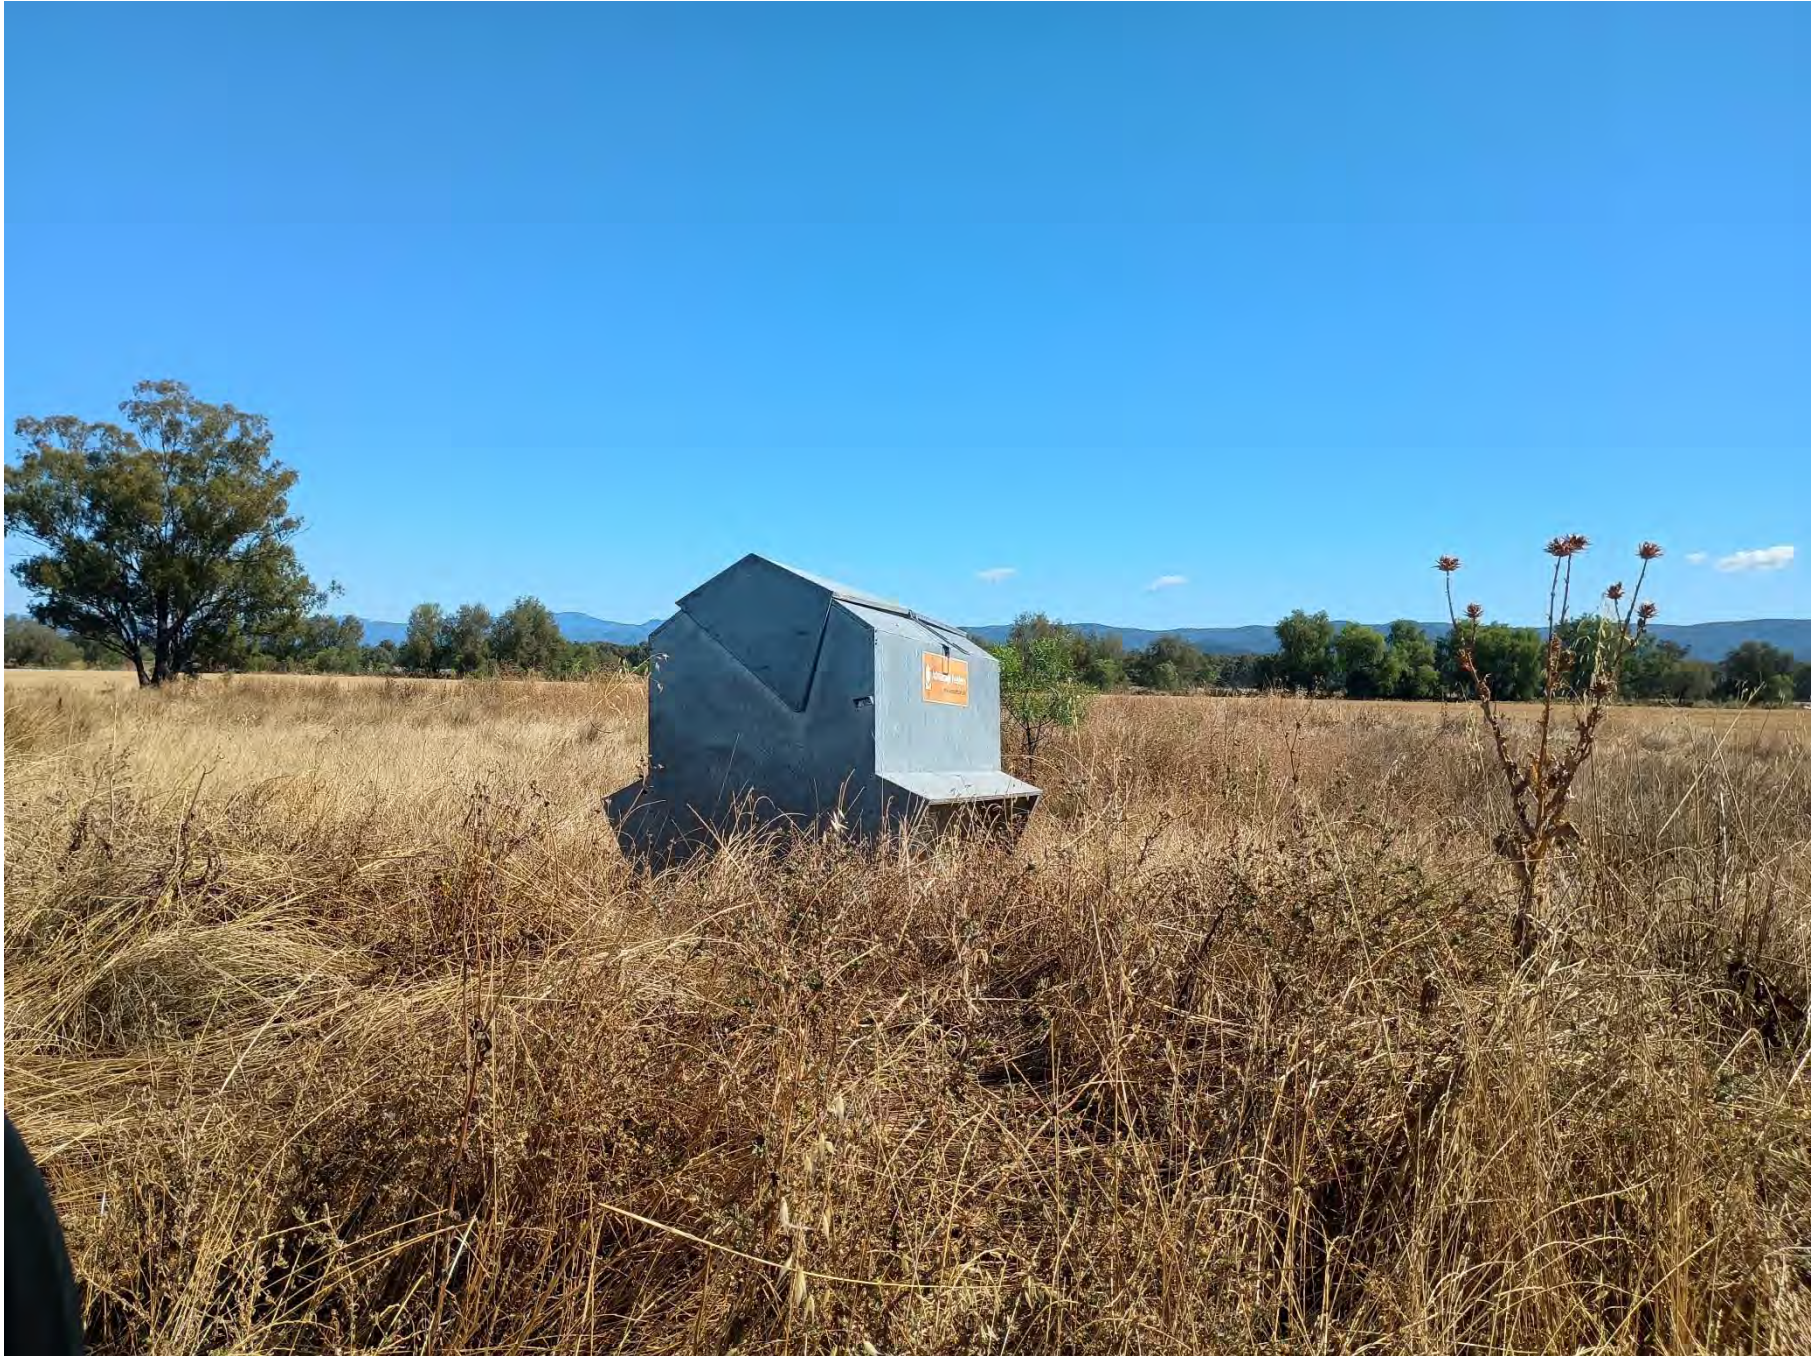
A feeder bin identified within the northern part of Zone 1.

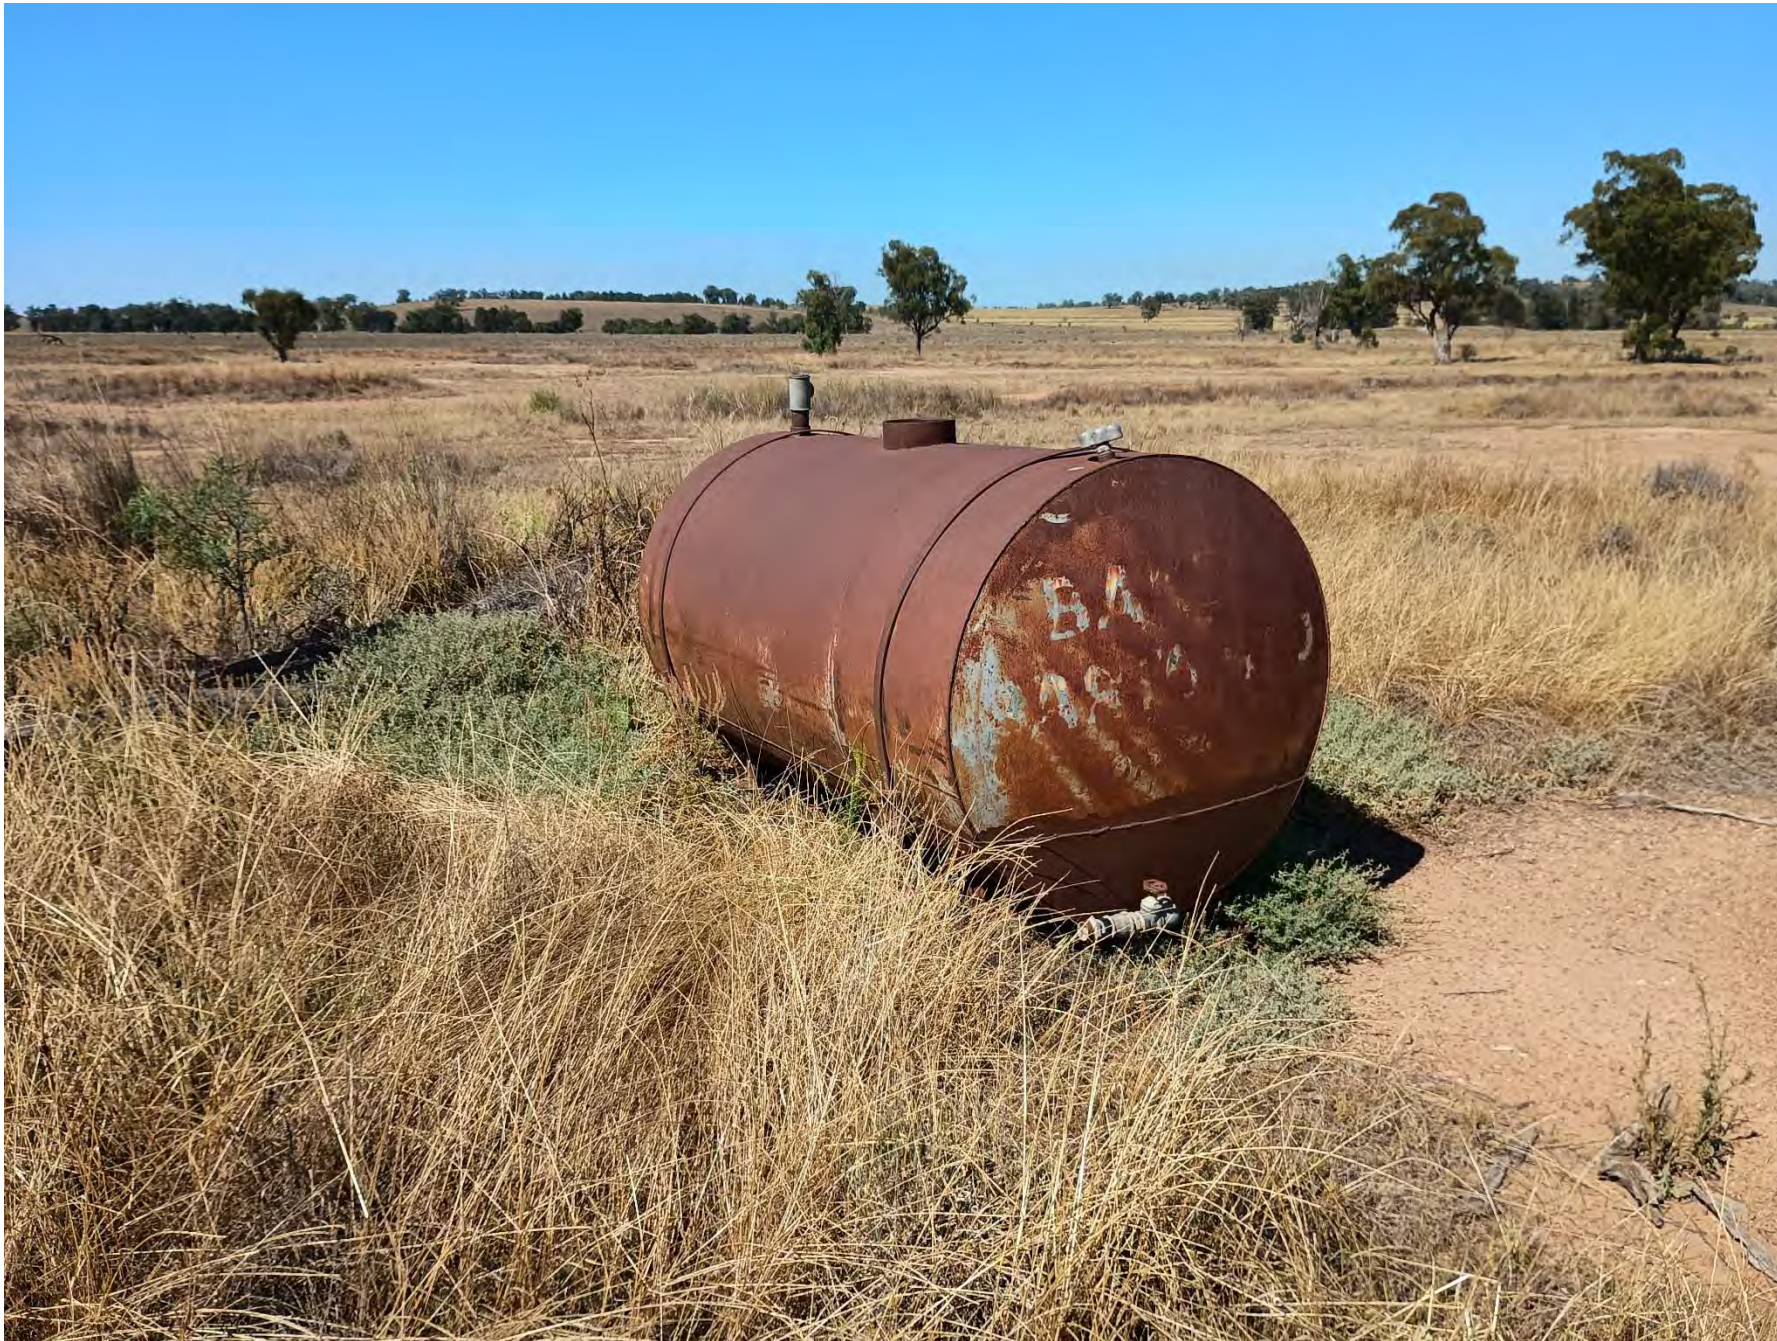
An above ground storage tank was identified close to the northern extent of Zone 1. The tank appeared to have been used to store water. There was no evidence of soil contamination around the AST.
