Maules Creek Continuation Project

Appendix L
Land Contamination Assessment

**RE: MAULES CREEK CONTINUATION PROJECT,
PRELIMINARY SITE INVESTIGATIONS**

**Maules Creek Continuation Project
Mine Site
Preliminary Site Investigation**

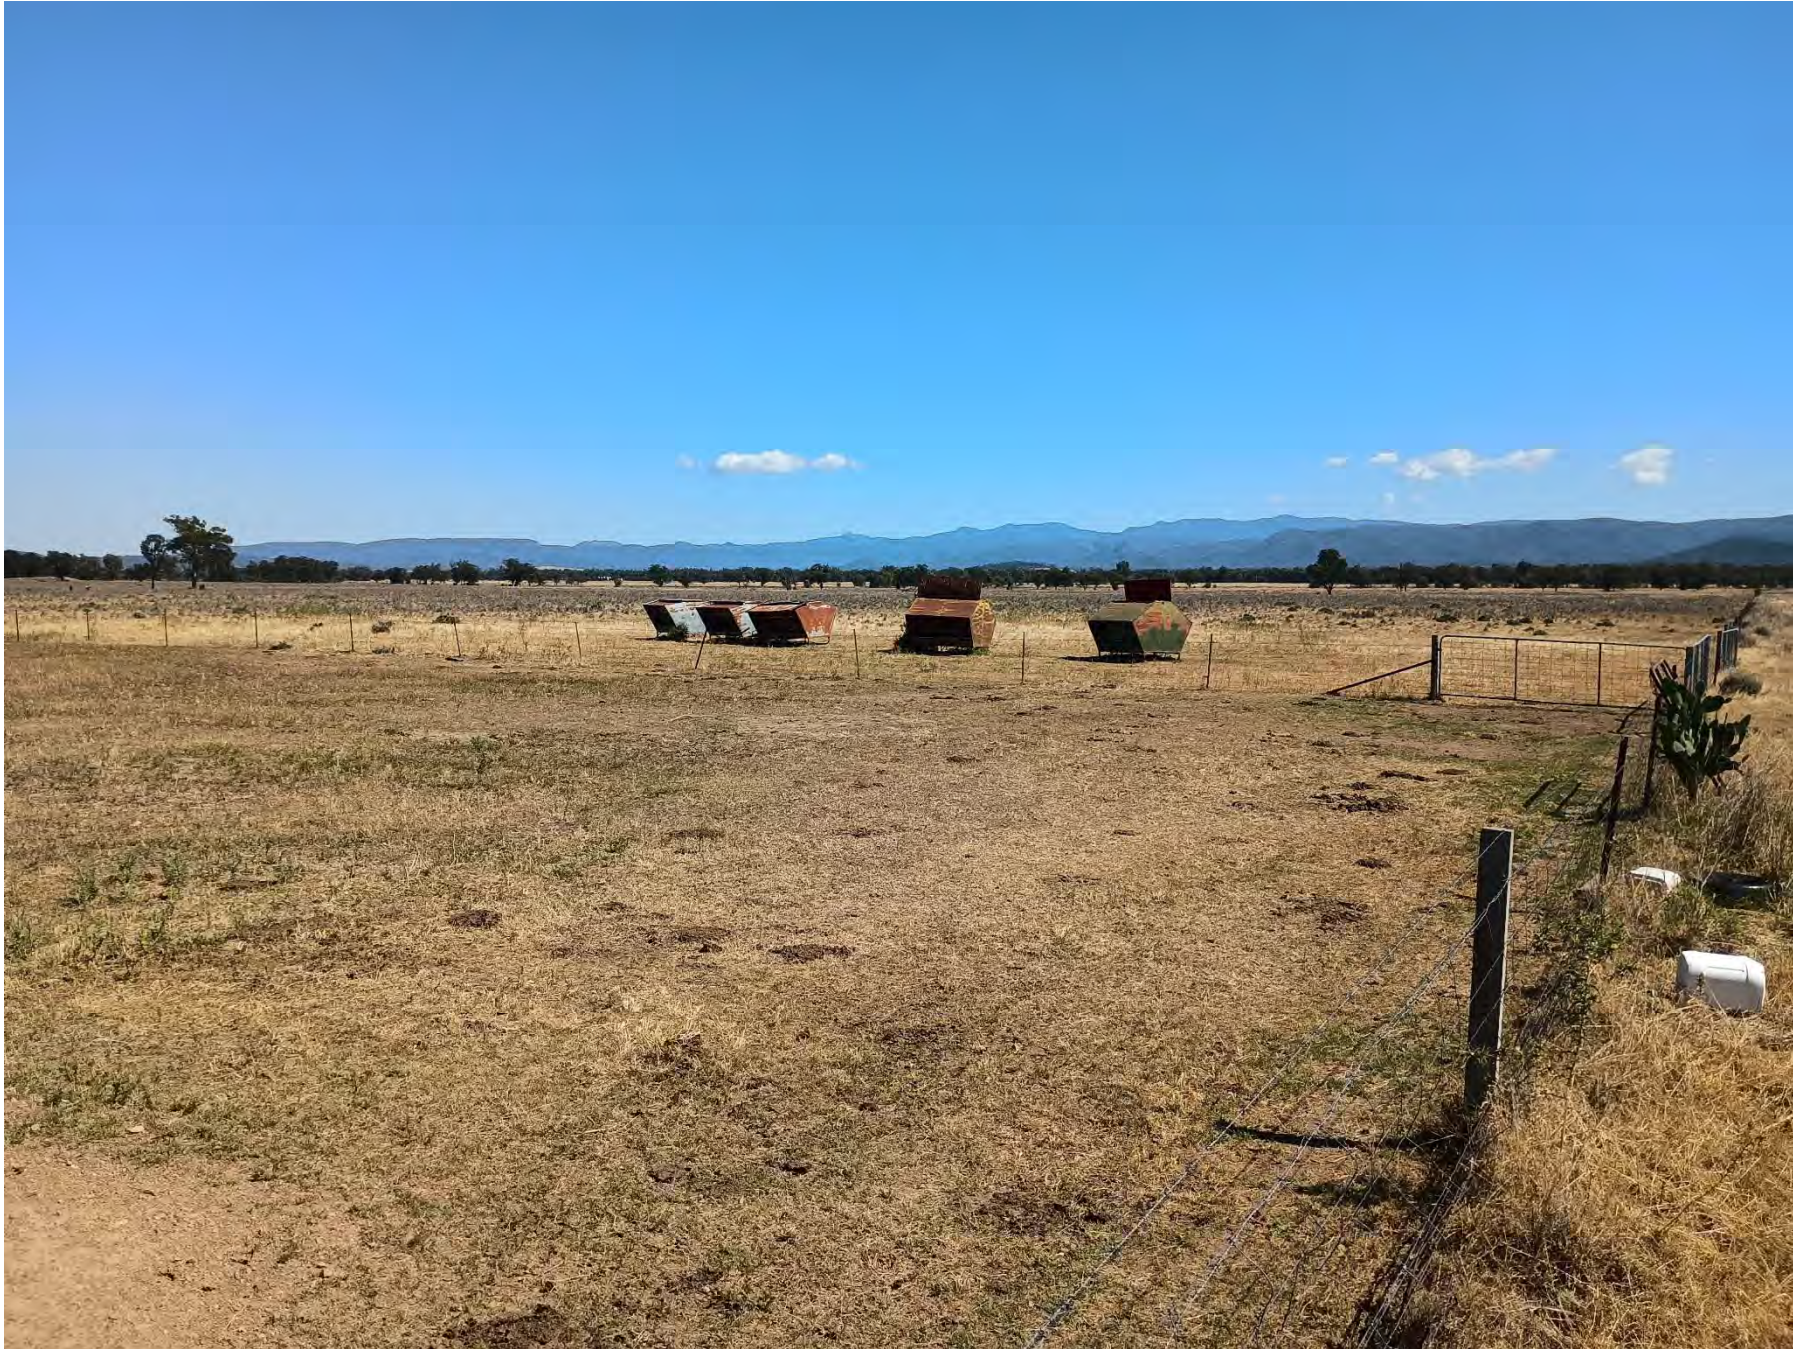
Livestock feeder bins in the central northern portion of Zone 1. Feeder bins were identified at various locations across the Study Area. Feeder bins are not a potential source of contamination.

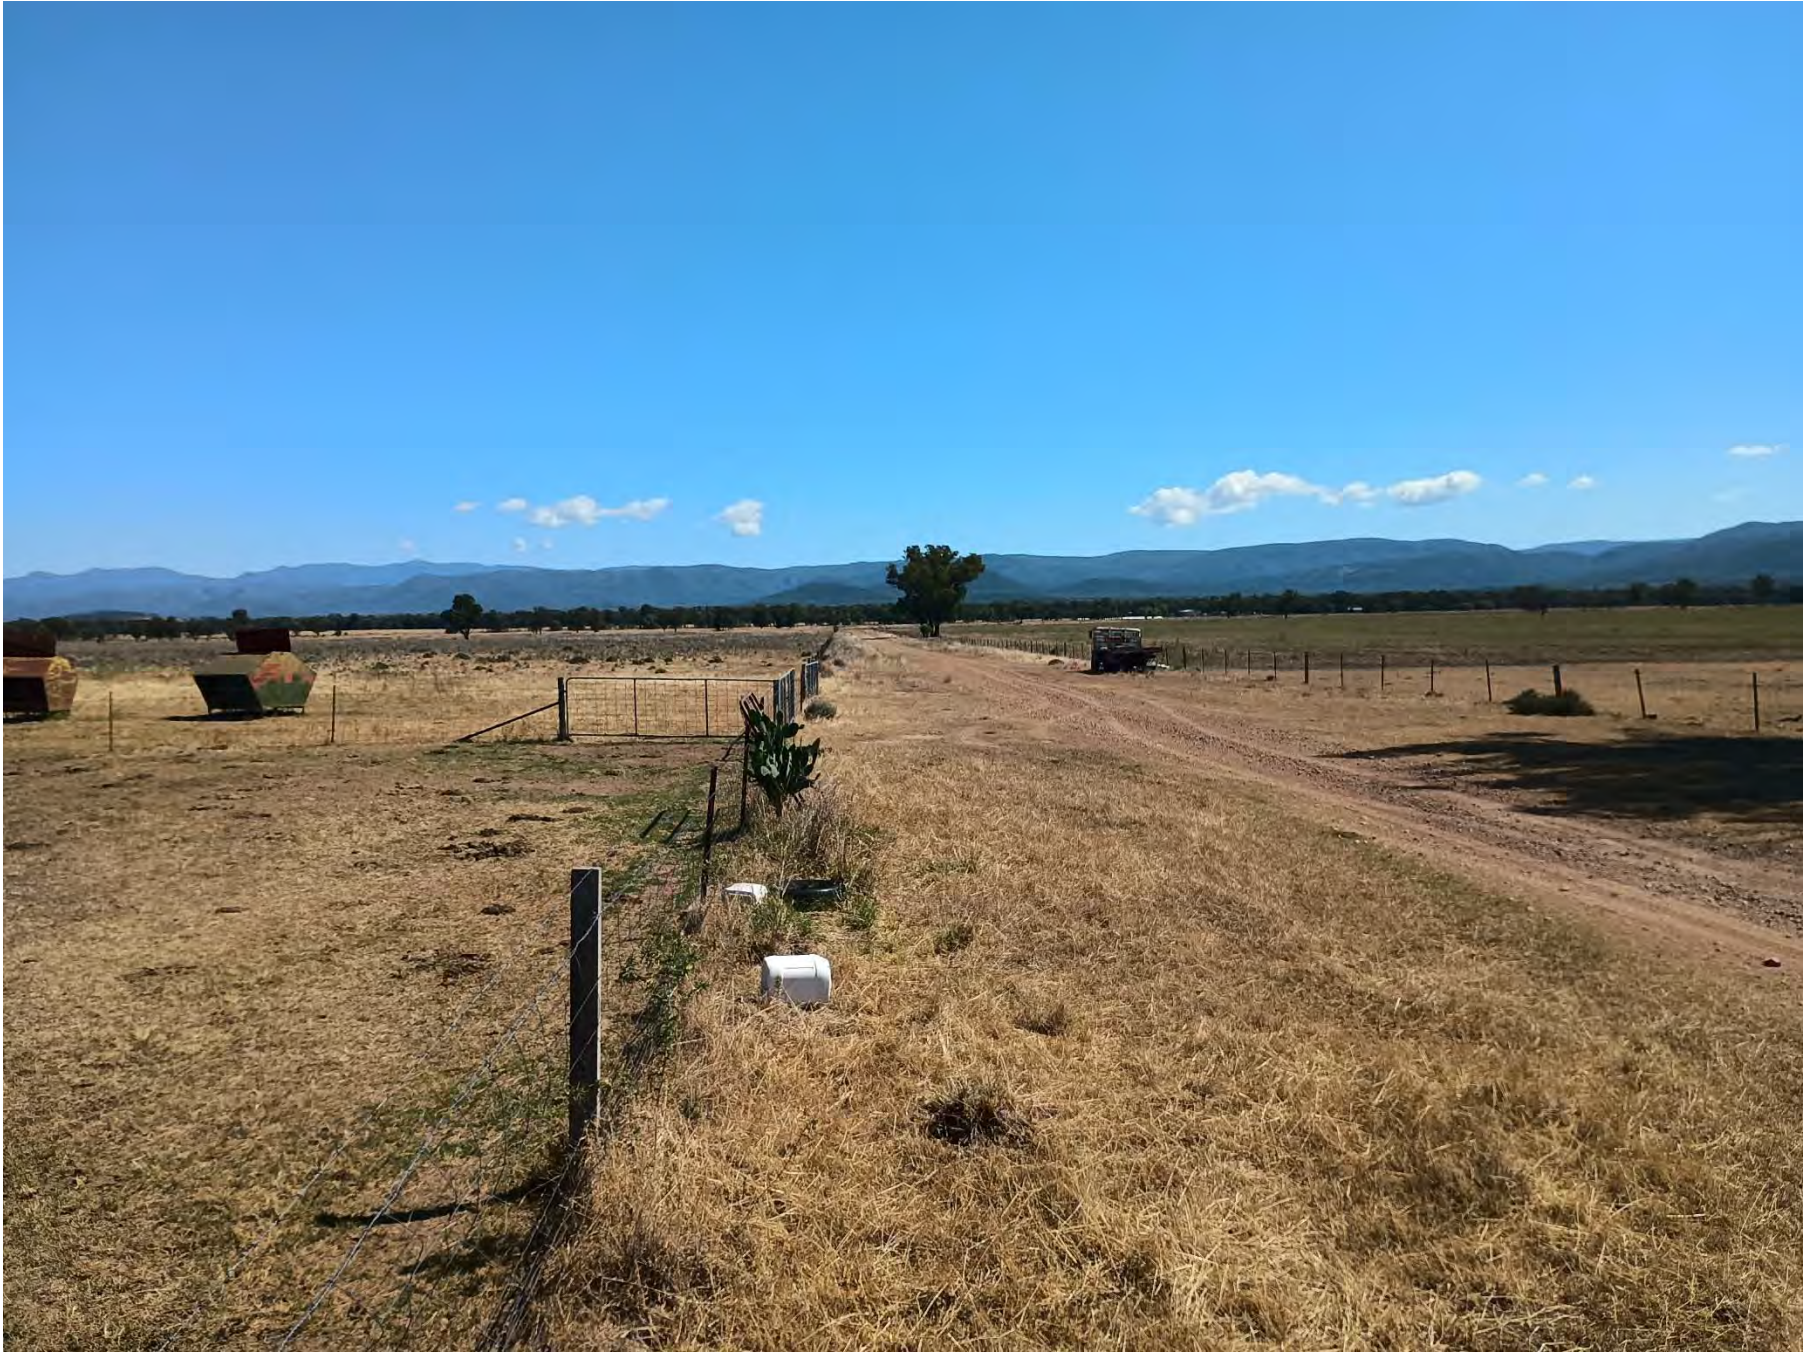
An old farm truck was identified in the central northern portion of Zone 1.

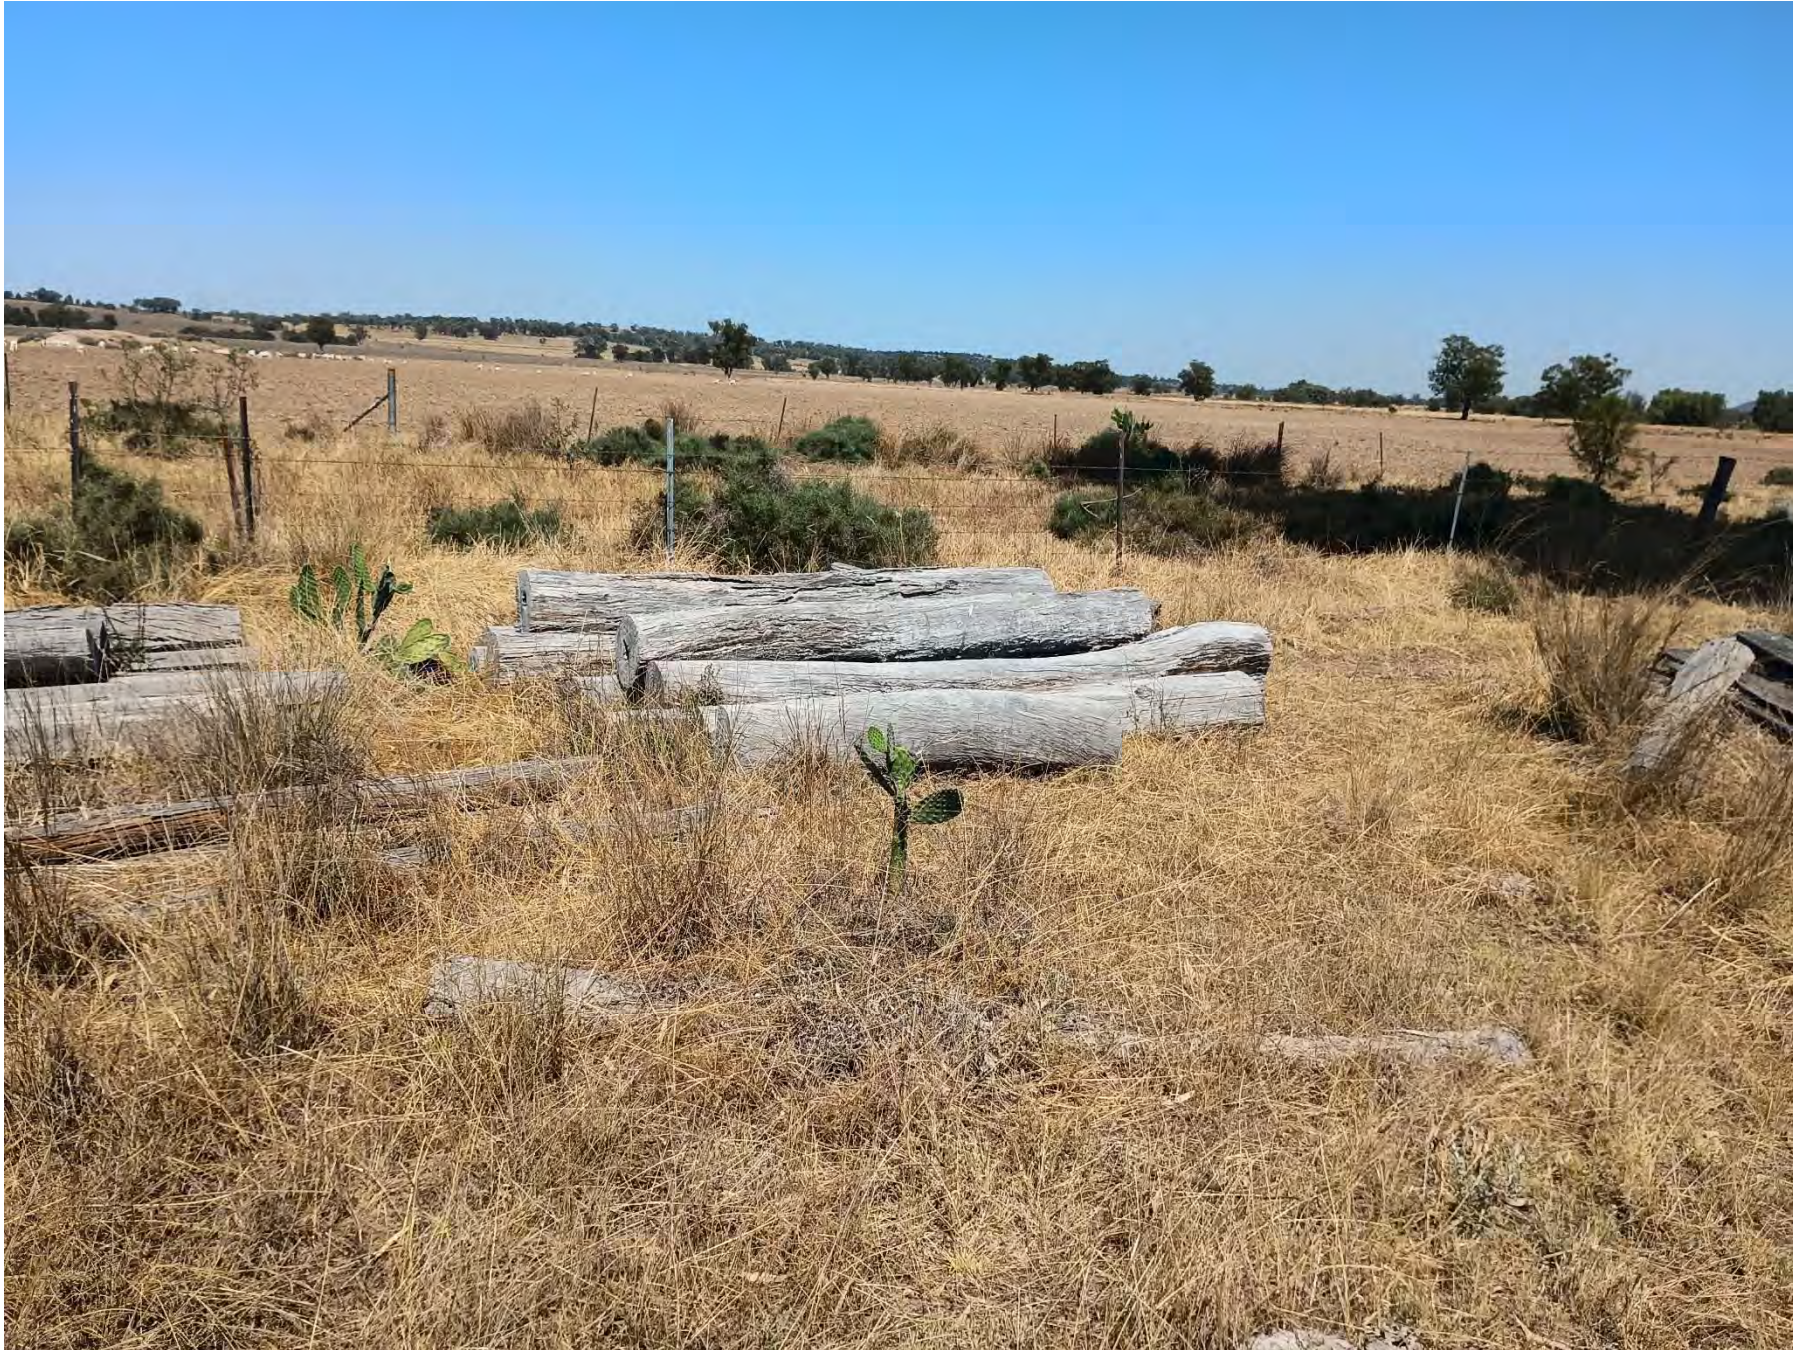
A pile of milled or semi-milled timber was identified in the north east part of Zone 1. The timber appeared to have been sourced locally and was not treated. The timber is not a potential source of contamination.

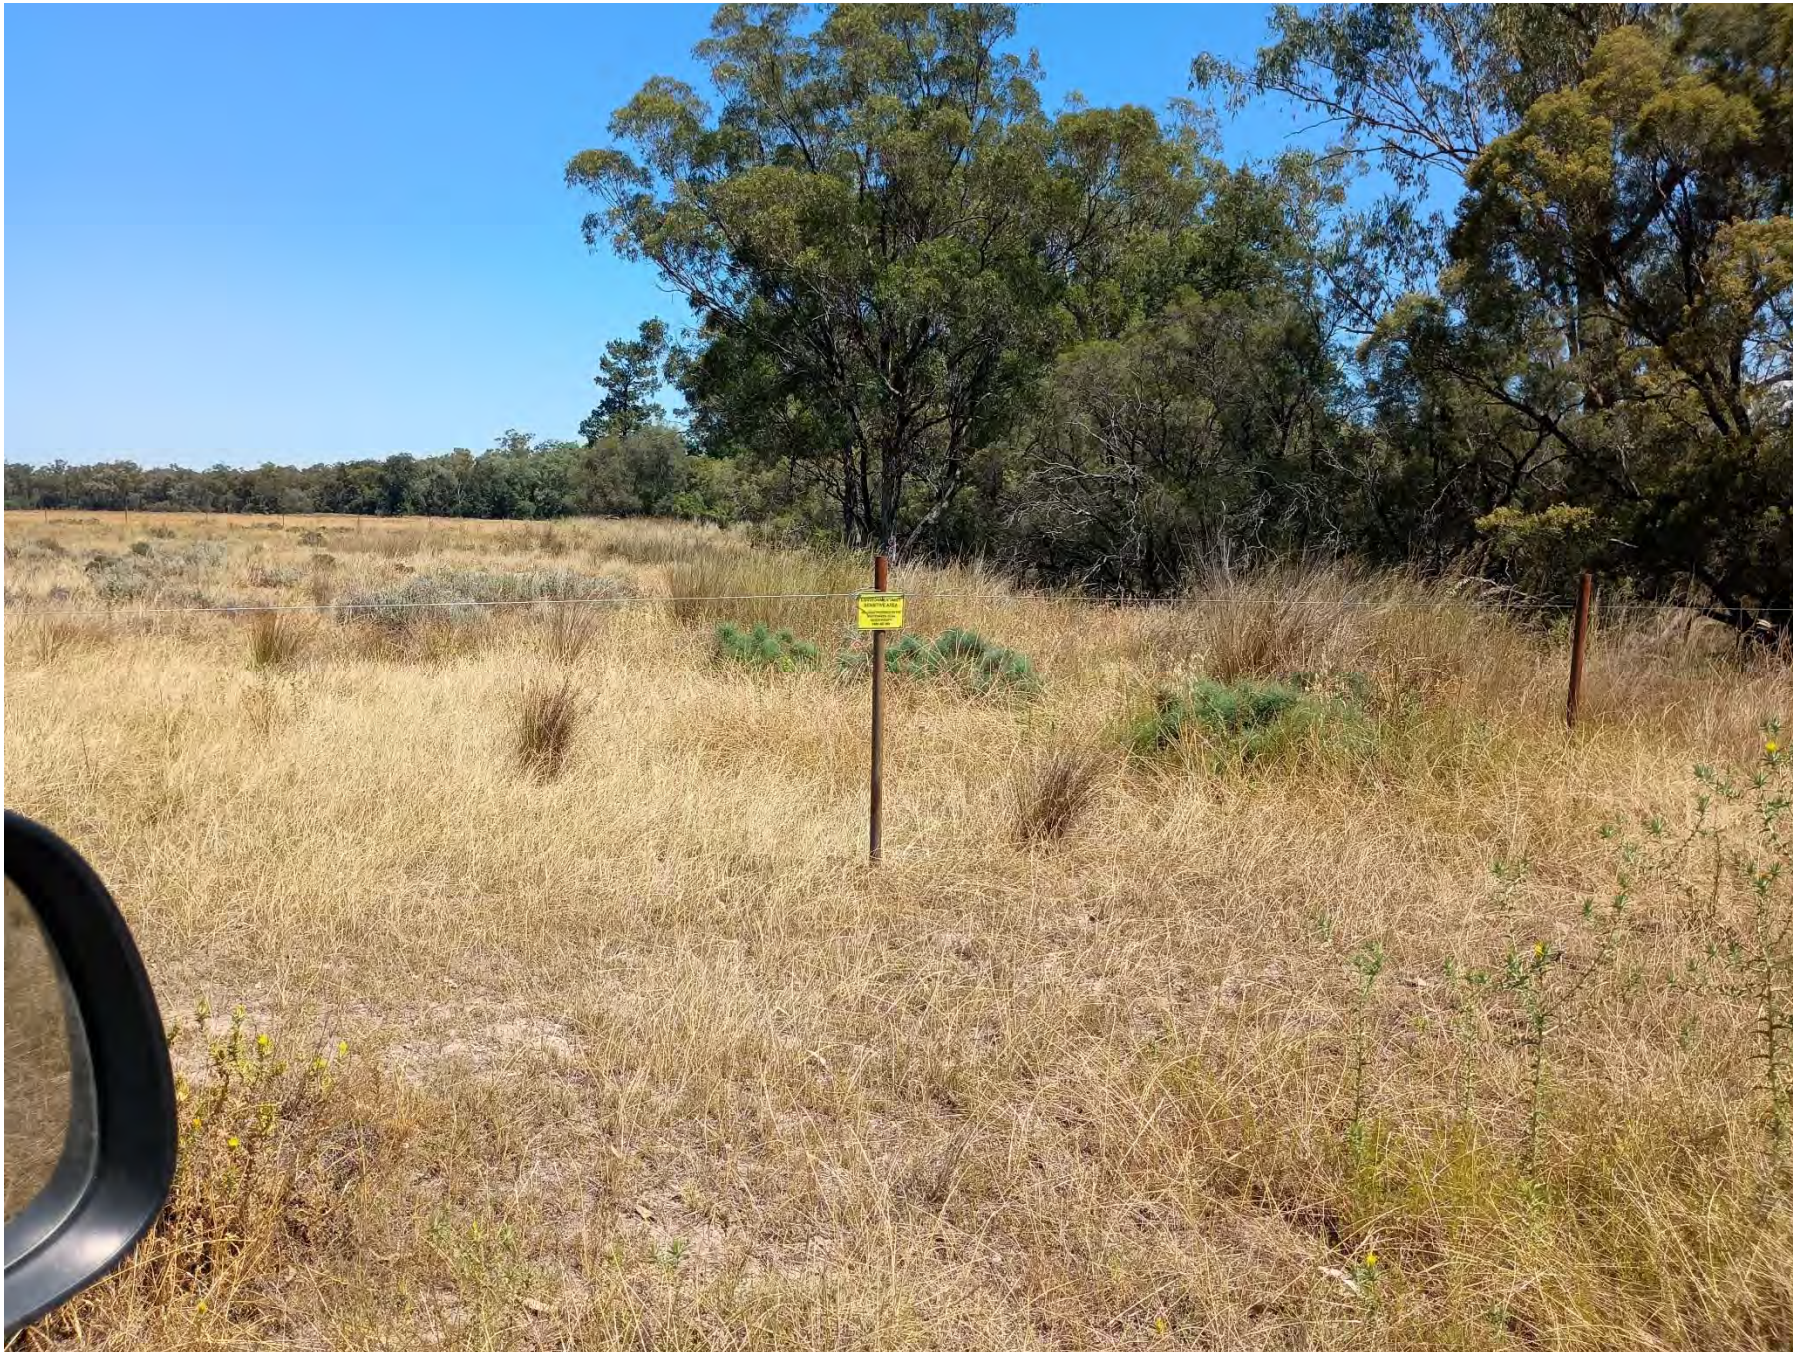
A fenced “environmentally sensitive area” within or close to the central part of Zone 1. The fencing presumably protecting an area of sensitive vegetation.

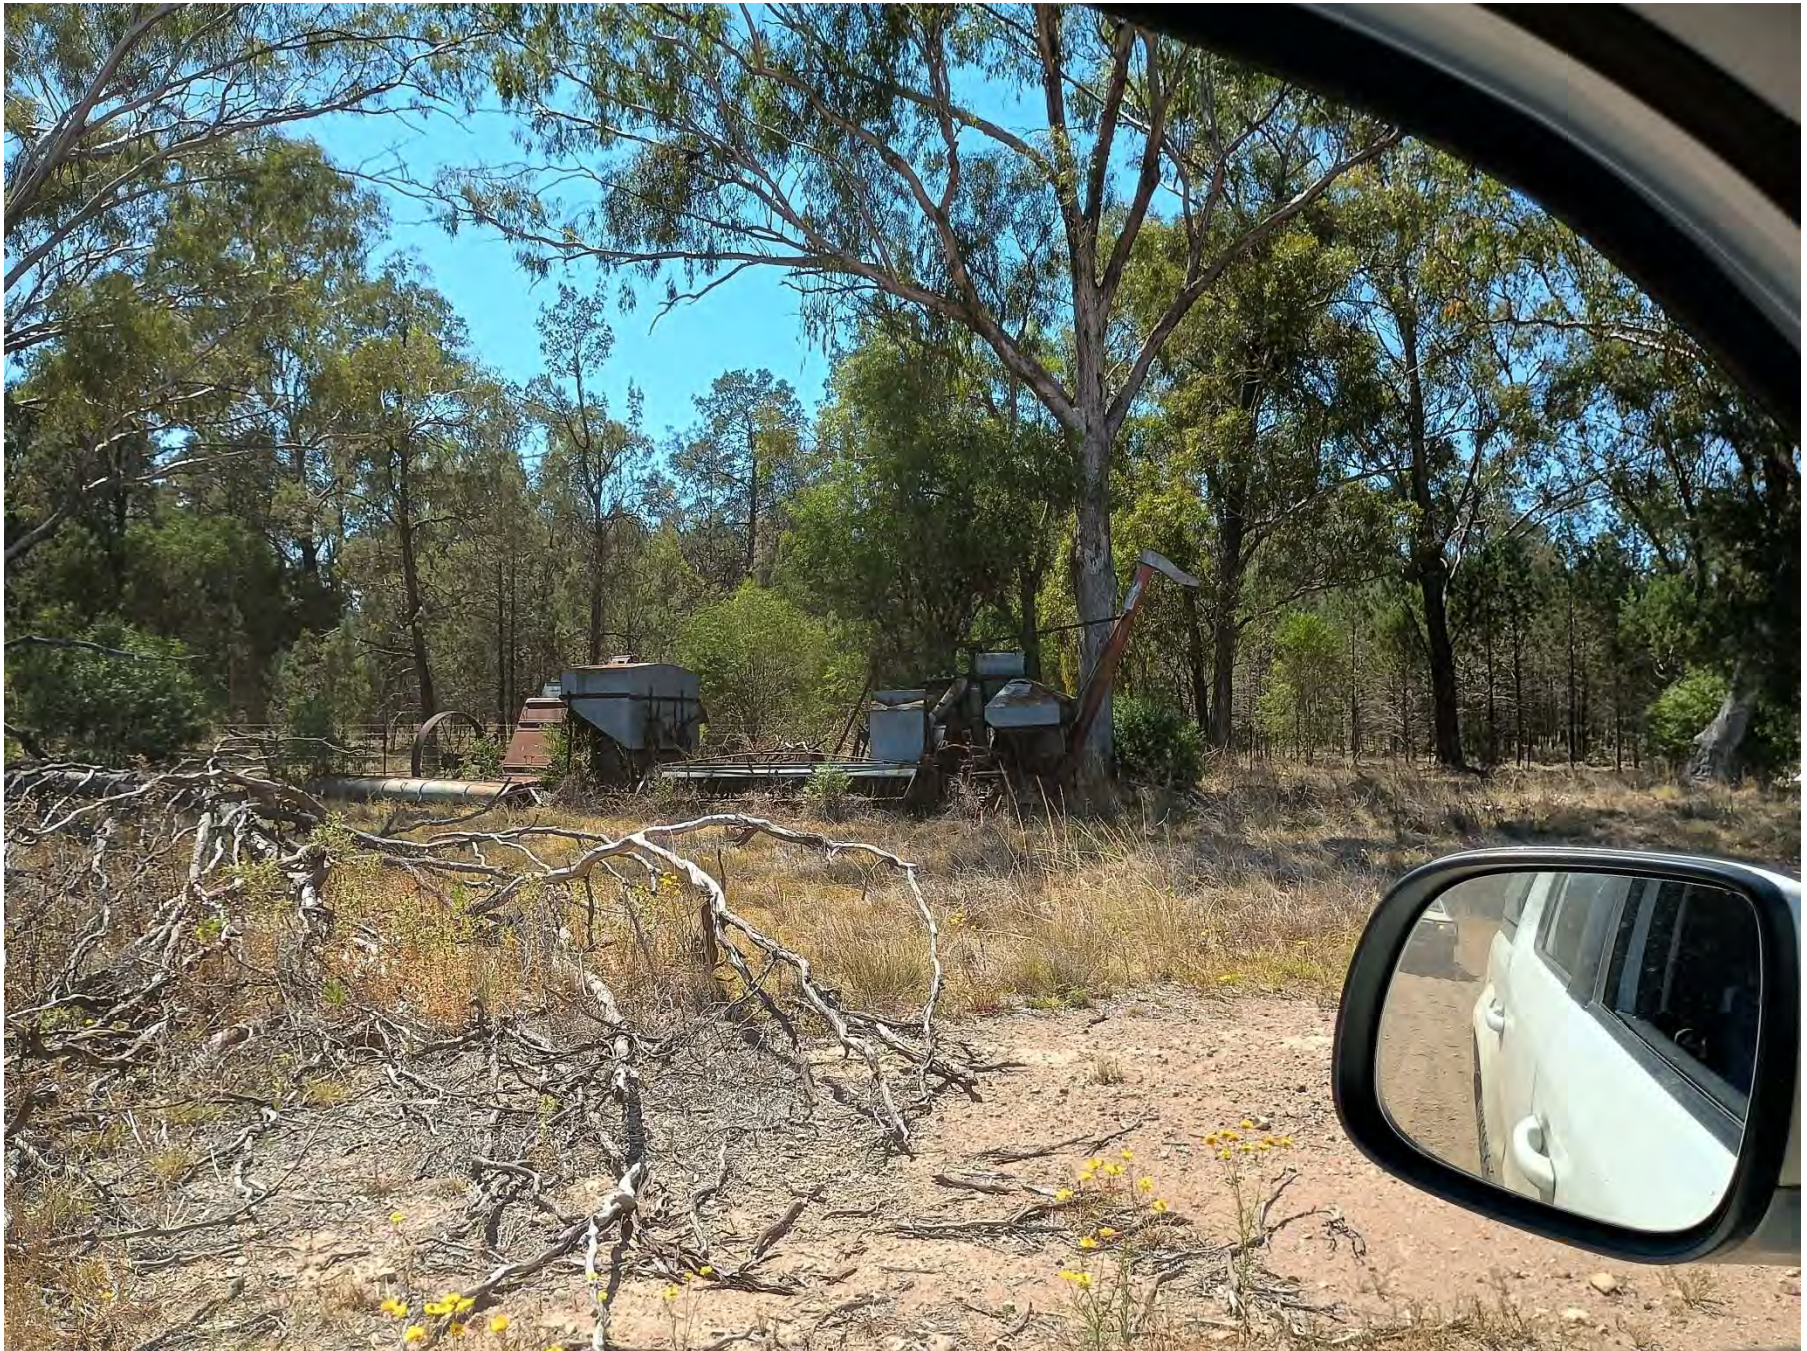
Abandoned farm machinery was identified close to the Study Area boundary in the central part of Zone 1. The machinery was not a potential source of significant land contamination.

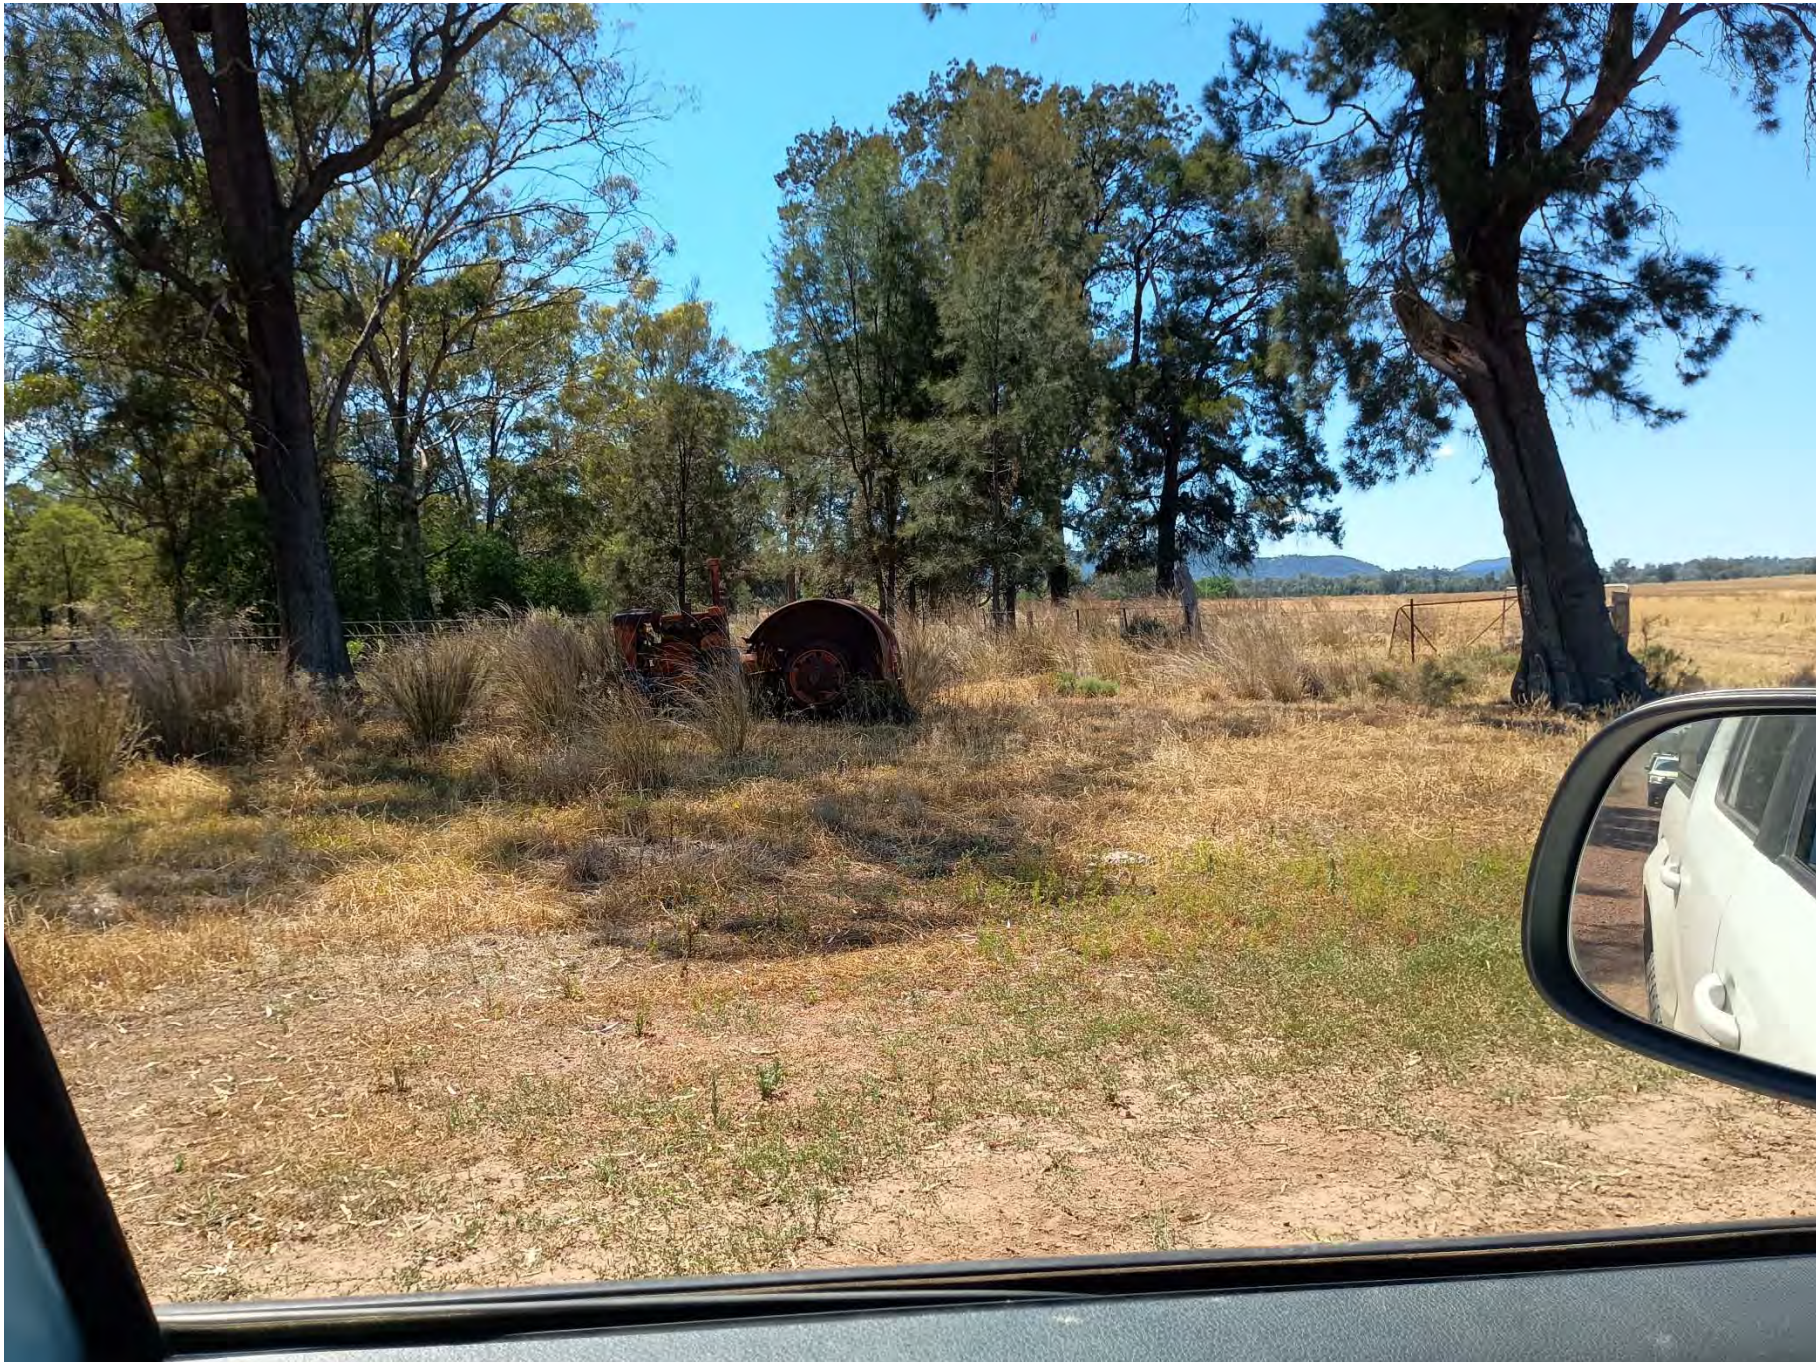
Abandoned farm machinery was identified close to the Study Area boundary in the central part of Zone 1. The machinery was not a potential source of significant land contamination.

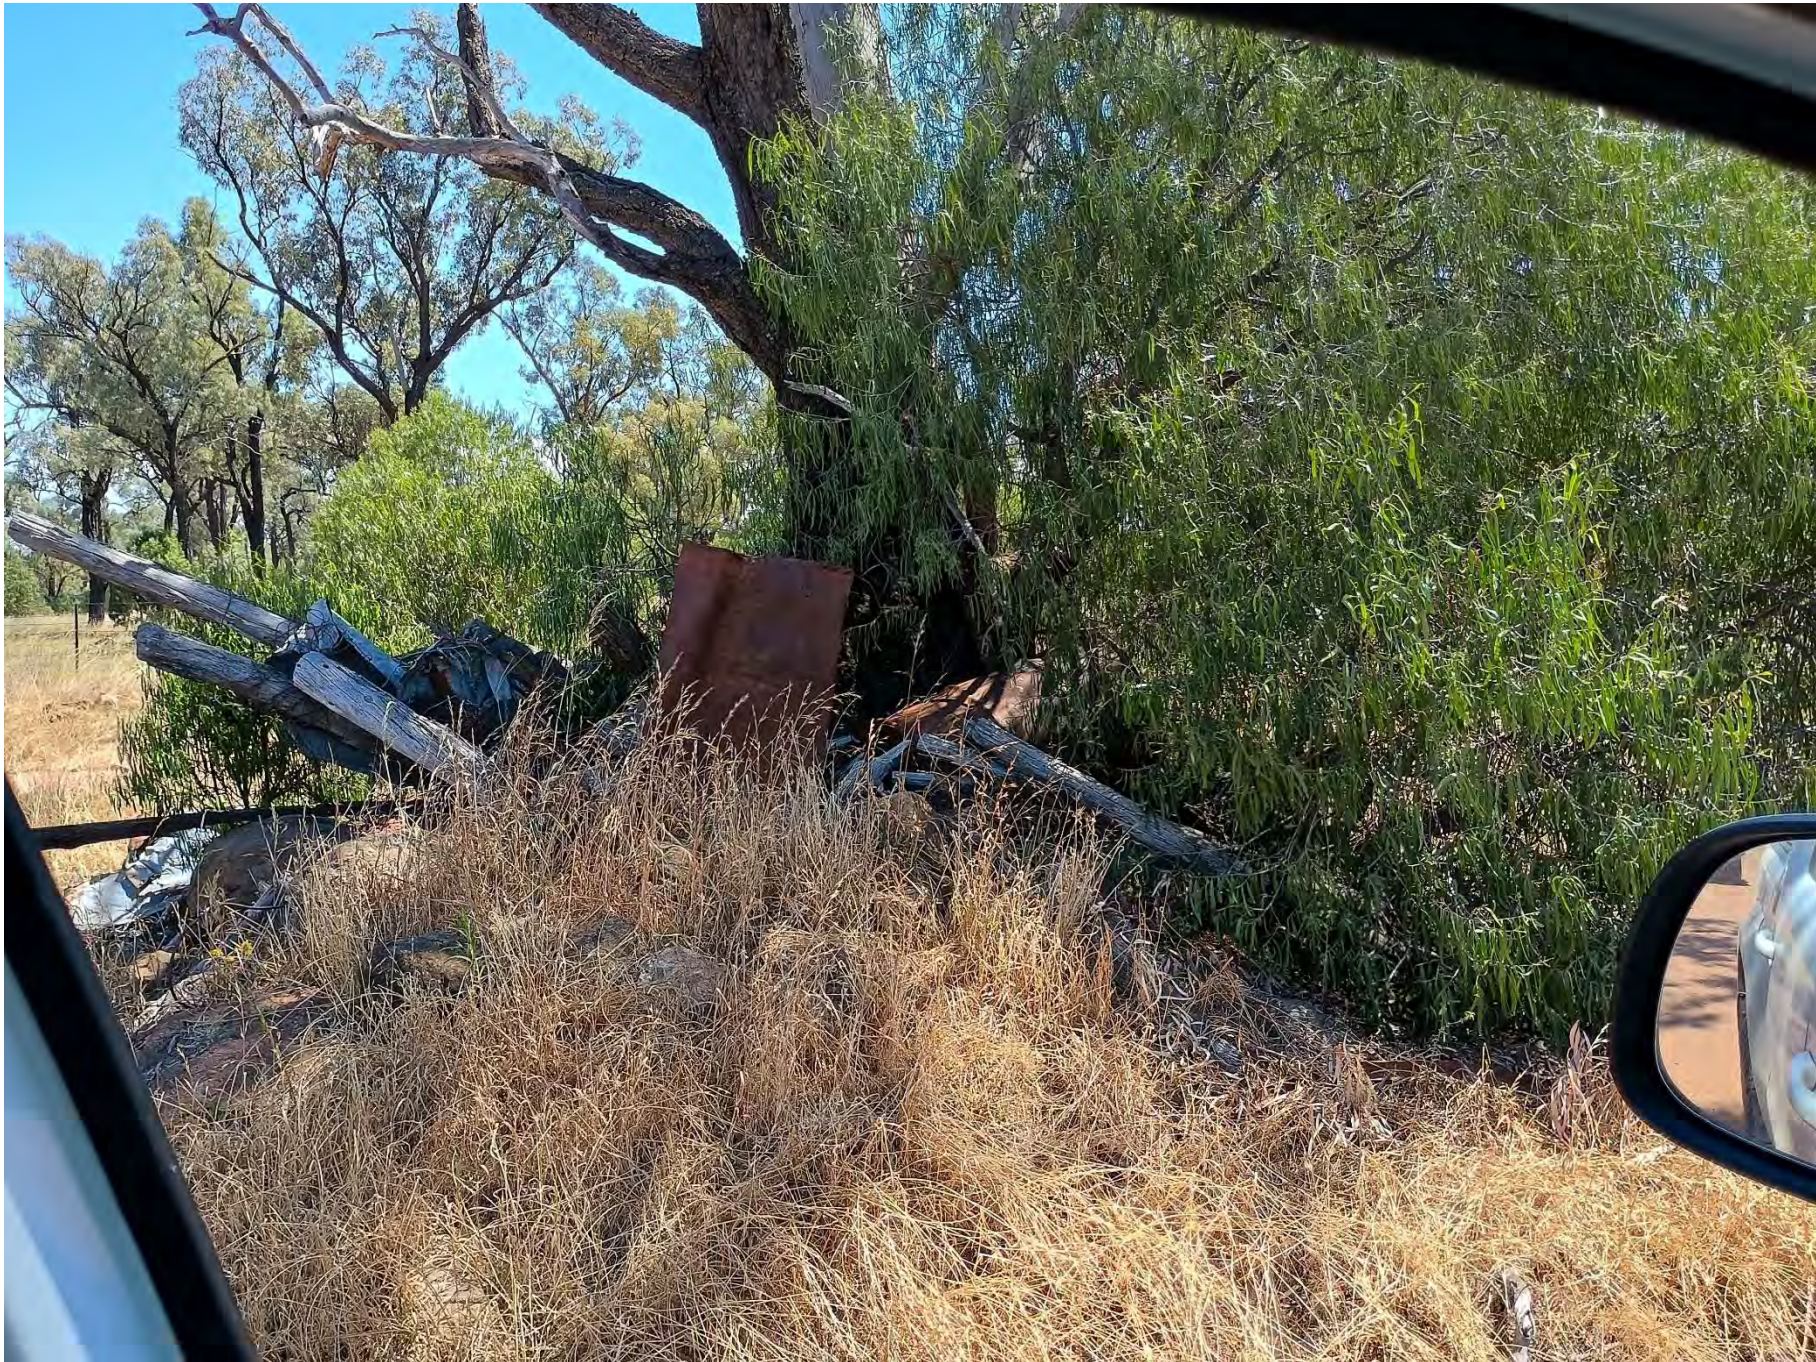
A pile of farm waste was identified close to the Study Area boundary in the central portion of Zone 1. The waste included timber posts, fencing wire, sheet metal and some metal drums. The identified waste did not appear to be a potential source of significant land contamination.

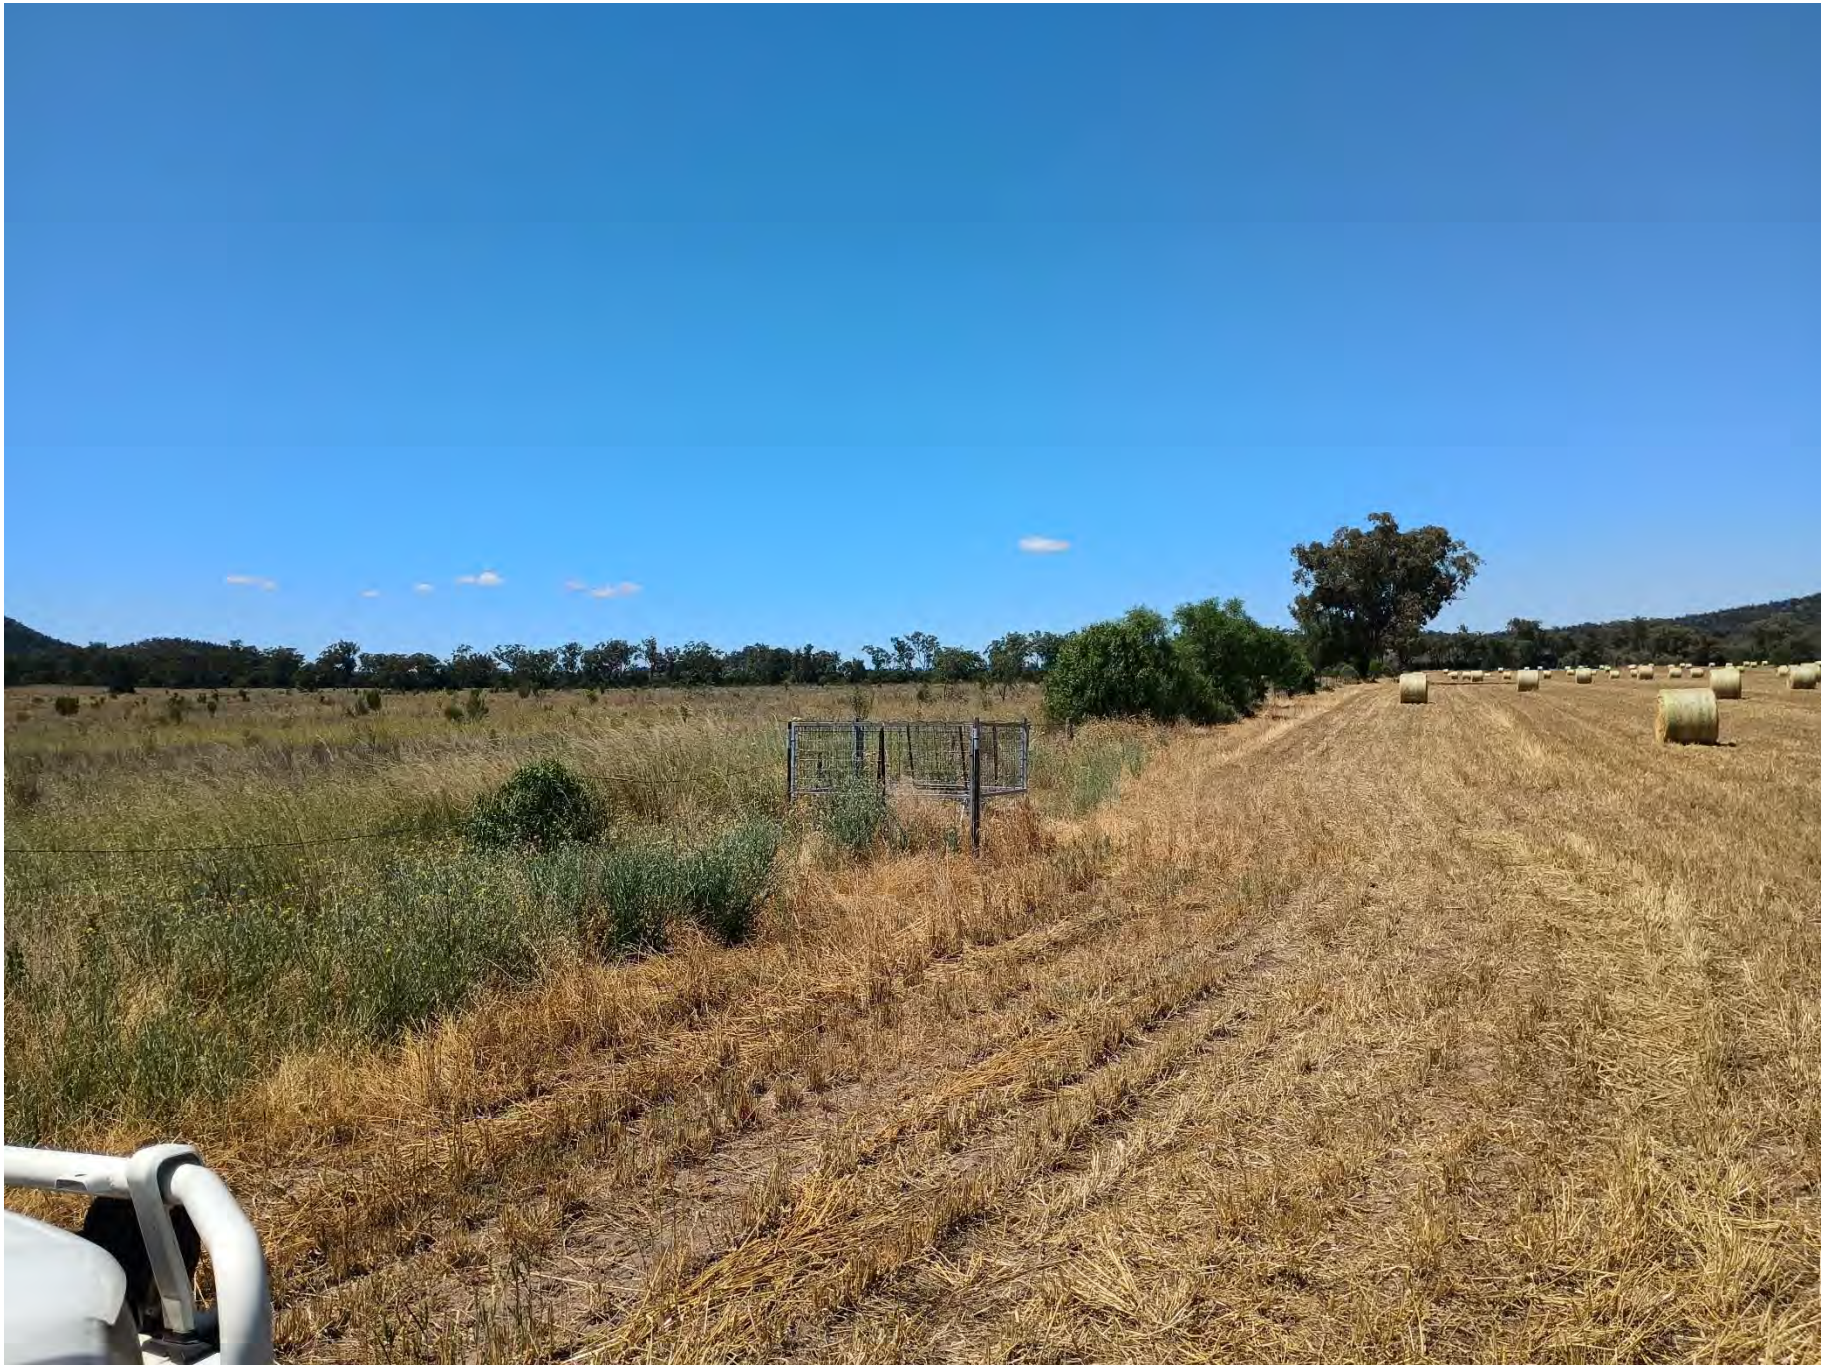
Pig traps were identified along the eastern boundary of Zone 1. These are not a potential source of significant contamination.

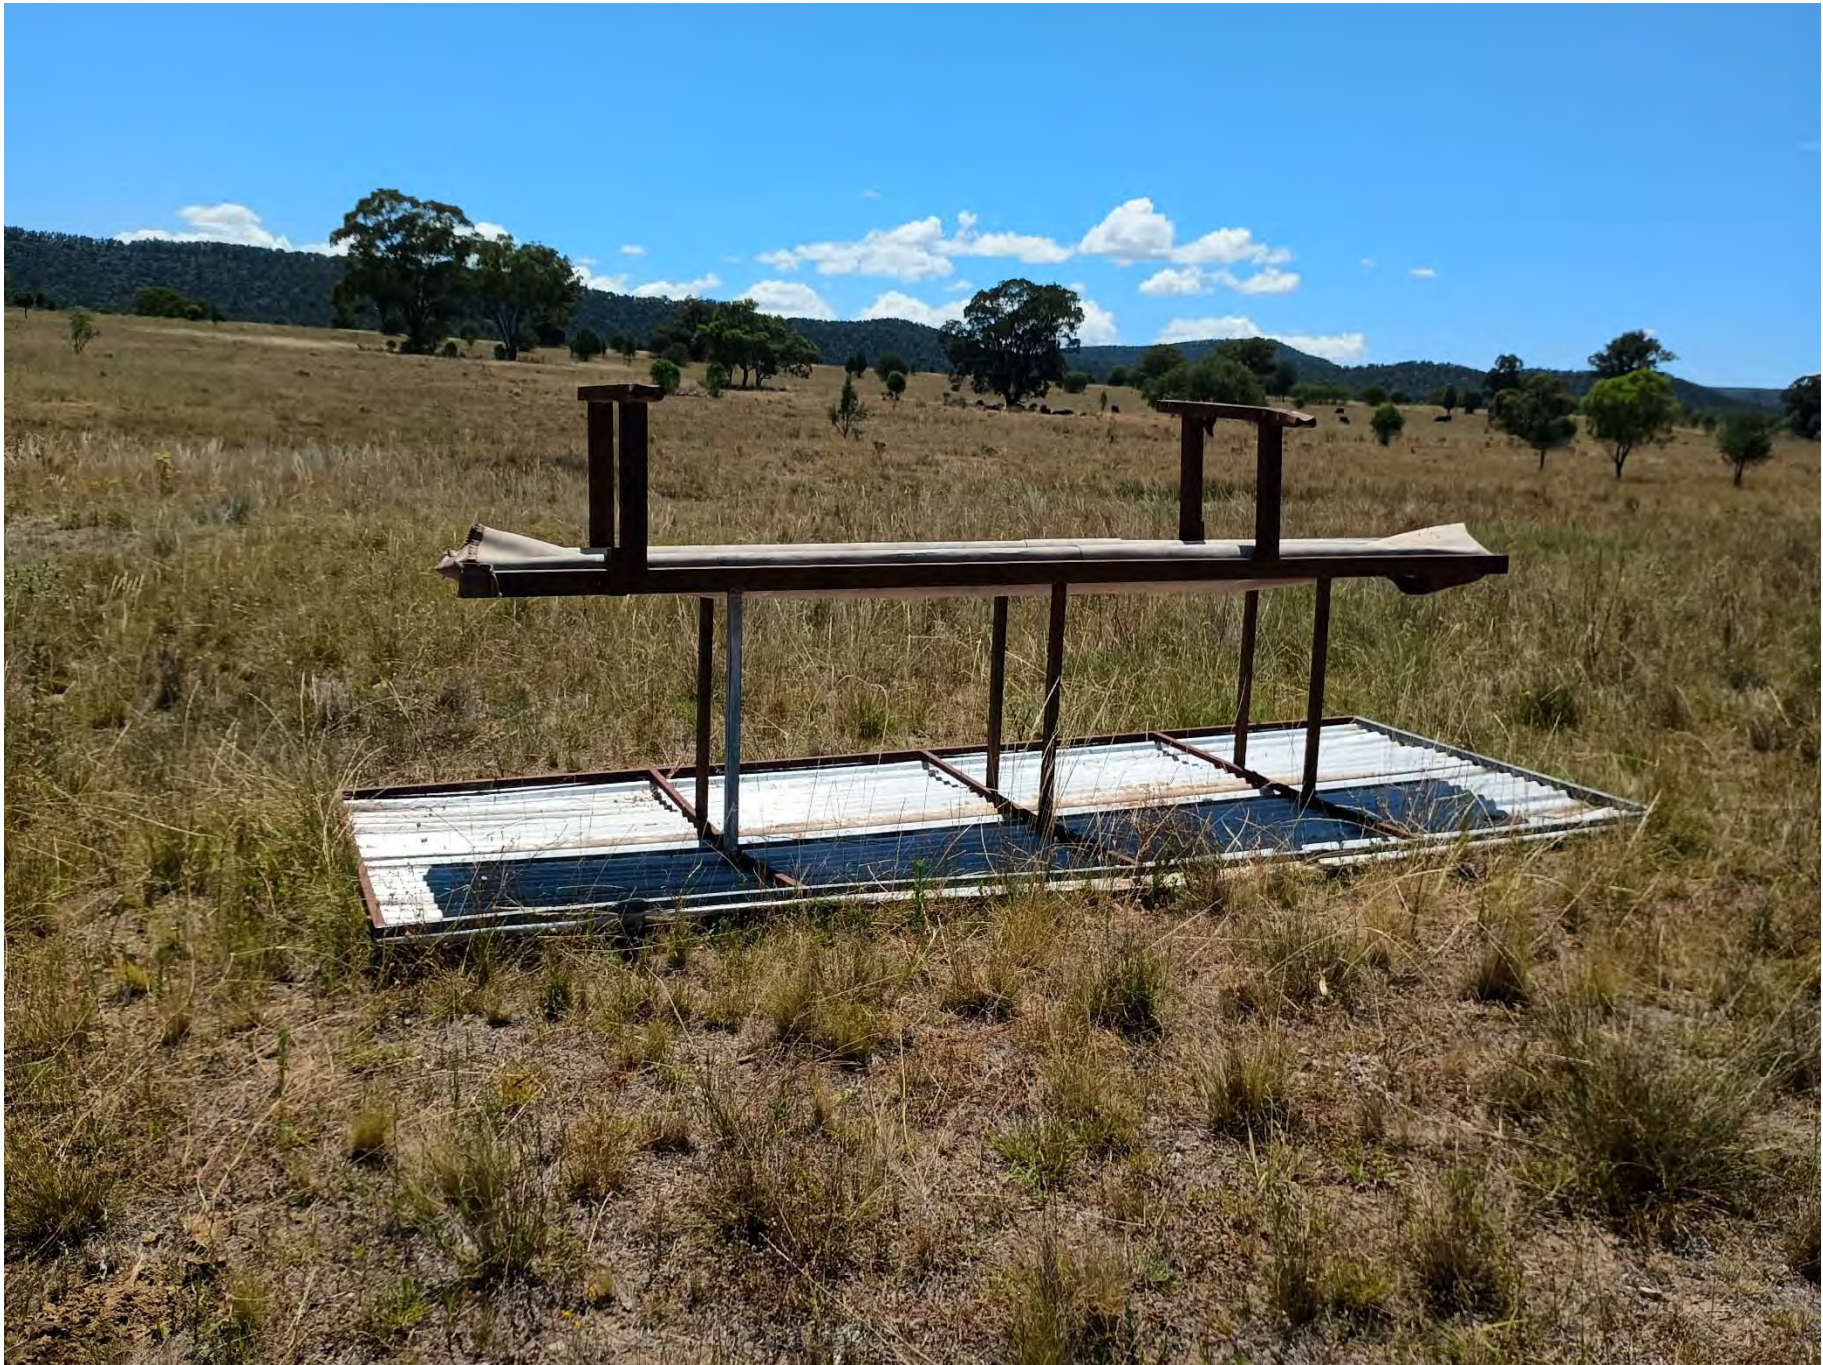
A feeder identified in the southern part of Zone 1.
