Maules Creek Continuation Project

Appendix L
Land Contamination Assessment

**RE: MAULES CREEK CONTINUATION PROJECT,
PRELIMINARY SITE INVESTIGATIONS**

**Maules Creek Continuation Project
Mine Site
Preliminary Site Investigation**

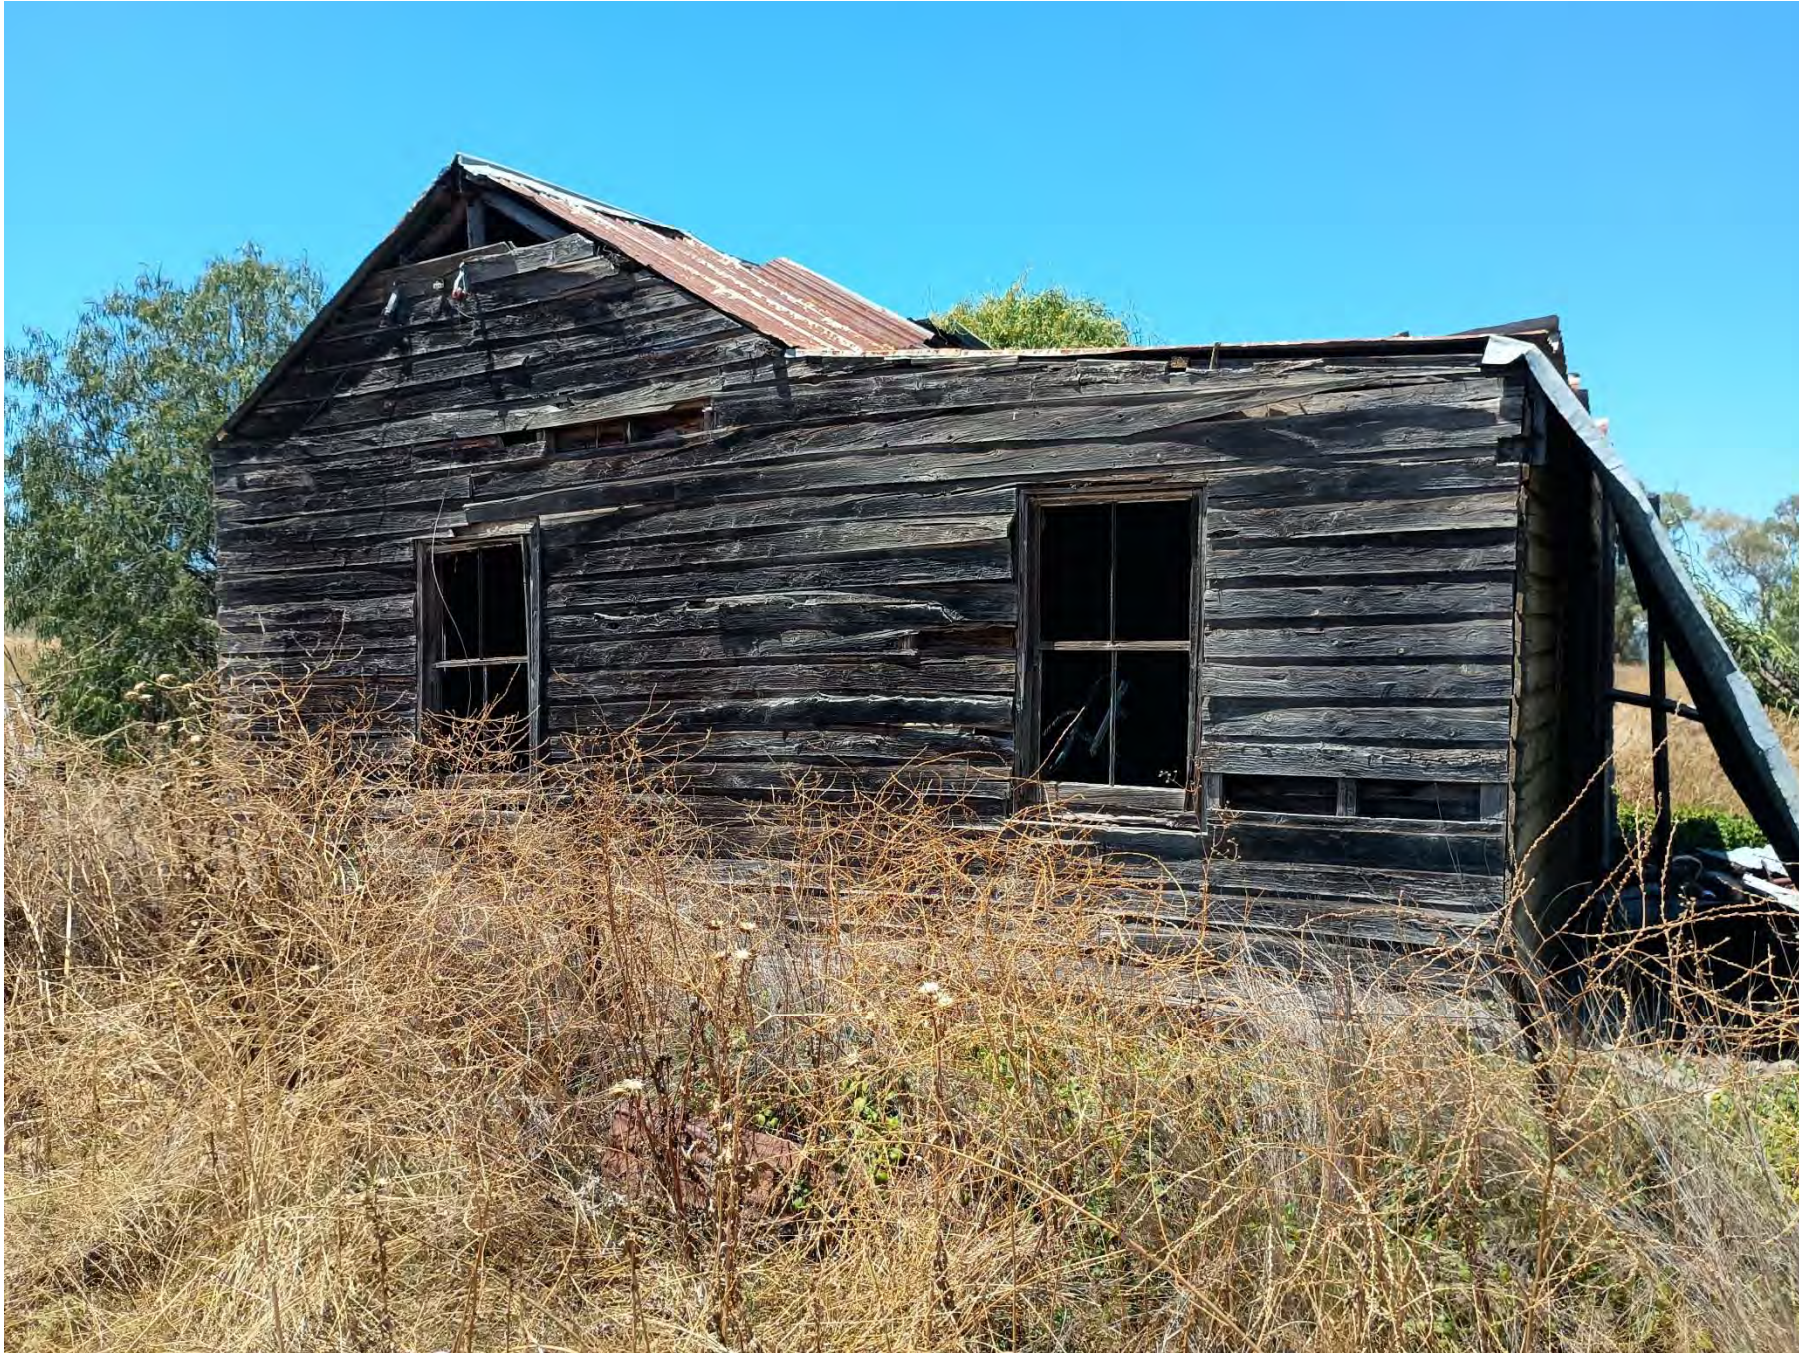
A dwelling ruin was identified close to the southern part of Zone 1. The dwelling footprint is excluded from the Study Area. The dwelling appeared to have been constructed of timber and sheet metal. Ground Doctor did not identify any potential ACMs around the ruin.

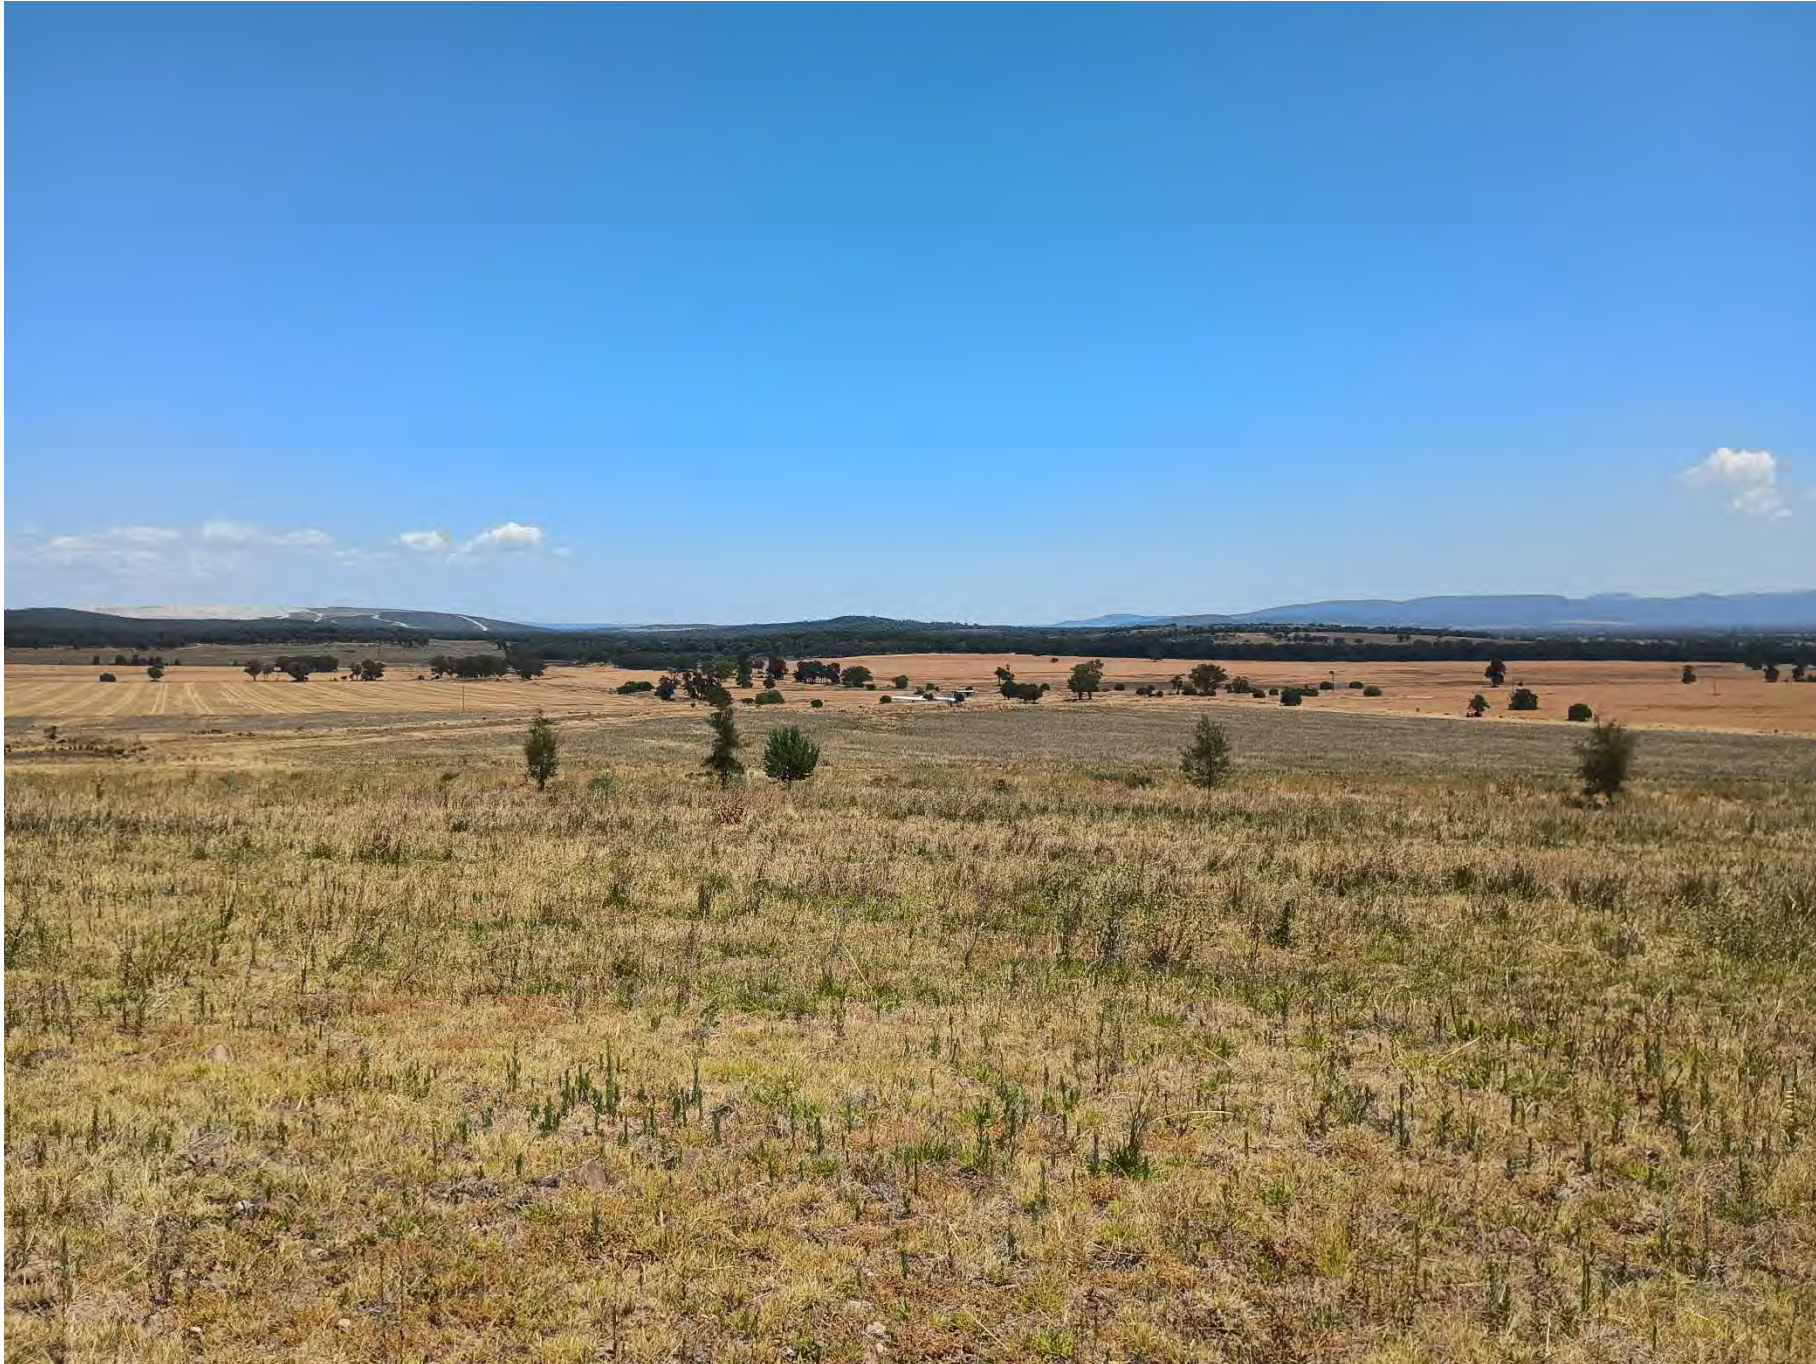
Two metal sheds and a fuel trailer (or possibly a water cart) were identified in the southern central portion of Zone 1. There was no evidence of soil contamination around the fuel trailer.

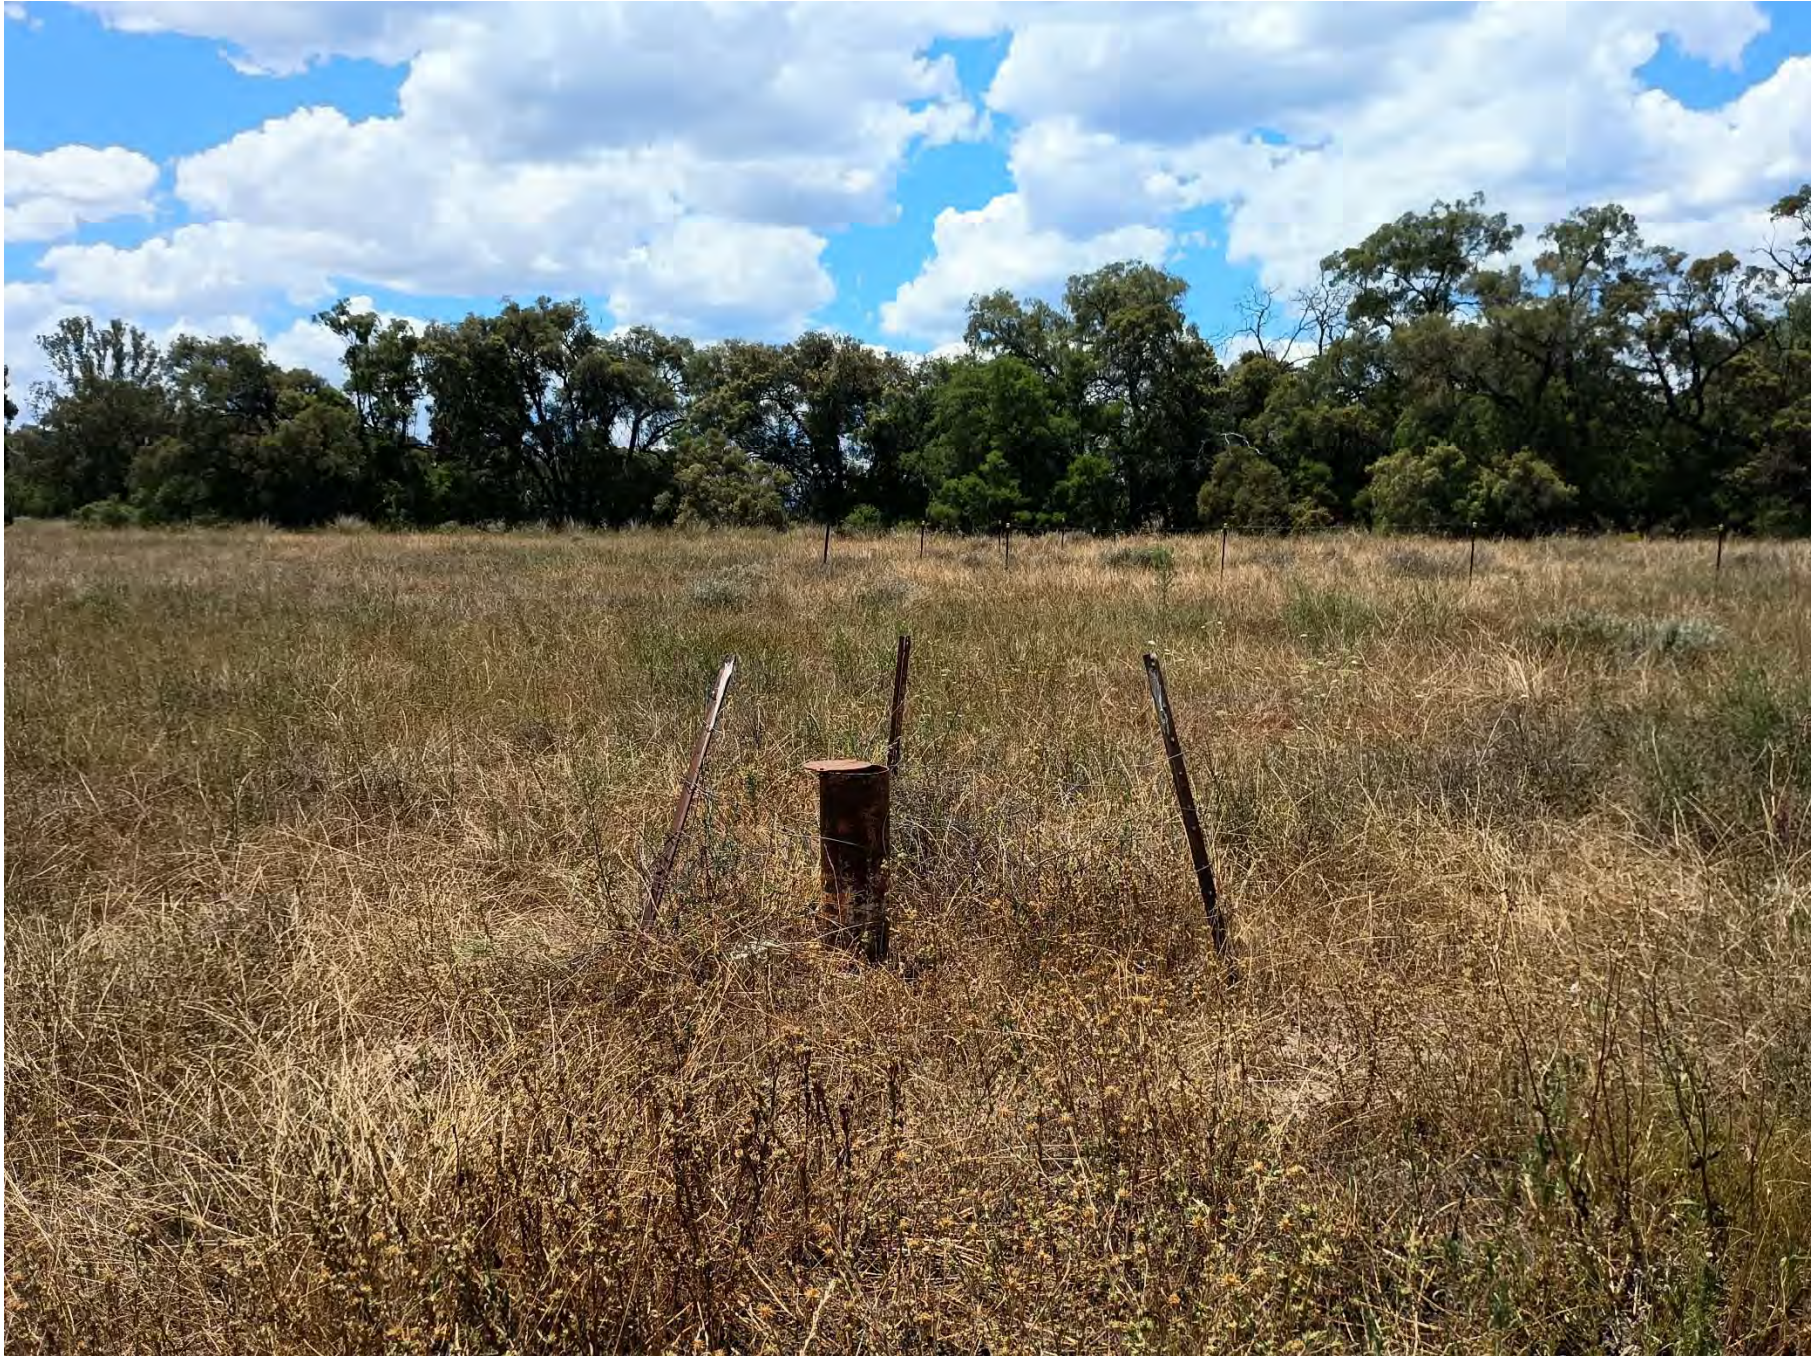
A groundwater bore identified in the south west corner of Zone 2 was one of the only points of interest noted. The majority of land within Zone 2 is cleared open space used for livestock grazing and dryland cropping.

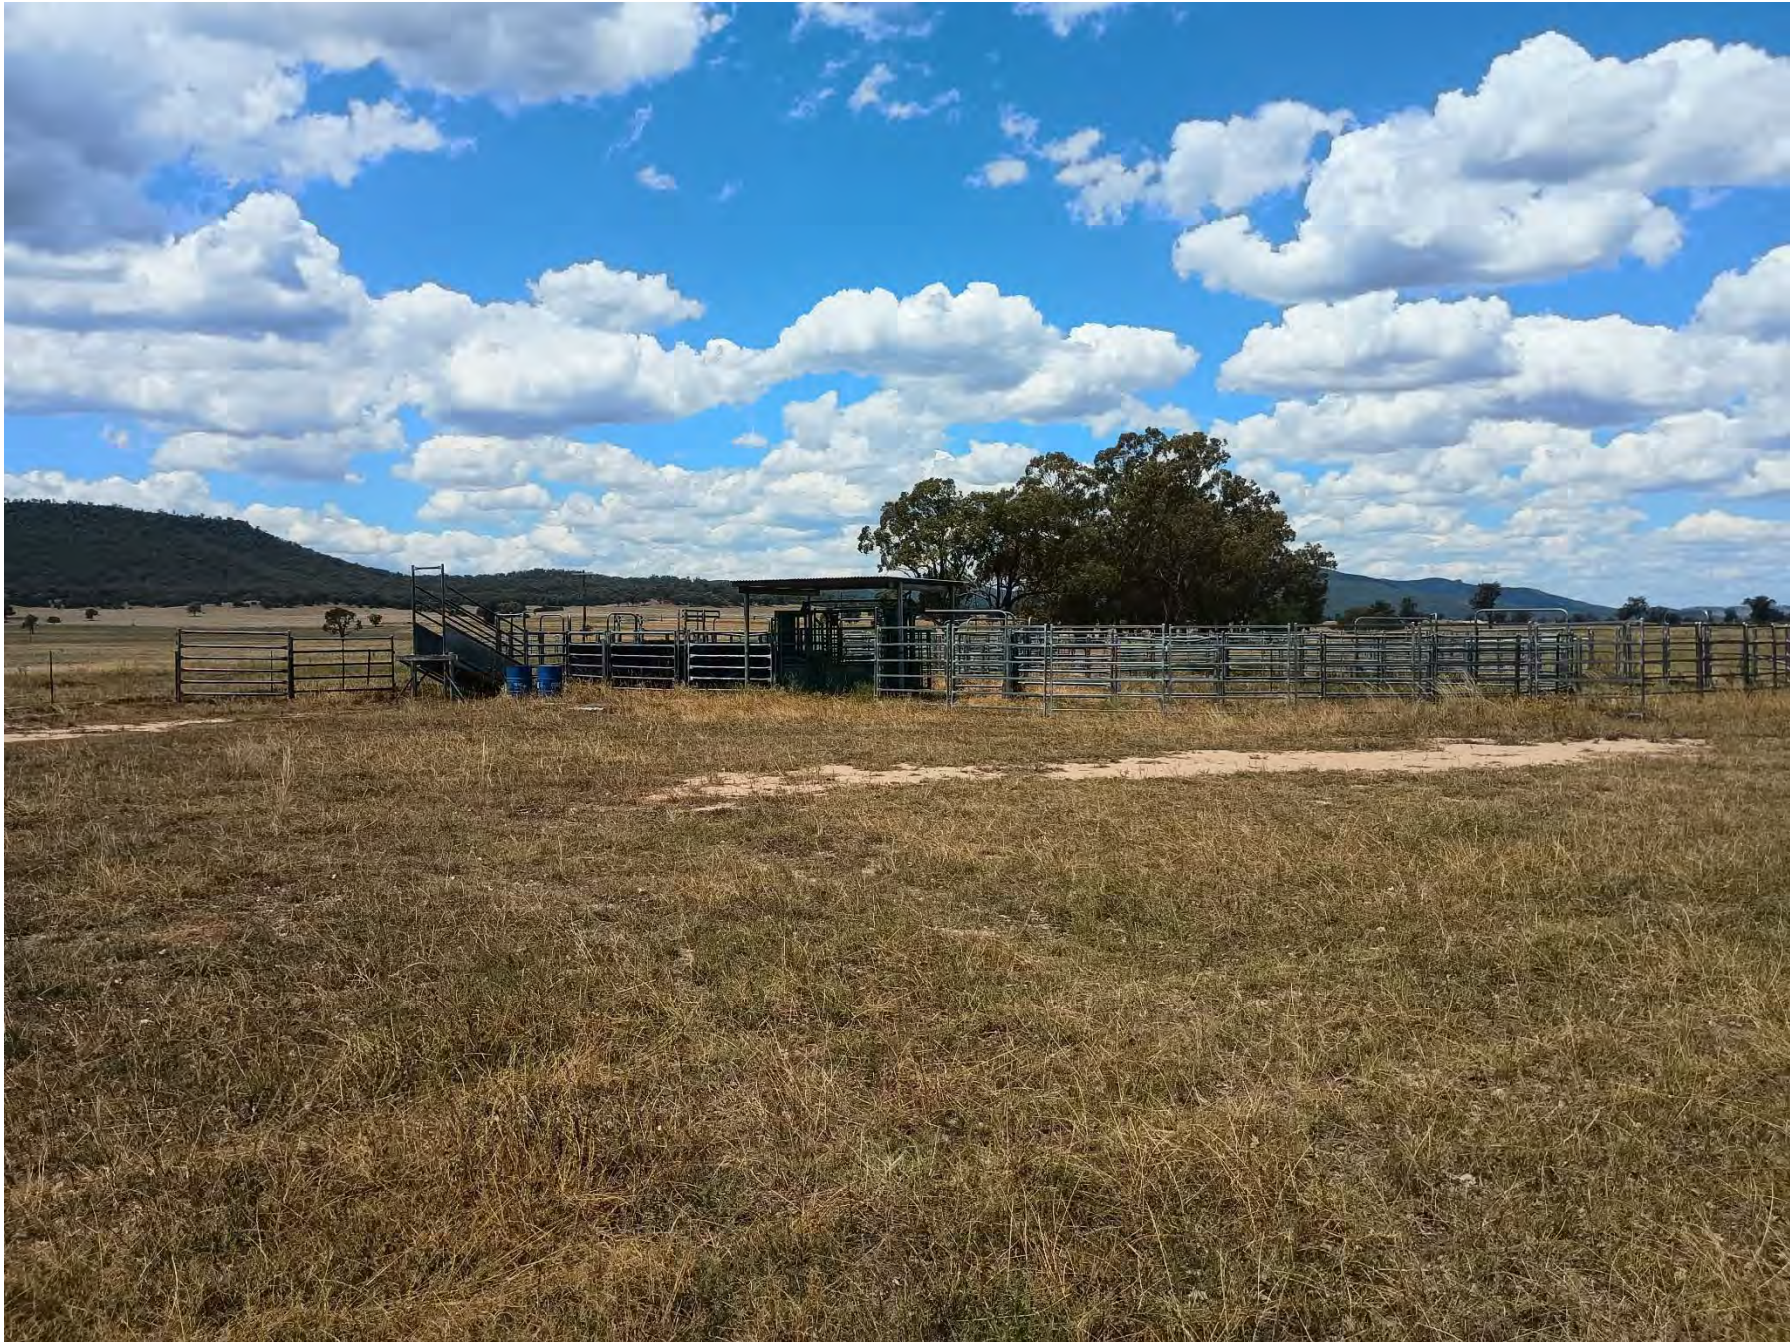
A cattle yard including a crush identified in the south west part of Zone 2. Pesticides may have been applied to livestock in the yards. Aerial photographs indicate the yards have been present for less than 2.5 years so significant contamination is unlikely.

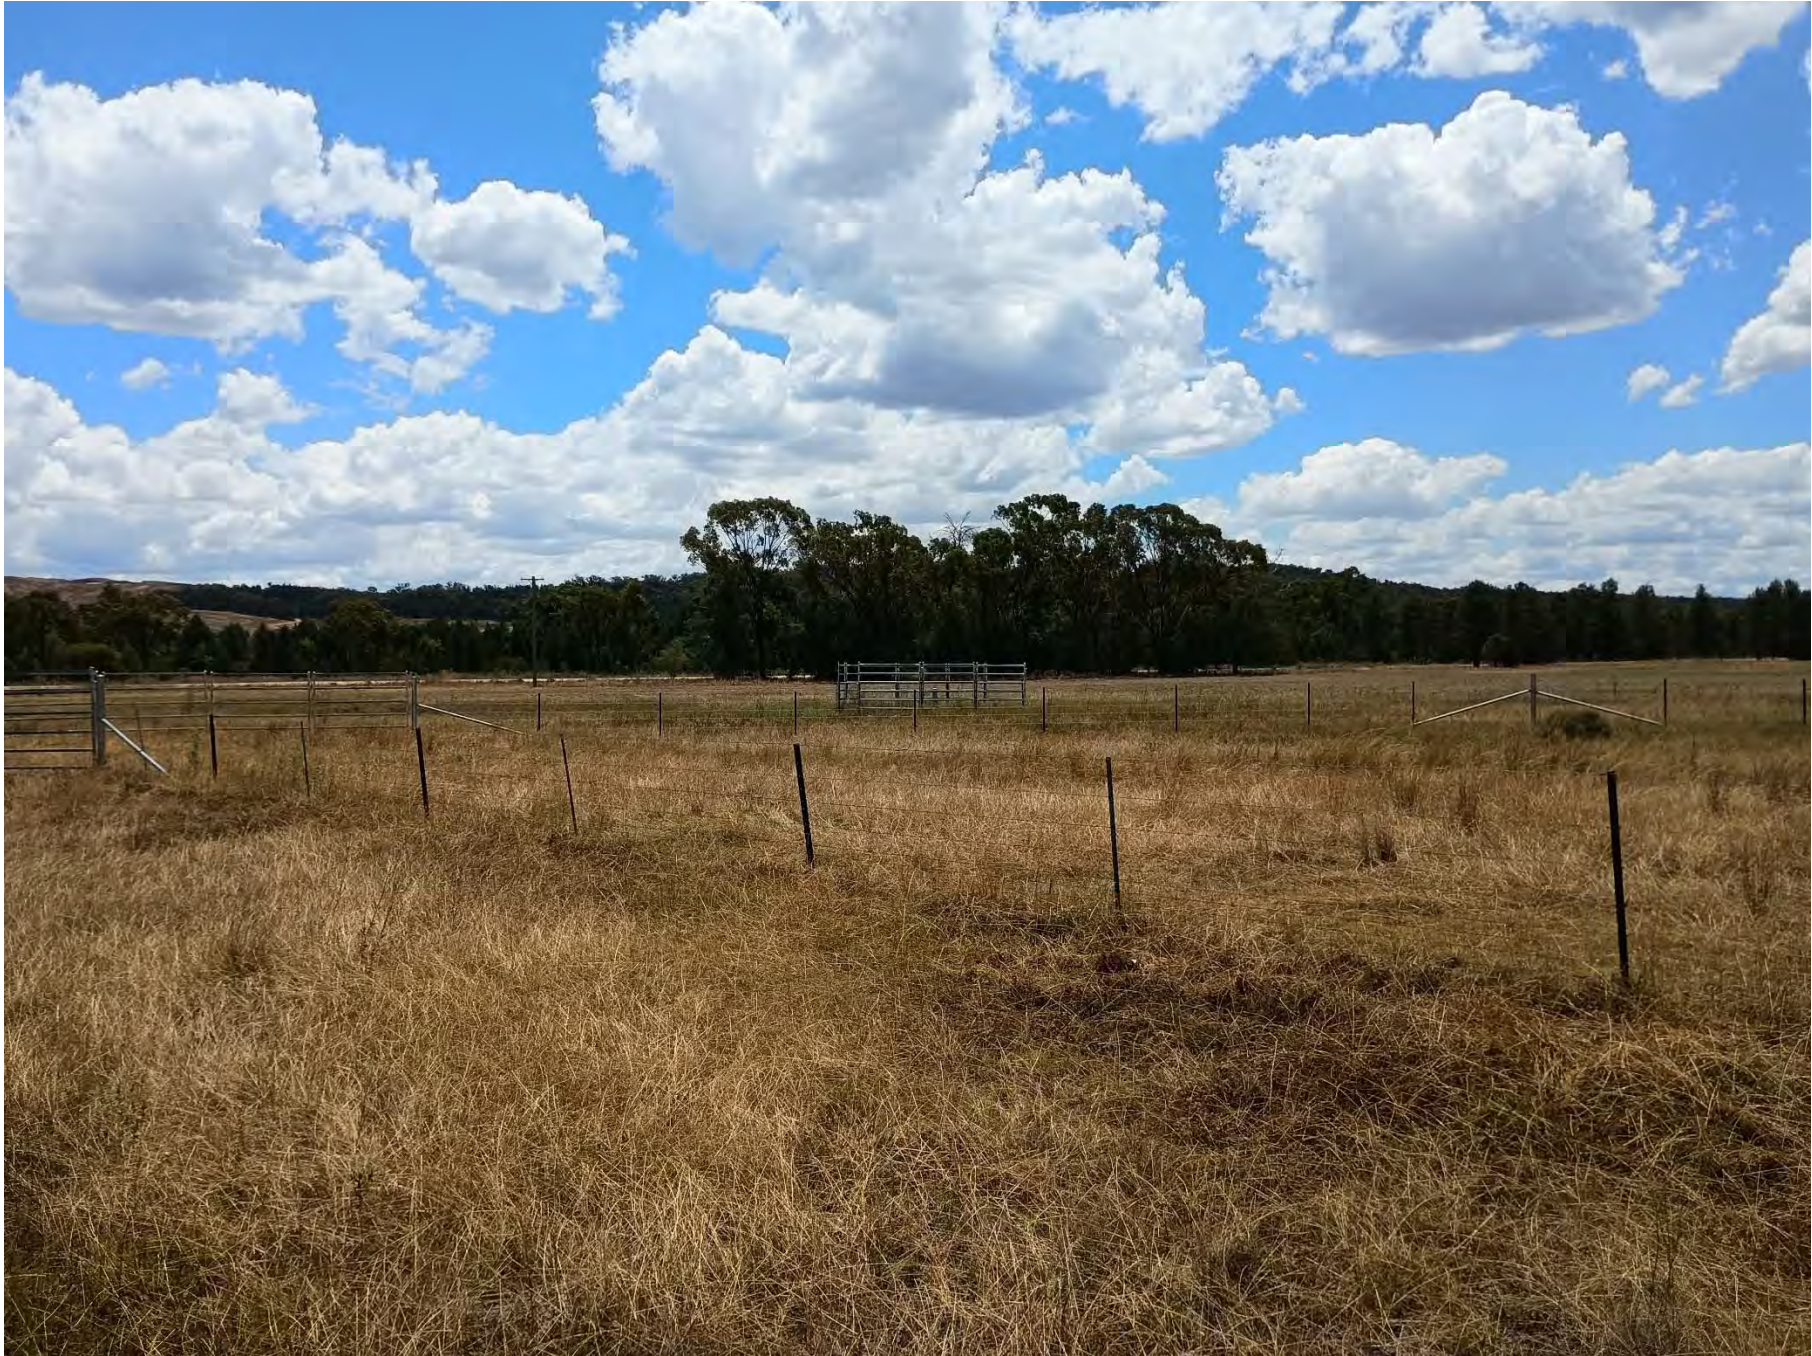
A cluster of groundwater monitoring bores was identified in the south west part of Zone 2 and were likely associated with the nearby Tarrawonga Coal mine.

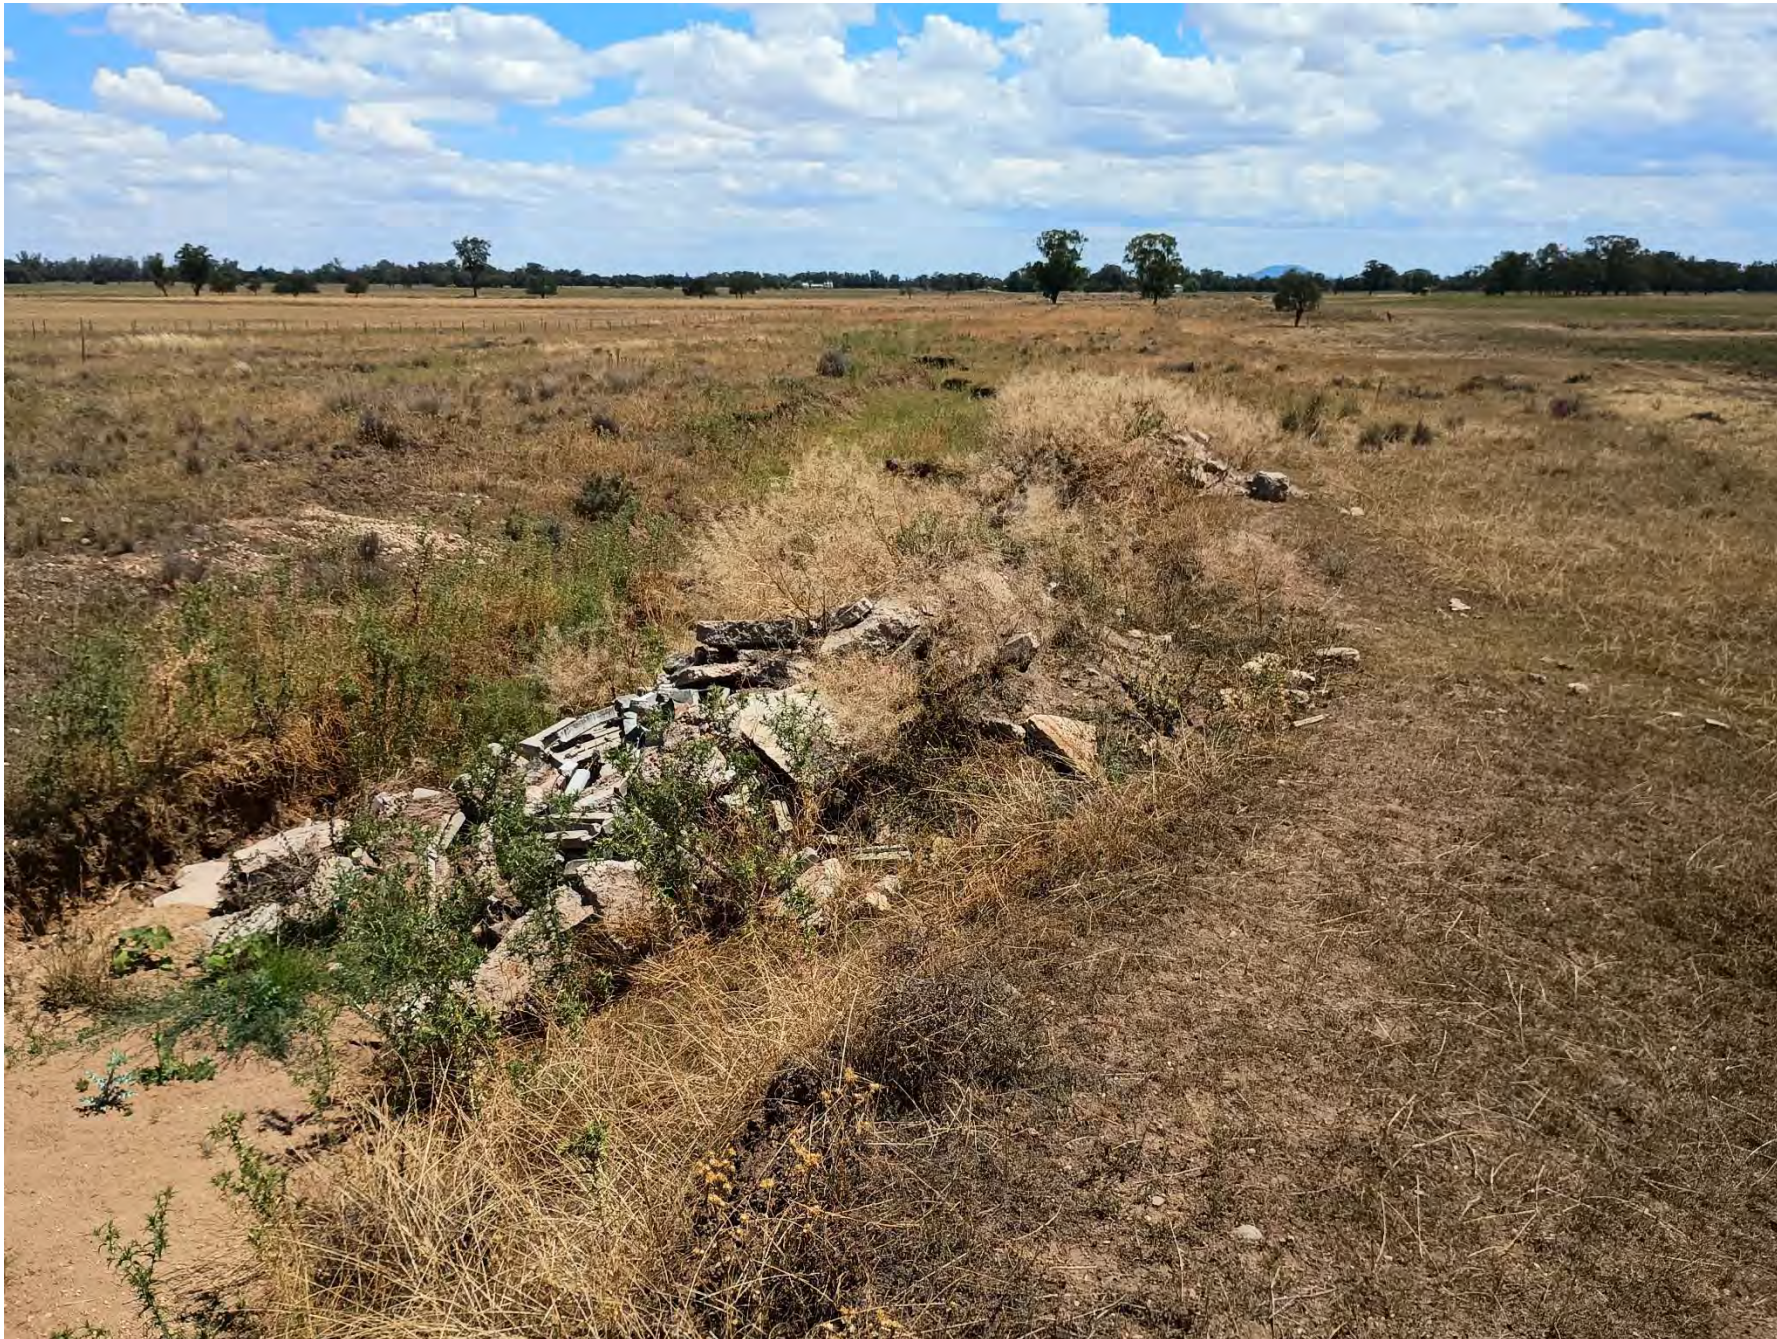
Gully fill was identified in the southern central part of Zone 2. The fill comprised soil and building and demolition waste including broken concrete and brick. Small pieces of fibre cement sheeting were identified within the fill and appeared to be asbestos containing.

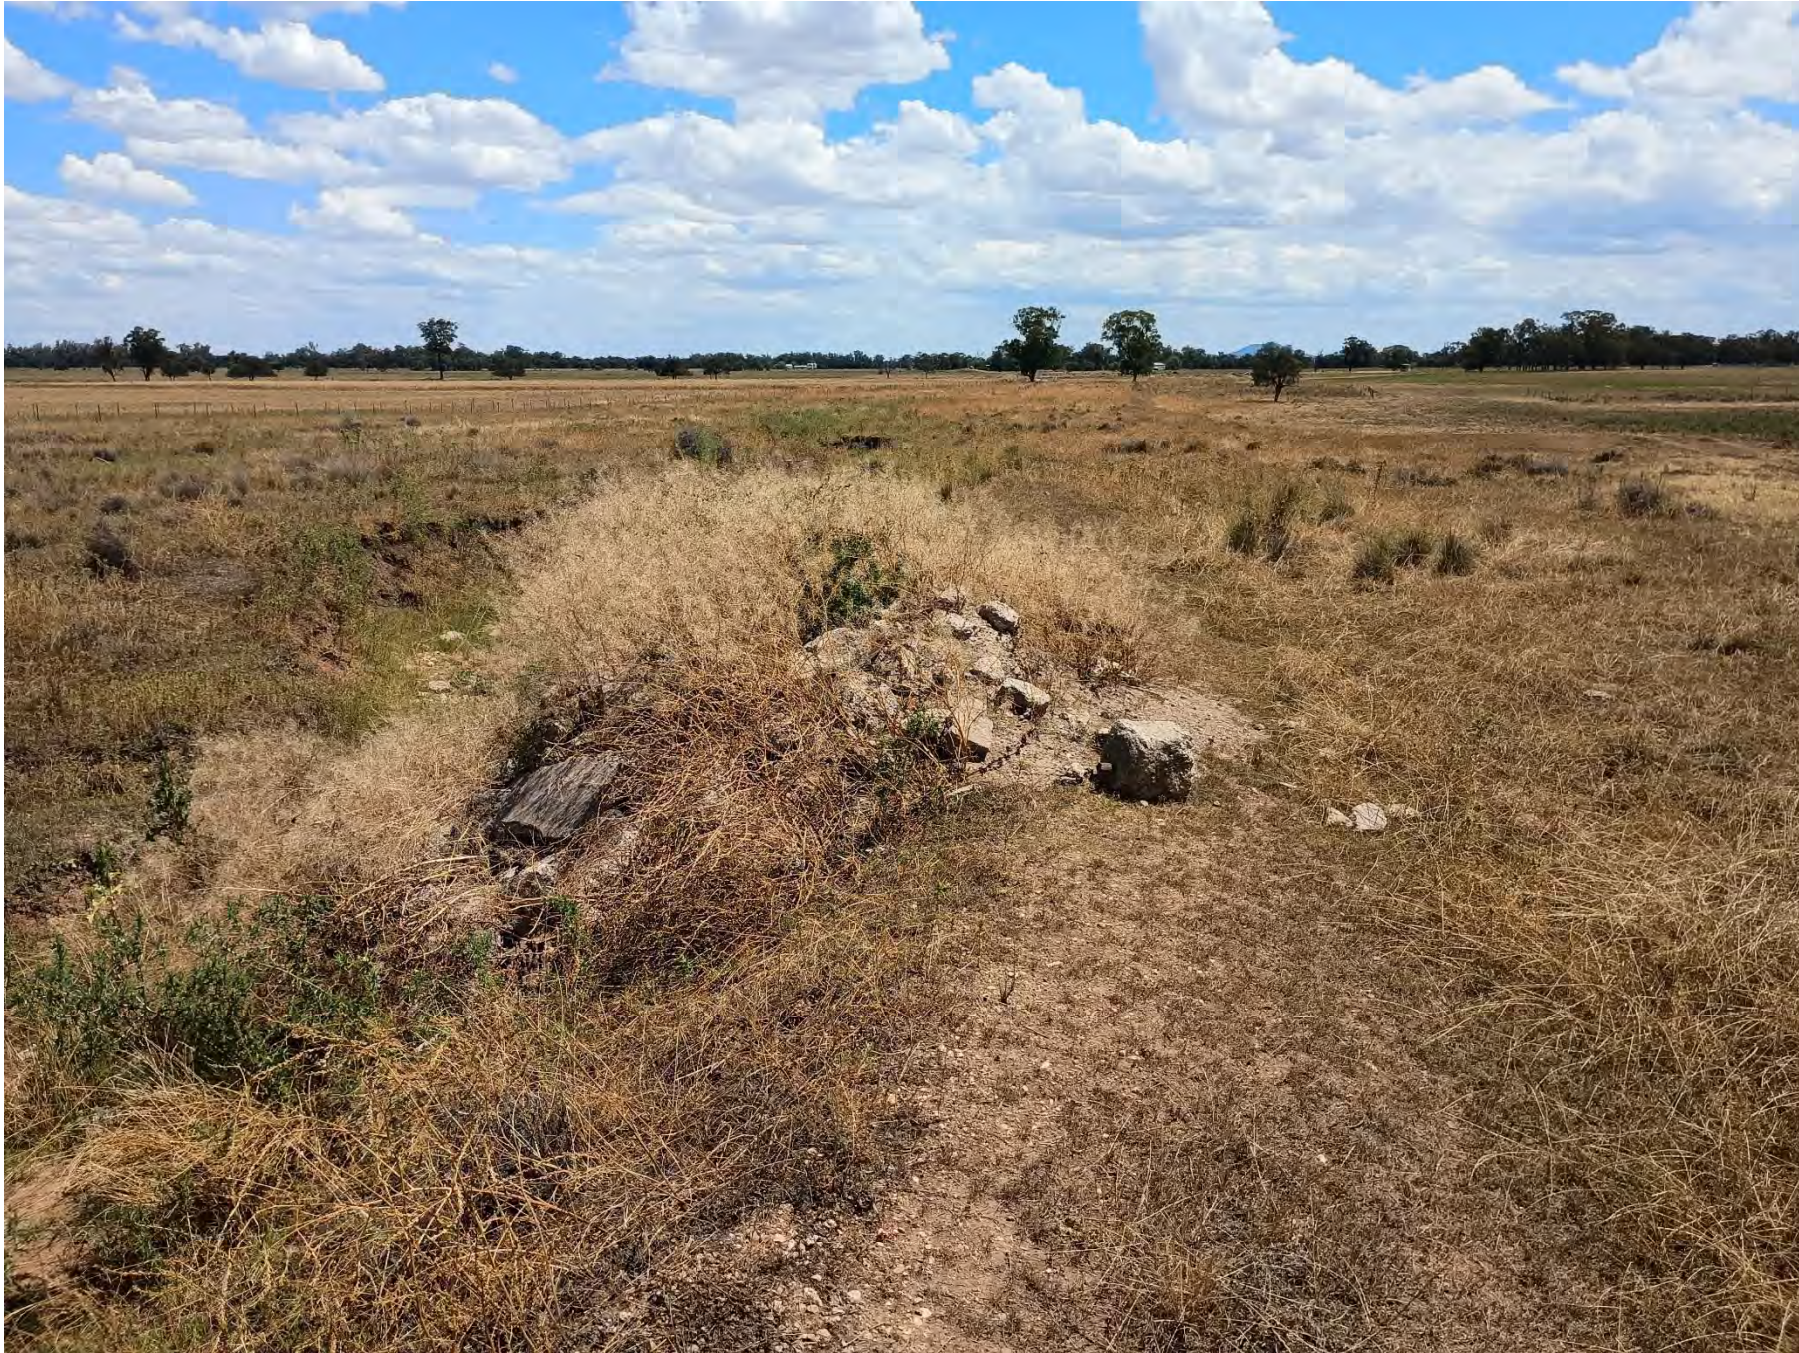
Gully fill was identified in the southern central part of Zone 2. The fill comprised soil and building and demolition waste including broken concrete and brick. Small pieces of fibre cement sheeting were identified within the fill and appeared to be asbestos containing.

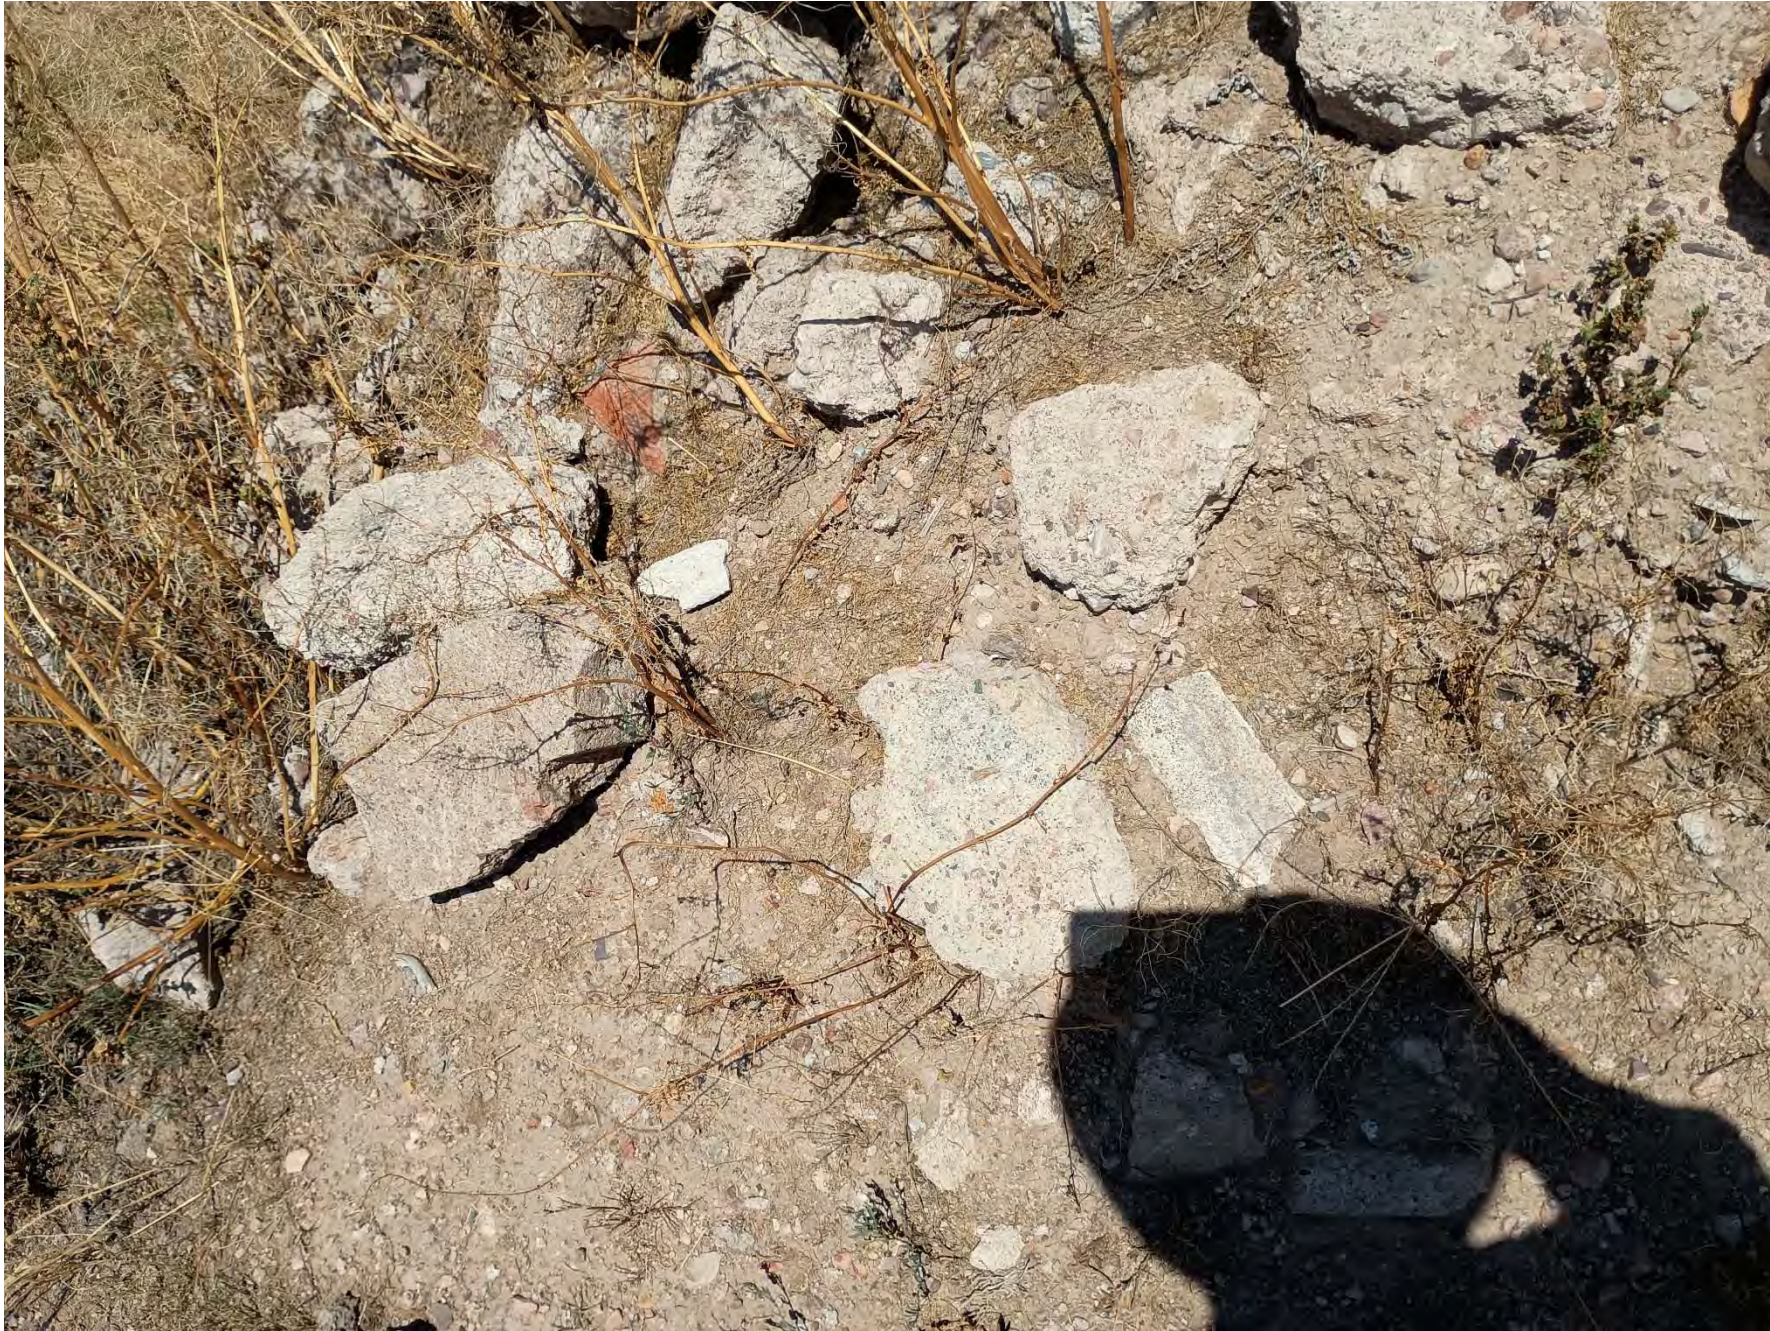
Gully fill was identified in the southern central part of Zone 2. The fill comprised soil and building and demolition waste including broken concrete and brick. Small pieces of fibre cement sheeting were identified within the fill and appeared to be asbestos containing.

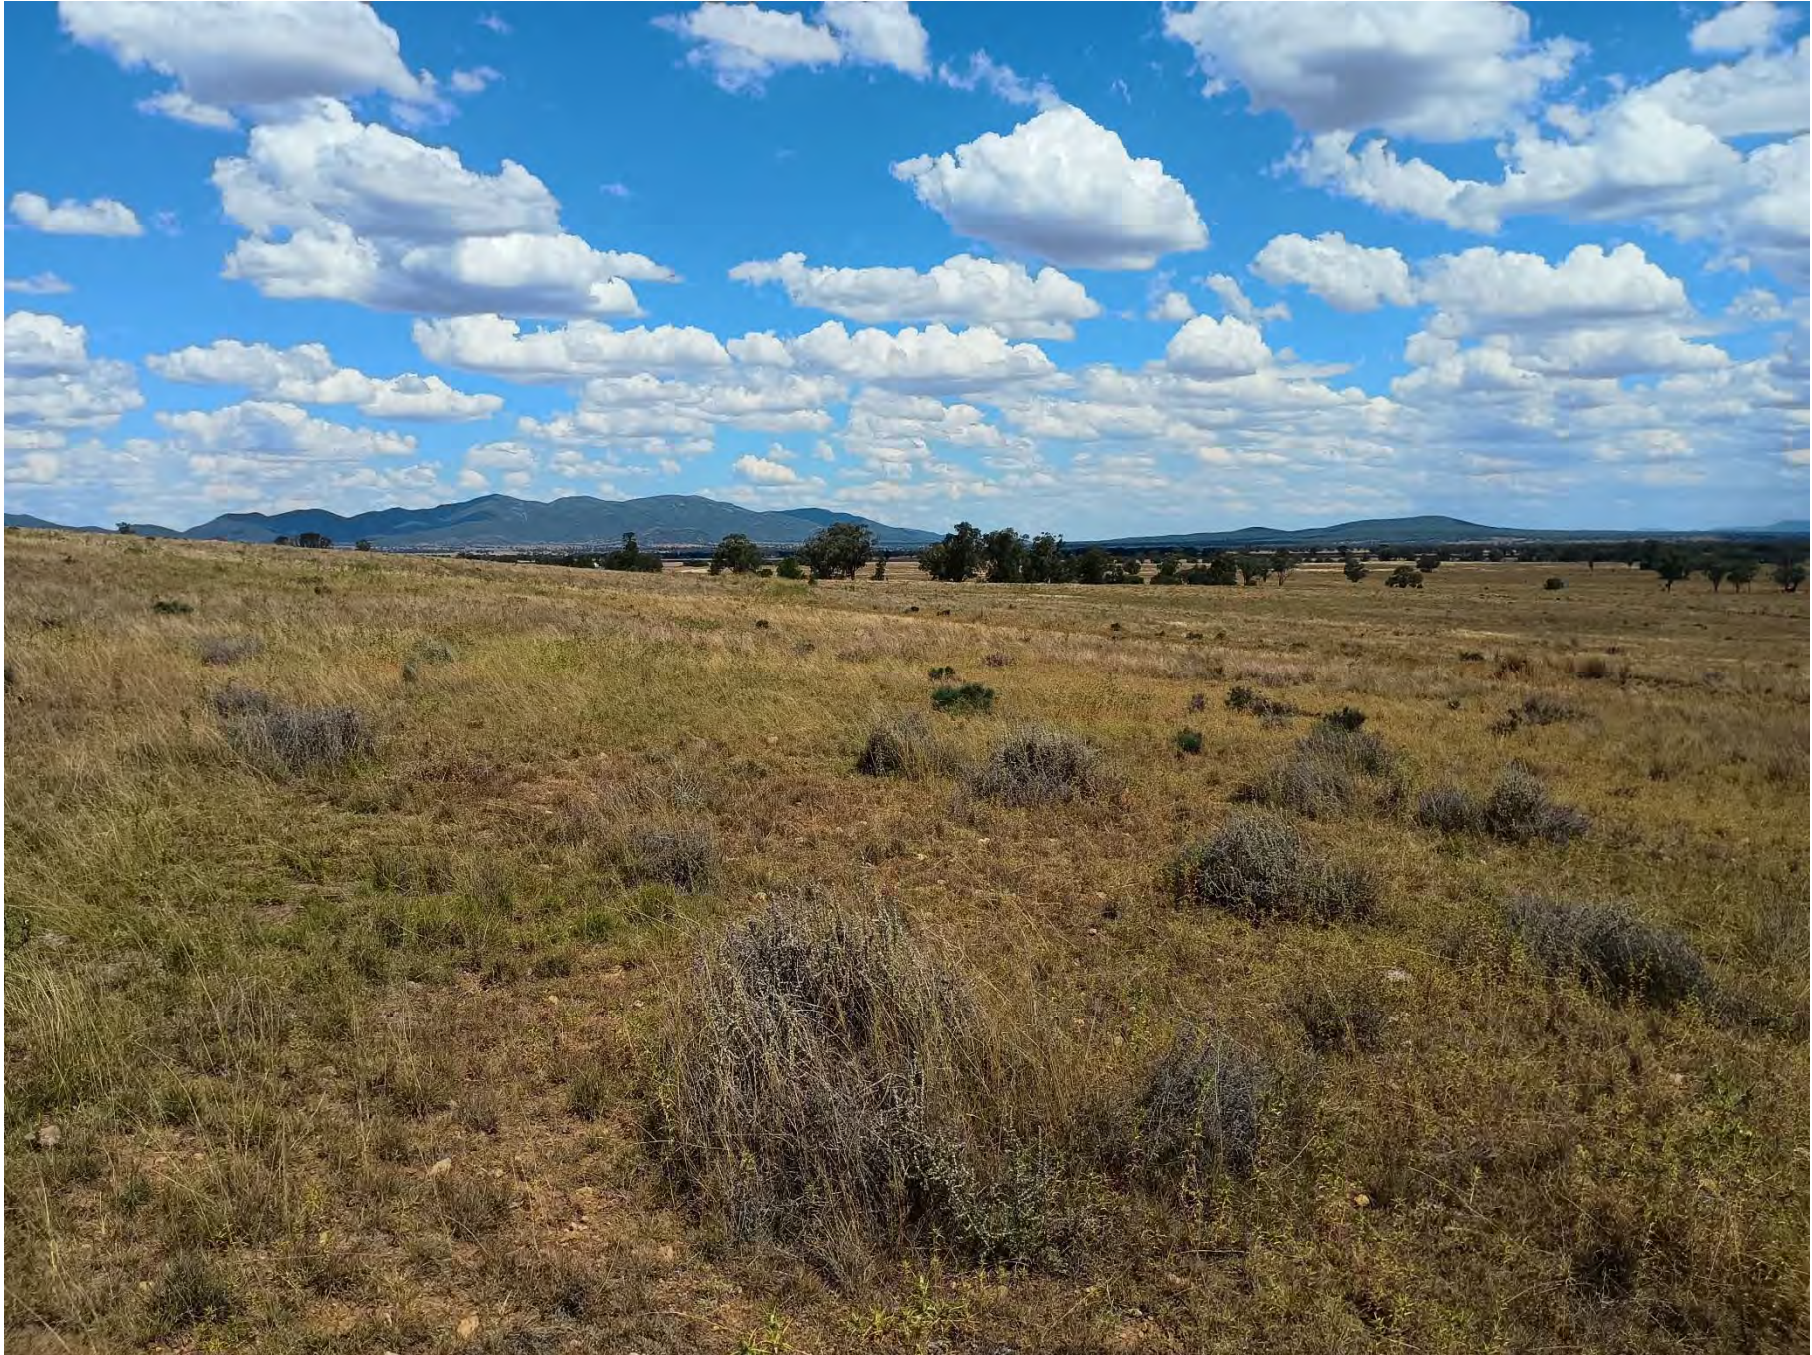
Looking in a south easterly direction across the southern portion of Zone 2. Most of the land within the Study Area was cleared open space that was used for livestock grazing and dryland cropping.
