Maules Creek Continuation Project

Appendix L
Land Contamination Assessment

**RE: MAULES CREEK CONTINUATION PROJECT,
PRELIMINARY SITE INVESTIGATIONS**

**Maules Creek Continuation Project
Mine Site
Preliminary Site Investigation**

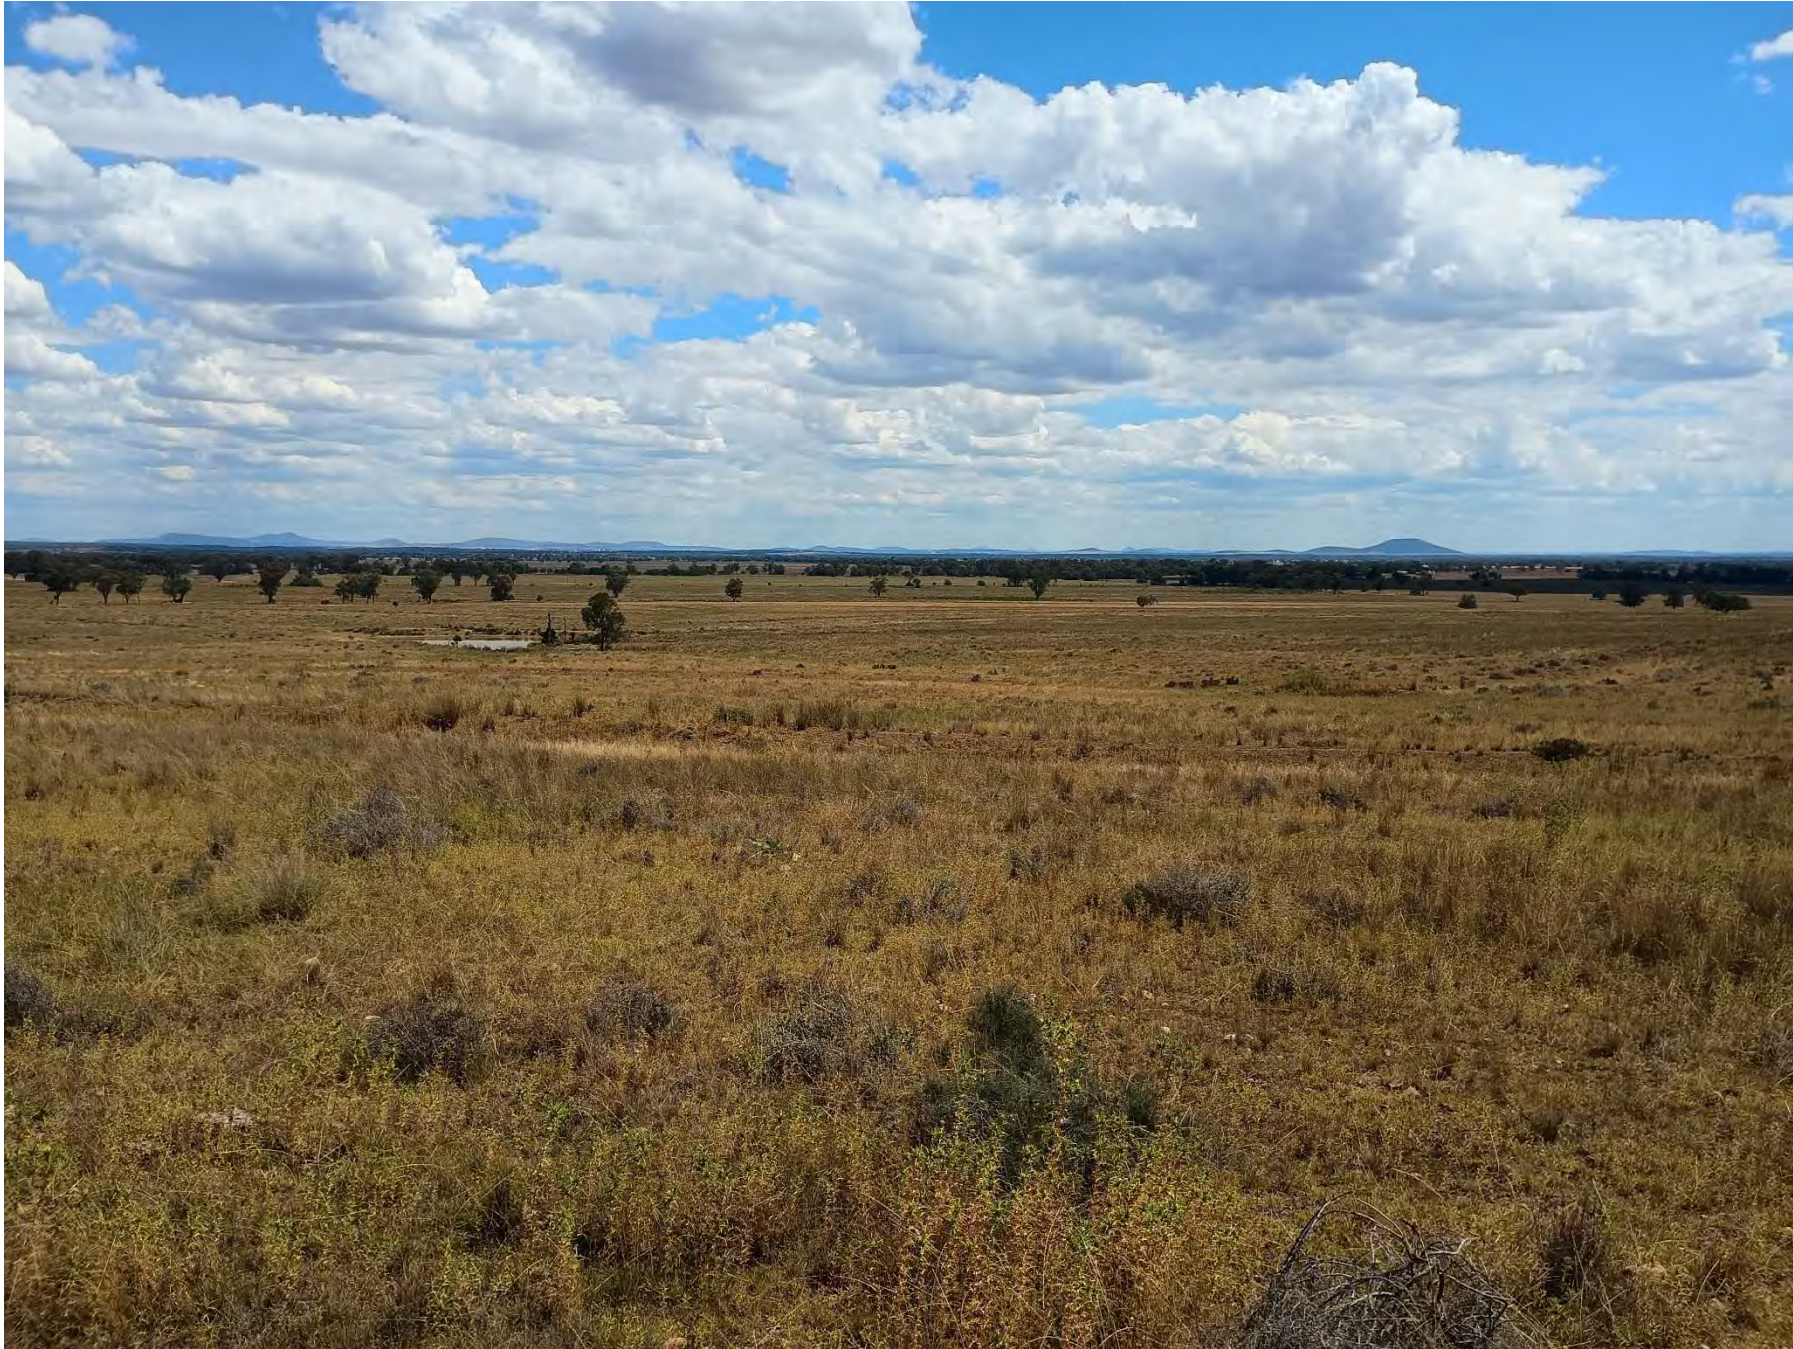
Looking in a south westerly direction across the southern portion of Zone 2. Most of the land within the Study Area was cleared open space that was used for livestock grazing and dryland cropping.

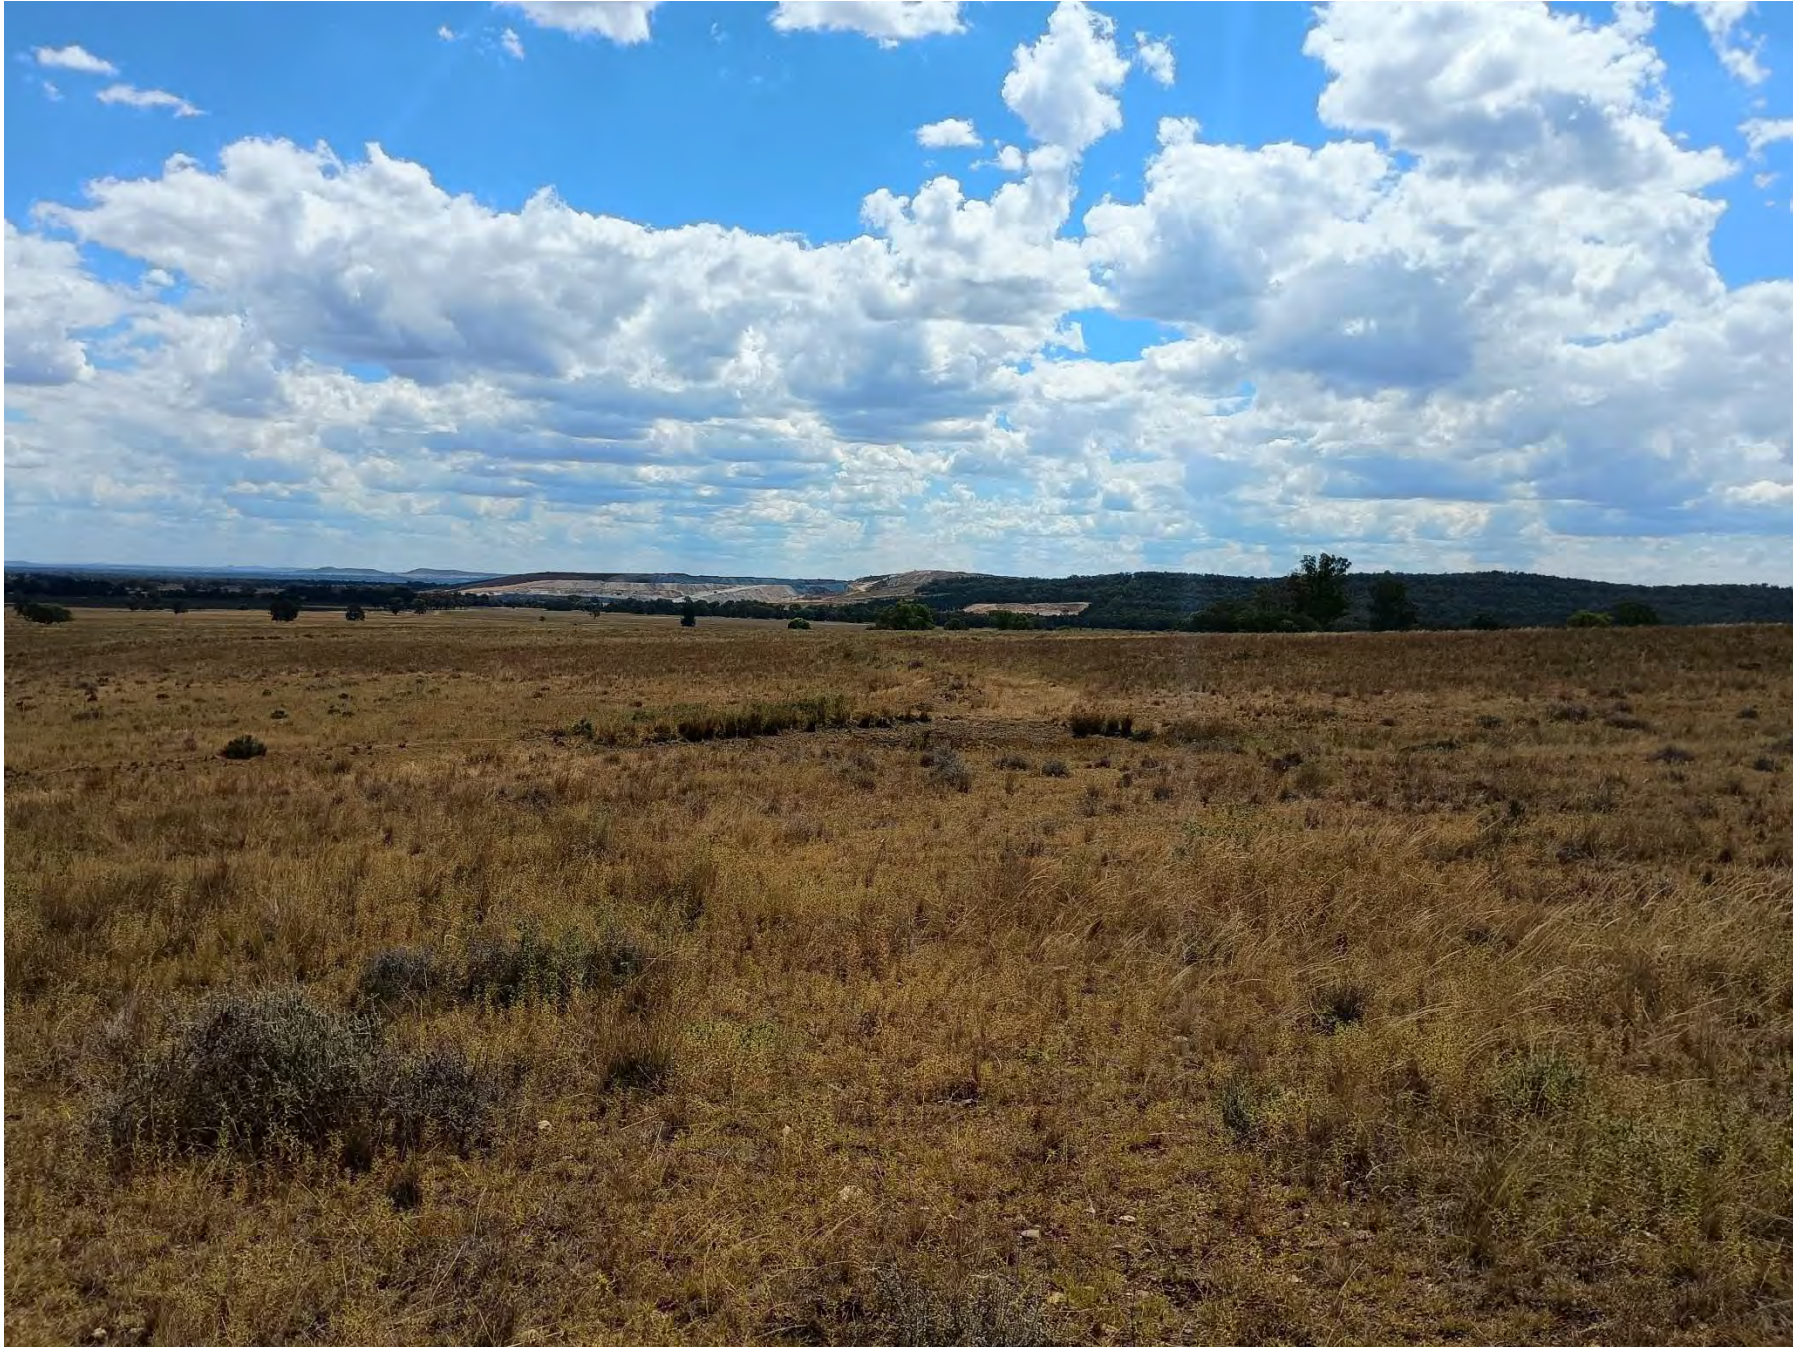
Looking in a westerly direction across the southern portion of Zone 2. Most of the land within the Study Area was cleared open space that was used for livestock grazing and dryland cropping.

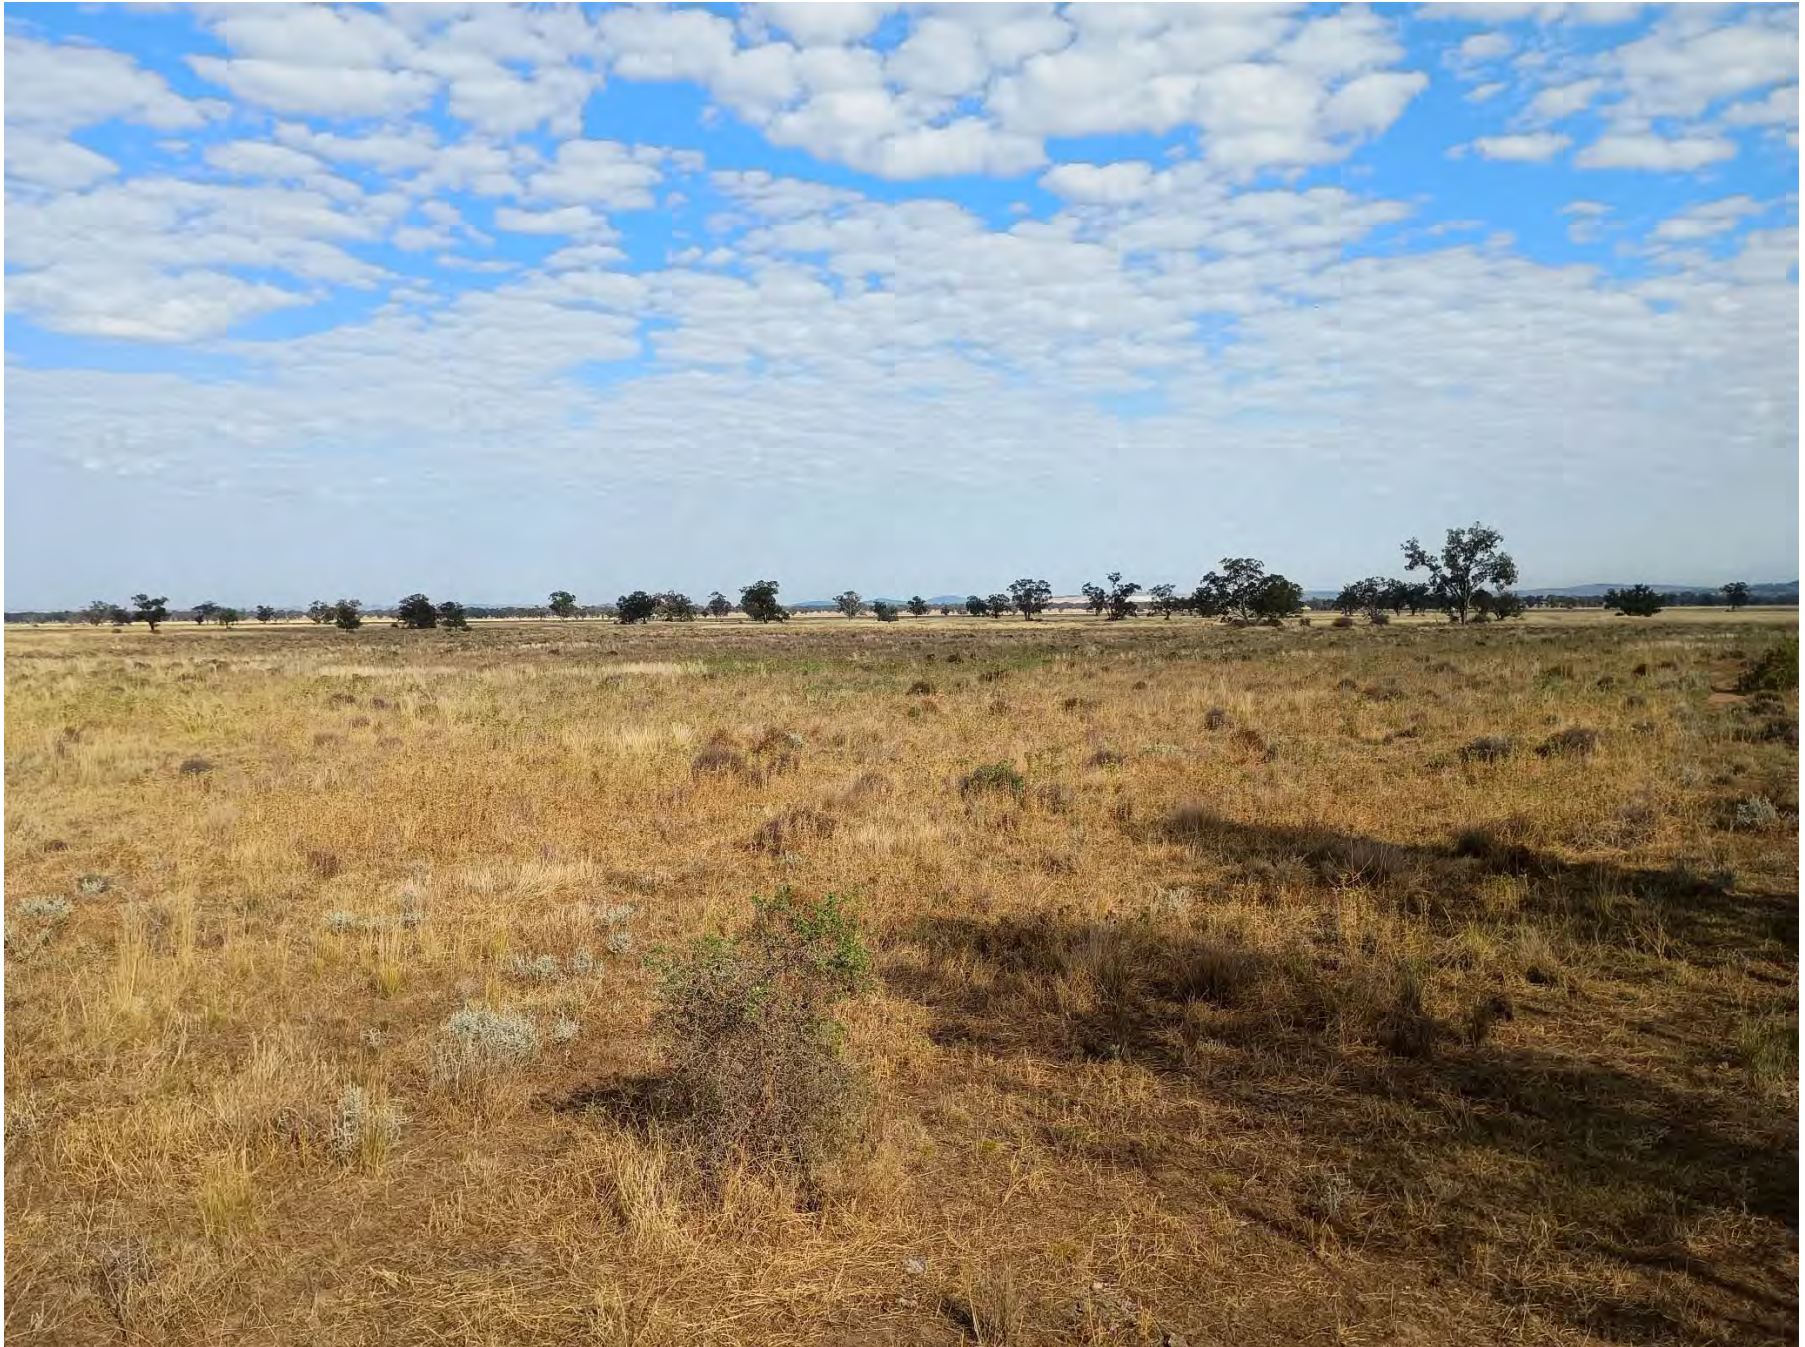
Looking in a westerly direction across Zone 3. Most of the land within the Study Area was cleared open space used for livestock grazing and dryland cropping. Points of interest identified within Zone 3 were limited to livestock watering points and water tanks.

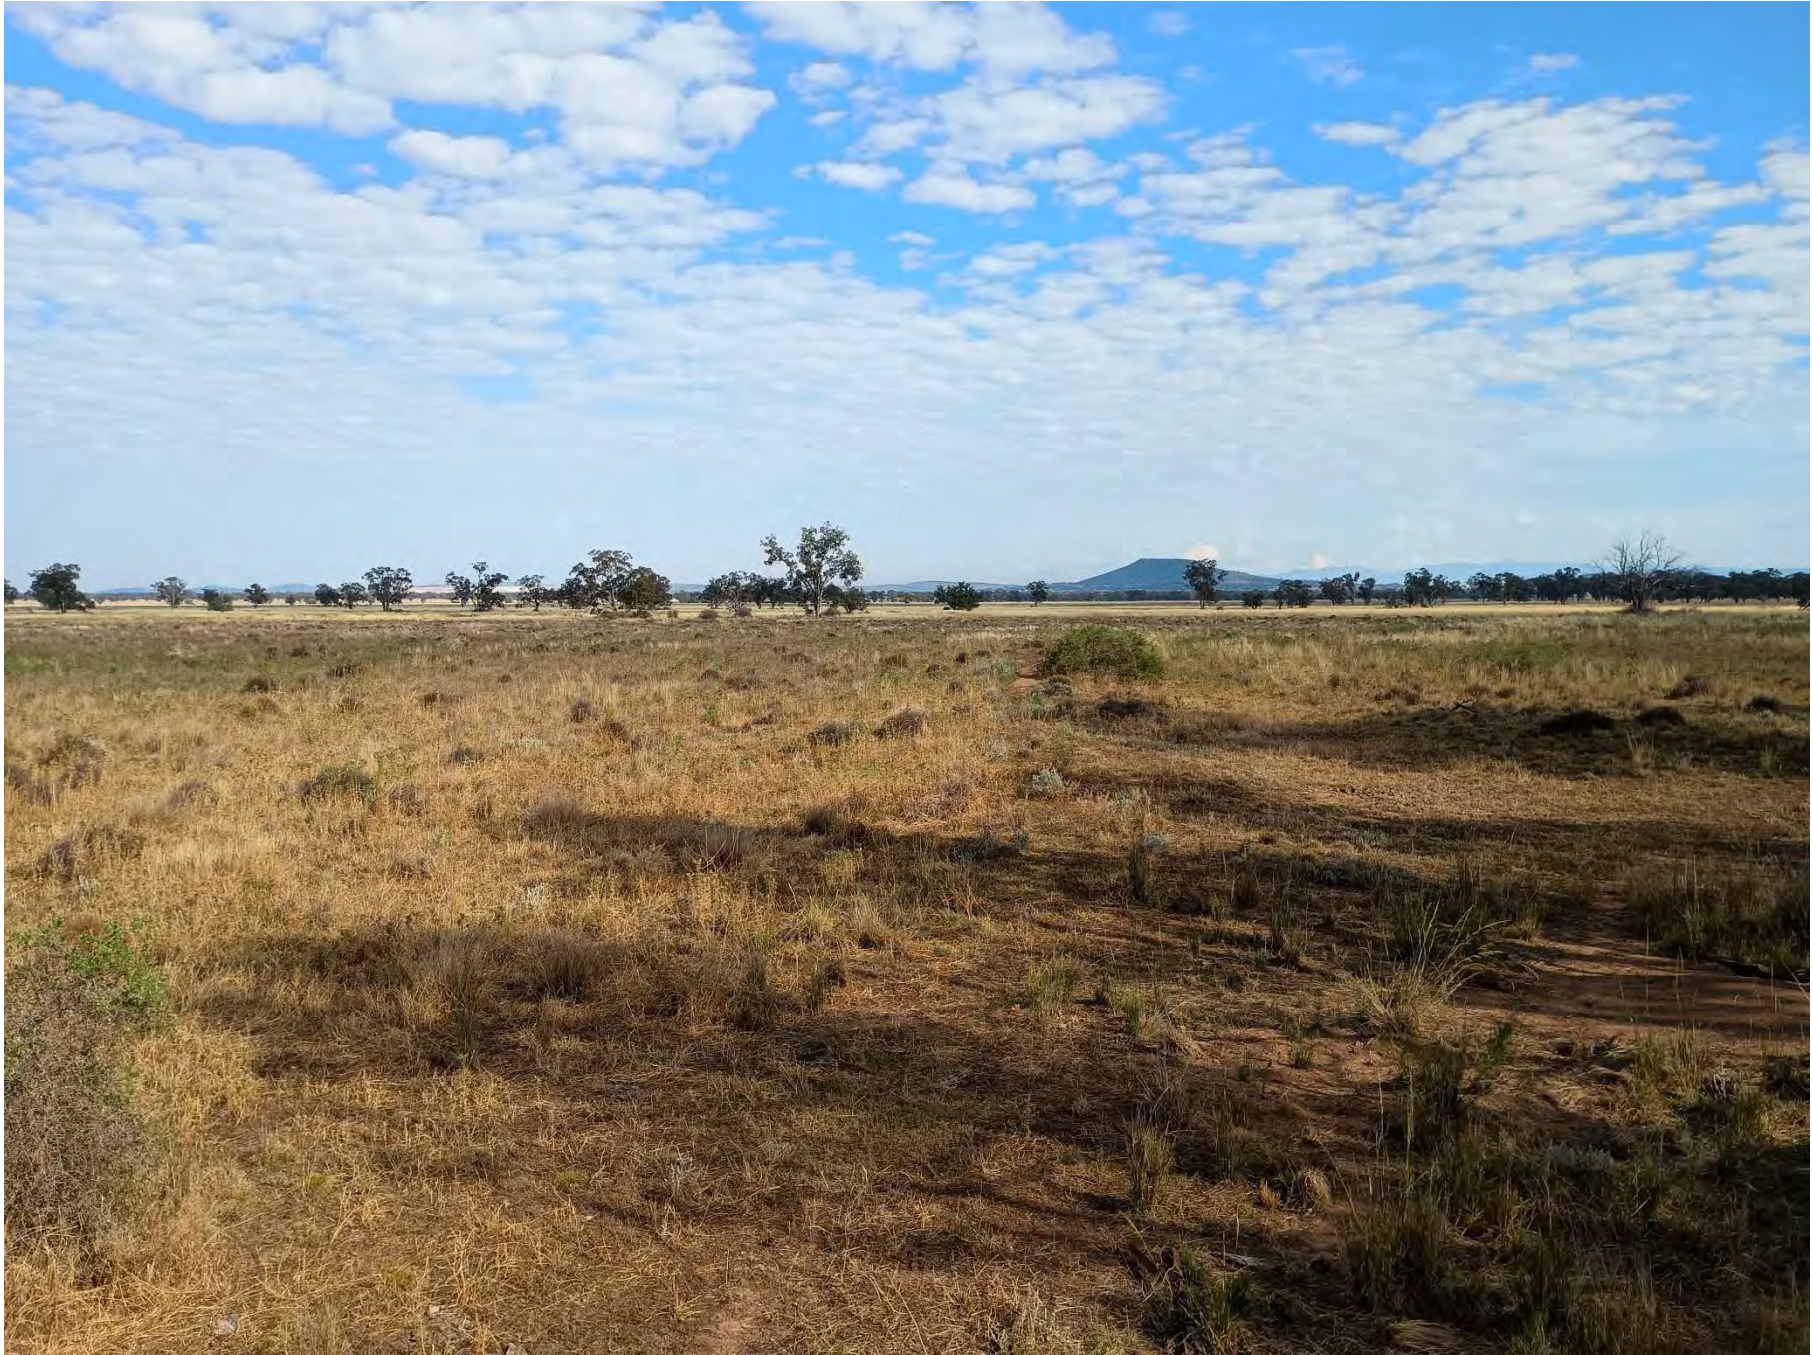
Looking in a north westerly direction across Zone 3. Most of the land within the Study Area was cleared open space used for livestock grazing and dryland cropping. Points of interest identified within Zone 3 were limited to livestock watering points and water tanks.

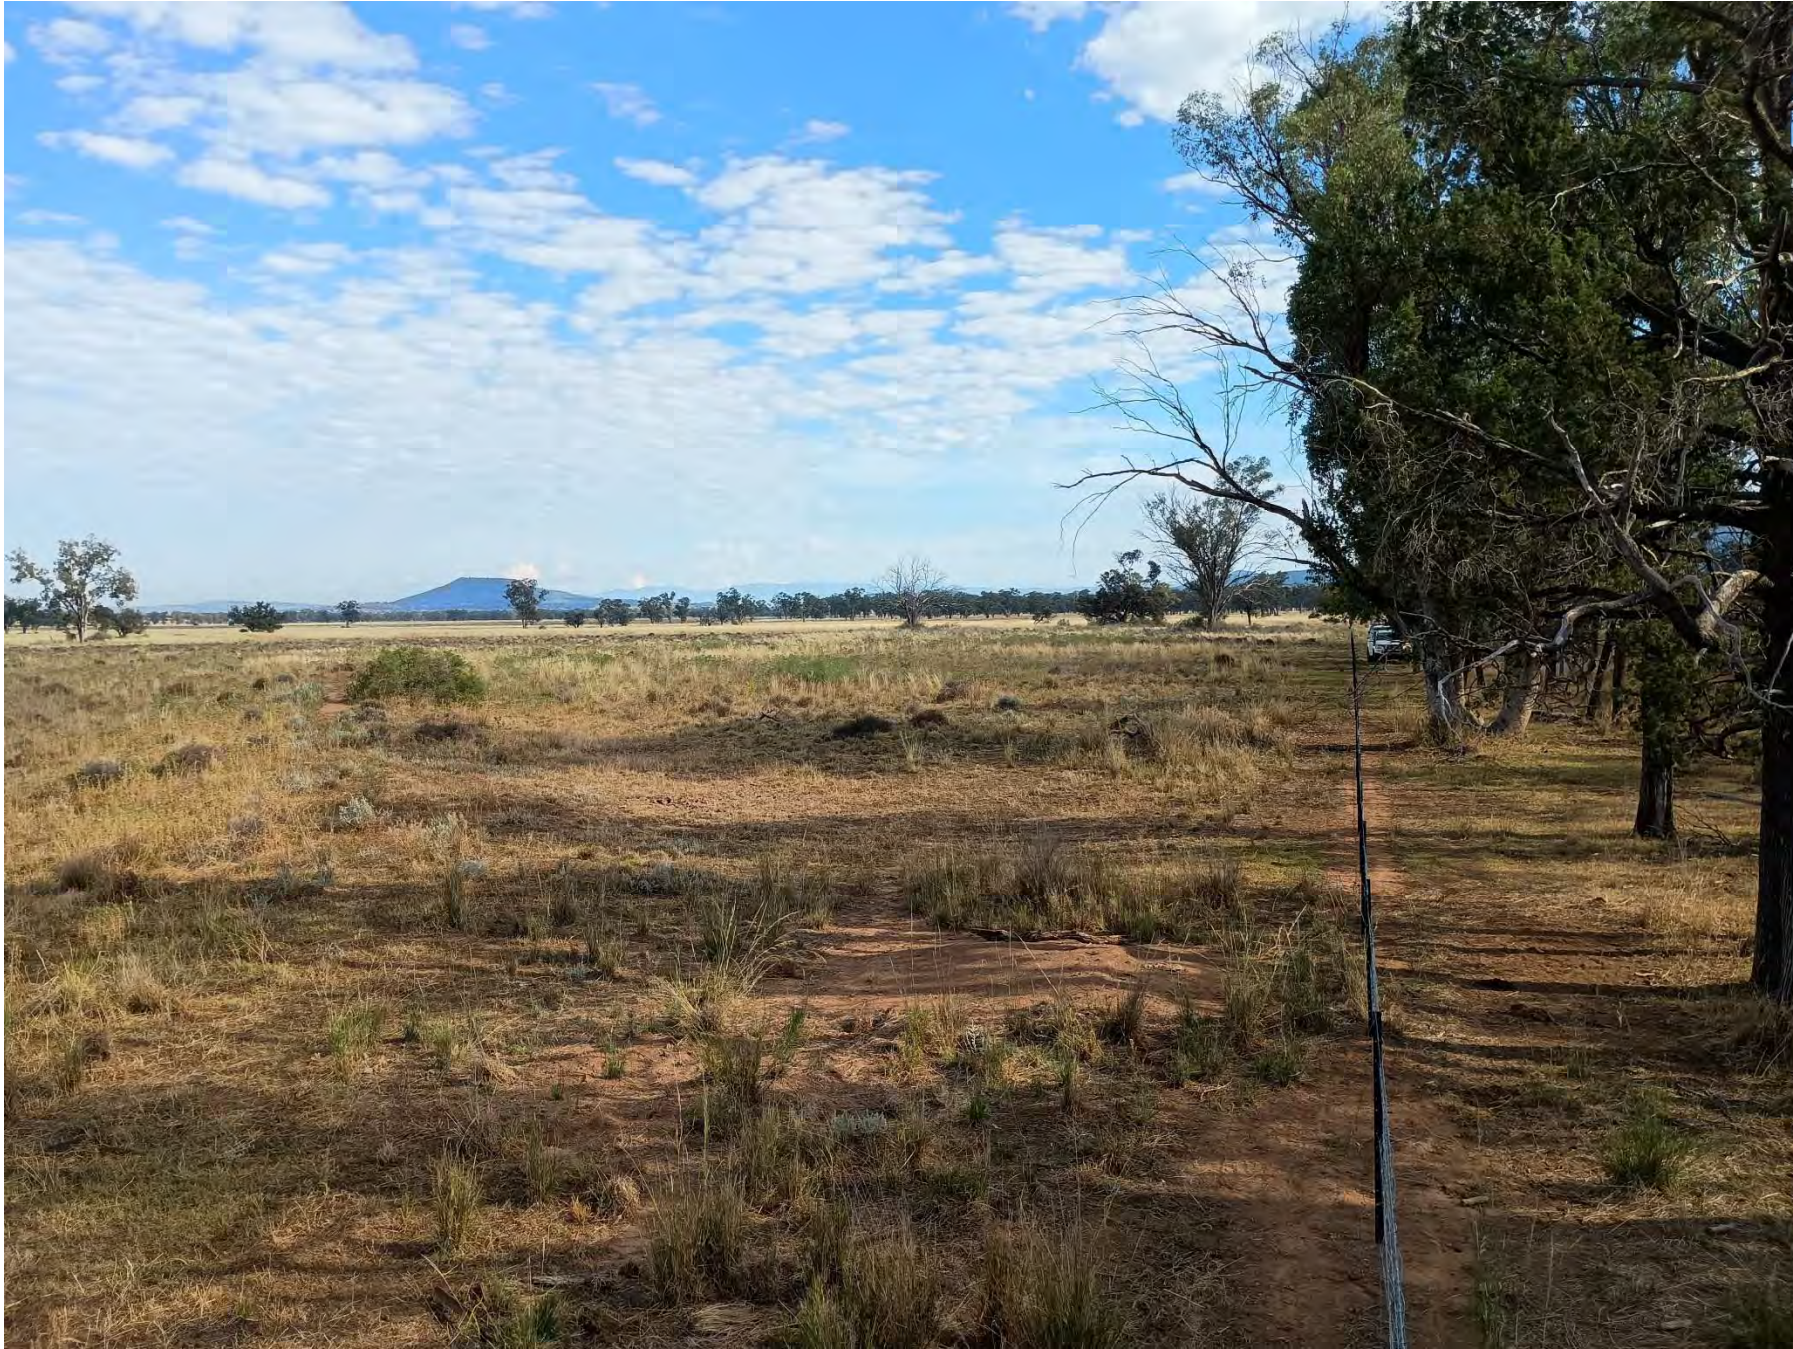
Looking in a northerly direction along the eastern boundary of Zone 3. Most of the land within the Study Area was cleared open space used for livestock grazing and dryland cropping. Points of interest identified within Zone 3 were limited to livestock watering points and water tanks.

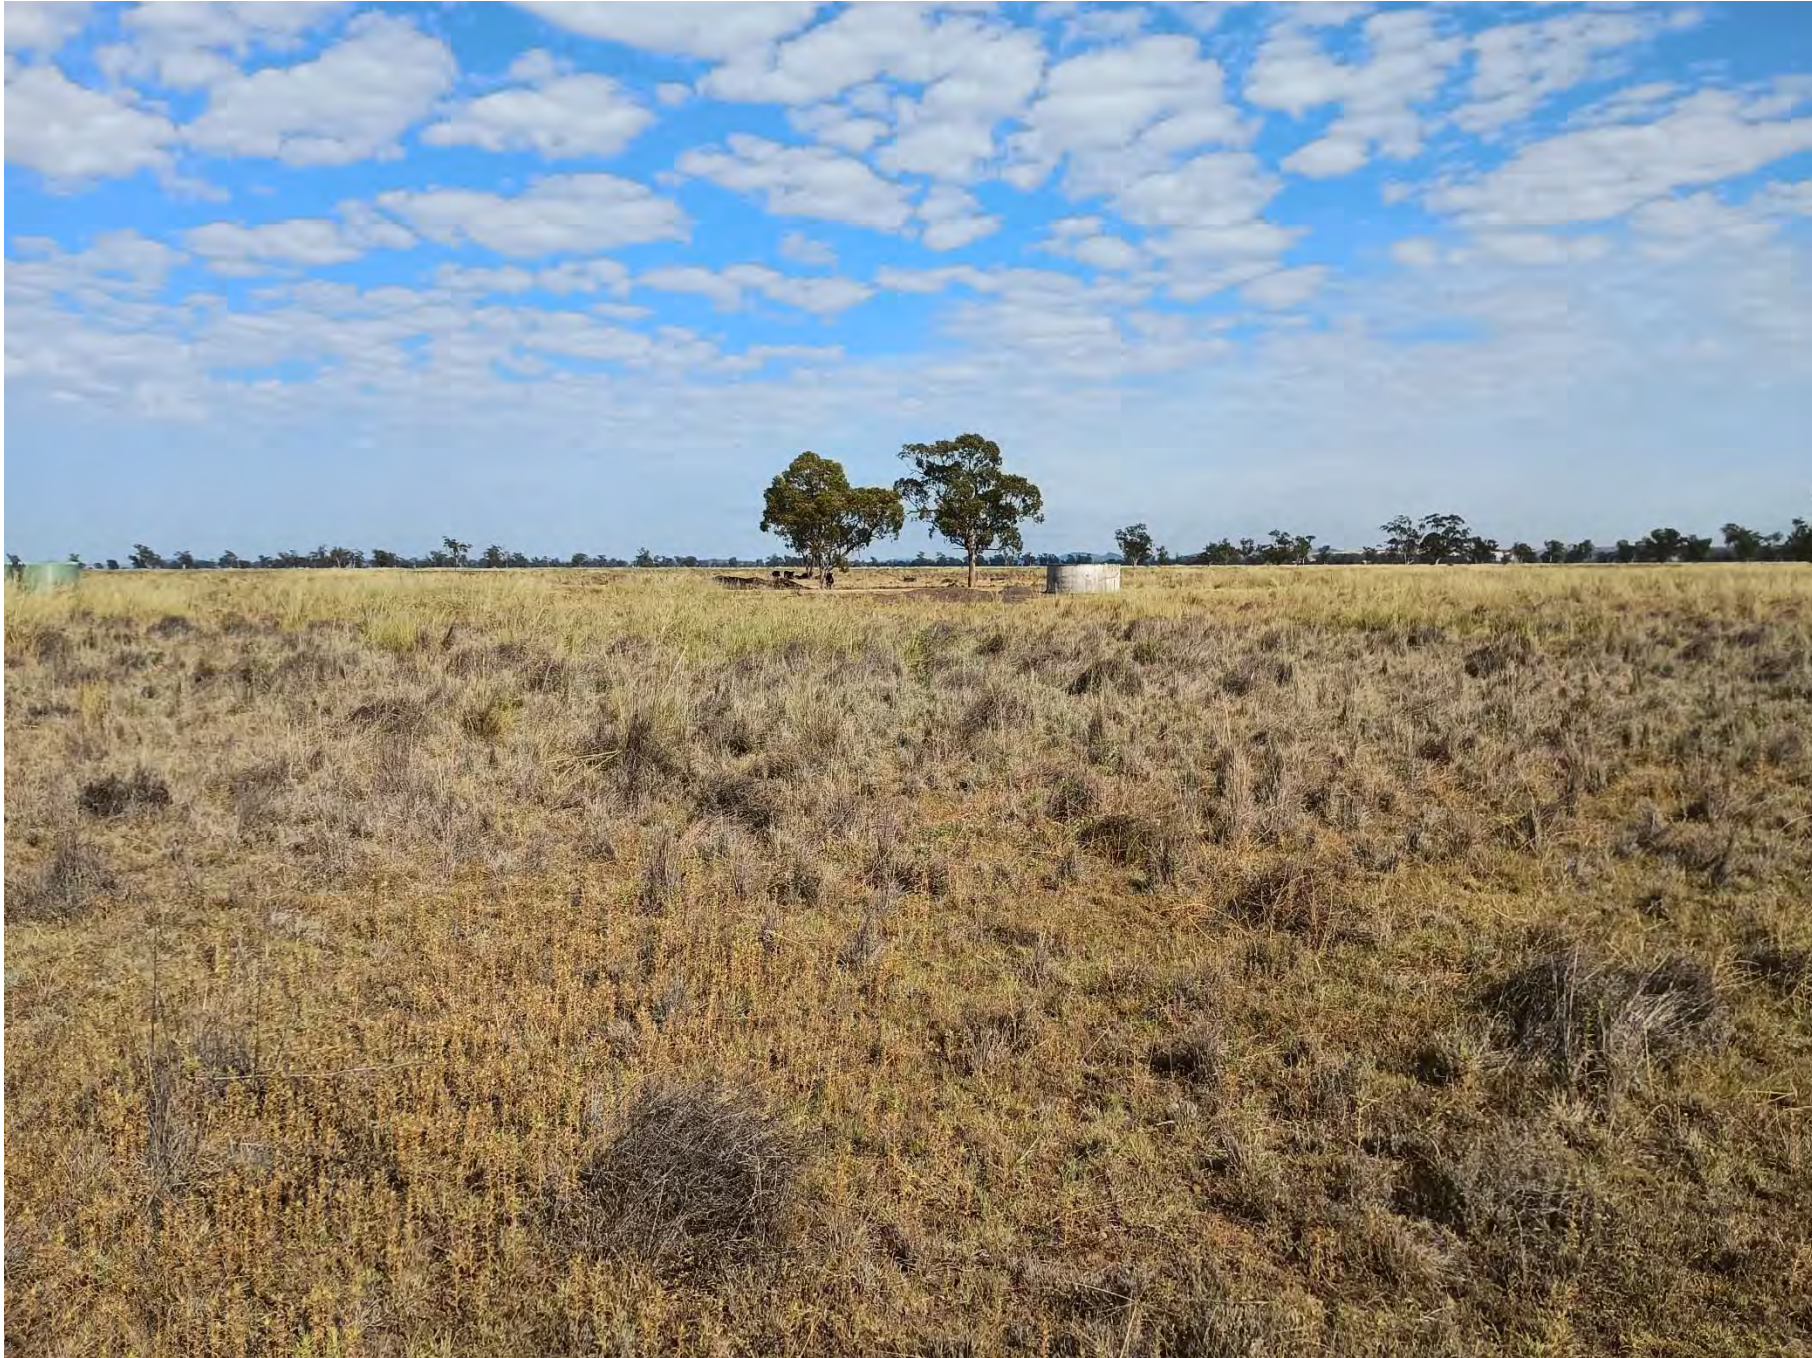
Looking in a westerly direction across the central part of Zone 3. Most of the land within the Study Area was cleared open space used for livestock grazing and dryland cropping. Points of interest identified within Zone 3 were limited to livestock watering points and water tanks.

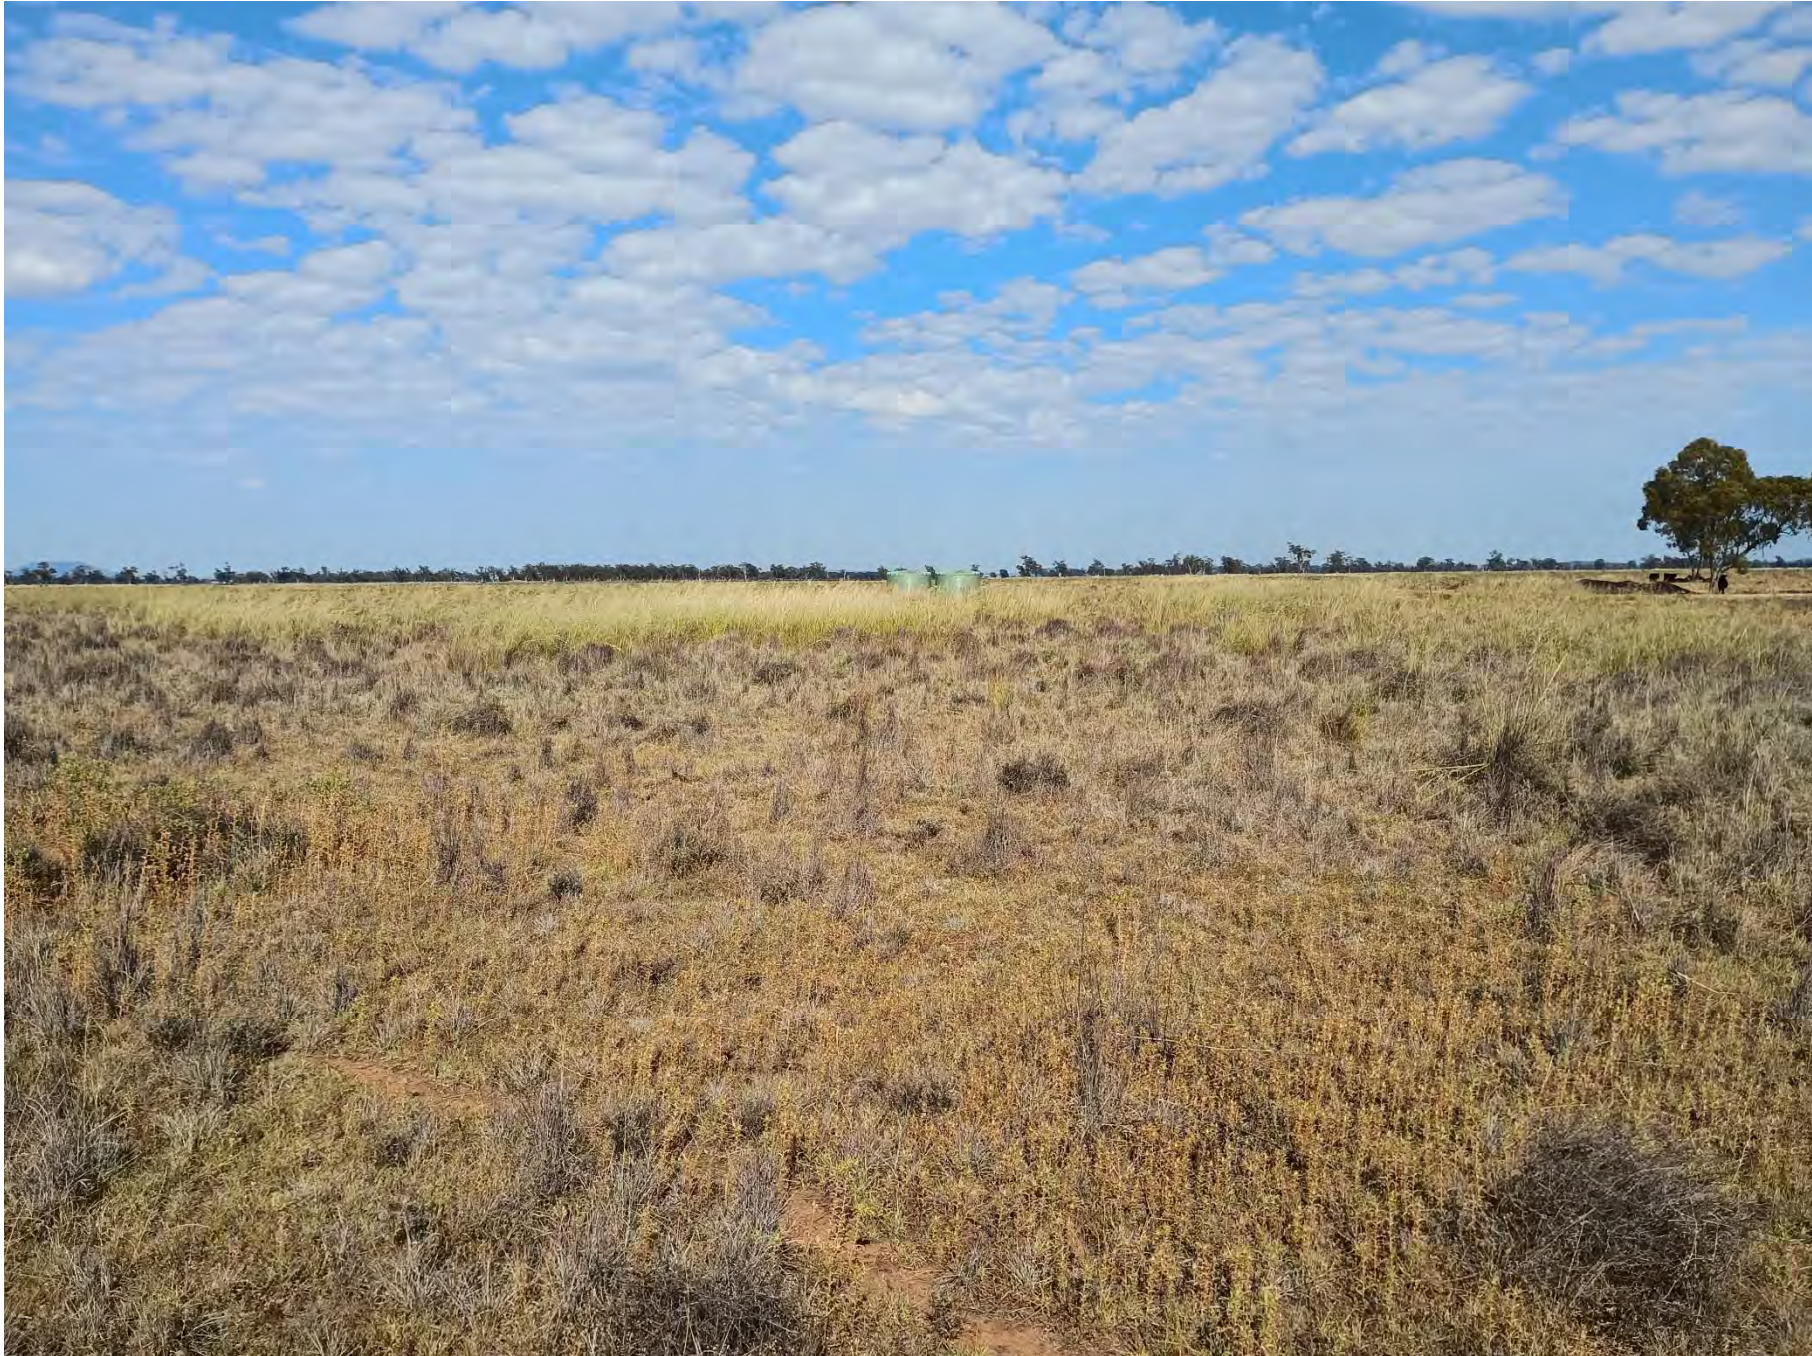
Looking in a westerly direction across the central part of Zone 3. Most of the land within the Study Area was cleared open space used for livestock grazing and dryland cropping. Points of interest identified within Zone 3 were limited to livestock watering points and water tanks.

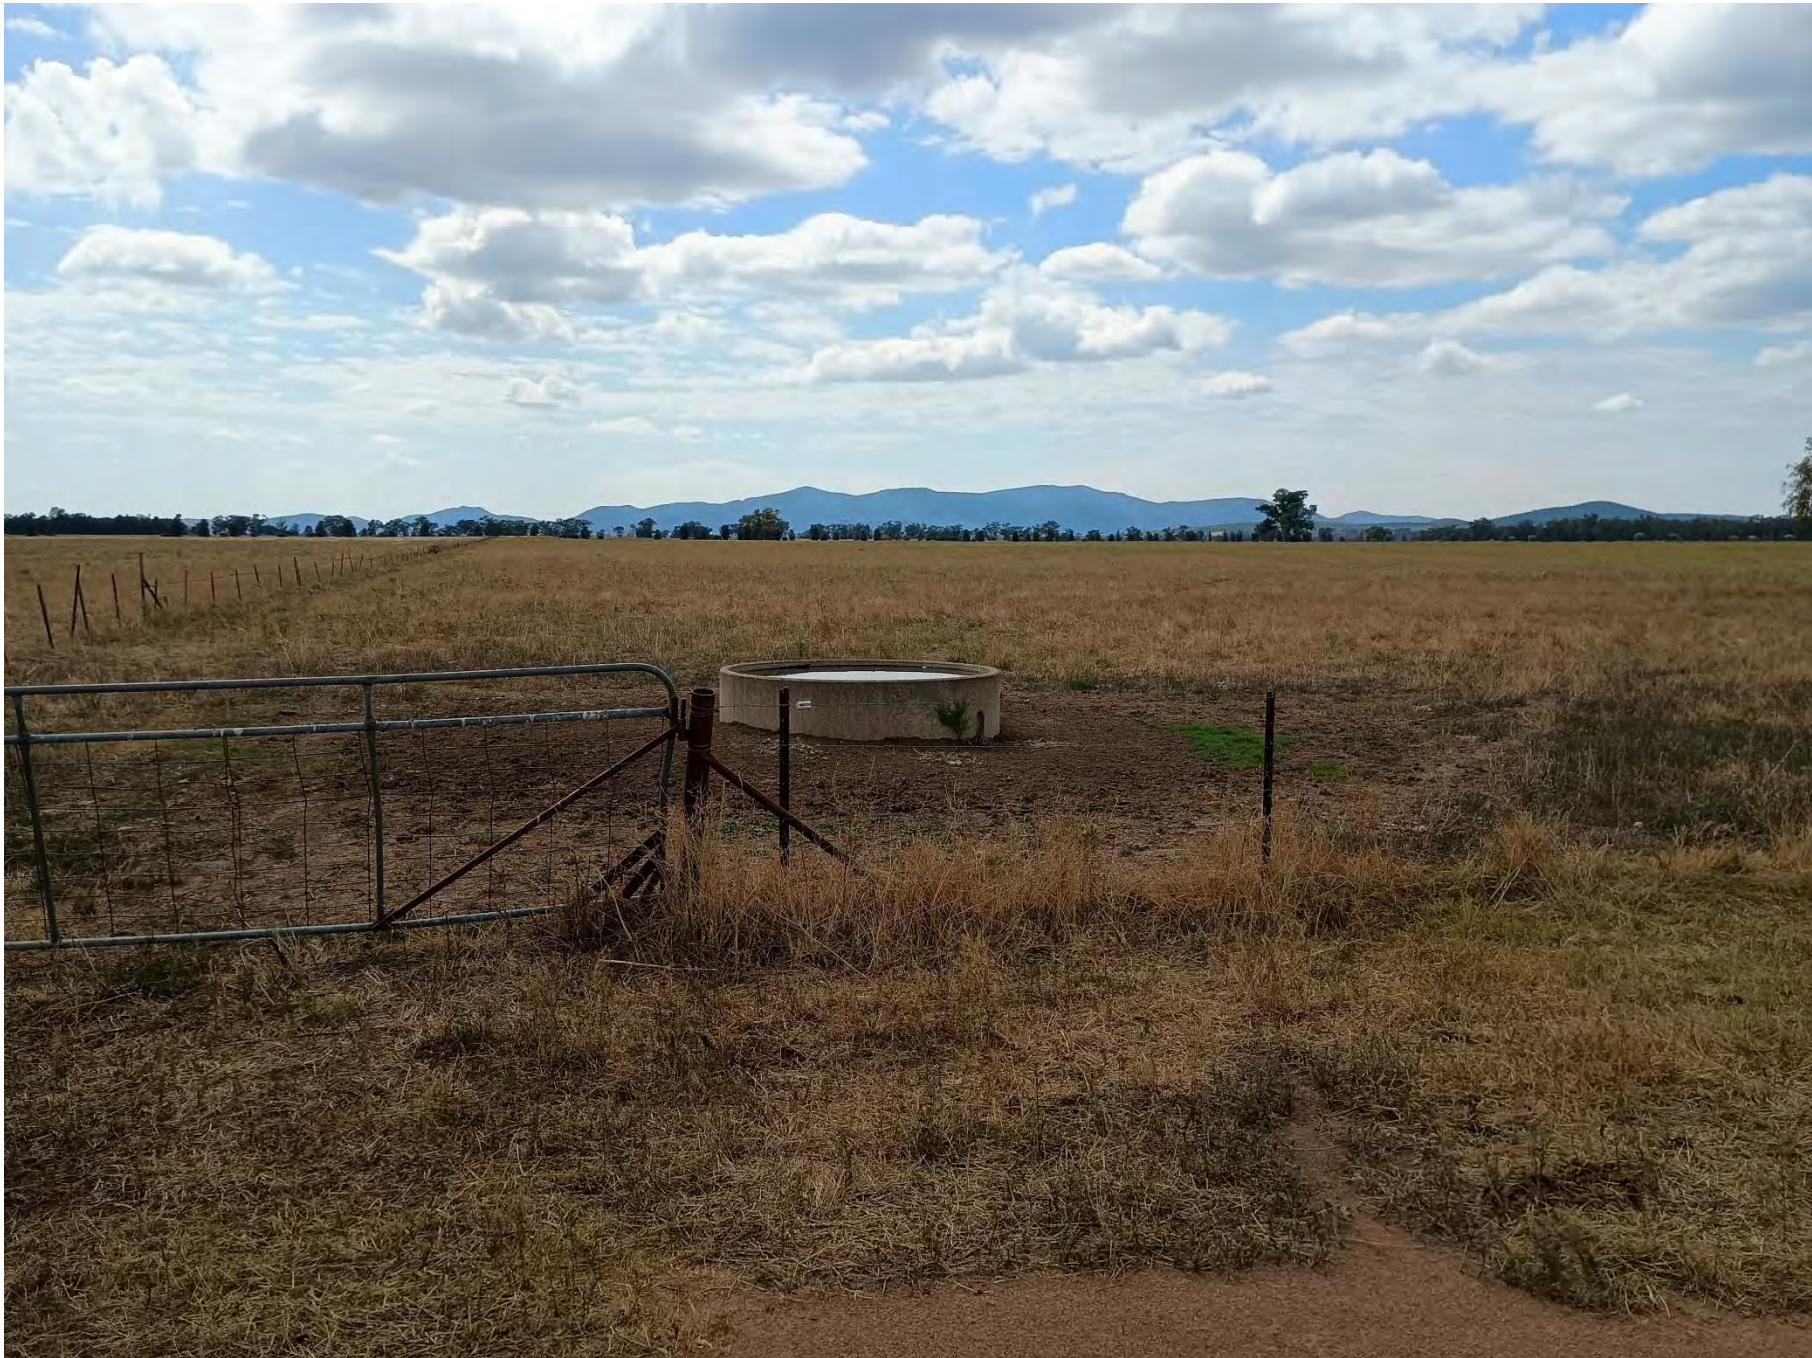
Looking in an easterly direction across the central part of Zone 3. Most of the land within the Study Area was cleared open space used for livestock grazing and dryland cropping. Points of interest identified within Zone 3 were limited to livestock watering points and water tanks.
