## SSD-63475709 Tumbi Umbi Retirement Living Project

Please find enclosed a response to the submissions received on the Tumbi Umbi Retirement Living Project from Central Coast Council (dated 22 August 2025) and NSW Department of Climate Change, Energy, the Environment and Water (DCCEEW) (dated 18/08/2025).

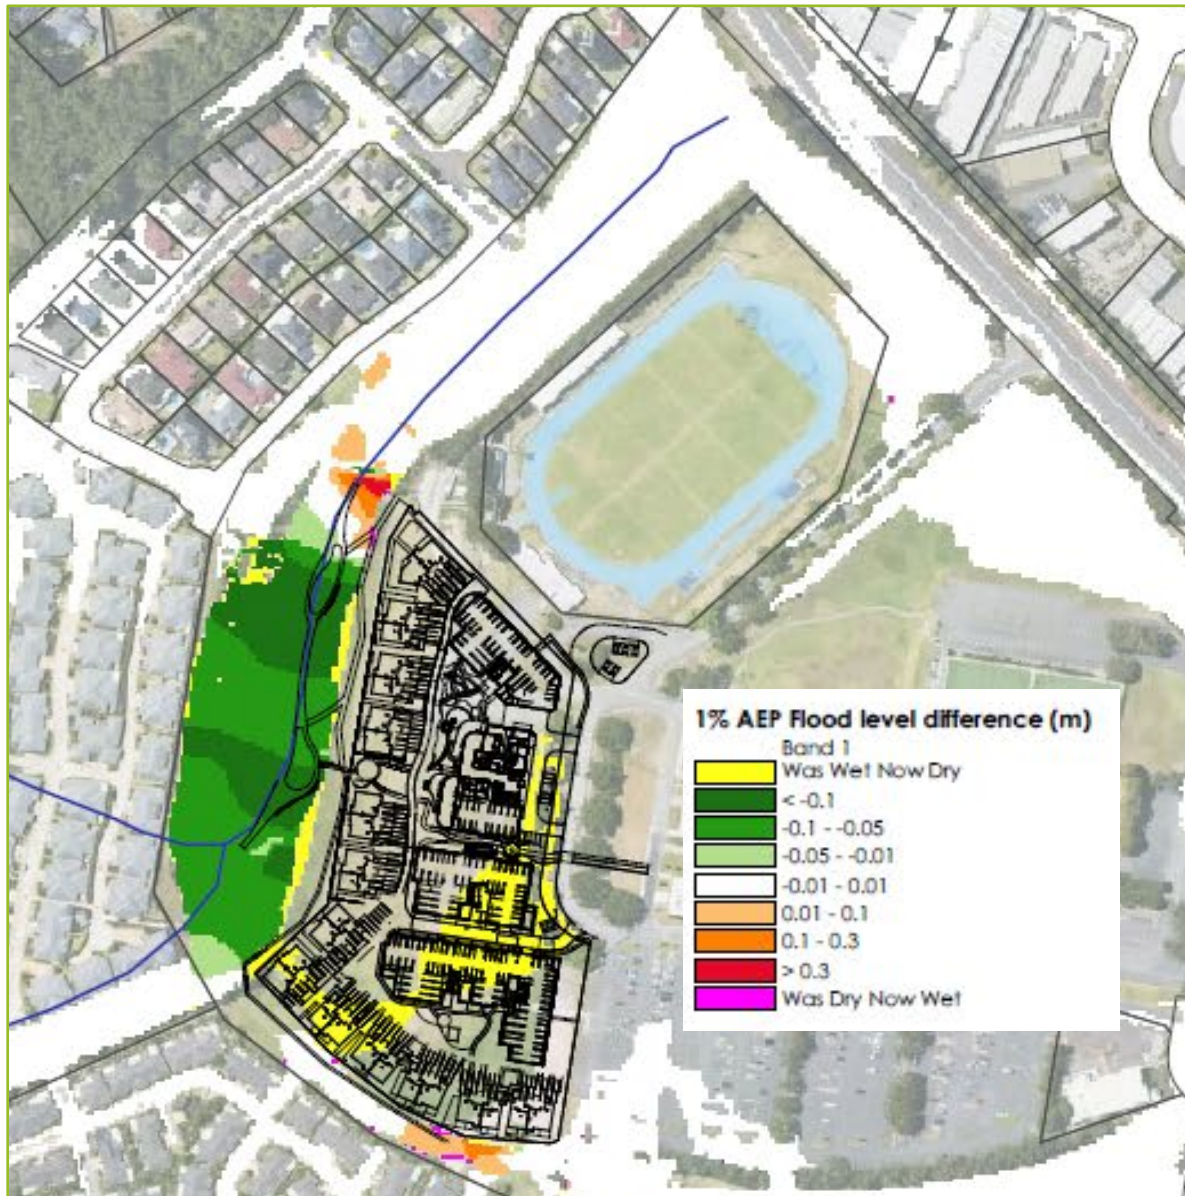
**Figure 1. 1% AEP flood level difference**

| Submission | Response |
|---|---|
| <b>FLOODPLAIN DEVELOPMENT</b><br>The Flood Impact Assessment shows an isolated increase in flood level in the existing watercourse presumably because that is where flow is being directed. The increase is shown to be greater than 300mm during the 1%AEP event. Floodplain Management acknowledge that this increase does not affect any neighbouring properties however cannot be sure that it is not | The existing drainage channel adjacent to the site is concrete lined and the downstream wetland was constructed in the late 1990s. The constructed wetland was planted with macrophytes that are true aquatic species and capable of surviving various inundation levels. The 1% AEP flood level differences are shown in Figure 1 and the wetland shown in photo plates 1 & 2. |

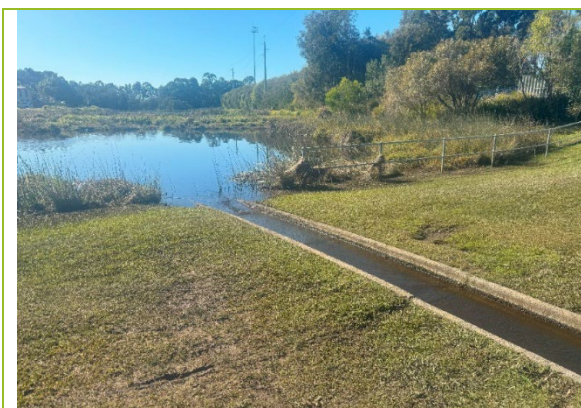
**Photo 1:** drainage channel and constructed wetland shown in area of potential 300mm increase during 1% AEI (viewed from south-southwest)

| Submission | Response |
|---|---|
| <p>going to have a detrimental impact on the existing natural habitats within the watercourse.</p> <p>Floodplain Management recommend that an ecologist provide comment about the significance (if any) of this impact. If there is not predicted to be any ecological impact resulting from this development Floodplain Management have no further issues.</p> | <p>Native vegetation growing on the batters of the existing channel also comprise terrestrial and semi-aquatic plant species (e.g., sedges, rushes, aquatic grasses and paperbarks); and that found in Forested Wetland vegetation formation and Coastal Forested Floodplain class.</p> <p>These wetland communities have evolved under periodic flooding conditions that would last longer than that of a post-development 1% AEP event.</p> <p>Temporary, infrequent increases in water levels of &gt;300mm are considered highly unlikely to impact on wetland flora or fauna at this locality, or further downstream of the site.</p> |

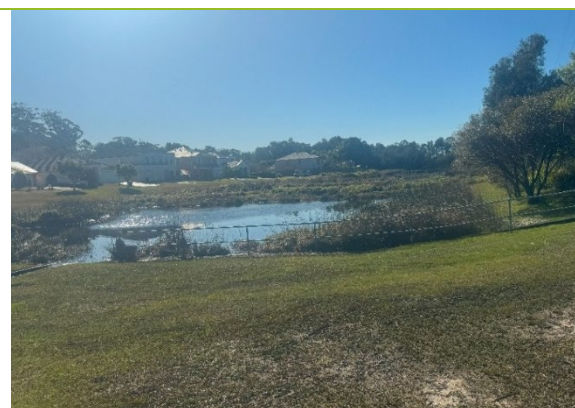
**Photo 2:** constructed wetland shown in area of potential 300mm increase during 1% AEI (viewed from southeast)

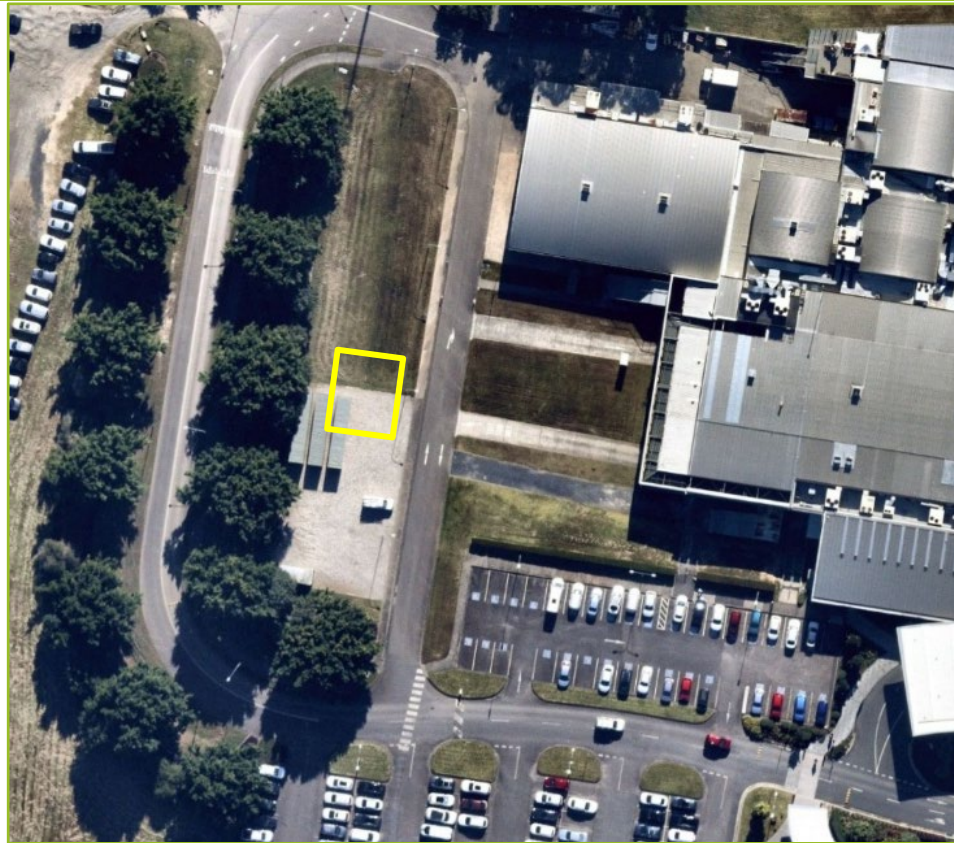
- + Existing cleared land that comprises turf maintained by mowing, and
- + Land previously containing hardstand and containers (as shown in photo plate 1).

**Photo plate 1:** Aerial photographs from 17 June 2022
