**SEARS 13: GROUNDWATER, SURFACE  
WATER & SALINITY IMPACT  
ASSESSMENT**

Prepared for:  
Mingara Leisure Group Pty Ltd

Prepared by:  
Stantec Australia Pty Ltd

Project Number:  
301351398 Tumbi Umbi Retirement Living  
Project

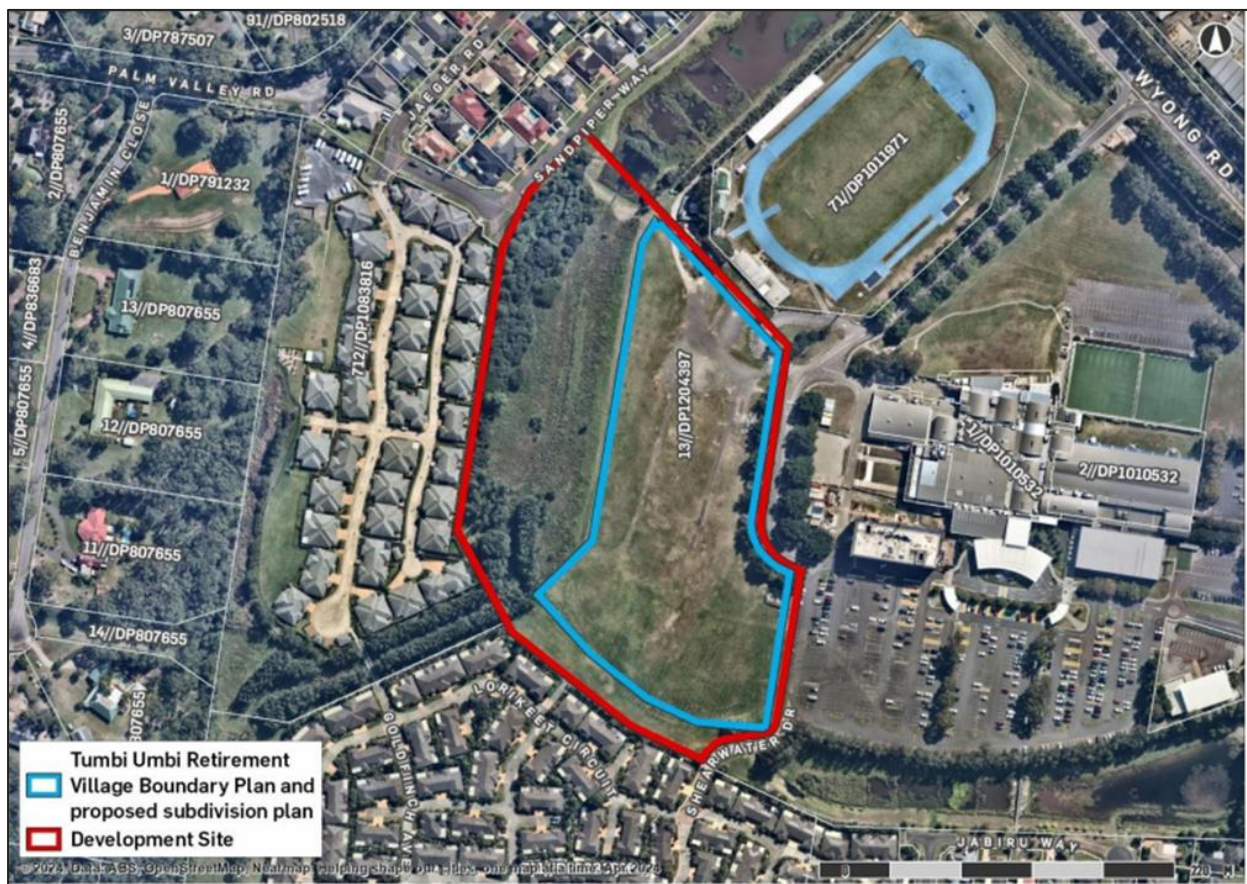
Figure 1-1: Development Site (red line) & Tumby Umbi Retirement Village (blue line), Urbis 2023)

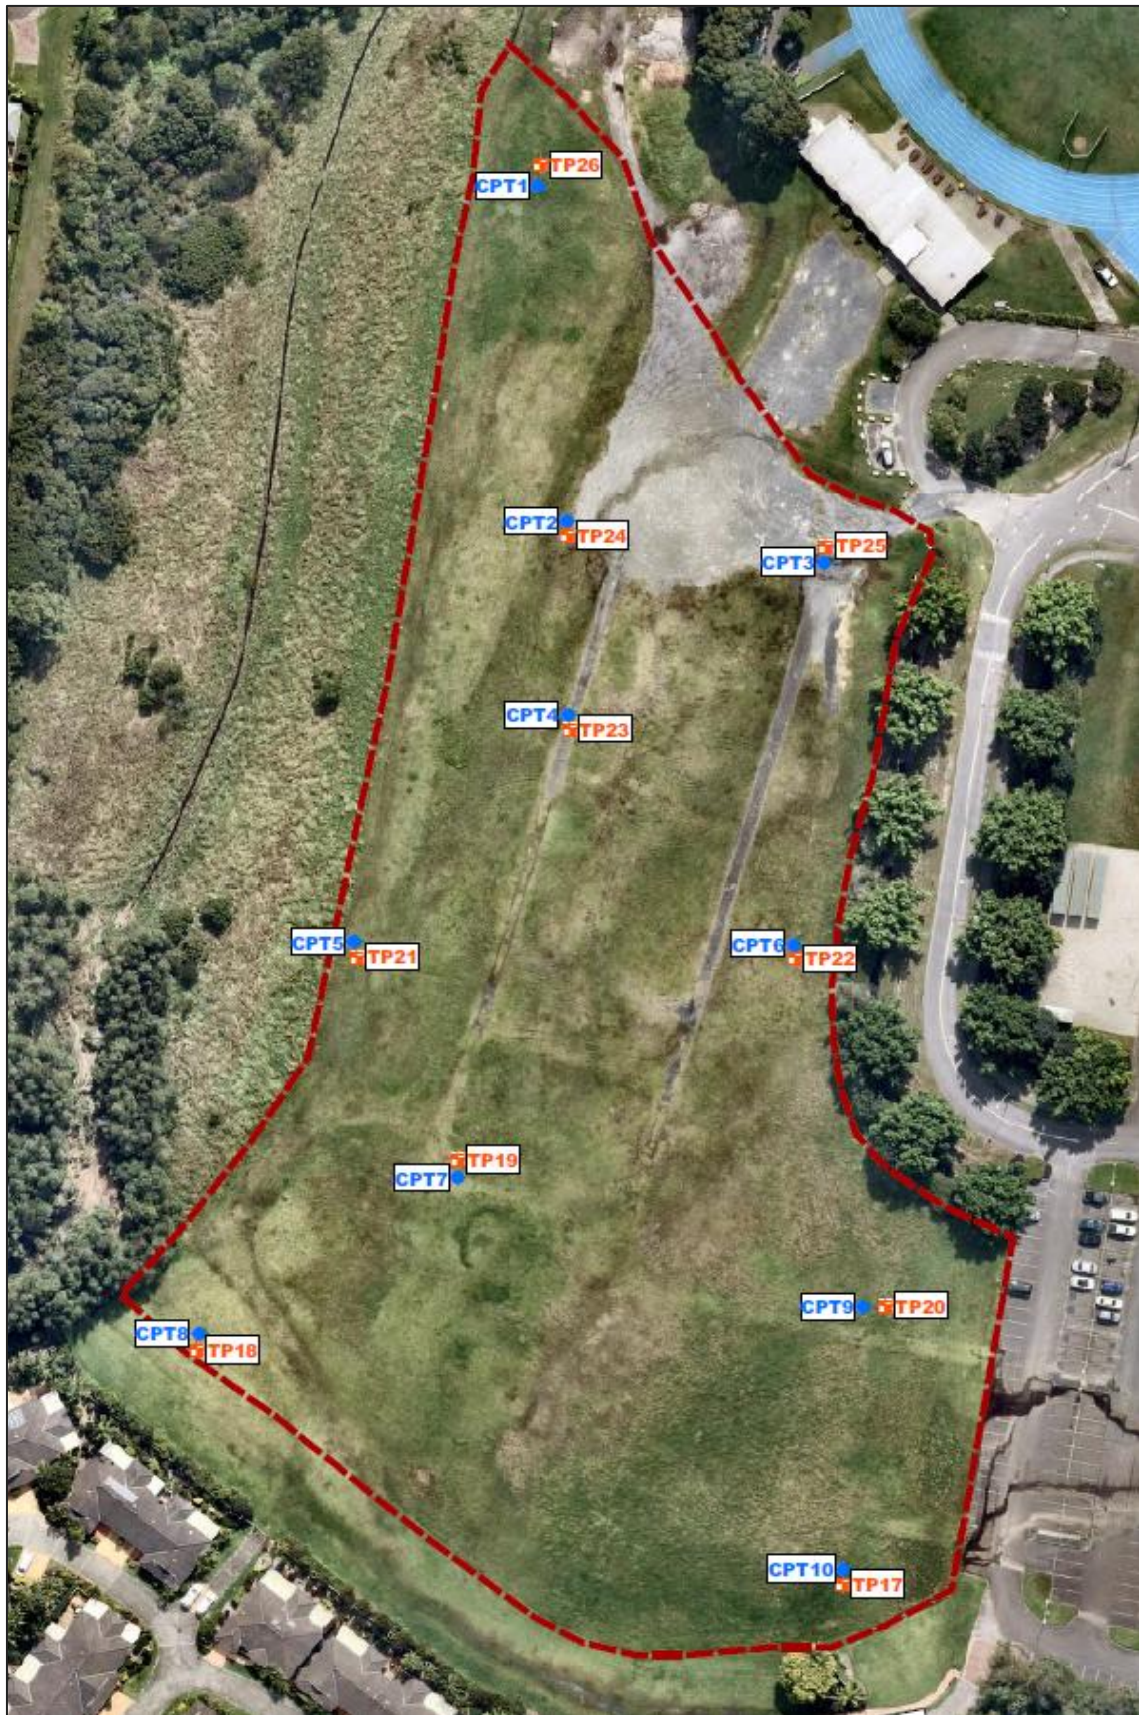
Figure 2-1: RCA (2022a) Geotech Test Pit and CPT Location and approximate site boundary.

Perched groundwater was encountered at TP 23 and TP 26 at 2.1 m and 0.9 mbls, respectively. Note that TP26 is positioned within the northwestern bounds of the Site, within the proximity of the watercourse. All CPT soundings, which were advanced up to 20 mbls, reported groundwater at varying depths (0 mbls to 2.5 mbls). Although it should be noted that this is based on interpretation of CPT pore pressure data or limited observation during / after testing. Groundwater conditions may vary with climate and Site conditions.

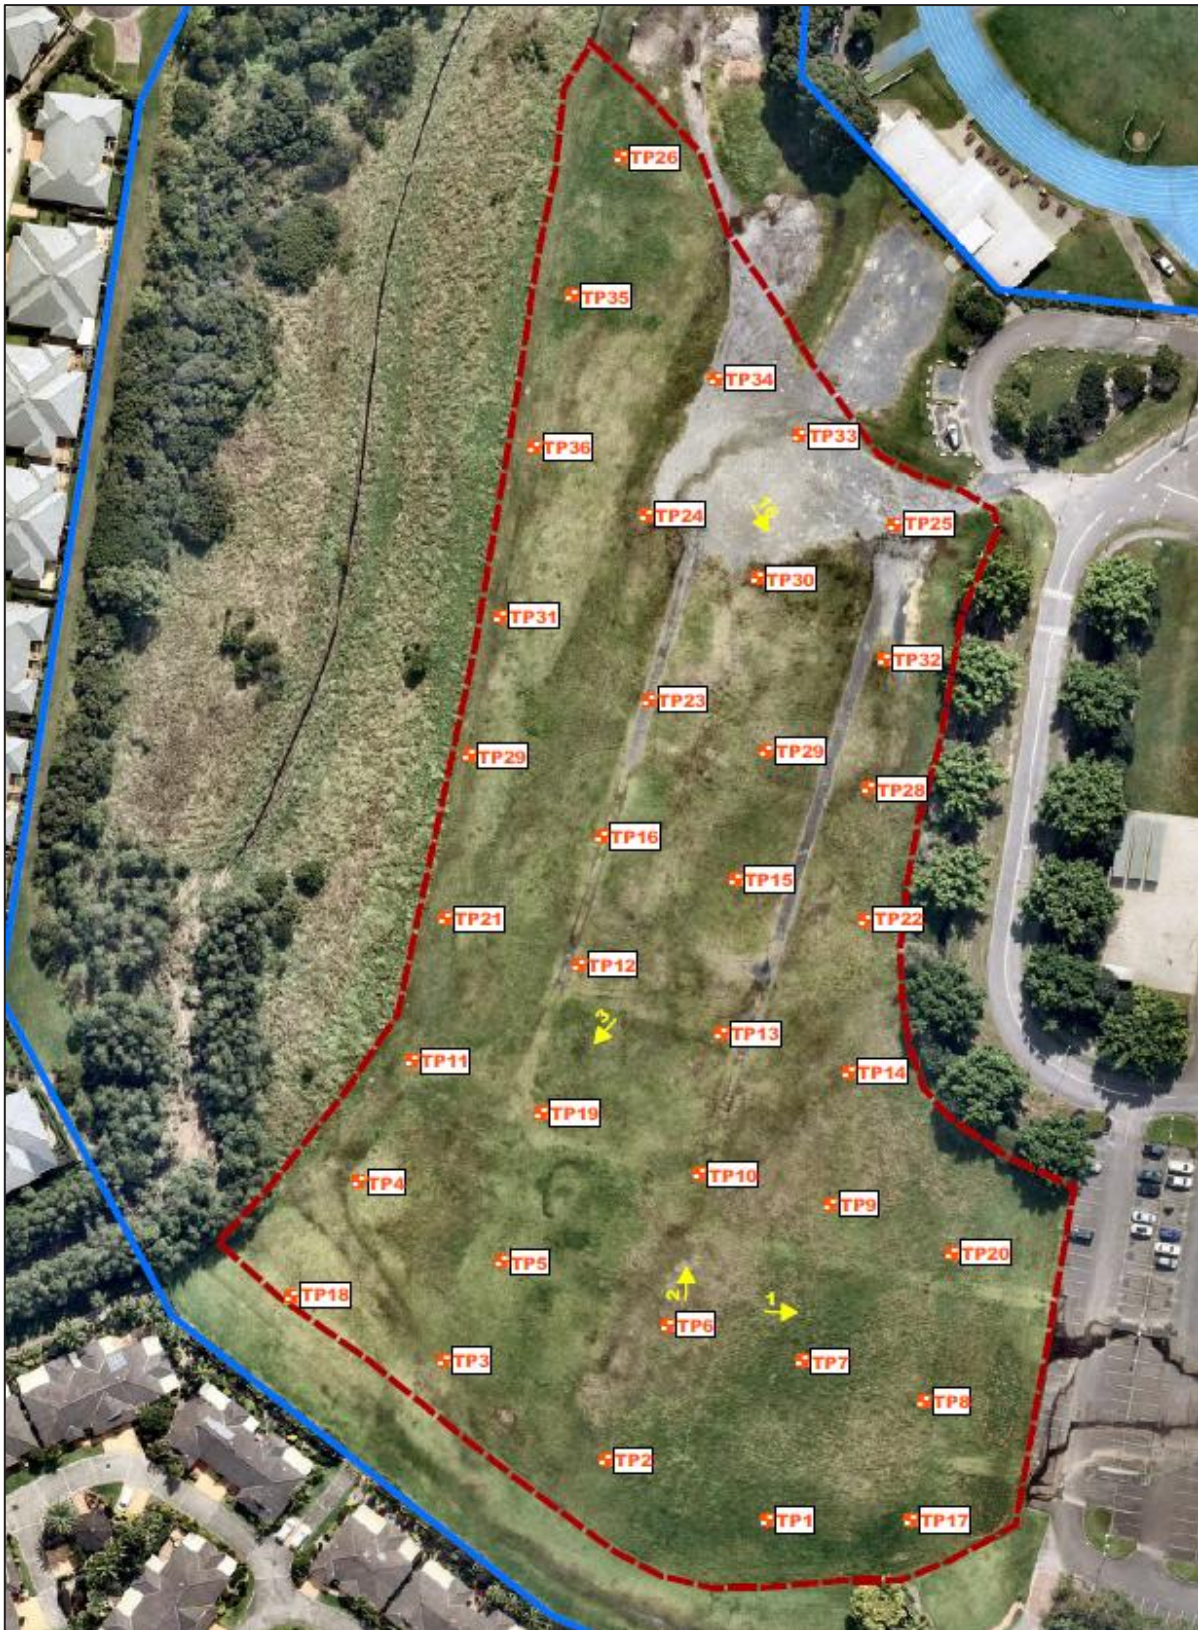
Figure 2-2: RCA (2022b) Sampling and Test Pit Locations

- No groundwater assessment was undertaken. Perched groundwater was encountered as seepage from overlying clays in test pit locations TP23 and TP29.

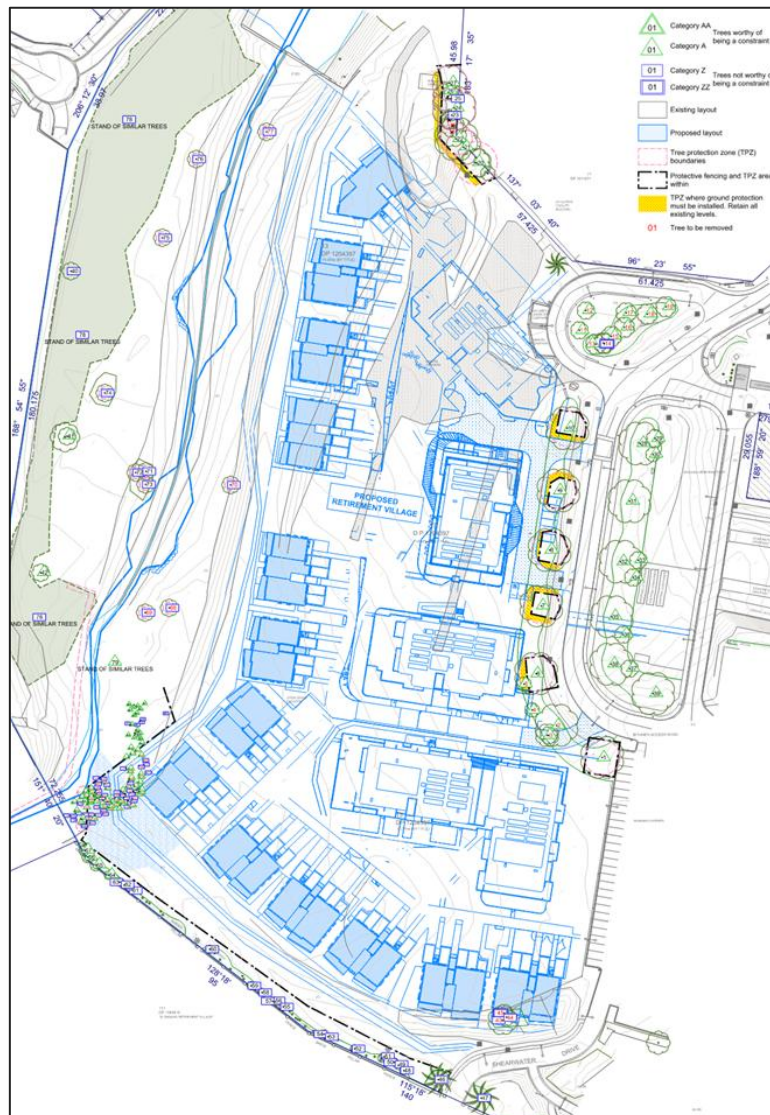
Figure 4-4: Existing vegetation coverage (Naturally Trees, 2024), with existing trees and proposed to be removed as indicated.

Based on Site Analysis – Topography, & Existing Vegetation information (Marchese Partners, 2024), there are twelve identified high significant trees within the precinct, which are proposed to be preserved as they add character and setting of the site. Most trees within the site area are identified as having low to medium significance. Trees that are proposed to be removed are within the proposed new vehicle entry and locations where will impede with the development footprint. Several trees within the northeastern area outside of the project bounds are recommended to be removed to allow construction of future road adjacent to the athletics track for coaches drop off and pick up.

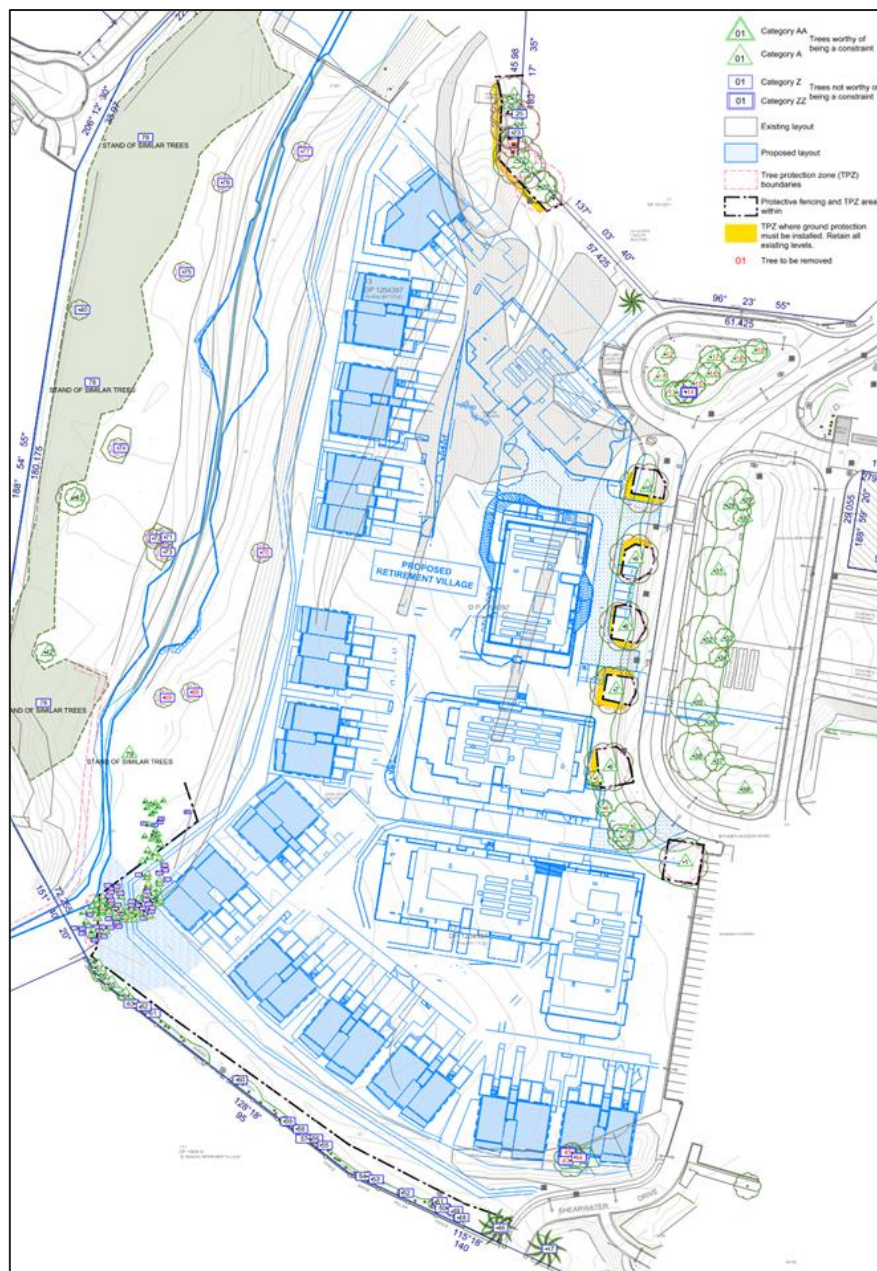
Figure 7-2: Vegetation Clearance Plan (adapted from Naturally Trees, 2024)

Based on the arboricultural impact appraisal and method statement (Naturally Trees 2024, see Figure 7-2), there would be a total of 90 trees to be removed based on the proposed upgrades within Site. New building footprint will take up the existing landscape areas.

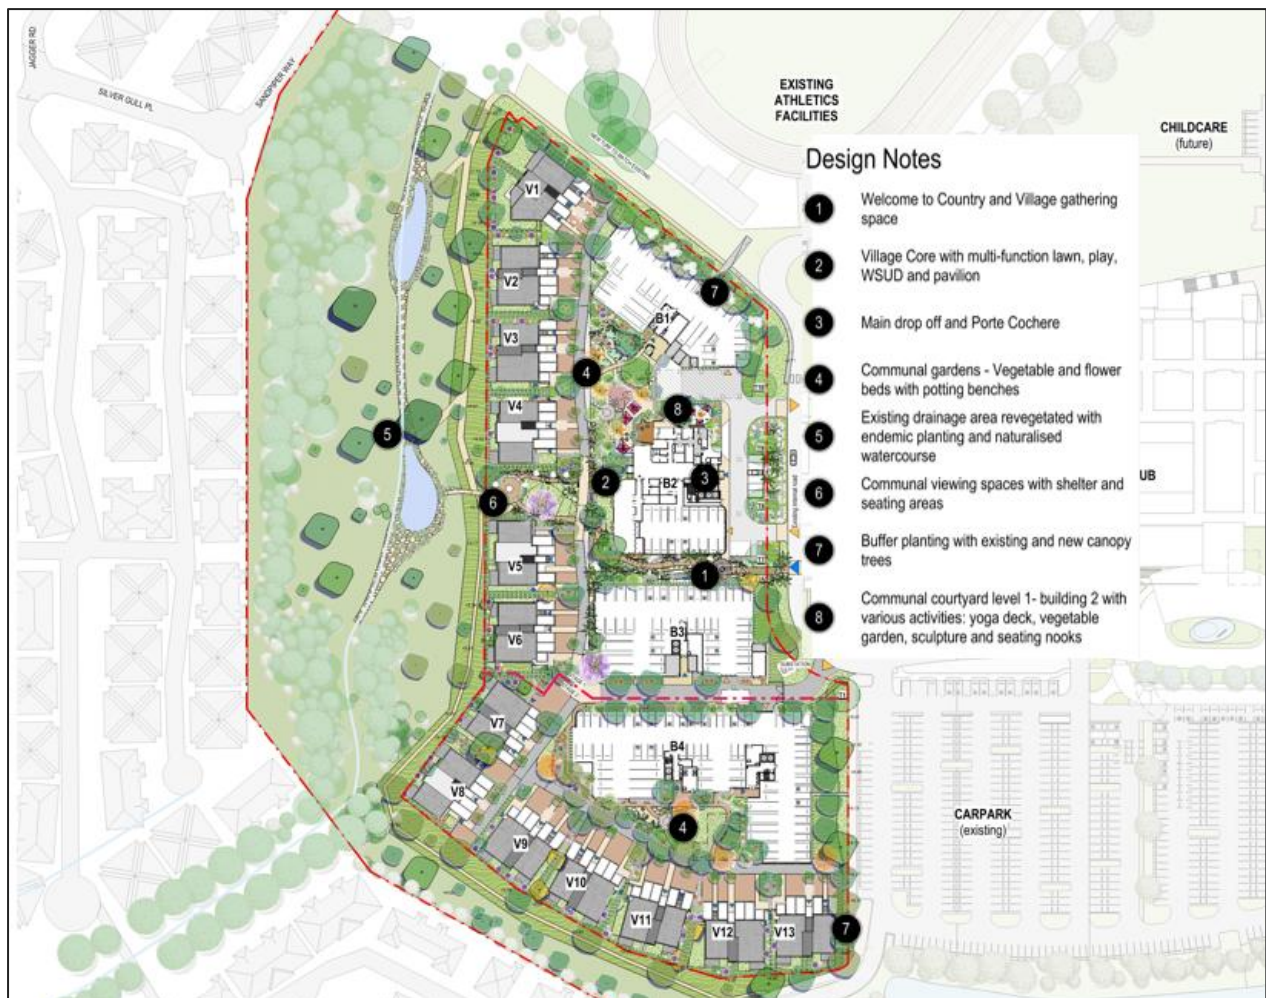
Figure 7-3: Landscape Masterplan for the Site (adapted from Taylor Brammer, 2024)

Additionally, from the Landscape Masterplan provided by Taylor Brammer (LA 100, revision B), areas around the proposed buildings and existing wetlands will be planted with trees, including a dedicated space within the vicinity of Building 1 for the proposed communal vegetable and flower garden. Several passive spaces will also be converted in lawn and planting areas (see Figure 7-3).

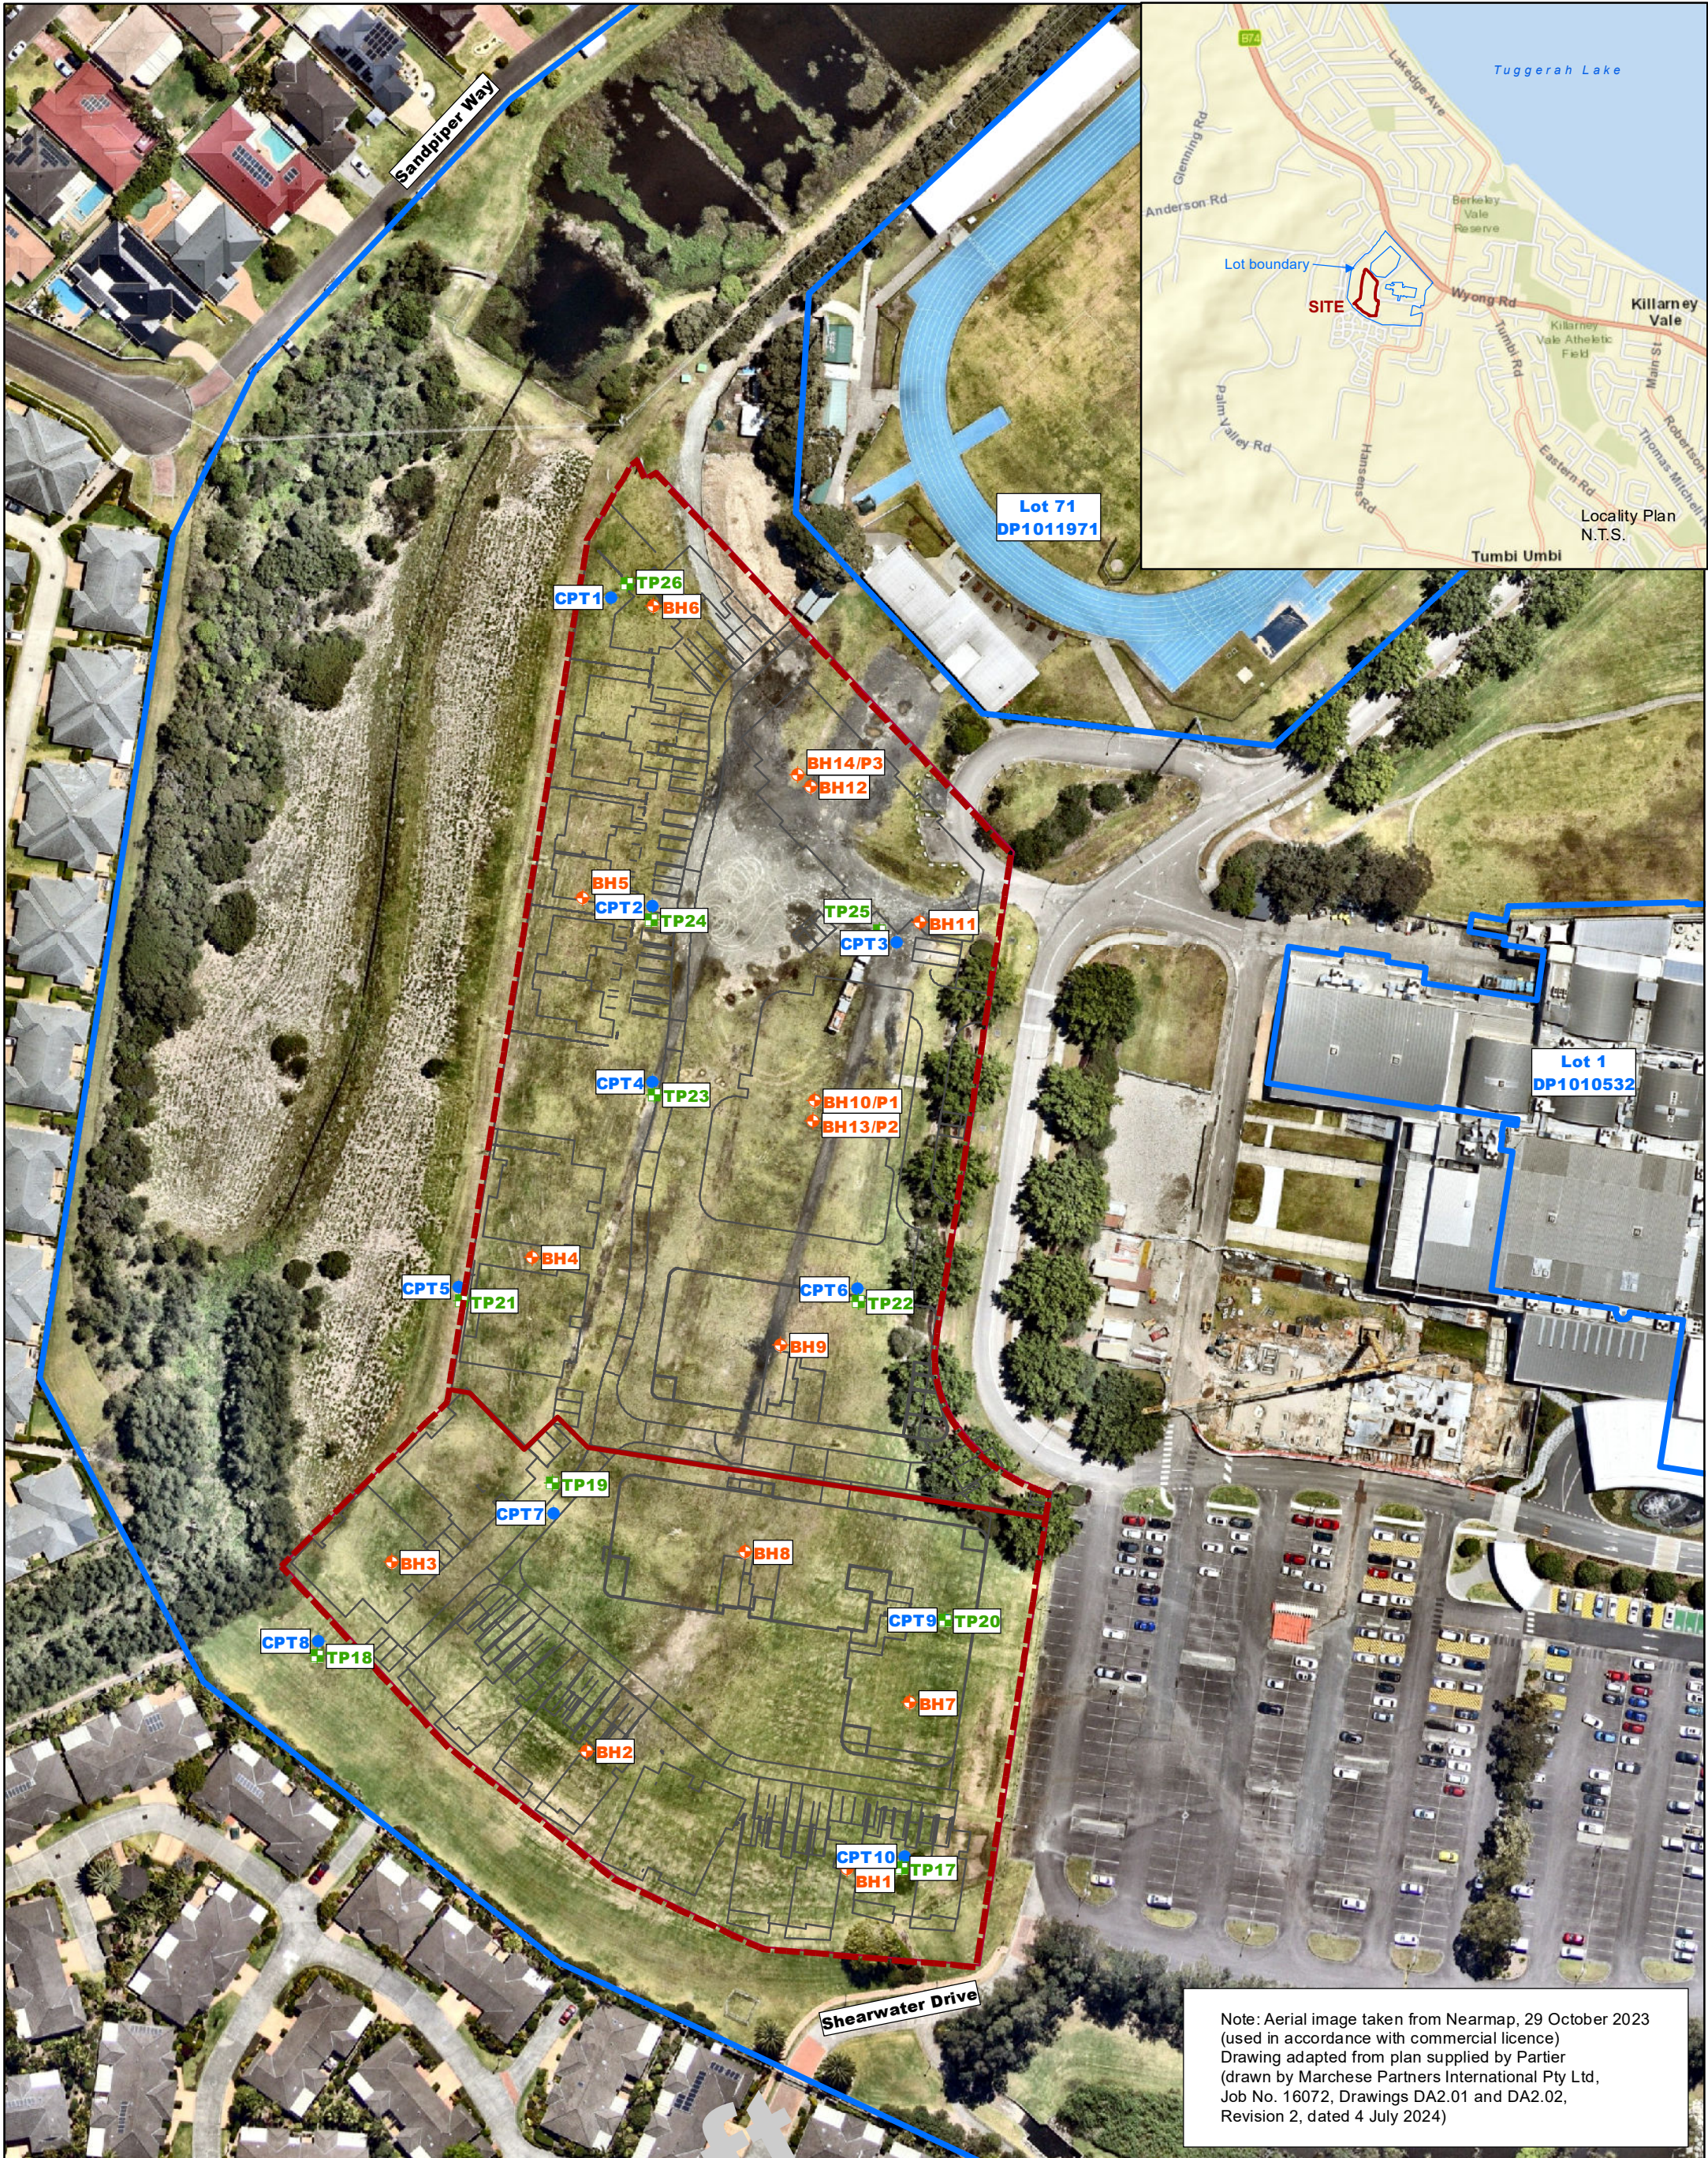
**SITE AND BOREHOLE LOCATION PLAN  
 MINGARA RECREATION CLUB  
 TUMBY UMBI**

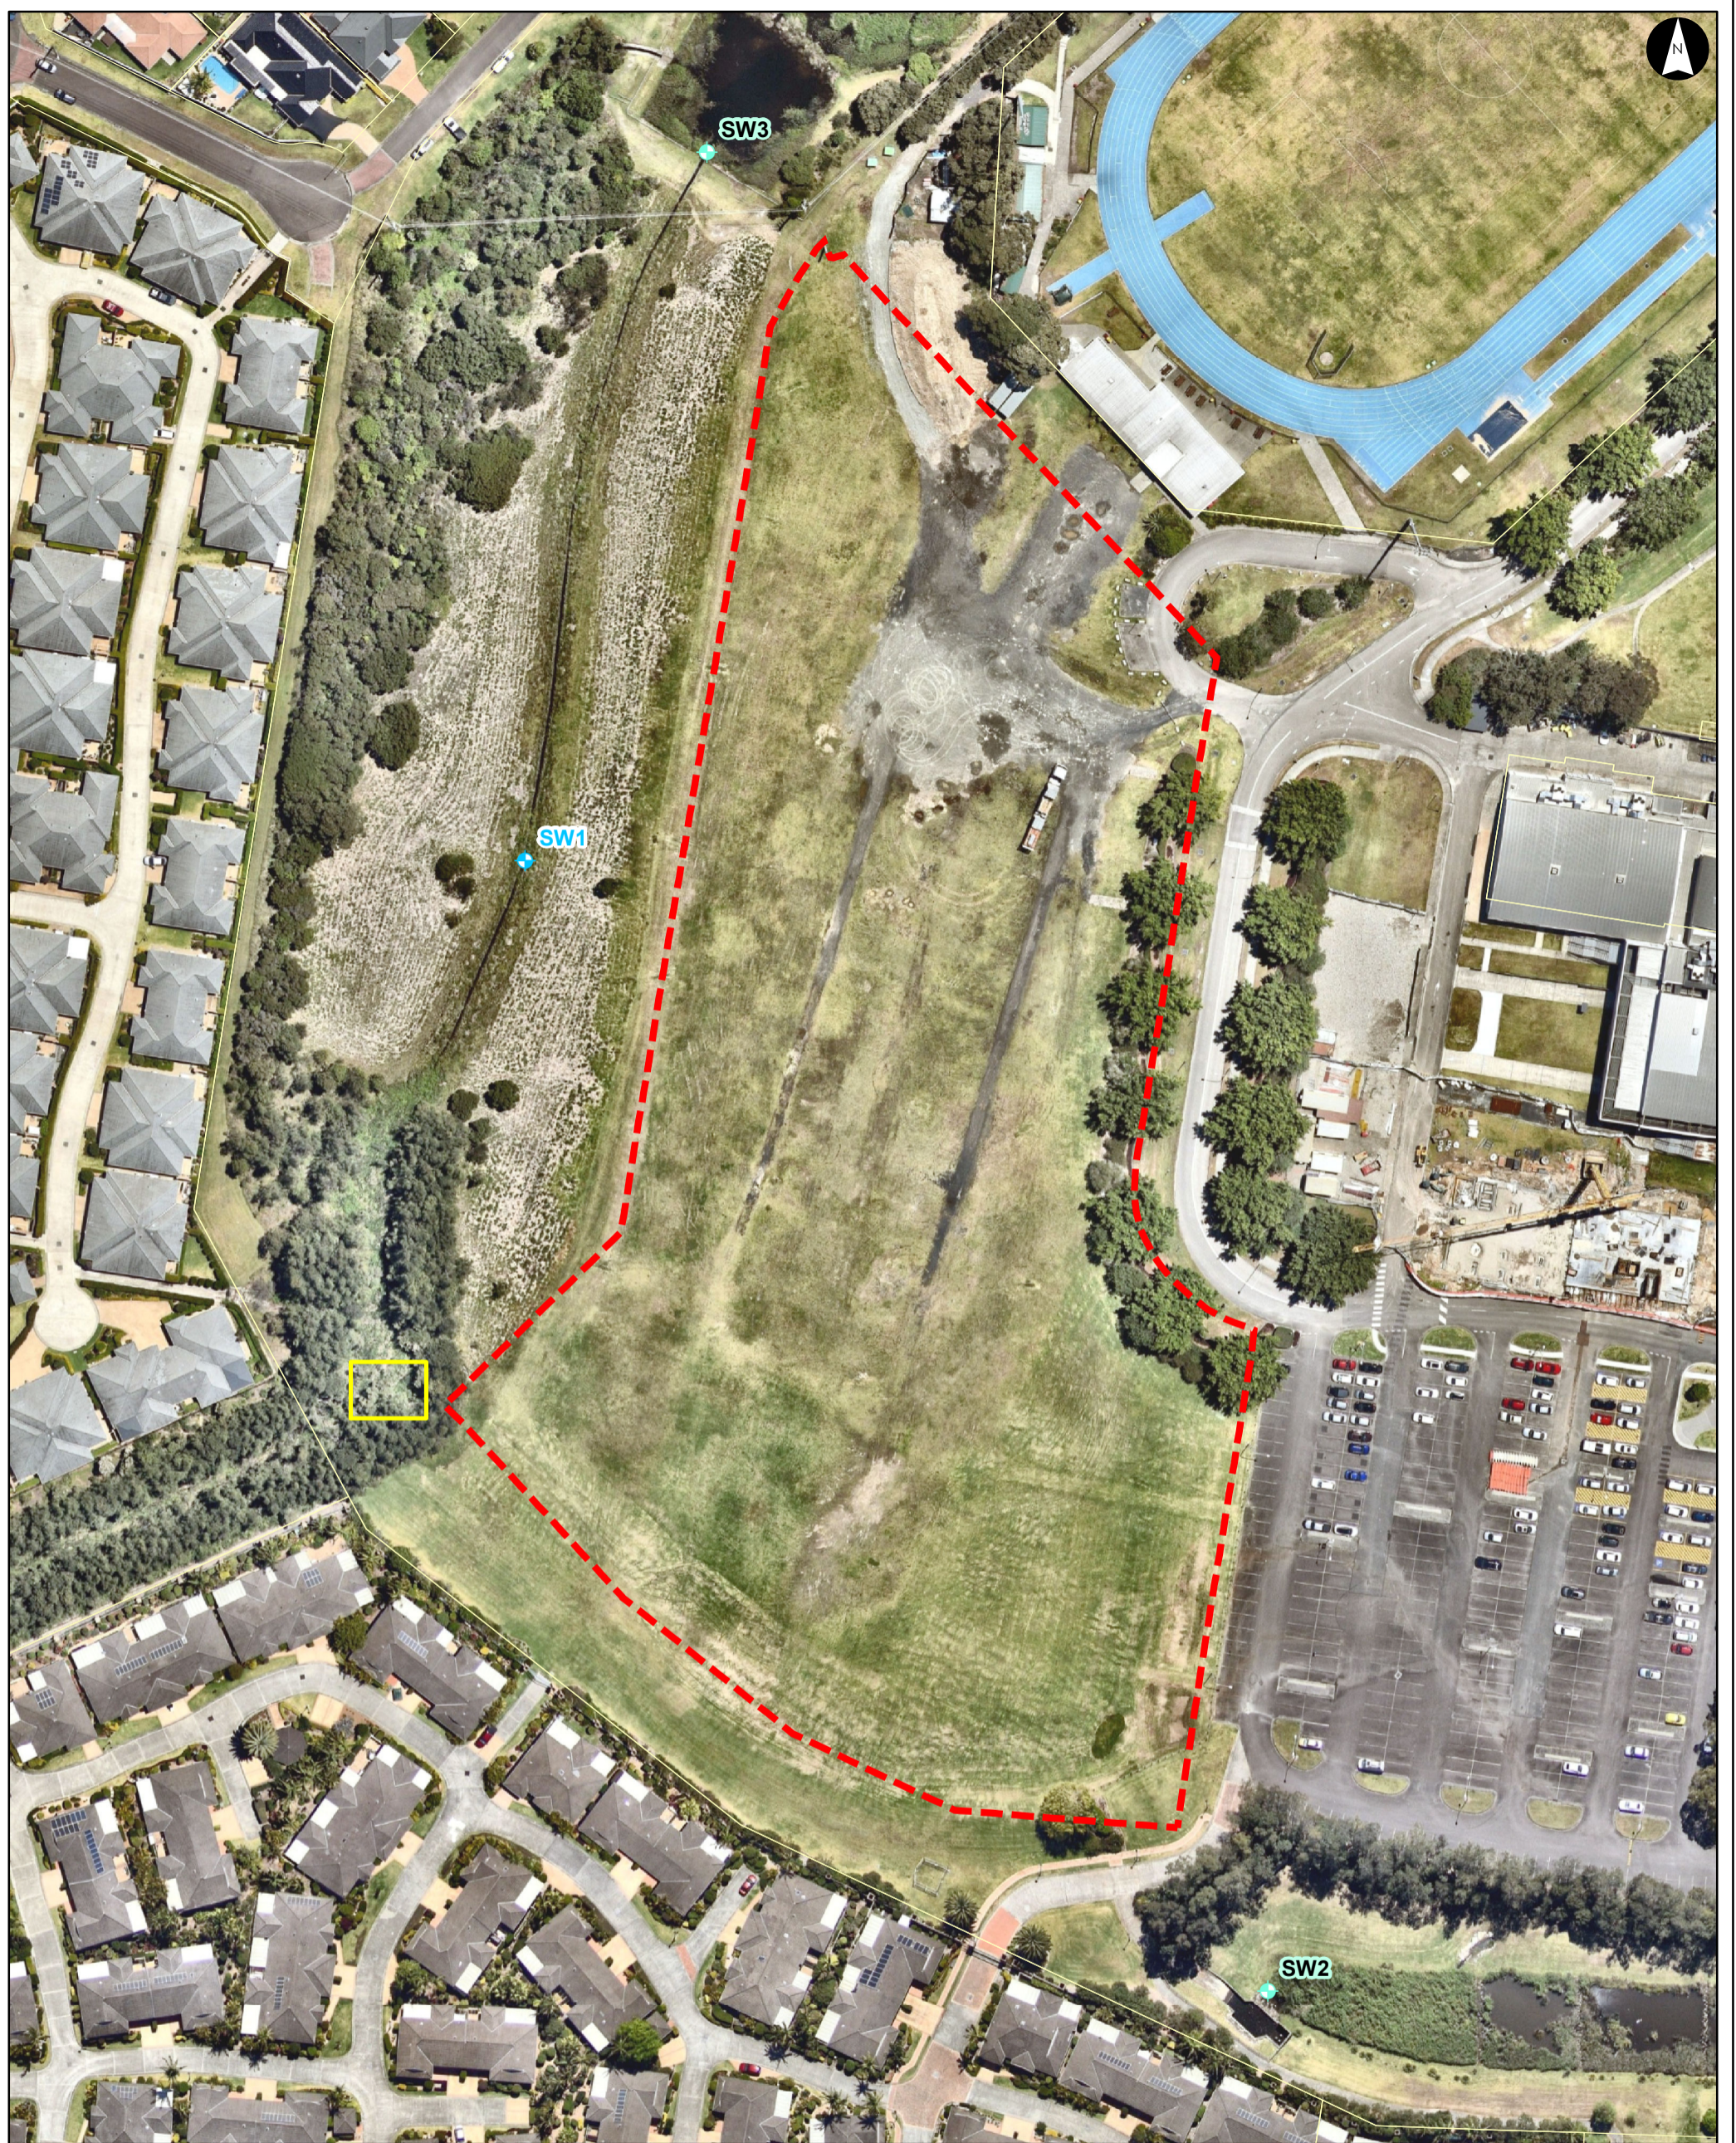
**Tumbi Umbi Retirement Living**  
Sample Location Plan

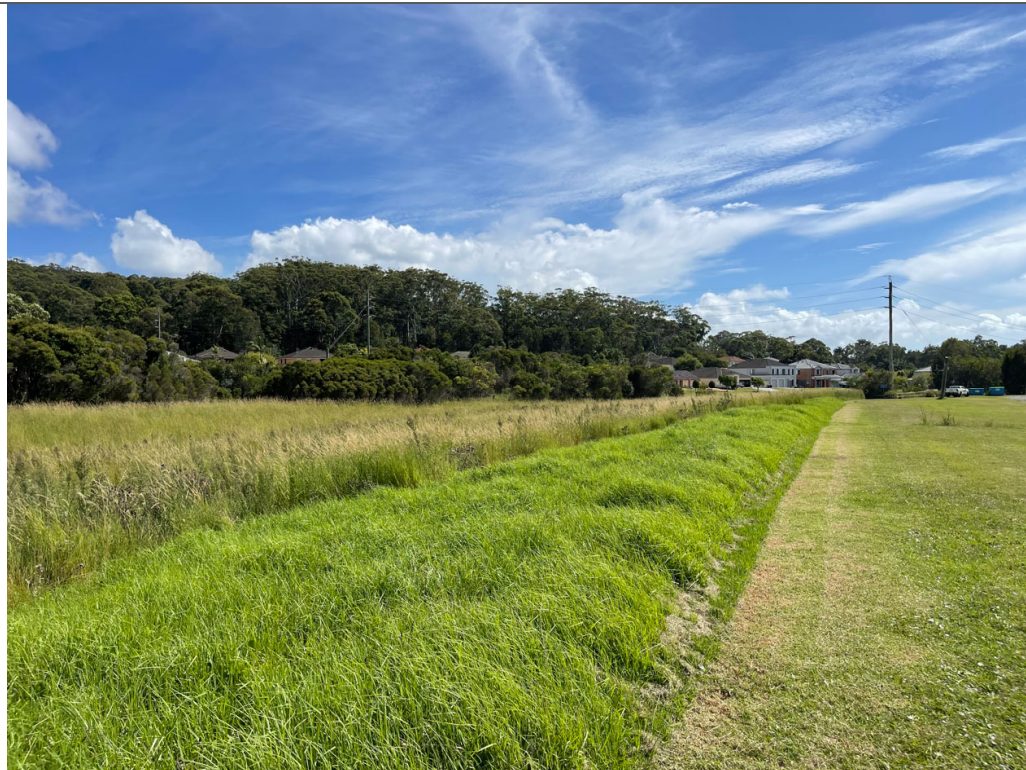
**IMAGE 4** – Highly modified natural unnamed drainage creek immediately west of the site, looking northwest.

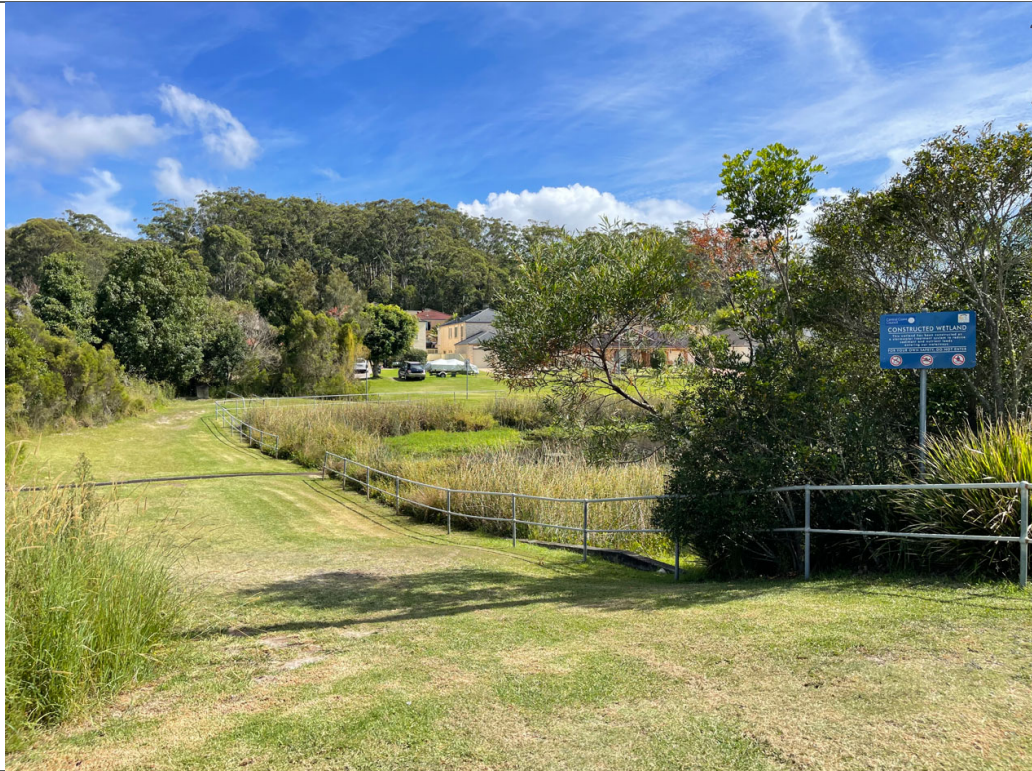
**IMAGE 5** – Artificial wetland constructed northwest of site.

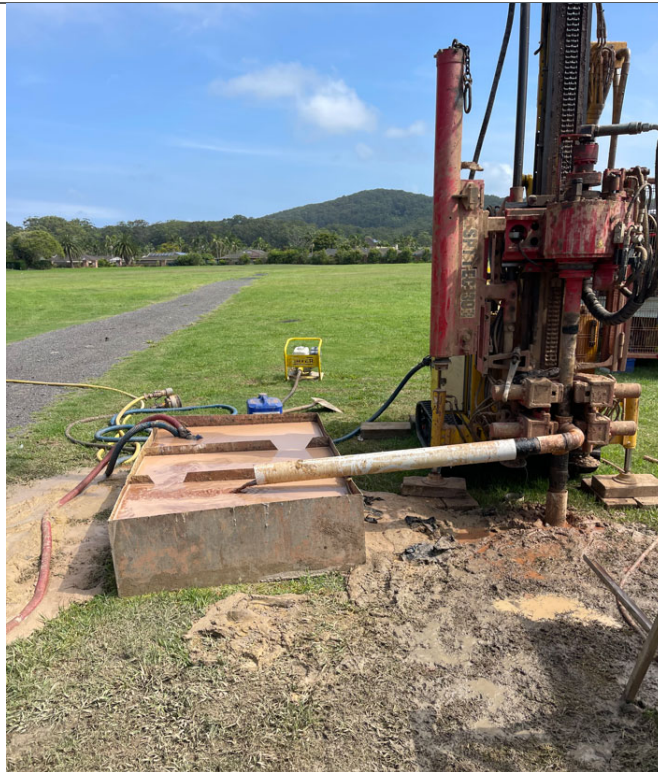
**IMAGE 6** – Ongoing drilling at BH10.

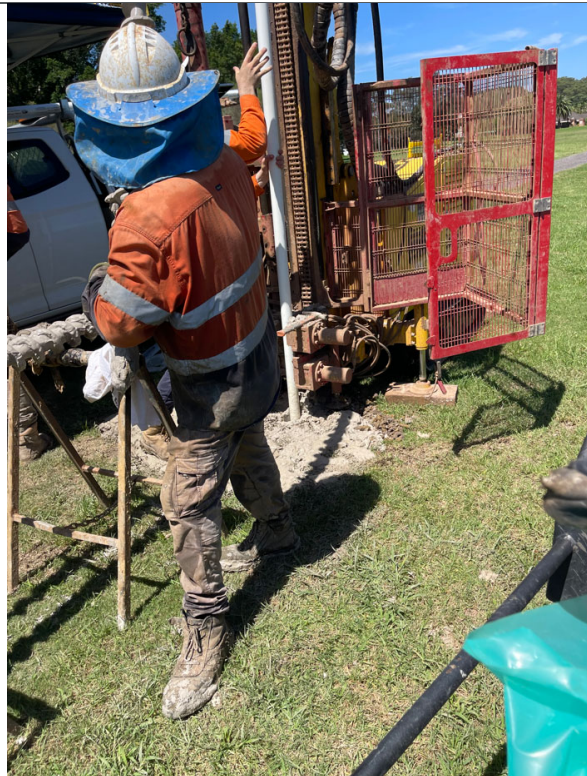
**IMAGE 7** – Installation of PVC pipe in one of the groundwater monitoring bores.

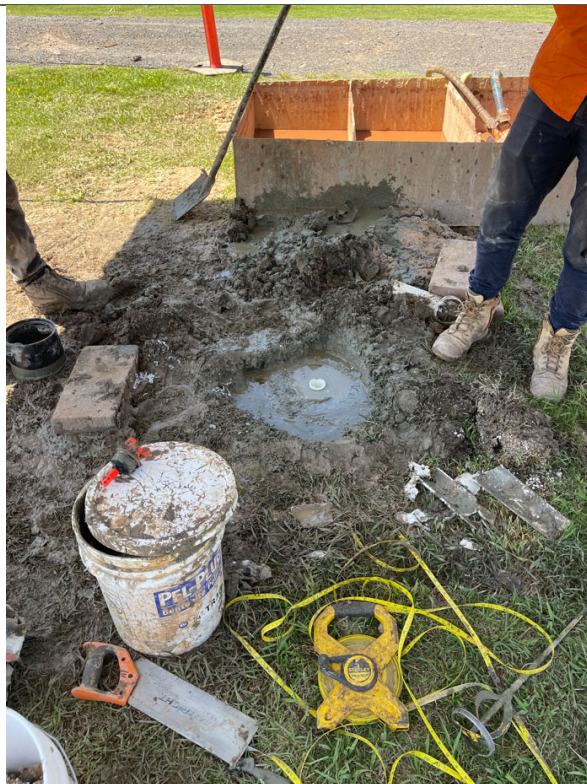
**IMAGE 8** – Quickset concrete installation prior to addition of gatic cover on installed piezometers.

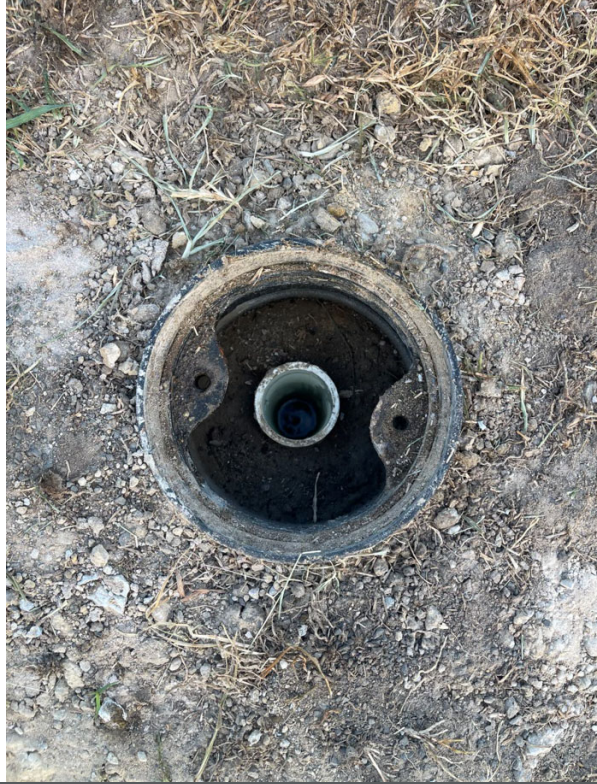
**IMAGE 9** – Installed piezometer during groundwater testing and sampling.

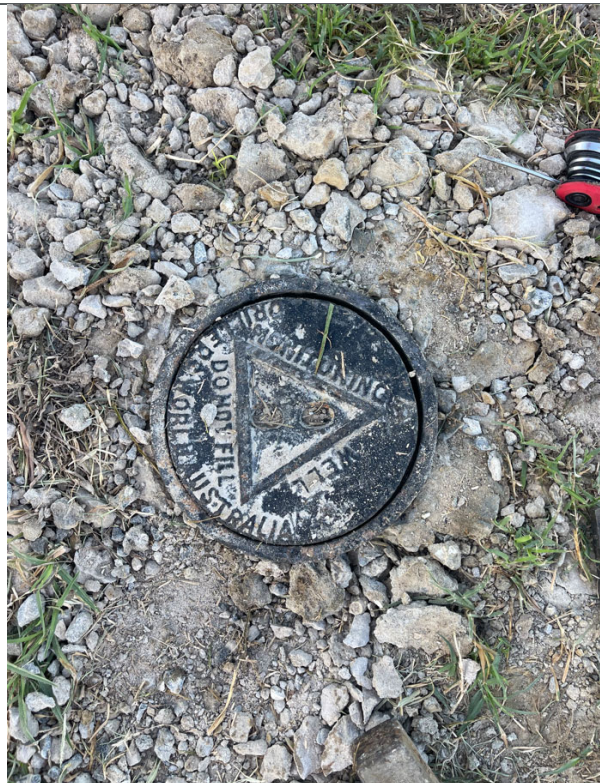
**IMAGE 10** – Gatic cover of piezometer.
