**RE: LOT 1, DP 859608 BURROWAY ROAD, HOMEBUSH BAY**  
**GEOTECHNICAL INVESTIGATION**

**LOT 1, DP 859608 BURROWAY ROAD, HOMEBUSH BAY  
GEOTECHNICAL INVESTIGATION**

**Report PSM2043-003R**

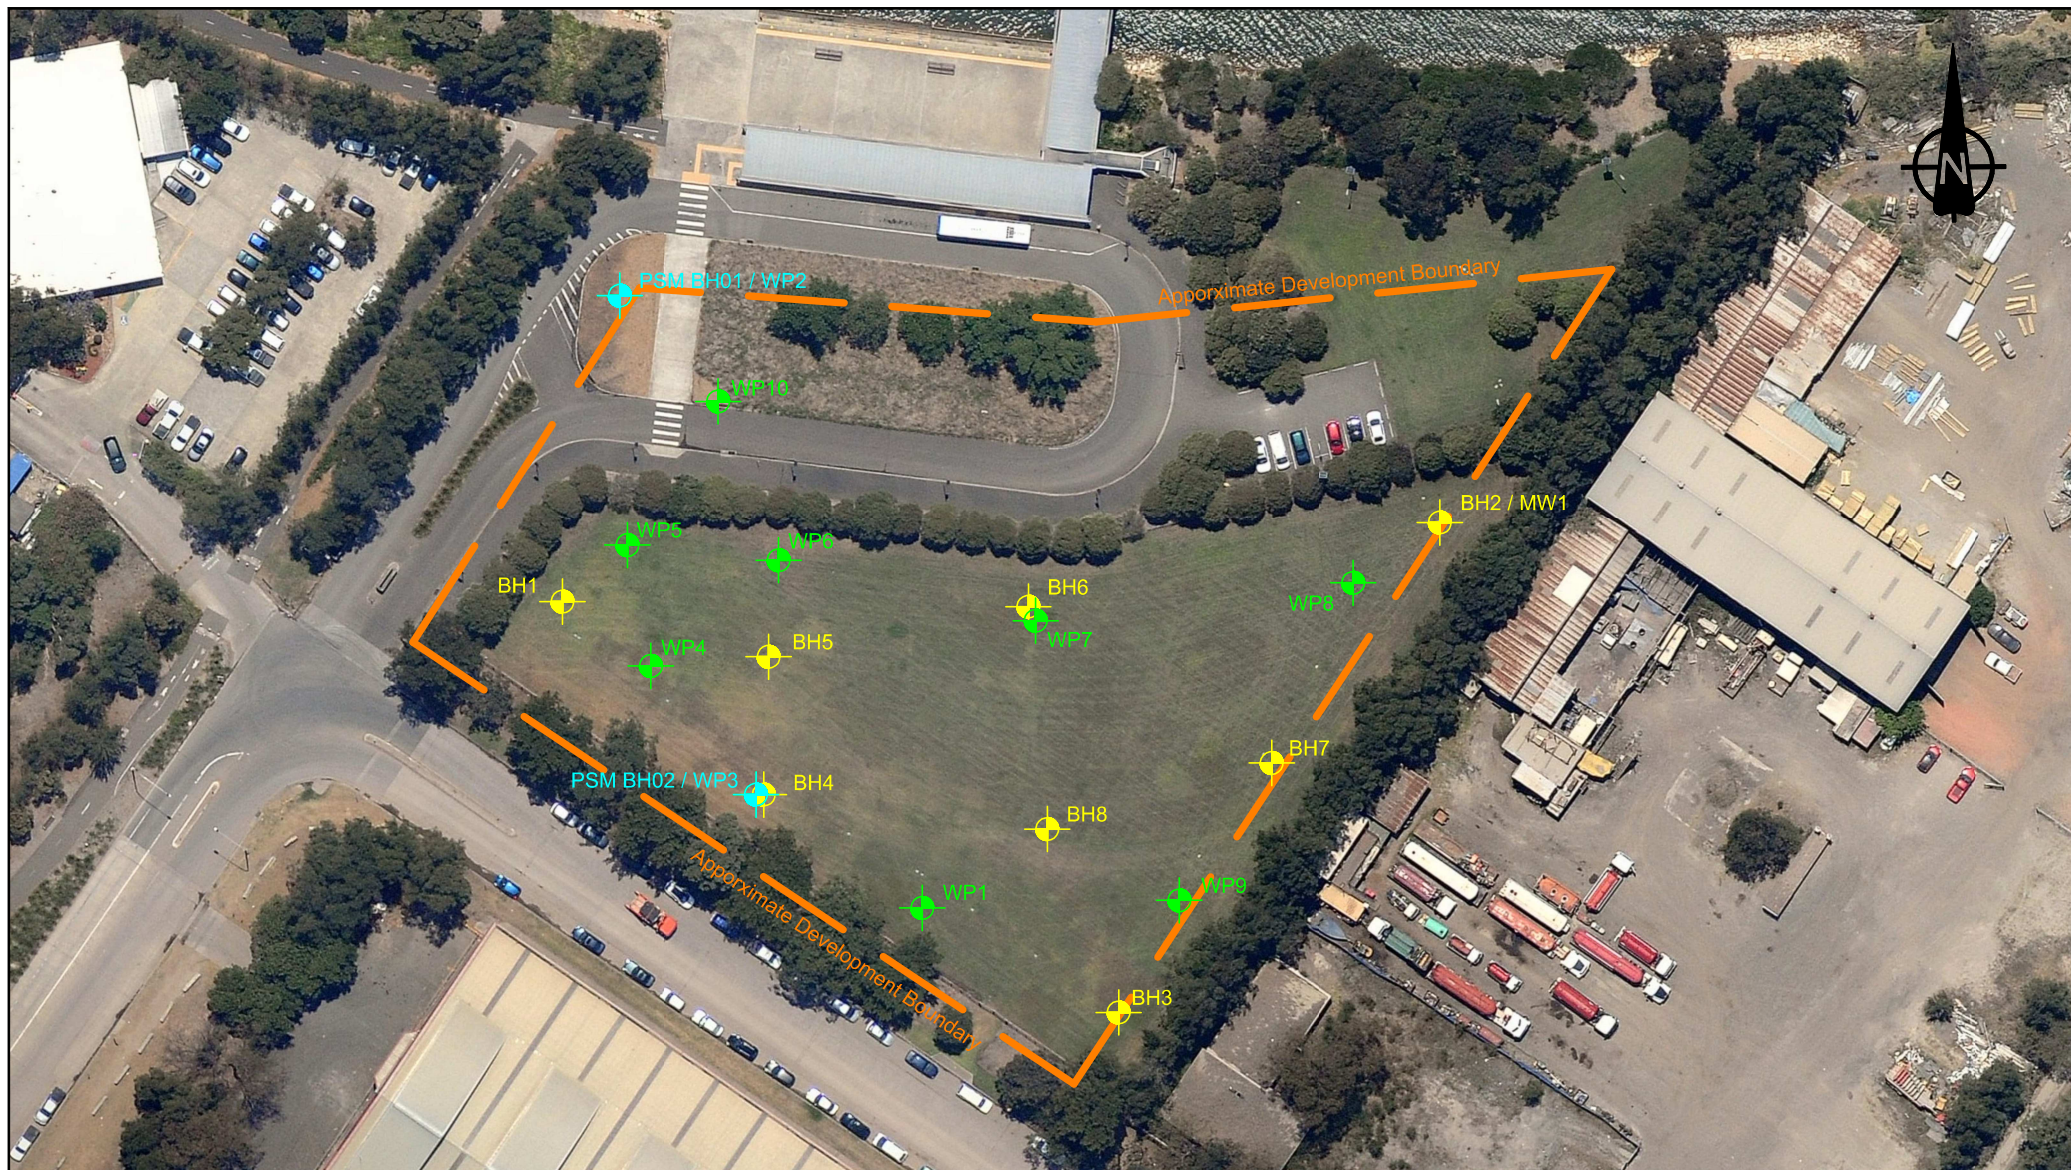
The fieldwork was undertaken on 15 and 16 November 2012. It comprised drilling of two (2) boreholes to a maximum depth of 19.85 m. The boreholes were drilled using a 16 tonne truck mounted drill rig. Figure 1 presents the locations of these boreholes.

Ionic Management Pty Ltd  
 Lot 1, DP 859608 Burroway Road  
 Homebush Bay, NSW  
**GEOTECHNICAL INVESTIGATION  
 BOREHOLE LOCATION PLAN**

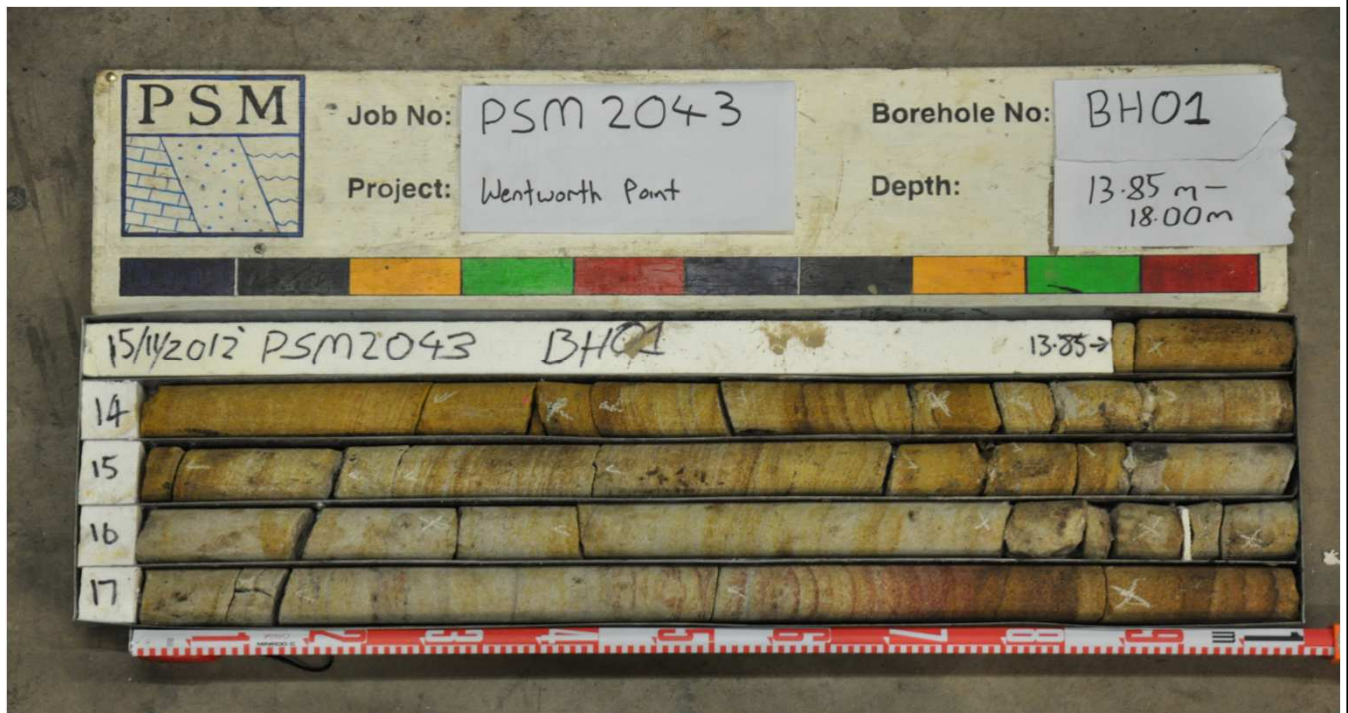
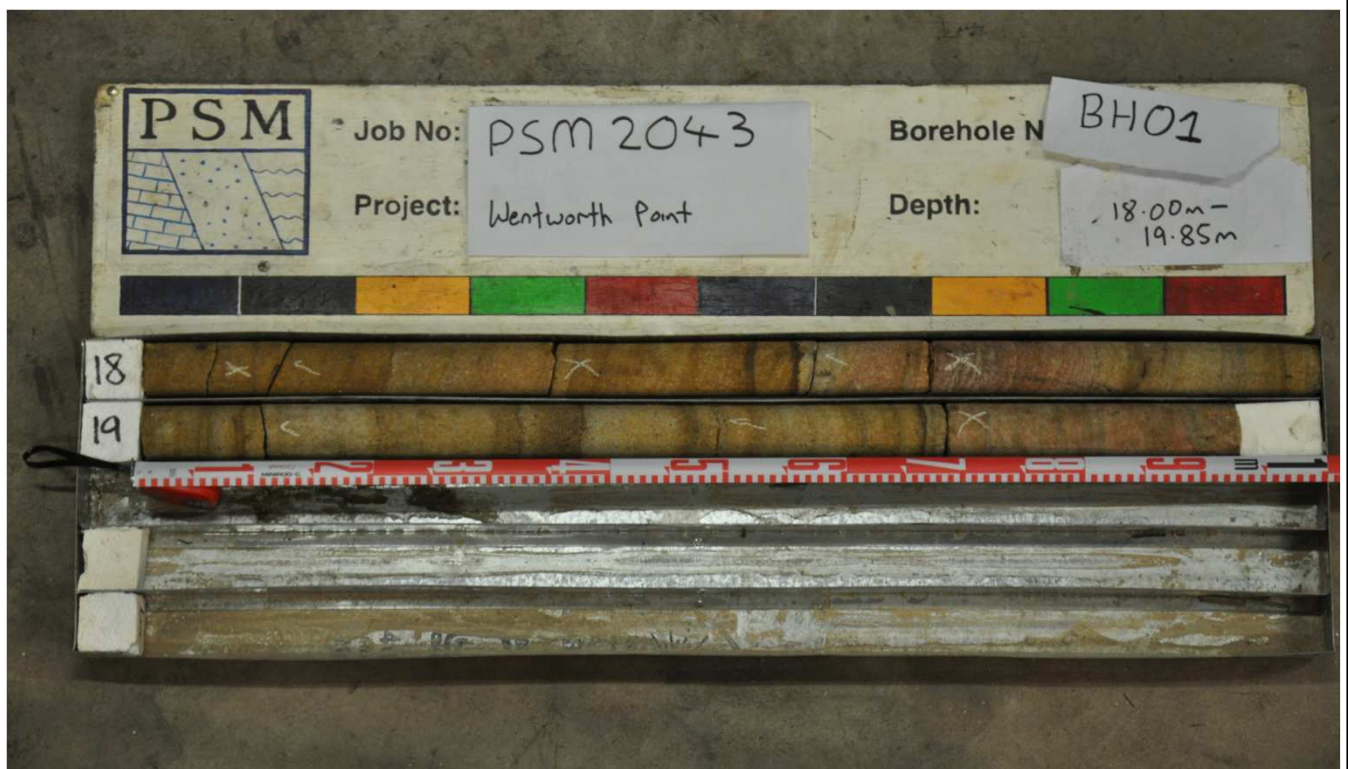
The boreholes were drilled in the full time presence of a PSM Geotechnical Engineer who set out the test locations, prepared engineering logs and took photographs of the rock cores from each borehole. Engineering borehole logs together with the explanation sheets and core photos are presented in Appendix A.

**Ionic Management Pty Ltd  
LOT 1, DP 859608 Burroway Road  
Homebush Bay, NSW  
GEOTECHNICAL INVESTIGATION  
CORE PHOTOGRAPHS**

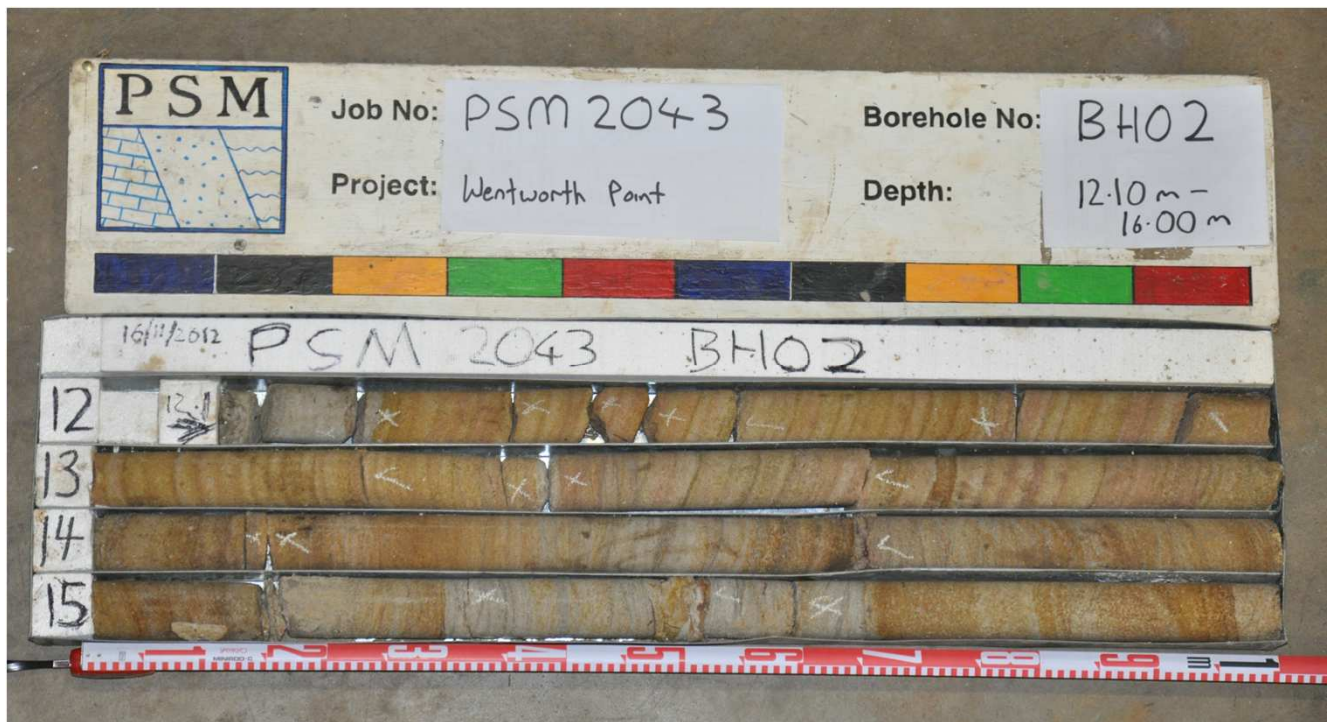
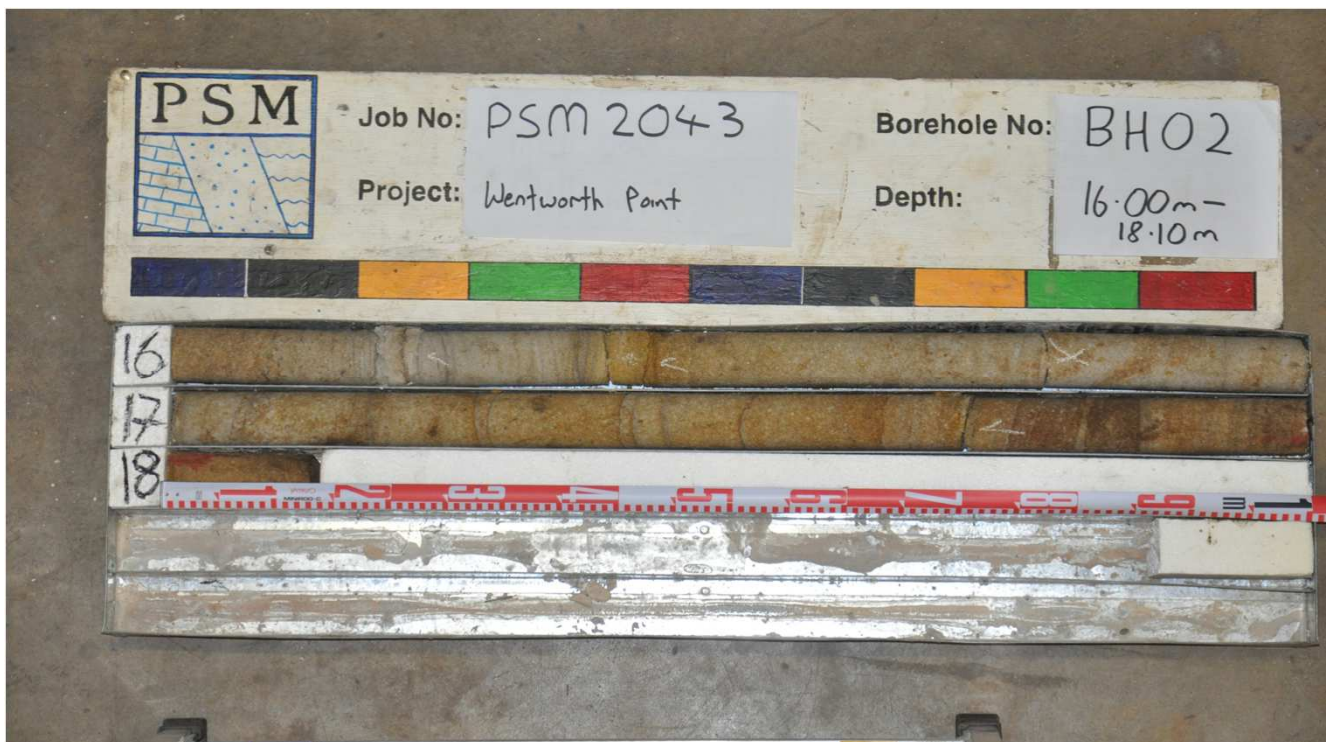
Ionic Management Pty Ltd  
 LOT 1, DP 859608 Burroway Road  
 Homebush Bay, NSW  
 GEOTECHNICAL INVESTIGATION  
 CORE PHOTOGRAPHS
