Phase 2 Environmental Site Assessment

Fifteenth Avenue Business Hub, West Hoxton NSW

Prepared for Western Sydney Parkland Trust
23 May 2016

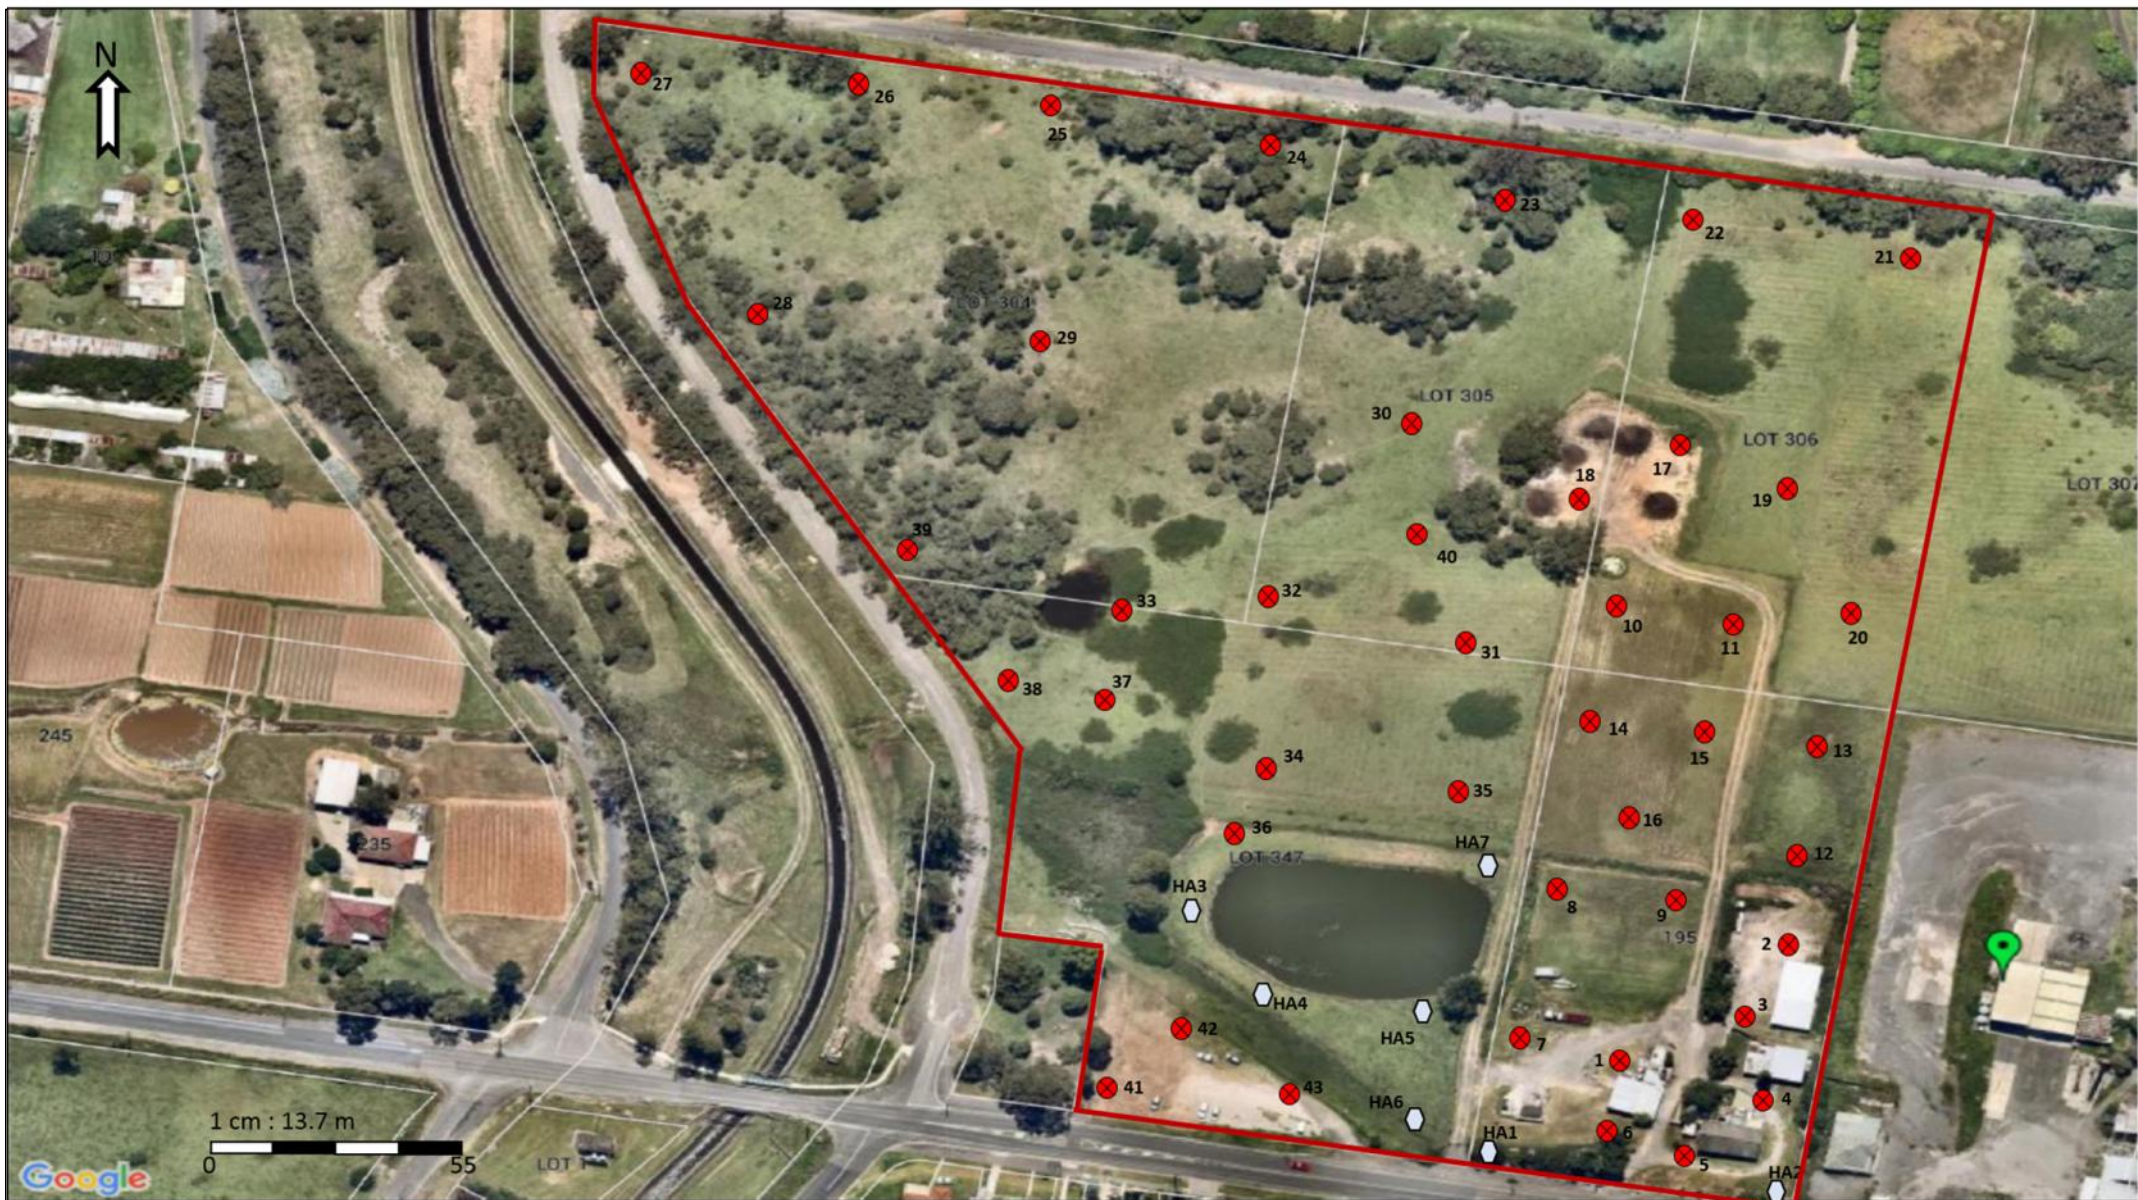
Detailed Site Investigation,
195 Fifteenth Avenue, West Hoxton, NSW

- ✕ Test pits
- Hand auger

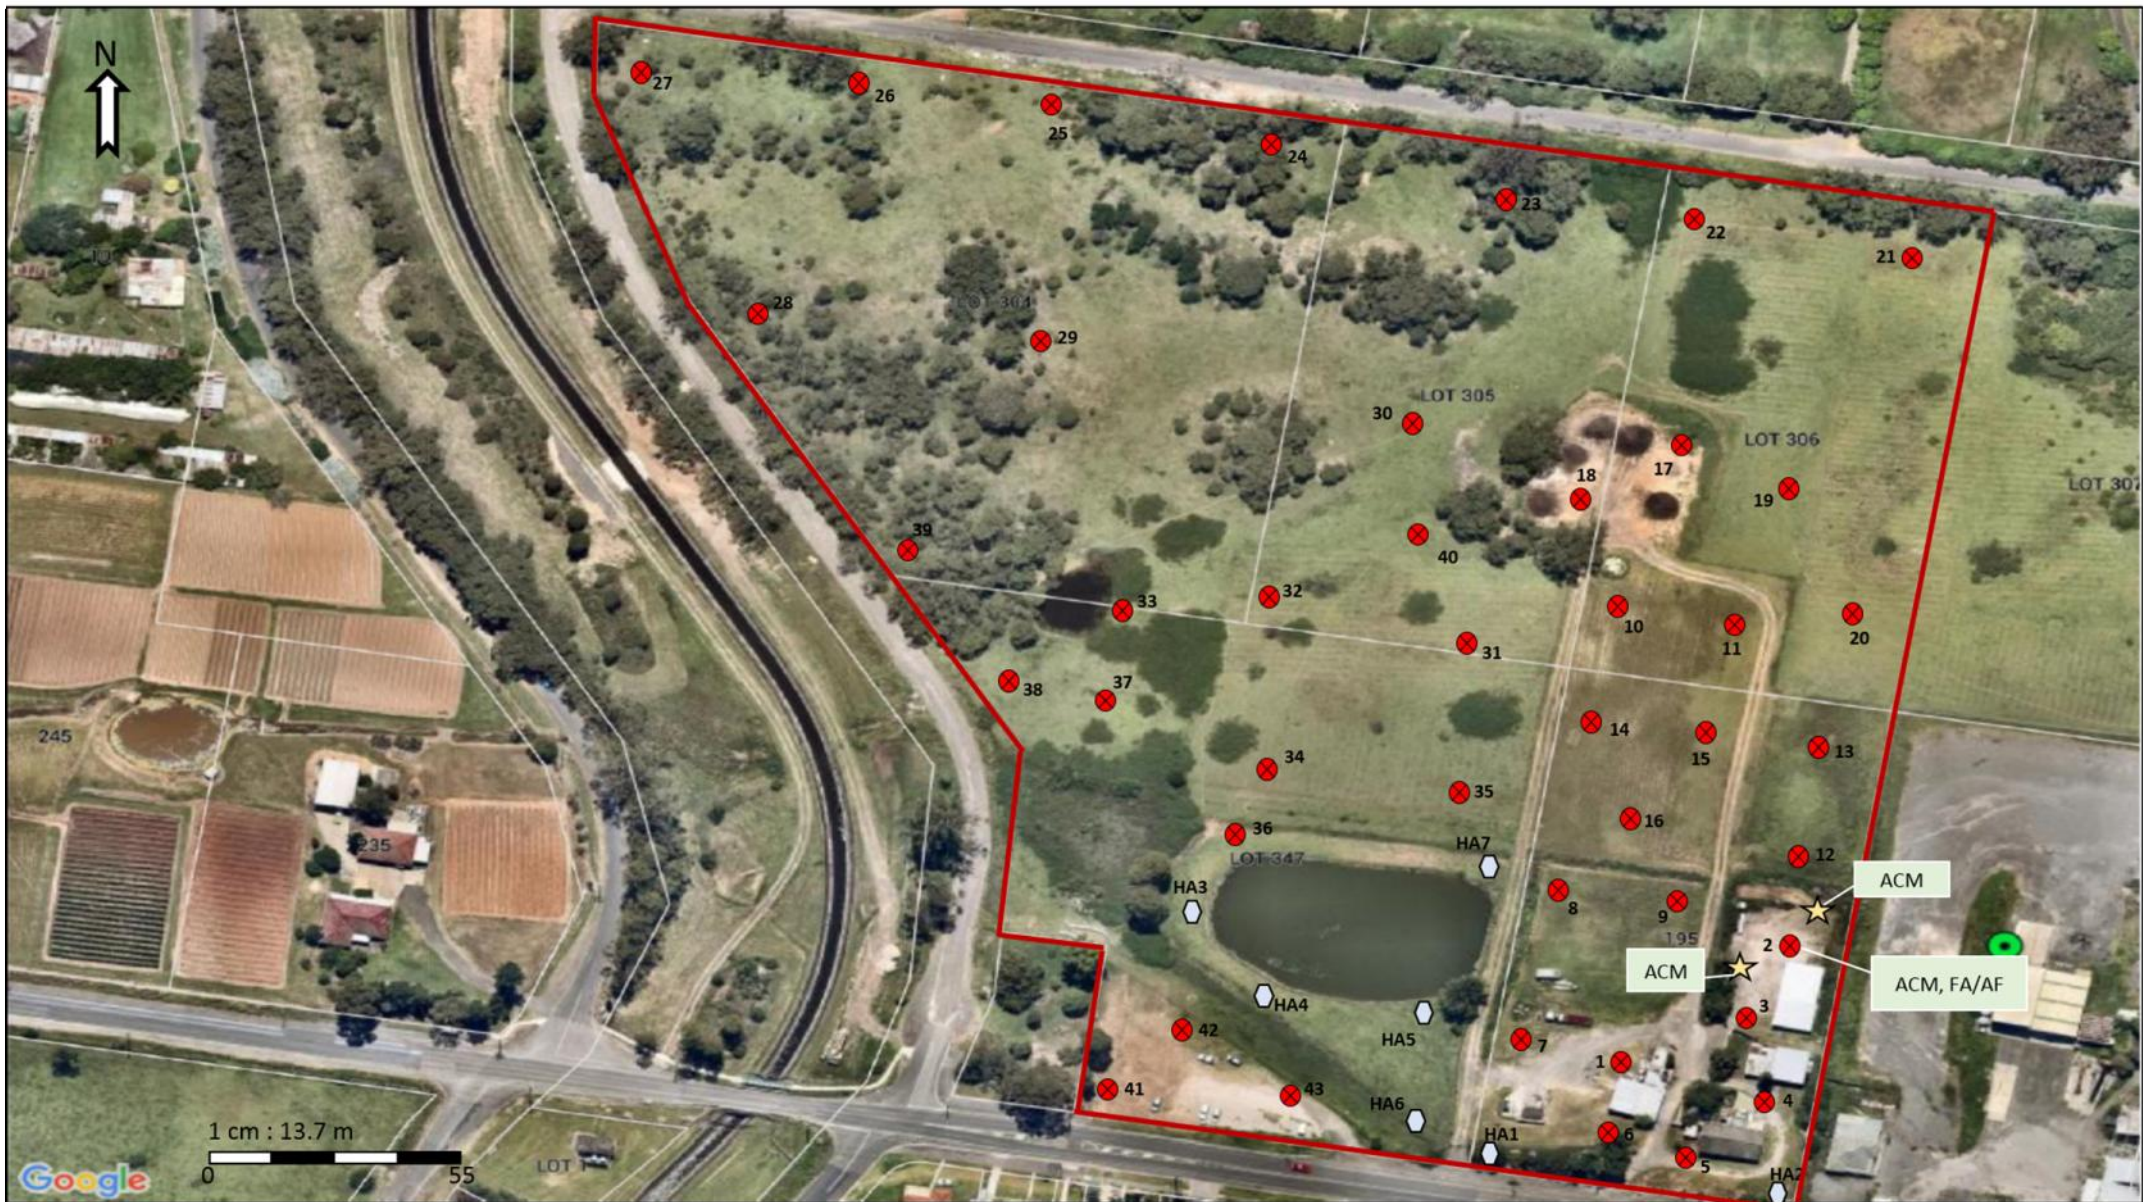
FIGURE 3
Areas Requiring Remediation
Detailed Site Investigation,
195 Fifteenth Avenue, West Hoxton, NSW

- Asbestos (ACM, FA/AF) were identified in TP2 near one of the sheds in the south-eastern portion of the site. Based on the previous Golders (2015) Phase 1 ESA, this portion of the site was previously found to contain two confirmed ACM fragments.
- Localised dumped household waste and rubbish identified along the northern boundary with Flynn Avenue and to a lesser extent along the north-western boundary with Twenty-Seventh Avenue are aesthetically unsuitable.

- A hazardous materials survey should be completed on the residential house and sheds in accordance with the requirements of Australian Standard AS 2601. Asbestos should be removed in accordance with Code of Practice: How to Safely Remove Asbestos (SWA 2011) and relevant WorkCover NSW guidance. A clearance certificate must be issued by a competent person prior to commencement of demolition works.

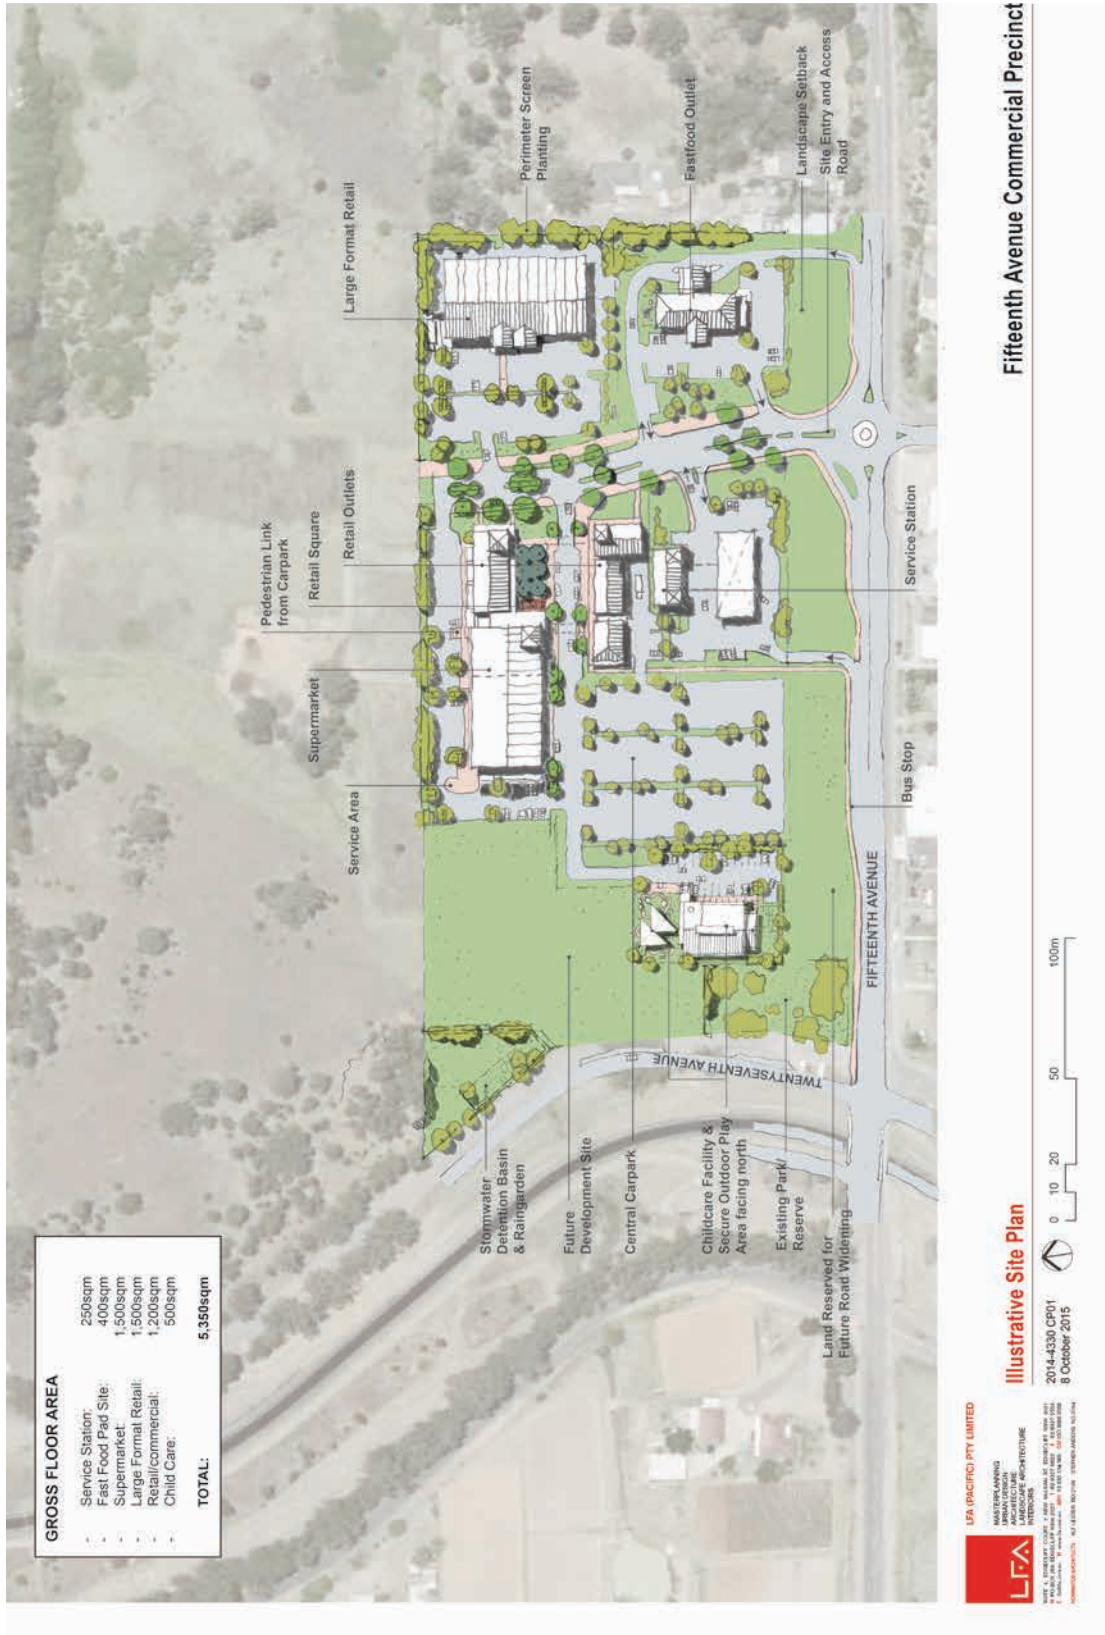
FIGURE 10: Indicative Site Layout Plan

It is understood that the development of FABH will include a supermarket, retail outlets, large format retail, fast food outlet, service station, central carpark and childcare facility in addition to internal roads and landscaped areas.
