# Remediation Action Plan

185 – 195 Fifteenth Avenue, West Hoxton, NSW

Prepared for Western Sydney Parkland Trust  
July 2016

Project No.16058

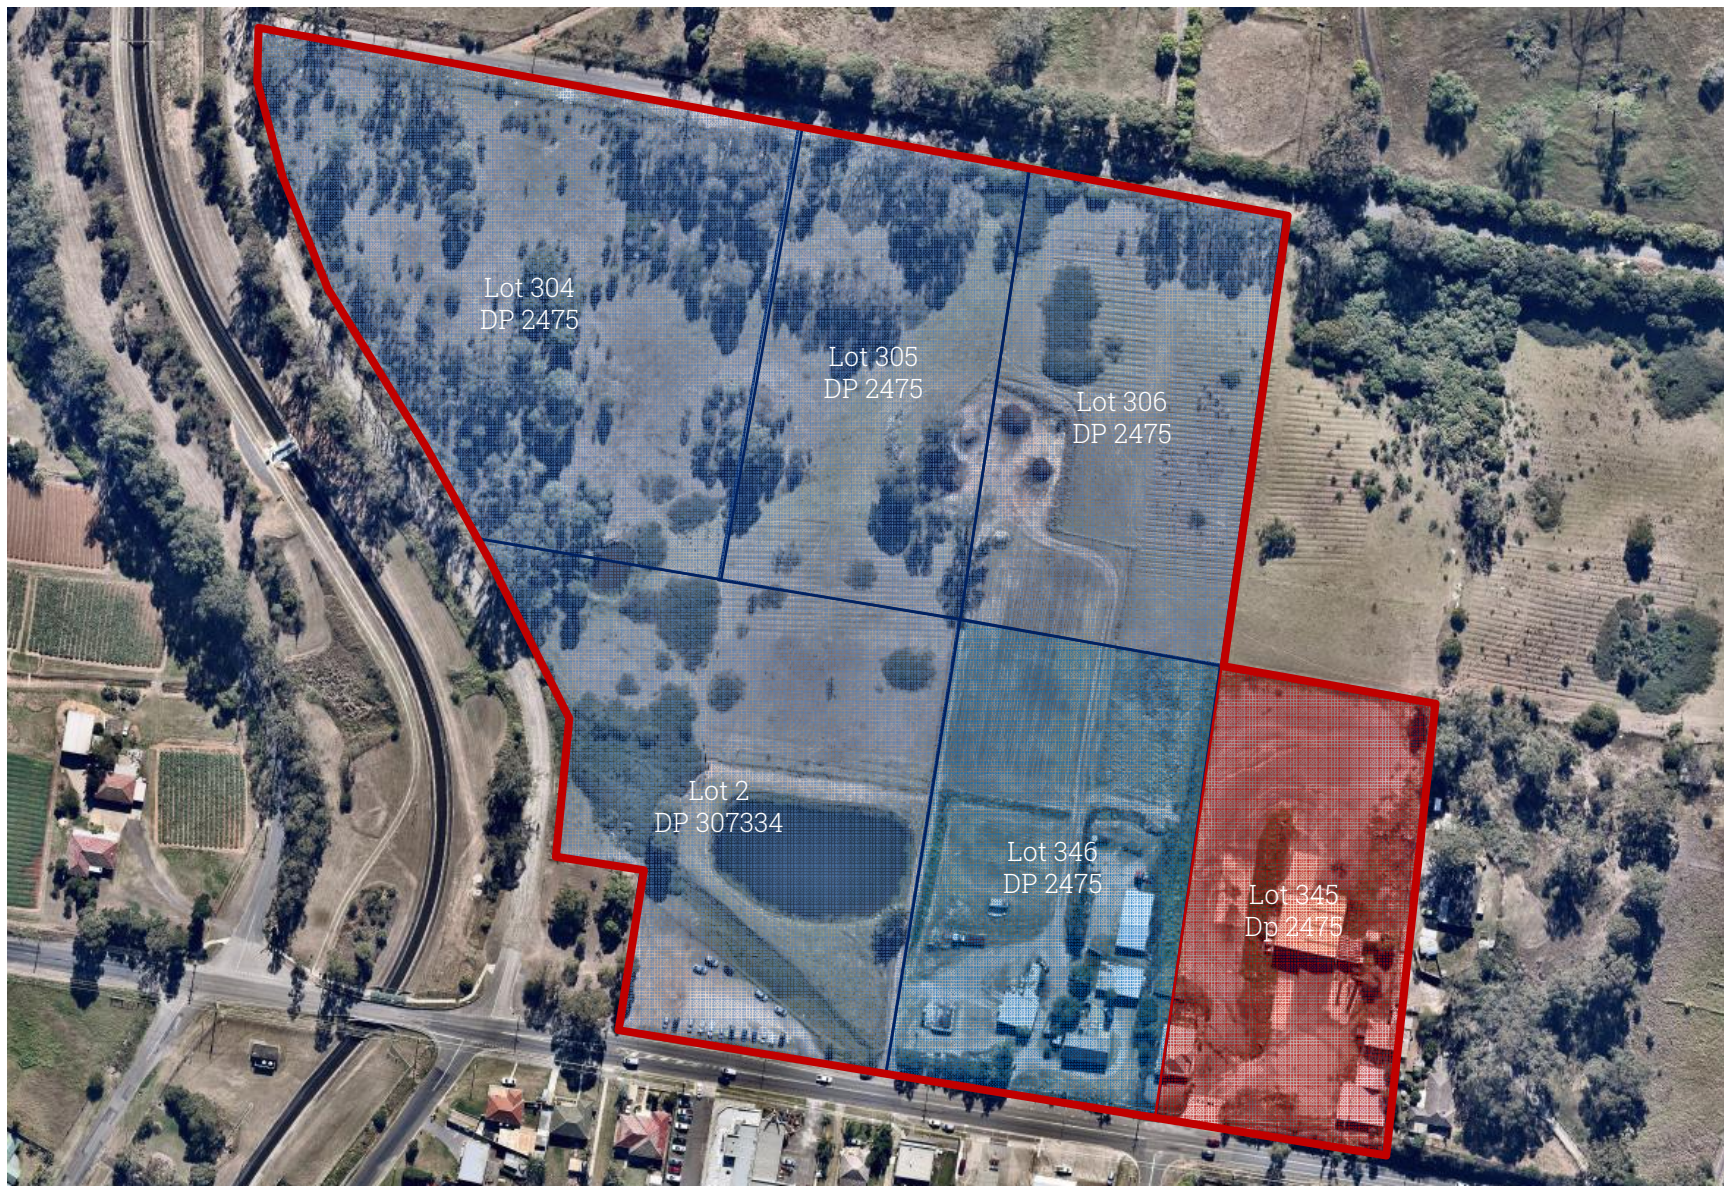
**FIGURE 2**  
 Site Layout Plan  
 Remediation Action Plan  
 185-195 Fifteenth Avenue, West Hoxton NSW

- Site Boundary
- Zoic 2016 Area (195 Fifteenth Ave)
- DP 2015 Area (185 Fifteenth Ave)

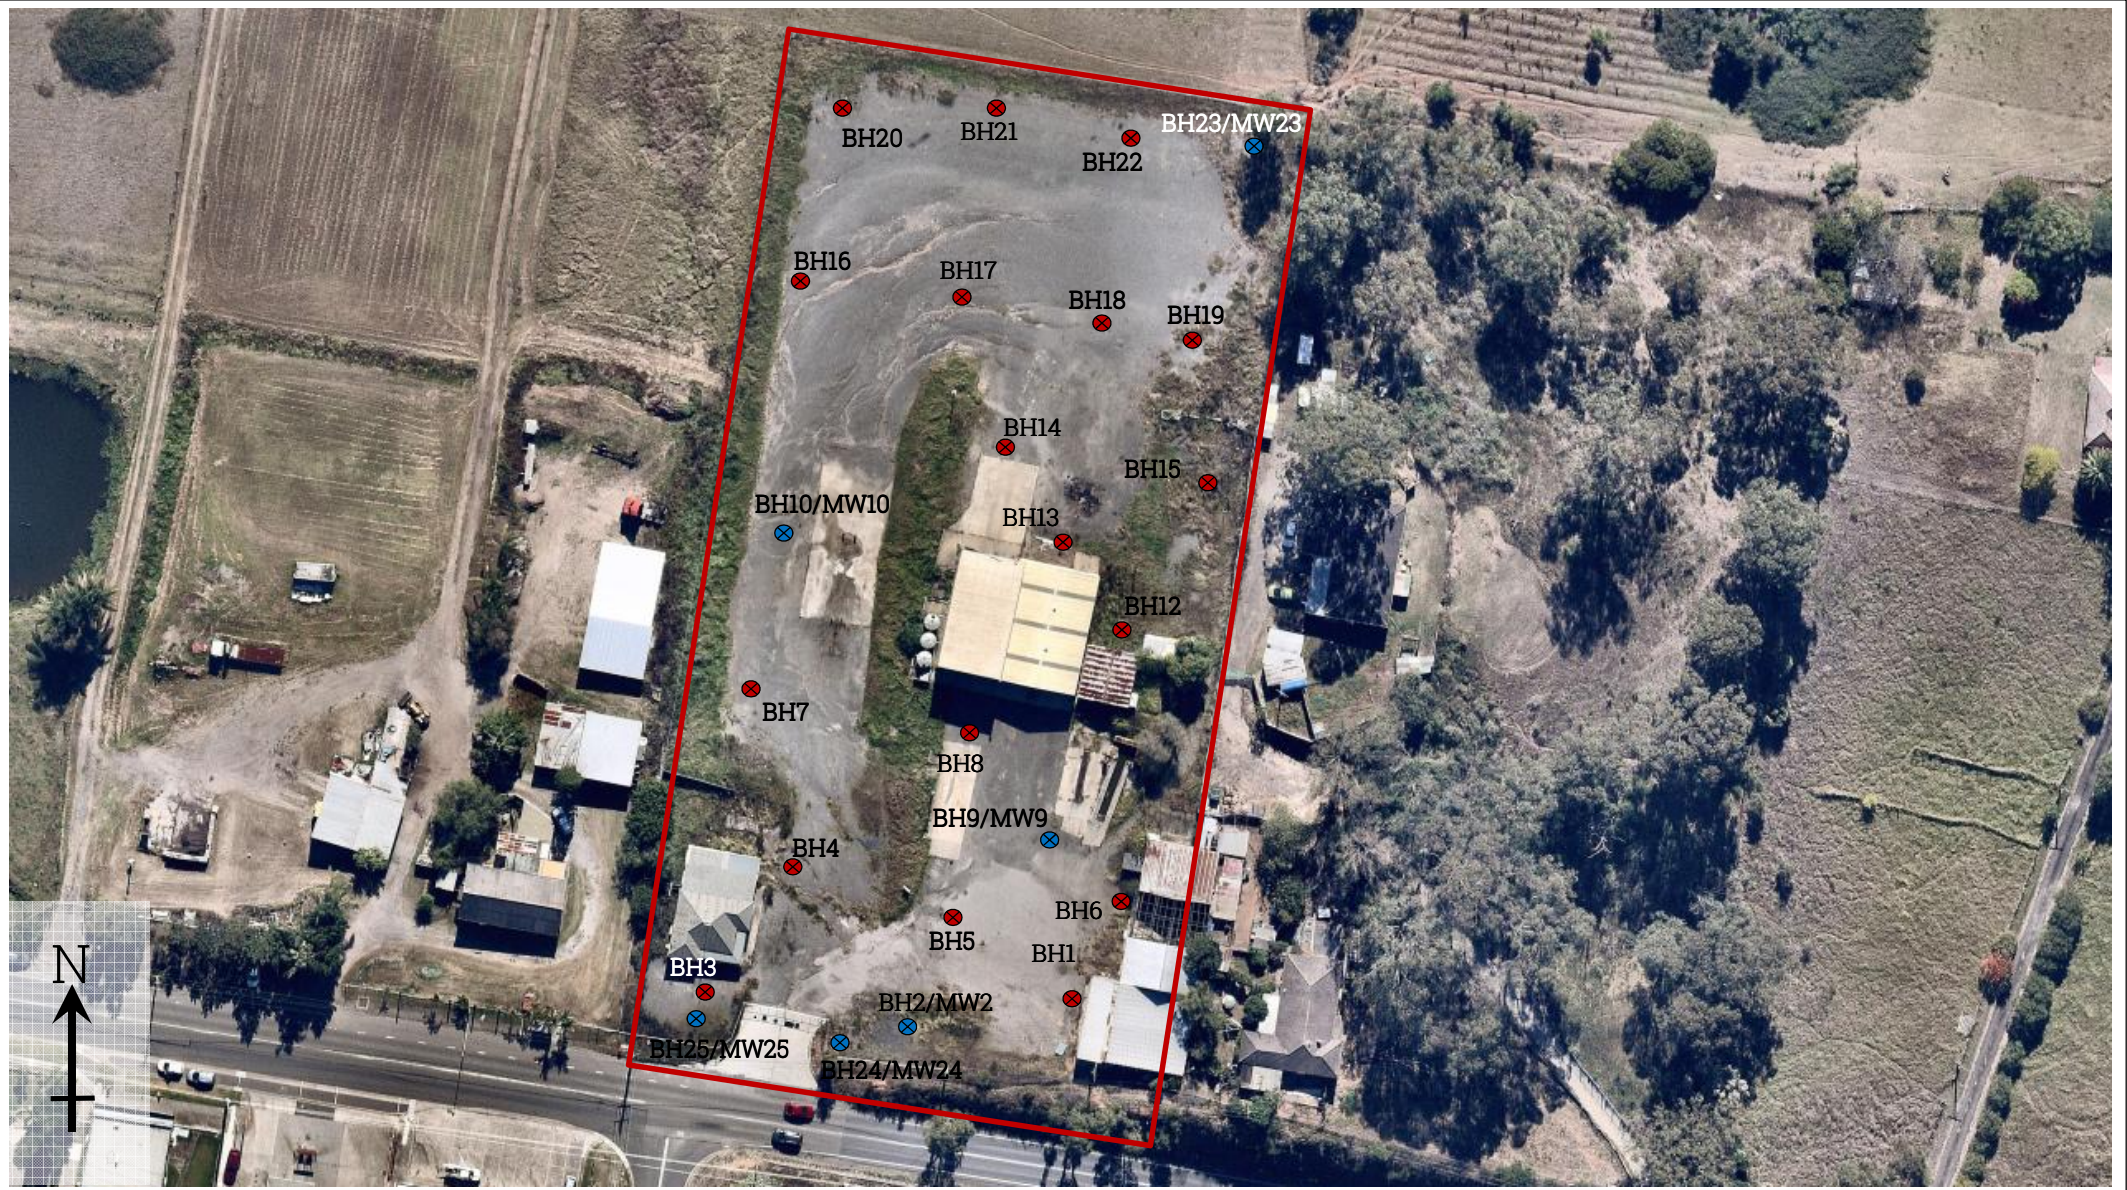
DP 2015 Investigation Locations  
 Remediation Action Plan  
 185-195 Fifteenth Avenue, West Hoxton NSW

- DP 2015 Investigation Area
- ⊗ Borehole
- ⊗ Groundwater Monitoring Well

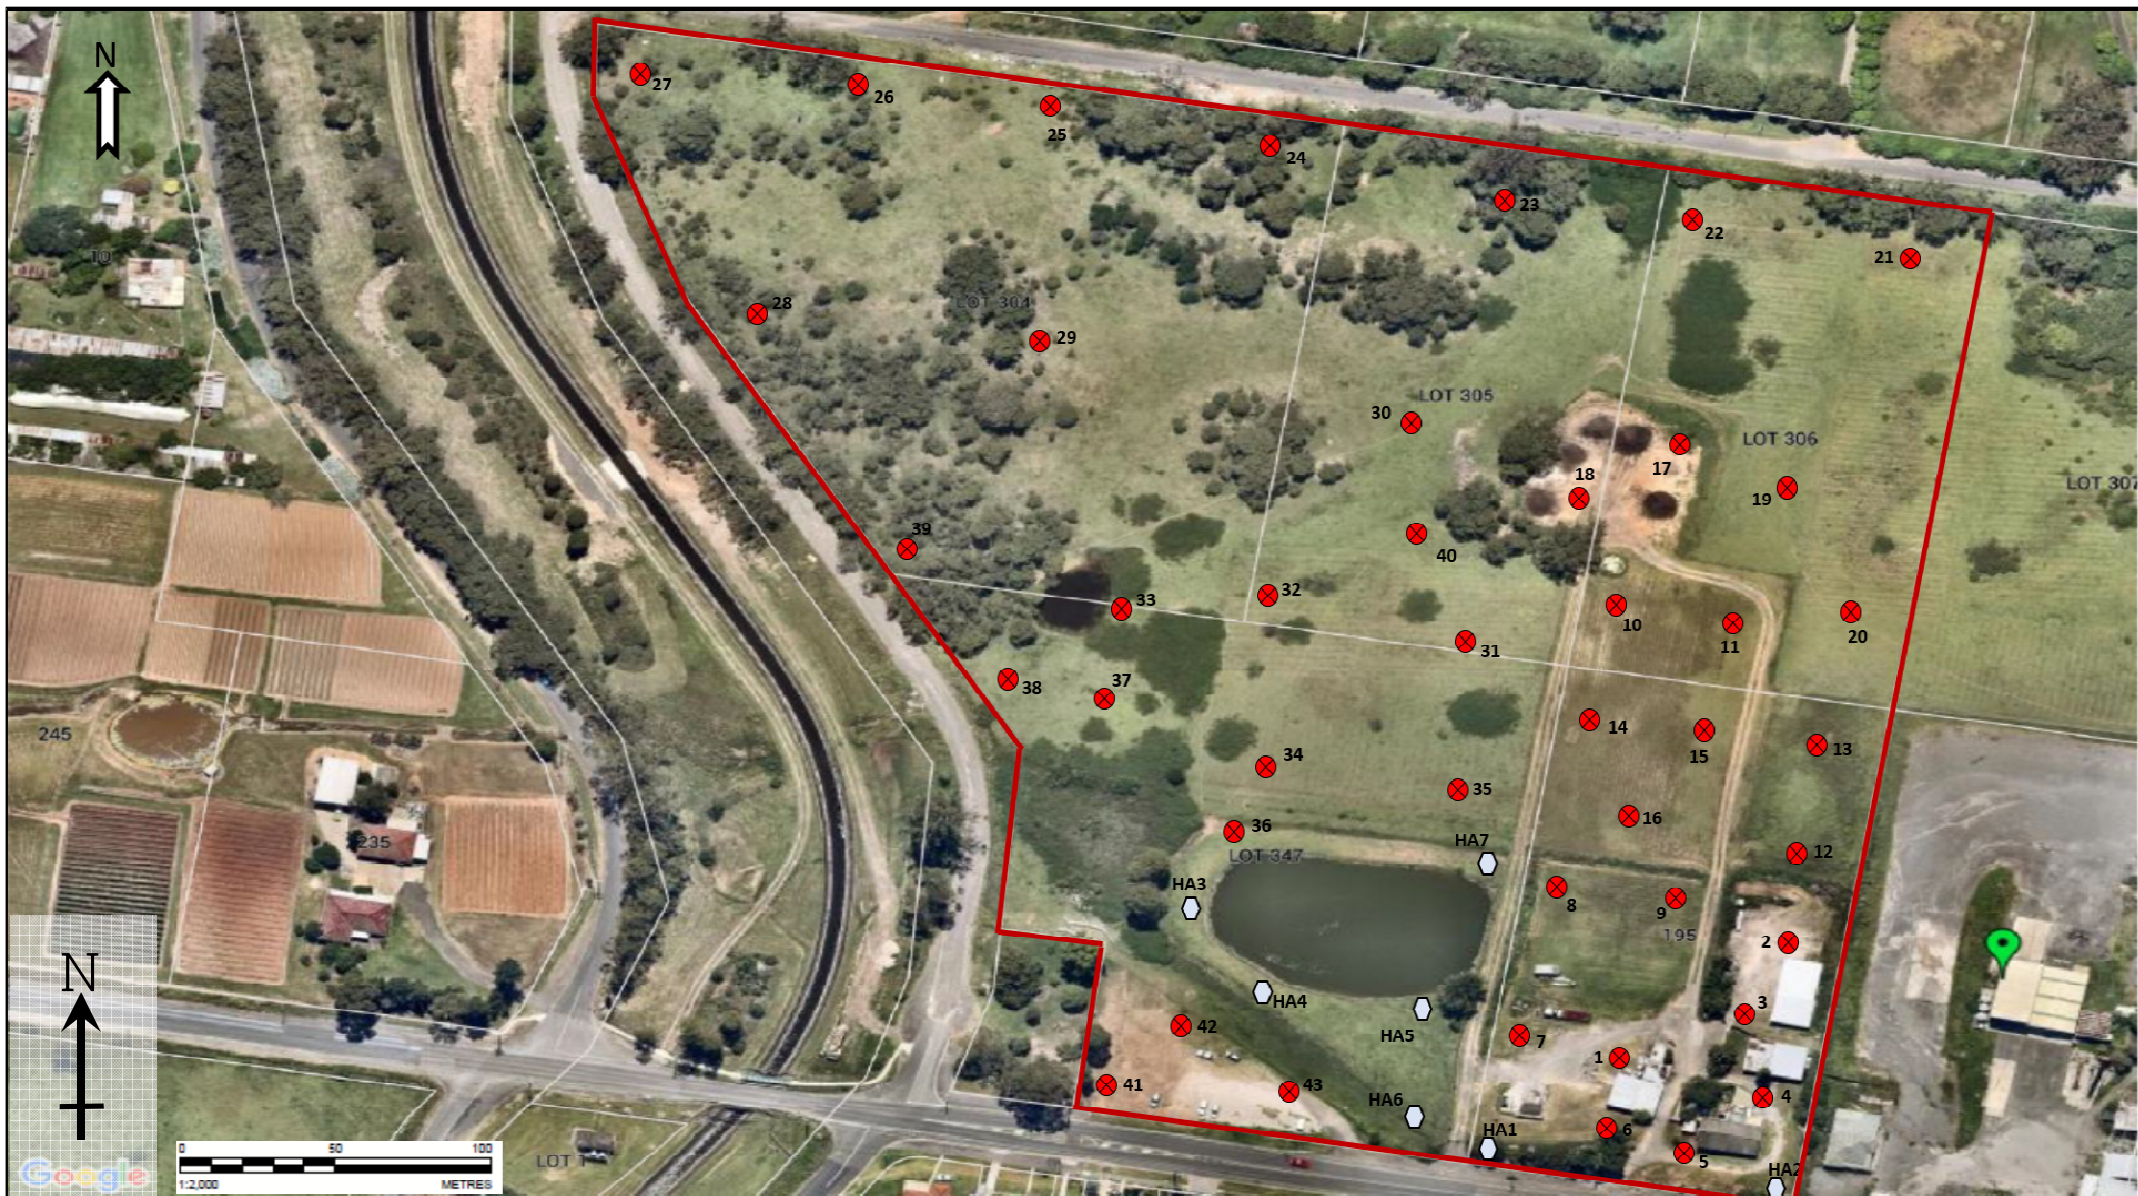
- ✕ Test pits
- Hand auger

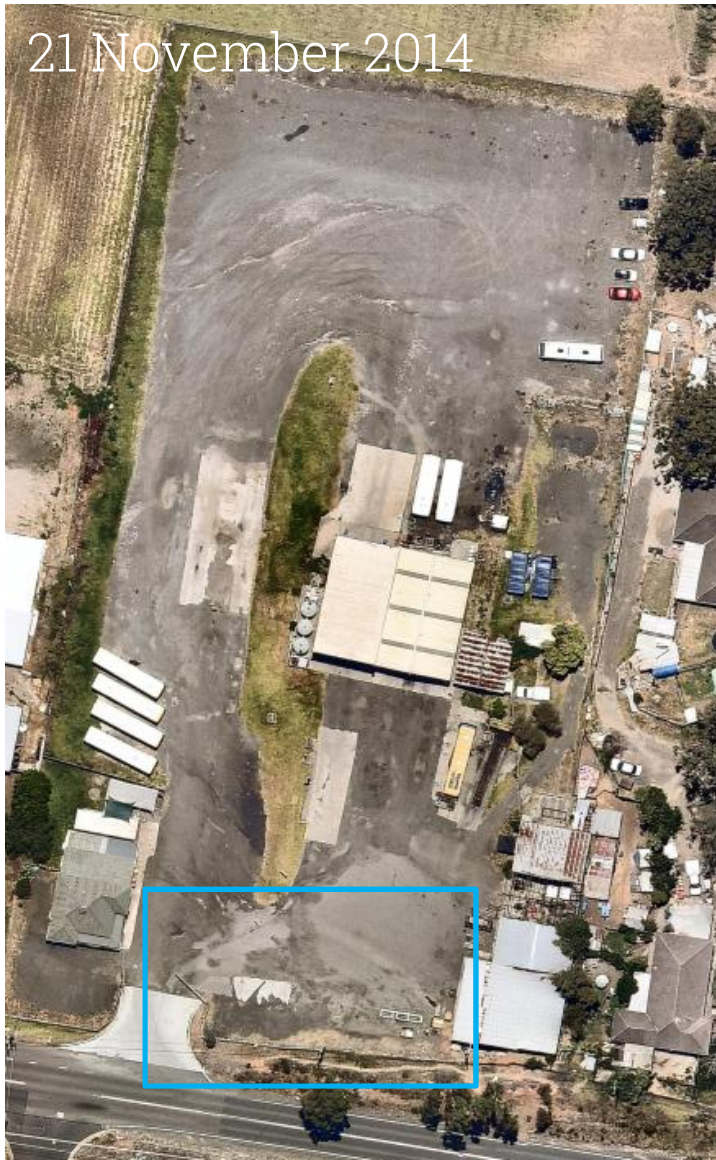
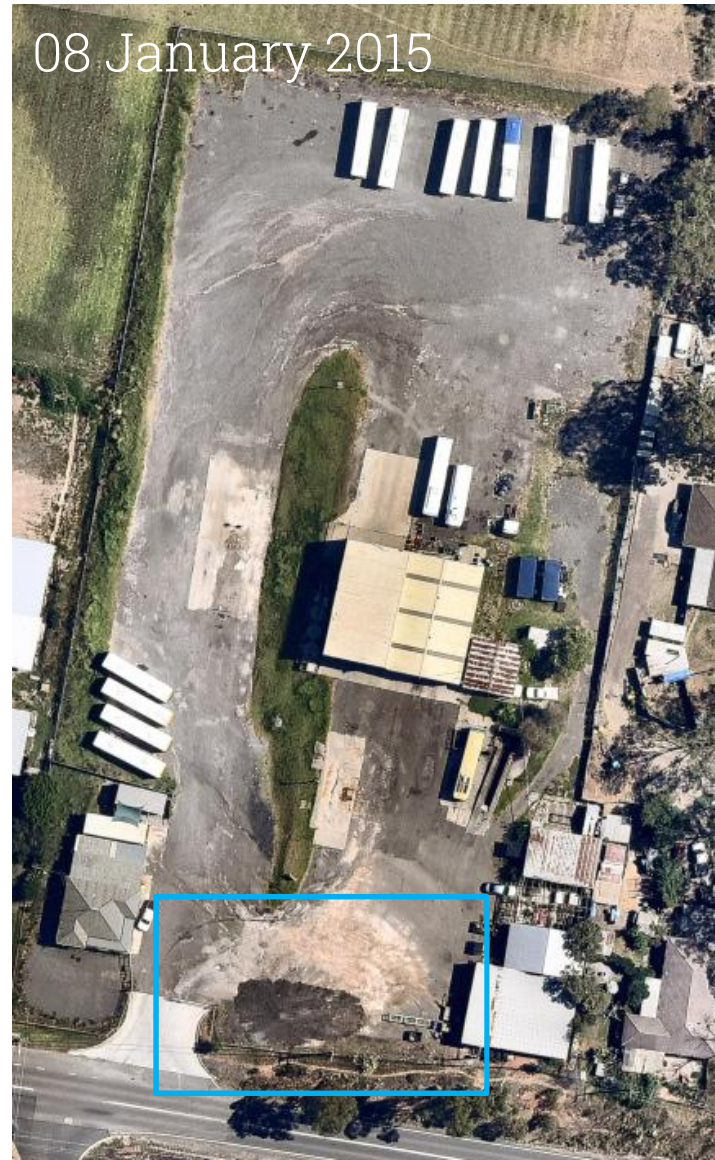
**FIGURE 5**  
Indicative Tank Removal Satellite Imagery  
Remediation Action Plan  
185-195 Fifteenth Avenue, West Hoxton NSW

— Tank Removal Area

- There were two 45 kL diesel ASTs (One located behind the main workshop while the other was located on a concrete pad on the western portion of Lot 345 directly west of the wash bay). Minor hydrocarbon staining was observed around the AST located north of the workshop, with water pooled on the concrete pad making observations of staining impossible. Of note, the AST on the concrete pad was removed offsite before the start of fieldwork.

Zoic note that at the time of the fieldworks for 195 Fifteenth Avenue (3 May 2016), the bus depot at 185 Fifteenth Avenue was no longer operational and was boarded up and locked. Zoic noted that the ASTs observed by DP had been removed and there were no buses/shipping containers present on Lot 345.

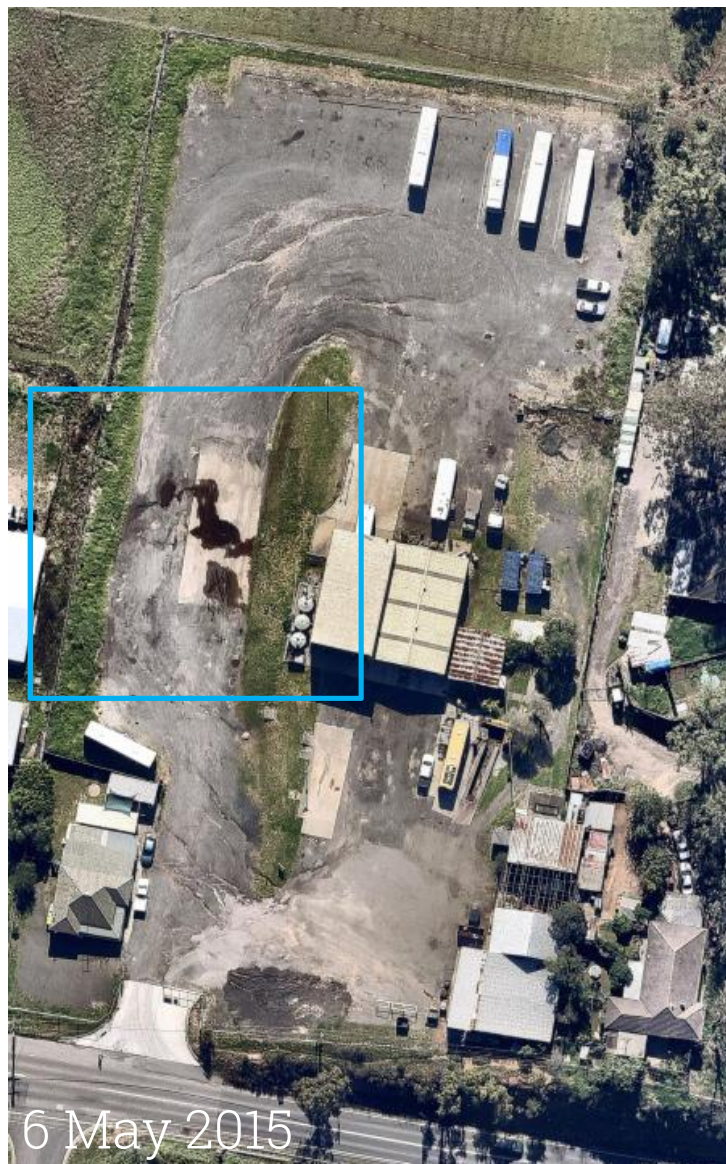
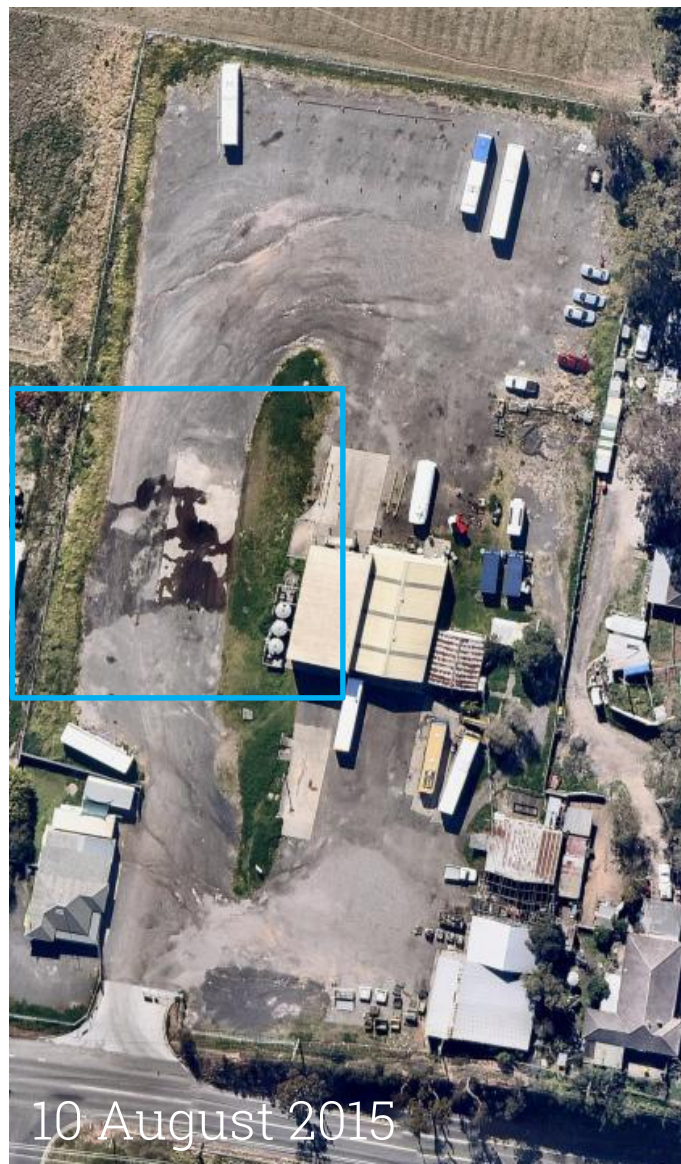
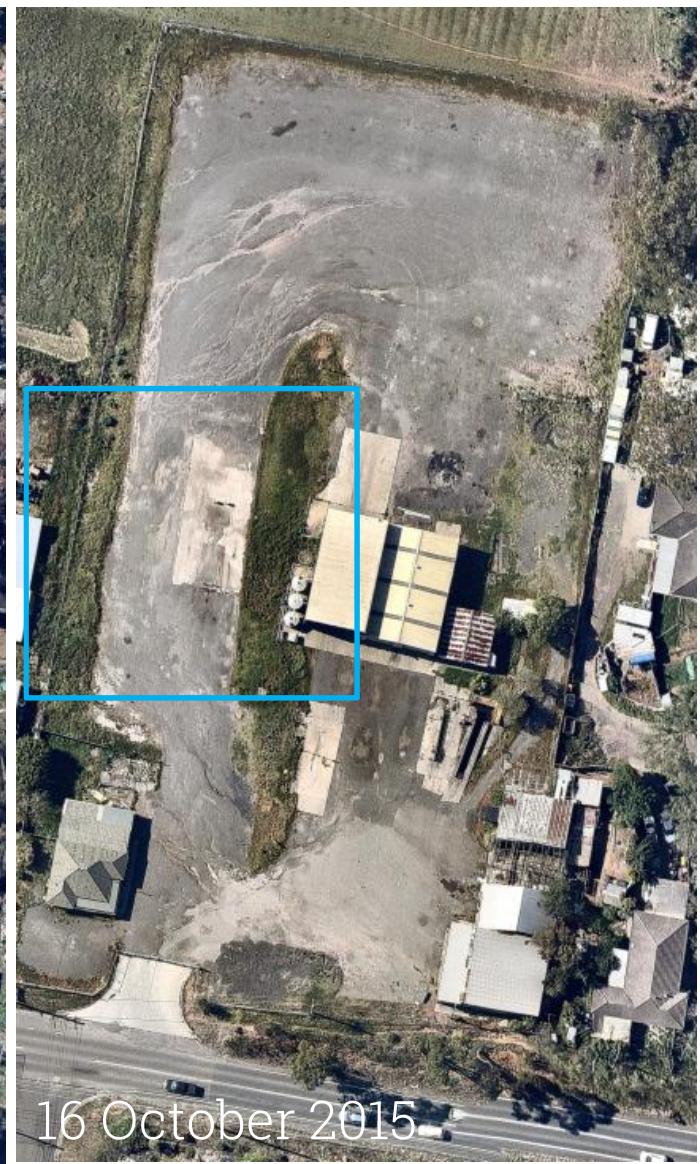
Remediation Action Plan  
 185-195 Fifteenth Avenue, West Hoxton NSW

— Potential Spill Area

Potential asbestos in near-surface soils of Lot 345	<p><b>Human:</b></p> <ul style="list-style-type: none"> <li>• Current residents</li> <li>• Future onsite construction / maintenance works (intrusive works)</li> <li>• Future site users</li> <li>• Adjoining occupants</li> </ul> <p><b>Ecological:</b> none</p>	<ul style="list-style-type: none"> <li>• Inhalation of fibres</li> <li>• Aesthetics</li> </ul>	Identified data gap - it is recommended that confirmatory asbestos sampling be completed in accordance with current NEPM 2013 and WA DOH (2009) guidelines.
Potential surface spill in	<b>Human:</b> Onsite construction workers/ maintenance workers.	Human: dermal or oral contact to potentially impacted soil.	Identified data gap – sampling recommended across potential spill area.

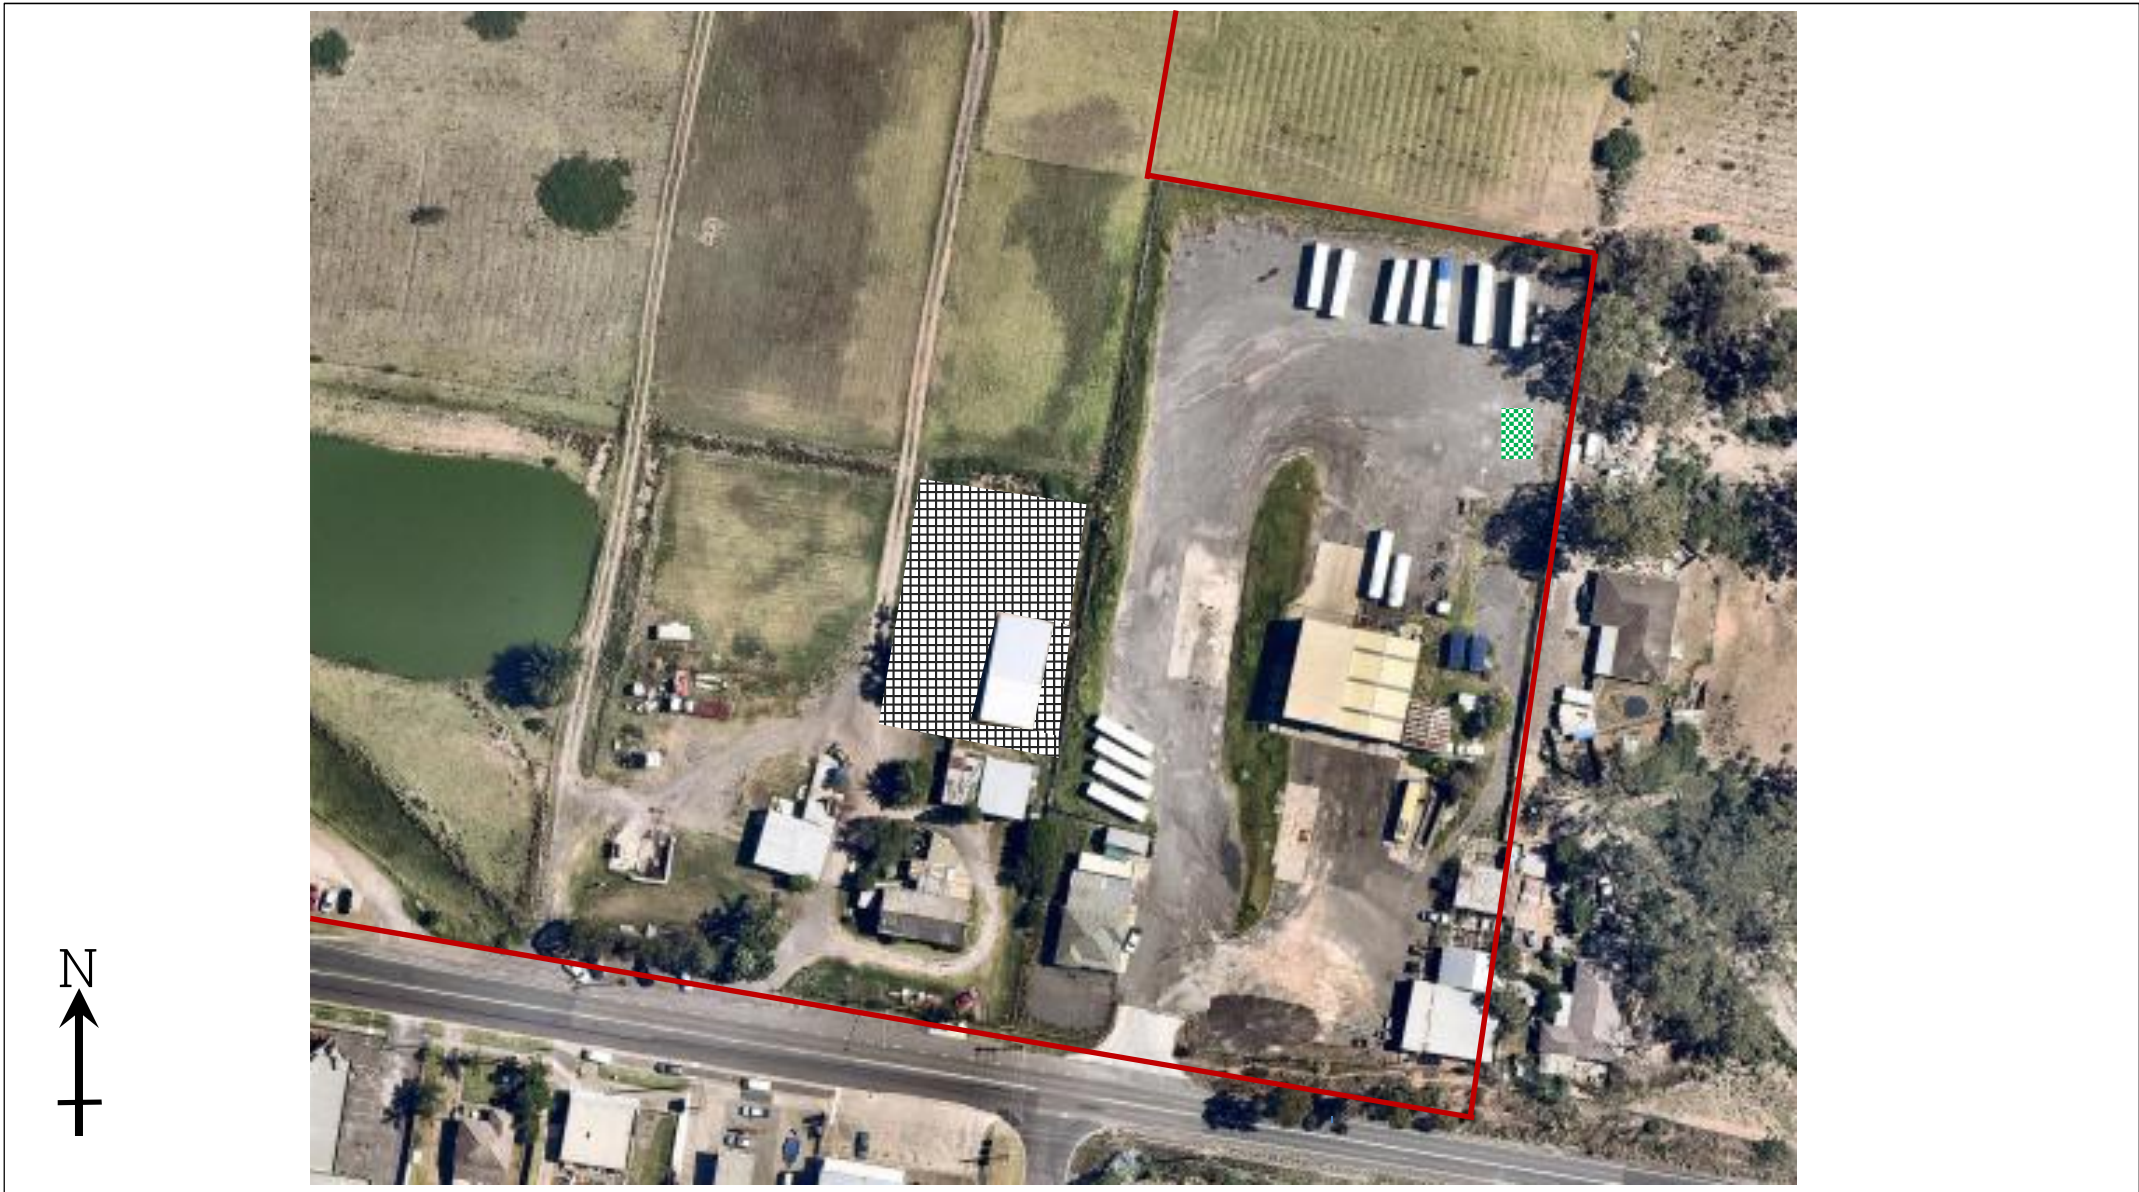
**FIGURE 7**  
**Remediation Areas**  
 Remediation Action Plan  
 185-195 Fifteenth Avenue, West Hoxton NSW

- ▣ Area 1 (ACM/FA/AF)
- ▣ Area 2 – only if in landscaping area (EIL BaP)

- **Area 1:** associated with near-surface asbestos ACM fragments identified by Golder and ACM/FA/AF identified by Zoic (TP2/0.1-0.2) in the south-eastern portion of Lot 346 estimated total volume 180m<sup>3</sup>
- **Potential Remediation at Area 2:** associated with BHI9 (DP, July 2015) which had BaP above adopted commercial EIL criteria. Remedial works only considered to be required if landscaping is proposed in this area as this fill may not be suitable for growing media.

The preferred remedial options, as evaluated in the RAP, is for excavation and offsite disposal to licenced landfill facility for Area 1; and if remediation of Area 2 is required, then these soils are suitable to be relocated beneath proposed buildings or roadways.

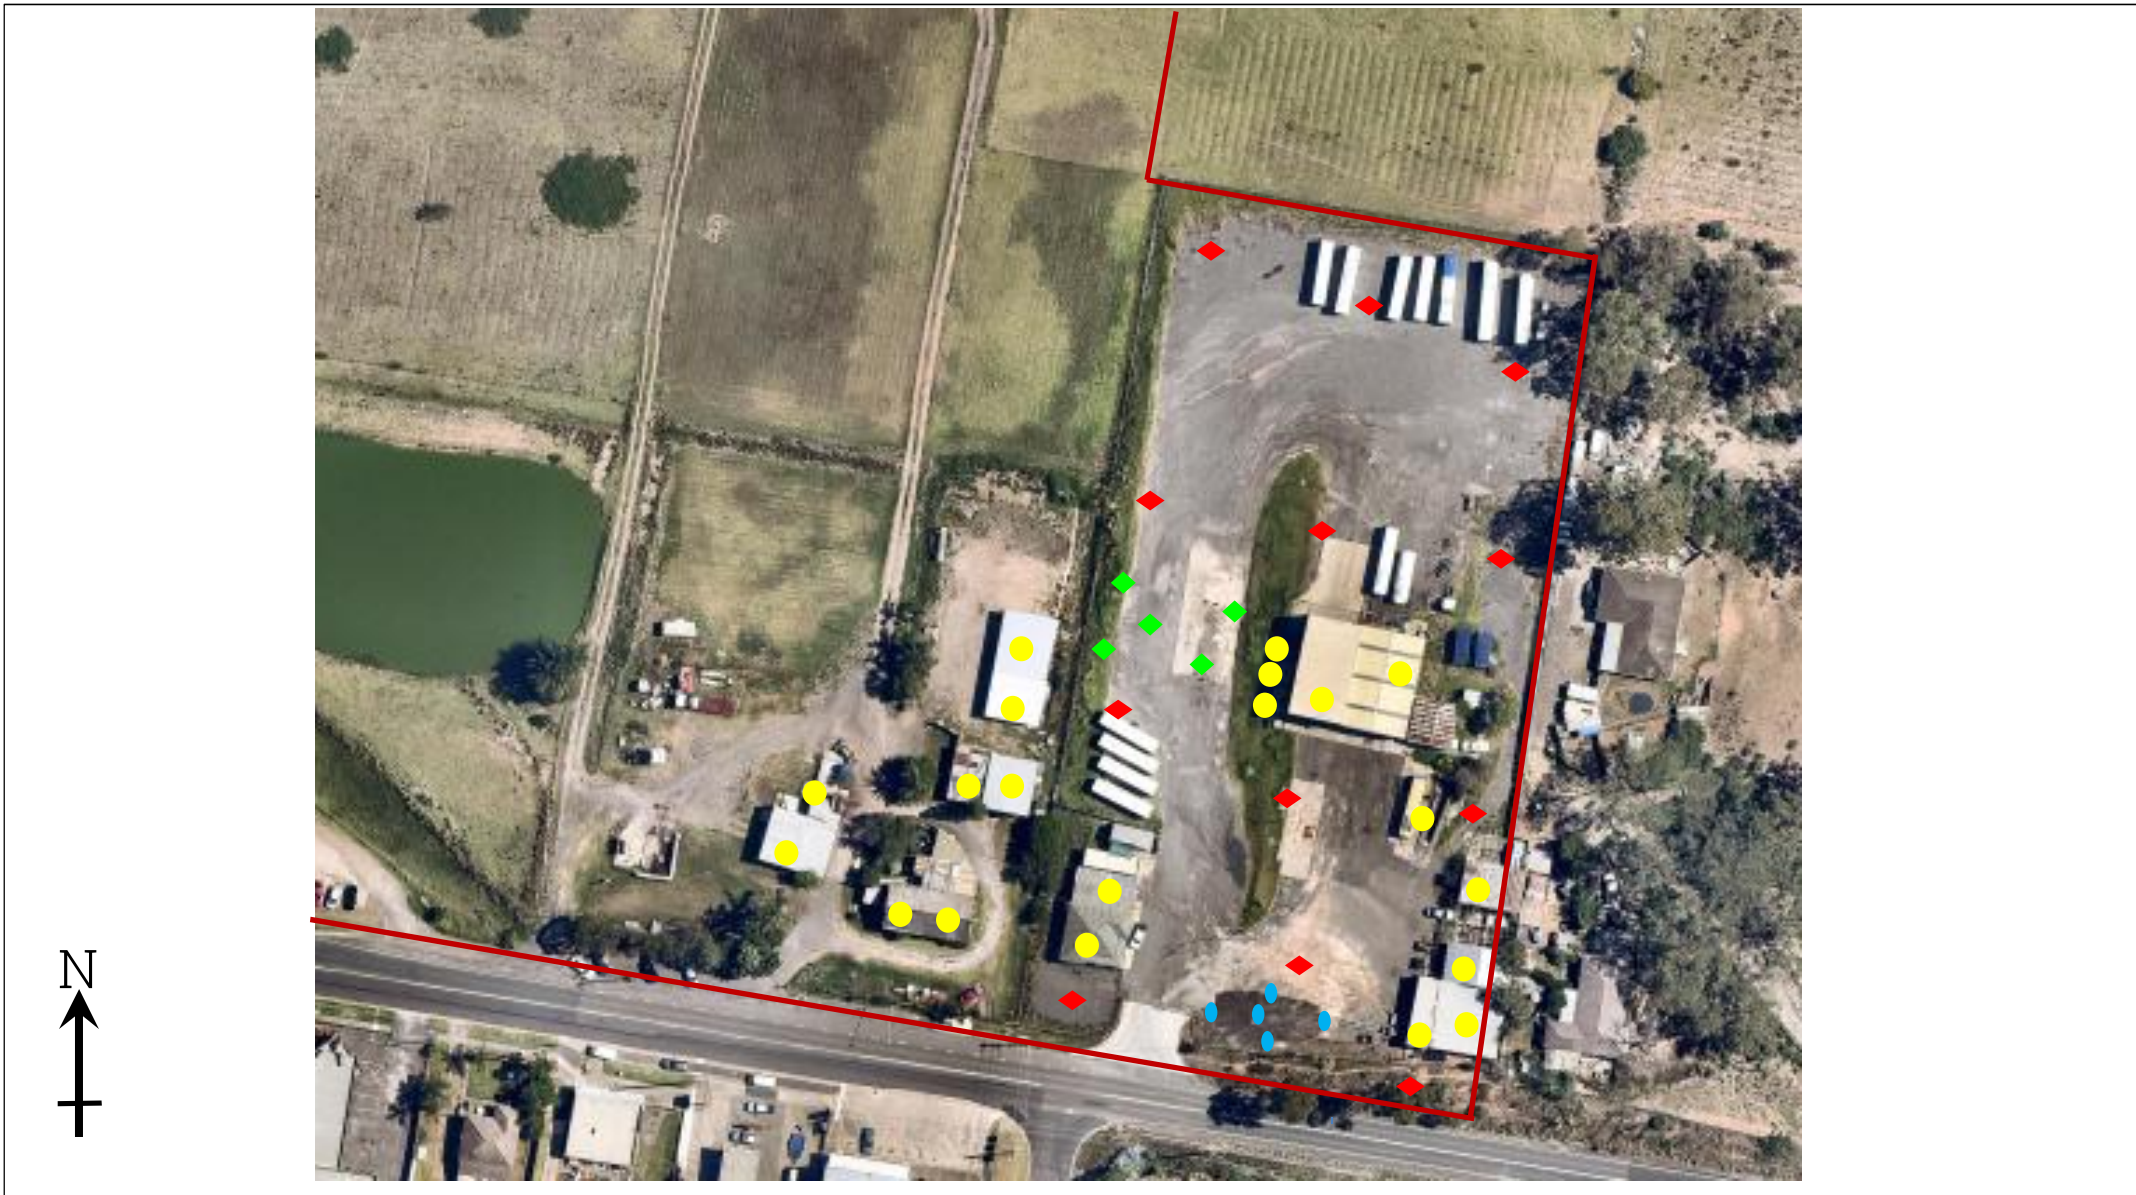
- Data Gap 1 (buildings/ structures)
- Data Gap 2 (former UST validation)
- ◆ Data Gap 3 (Asbestos sampling)
- ◆ Data Gap 4 (potential spill area)

- **Data Gap 1:** Confirmatory sampling beneath buildings and structures (once removed).
- **Data Gap 2:** Validation of the former UST area.
- **Data Gap 3:** Confirmatory asbestos sampling in accordance with NEPM 2013 requirements of near-surface soils across the former bus depot portion of the site
- **Data Gap 4:** Confirmatory sampling potential surface spill area in the central-western portion of the bus depot.

- **Data Gap 3: Asbestos Analysis (Lot 345):** Sampling for asbestos completed across Lot 345 included 37 analysis of 40g samples. Although no asbestos was identified, given that the sampling and analysis was not in accordance with NEPM 2013 or WA (2009) DoH guidance, some confirmatory asbestos should be carried out. Zoic recommends 12 grid-based testpits across the former bus depot with appropriate 500g samples analysed in accordance with NEPM 2013 from surface and/or near surface fill.
